# Building and Timber Pest Inspection Report

Inspection Date: Tue, 24 Mar 2026

Property Address: 44 Grandview Terrace, East Albury NSW  
2640, Australia

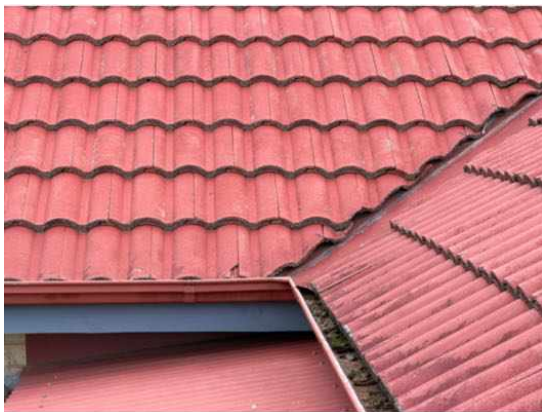
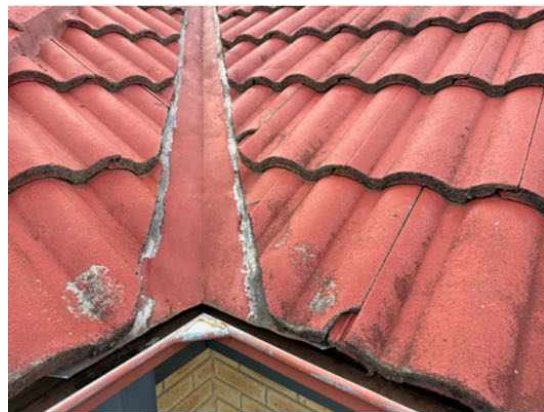
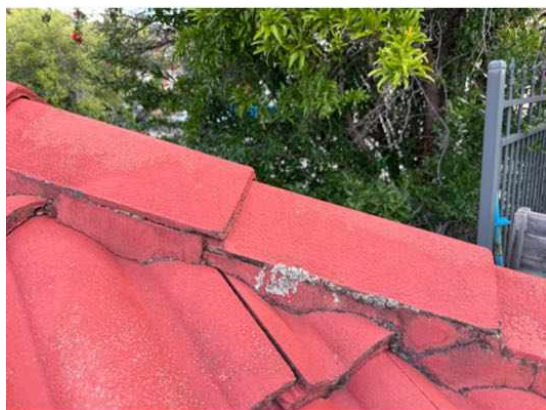
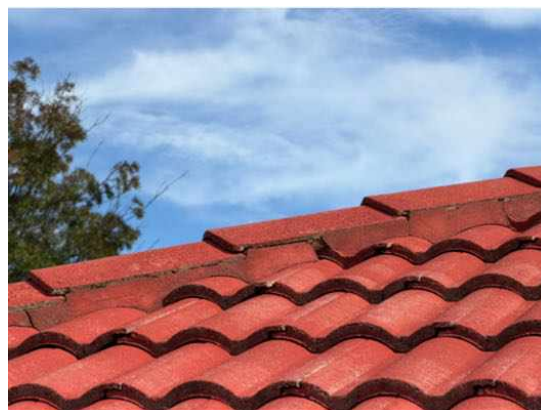
#### Finding 3.01

Building: Main Building  
Location: Roof Exterior  
Finding: Roof Exterior - Cracking, Weathered  
Information: Areas of chipped roof tiles and cracking in the tile pointing were identified to the roof exterior. While weathering of the tiles is consistent with the age of the property, maintenance works are advised.

Where left unmanaged, deteriorating and damaged roof tiles are likely to lead to secondary defects, including water leaks.

Weathering and cracked roof tiles were identified to the roof exterior. A licensed roofing contractor should be engaged to assess and carry out necessary maintenance in the short term.

Recommend consulting with a licensed roofing contractor in the short term, to provide further advice on maintenance works needed.

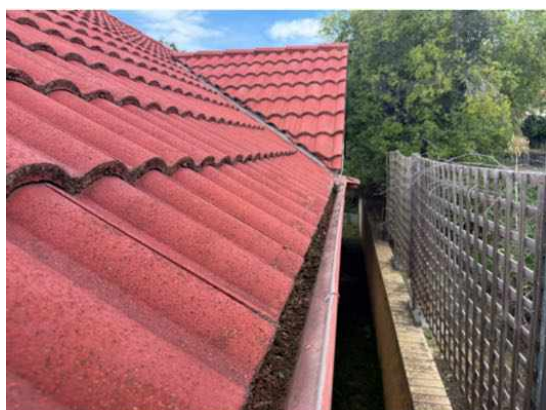
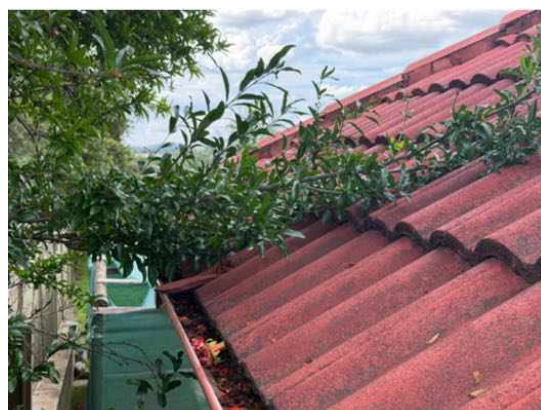
### Finding 3.02

Building:	Main Building
Location:	Guttering
Finding:	Debris in Gutters
Information:	It appears that there is some debris in the gutters. Accumulation of debris can lead to blockages of the gutters & water overflows, if neglected.

Recommend engaging a general handyman to remove all debris from the gutters promptly to prevent overflows & blockages.

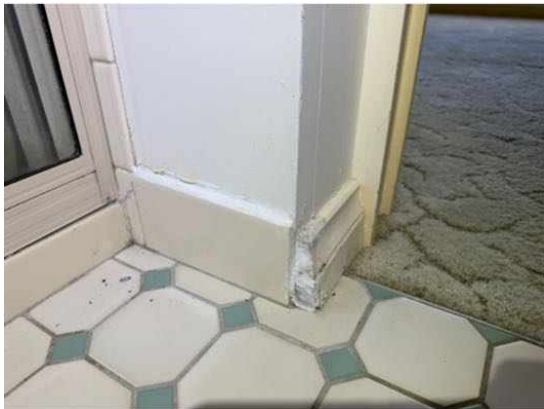
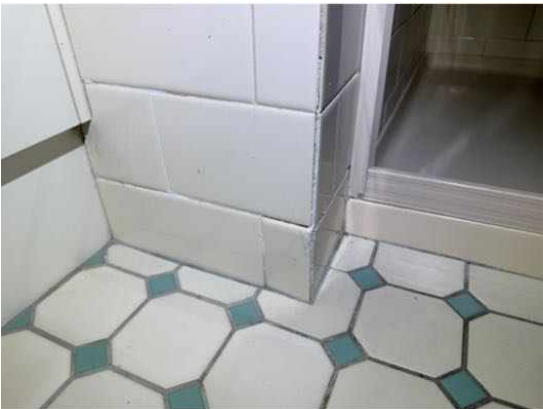
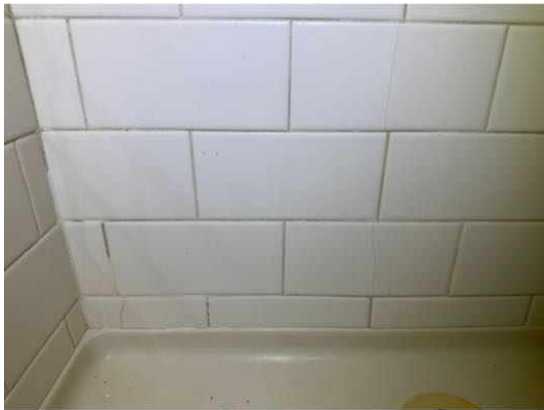
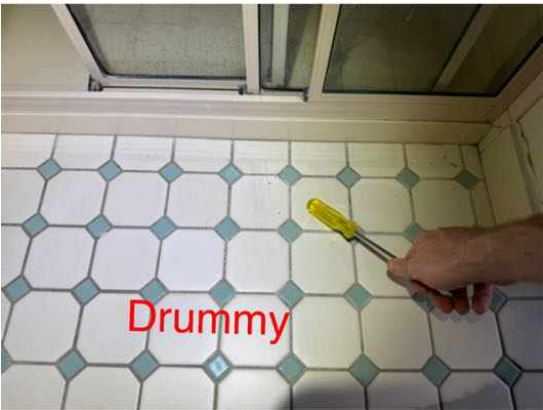
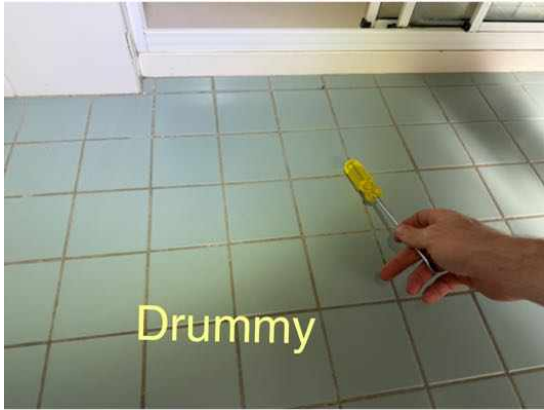
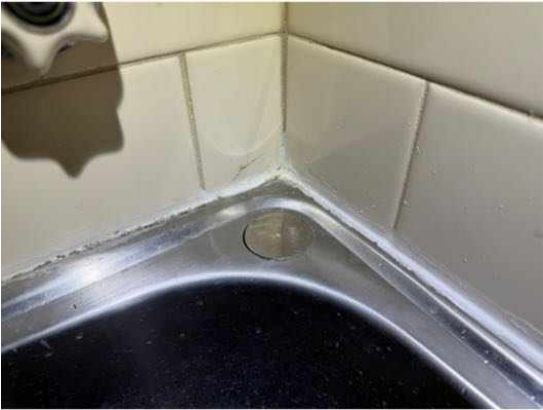
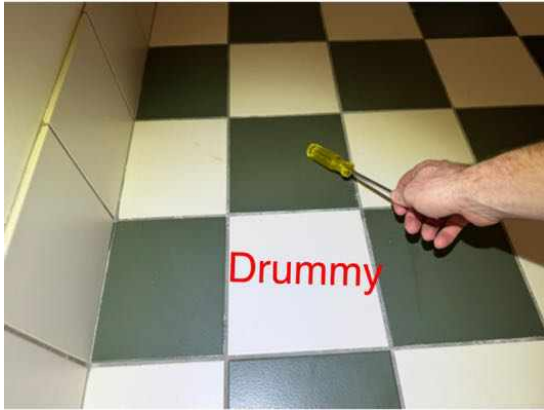
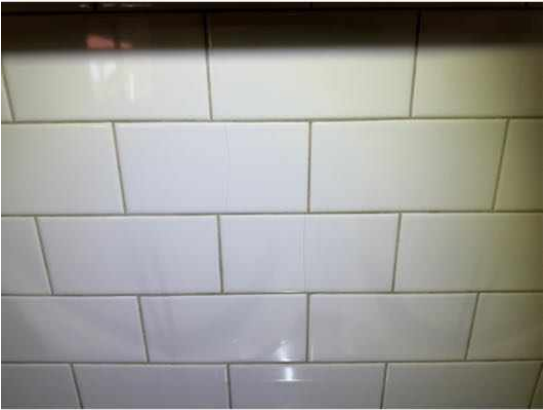
### Finding 3.03

Building:	Main Building
Location:	Tiled Areas
Finding:	Sealant / grouting - deteriorated or missing & Cracked & Drummy Tiles
Information:	It appears that the sealant and grout has deteriorated in some tiled areas, a common defect in buildings of a similar age. Areas of cracked and drummy tiles were also noted, which can allow for moisture ingress behind the tiles, if neglected.

Sealant and grouting in areas that come into regular contact with water should be maintained for the long term care of your property.

Cracked and drummy tiles were identified to tiled areas and showers, with deteriorated sealant and grout noted in sections. Maintenance works are recommended in the short term by a licensed tiling contractor.

Recommend engaging a licensed tiling contractor in the short term, to provide

maintenance works where necessary.

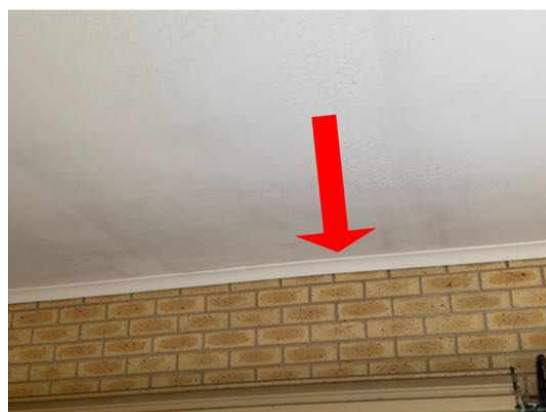
### Finding 3.04

Building:	Main Building
Location:	Garage Ceiling
Finding:	Ceiling - Sagging
Information:	It appears that the garage ceiling was slightly sagging. Causes of ceiling sagging include fixings (e.g. nails or glue) that have become loose and require re-fixing. Recommend that the client monitor the sagging.

Should the sagging develop, a licensed plasterer and/or licensed carpenter should be engaged to provide maintenance works where necessary.

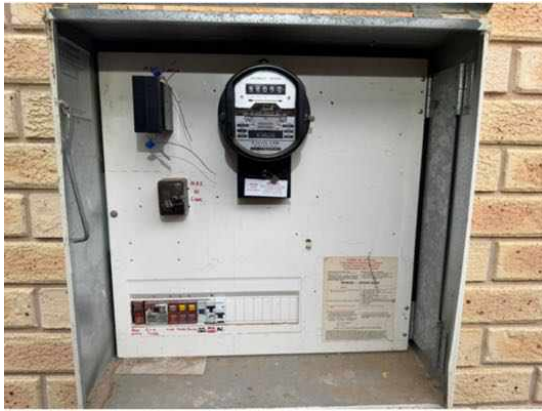
#### Finding 6.01

Building:	Main Building
Location:	Switchboard
Finding:	Termite Management System - no evidence of a chemical installation
Information:	The application of a termite barrier is strongly recommended, as it appears no termite management system has been installed, with no evidence or durable notice to suggest works taking place. Generally, a durable notice is placed in the meter box to indicate current termite barriers.

Such barriers are highly effective in preventing termite attack on the building and therefore should be installed.

A termite management system was not evident at the time of inspection. Installation of a termite barrier and ongoing 12-monthly inspections by a qualified pest inspector are strongly recommended. Recommend engaging a licensed pest controller for further advice.

Recommend seeking further advice from a licensed pest controller.

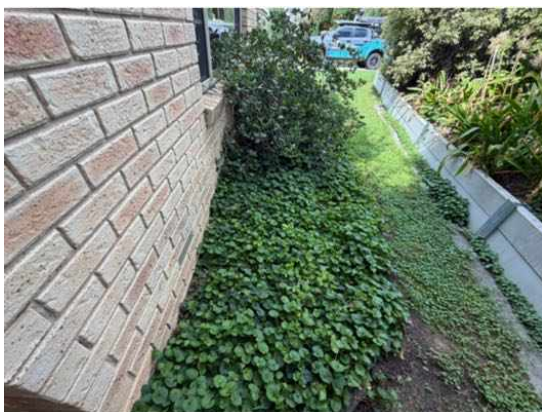
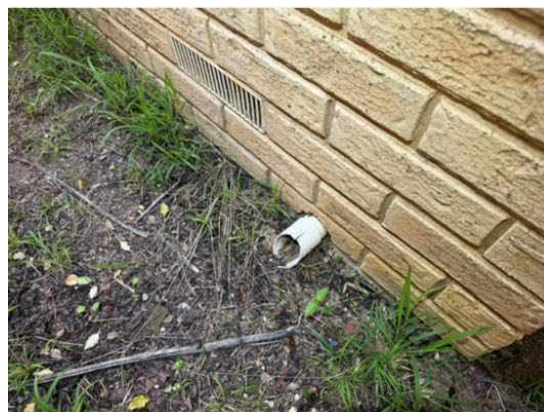
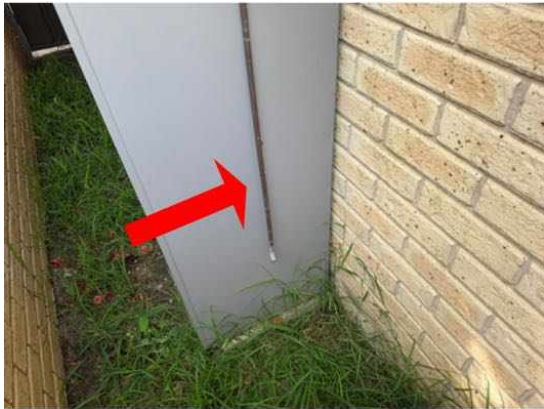
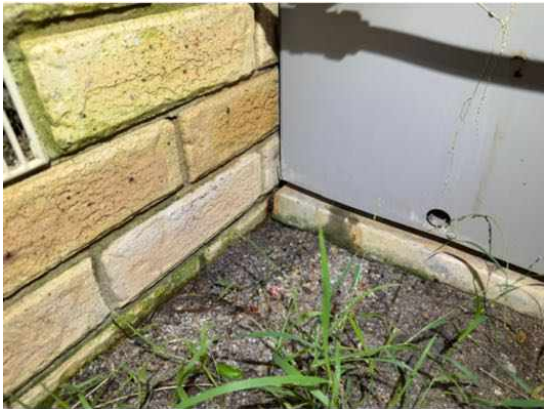
### Finding 6.02

Building: Main Building  
 Location: All external areas  
 Finding: Potential Water pooling - against property  
 Information: Potential areas of water pooling around the perimeter of the property were identified. It appears that the hot water system was leaking at the base. Where insufficient drainage hot water system and garden beds against the house are present, water pooling is likely to occur, and can create areas conducive to timber pests.

Recommend consulting with a licensed plumber and/or landscaping contractor to provide further advice.

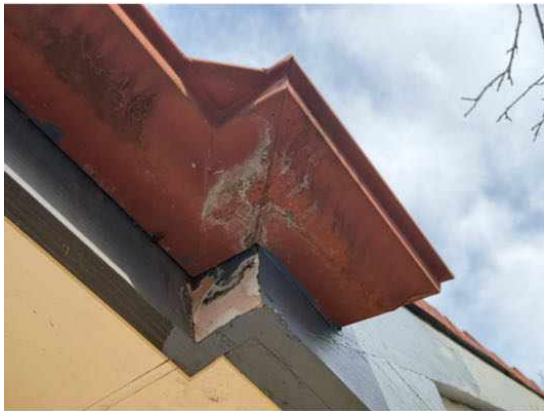
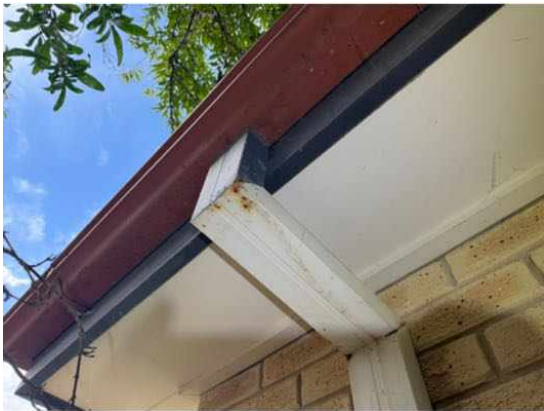
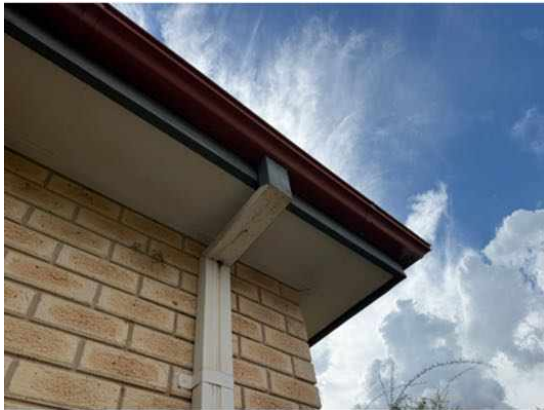
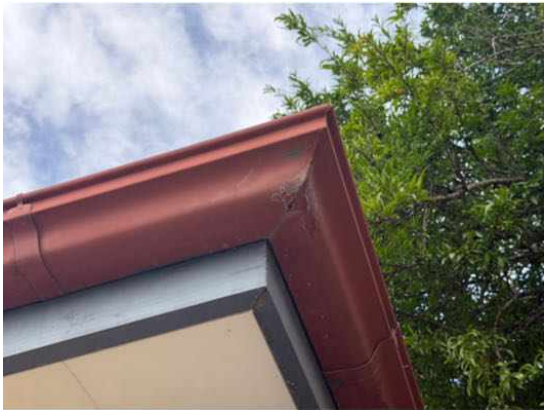
**Finding 6.03**

Building: Main Building  
Location: Gutters, Down-pipes  
Finding: Roof Plumbing - Rust & Leaking  
Information: It appears that areas of the roof plumbing showed signs of leaking & had areas of rust. Overtime, this can lead to the development of holes, and create an environment conducive to termite activity.

Recommend consulting with a licensed roof plumber in the short term, to provide further advice & maintenance works where necessary.

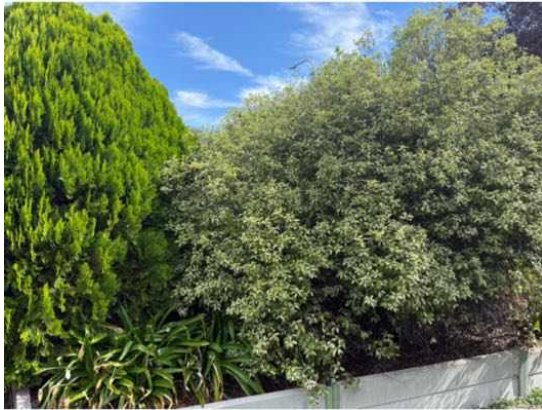
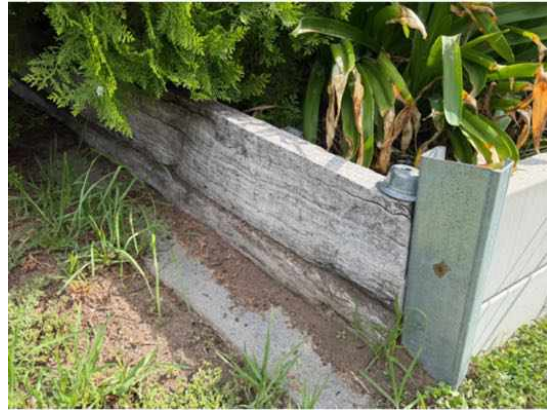
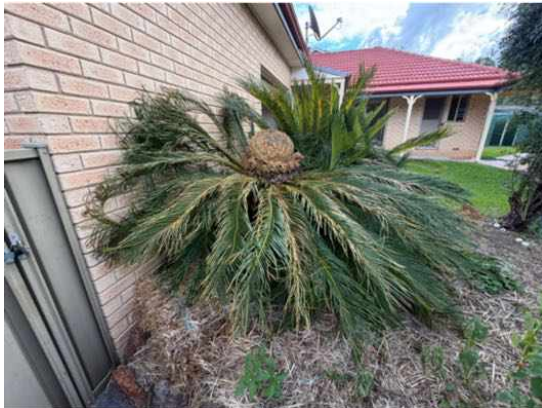
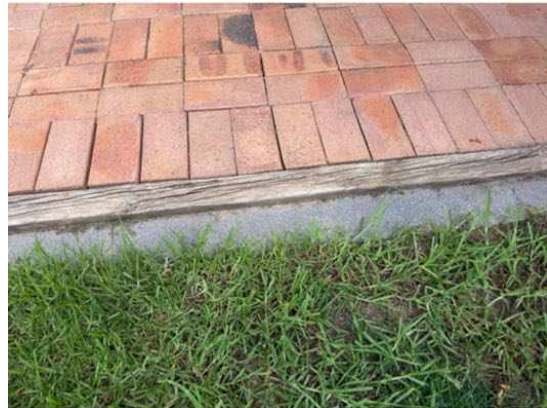
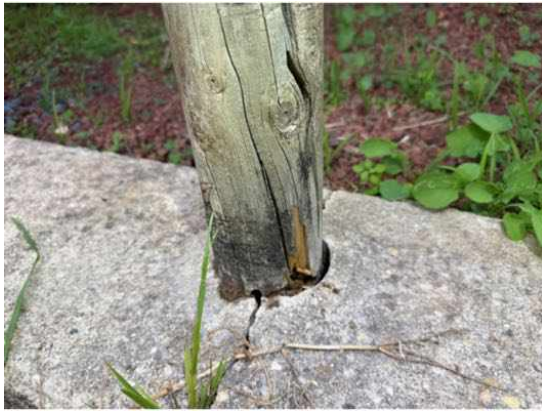
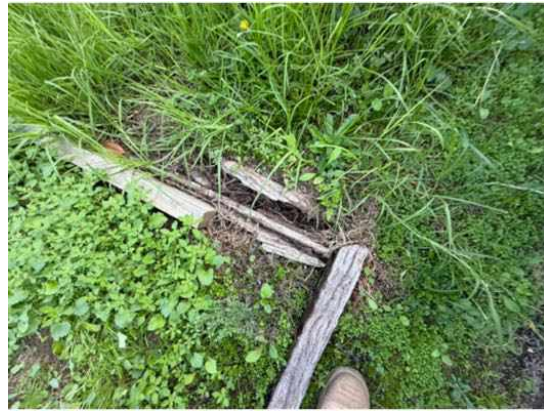
## Finding 6.04

Building:	Main Building
Location:	All External Areas
Finding:	Timber in direct ground contact & trees - conducive to termites
Information:	Where timber materials are in direct contact with the ground and consequently moisture, they become conducive to termite activity. The tree stumps, landscaping timbers, and trees surrounding the building create an environment conducive to termite activity.

Where feasible, any timbers in direct contact with the ground should be removed and any trees in close proximity to the building should be removed or test drilled (inspected) at least annually to reduce the risk of termite infestation & detect any early signs of termite activity.

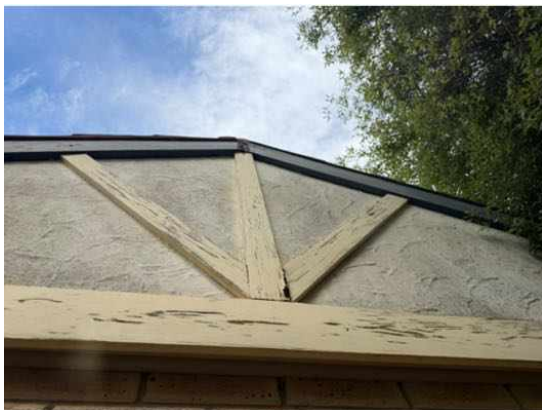
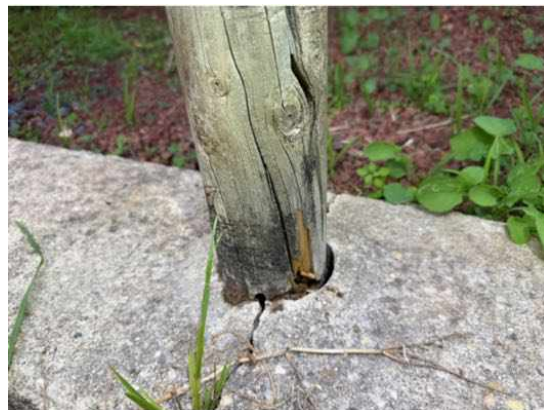
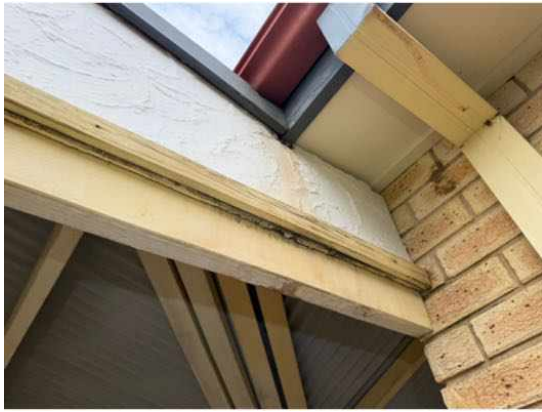
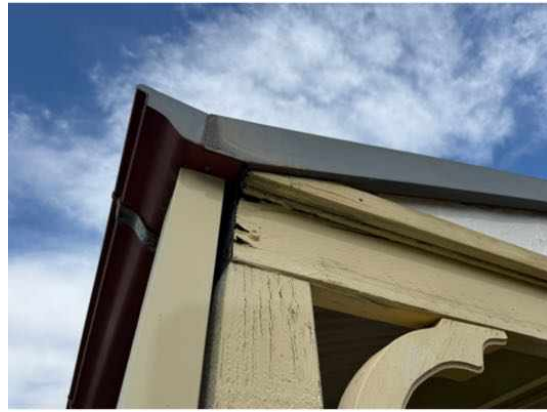
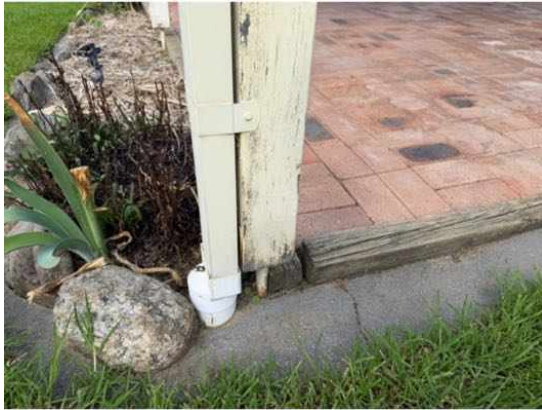
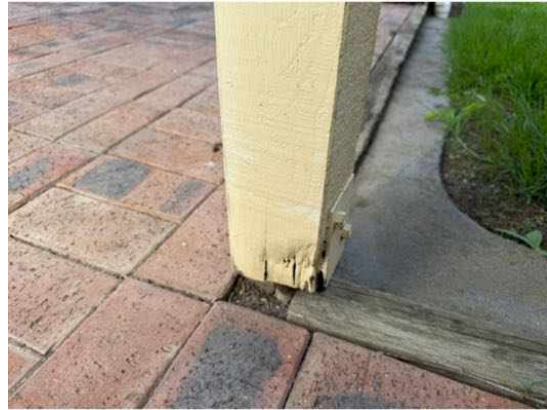
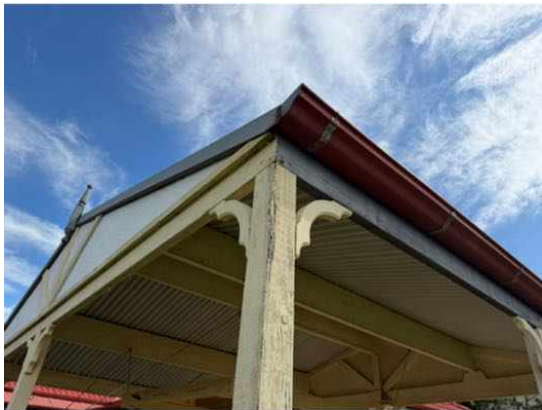
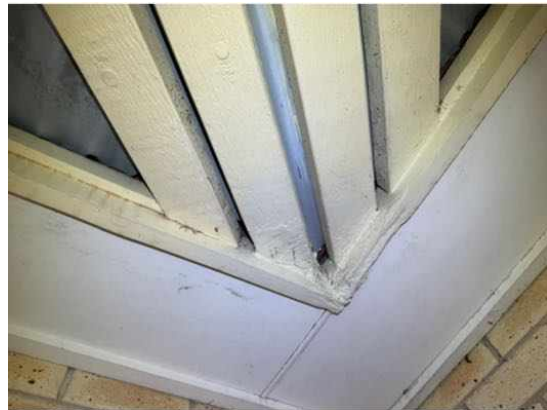
### Finding 7.01

Building:	Main Building
Location:	Patio framing, posts, fascias
Finding:	Fungal decay & weathering
Information:	Areas of fungal decay (wood rot) & weathering were identified at but not limited to some verandah posts, external trims, patio framing and fascias.

For areas of fungal decay, the client can engage a licensed carpenter at their discretion to replace affected materials. For areas of general weathering, it is advised the client engage a licensed painter to apply protective sealant or coating to areas of weathered external timbers.

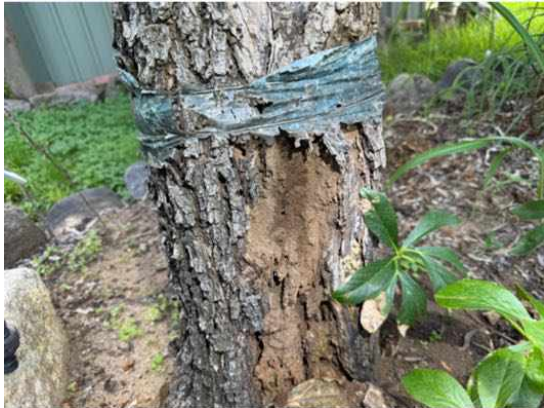
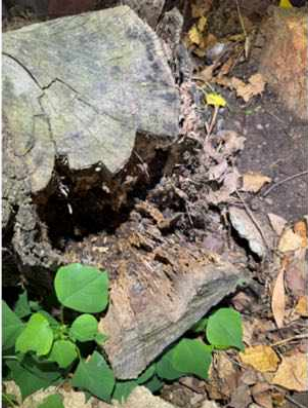
### Finding 8.01

Building: Main Building  
Location: Trees & Tree Stumps  
Finding: Evidence of wood borer damage identified (powder-post)  
Information: Evidence of previous Lyctus Borer (powder-post beetle) damage was identified at but not limited to a tree and tree stump in the backyard.

As no live wood borer activity was identified treatment is not required.

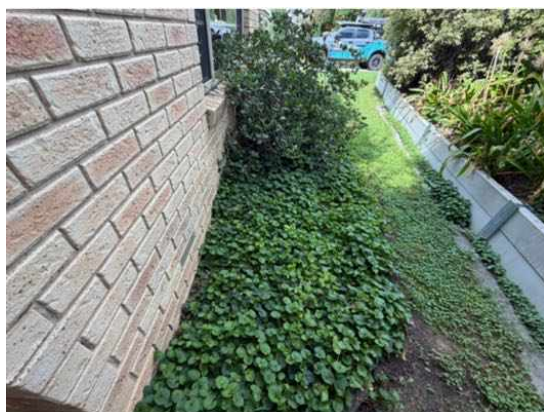
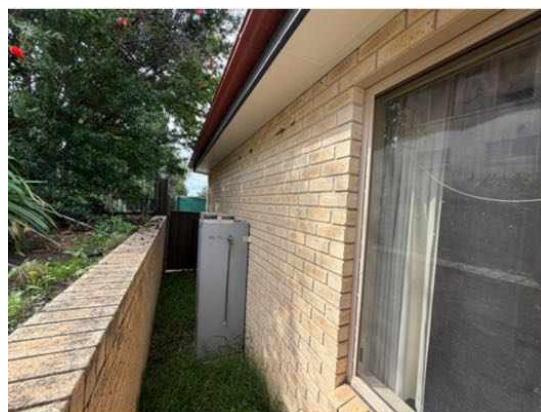
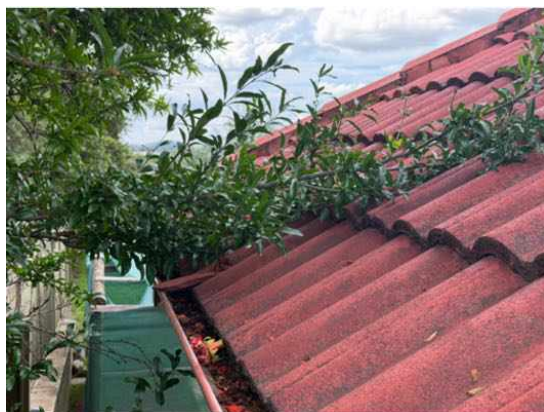
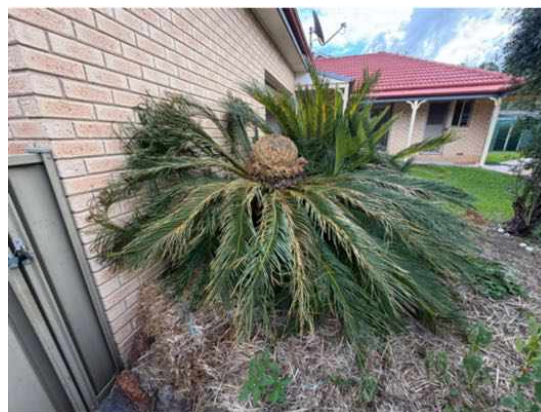
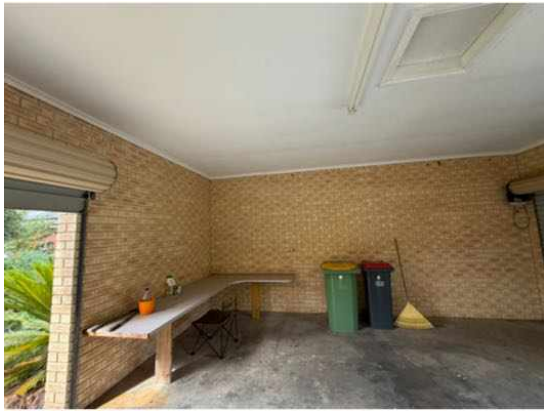
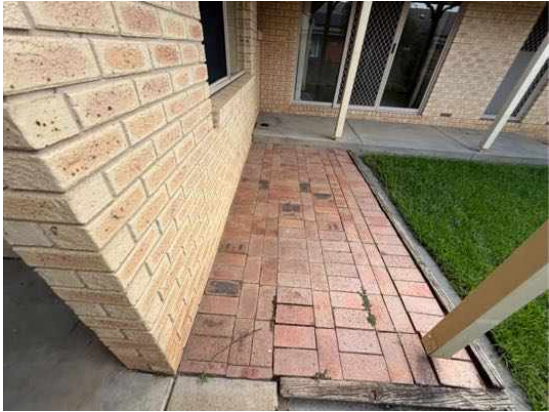
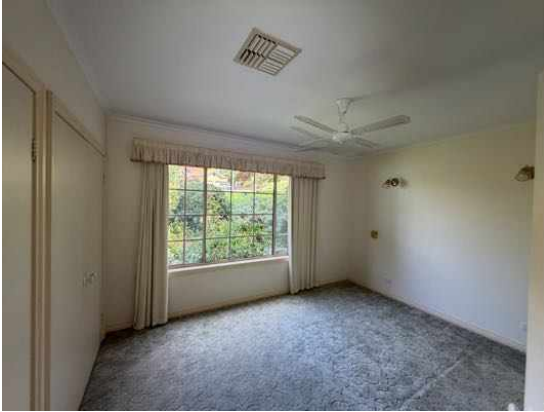
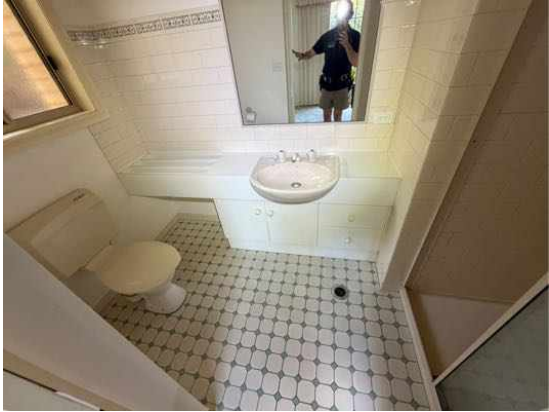
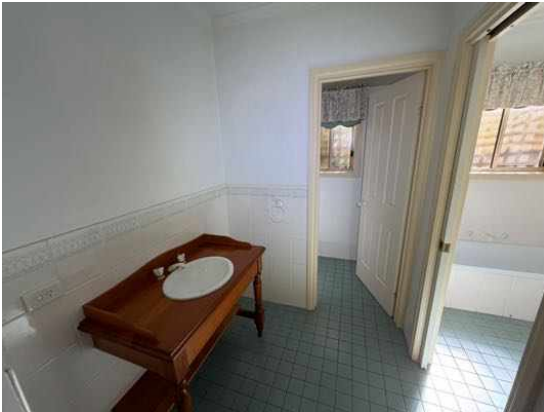
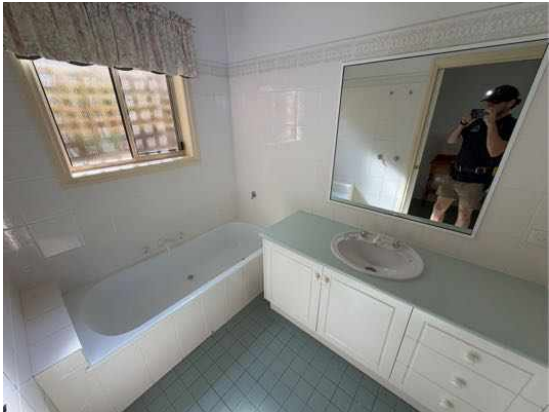
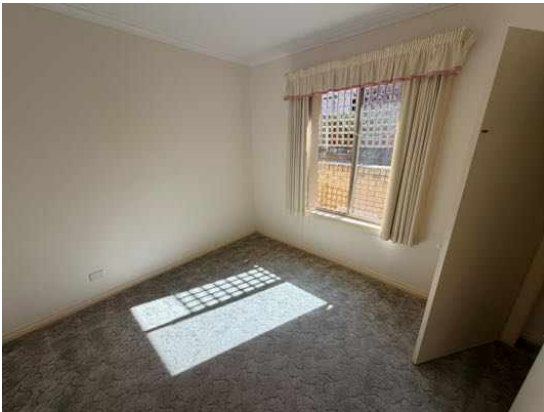
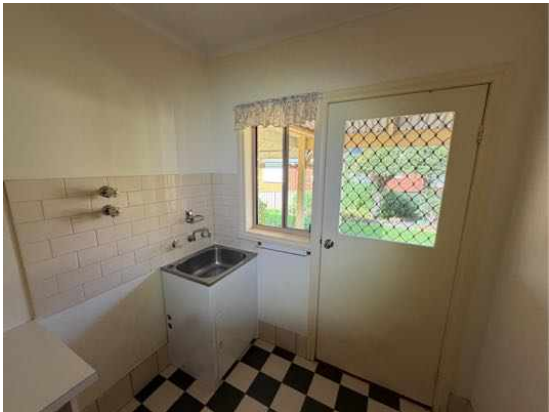
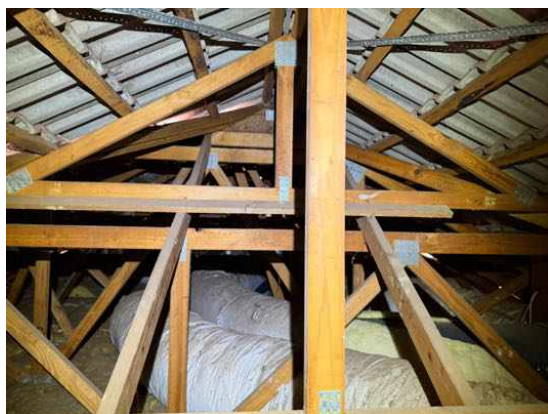
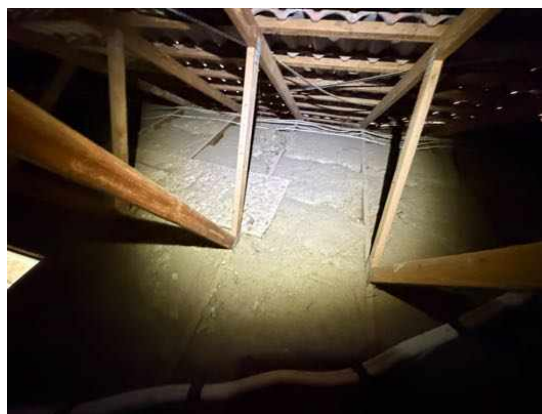
Several limitations and obstructions impeded the inspection and, if feasible, should be removed, and a further inspection should be performed. The roof void was unable to be fully inspected due to webbing of trusses not trafficable. Indicative images below depict some of the obstructions encountered.

Building: Main Building  
Location: All Areas  
Finding: Additional Photos - Obstructions and Limitations  
Information: These photographs are an indication of the obstructions and limitations which impeded full inspection of the property at the time of inspection. These obstructions can hide an array of defects and should be removed to allow full inspection to be carried out. A re-inspection is recommended once the areas are made accessible.

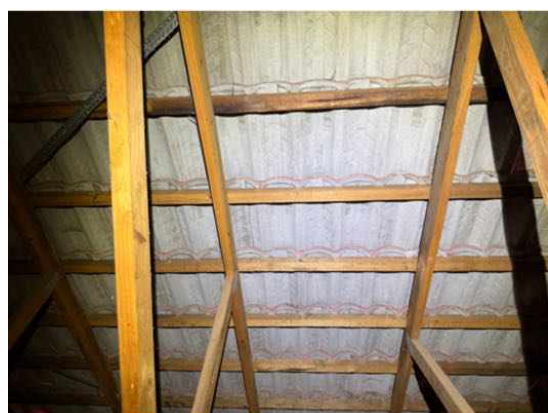
Building: Main Building  
 Location: Roof Void  
 Finding: Sarking - Not Present  
 Information: It is noted for your information that sarking has not been installed on the roof. Sarking is a laminated aluminium foil applied to the interior of the roof covering, assists in insulating the property and acting as a vapour-barrier to the roof void.

The client can consult with a licensed roofing contractor at their discretion, to provide further advice.

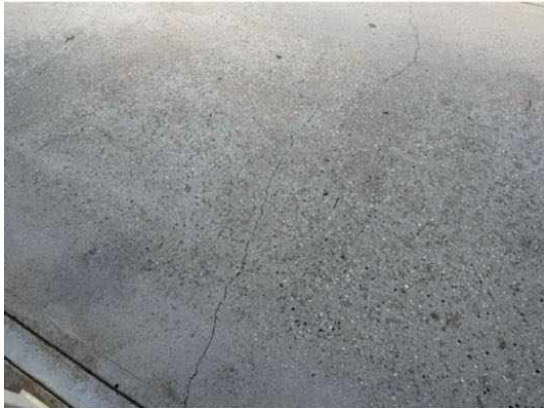
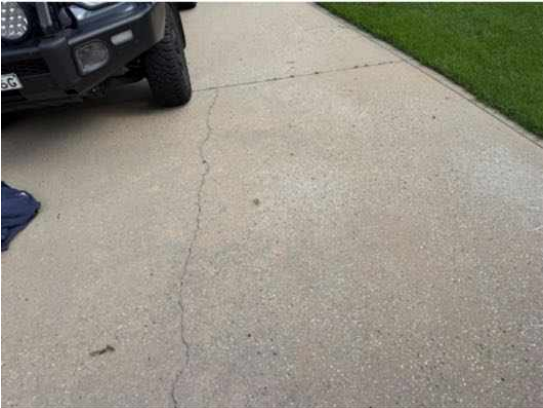
Building: Main Building  
 Location: Pavement, Driveway  
 Finding: Cracking - Pavement & Footpath  
 Information: It was noted there is cracking in areas of the pavement and driveway. Cracks in the pavement are a common occurrence in houses of a similar age.

Recommend that the client monitor the cracking. A licensed concreter can be engaged at clients discretion, should cracks widen, lengthen, or become more numerous.
