Building and Timber Pest Inspection Report

Inspection Date: Wed, 11 Mar 2026

Property Address: 8 Borealis Wy, Box Hill NSW 2765, Australia

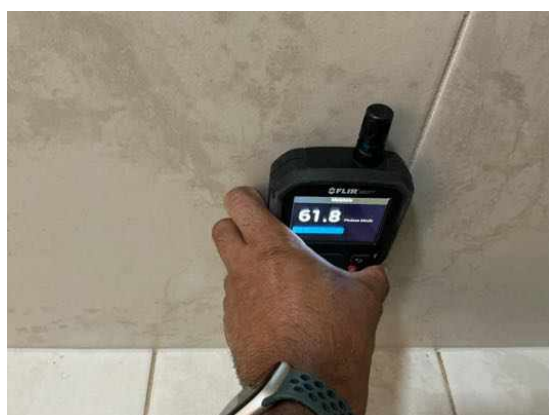
Building:	Main Building
Location:	Ground Floor Bathroom
Finding:	Excessive Moisture - Shower Damp
Information:	At the time of inspection, excessive moisture was noted within the shower area, which is a common issue in wet areas due to the continual exposure to water. This condition is typically caused by moisture seeping through grout lines and settling behind tiles, resulting in localised high-moisture zones. Provided there is no evidence of water staining or elevated moisture readings on the opposite side of the wall, this is considered a minor defect.

However, persistently damp conditions may act as conducive conditions for termite activity, as termites are strongly attracted to moisture-rich environments. It is recommended that the client ensures regular use of the exhaust fan and maintains adequate ventilation after shower use to promote drying and reduce long-term moisture build-up, thereby also reducing the risk of attracting termites.

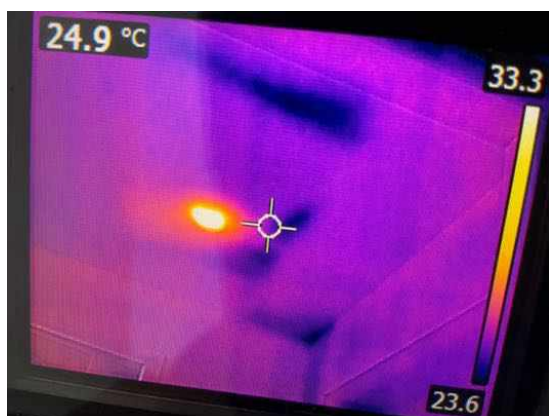
Finding 3.02

Location: Upstairs Hallway, Bedroom 4 Closet
Finding: Moisture Detected on Ceiling
Information: At the time of inspection, thermal imaging indicated a moisture signature on the ceiling surface. The affected area displayed temperature variations consistent with possible moisture presence.

The roof space above this area was inaccessible at the time of inspection, and therefore the exact source of the moisture could not be confirmed. Potential causes may include roof leaks, flashing defects, or gaps around roof penetrations such as skylights, which may allow water to enter the ceiling cavity during rainfall.

This matter should be treated as a priority, as ongoing moisture intrusion can lead to progressive damage to plasterboard, insulation, and structural elements, potentially resulting in more costly repairs and major defect if not addressed in a timely manner.

It is recommended that a qualified roofer be engaged to inspect the roof covering, flashing details, and the skylight installation to ensure there are no defects allowing water ingress.

If no roof-related issues are identified, the moisture may be associated with condensation from nearby air conditioning ducting or equipment, in which case an air conditioning specialist should be engaged to inspect the system and associated ductwork.

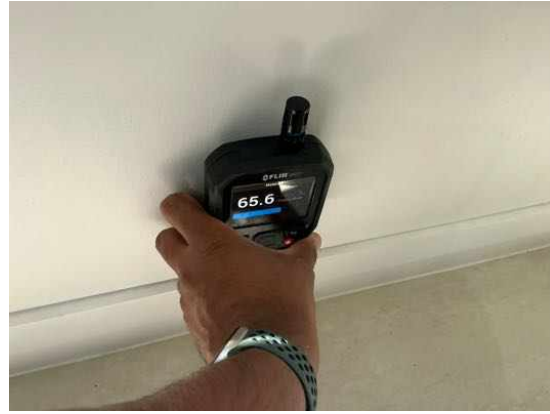
Finding 3.03

At the time of inspection, evidence of rising damp was observed in areas of the building. External ground levels were noted to be higher than the internal floor level, with the surrounding ground surfaces sloping towards the building. This condition can allow moisture to migrate into the lower sections of the walls and flooring, which may lead to dampness, deterioration of building materials, and ongoing moisture-related issues.

While drainage points were observed at the rear of the property, the existing garden slope directs water towards the building foundation, and it appears that not all surface water is effectively captured by the drainage system.

To minimise moisture ingress, it is recommended that external ground levels be reduced where necessary and that site drainage be improved, ensuring that ground surfaces are graded to fall away from the building so that water is directed away from the foundation. Appropriate drainage solutions may be required to effectively manage surface water runoff.

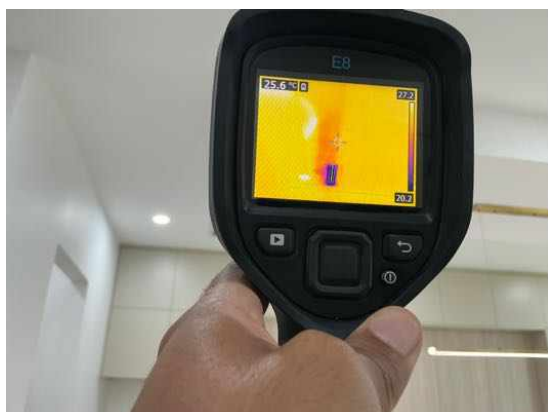
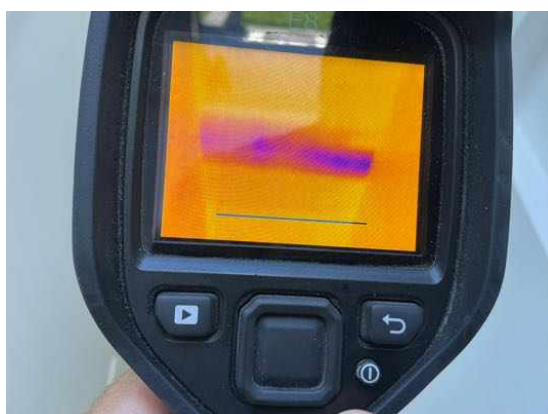
Building:	Main Building
Location:	Downstairs Hallway, Lounge, Kitchen
Finding:	Thermal Variation Noted Near Air Conditioning Vent
Information:	At the time of inspection, a thermal variation was noted on the ceiling surface adjacent to the air conditioning vent during thermal imaging. This pattern may be associated with the air conditioning ductwork located within the ceiling cavity, which appears to be positioned close to or directly against the plasterboard surface.

Such thermal signatures can occur where ductwork transfers cooler air temperatures to the ceiling lining, making the area visible under thermal imaging. No visible signs of active moisture damage were observed at the time of inspection.

However, it is also possible that condensation from the air conditioning system could produce similar thermal patterns if present. The client is therefore advised to monitor the area over time for any signs of moisture staining, dampness, or deterioration of the ceiling surface.

If evidence of condensation or moisture ingress becomes apparent, it is recommended that an air conditioning specialist be engaged to inspect the system and ductwork to ensure there are no leaks or insulation deficiencies.

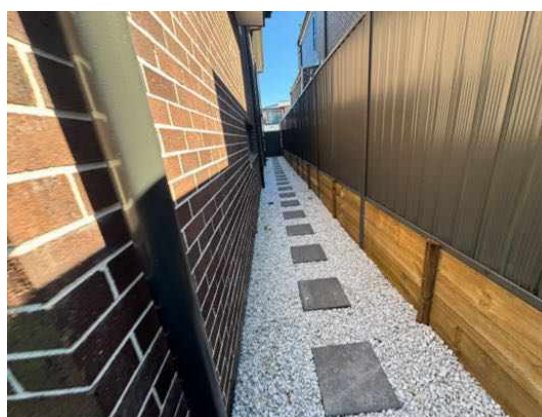
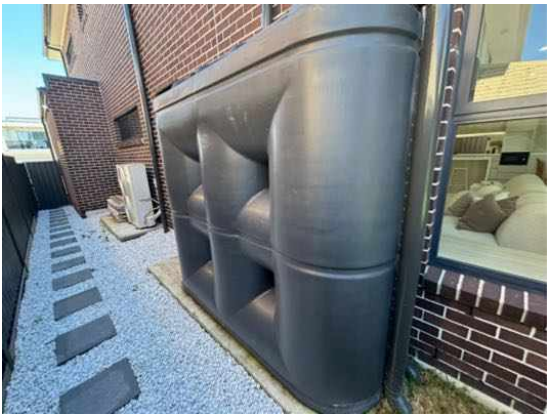
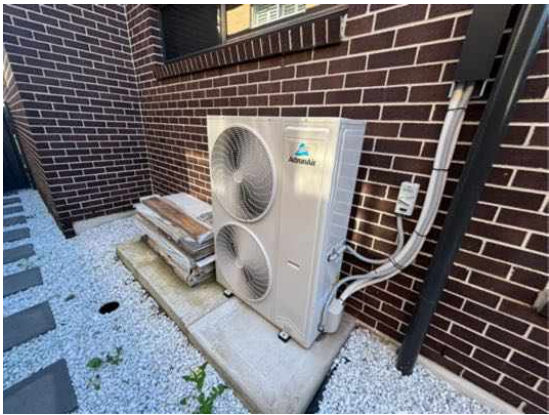
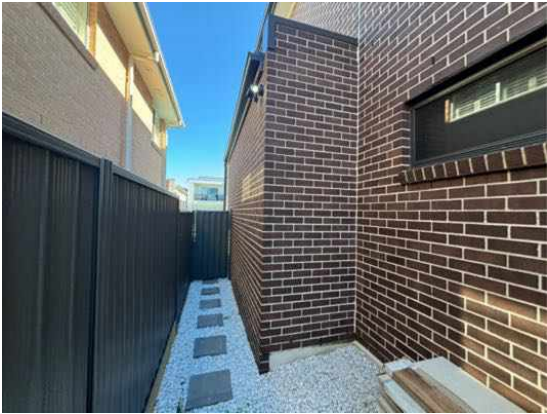
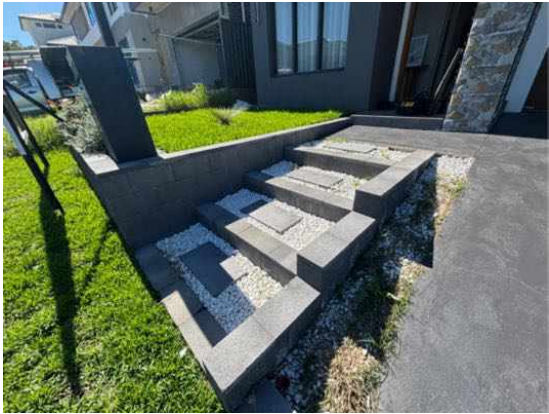
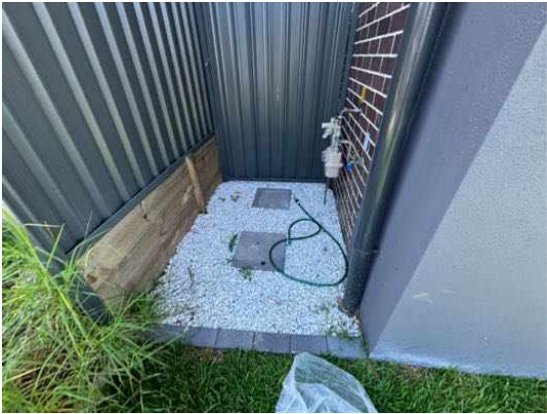
It is essential that these obstructions be cleared to allow for a comprehensive inspection of the external areas. Removing these barriers will enable a more accurate assessment of the property's condition and allow any hidden defects to be identified and addressed promptly. Failure to do so could result in undetected issues worsening over time, potentially leading to more costly repairs in the future.

Therefore, it is strongly recommended that the obstructions be removed and a re-inspection be scheduled once the affected areas are made fully accessible. This will ensure a complete evaluation of the property's exterior and provide the client with a clear understanding of any potential issues that may have been concealed during the initial inspection.

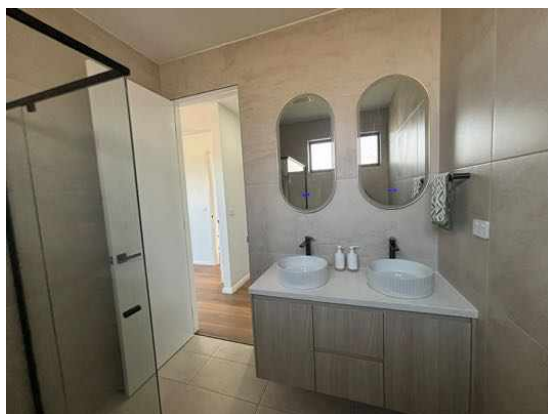
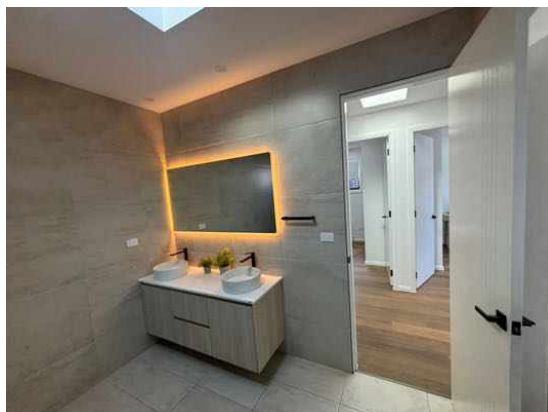
Building: Main Building
Location: All Internal Areas
Finding: Obstructions and Limitations - Internal Areas
Information: The accompanying photographs provide clear evidence of the obstructions and limitations that restricted a comprehensive inspection of the internal areas of the property at the time of assessment. These obstructions, which may include furniture, personal belongings, stored items, or structural elements such as wall coverings and built-ins, significantly hindered the ability to thoroughly evaluate these areas. It is important to note that such obstructions can potentially conceal a wide array of defects, ranging from hidden structural damage, water leaks, pest infestations, or electrical issues, to deteriorating materials that may not be visible during the initial inspection.

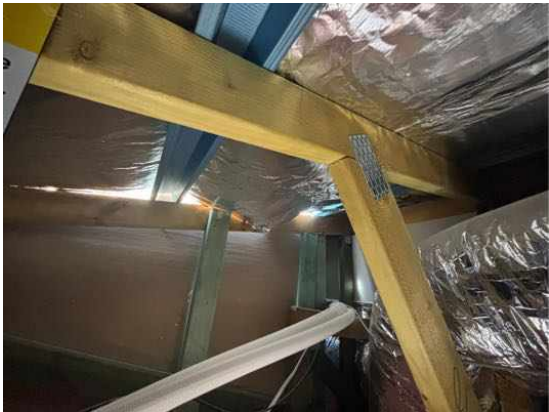
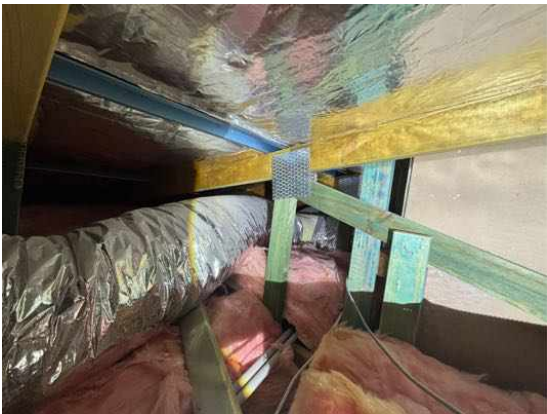
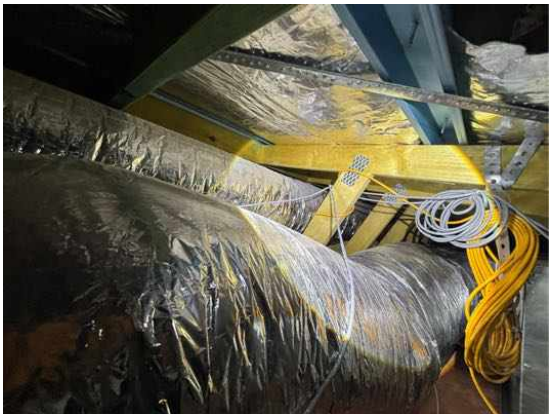
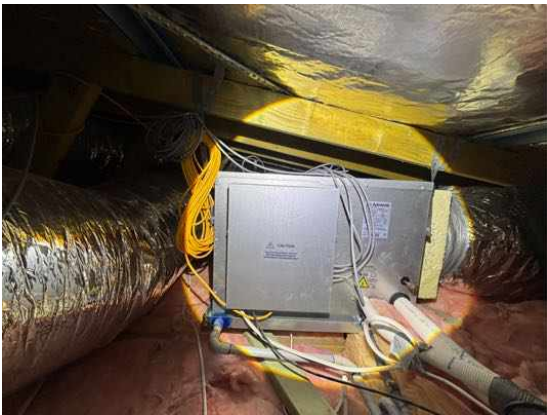
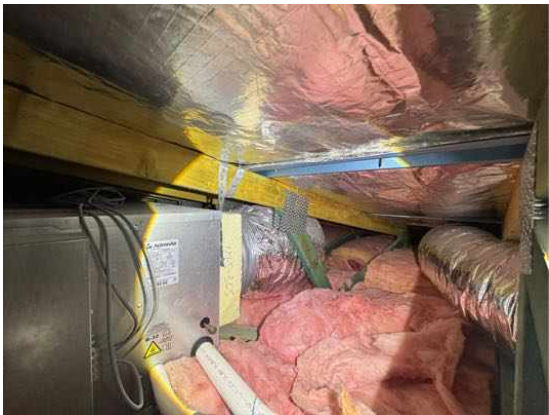
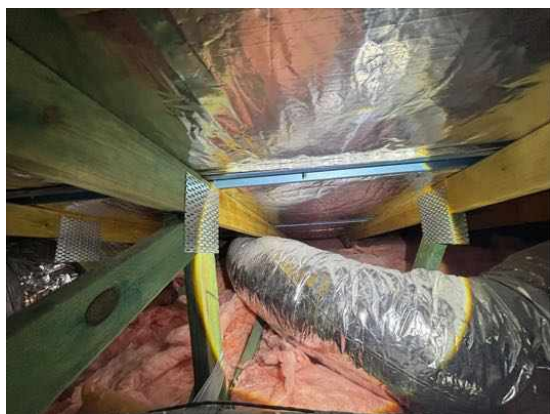
Building: Main Building
 Location: Roof Void
 Finding: Obstructions, Limitations, and General Roof Space Condition
 Information: The photographs provided document both the general condition and the obstructions and limitations that were present in the roof cavity of the main building at the time of inspection. These obstructions—such as insulation materials, stored items, structural elements, or electrical wiring—restricted safe and adequate access to key areas within the roof space. As a result, a comprehensive inspection of all components could not be completed.

damaged framing, compromised insulation, evidence of moisture ingress, pest activity, or electrical hazards. While no major issues were observed in the visible areas, the presence of these limitations means that some defects may remain undetected.

It is recommended that these barriers be removed or repositioned to facilitate full and safe access to the roof space. Once clear, a follow-up inspection should be conducted to allow for a thorough assessment of all concealed areas. This will help ensure that the condition of the roof cavity is accurately evaluated and any hidden issues are appropriately identified and addressed.

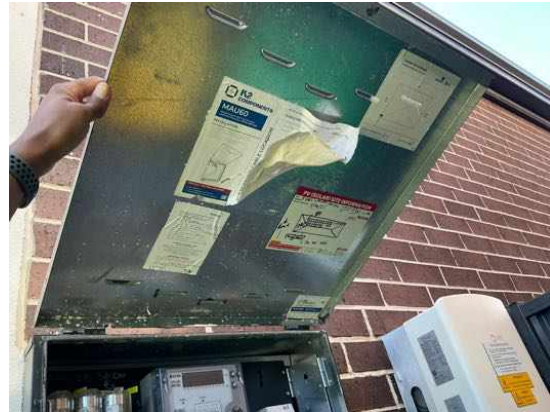
Building:	Main Building
Location:	Meter Box
Finding:	Termite Management Recommendation – No Evidence of Chemical Installation
Information:	At the time of inspection, there was no visible evidence of a chemical termite management system installed around the property. Chemical barriers are a key component of termite protection and are particularly important in preventing concealed termite entry into timber elements of the structure.
