# Building and Timber Pest Inspection Report

Inspection Date: Tue, 10 Mar 2026

Property Address: 140 Victory Rd, Airport West VIC 3042, Australia

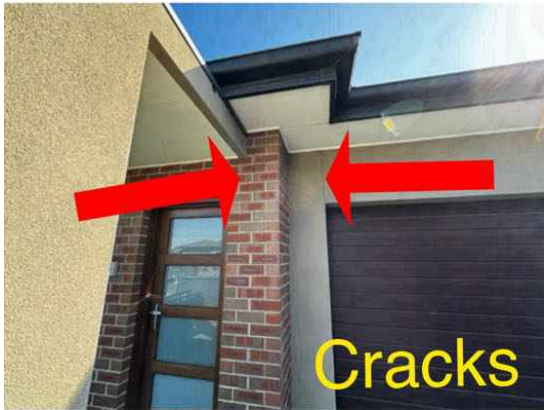
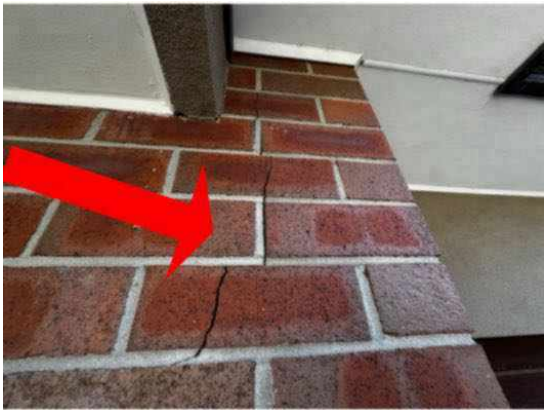
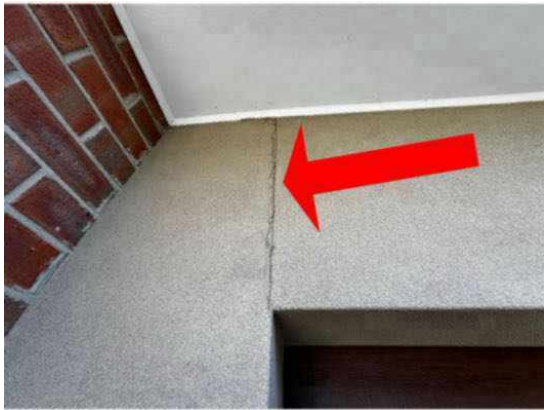
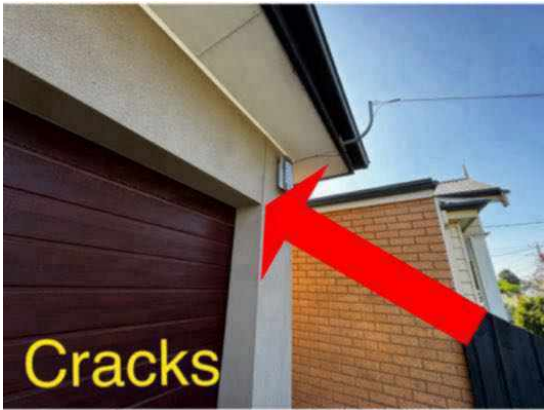
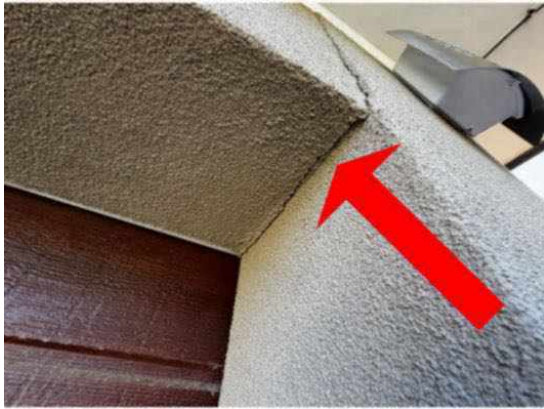
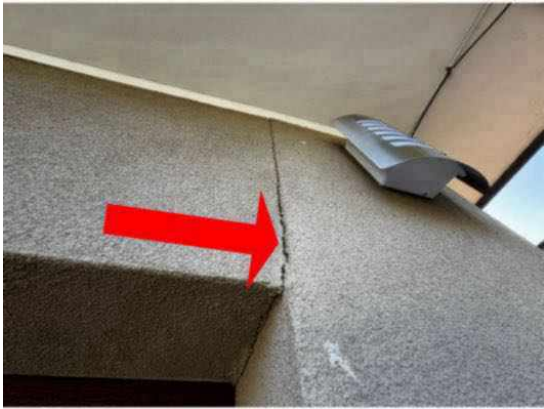
Building:	Main Building
Location:	Interior/Exterior Walls & Ceilingsd > All Areas
Finding:	Cracking and Floor Level Variation – Suspected Building Movement (Major Defect)
Information:	Cracking was observed to several internal and external areas of the building, including the front façade brickwork and rendering, the hallway ceiling, garage walls, kitchen walls, and the rear alfresco ceiling. The cracks were visible in both plaster finishes internally and masonry or rendered surfaces externally.

In addition to the cracking, floor level variations were detected in multiple areas of the building. Measurements were taken using a laser level and indicated notable variations across relatively short spans:

Further evidence of ground movement was observed externally, where a section of concrete paving to the right-hand side of the garage had sunk and was sloping toward the garage wall.

The combination of multiple cracking locations and significant floor level variations suggests the possibility of foundation movement or settlement affecting the building. In accordance with the defect classifications under AS 4349.1–2007 (Inspection of Buildings), defects that indicate possible structural movement affecting the serviceability of the building are classified as Major Defects.

It is recommended that the property be assessed by a qualified structural engineer to determine the cause and extent of the building movement and to provide appropriate rectification recommendations. Further investigation may include assessment of

foundation conditions, site drainage, soil conditions and structural elements of the building.

Immediate – Engineering assessment is recommended as soon as practicable to determine the cause of the movement and prevent potential progression of structural damage.

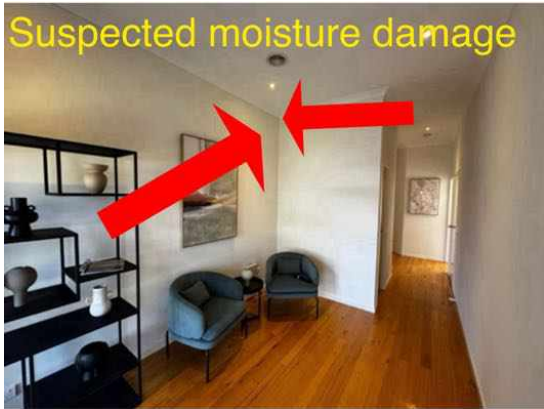
Building: Main Building  
Location: Main entry & Wet areas > All Areas  
Finding: Suspected Moisture Damage and Elevated Moisture Readings (Major Defect)  
Information: Suspected moisture damage was observed to the entry wall on the party wall side of the building. The plaster surface in this area showed visible swelling and rippling, which is typically consistent with historical moisture exposure. Moisture testing using a moisture meter was undertaken during the inspection; however, no elevated moisture readings were detected at the time of inspection in this particular wall area.

Given the location of the affected wall along the party wall, it is suspected that moisture ingress may have previously occurred due to defects in the box gutters above or issues with flashings or cappings associated with the party wall roof junction. This could allow water to enter the wall cavity and affect the plaster lining.

Suspected moisture damage

It is recommended that the source of the moisture be further investigated by a licensed plumber or building specialist, and that the wet areas and roof junctions above the party wall be inspected for potential leaks or waterproofing failures. Rectification works should be undertaken once the source of moisture has been identified.

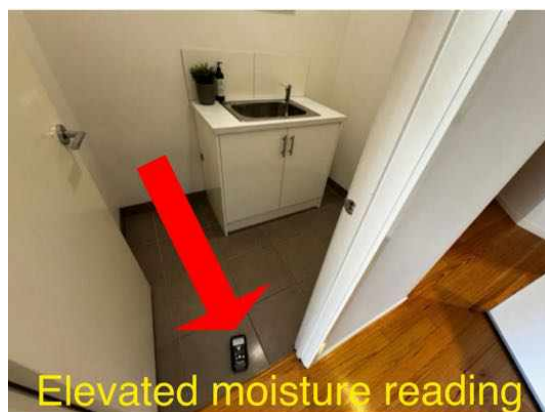
Additional moisture-related concerns were identified internally. The door jamb to the main bathroom showed visible signs of moisture damage, including deterioration consistent with prolonged exposure to moisture. Moisture meter testing indicated elevated moisture readings of approximately 75% to the adjacent floor tiles.

Similarly, elevated moisture readings were also detected to the floor tiles in the laundry and ensuite areas, suggesting the possible presence of ongoing moisture accumulation beneath the tiled surfaces. While the exact source of the moisture could not be confirmed during the inspection, potential causes may include water leakage from plumbing fixtures, wet area waterproofing failure, or moisture trapped beneath the tiles.

Elevated moisture reading

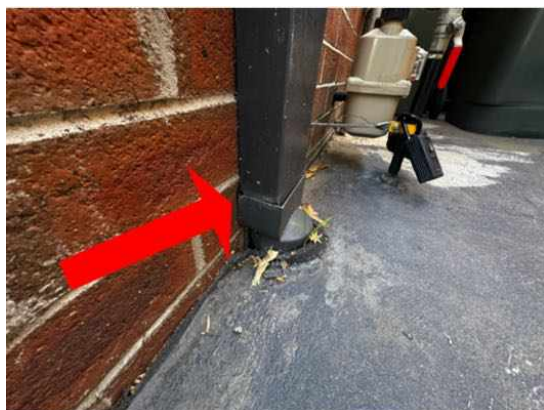
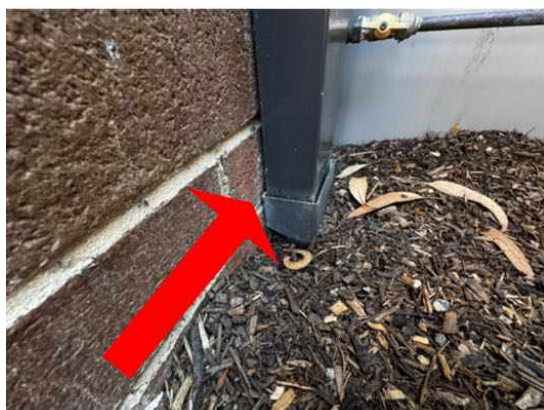
Building:	Main Building
Location:	Walls > All Areas
Finding:	Downpipes hard against brickwork concealing inspection zones (TP)
Information:	At the time of inspection, several downpipes were observed to be installed hard against the external brick walls. This configuration restricts visual access to the wall surface and slab edge behind the downpipes, making it difficult to identify early signs of termite activity.

Effective termite risk management relies on maintaining clear and accessible inspection zones to allow early detection of termite activity. Where services such as downpipes are installed directly against masonry walls, concealed termite entry paths may develop behind these elements without being readily visible, increasing the likelihood of undetected termite ingress.

As a result, the positioning of downpipes hard against the brickwork is considered to increase the risk of concealed termite entry. It is recommended that a licensed termite management or pest control contractor be engaged to assess these locations and provide advice on improving inspection access or implementing supplementary termite management measures to address the increased risk.

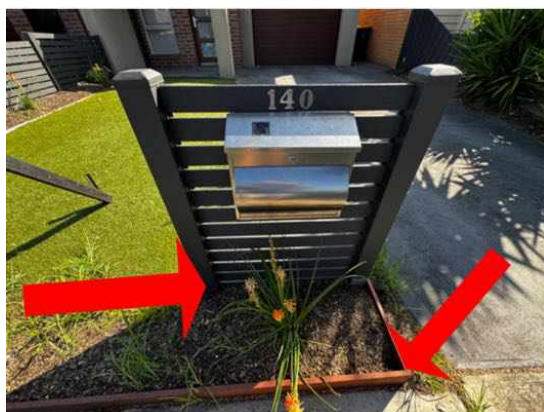
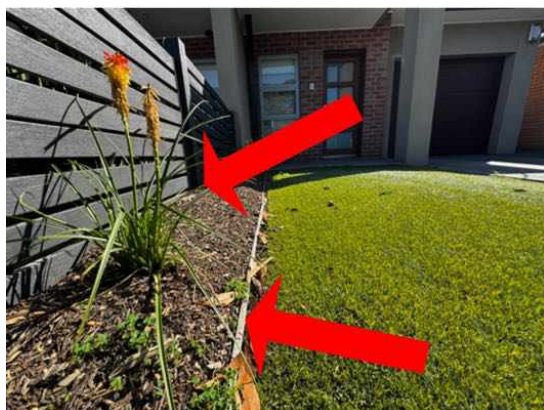
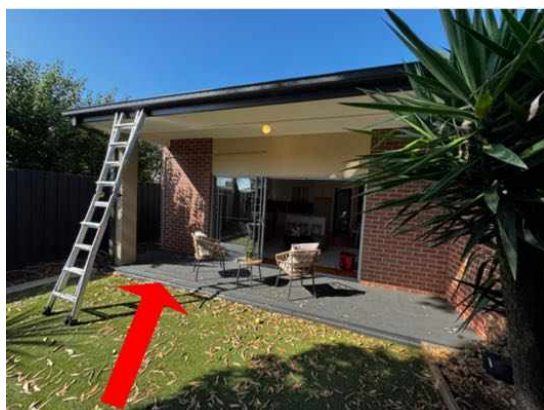
Building:	Main Building
Location:	All Areas > All Areas
Finding:	Inground timber contact (TP)
Information:	At the time of inspection, in-ground timber contact was observed to the front, side and rear yards, including timber garden edging, fence posts and timber decking all in direct contact with the ground. These timber elements are positioned within the soil zone and in close proximity to the building and associated structures.

In accordance with AS 3660.2, conditions that facilitate termite access or provide a direct food source are recognised as increasing the risk of termite activity to existing buildings. Timber elements in direct contact with the ground are particularly vulnerable, as they can attract subterranean termites and support concealed foraging activity, potentially allowing termite colonies to establish and migrate toward nearby structures without early detection.

As a result, the presence of in-ground timber elements is considered to increase the risk of termite activity to the property. It is recommended that a licensed termite management or pest control contractor be engaged to assess these conditions and provide advice on appropriate risk mitigation measures, which may include removal or replacement of timber elements with non-susceptible materials, isolation of timber from soil contact, and integration of suitable termite management measures to suit the existing site conditions.

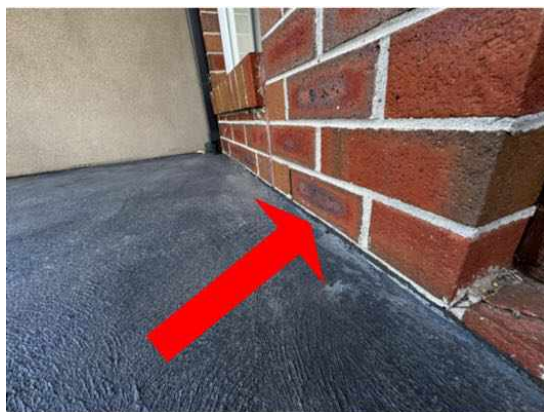
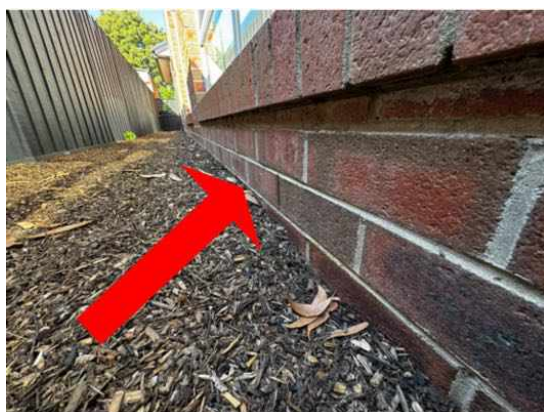
Building:	Main Building
Location:	All Areas > All Areas
Finding:	Slab edge - concealed (TP)
Information:	At the time of inspection, the slab edge to most areas of the building was observed to be concealed behind concrete paving, landscaping and timber decking. This condition restricts clear visibility of the slab perimeter and limits the ability to visually inspect critical inspection zones intended for the early detection of termite activity.

Where slab edges and inspection zones are concealed, concealed termite entry paths may develop without early warning. In accordance with AS 3660.2, existing buildings are required to maintain conditions that allow for effective inspection and management of termite risk, noting that obstructions such as paving, paths, or landscaping can compromise the effectiveness of termite management measures. Where inspection zones are obstructed, the likelihood of undetected termite activity is increased.

As a result, the current configuration is considered to increase the risk of concealed termite entry to the building. It is recommended that a licensed termite management or pest control contractor be engaged to assess the extent of the concealed slab edges and provide advice on rectification options, which may include modifying paving or landscaping to reinstate suitable inspection access and integrating appropriate termite management measures to suit the existing conditions.

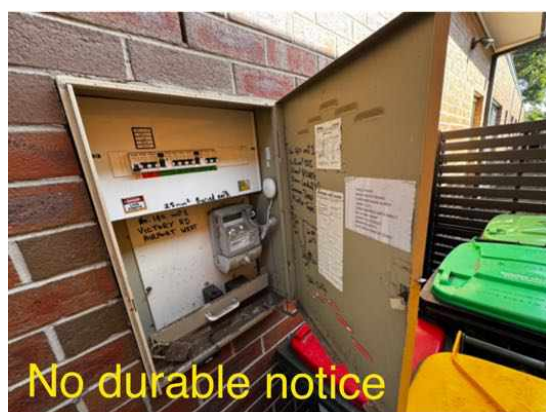
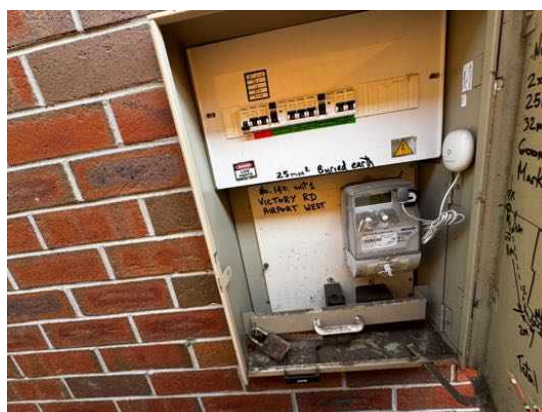
Building: Main Building  
Location: Meter Box > Front Right  
Finding: Termite management system - no evidence of chemical installation (TP)  
Information: At the time of inspection, there was no visible evidence to suggest that a chemical termite management system has been installed or remains effective. In addition, no durable notice was observed within the electrical switchboard to identify the presence, type, or date of any termite protection measures.

For this reason, the installation of a post-construction chemical termite management system is highly recommended to reduce the risk of termite activity. A durable notice should also be installed within the electrical switchboard to clearly identify the treatment provided and support ongoing inspection and maintenance.

Engagement of a licensed termite management or pest control contractor is recommended as a matter of priority to assess the site conditions, consider local termite risk, and determine the most appropriate treatment method and procedures for this property.
