Building Inspection Report

Inspection Date: Tue, 15 Apr 2025

Property Address: 888 Collins St, Docklands VIC 3008,
Australia

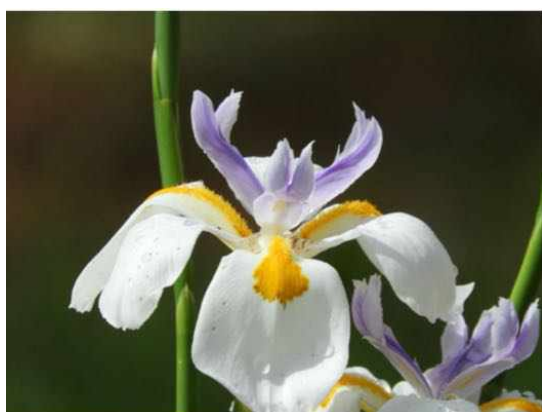
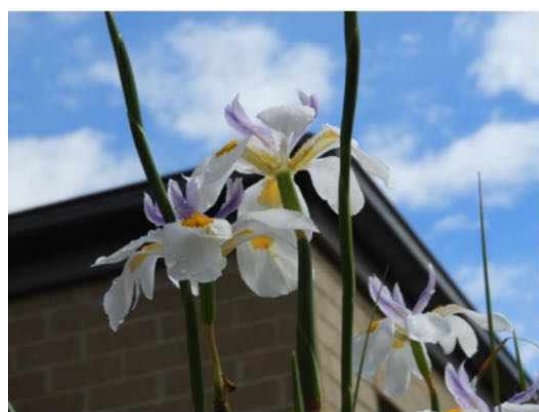
Defects 3.01

Building: Building 1
Location: All Areas > All Areas
Finding: Additional Photos - Obstructions and Limitations
Information: These photographs are an indication of the obstructions and limitations which impeded full inspection of the property at the time of inspection. These obstructions can hide an array of defects and should be removed to allow full inspection to be carried out. A re-inspection is recommended once the areas are made accessible.
