Building and Timber Pest Inspection Report

Inspection Date: Tue, 3 Mar 2026

Property Address: 6/143 Regent St, Redfern NSW 2016,
Australia

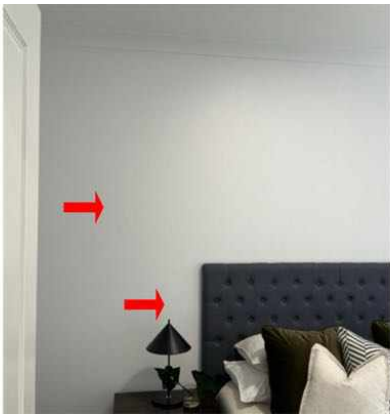
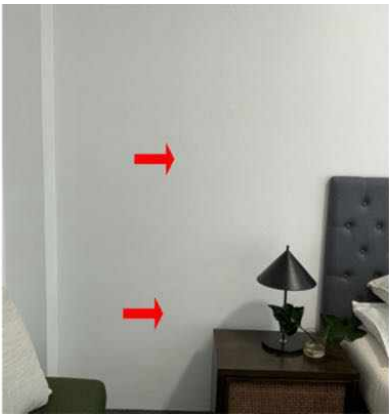
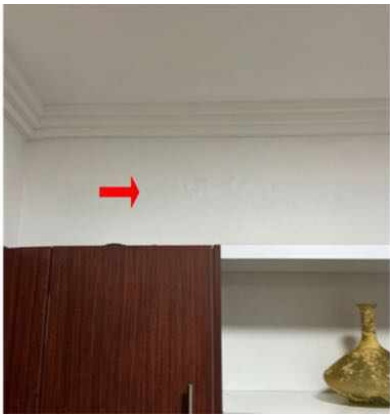
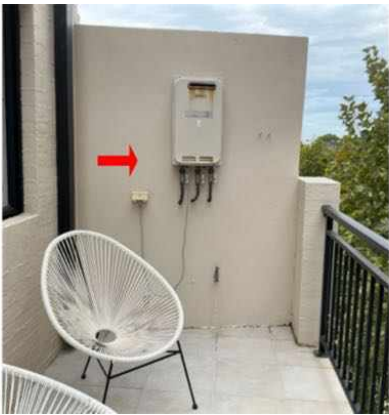
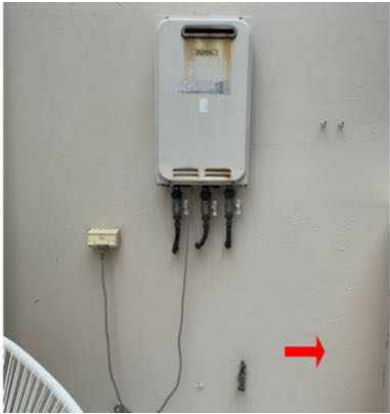
Building:	Main Building
Location:	All Internal Areas - left (Kitchen, bedroom, balcony)
Finding:	Damp
Information:	Damp (or structural damp) refers to the presence of unwanted moisture in the structure of a building, either as the result of intrusion from outside, or condensation from within the structure. Generally, structural damp is caused by rain penetration, rising damp, and leaks from plumbing pipes.

Unmanaged damp facilitates the formation and development of mould, fungi growth and wood rot, decaying associated building materials and compromising their structural integrity. Damage to finishes is also likely to occur, including lifting, bubbling, peeling and staining of paint, plaster and wallpaper.

Consultation with a strata appointed qualified plumber is advised immediately to identify the cause of damp and perform remedial works as required. Where excessive mould growth is present, further inspection by a specialist environmental health inspector should also be considered.

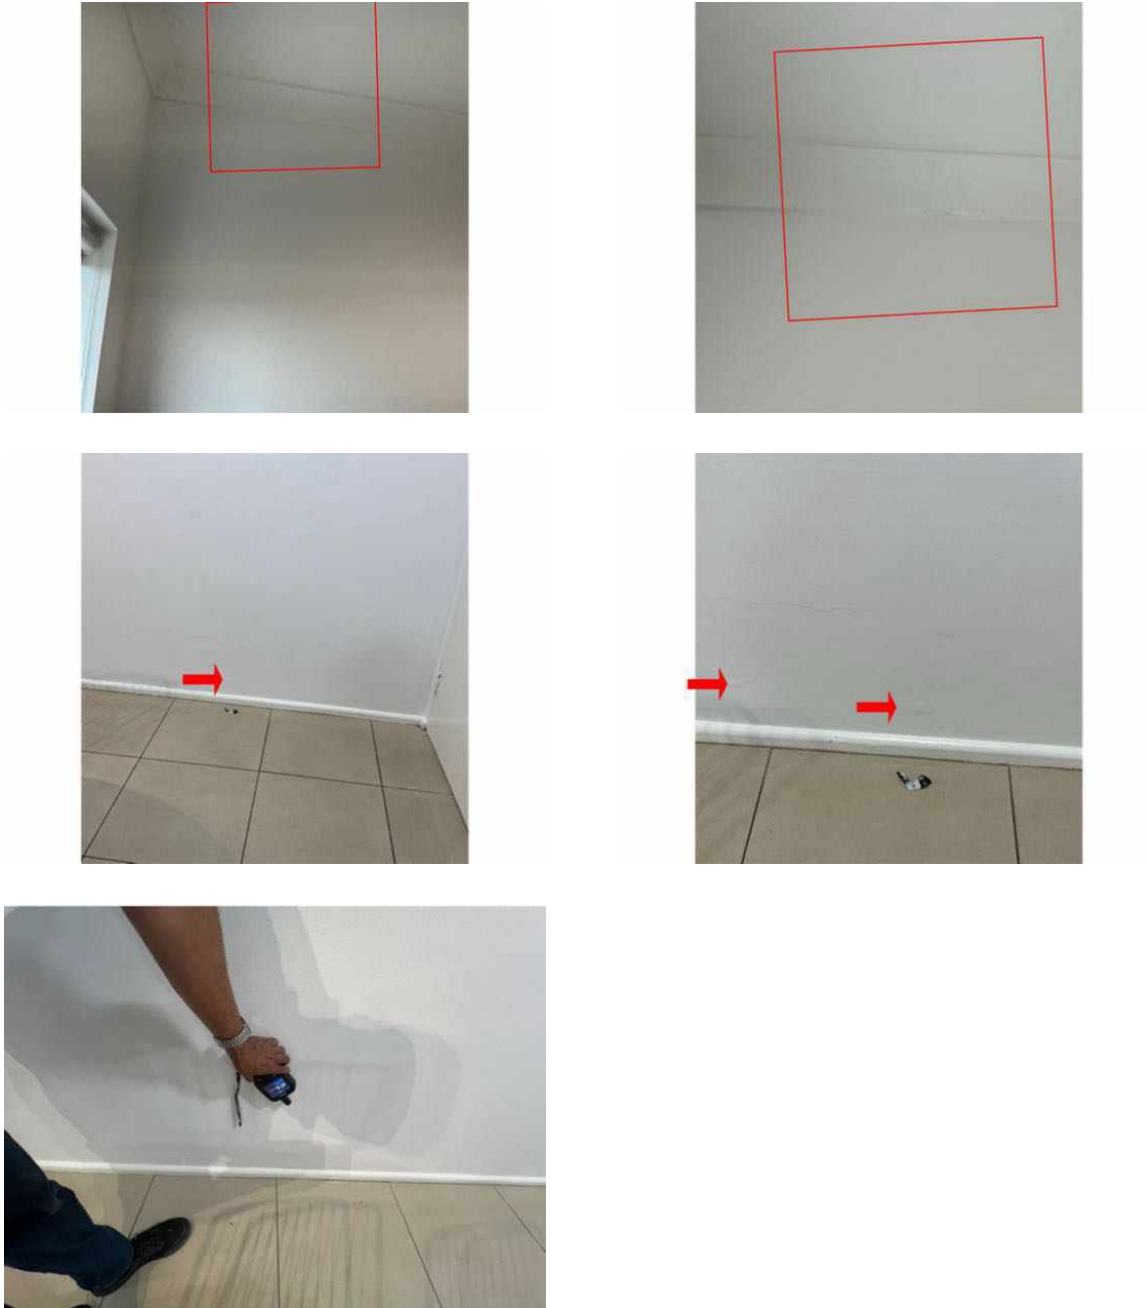
Finding 3.01

Building:	Main Building
Location:	Bedroom, Lounge, kitchen
Finding:	Painted surface - Bubbling (Further investigation required)
Information:	Sections of paint in this area was found to have bubbled and deteriorated. Paint bubbling is generally an indication of excessive moisture in the area, that is currently

The presence of excessive moisture can have major implications on associated building elements if left unattended. While only seemingly minor at this stage, the damage cannot be determined due to the paint obstructing any further inspection of the damage.

It is highly advised that the affected paint be cleaned to allow a further, more invasive inspection by a licensed plumber. Failure to act on this defect may necessitate major works in the future.

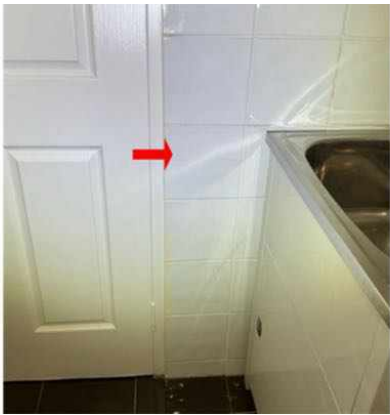
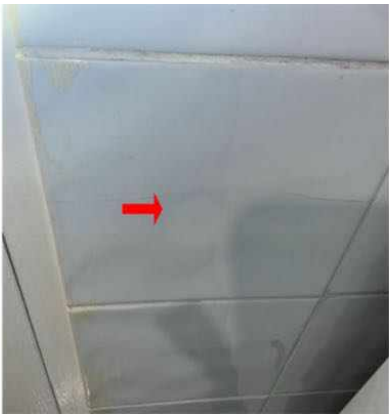
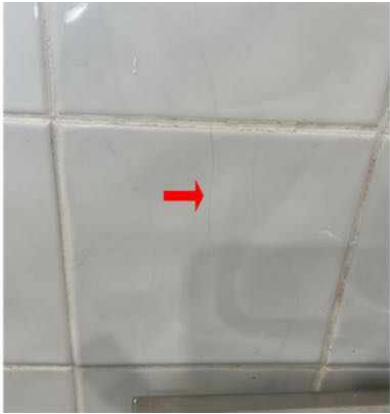
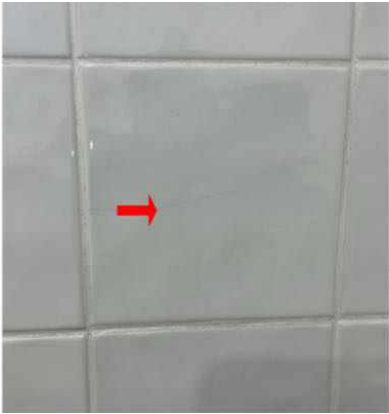
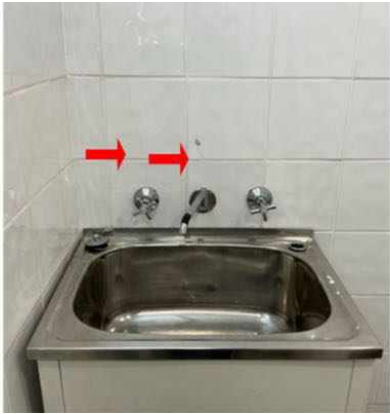
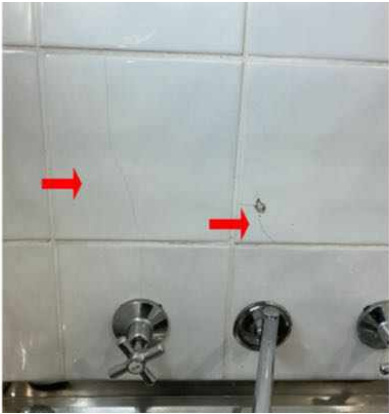
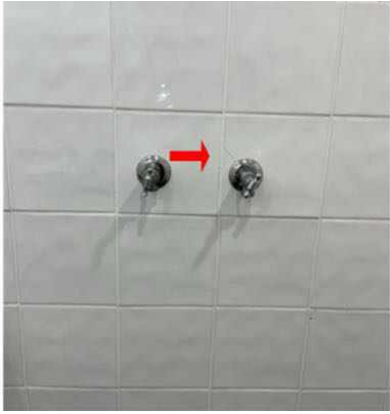
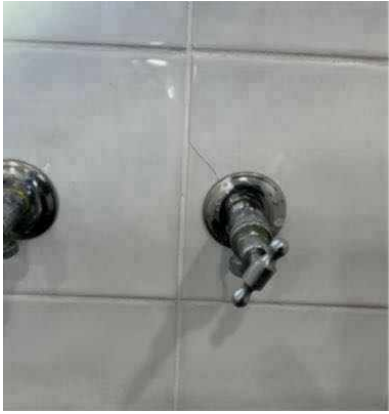
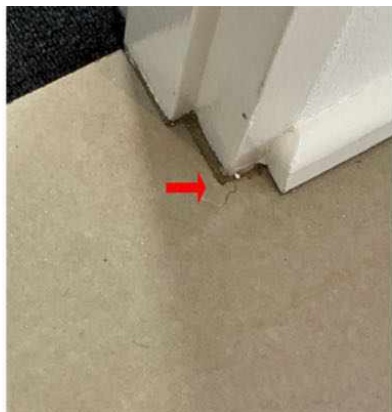
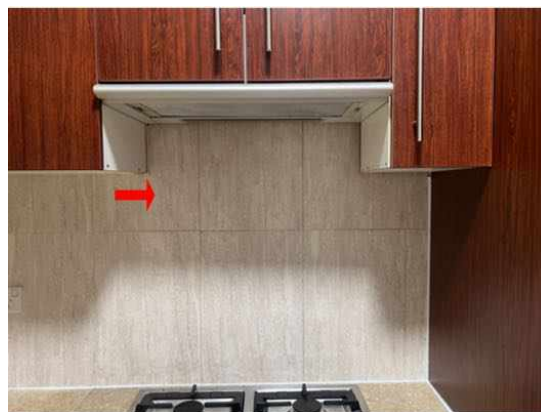
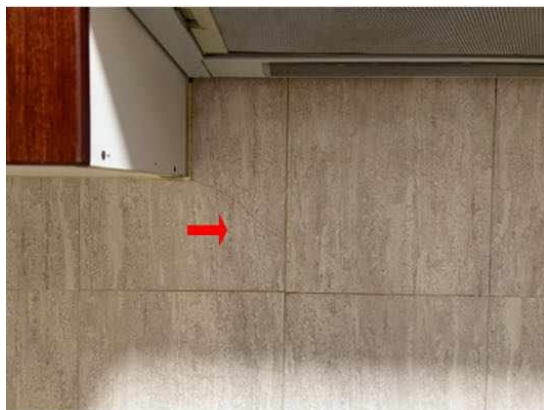
Finding 3.02

Building: Main Building
Location: All Internal Areas - Bathroom , Kitchen , Lounge
Finding: Tiles - Cracked or damaged - to some areas
Information: Cracking was evident to the tiling in this area at the time of inspection. While the cracking appears to be minor, this area is frequently exposed to water, allowing potential for water penetration into adjoining sections of walls or flooring.

If left unmanaged, water penetration to these areas may lead to subsequent water damage, which is likely necessitate repair work to affected building elements.

A tiling contractor should be appointed to ensure that no further water damage occurs. The re-application of silicone and grouting throughout remaining tile work is also advised, to further protect the area against water penetration.

Where water penetration has led to water damage, appointment of a relevant tradesperson may be required to repair damaged building elements.

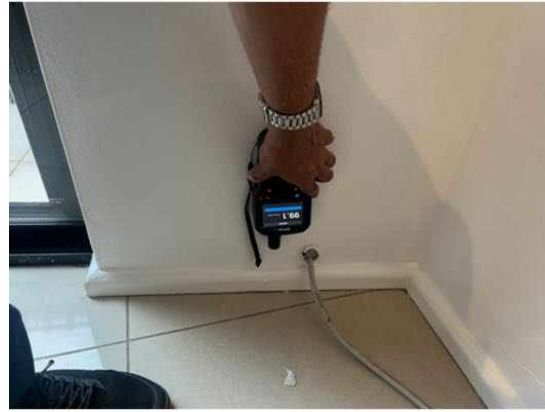
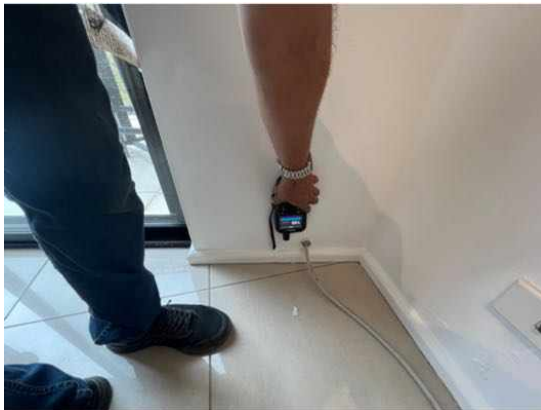
Finding 3.03

Building:	Main Building
Location:	Balcony
Finding:	Balcony Elevated Moisture - Strata (Further investigation required)
Information:	Elevated moisture was recorded at the base of the balcony adjacent wall and floor tiles. While no internal visible damage was visible at the time of inspection, balconies in multi-unit dwellings are high-risk areas for waterproofing failure, which can lead to leaks into adjoining units and significant rectification costs. Further investigation by a licensed waterproofing contractor is strongly recommended.

Depending on the strata plan, this area may form part of the common property, in which case remedial responsibility may rest with the owners corporation (strata). Purchasers should seek clarification from the strata manager and legal adviser prior to purchase.

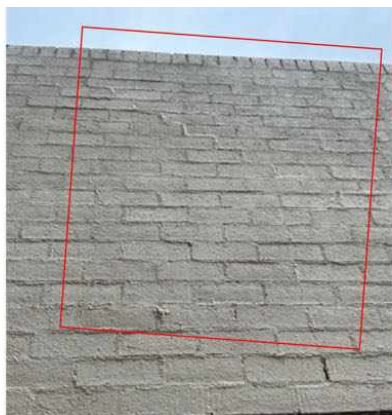
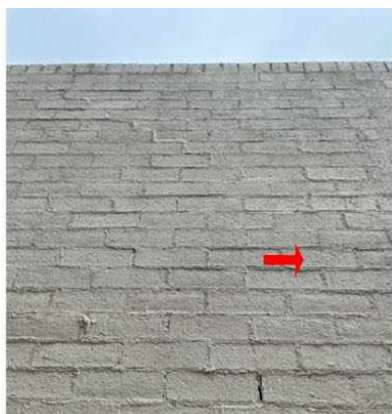
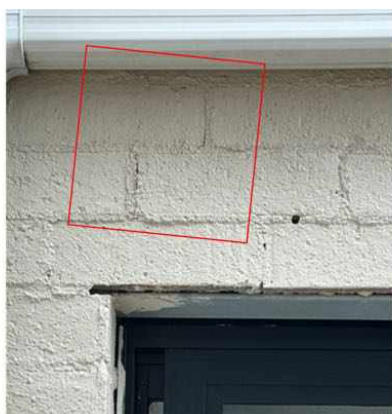
Finding 3.04

Building: Main Building
 Location: Balcony
 Finding: Brickwork - Step cracking
 Information: Step cracking was identified to the brickwork in this area at the time of inspection. Step cracking, which is similar to other forms of cracking, has a variety of possible causes. However, the most common is the subsidence of adjacent footings.

Step cracking is a relatively common defect, and is most likely to occur adjacent to windows, doors and other openings. Mortar failure in the gaps between affected bricks indicates the stresses and tensions affecting the wall.

Where step cracking is extensive or severe, the client is advised to consult a structural engineer. Minor step cracking can be used as a warning sign to address factors causing stress to the wall, which can include the effect of surrounding trees, water leaks, soil erosion, or even the presence of reactive soils in the surrounding area.

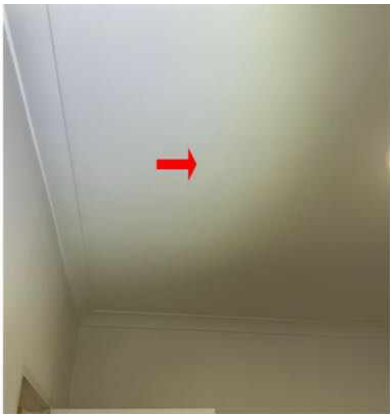
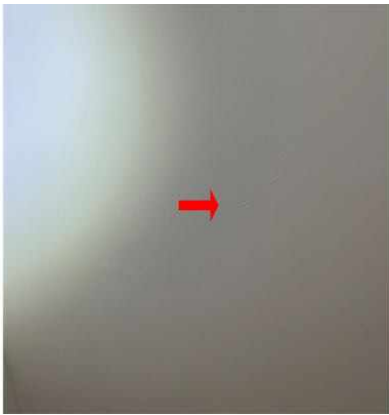
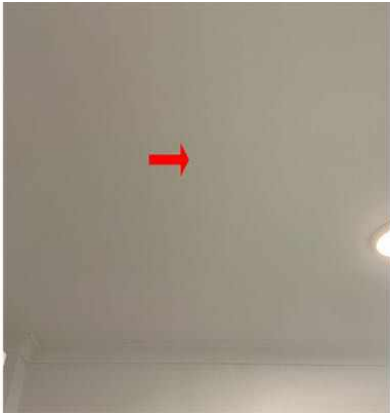
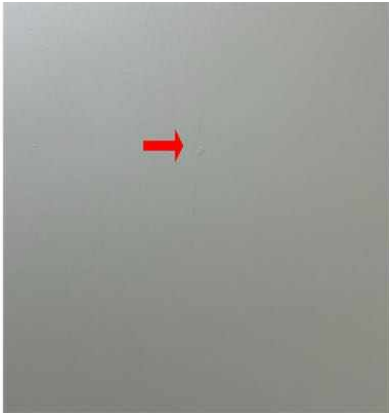
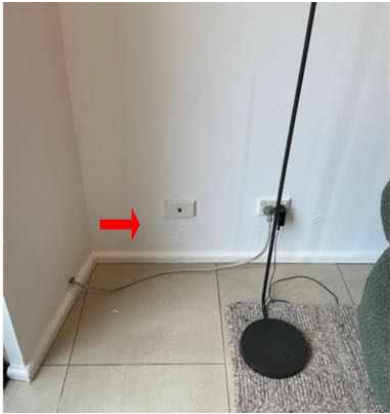
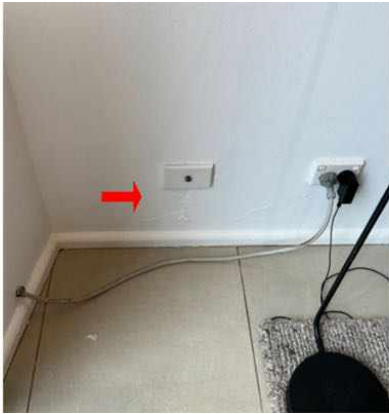
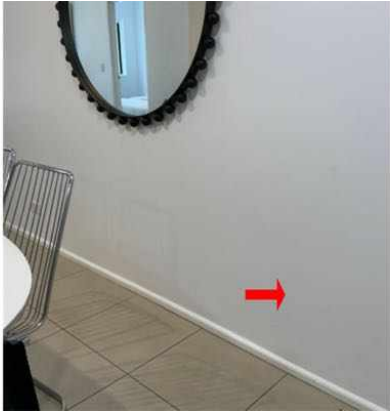
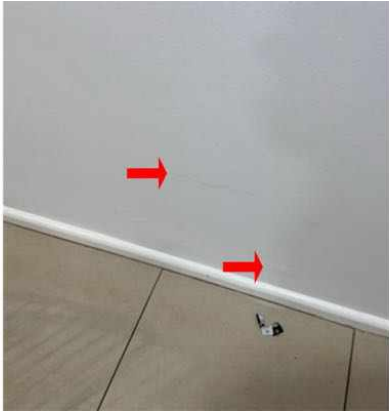
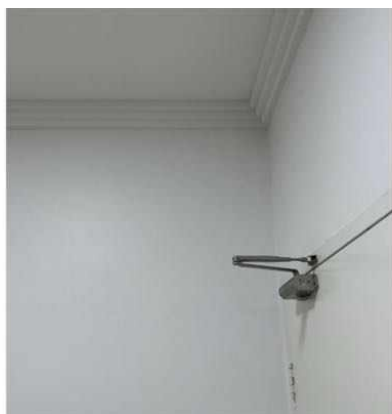
Finding 3.05

Building: Main Building
 Location: All Internal Areas
 Finding: Paint finish and hairline cracking
 Information: The paint finish in this area was identified as being incomplete at the time of inspection including some hairline minor cracking.

Whilst incomplete or missing paint finish is generally an appearance defect, it can also lead to the development of secondary building defects over time. Incomplete areas of paint finish expose the area to moisture, potentially accelerating the deterioration of underlying building materials.

Incomplete paint finishes should be sanded back, filled, leveled and painted, as applicable. Where inadequate or missing paint protection has led to the deterioration of the associated building element, repair and/or replacement of this building element may be required.

A painting contractor should be appointed as soon as possible to perform necessary works to aid the appearance of the affected area and to ensure the area is protected against further deterioration. Alternatively, the homeowner following manufacturer instructions may perform these works.

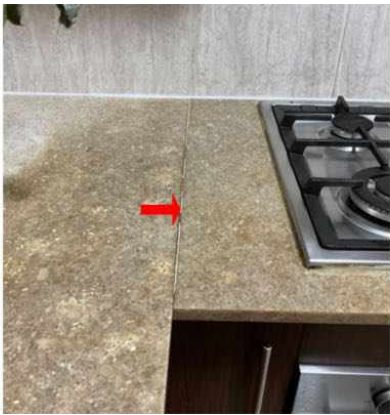
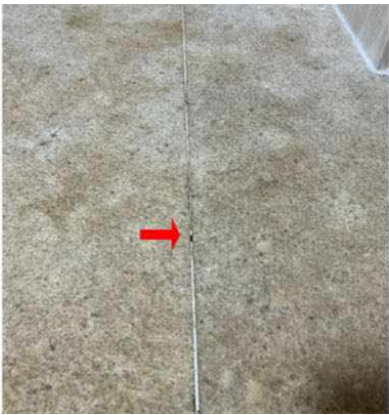
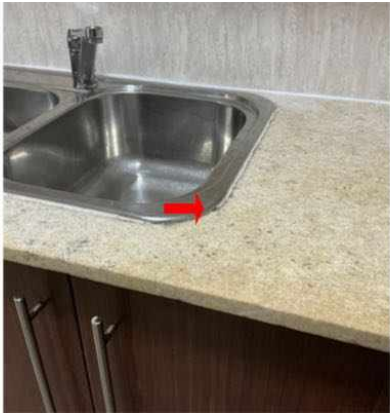
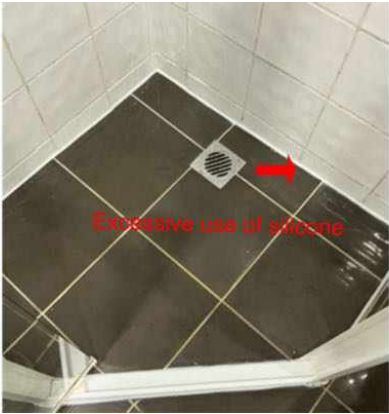
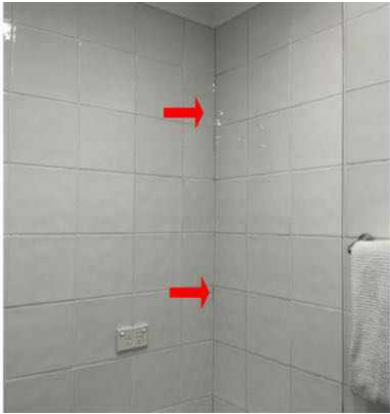
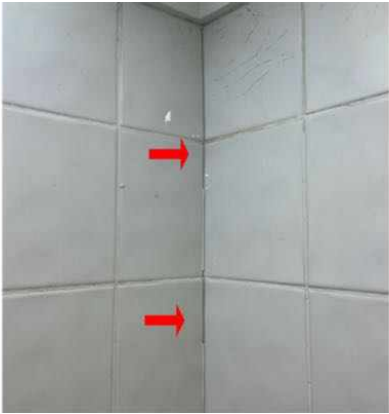
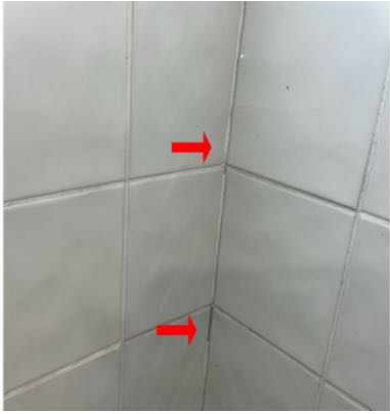
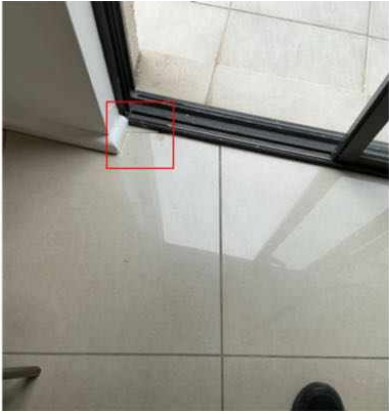
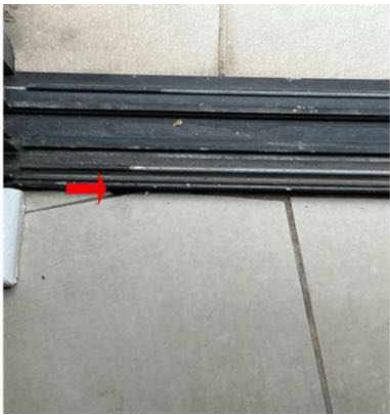
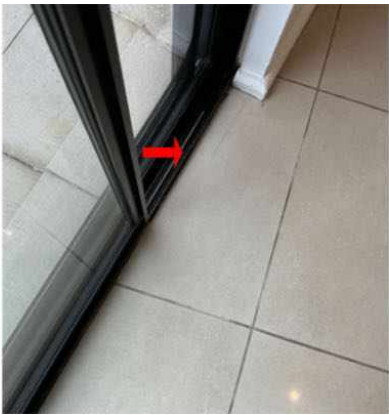
Finding 3.06

Building:	Main Building
Location:	All Internal Areas
Finding:	Sealant and grouting - Missing or degraded
Information:	It was noted on inspection that sealant or grout is degraded. There is also evidence of poor workmanship and excessive use of sealant. Silicone should never be used as a first line of defence against waterproofing. Further inspection by a licensed waterproofing contractor is highly recommended.

Different materials and floor areas move at different rates, generally causing cracking to grout or sealant at this point. A flexible sealant is required to allow for expected expansion and contraction, while keeping the joint water tight and protective of all associated building materials.

There appears to be excessive mould to the sealant and grout which will likely require scraping out and replacement.

Flexible and mould resistant materials should be applied to affected areas to prevent any subsequent water damage that is likely to occur. Regular maintenance and replacement of damage or missing or damaged sealant and grout is highly recommended to the wet areas, as this is a regular wear and tear defect. Sealant and grouting in areas that come into regular contact with water should be maintained for the long term care of your property.

A sealant specialist or tiling contractor should be appointed to complete these works as soon as possible.

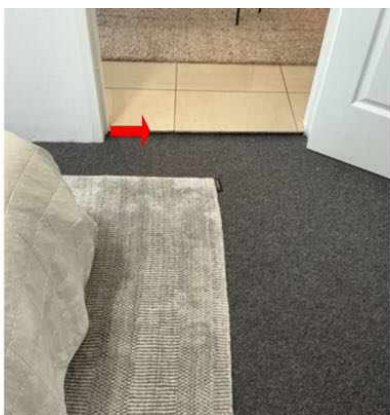
Information: The installation of this building element appears to have been completed to a substandard level of workmanship or is incomplete. Generally substandard repairs or installation are related to poor workmanship, the use of inappropriate materials, or a failure to complete installation to a suitable standard.

Where installation is substandard and/or incomplete, the client should contact the responsible trade to undertake rectification. Unfinished and substandard building works are likely to degrade more quickly and may create potential for secondary defects to associated building elements.

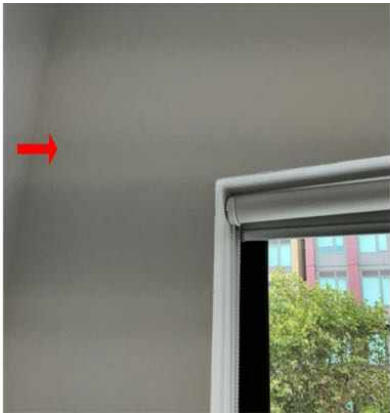
Finding 3.09

Finding: Cracks to internal render - Category 1 or repairs to some areas

Information: It has been observed that cracking to internal rendered surfaces has occurred. The degree of damage falls within Category 1, described as fine cracks that do not need repair and which are less than 1.0mm in width limit.

Damage of this category is not considered a defect for rectification. Always contact your building inspector should cracks widen, lengthen, or become more numerous.

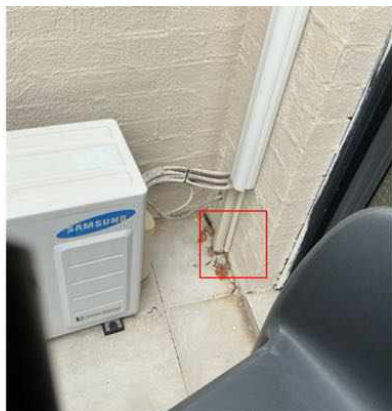
Finding 3.10

Building: Main Building
Location: All Internal Areas
Finding: Air conditioner - Disconnected overflow
Information: The Air Conditioner (A/C) overflow was found to be disconnected from storm water drainage and is creating excessive moisture in the surrounding area.

Such leaking creates an environment which is conducive to an array of defects,

including water damage to associated building elements and the attraction of termite or timber pest infestation.

It is highly recommended that a licensed plumber be appointed to connect the A/C overflow in order to prevent such an environment from being created. These minor works should be carried out as soon as possible.

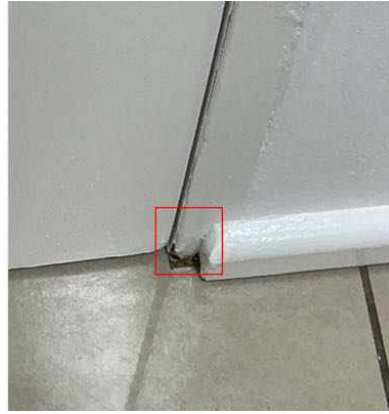
Finding 3.11

Building:	Main Building
Location:	Front Elevation
Finding:	Building element - Rusted or corroded
Information:	This building element shows evidence of rusting and corrosion, which is likely to have developed as a result of excessive exposure to moisture and or inadequate coatings.

As surface rust provides no protection to the underlying iron, the deteriorating condition is likely to worsen if not addressed in the short-term future.

Where possible, the use of galvanized (treated) metals or aluminium coated metals aid in rust prevention, as does regular general maintenance. Rust formation can be controlled with coatings, such as paint, that isolate the iron from the environment.

Rusting and corrosion should be managed by ideally removing or limiting the affected surface from exposure to moisture. A registered builder may be appointed to replace any building elements that have been severely affected by rust or water damage.

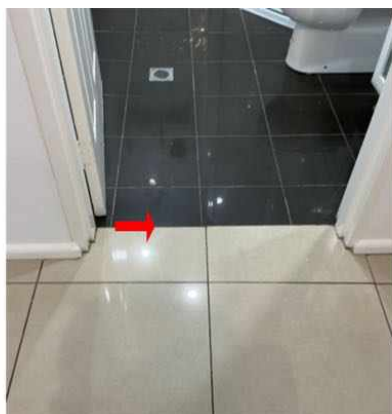
Building: Main Building
 Location: All Internal Areas
 Finding: Bathroom & external floor threshold
 Information: The bathroom floor is at the same level as the adjoining timber flooring. This configuration is typical in modern apartments and is permitted where compliant waterproofing and floor falls are provided. No evidence of moisture damage was observed at the time of inspection; however, waterproofing performance cannot be confirmed without invasive inspection.

Care should be taken to avoid excessive water migration beyond the bathroom during use.
