Building and Timber Pest Inspection Report

Inspection Date: Thu, 15 Jan 2026

Property Address: 3A Coach Cres, Currans Hill NSW 2567,
Australia

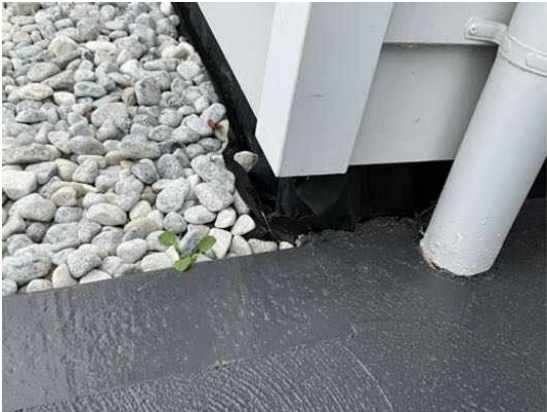
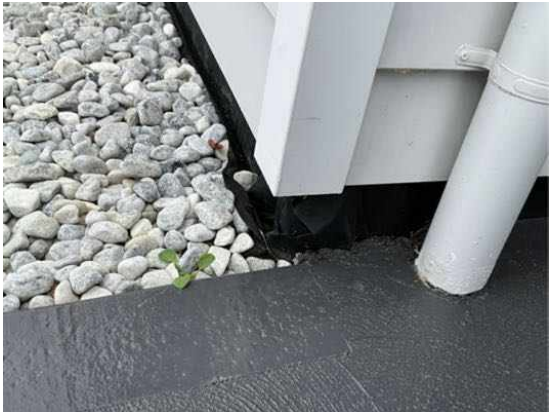
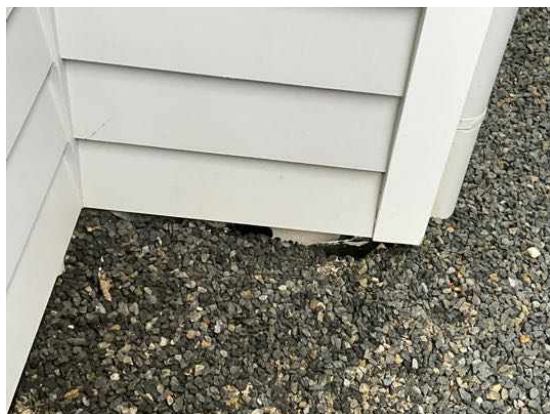
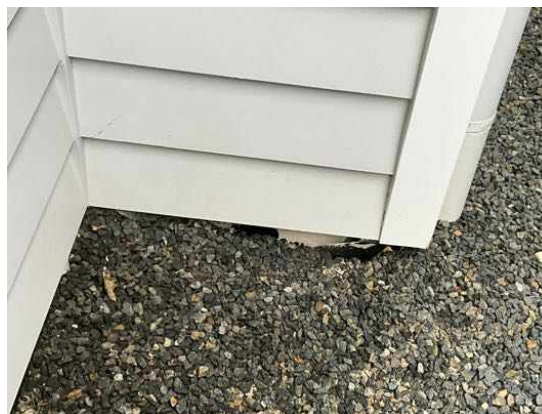
Building: Main Building
 Location: All Areas
 Finding: Flashing deteriorated
 Information: The flashing installed between the timber frameworks and the panels of the building is deteriorated. This deterioration includes visible corrosion, gaps, and cracks, which compromise the effectiveness of the flashing in preventing water ingress.

1. Water Ingress: Compromised flashing can lead to water penetration causing moisture to infiltrate the building envelope.
2. Structural Damage: Continuous exposure to moisture can lead to timber rot, weakening the structural integrity of the timber framework and surrounding materials.
3. Mold and Mildew Growth: Moist conditions promote mold and mildew growth, which can cause health issues for occupants and further damage building materials.
4. Insulation Damage: Water ingress can damage insulation, reducing the building's energy efficiency and increasing heating and cooling costs.
5. Aesthetic Issues: Water staining and damage can affect the building's appearance, potentially lowering property value and requiring costly repairs.

A licensed and qualified roofer with experience in flashing installation and repair should be engaged to address this issue. The contractor will:

- 1. Assess the extent of the deterioration.
- 2. Remove the damaged flashing.
- 3. Install new, properly sealed flashing to ensure water tightness.
- 4. Inspect adjacent areas for any signs of water damage and repair as needed.

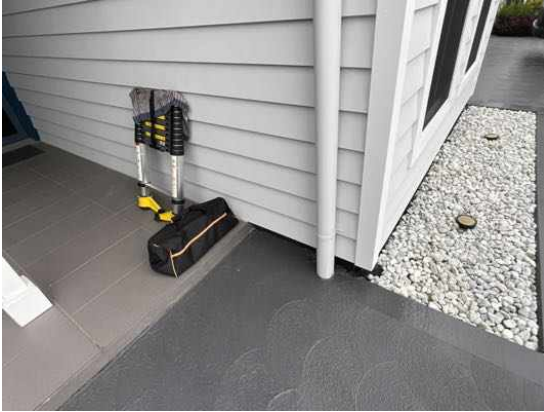
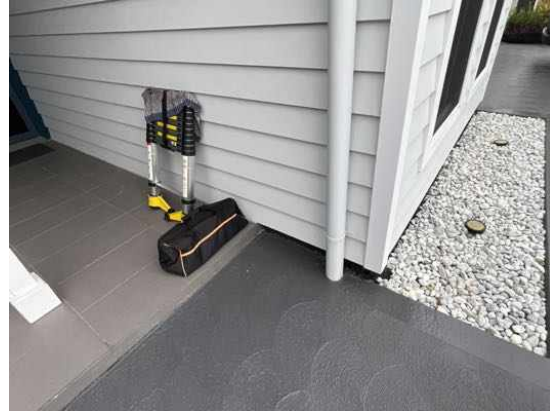
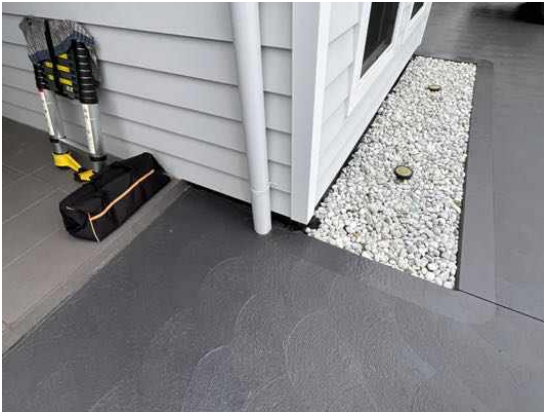
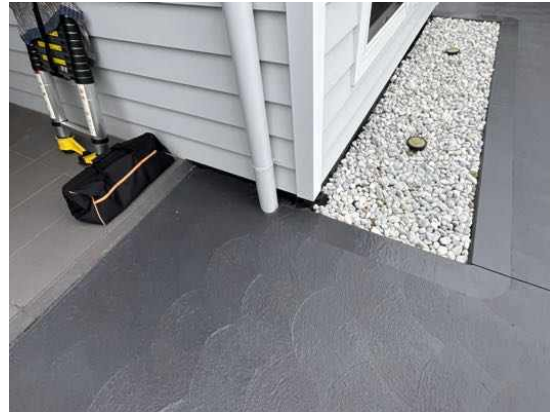
Finding 3.02

Building:	Main Building
Location:	Front Elevation
Finding:	External Cladding – Missing Bottom/starter Trims
Information:	The bottom trims / starter trims to the external wall cladding were observed to be missing in areas inspected. This has resulted in exposed lower edges of the cladding and gaps at the base.

- Increased risk of moisture ingress behind the cladding, potentially leading to deterioration of framing and wall components.
- Potential pest entry (including insects and vermin) through exposed gaps.
- Reduced durability of cladding due to exposure of cut edges.
- Possible non-compliance with manufacturer installation requirements and building standards.

The missing bottom trims should be installed to adequately seal and protect the lower edge of the cladding system.

A licensed builder or qualified cladding installer should be engaged to supply and install appropriate bottom trims in accordance with the cladding manufacturer's specifications and relevant Australian Standards.

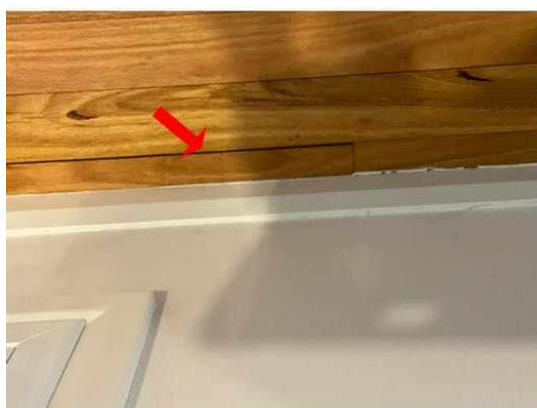
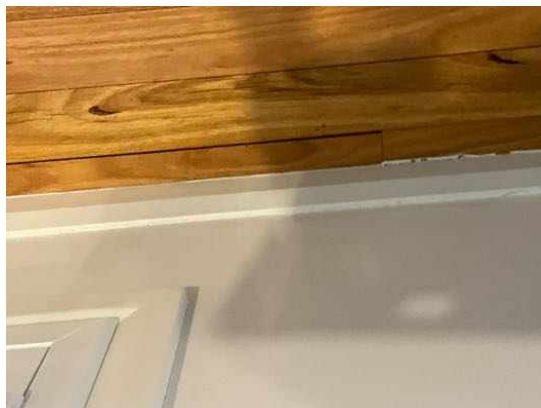
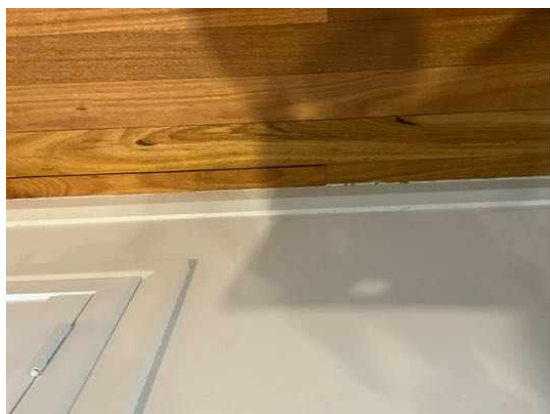
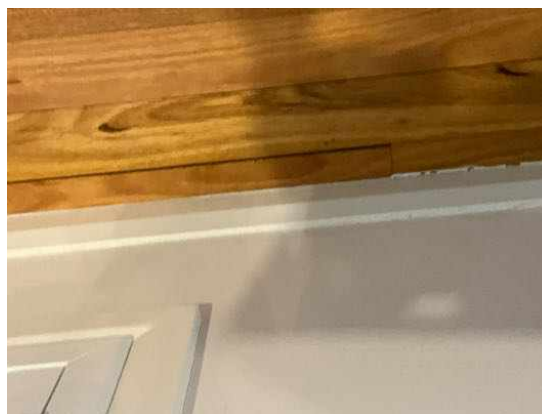
The gaps pose a tripping hazard and can accumulate dirt and debris, affecting the aesthetic appeal of the flooring. Additionally, exposure to moisture or changes in humidity may exacerbate the issue, potentially leading to long-term damage.

A flooring specialist should inspect and address the gaps in the timber flooring. The professional can employ appropriate techniques, such as filling, sealing, or adjusting the floorboards to ensure a safe and aesthetically pleasing floor surface.

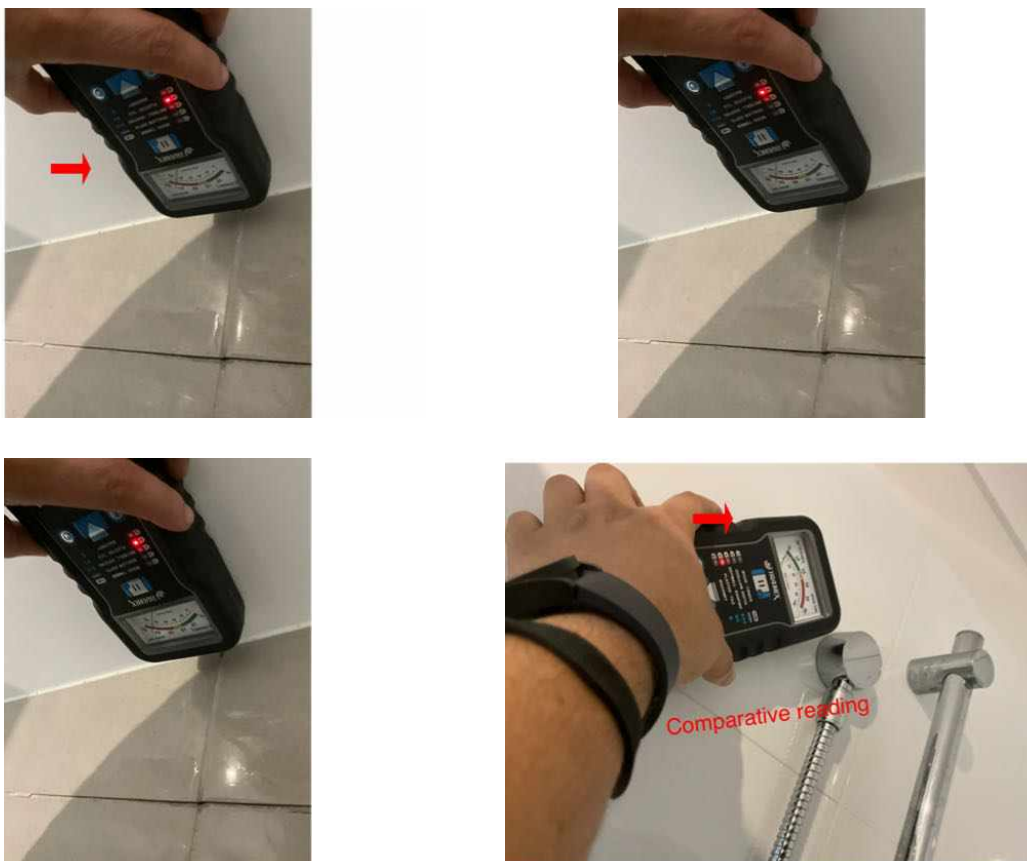
Finding 3.05

Building:	Main Building
Location:	Ensuite
Finding:	Shower - Damp
Information:	Damp is evident to the lower 300mm of wall to the shower alcove. This defect is quite common, and is suspected to have been caused by moisture permeating through the grouting in this area, which shows evidence of deterioration. Leaking pipes within the adjoining wall is also a possible cause.

Damp (or structural damp) refers to the presence of unwanted moisture in the structure of a building, either as the result of intrusion from outside, or condensation from within the structure. In the shower area, internal water leaks or other sources of excessive moisture are generally the cause of damp.

Unmanaged damp in the shower recess is likely to facilitate the formation and development of mould and fungi growth, decaying associated building materials and compromising their structural integrity. It is important to address damp conditions, as the World Health Organisation notes that excess moisture leads - on almost all indoor materials - to growth of microbes such as moulds, fungi and bacteria, which subsequently emit spores and other matter into the indoor air. Exposure to these contaminants is associated with a wide range of respiratory and other health-related problems.

Consultation with a qualified plumber or bathroom specialist is advised immediately to identify the cause of damp and to perform remedial works as required. Where excessive mould growth is present, further inspection by a specialist environmental health inspector should also be considered.

Always ensure that sealant and grout is in good condition to prevent any moisture issues occurring in the future.

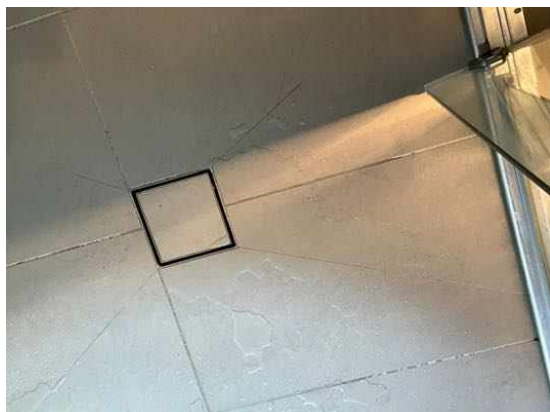
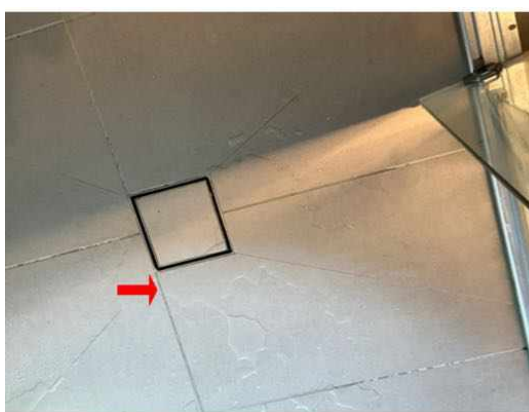
Finding 3.06

Building:	Main Building
Location:	Ensuite
Finding:	Shower base - Water pooling
Information:	Evidence of water pooling around the floor waste in the shower recess was noticed at the time of inspection. It is suspected that this excessive moisture is attributed to insufficient fall in the shower floor tiles.

This pooling is minor overall but is still considered unsatisfactory, as standard tiling practices would not permit this situation to occur. Pooling water around floor wastes can create a slip hazard in extreme cases and create conditions that are conducive to mould growth over time. Where left unmanaged, the degradation of sealant and grouting is also likely to occur, possibly necessitating further repair works.

Remedial works may involve some sections of tiling and flooring repair and replacement. A tiling contractor or bathroom specialist should be appointed to provide further advice on reparation options and to perform works as necessary.

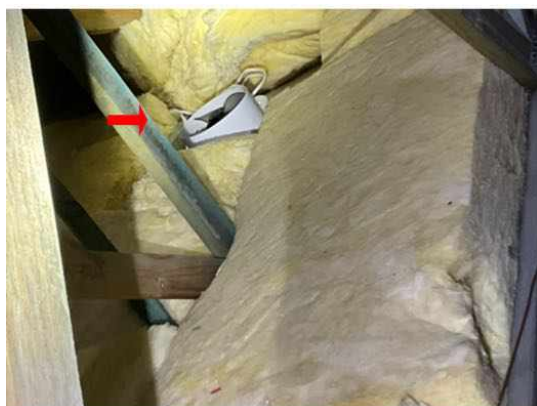
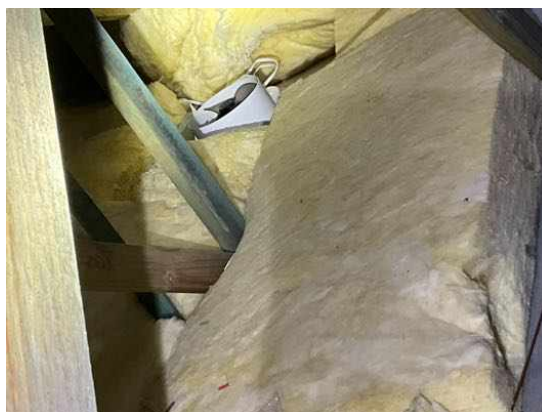
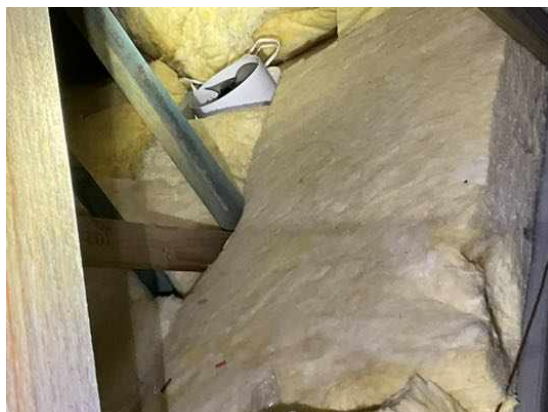
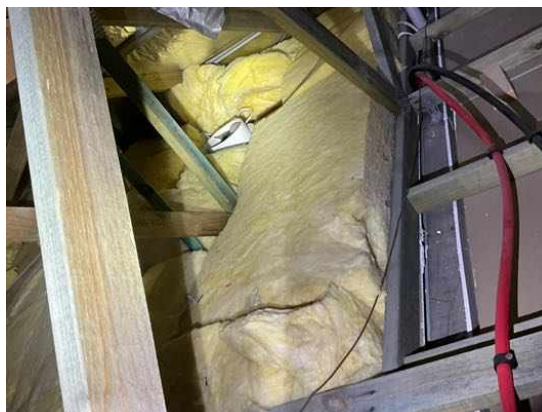
Finding 3.07

Building:	Main Building
Location:	Roof Void
Finding:	Exhaust fan not vented out
Information:	The exhaust fan located within the roof void is not appropriately ducted to the external atmosphere and is currently discharging moist air directly into the roof space. This is considered a defect under AS 4349.1, as it does not meet the minimum standard of residential building performance expected under normal residential building practices.

This condition may lead to excessive condensation within the roof void, increasing the risk of mould growth, deterioration of insulation, timber decay, and overall reduced durability of building elements. It may also result in poor indoor air quality, potentially affecting occupant health.

It is recommended that the exhaust fan be modified by a licensed HVAC contractor or qualified builder, ensuring it is properly ducted to discharge externally in accordance with manufacturer specifications, the National Construction Code (NCC), and applicable Australian Standards.

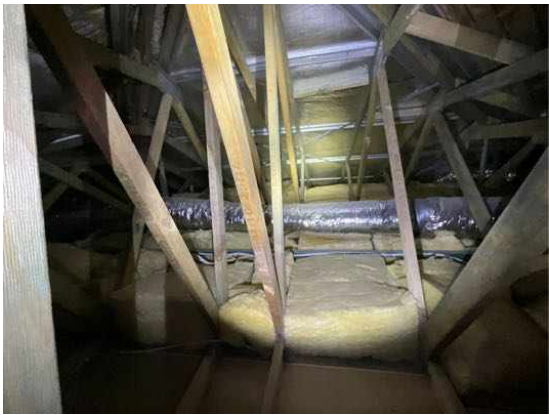
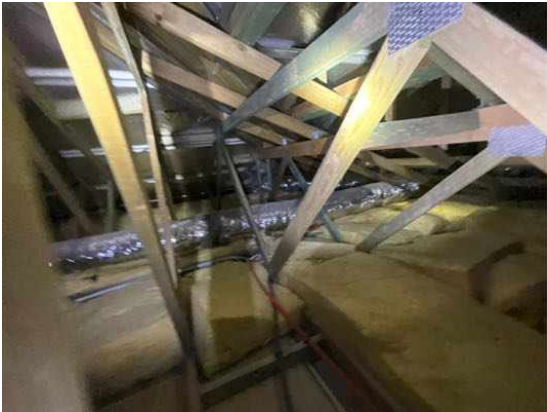
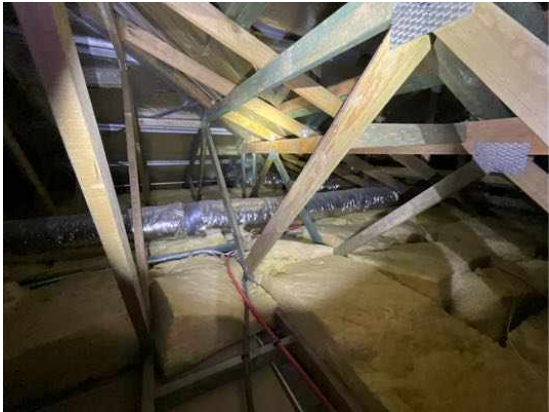
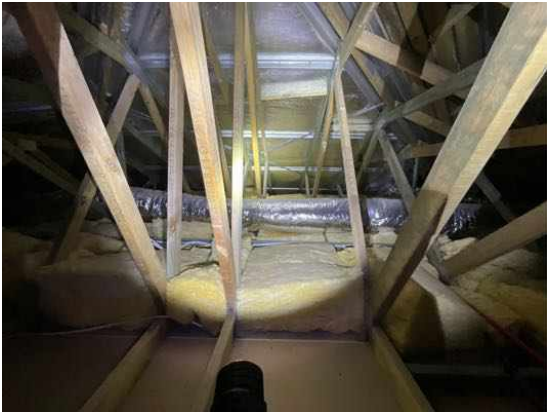
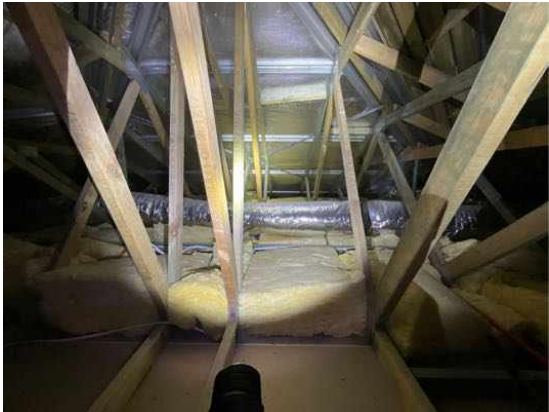
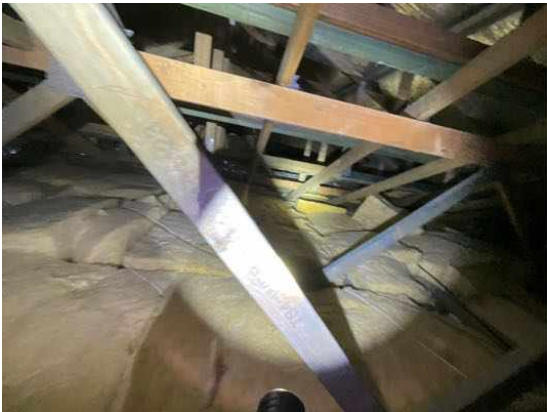
Finding 3.08

Information: Sections of insulation in the roof void have been poorly installed or moved from their original position and are covering down light fittings. While the down lights have been fitted with appropriate protective covers, the presence of this insulation creates a potential fire hazard.

Any insulation within the vicinity of down light fixtures should be moved and re-applied to more appropriate sections of the roof void, thus ensuring the area is fire-safe. An insulation contractor should be appointed as soon as possible to perform any necessary works as required.

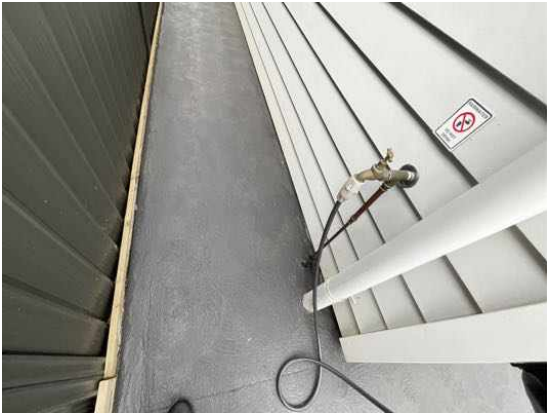
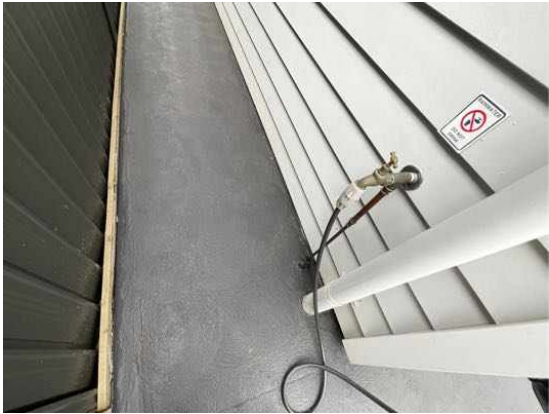
Finding 6.02

Building: Main Building
Location: All Areas
Finding: No Drain under tap
Information: There is no drain installed under the tap, leading to water accumulation and creating conducive conditions for timber pests. This defect needs immediate attention to prevent potential damage and pest infestation.
Risk:
1. Water Accumulation: Without proper drainage, water can accumulate around the base of the tap, leading to persistent dampness in the surrounding area.

2. Timber Pest Infestation: The damp environment created by standing water is highly conducive to timber pests, such as termites and wood borers, which thrive in moist conditions and can cause significant damage to wooden structures.

3. Structural Damage: Prolonged exposure to moisture can lead to wood rot and deterioration of structural timber, compromising the integrity of the building.

A licensed plumber or a qualified building contractor can address this defect by:

1. Assessment: Evaluating the area to determine the best approach for installing a proper drainage system under the tap.
2. Installation: Installing a drain that effectively channels water away from the base of the tap, preventing water accumulation and dampness.
3. Repair and Prevention: Inspecting and repairing any existing water damage and implementing measures to prevent future water accumulation and pest infestations.

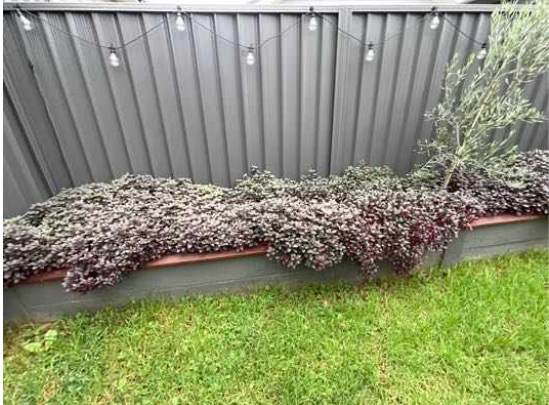
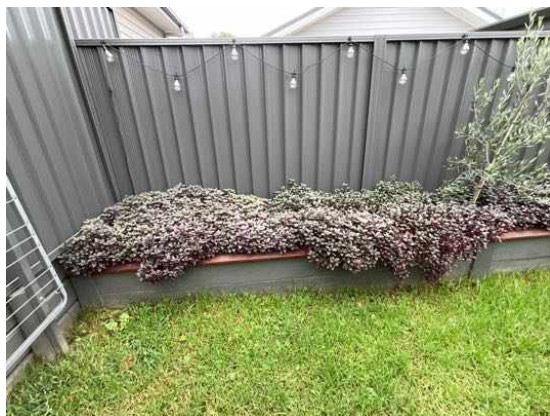
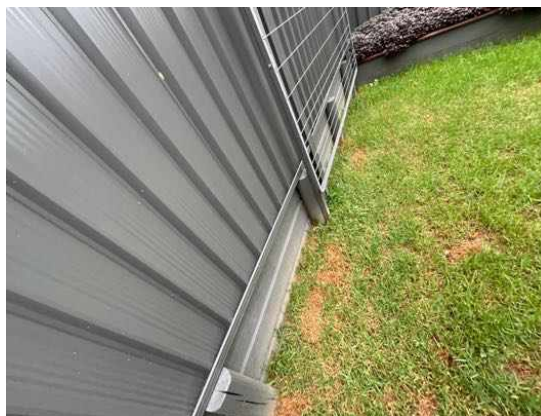
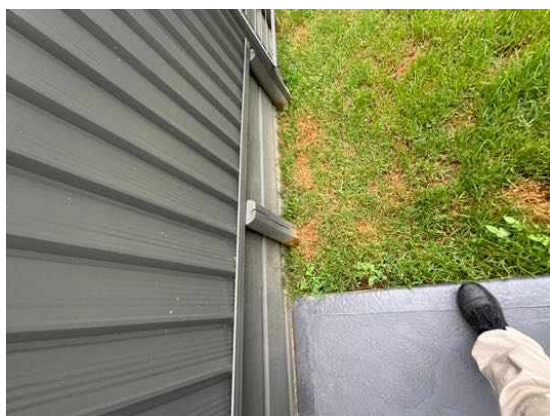
Finding 6.03

Building: Main Building
 Location: All Areas
 Finding: Timber on ground / conducive conditions to termite damage
 Information: Timber on the ground is indeed conducive to termite damage. Termites are known to thrive in moist environments, and wood in contact with soil or moisture is more susceptible to infestation.

To prevent this, it's important to keep timber elevated and away from direct ground contact. Regular inspections and proper termite control measures are also essential to protect your wooden structures from termite damage.

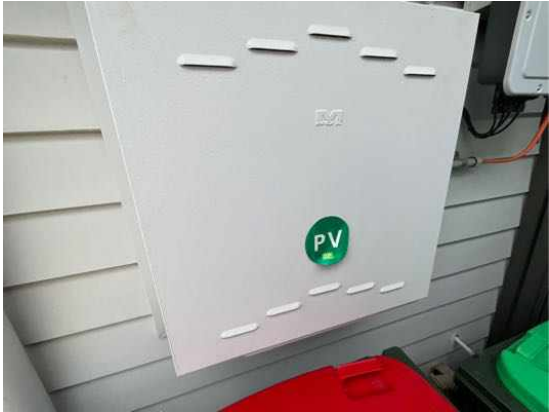
- Building: Main Building
- Location: Exterior walls - right side
- Finding: Evidence of Termite Management System - Durable notice / Legible Sticker - seek further information
- Information: The application of a pre & post-construction chemical termite barrier is highly recommended for all properties. Such barriers are highly effective in preventing termite

A durable notice placed in the switchboard unit to indicate termite barriers at the time of inspection.

Client must seek further information from the vendor or real estate agent if the conditions of termite management systems were maintained as per the label or seek advise from licensed pest controller.
