Building and Timber Pest Inspection Report

Inspection Date: Fri, 6 Feb 2026

Property Address: 4 Drapers Rd, Willow Vale NSW 2575,
Australia

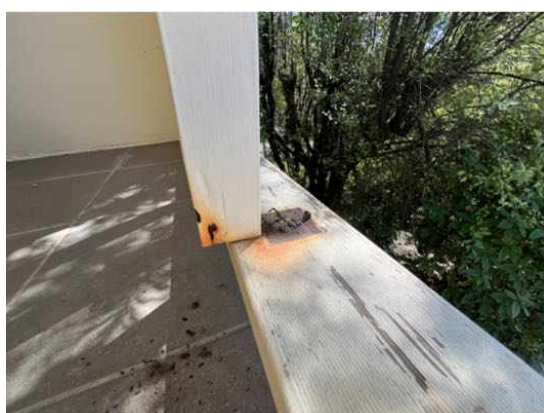
Building:	Building 1
Location:	Balcony
Finding:	Balustrade - Rusted Fixings
Information:	Corrosion was observed to fixings associated with the balustrade. Rusted fixings can reduce the effectiveness of connections over time and may contribute to loosening or instability of the balustrade if deterioration progresses.

Ongoing exposure to weather and moisture is a common contributing factor to this condition. Continued corrosion may lead to further deterioration of both fixings and adjoining timber elements.

It is recommended that a registered builder or qualified carpenter assess the balustrade fixings and determine whether repair or replacement is required to maintain adequate performance.

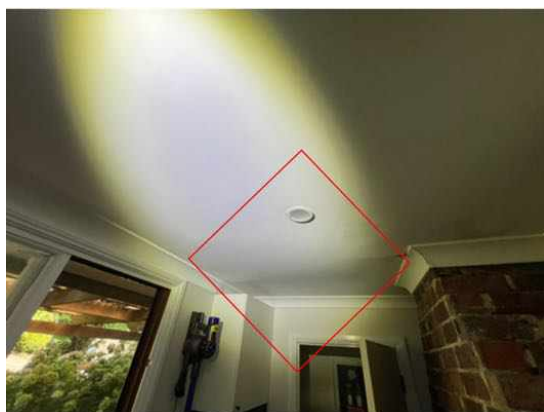
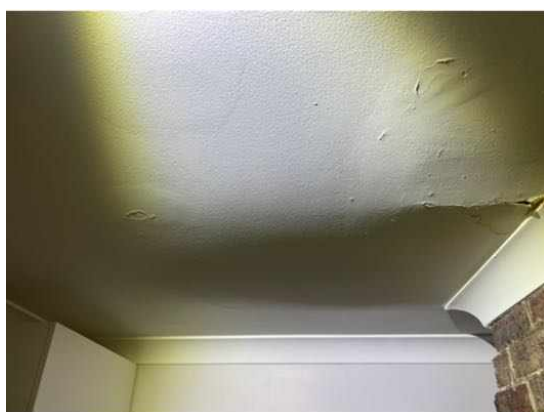
Information: Sections of the ceiling were found to be sagging at the time of inspection. Sagging to the fixed ceiling structure generally indicates that the building materials have swollen, due to contact with water, or that fixings (e.g. nails or glue) have become loose and require reattachment.

In some cases, sagging ceiling linings may also indicate that there are structural issues, causing surfaces to warp, twist or sag. Where sagging appears to be major, appointment of a structural engineer is advised to further inspect the property and identify the source and rectification works required.

Where minor sagging is evident, comparatively minor works, such as re-gluing of ceiling sheets, may be required. Such works may be performed by relevant tradespeople, such as plasterers and painters. Where excessive moisture has caused the roofing structure to swell and sag, the source of the water leak should primarily be identified prior to any remedial works being performed.

The appropriate action should be taken by the client as soon as possible to ensure that any potential further damage is limited.

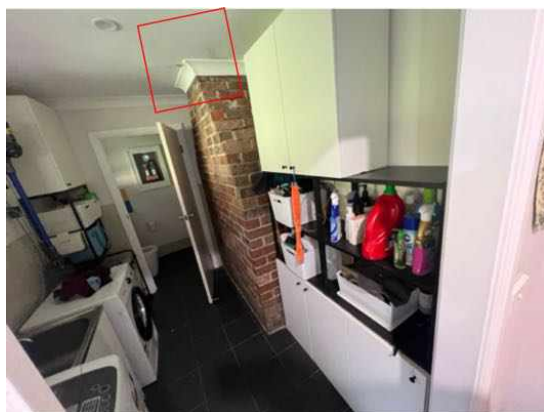
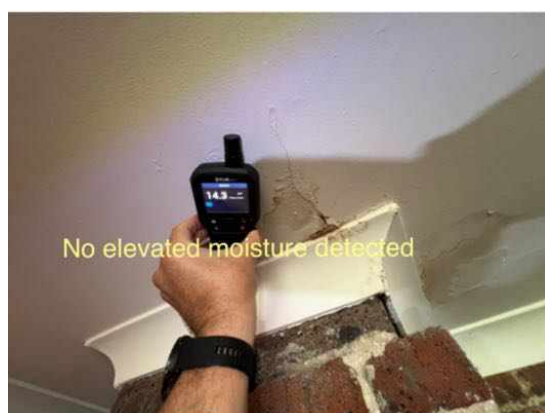
Finding 2.03

Building: Main Building
Location: Laundry

Finding: Ceiling - Water damaged.
Information: Water damage to the ceiling lining is generally an indication of excessive moisture being present in the roof void, usually via a leak to the roof covering.

Where water damage is evident to the ceiling, the primary requirement is to identify and rectify the source of the leak. A roofing plumber should be appointed as soon as possible to identify the leak and perform rectification works as necessary, ensuring the water damage is restricted.

Once the leak is repaired, consultation with relevant tradespeople, including plasterers and painters, is advised. Rectification works may include replacement of ceiling lining or minor repainting, depending on the extent of the damage.

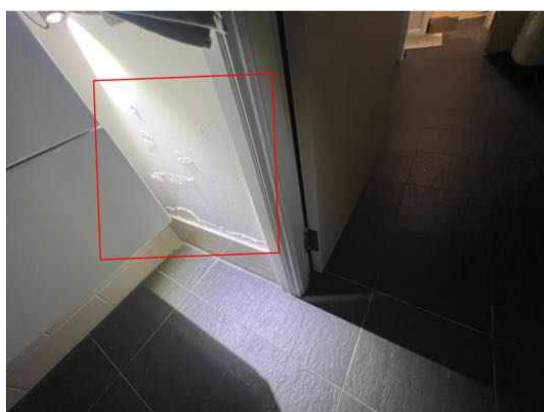
Building:	Main Building
Location:	Toilet (WC)
Finding:	Walls - Lateral damp
Information:	Lateral penetrating damp refers to the sideways movement of moisture,

predominantly from the surrounding ground, which tends to affect basement walls and other earth-retaining walls. The implications of unmanaged damp range from mould fungi growth, wood rot and decaying building materials, to finishes including lifting, bubbling, peeling and staining of paint, plaster and wallpaper.

It is important to address damp conditions as the World Health Organisation notes that excess moisture leads - on almost all indoor materials - to the growth of microbes such as moulds, fungi and bacteria, which subsequently emit spores and other matter into the indoor air. Exposure to these contaminants is associated with a wide range of respiratory and other health-related problems. Additionally, the development of damp in timber building elements also provides an environment that is conducive to termite / timber pest attack.

Structural waterproofing barriers or tanking barriers are often used to protect internal surfaces against the effects of lateral penetrating dampness. These types of work are generally undertaken where the source of the penetrating damp cannot be prevented.

Immediate consultation with a licensed plumber is advised to address the cause of the damp and to perform remedial works as necessary.

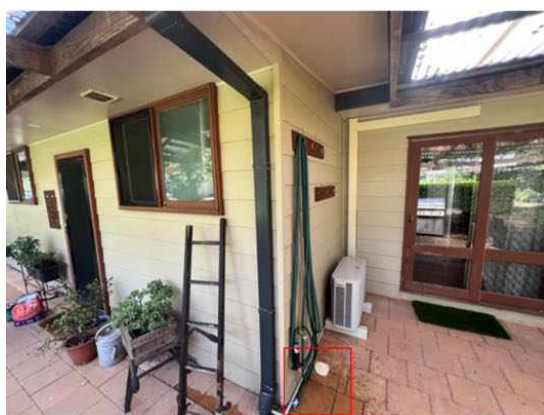
Finding 3.34

Building:	Main Building
Location:	Exterior walls - rear
Finding:	External taps - Not plumbed for drainage
Information:	The External taps is not plumbed or connected to suitable drainage, which has resulted in the surrounding area becoming excessively damp. These damp conditions can lead to secondary defects such as rot, rust or corrosion of associated building elements, the formation of fungal decay, or even the creation of potential slip hazards. When coupled with poor site drainage, pooling of water may also attract termite activity to this area. It is highly recommended that a qualified plumber be appointed to install adequate drainage to the overflow. These works will ensure that the area remains dry and free of any secondary defects.

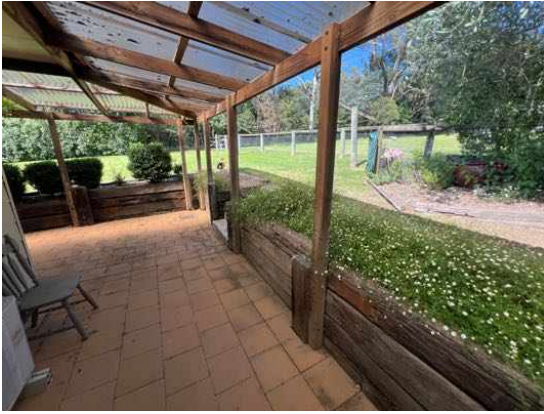
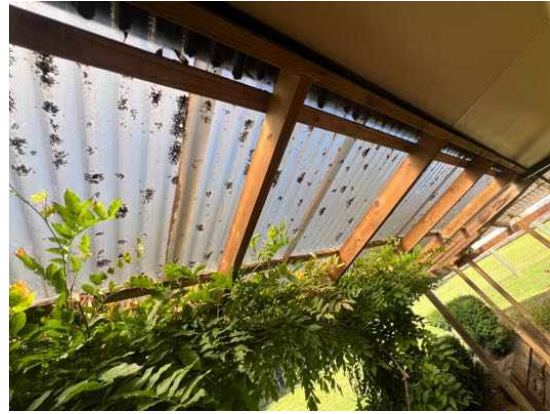
Finding 3.43

Building:	Main Building
Location:	Roof Exterior
Finding:	Roof plumbing - Loose flashing
Information:	Metal and other material flashings are applied to seals and intersections between roof coverings and building elements. They are designed to aid in weatherproofing of roof joins, and require regular inspection and maintenance as they are more subject to rust-related deterioration.

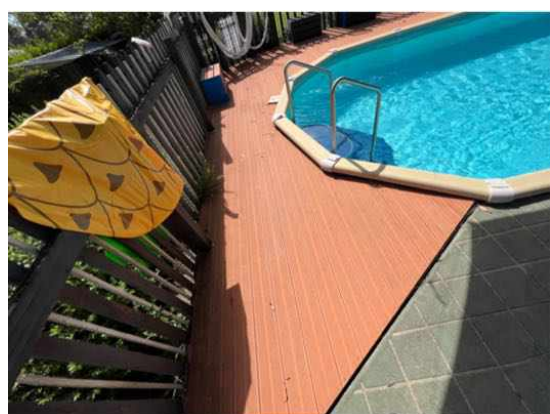
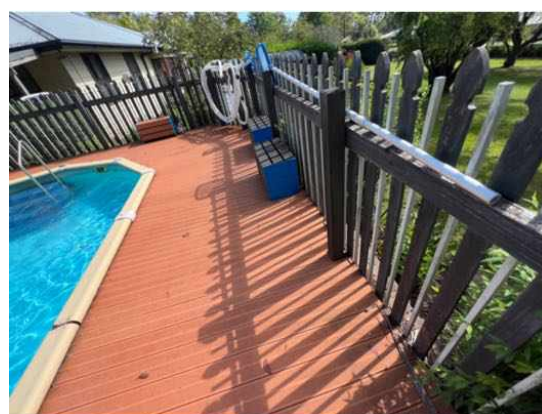
Finding 3.51

Building:	Main Building
Location:	Deck
Finding:	Subfloor structure - Wood rot
Information:	The subfloor structures are showing signs of deterioration and wood rot (fungal decay) of the timbers. It is suspected that this defect has developed as a result of damp conditions in the subfloor.

A registered builder, licensed carpenter or deck specialist should be engaged to assess and rectify the issue to ensure the deck's stability and longevity.

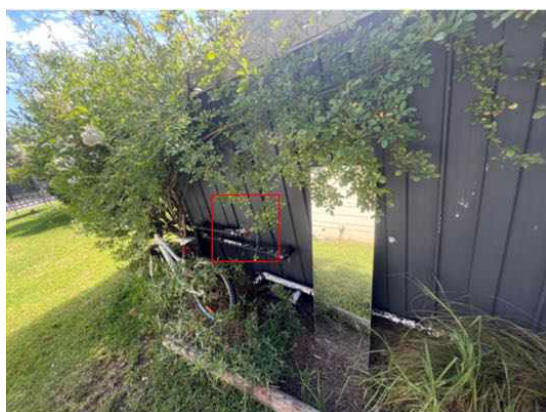
Finding 3.54

Building:	Yard
Location:	Shed
Finding:	Metal Sheets – Surface Rust and Deterioration (pool shed)
Information:	Surface rust and deterioration were observed to metal sheeting located adjacent to

If left unmanaged, continued corrosion may affect the durability and appearance of the metal components. The client should seek advice from a registered builder to assess the extent of deterioration and advise on maintenance or replacement as required.

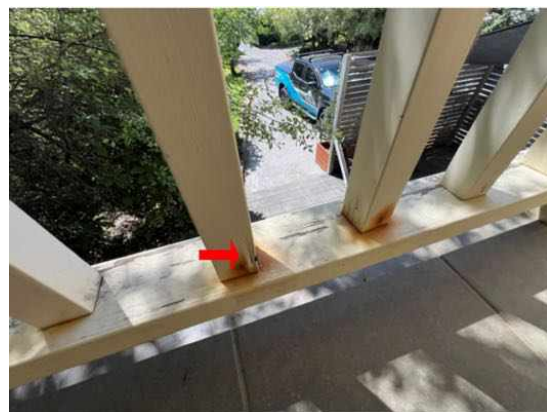
Finding 3.67

Building:	Building 1
Location:	Balcony
Finding:	Balustrade - Timber Decay
Information:	Timber Decay was observed to sections of the external balustrade. This type of condition is commonly associated with prolonged exposure to moisture and general weathering over time.

It is recommended that a registered builder or qualified carpenter assess the affected balustrade components and carry out maintenance or repair as required to limit further deterioration and maintain serviceability.

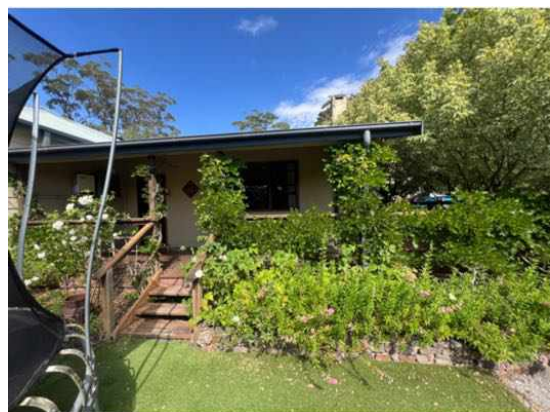
Finding 6.17

Building:	Main Building
Location:	All External Areas
Finding:	Vegetation Against Building - Conducive to Termite Activity
Information:	Vegetation and trees were observed in direct contact or in close proximity to the building at the time of inspection. This condition creates a conducive environment for termite activity by providing concealed access points, retaining moisture against the structure, and reducing ventilation. Additionally, vegetation can contribute to organic debris buildup, further increasing the risk of pest infestation.

It is recommended that all vegetation be trimmed back to allow adequate clearance from the building. Ongoing maintenance is advised to reduce the risk of termite activity and improve ventilation around the structure. Regular termite inspections should also be conducted to monitor for any signs of infestation.

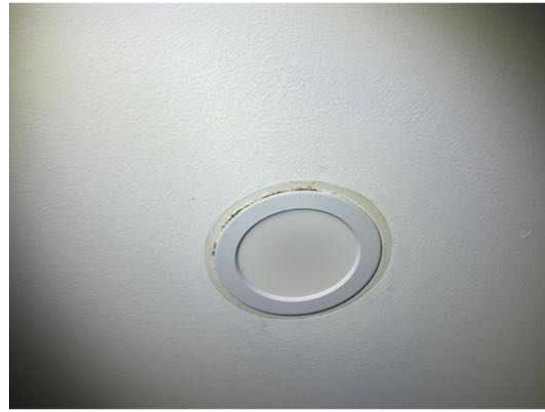
Building:	Main Building
Location:	Entry
Finding:	Paint finish - Incomplete
Information:	The paint finish in this area was identified as being incomplete at the time of inspection.

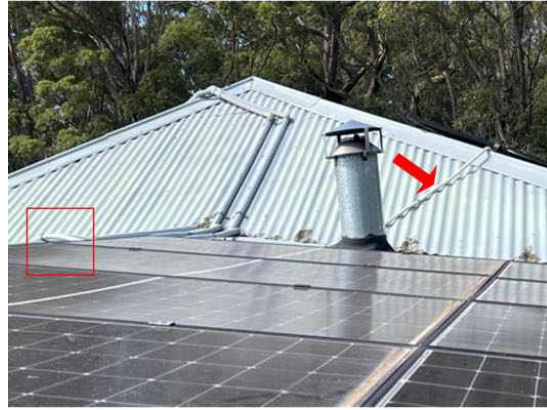
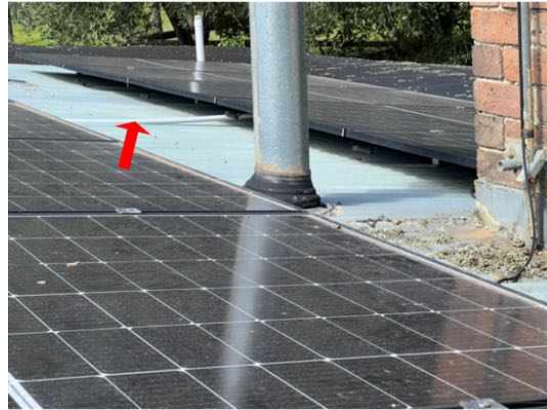
Building:	Main Building
Location:	Roof Exterior
Finding:	Roof - Redundant Pool Solar Pipework
Information:	Redundant pipework associated with a former pool solar heating system remains installed across sections of the metal roof sheeting. In addition, residual sealant and adhered material from the original solar heating installation were observed on the roof sheets beneath the current solar panel array.

This item is noted for the client's information only. The client may wish to make further enquiries with the installer or vendor regarding the installation method and any available alternatives, particularly if future roof works or maintenance are planned.

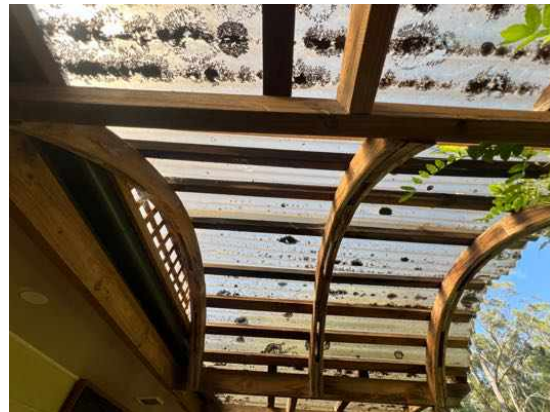
Building:	Main Building
Location:	Pergola
Finding:	Additional structure built without a permit (Suspected) NSW
Information:	The pergola structure abutting the house is suspected to have been constructed without the necessary council approval. In New South Wales, approval is generally required prior to construction of such structures, either by way of a Complying Development Certificate (CDC) or through the Development Application (DA) process followed by a Construction Certificate.

This inspection report does not constitute formal approval, and any informal assessment should not be relied upon to confirm compliance. Further enquiries with the local council or an accredited certifier are strongly recommended prior to settlement.
