Building and Timber Pest Inspection Report

Inspection Date: Tue, 17 Mar 2026

Property Address: unit 34/24 Walker St, Rhodes NSW 2138,
Australia

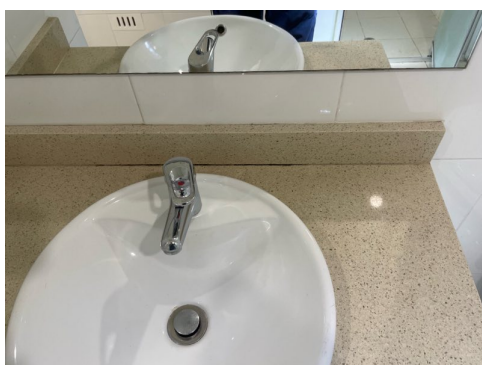
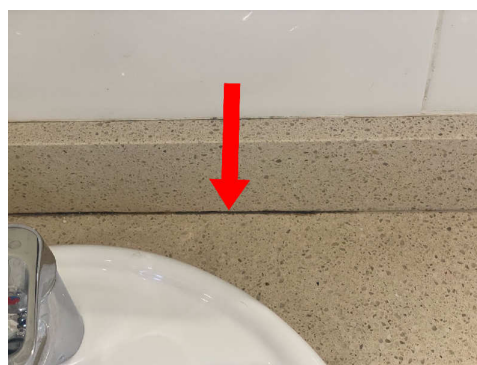
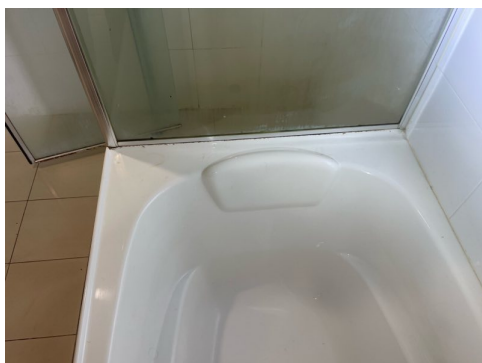
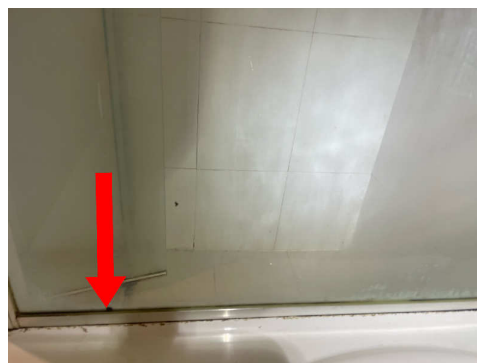
Information: Where evidence of mould growth was noted, there may be environmental, biological or health issues associated with the report. A specialist inspection by a suitably qualified environmental health inspector is warranted, where mould is extensive or where any queries regarding air quality spores or other related issues apply.

Generally, the client is advised to ensure that the general environment is free of moisture and humidity to aid in the prevention of mould formation and development. Any mould found during the inspection should be cleaned immediately by a cleaning contractor or the homeowner as applicable.

Please note that severely affected building elements may require replacement by a registered builder or qualified trade.

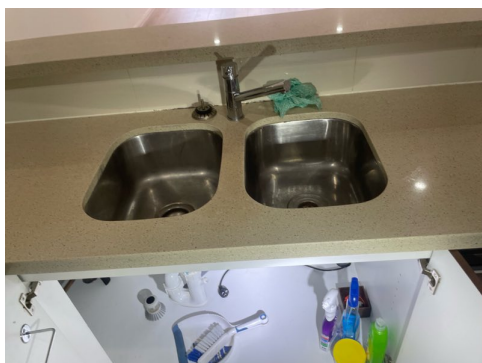
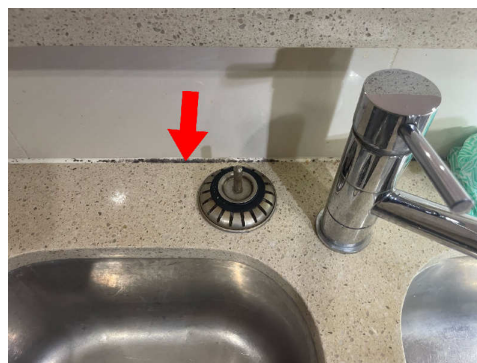
Finding 1.02

Information: Where evidence of mould growth was noted, there may be environmental, biological or health issues associated with the report. A specialist inspection by a suitably qualified environmental health inspector is warranted, where mould is extensive or where any queries regarding air quality spores or other related issues apply.

Generally, the client is advised to ensure that the general environment is free of moisture and humidity to aid in the prevention of mould formation and development. Any mould found during the inspection should be cleaned immediately by a cleaning contractor or the homeowner as applicable.

Please note that severely affected building elements may require replacement by a registered builder or qualified trade.

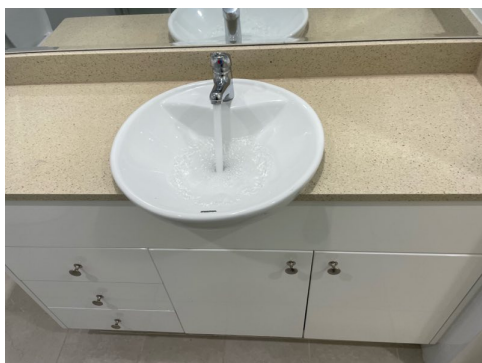
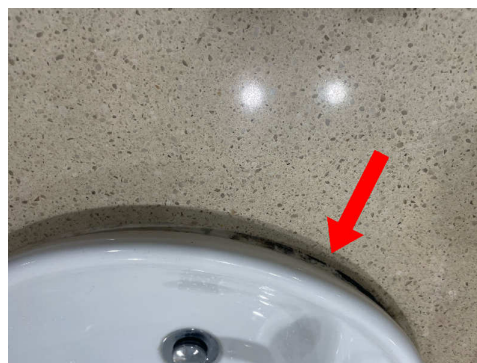
Finding 1.03

Information: Where evidence of mould growth was noted, there may be environmental, biological or health issues associated with the report. A specialist inspection by a suitably qualified environmental health inspector is warranted, where mould is extensive or where any queries regarding air quality spores or other related issues apply.

Generally, the client is advised to ensure that the general environment is free of moisture and humidity to aid in the prevention of mould formation and development. Any mould found during the inspection should be cleaned immediately by a cleaning contractor or the homeowner as applicable.

Please note that severely affected building elements may require replacement by a registered builder or qualified carpenter.

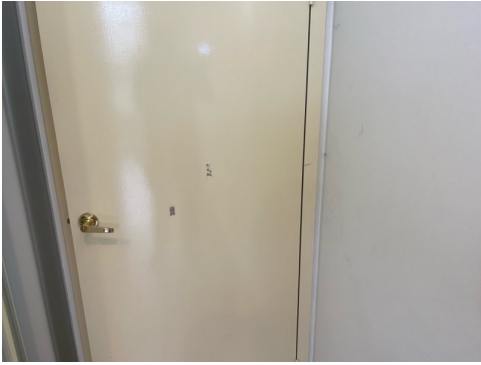
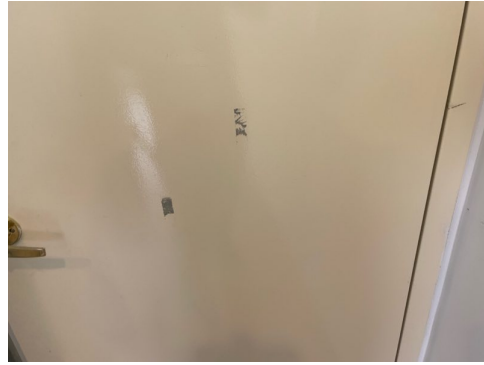
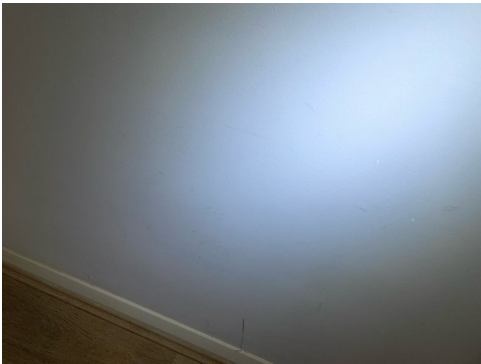
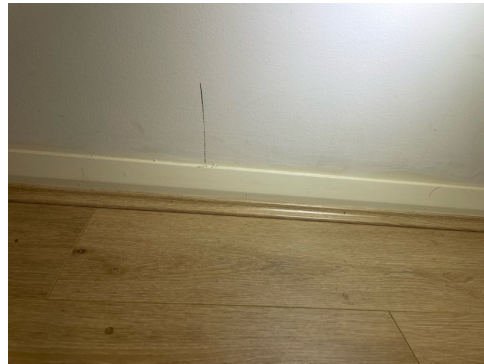
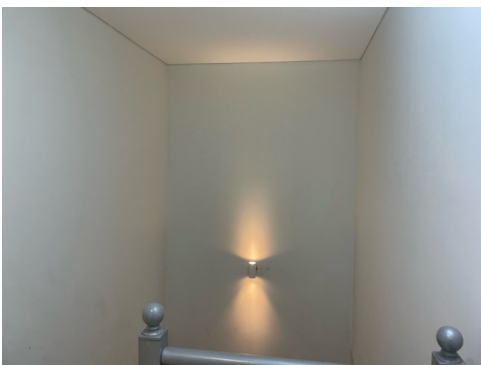
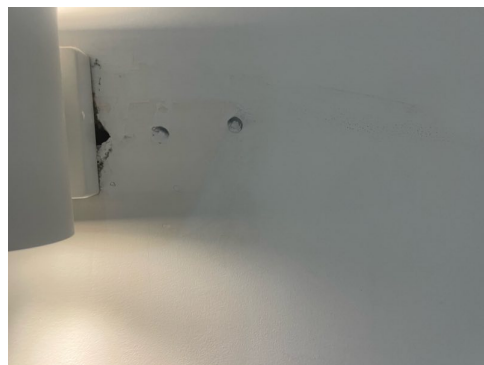
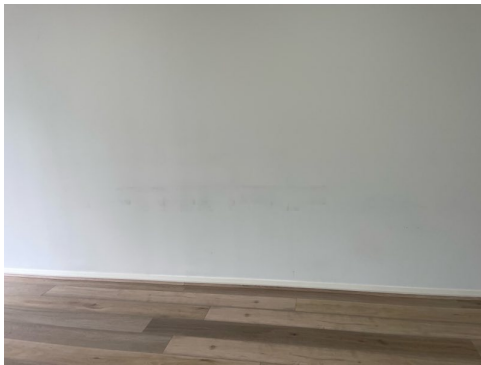
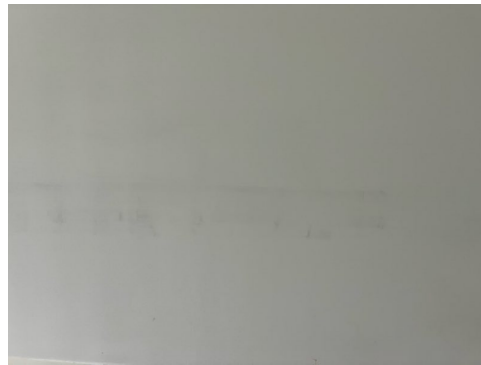
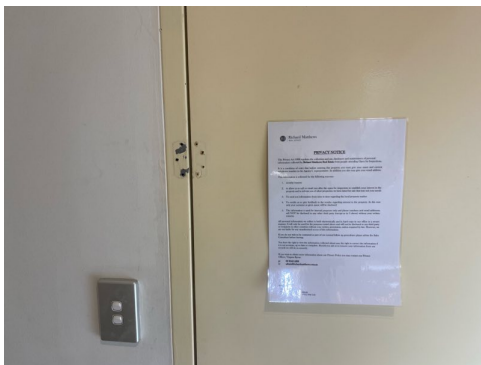
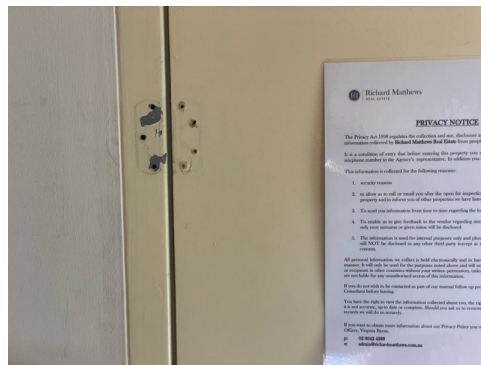
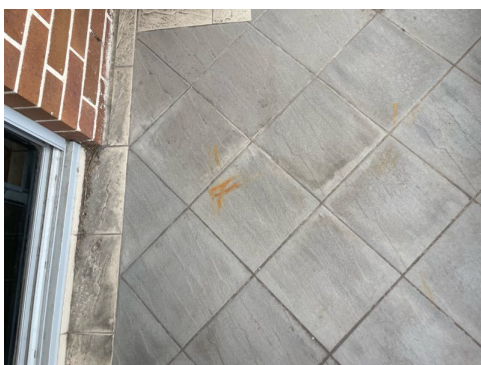
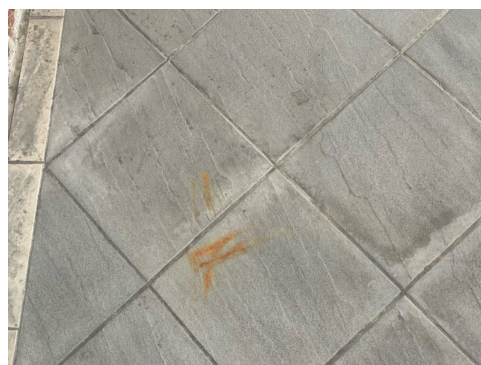
Information: Some areas of the painted wall surfaces, ceilings, door frames, and other internal finishes were observed to have marks and scuffs, likely resulting from the normal use of the property. These marks do not indicate structural damage but have affected the overall aesthetic appearance of the internal spaces.

If left unaddressed, the marks may become more noticeable over time, particularly in high-traffic areas, which could reduce the visual appeal of the interiors. The integrity of the paint and finishes is not compromised, but cosmetic touch-ups may be required to maintain a uniform presentation.

It is recommended that the affected surfaces be cleaned or repainted in the near future by a suitably qualified tradesperson to restore the appearance and uniformity of the internal finishes. Regular maintenance of painted surfaces, including walls, ceilings, and trims, can help prolong their life and visual quality.

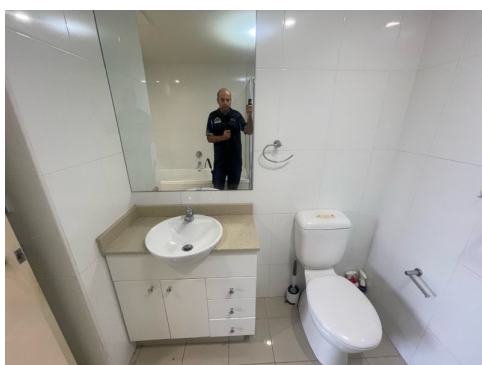
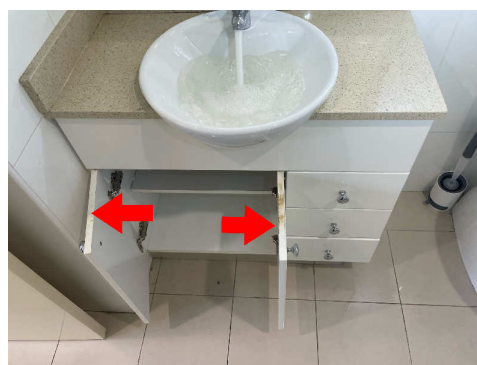
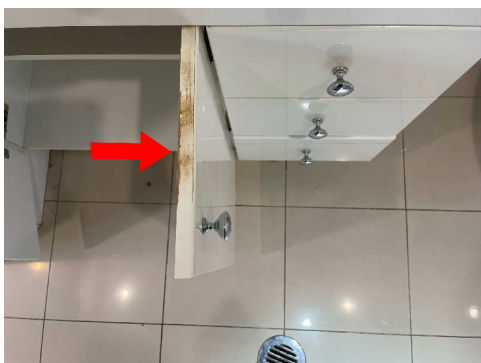
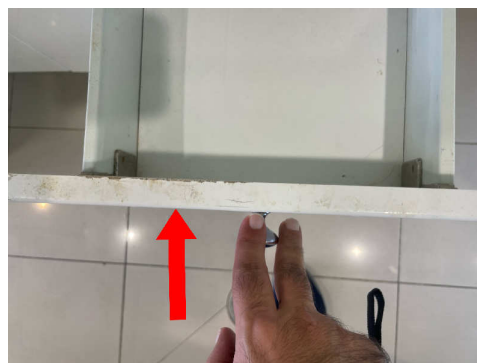
Finding 3.02

Finding: Bathroom Vanity – Damaged (Scratches, Water Staining, Wear & Tear, Broken Shelf)

Information: The bathroom vanity was observed to be in a damaged condition at the time of inspection, including visible scratches to the vanity surfaces, water staining, general wear and tear, and a broken internal shelf. This condition affects both presentation and serviceability of the fixture.

The observed staining and deterioration may be consistent with ongoing moisture exposure (splashing, minor leakage, or poor drying/ventilation) combined with normal use over time. Where laminated or painted finishes are scratched, worn, or water stained, the protective coating can be compromised, which may allow moisture absorption and lead to swelling, delamination, and progressive deterioration of the cabinet materials.

It is recommended that the client arrange further assessment and repair or replacement of the affected vanity components as required to restore function and reduce the risk of further deterioration. If water staining is active or worsening, it is also recommended that the plumbing and surrounding junctions (basin waste, taps, silicone seals, and adjacent wall/floor interfaces) be checked to confirm there is no ongoing leak contributing to the damage.

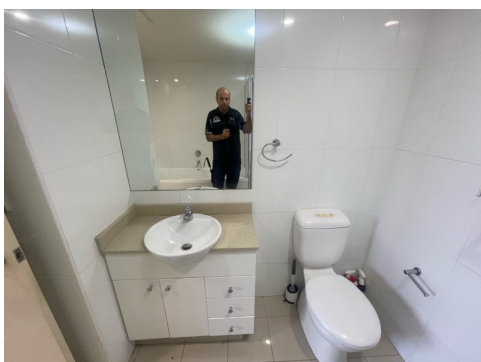
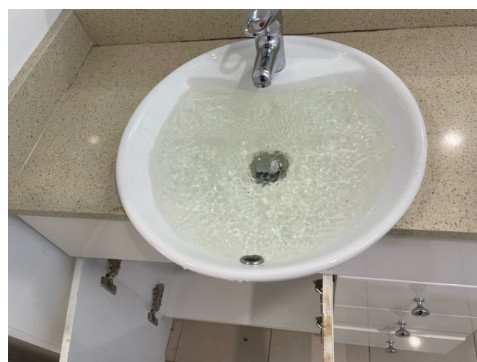
Finding 3.03

Finding: Slow-Draining Bath Sink

Information: The bath sink was observed to drain slowly, indicating a possible partial blockage or inadequate fall in the waste pipe. This condition is a plumbing defect as it affects the intended function and hygiene of the fixture. Slow drainage can lead to standing water in the basin, which may cause unpleasant odours, soap scum buildup, and potential overflow during use. Over time, it can also promote bacterial growth and contribute to water damage around the fixture. This defect should be investigated and rectified by the plumbing contractor, which may involve clearing any blockages, checking the trap, or adjusting pipe gradients. The issue must be resolved prior to handover to ensure the plumbing system performs as intended and complies with the relevant standards.

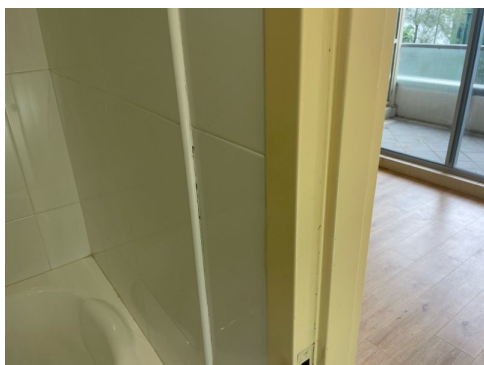
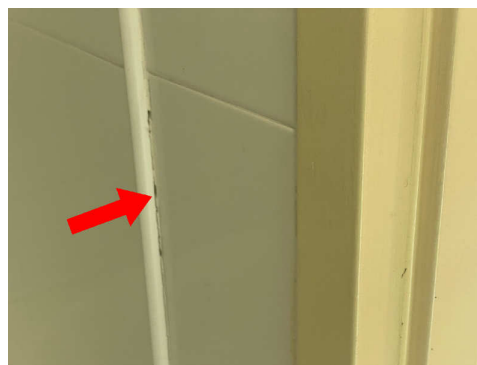
Finding 3.04

Building: Main Building
Location: Ensuite - Master
Finding: Sealant and grouting - Missing or damaged
Information: It was noted on inspection that sealant or grout is degraded to the tiled shower alcove and or other areas of the bathroom.

Different materials and floor areas move at different rates, generally causing cracking to grout or sealant at this point. A flexible sealant is required to allow for expected expansion and contraction, while keeping the joint water tight and protective of all associated building materials.

There appears to be excessive mould to the sealant and grout which will likely require scraping out and replacement.

Flexible and mould resistant materials should be applied to affected areas to prevent any subsequent water damage that is likely to occur. Regular maintenance and replacement of damage or missing or damaged sealant and grout is highly recommended to the wet areas, as this is a regular wear and tear defect. Sealant and grouting in areas that come into regular contact with water should be maintained for the long term care of your property.

A sealant specialist or tiling contractor should be appointed to complete these works as soon as possible

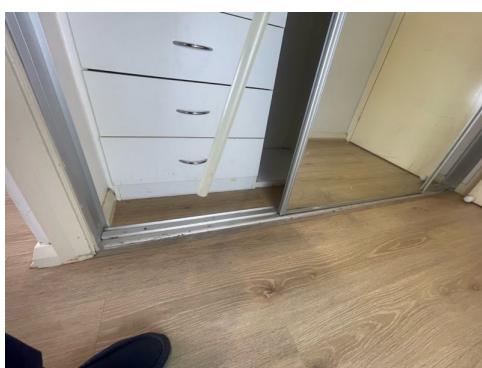
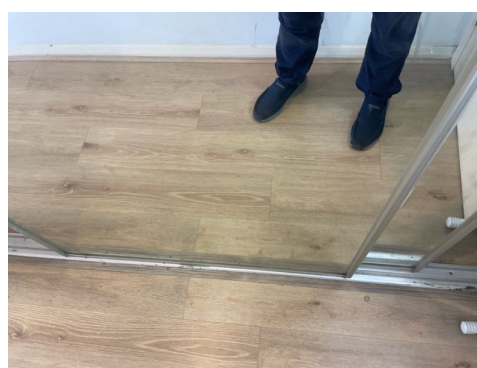
Finding 3.05

Building: Main Building
Location: wardrobe - Master
Finding: Door - Stiff to slide

Information: The door in this area was jammed and difficult to slide along the associated tracks at the time of the inspection. Restricted function of the affected door may pose as a potential safety hazard if required for emergency egress from the building.

Generally, factors such as general age of the building element and a lack of maintenance are the usual causes for this type of defect.

Replacement of door hardware or tracks may be required, as well as minor repairs and cleaning. A registered builder or general handy person will be required to repair the affected doors.

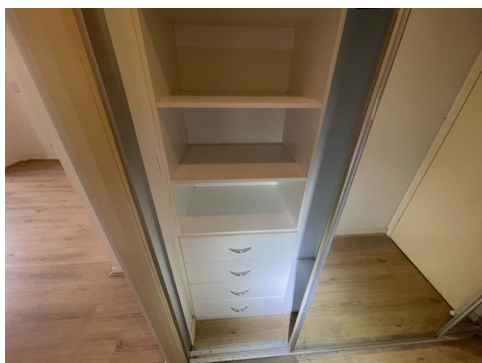
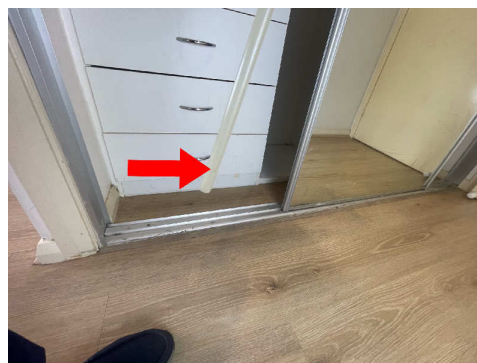
Finding 3.06

Information: During the inspection, it was noted that the rubber trim fixed to the edge of the wardrobe sliding door was loose and had become displaced from its intended position. The item was not sitting properly within the door edge at the time of inspection.

This condition is generally associated with wear and tear, adhesive failure, minor impact, or movement from repeated use of the sliding door. When the edge rubber becomes detached, it may affect the neat finish of the door and can interfere with smooth operation, alignment, or closing of the sliding panel.

This is considered a minor maintenance item and not an urgent defect at the time of inspection. A qualified handyman, carpenter, or wardrobe door specialist should be engaged to refix or replace the loose rubber trim as required.

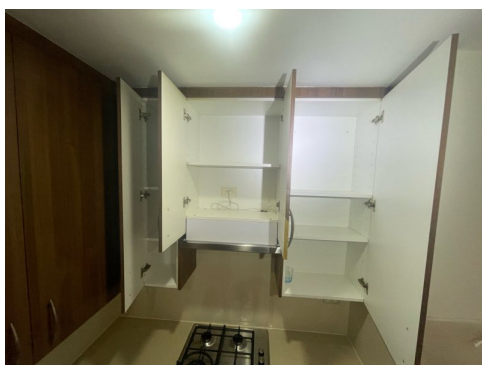
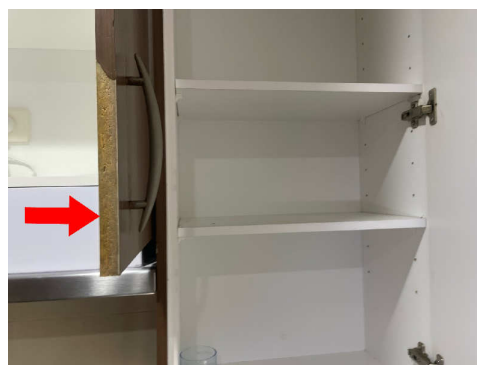
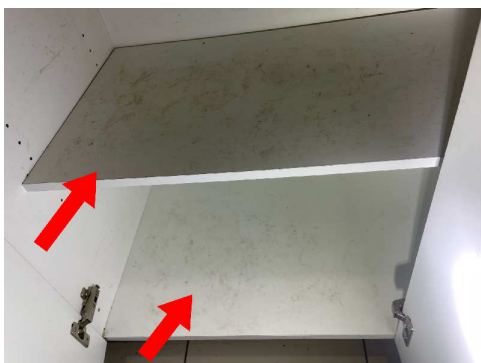
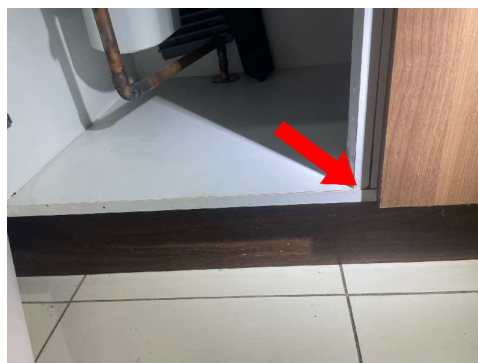
Finding 3.07

Finding: Cabinetry – Aged and Deteriorated Kitchen Cabinets

Information: The kitchen cabinetry was observed to be in poor overall condition and appears to be aged and worn. Several cabinet doors and drawers show signs of surface deterioration, delamination, and moisture damage, while hinges, handles, and fittings exhibit general wear and reduced functionality.

The finishes have deteriorated due to age, humidity, and prolonged use, resulting in an untidy appearance and reduced serviceability.

It is recommended that the kitchen cabinetry be repaired or replaced by a qualified cabinetmaker or licensed builder at client discretion. Installation of new, moisture-resistant cabinetry will restore functionality, improve hygiene, and enhance the overall appearance of the kitchen.

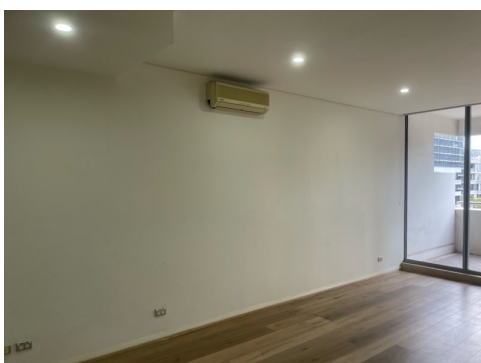
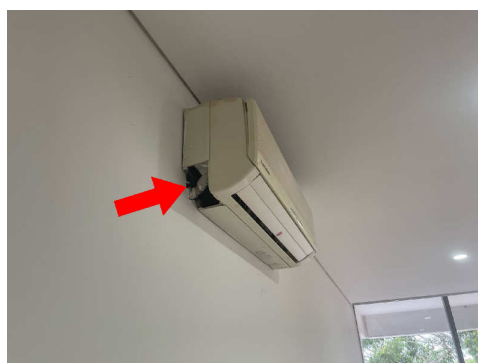
Finding 3.08

Finding: Building element - Damaged

Information: Breakage occurs generally when the building materials have either aged and decayed, or as a result of damage (accidental or deliberate).

Repair and/or replacement of broken elements is advised to ensure that additional secondary defects do not arise as a consequence. Such works are necessary, as all building elements play a key role in the operation and function of the overall structure and its performance.

A relevant tradesperson should be appointed to repair or replace the affected building element prior to any subsequent damage being caused.

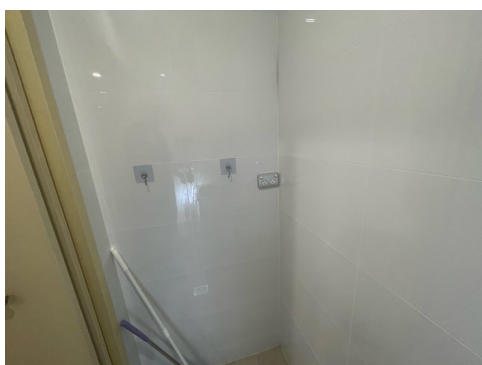
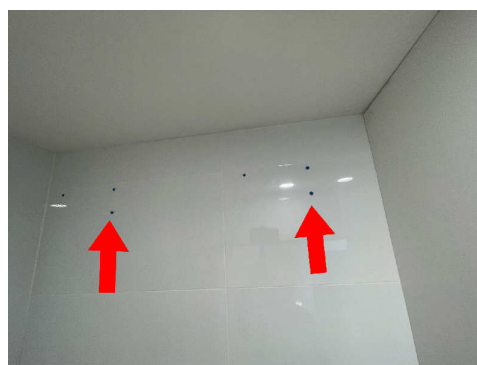
Finding 3.09

Finding: Tiles - Cracked or damaged

Information: Cracking was evident to the tiling in this area at the time of inspection. While the cracking appears to be minor, this area is frequently exposed to water, allowing potential for water penetration into adjoining sections of walls or flooring.

If left unmanaged, water penetration to these areas may lead to subsequent water damage, which is likely necessitate repair work to affected building elements.

A tiling contractor should be appointed to ensure that no further water damage occurs. The re-application of silicone and grouting throughout remaining tile work is also advised, to further protect the area against water penetration.

Where water penetration has led to water damage, appointment of a relevant tradesperson may be required to repair damaged building elements.

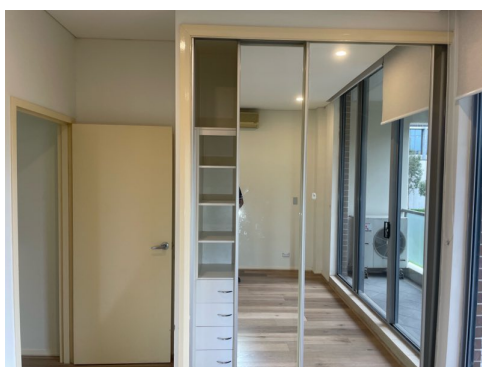
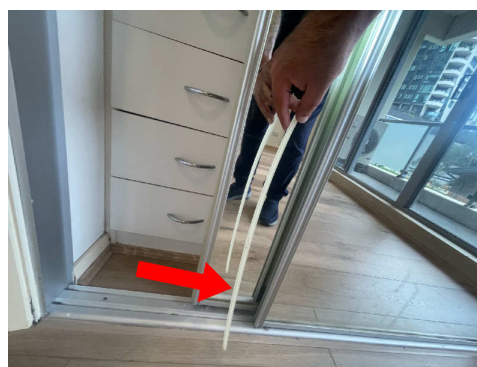
Finding 3.10

Information: During the inspection, it was noted that the rubber trim fixed to the edge of the wardrobe sliding door was loose and had become displaced from its intended position. The item was not sitting properly within the door edge at the time of inspection.

This condition is generally associated with wear and tear, adhesive failure, minor impact, or movement from repeated use of the sliding door. When the edge rubber becomes detached, it may affect the neat finish of the door and can interfere with smooth operation, alignment, or closing of the sliding panel.

This is considered a minor maintenance item and not an urgent defect at the time of inspection. A qualified handyman, carpenter, or wardrobe door specialist should be engaged to refix or replace the loose rubber trim as required.
