Building and Timber Pest Inspection Report

Inspection Date: Tue, 10 Mar 2026

Property Address: 39 Hollywood St, Monterey NSW 2217,
Australia

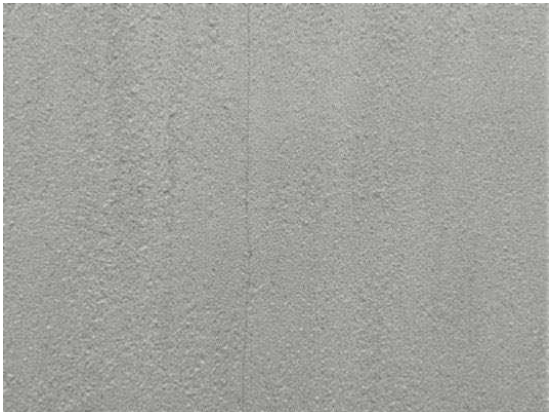
Building: Main Building
Location: All Areas
Finding: Wall cladding - Cracking
Information: The wall cladding in this area has cracked.

Wall cladding cracking can be caused by structural movement, thermal expansion and contraction, poor installation, or moisture infiltration.

Possible rectification of wall cladding cracking includes repairing or replacing damaged sections, improving joint detailing for movement tolerance, sealing gaps to prevent moisture ingress, and reinforcing the structure if necessary to address underlying movement or settling issues.

A remedial builder may be engaged to rectify this issue.

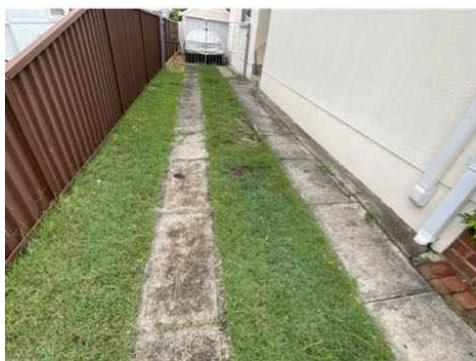
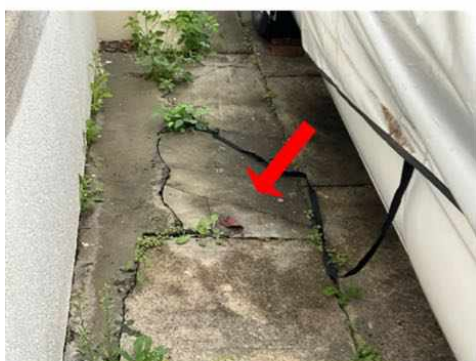
Lipping in the slab is likely to lead to the development of trip hazards.

Deterioration of the substrate is a common cause of this type of defect.

Where factors include variable moisture conditions, uncontrolled water flows under the concrete paving, the presence of trees and their roots having a settling or lifting effect on the soil.

Poor compaction of the sub surface and/or inadequate reinforcing of the slab may create lipping and other secondary defects.

Monitoring of this area is recommended , with the potential of engaging a specialist

concreter to advise on rectification or replacement of the paved area.

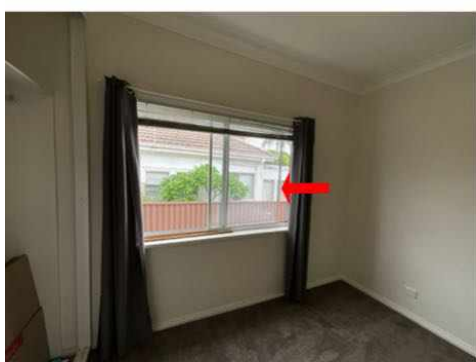
Generally, factors such as age and a lack of maintenance are the usual causes for this type of defect.

Replacement of hardware or frame may be required, as well as minor repairs and cleaning. A registered builder will be required to repair the windows and doors.

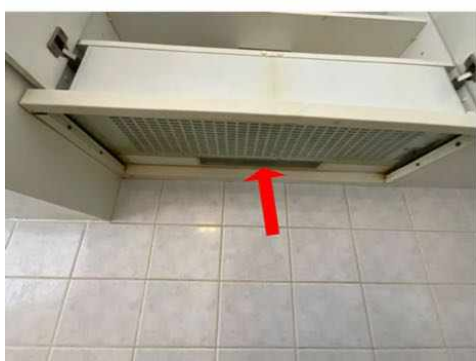
Building:	Main Building
Location:	Kitchen
Finding:	Rangehood - Light not working
Information:	While the range hood appears to be working at a satisfactory level, the light to the appliance was not working at the time of inspection.

A licensed electrician should be appointed to replace the light on the range hood to restore it to a fully operational state.

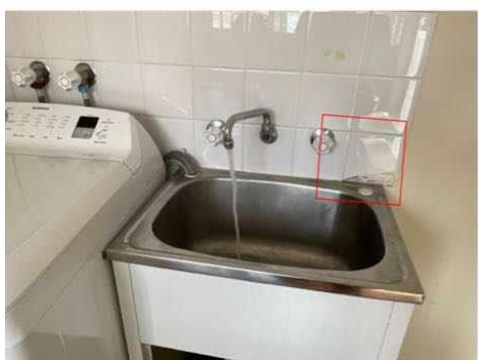
that no further water damage occurs.

The re-application of silicone and grouting throughout remaining tile work is also advised, to further protect the area against water penetration.

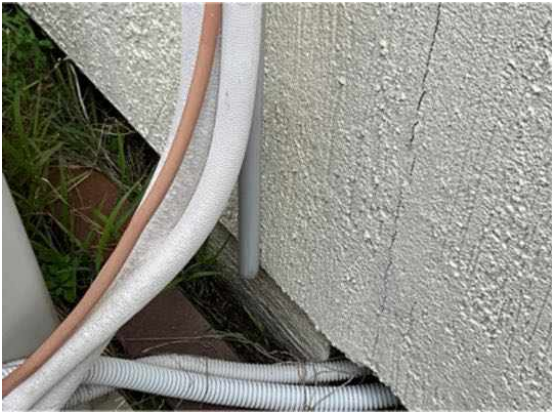
Building: Main Building
Location: Exterior walls - right side
Finding: HWS/AC overflow not connected
Information: The Hot Water System (HWS) and A/C overflows were found to be disconnected from storm water drainage and is creating excessive moisture in the surrounding area. These damp conditions can lead to secondary defects such as rot, rust or corrosion of associated building elements, the formation of fungal decay, or even the creation of potential slip hazards. When coupled with poor site drainage, pooling of water may also attract termite activity to this area. It is highly recommended that a licensed plumber be appointed to connect the HWS and A/C overflows in order to prevent such an environment from being created. These minor works should be carried out as soon as possible.

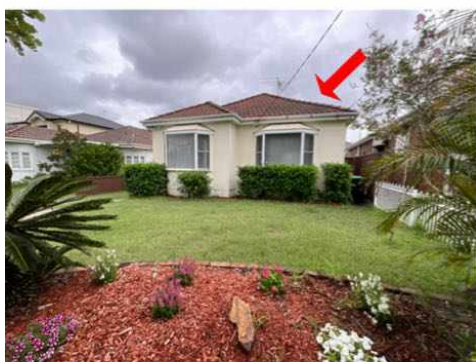
due to, but not limited to height restrictions, ladder limitations, steepness of roof, roof obstructions and poor visibility(line of sight)to some areas.

Where a full inspection was not possible it is recommended that a qualified roofing contractor be engaged to undertake a comprehensive inspection of those areas.
