Building Inspection Report

Inspection Date: Fri, 6 Feb 2026

Property Address: 77 Fairway Dr, Kensington Grove QLD
4341, Australia

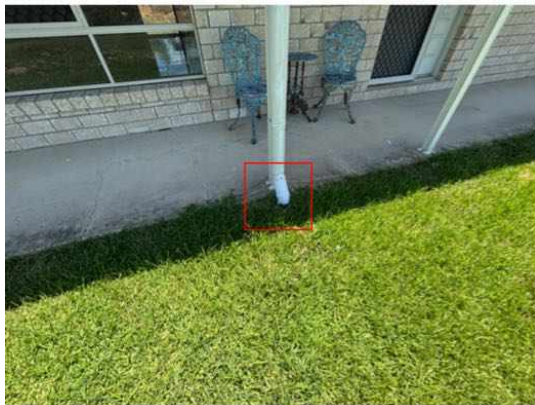
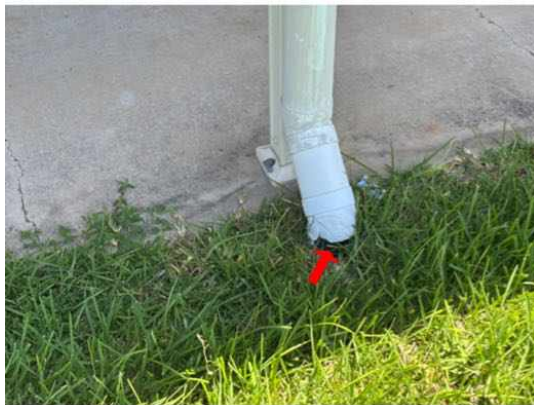
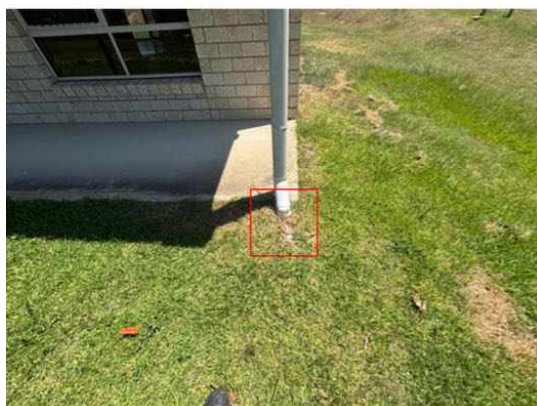
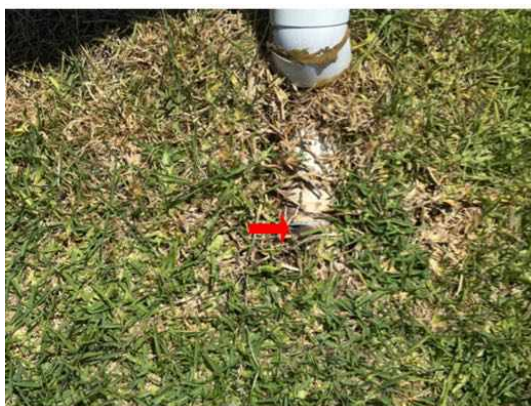
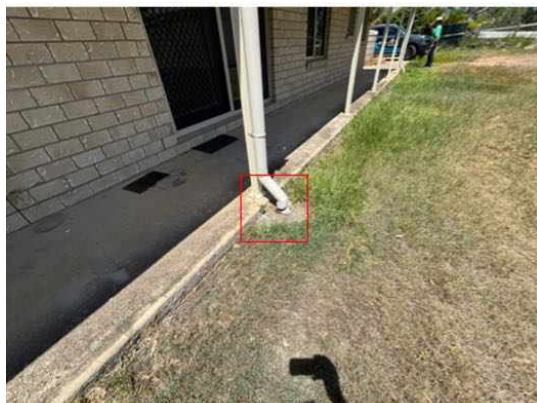
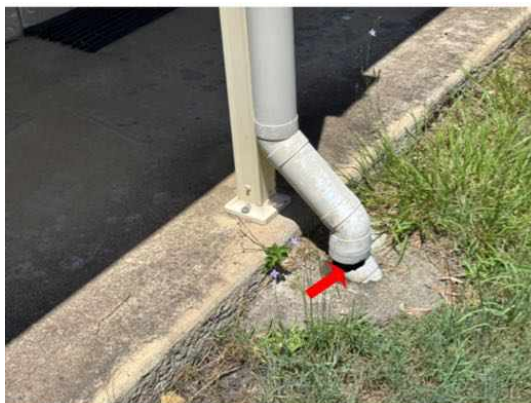
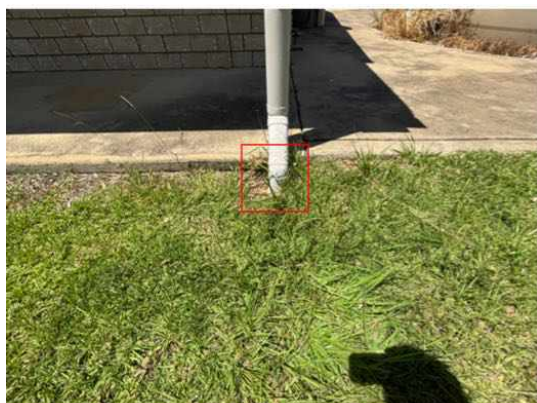
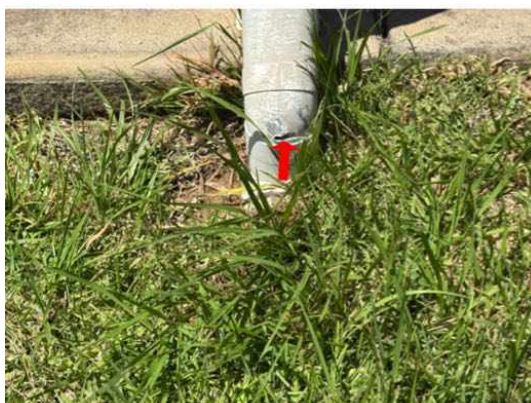
Defects 3.01

Building: Main Building
Location: All External Areas
Finding: Down pipes - damaged
Information: At the time of the inspection, it was noted that the bottom section of the down pipes at the front and rear of the dwelling were damaged. This affects the functionality of the down pipe and allows water to escape near the foundation.

Excessive moisture next to the foundations of a building creates a conducive condition for termite activity. Excessive moisture may also cause deterioration of the associated building materials.

A licensed plumber specialising in roof plumbing should be engaged to carry out this repair. This can be done at the clients discretion.

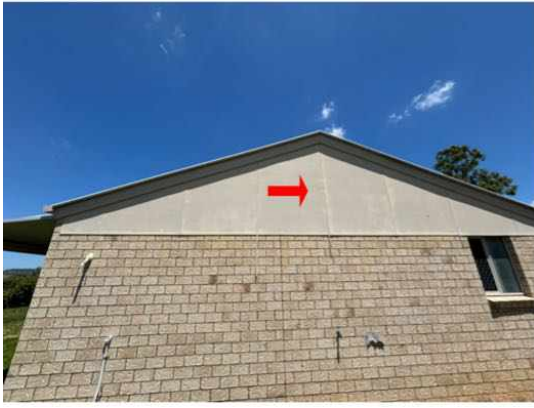
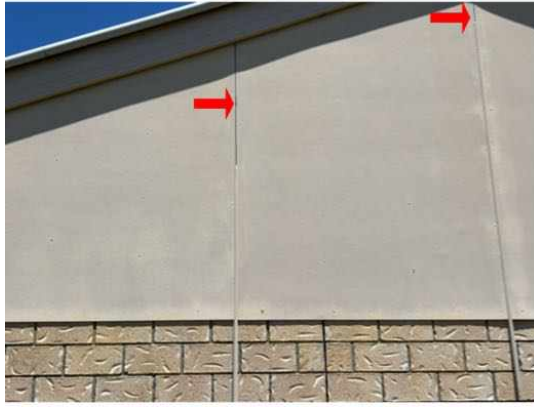
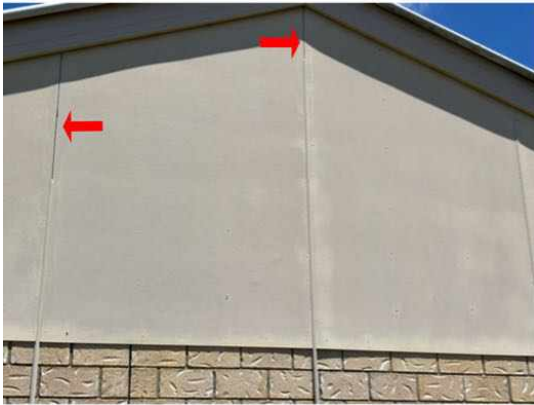
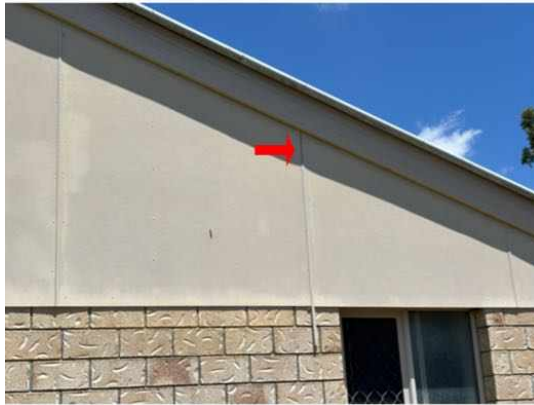
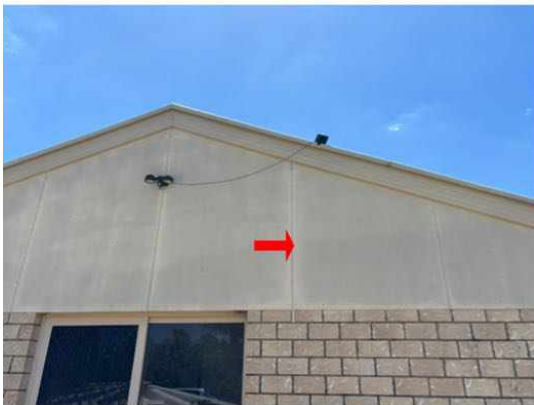
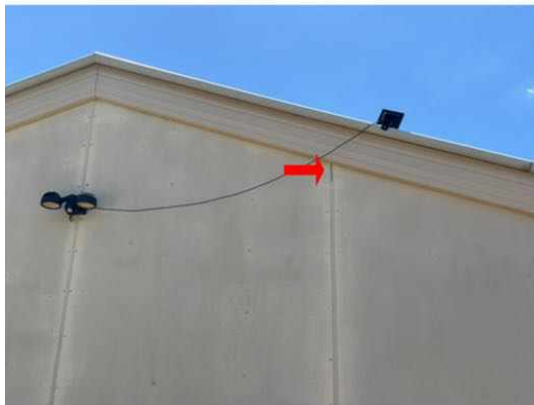
Defects 3.02

Building: Main Building
 Location: Gable ends
 Finding: Gable ends - cover strips dropped
 Information: At the time of the inspection, it was noted that several cover strips for the fibre cement cladding on the gable ends have dropped and as a result this creates a potential ingress point for moisture into the roof void.

A building maintenance professional could be engaged to re-position the cover strips. This can be done at the clients discretion.

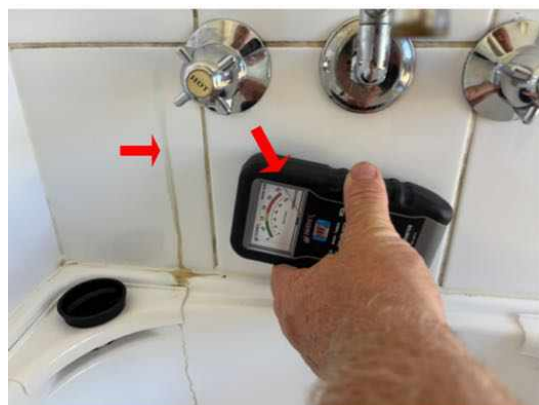
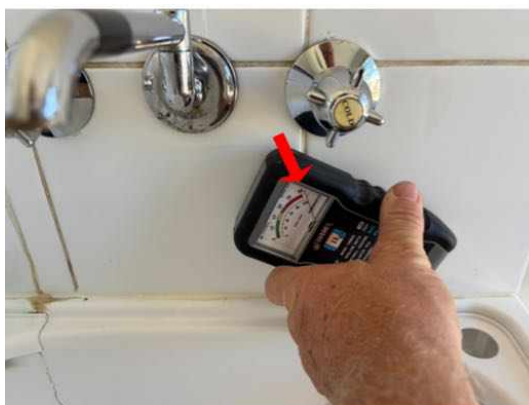
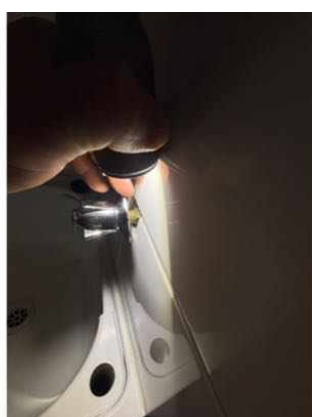
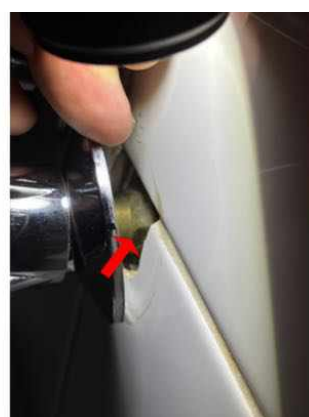
Defects 3.03

Finding: Laundry - excessive moisture reading

Information: At the time of the inspection, it was noted that there were excessive moisture readings below the taps for the laundry tub. There is a water stain on the wall tile and no sealant to the tap penetrations. No evidence of moisture or damage was found under the laundry tub. It is suspected that moisture has gotten behind the tiles through the tap penetrations.

The client should monitor this area for any change in appearance.

A building maintenance professional should be engaged to apply sealant to the tap penetrations. This should be done as a short term priority.

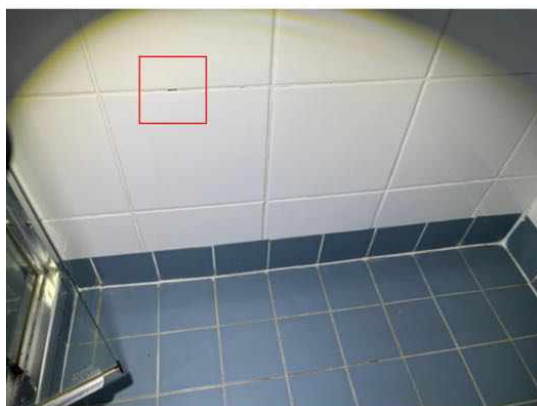
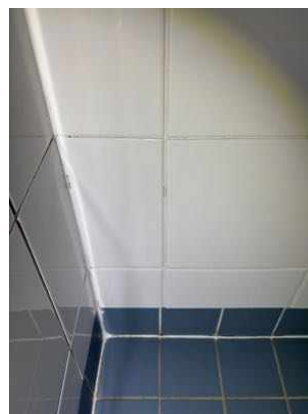
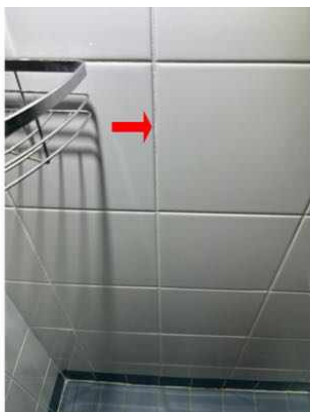
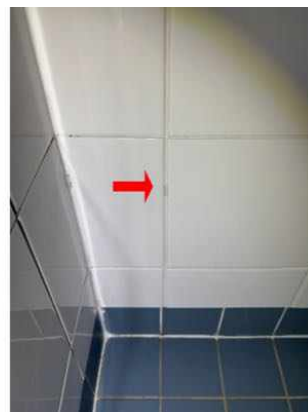
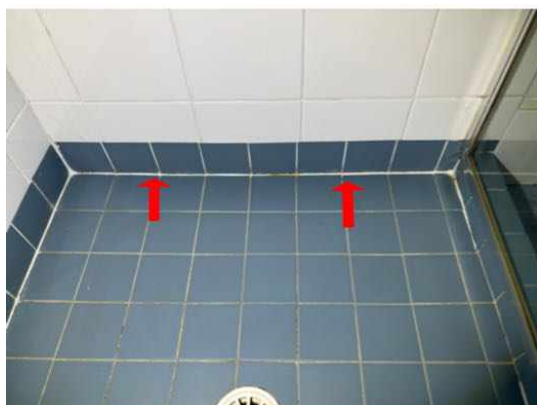
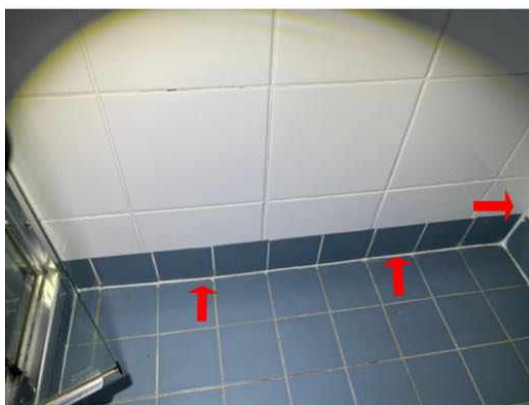
Defects 3.04

Building:	Main Building
Location:	Ensuite
Finding:	Ensuite - shower area maintenance required
Information:	At the time of the inspection, it was noted that the grout and sealant in the shower area of the ensuite is deteriorating. Missing sections of grout were found. This may be due to general wear and tear.

Grout and sealant is meant to keep moisture from penetrating behind the tiles.

A bathroom specialist should be engaged to assess the shower area and provide a solution for these issues. This should be done as a matter of urgency.

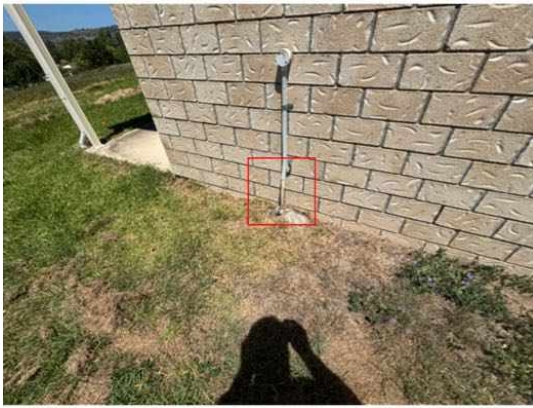
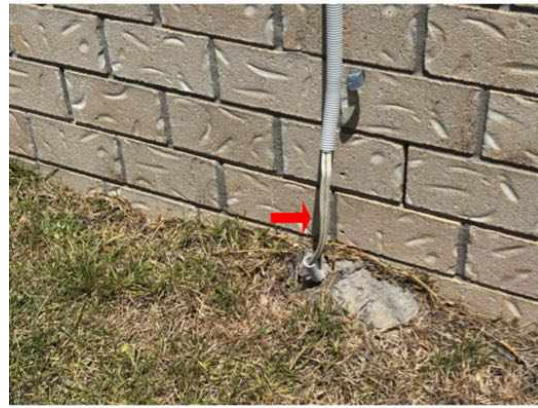
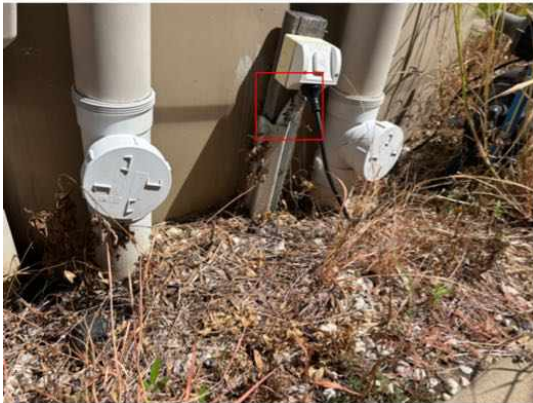
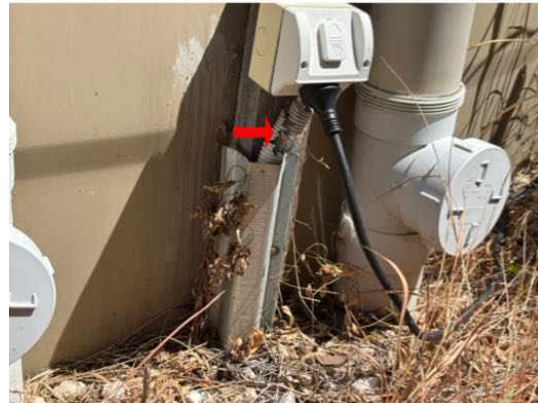
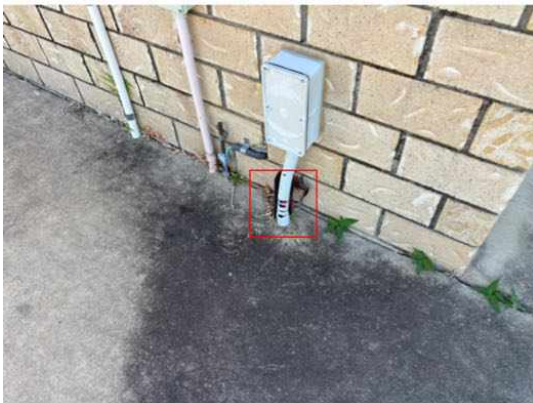
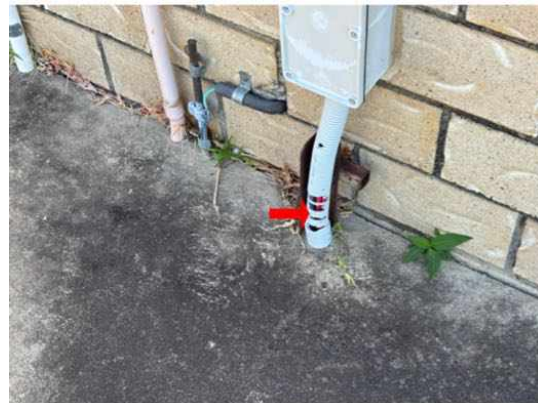
Defects 3.05

Building: Main Building
 Location: All External Areas
 Finding: Exterior - electrical conduit deteriorating
 Information: At the time of the inspection, it was noted that several plastic conduits to electrical cables on the exterior of the building have deteriorated. This exposes the electrical cable to weathering. Accelerated deterioration of the plastic of the electrical cable may occur.

A licensed electrician should be engaged to replace the deteriorated conduit. This should be done as a matter of urgency.

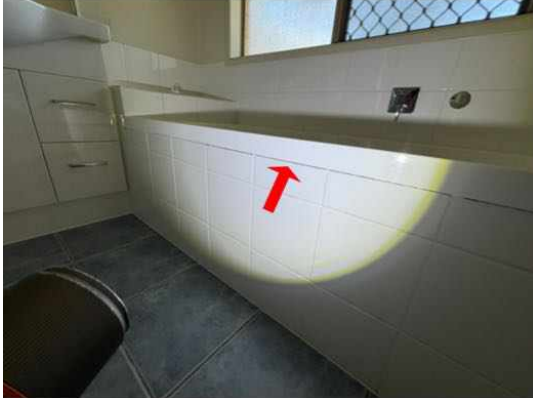
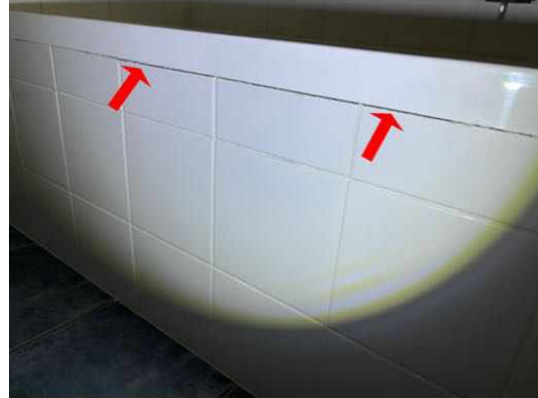
Defects 3.06

Building: Main Building
 Location: Family bathroom
 Finding: Family bathroom - sealant deteriorating
 Information: At the time of the inspection it was noticed that the sealant to the bath tub lip has deteriorated.

Sealant is used in tiled areas to prevent moisture from entering the wall cavity and causing damage to the building elements. A moist environment in the wall cavity may also be a conducive condition for termite activity.

If it is not addressed, damage to building elements will occur and would require invasive works to rectify any damage.

A building maintenance professional or sealant applicator should be appointed to replace all sealant as a matter of urgency.

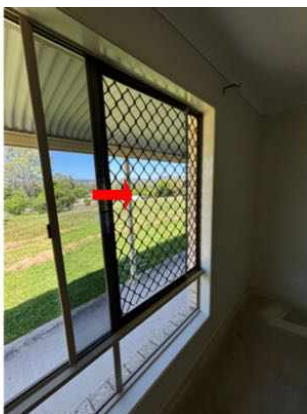
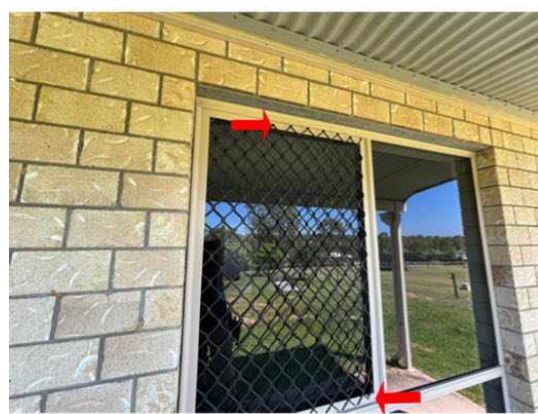
Defects 3.07

Finding: Master bedroom - security screen damaged

Information: At the time of the inspection, it was noted that the security screen to the window in the master bedroom is damaged. It appears to have been pulled out of its channel at the top and bottom. The security screen is obstructing the window from being opened. The window is binding on the security screen.

A security screen specialist should be engaged to replace the damaged security screen. This should be done as a short term priority.

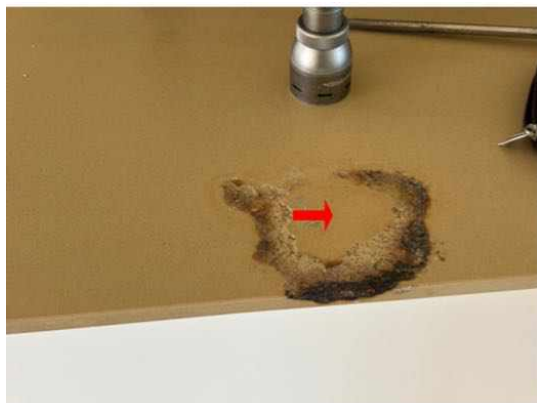
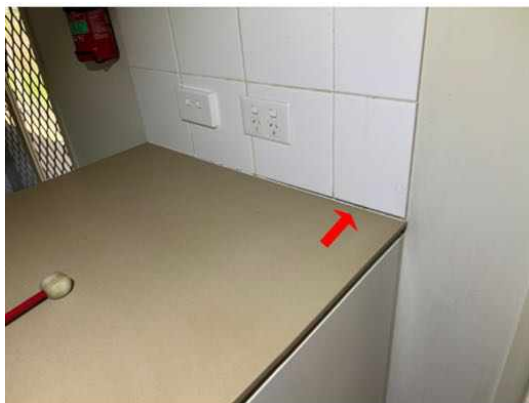
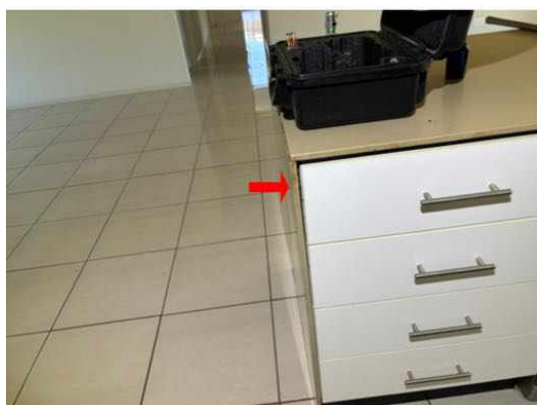
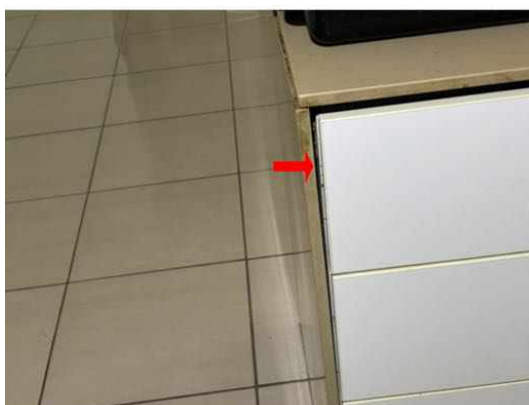
Defects 3.08

Finding: Kitchen - bench top damaged
 Information: At the time of the inspection, it was noted that there was damage to the kitchen bench top. There is a burn mark, the end gable is loose and it appears to have pulled away from the wall.

A kitchen specialist could be engaged to replace the affected kitchen bench top. This can be done at the clients discretion.

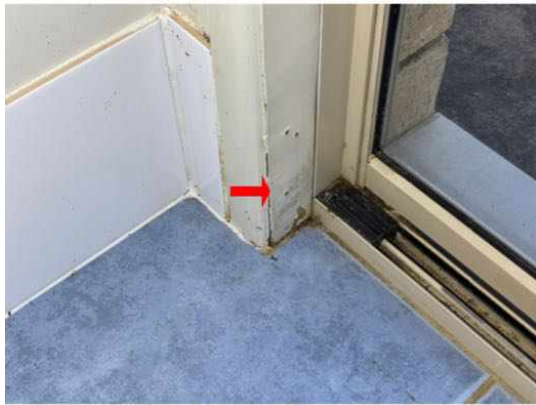
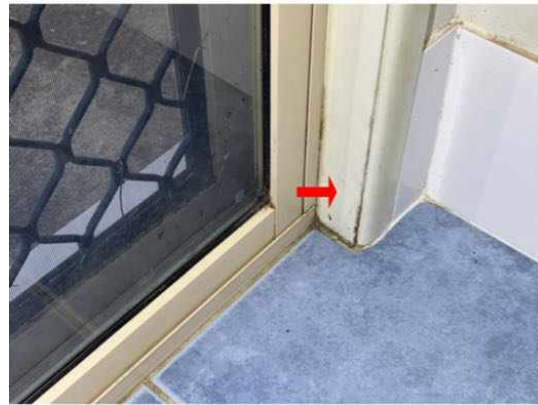
Defects 3.09

Building: Main Building
 Location: Laundry
 Finding: Laundry - timber door frame moisture damaged
 Information: At the time of the inspection, it was noted that the bottoms of the timber door frame in the laundry had some moisture damage to it. This is due to the door frame being made from MDF. MDF is an economical building product but is highly reactive to moisture if not sealed.

A building maintenance professional or painting contractor could be engaged to repair the bottoms of the timber door frame in the laundry. This can be done at the clients discretion.

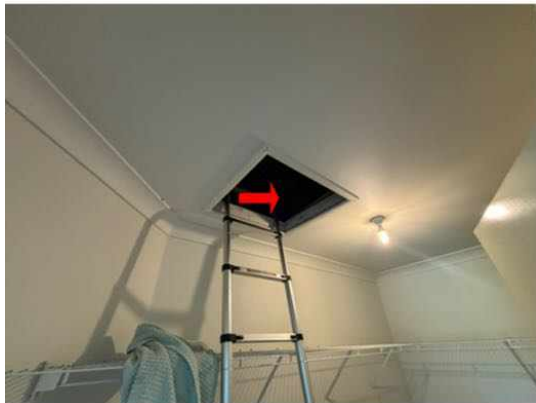
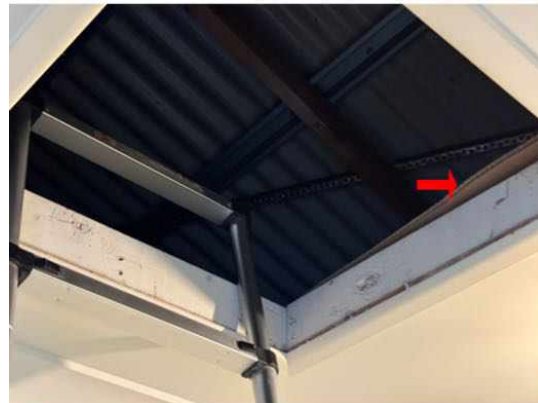
Defects 3.10

Building: Main Building
Location: Walk in robe
Finding: Walk in robe - manhole cover missing
Information: At the time of the inspection, it was noted that the manhole cover was missing and has been replaced with cardboard.

A building maintenance professional could be engaged to install a new manhole cover. This can be done at the clients discretion.

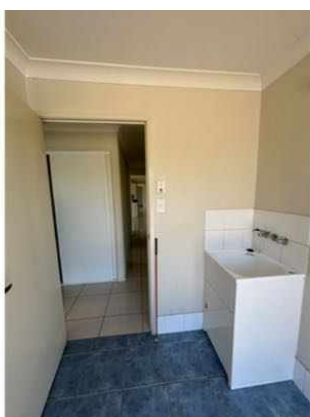
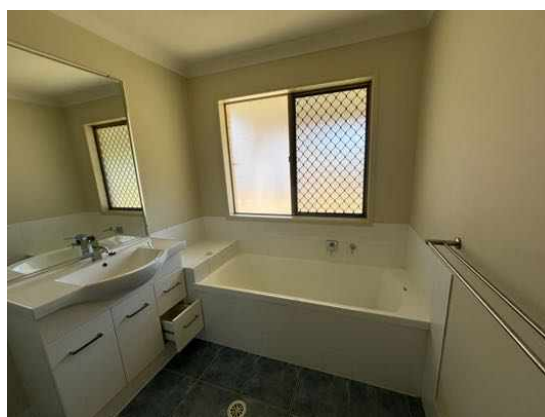
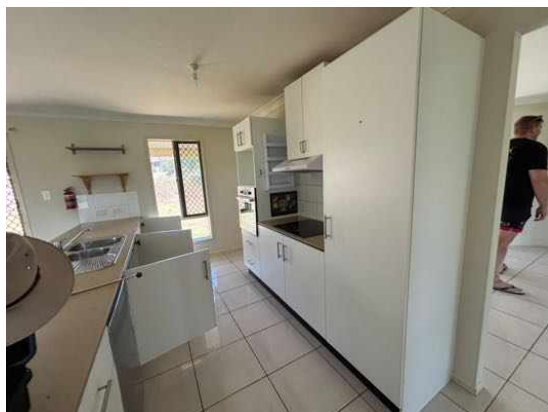
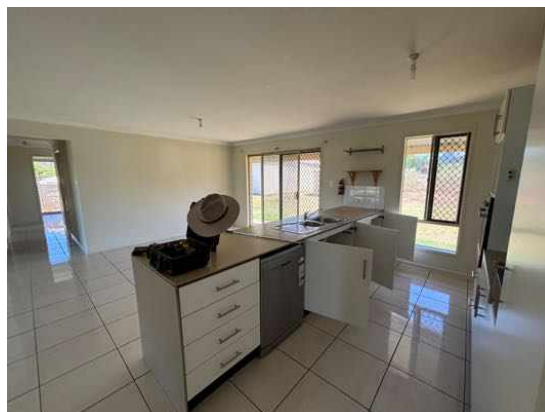
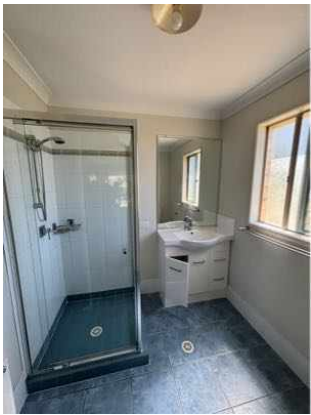
Building: Main Building
Location: All Internal Areas
Finding: Obstructions and Limitations - Internal areas
Information: These photographs are an indication of the obstructions and limitations which impeded full inspection of the property of the internal areas at the time of inspection. These obstructions can hide an array of defects and should be removed to allow full inspection to be carried out. A re-inspection is recommended once the areas are made accessible.

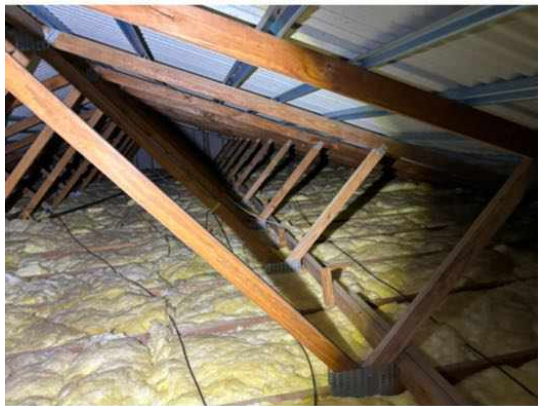
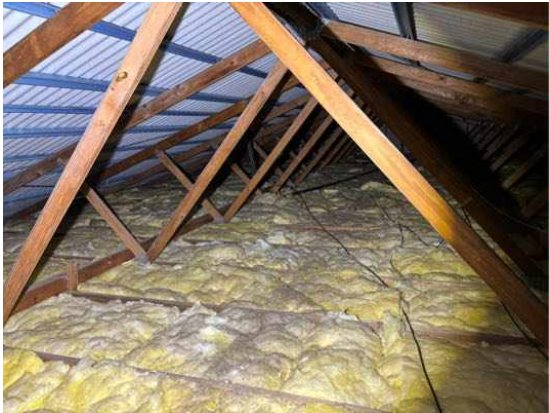
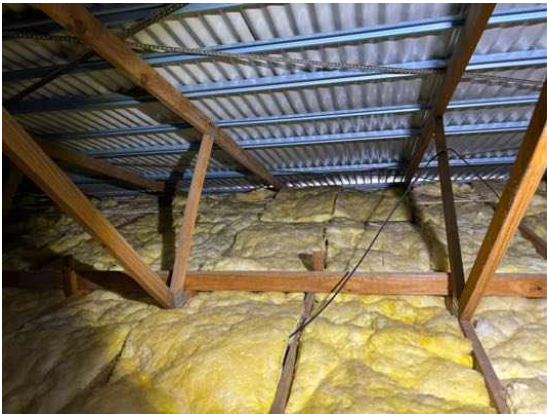
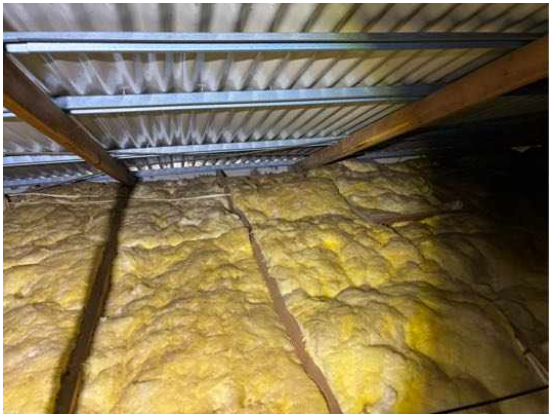
Building: Main Building
Location: Roof Void
Finding: Obstructions and Limitations - Roof cavity
Information: These photographs are an indication of the obstructions and limitations which impeded full inspection of the property of the roof cavity

at the time of inspection. These obstructions can hide an array of defects and should be removed to allow full inspection to be carried out. A re-inspection is recommended once the areas are made accessible.
