# Building and Timber Pest Inspection Report

Inspection Date: Wed, 1 Apr 2026

Property Address: 8 Centennial Dr, Mooroopna VIC 3629,  
Australia

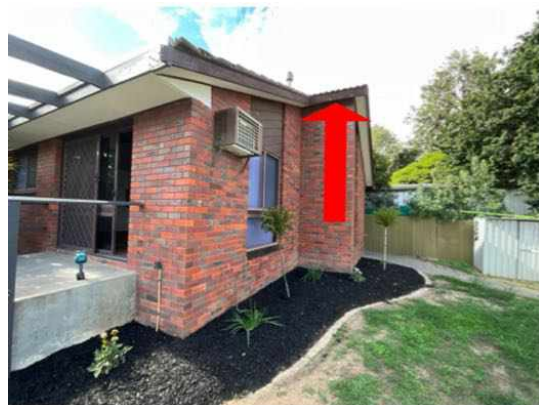
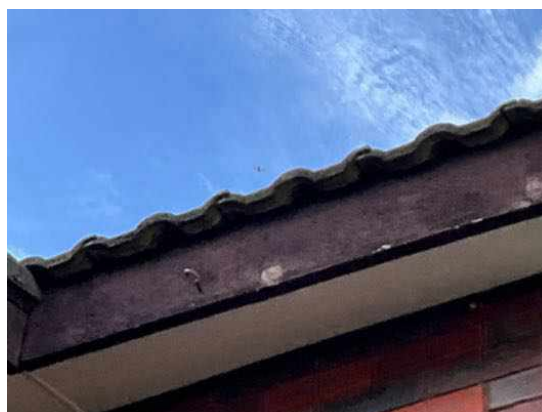
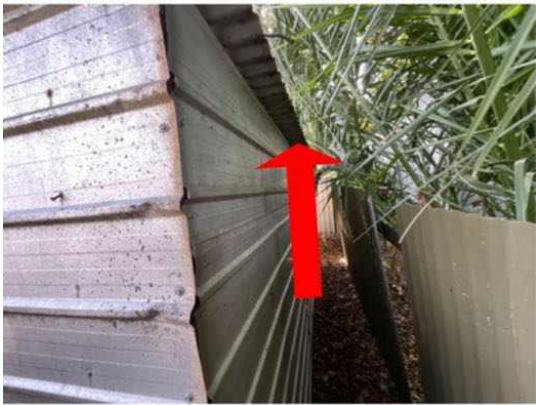
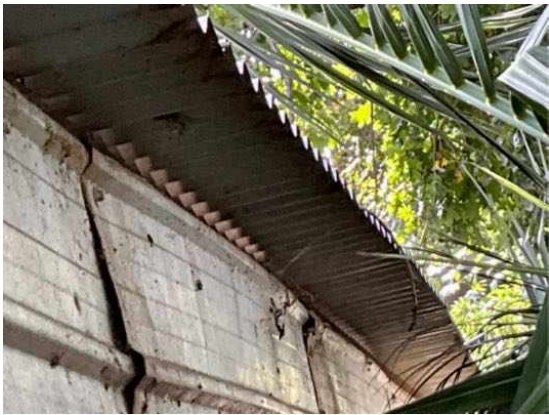
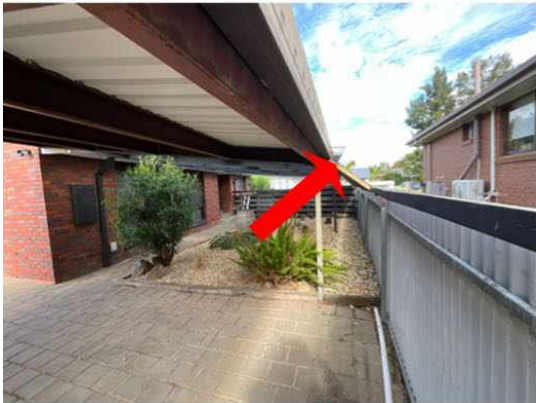
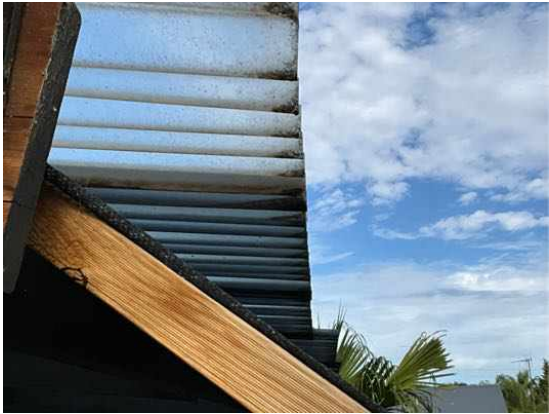
#### Finding 3.01

Building: Building 1  
Location: Yard - Back, shed and eaves, alfresco  
Finding: Guttering Missing  
Information: The Guttering in this area was missing at the time of inspection. Guttering, Downpipes and Stormwater drainage are vital to protect the integrity of the structure and to prevent an environment conducive to Timber Pest attack.

A Plumber should be contacted as soon as possible to replace and connect to drainage the missing Guttering.

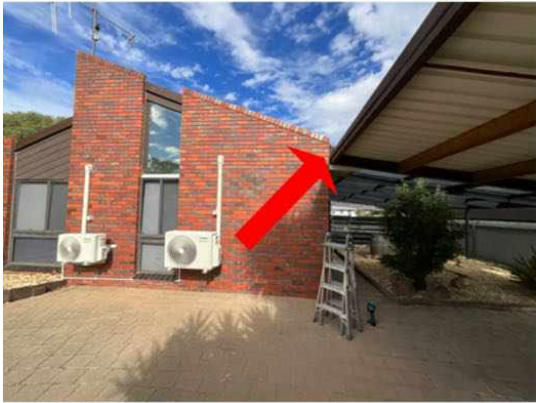
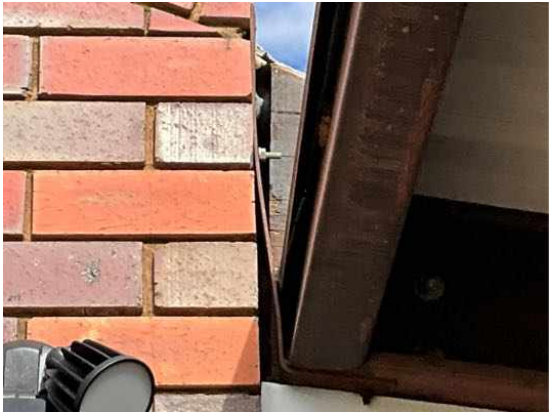
**Finding 3.02**

Building: Building 1  
 Location: Carport  
 Finding: Flashing - missing  
 Information: Flashing is required to be installed wherever walls are interrupted by openings within the cavity where the roof abuts a cavity wall or the like at the base of cavities and where masonry chimney's abut the roof. Instances where flashing is missing in locations nominated by BCA3.3.4.7 this should be reinstated.

A plumber should be consulted soon to restore the area and prevent potential deterioration.

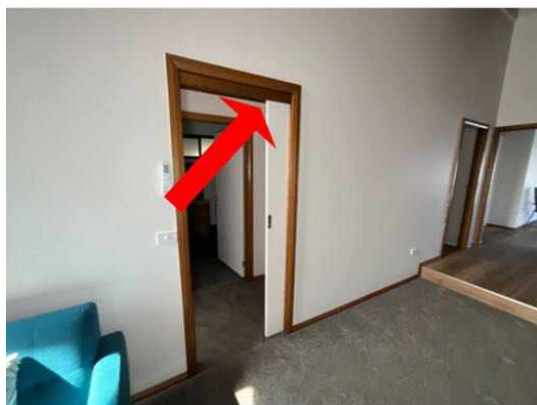
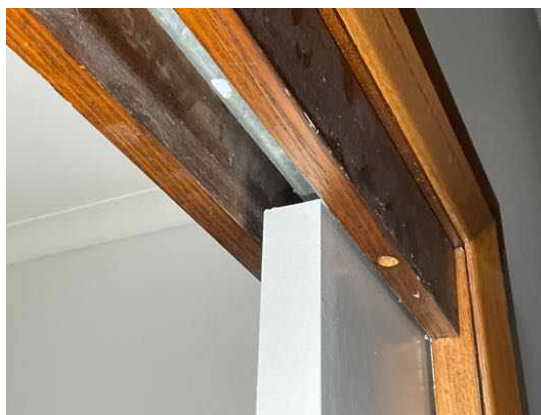
### Finding 3.03

Building:	Building 1
Location:	Living Room
Finding:	Door- Stiff to slide
Information:	The door in this area was jammed and difficult to slide along the associated tracks at the time of the inspection. Restricted function of the affected door may pose as a potential safety hazard if required for emergency egress from the building.

Generally, factors such as general age of the building element and a lack of maintenance are the usual causes for this type of defect.

Replacement of door hardware or tracks may be required, as well as minor repairs and cleaning. A registered builder or general handy person will be required to repair the affected doors.

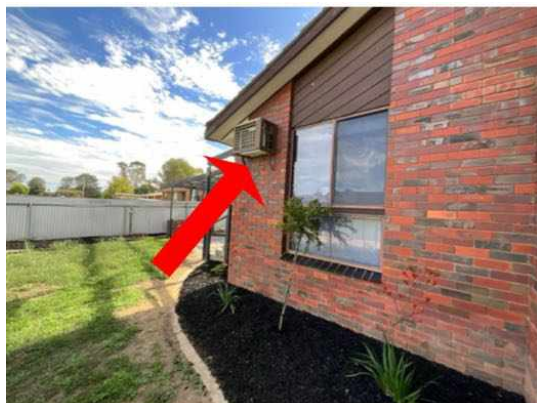
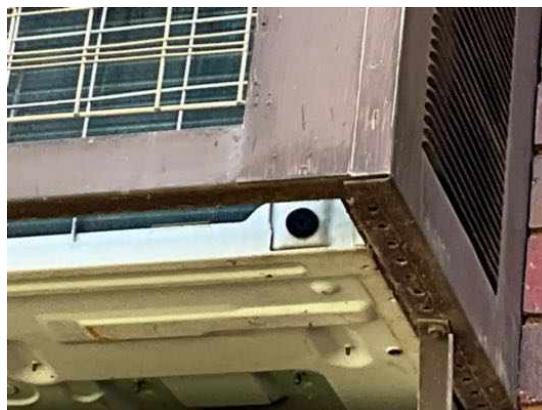
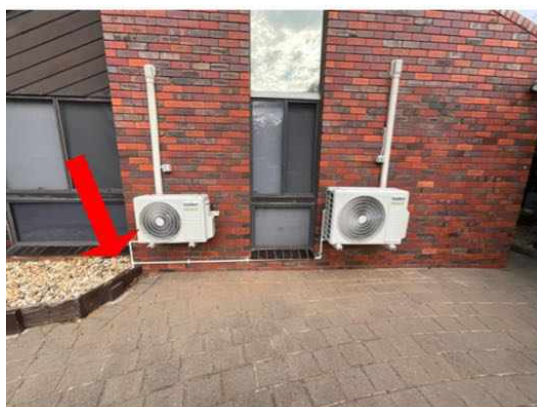
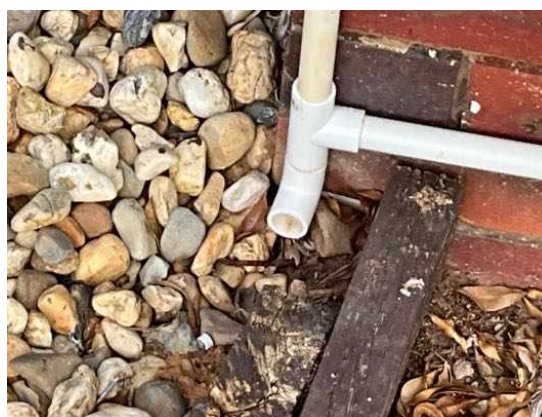
#### Finding 6.01

Building:	Building 1
Location:	Yard - Back, front
Finding:	Air conditioner - Disconnected overflow
Information:	The Air Conditioner (A/C) overflow was found to be disconnected from storm water drainage and is creating excessive moisture in the surrounding area.

Such leaking creates an environment which is conducive to an array of defects, including water damage to associated building elements and the attraction of termite or timber pest infestation.

It is highly recommended that a licensed plumber be appointed to connect the A/C overflow in order to prevent such an environment from being created. These minor works should be carried out as soon as possible.

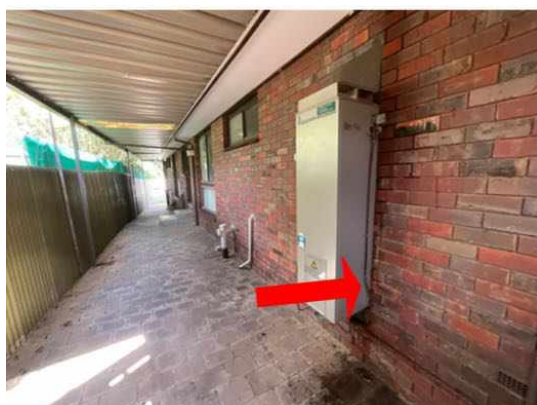
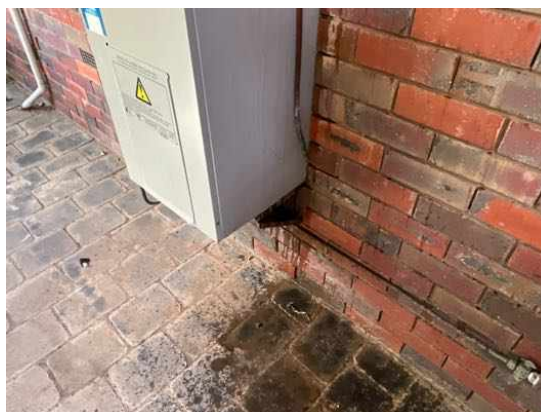
## Finding 6.02

Building:	Building 1
Location:	Alfresco
Finding:	HWS Overflow - Not Connected
Information:	The Hot Water System (HWS) overflow was found to be disconnected from storm water drainage and is creating excessive moisture in the surrounding area.

These damp conditions can lead to secondary defects such as rot, rust or corrosion of associated building elements, the formation of fungal decay, or even the creation of potential slip hazards. When coupled with poor site drainage, pooling of water may also attract termite activity to this area.

It is highly recommended that a licensed plumber be appointed to connect the HWS overflow in order to prevent such an environment from being created. These minor

works should be carried out as soon as possible.

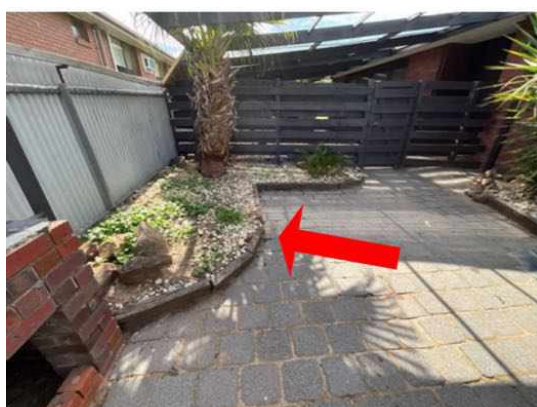
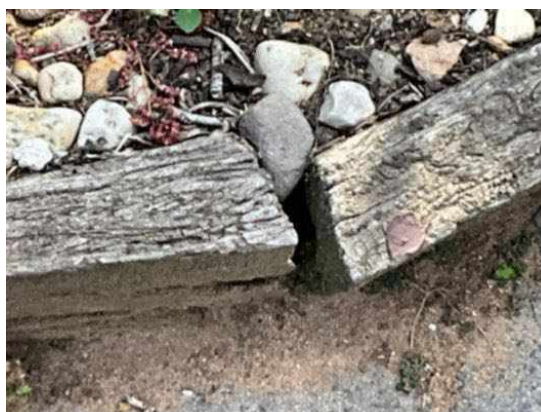
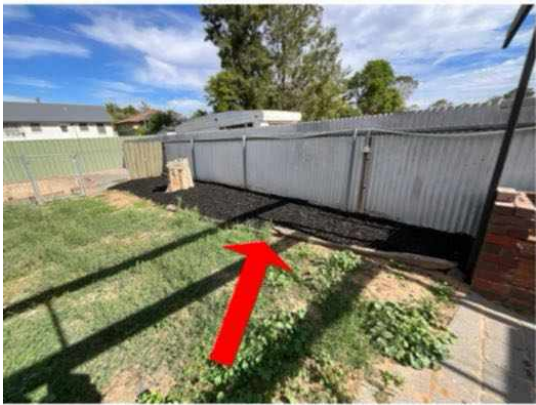
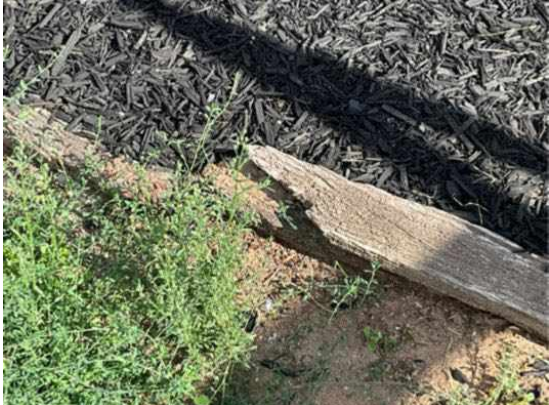
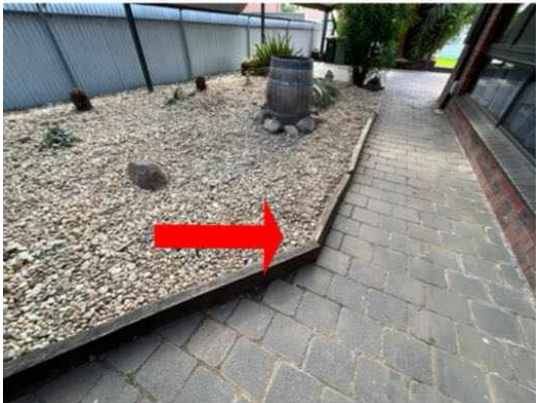
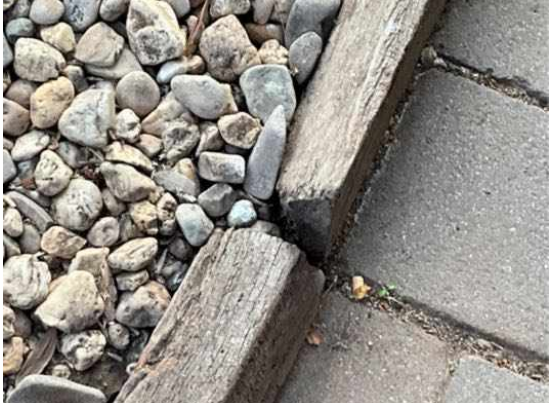
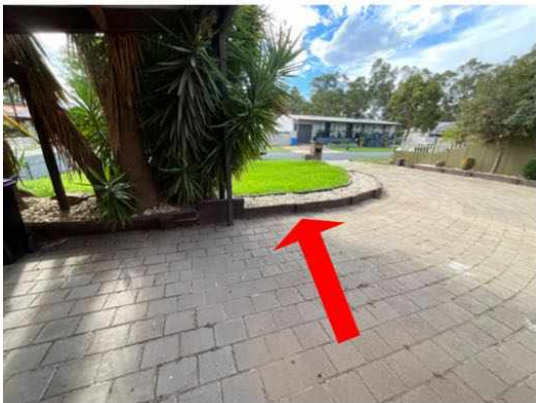
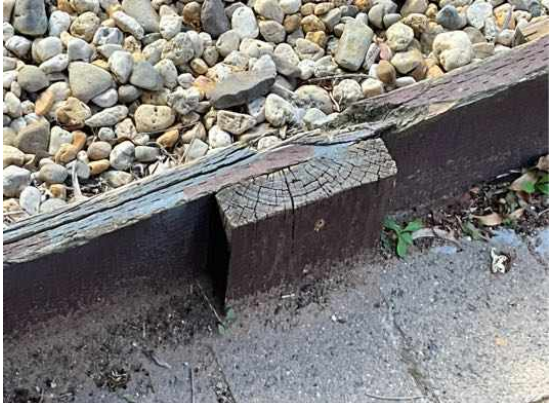
### Finding 6.03

Building:	Building 1
Location:	Yard - Back, front
Finding:	Untreated or non-durable timbers in a hazardous environment
Information:	To reduce the risk of timber pest attack it is essential that timber used in a hazardous environment (e.g. in direct contact with the ground or frequently exposed to damp conditions) is of sufficient durability and/or is adequately preservative treated.

Untreated timbers in direct contact with the ground are likely to develop severe wood rot and/or fungal decay if left unattended creating attraction for subterranean termites to infest the timbers from surrounding areas.

If untreated or non-durable timbers are found to be in a hazardous environment it is highly advised that replacement of these building elements be performed as soon as possible to aid the protection of the property against termite / timber pest attack.

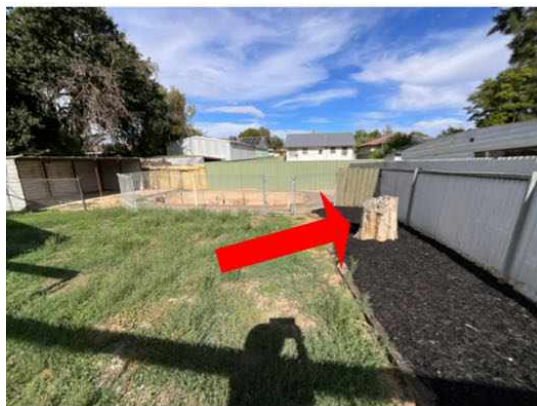
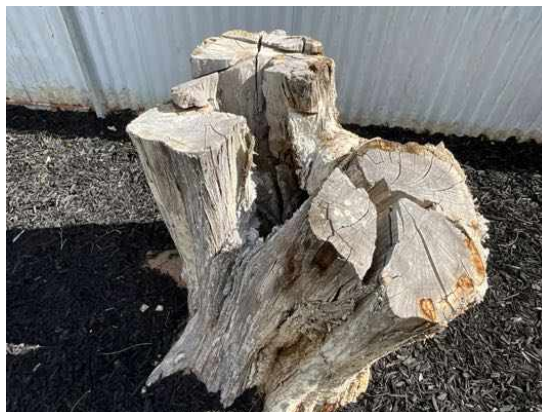
**Finding 6.04**

Building: Building 1  
 Location: Yard - Back  
 Finding: Tree Stump in Ground  
 Information: Any tree stumps in the yard not removed during the tree removal process provides the opportunity for Termite infestation and is likely to be subject to decay from damp conditions against the stump.

All tree stumps should be removed by professional tree removal services where possible. Meanwhile regular inspections are advised to identify any termite activity in the areas identified.

Services for tree stump removal should be contacted as soon as possible to reduce the risk of timber pest attack.

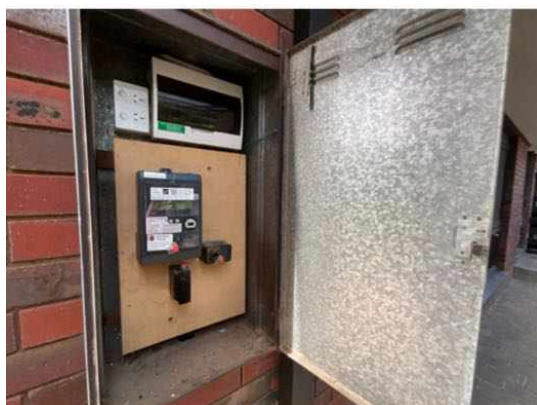
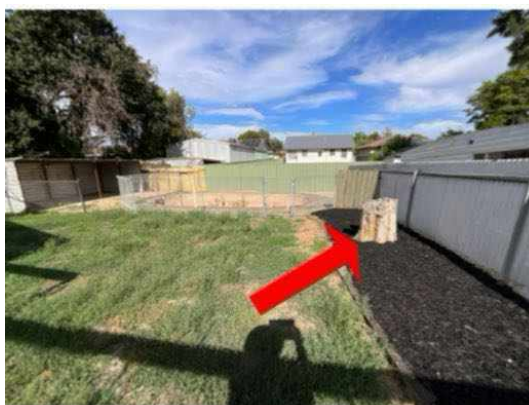
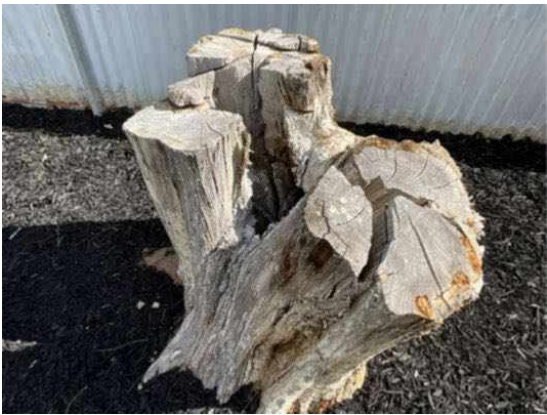
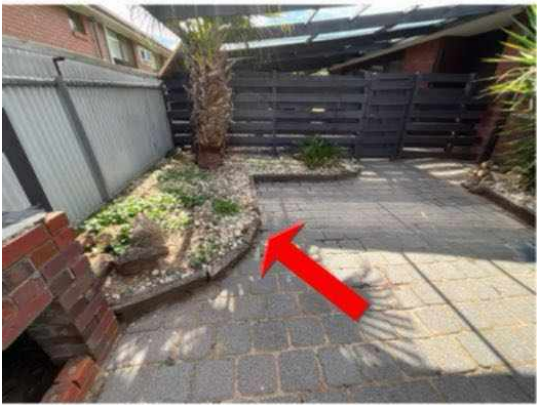
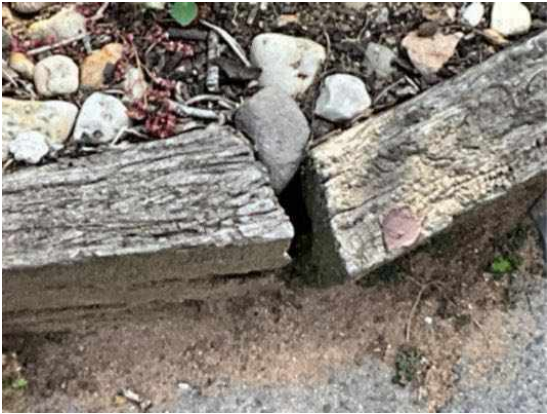
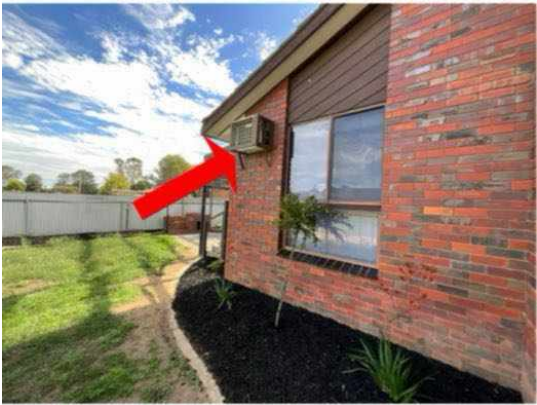
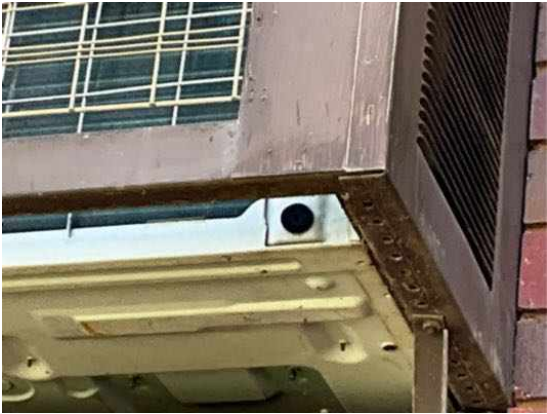
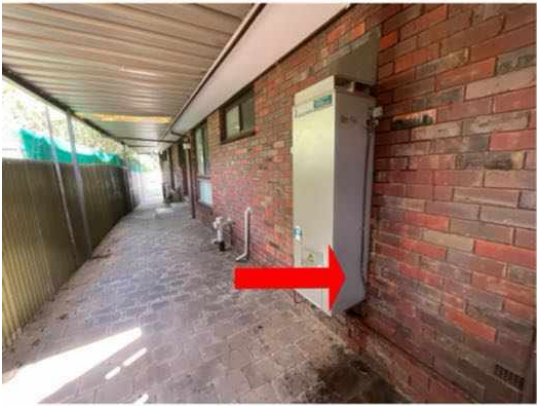
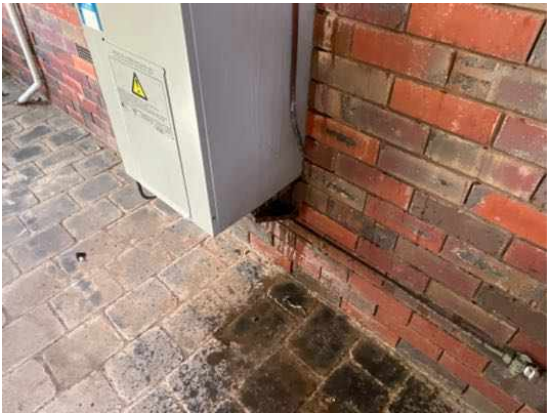
### Finding 6.05

Building: Building 1  
 Location: All External Areas  
 Finding: Termite Management System - no evidence of a chemical installation  
 Information: The application of a post-construction chemical termite barrier is highly recommended for all properties, particularly if live termite activity has been found on the site previously. Such barriers are highly effective in preventing termite attack on any timber building elements throughout the property.

A durable notice should be placed in the switchboard unit to indicate current termite barriers. At the time of inspection, it appeared as though no termite management system has been installed, with no evidence to suggest preventative works taking place.

The client may consider gaining further advice from a pest controller as to the costs and procedures involved with this application. It is recommended that obtaining such advice be a short-term priority.

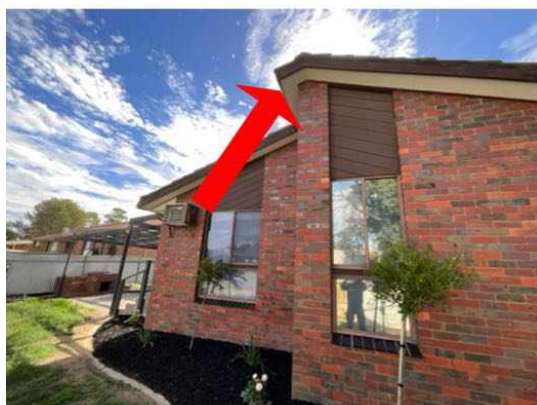
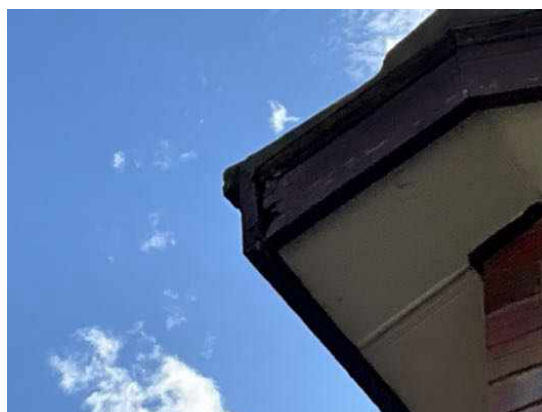
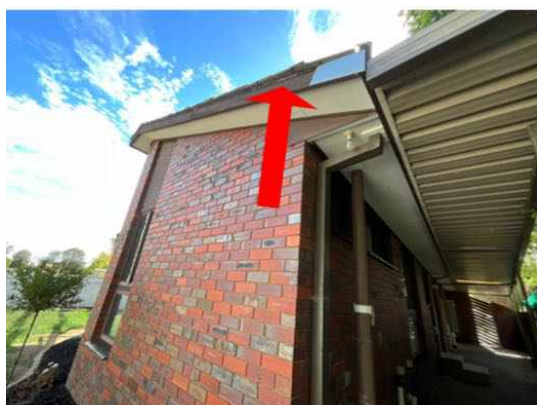
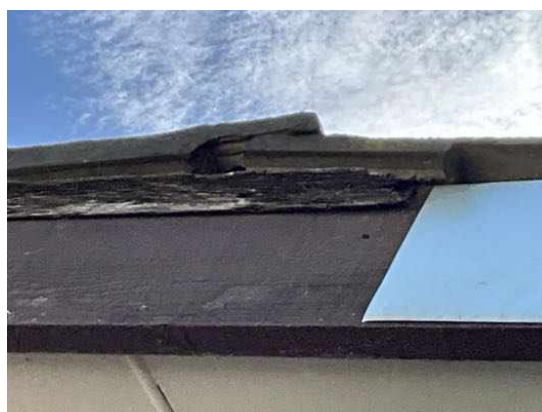
### Finding 7.01

Building:	Building 1
Location:	Eaves
Finding:	Fungal decay - present (localised)
Information:	Fungal decay also known as wood decay or wood rot generally refers to the deterioration of timber elements when in contact with excessive levels of moisture for a prolonged period of time.

The development of fungal decay is accelerated by temperatures in the range of 5degreeC to 40degreeC as well as the presence of oxygen. Generally fungal decay develops on timber elements that are in use in an external environment which are exposed to rain penetration.

In this case although the affected timber element is in a decaying state the extent of any visible damage appears to be localised to a specific area and is yet to spread to other parts of the building element or affect adjoining structures. The fungal decay is therefore likely to be of a relatively superficial nature with minimal impact on the structural integrity or tensile strength of the timber element.

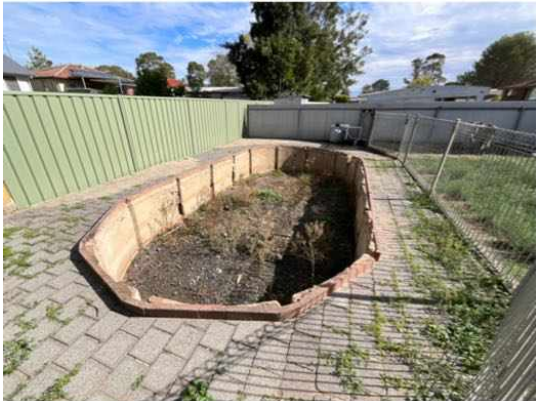
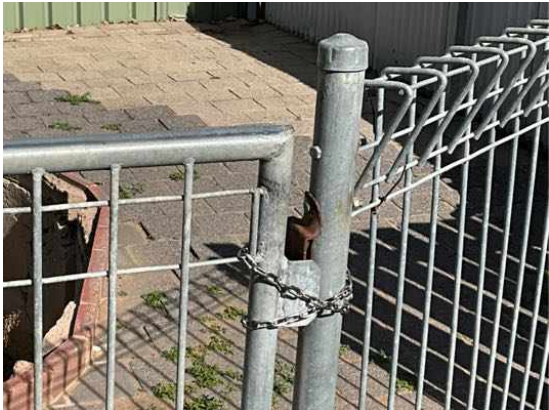
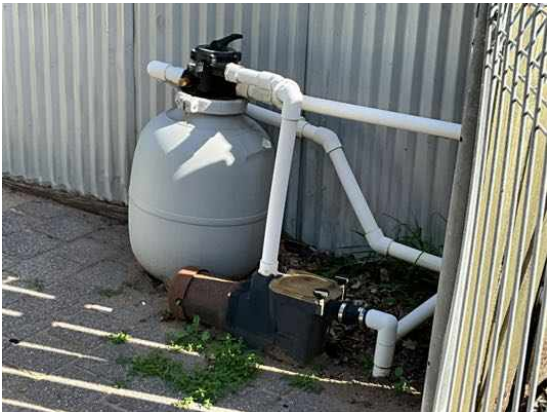
Building: Building 1  
Location: Pool Area  
Finding: Pool area  
Information: The pool area is really only a pit. It appears that an above ground pool was previously fitted into this excavated and lined structure.

The pool fence will need improvement and work to achieve local authority approval, if used for a functional pool in the future.

Advise from a pool company is advised at client discretion.

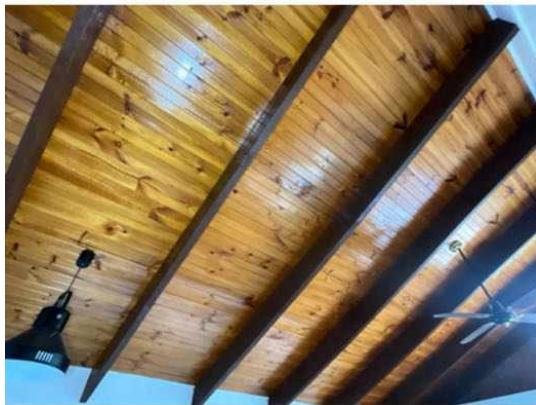
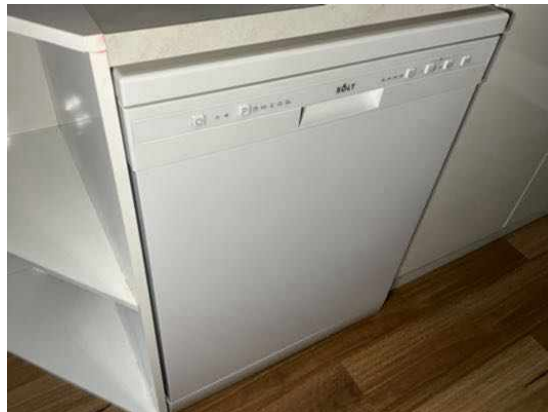
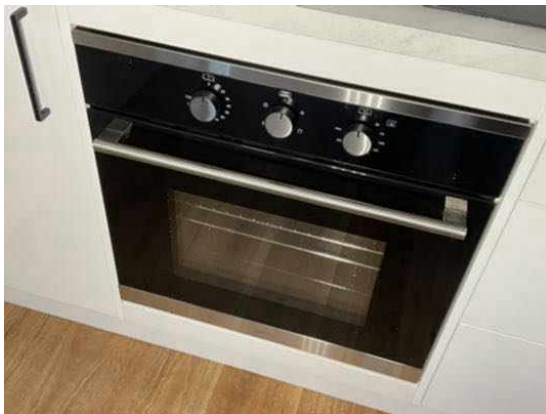
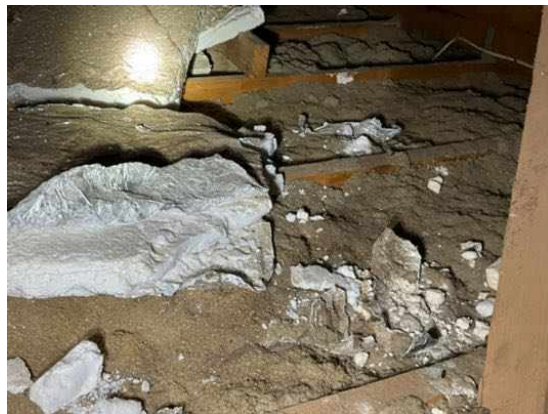
Building: Building 1  
Location: All Areas  
Finding: Additional Photos - Obstructions and Limitations  
Information: These photographs are an indication of the obstructions and limitations which

impeded full inspection of the property at the time of inspection. These obstructions can hide an array of defects and should be removed to allow full inspection to be carried out. A re-inspection is recommended once the areas are made accessible.
