Building and Timber Pest Inspection Report

Inspection Date: Fri, 27 Mar 2026

Property Address: 1/205 N Rocks Rd, North Rocks NSW 2151,
Australia

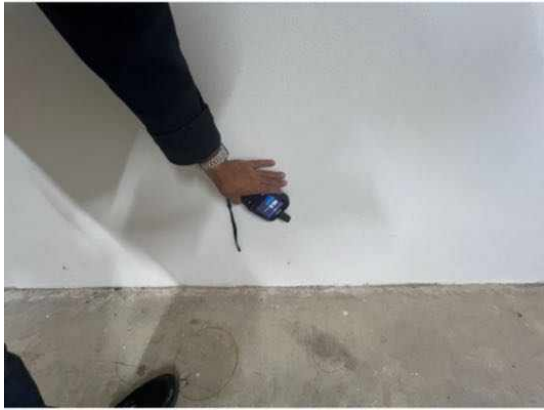
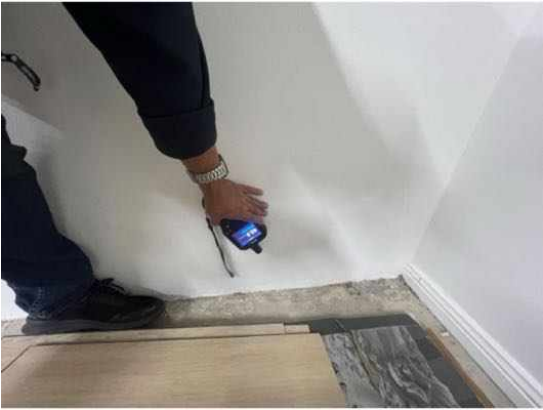
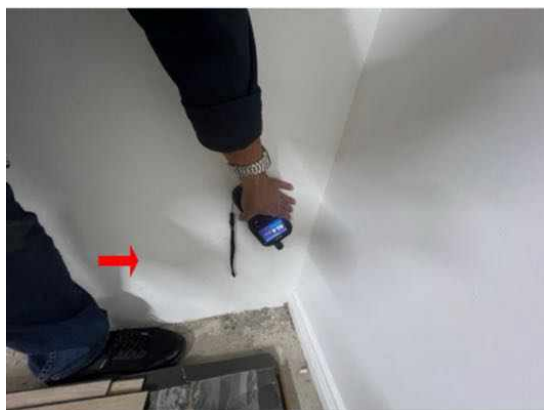
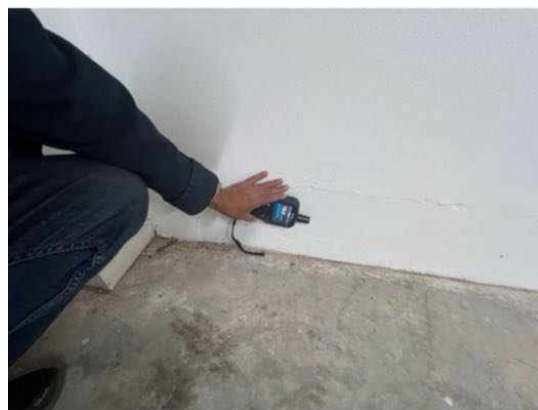
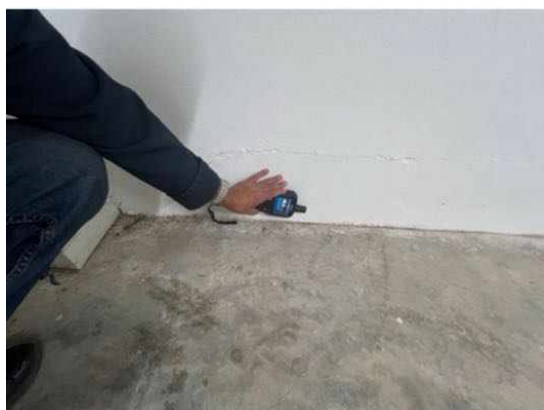
Finding 3.01

Building: Main Building
Location: Garage - Retaining wall
Finding: Elevated Moisture, cracking and past repairs – Further Investigation Recommended
Information: Elevated moisture readings were noted with some areas also showing signs of dampness and cracking, although no significant structural damage was evident at the time of inspection, dampness can contribute to deterioration if left unaddressed. A further investigation by a licensed plumber or waterproofing specialist is recommended to confirm the source and ensure no concealed issues are developing. The cracking to render appear to has been repaired, the extent of repairs could not be determined during a visual non invasive inspection and should be accessed by a licensed builder.

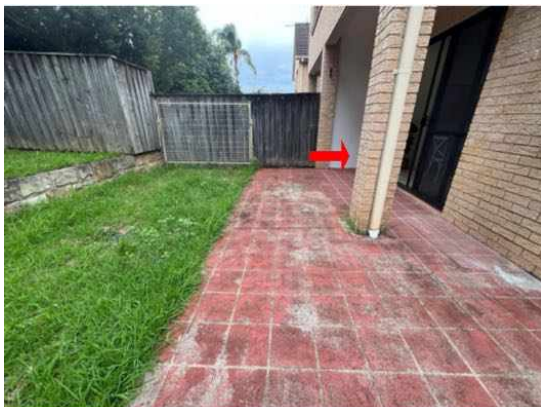
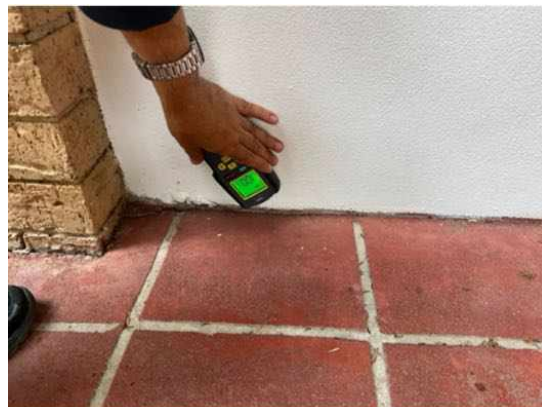
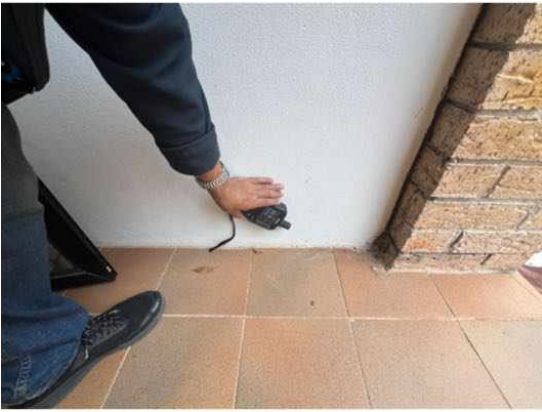
Finding 3.02

Building:	Main Building
Location:	All External Areas - Rear boundary wall, Right Party wall
Finding:	Damp
Information:	Damp (or structural damp) refers to the presence of unwanted moisture in the structure of a building, either as the result of intrusion from outside, or condensation from within the structure. Generally, structural damp is caused by rain penetration, rising damp, and leaks from plumbing pipes.

Unmanaged damp facilitates the formation and development of mould, fungi growth and wood rot, decaying associated building materials and compromising their structural integrity. Damage to finishes is also likely to occur, including lifting, bubbling, peeling and staining of paint, plaster and wallpaper.

Consultation with a qualified plumber is advised immediately to identify the cause of damp and perform remedial works as required. Where excessive mould growth is present, further inspection by a specialist environmental health inspector should also be considered.

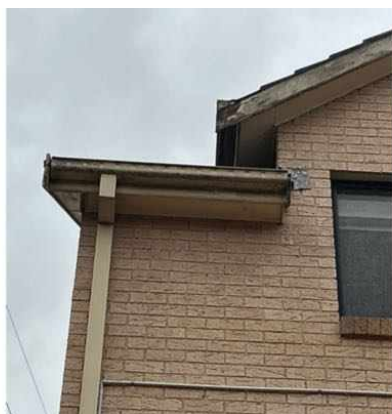
Building:	Main Building
Location:	All External Areas
Finding:	Fascias - Wood rot
Information:	Wood rot was found to be affecting fascias and barges in this area, evidenced by the presence of mould on the surface in some areas. Wood rot, also known as Fungal Decay, occurs when timbers and other cellulose building materials are exposed to damp conditions on an ongoing basis.

It is likely that this wood rot has developed as a result of faults in the roof plumbing, creating excessive moisture in this areas. Frequent exposure to rain and other weather conditions also make fascias and barges susceptible to accelerated deterioration.

It is advised that a roof plumber be appointed to inspect all roof plumbing and subsequently identify the cause of the wood rot. Replacement of affected fascias and barges may then be a necessary step in protecting surrounding building elements from such deterioration.

to provide advice on any remedial works as required. A qualified carpenter or registered builder may also be required to replace affected building materials.

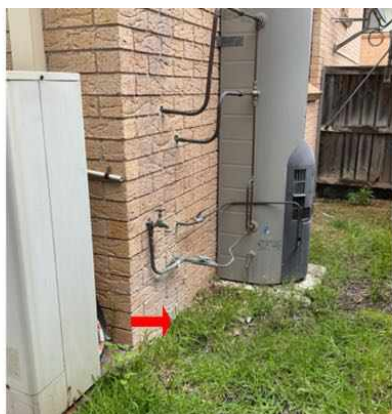
Finding: DPC & Weep Holes

Information: The ground level is nearly flushed or level with no visible step-down or separation from the weep holes or the damp-proof course (DPC). This presents a moisture risk, as AS 2870 and NCC Volume 2 Part 3.1.2 require ground levels or hard surfaces to be at least 75 mm below the DPC or the lowest course of brickwork with weep holes to prevent rising damp or lateral moisture ingress. Monitoring is recommended along with creating a 75 mm clearance or isolation gap along the wall line as required by NCC Vol 2 Part 3.1.2.3 and AS 2870 Clause 5.3.3. Monitor for any signs of rising damp or efflorescence.

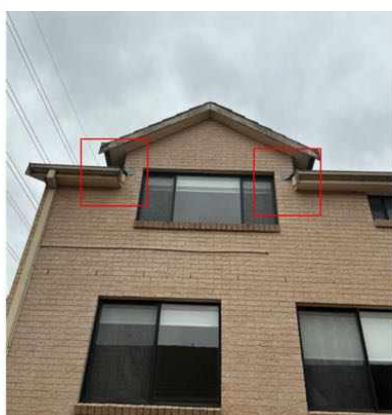
Finding 3.09

Building:	Main Building
Location:	Roof Exterior
Finding:	Roof plumbing - Loose flashing (Possible water ingress)
Information:	Metal and other material flashings are applied to seals and intersections between roof coverings and building elements. They are designed to aid in weatherproofing of roof joins, and require regular inspection and maintenance as they are more subject to rust-related deterioration.

The flashing in this section of the exterior roofing appears to have come loose from its original fixing. It is suspected that this minor defect has occurred as a result of general deterioration over time.

Re-fixing and potential replacement of certain areas of flashing is advised to promote adequate roof drainage and protection from water penetration. Failure to perform these works may result in water damage and accelerated deterioration of associated building elements.

A roofing contractor or roofing plumber should be appointed as soon as possible to restore the flashing to a fully operational state.

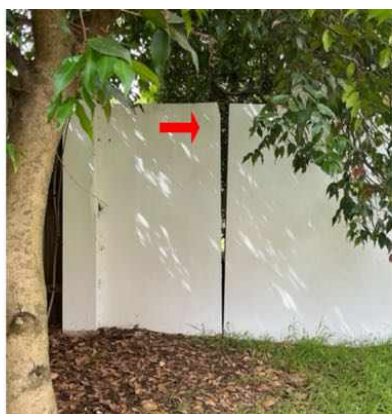
Finding 3.10

The separation indicates movement or inadequate jointing between panels, which may be due to, Thermal expansion/contraction, Ground movement or footing settlement, Insufficient fixing or joint detailing. Open joints can allow Water ingress behind panels, Debris accumulation, Long-term deterioration of fixings or framing. Vegetation in close proximity may also contribute to movement and moisture retention at the base.

Further assessment by a licensed bricklayer or licensed builder is recommended.

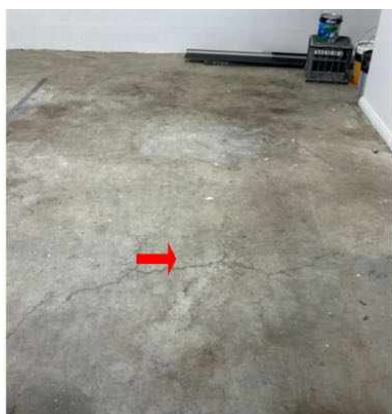
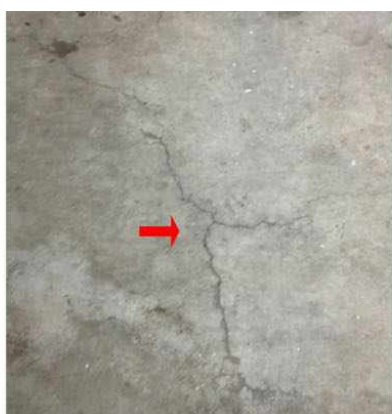
Finding 3.11

Building:	Main Building
Location:	All External Areas
Finding:	Cracking - External Concrete Paving Damage Category 2 - Distinct (less than 3mm)
Information:	Distinct cracks were identified in external concrete paving. Distinct cracks are generally found in older concrete paving, and may also present as a trip hazard as

General age and expected deterioration of the paved areas is a common cause of this type of cracking. However, expansion and contraction of the slab may also have occurred due to environmental factors. Such factors include variable moisture and weather conditions, the presence of trees and their roots having a settling or lifting affect on the soil, or the effect of load bearing, e.g. heavy vehicles over a sustained period of time.

Cracking to this degree may also be due to poor original installation of the concrete. Factors such as poor compaction of the sub surface and/or inadequate reinforcing of the slab may create cracking and other secondary defects.

Repairs are likely to be required to prevent further cracking and to reduce hazards associated with cracking, such as tripping. Monitoring of all cracking should be conducted frequently. Always contact a building inspector should cracks widen, lengthen, or become more numerous.

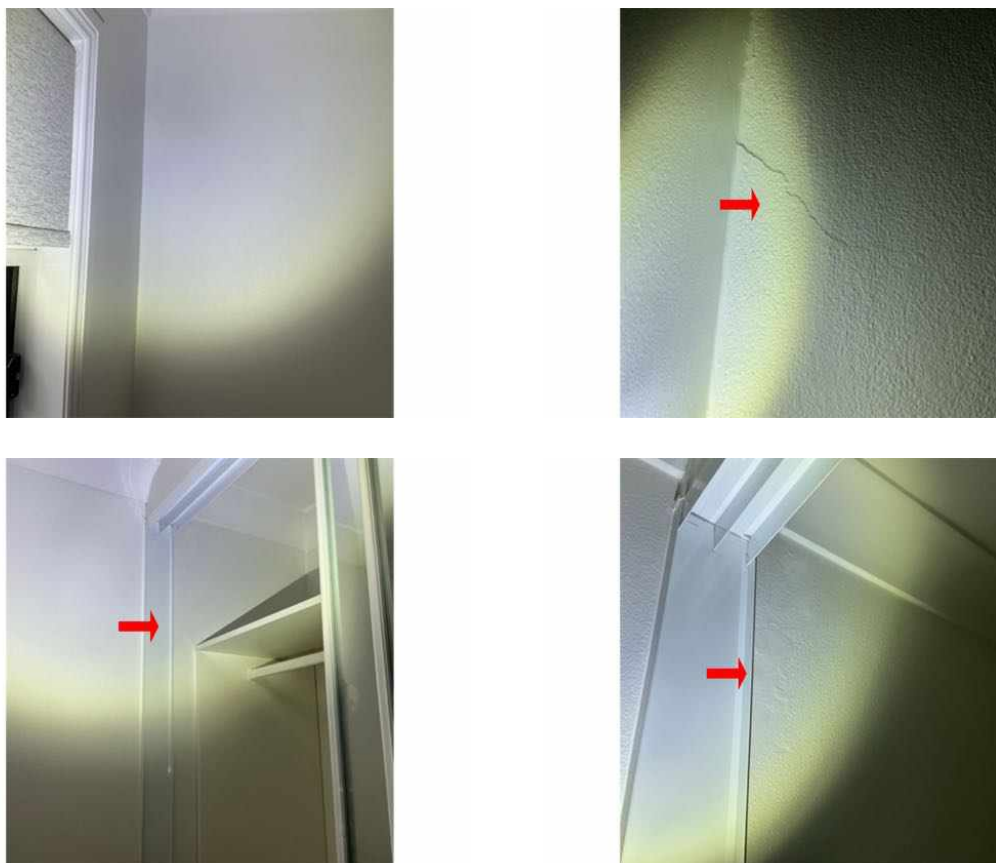
Building:	Main Building
Location:	All Internal Areas
Finding:	Cracks to internal render - Category 1 to some areas
Information:	It has been observed that cracking to internal rendered surfaces has occurred. The degree of damage falls within Category 1, described as fine cracks that do not need repair and which are less than 1.0mm in width limit. Evidence of past repairs was also noted extent of which could not be determined during a visual non invasive inspection.

Always contact your building inspector should cracks widen, lengthen, or become more numerous.

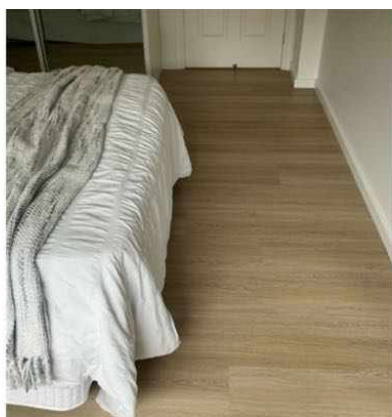
Building:	Main Building
Location:	All Internal Areas
Finding:	Bouncy/uneven Floor to some areas
Information:	floor flexing/minor unevenness was noted in isolated areas during normal walking conditions. This condition is typical of timber-framed floor systems and may be attributed to minor deflection in floor joists, insufficient subfloor support, or age-related settlement of structural elements.

No visible signs of structural damage or distress were observed at the time of inspection. If the deflection worsens or causes concern, further assessment by a licensed builder or carpenter is recommended. Remedial work may include installation of additional support noggins, blocking, or subfloor stiffening to reduce bounce and improve floor rigidity.

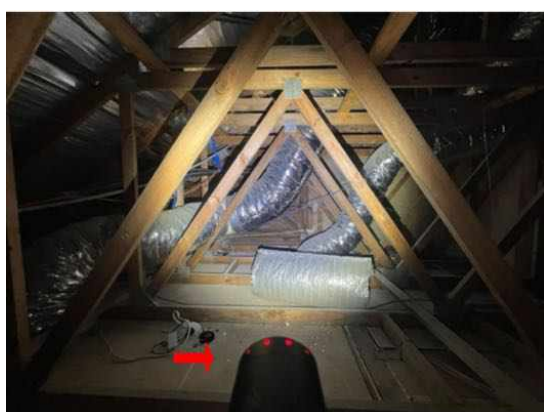
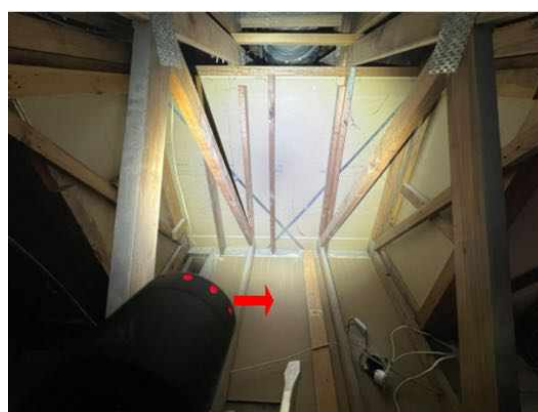
Where insulation is absent, the area does not meet current Australian Standards. Installation of adequate insulation is required and should be conducted as soon as possible.

Loose cables should also be secured by a licensed electrician

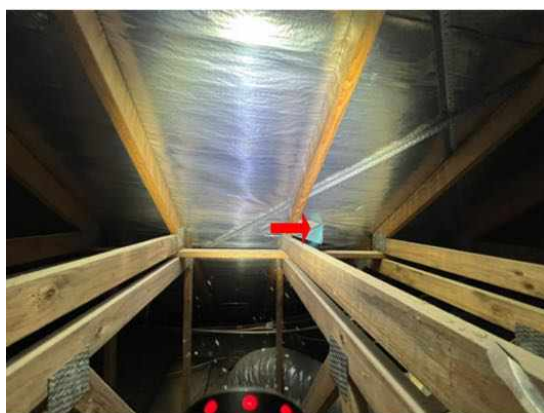
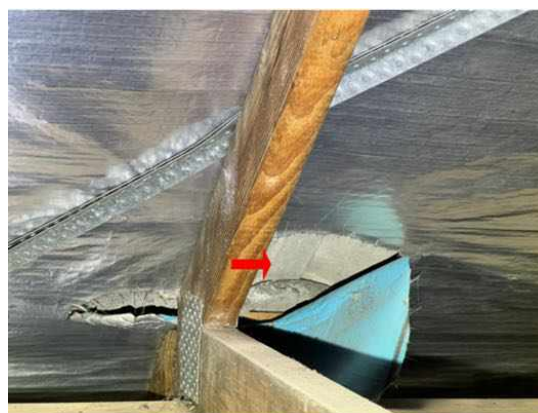
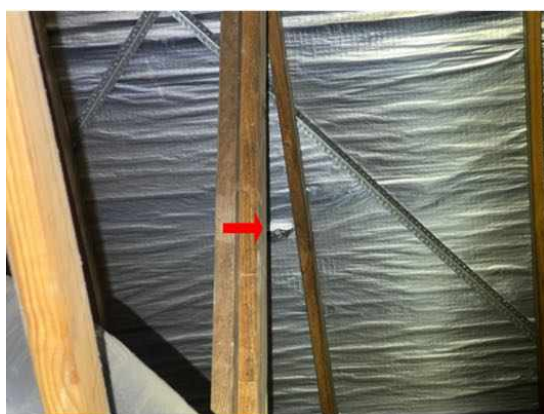
Finding 3.28

Building:	Main Building
Location:	Roof Void
Finding:	Sarking - Damaged

Where sarking is damaged, both insulation and moisture protection of the property are inhibited. This creates a loss of energy and thus negatively impacts the energy efficiency of the property, allowing potential for moisture ingress from condensation or leaking roof tiles.

It is important to repair any holes or damaged sections of sarking to ensure that the building material is fully functional. A registered builder or qualified carpenter should be consulted to provide further advice on this defect and to perform rectification works at client discretion.

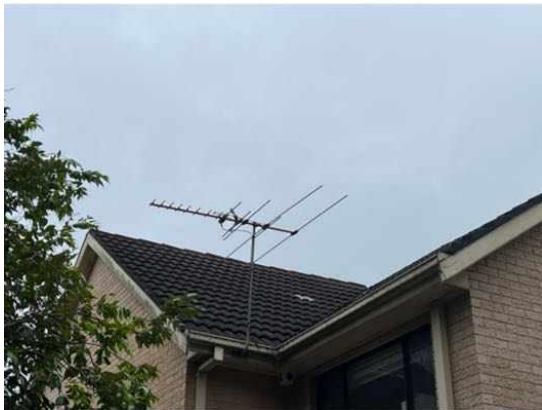
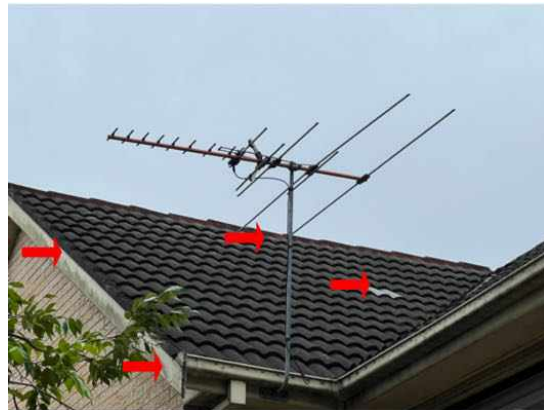
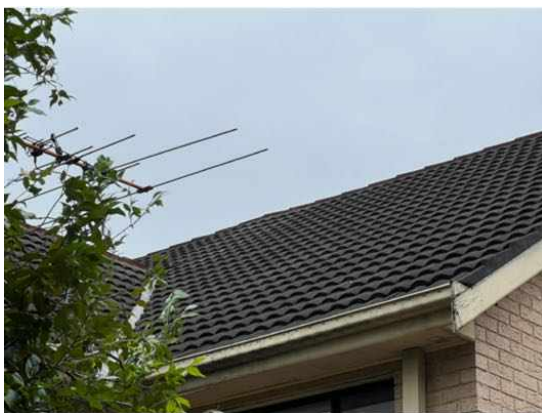
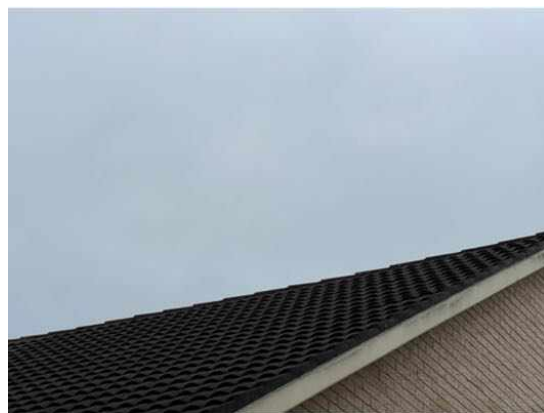
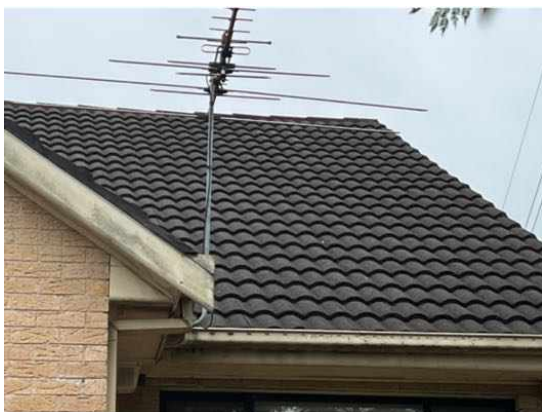
Finding 3.29

Building: Main Building
 Location: Roof Exterior
 Finding: Roof observation from ground
 Information: The roof covering appears generally serviceable from the areas viewed, however, the ridge capping shows signs of age-related deterioration consistent with minor mortar bedding wear. Localised staining to gutter and fascia elements was also observed, indicating maintenance is required. Roof fixtures, including the antenna, appear

installed but should be monitored for stability and fixing integrity. Ongoing maintenance is recommended to prevent deterioration and potential water ingress.

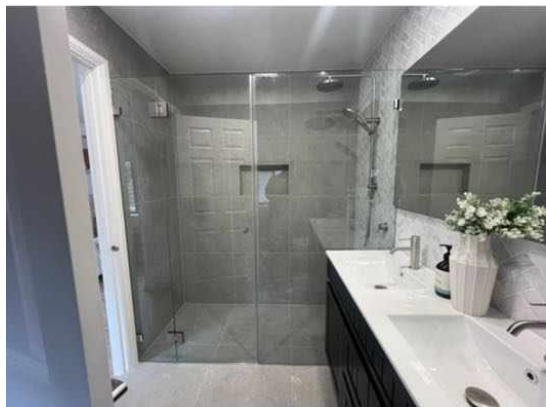
Finding 3.30

Building:	Main Building
Location:	bathrooms
Finding:	Shower screens
Information:	The shower screen exhibited movement when manually tested (slight movement is acceptable) appeared indicating possible inadequate fixing and/or installation. This may lead to instability and potential failure of the glass panel. Assessment and rectification by a qualified glazier is recommended.

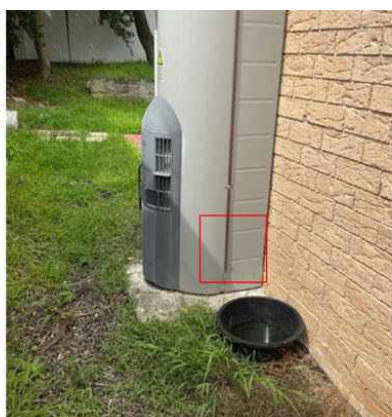
These damp conditions can lead to secondary defects such as rot, rust or corrosion of associated building elements, the formation of fungal decay, or even the creation of potential slip hazards. When coupled with poor site drainage, pooling of water may also attract termite activity to this area.

It is highly recommended that a licensed plumber be appointed to connect the HWS overflow in order to prevent such an environment from being created. These minor works should be carried out as soon as possible.

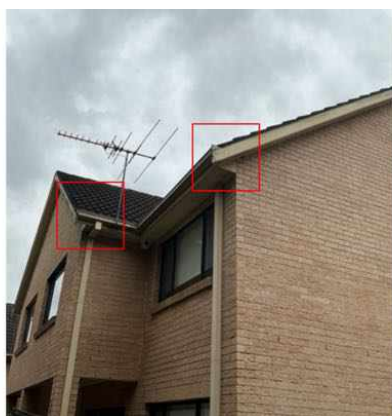
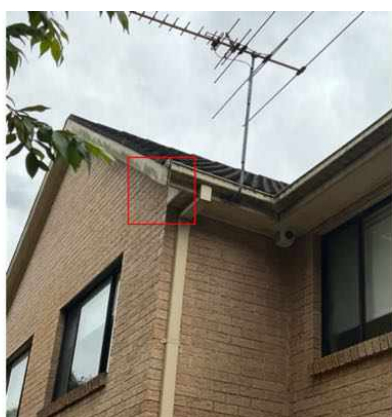
Finding 7.01

In this case although the affected timber element is in a decaying state the extent of any visible damage appears to be localised to a specific area and is yet to spread to other parts of the building element or affect adjoining structures. The fungal decay is therefore likely to be of a relatively superficial nature with minimal impact on the structural integrity or tensile strength of the timber element.

A further invasive inspection by a licensed timber pest technician is highly recommended to check for concealed activity.
