Building and Timber Pest Inspection Report VR

Inspection Date: Tue, 7 Apr 2026

Property Address: 405/91-93 Nicholson St, Brunswick East VIC
3057, Australia

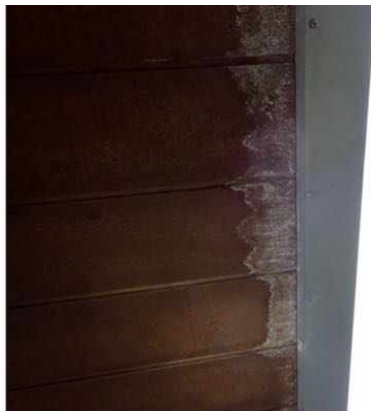
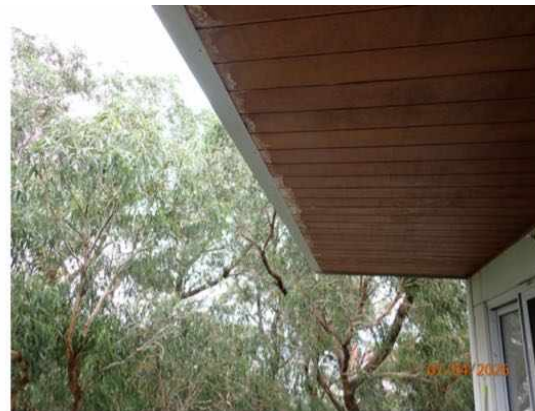
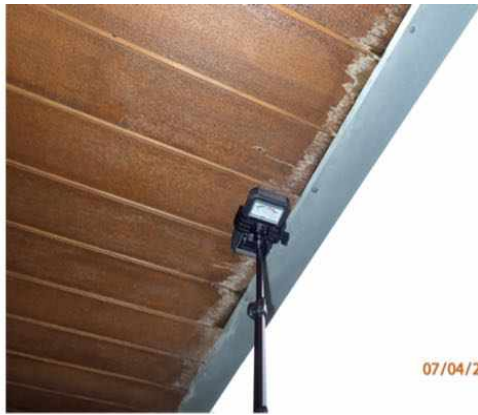
Finding 3.01

Building: Main Building
Location: Balcony
Finding: Balcony Ceiling Water Staining / Efflorescence
Information: Water staining and efflorescence were noted to the balcony ceiling during the inspection. No elevated moisture readings were detected at the time; however, this condition is suspected to be related to the balcony above, with staining possibly migrating from that area through the flashing or from the side. Assessment of the balcony tiles above was not possible due to lack of access from the adjoining property. As no evidence of active moisture was detected to the balcony ceiling at the time of inspection, the issue does not appear to be actively leaking; however, the area should be monitored, and a licensed plumber or registered builder should be engaged if further staining or moisture becomes evident.

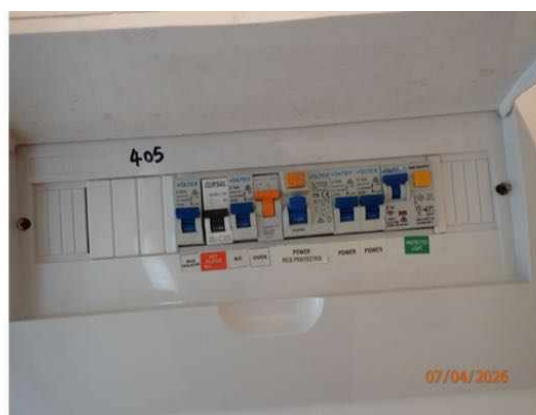
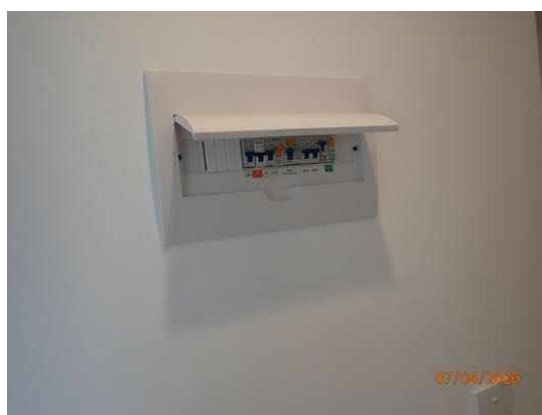
Building: Main Building
 Location: Electrical Switchboard
 Finding: Termite Management System - no evidence of a chemical installation
 Information: The application of a post-construction chemical termite barrier is highly recommended for all properties, particularly if live termite activity has been found on the site previously. Such barriers are highly effective in preventing termite attack on any timber building elements throughout the property.

A durable notice should be placed in the switchboard unit to indicate current termite barriers. At the time of inspection, it appeared as though no termite management system has been installed, with no evidence to suggest preventative works taking place.

The client may consider gaining further advice from a pest controller as to the costs and procedures involved with this application. It is recommended that obtaining such advice be a short-term priority.

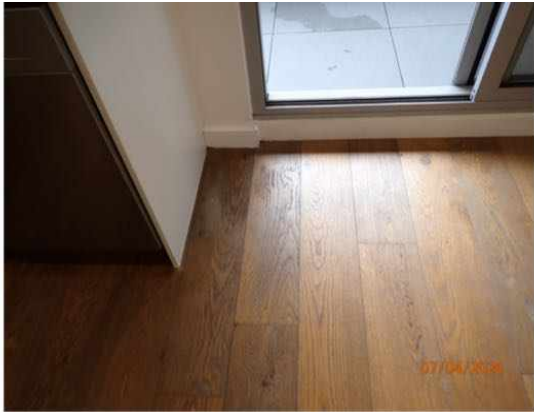
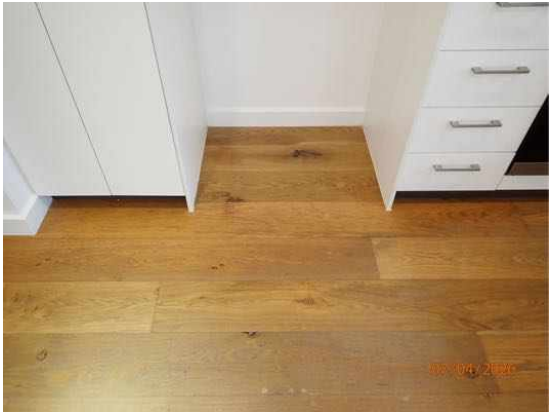
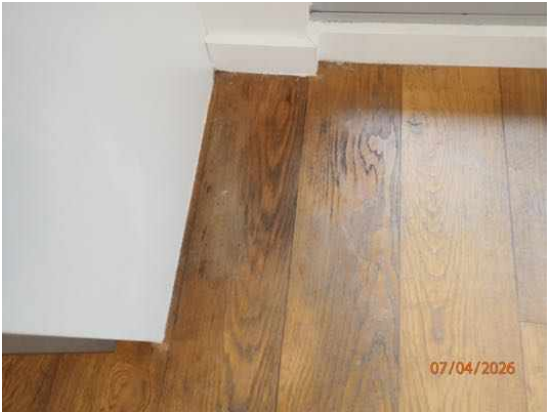
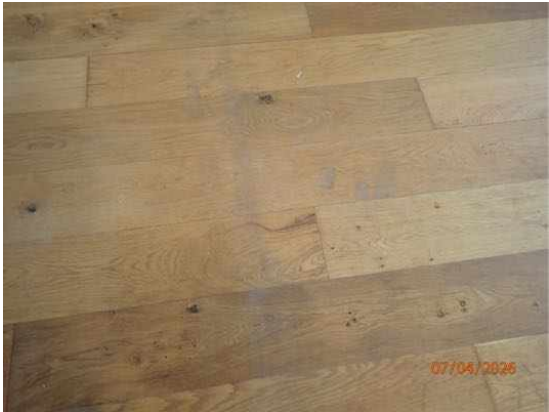
Building: Main Building
 Location: All Internal Areas
 Finding: Floor - Scuffed
 Information: Minor scuff marks were noted to the flooring in this area during inspection. This appears cosmetic only and is consistent with general wear and tear over time, with no structural or operational issue noted at the time of inspection. Repair is not considered essential; however, a handy person or flooring specialist can be engaged if the client wishes to improve the appearance.

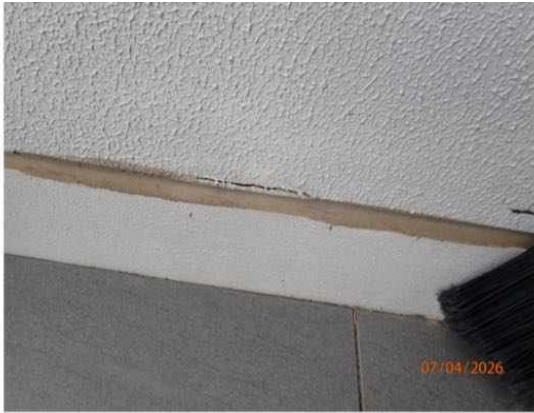
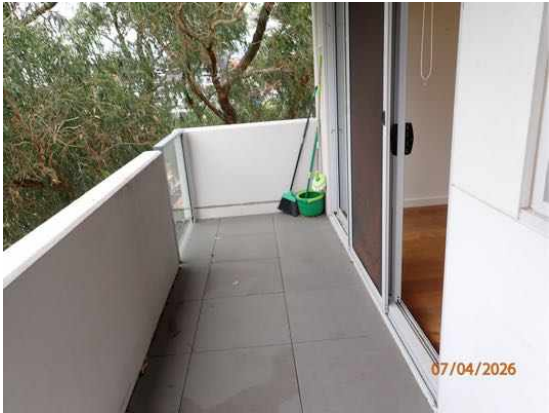
Building: Main Building
Location: Balcony
Finding: Sealant damaged
Information: The sealant to this section of the balcony was noted damaged and deteriorated during the inspection. This may allow water entry over time and contribute to moisture-related issues if left unattended. A licensed plumber or registered builder should be engaged to re-seal this area as required.

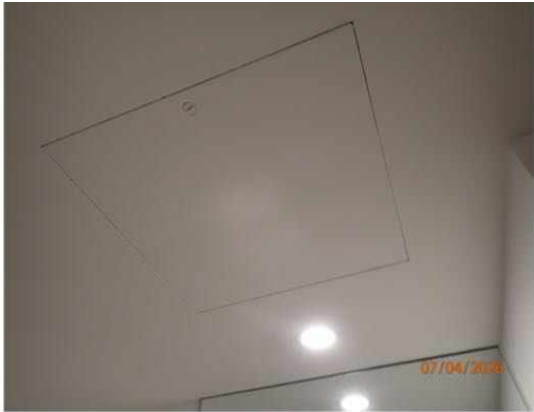
Building: Main Building
Location: All Areas
Finding: Roof Void Not Accessible
Information: Access to the roof void through the bathroom manhole was not possible during the inspection, as the access panel appeared painted shut. As a result, this area could not be inspected. A range of defects may be concealed in inaccessible areas, and a re-inspection is recommended once access is made available.

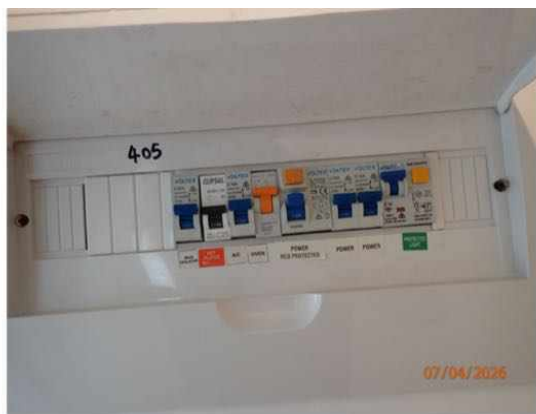
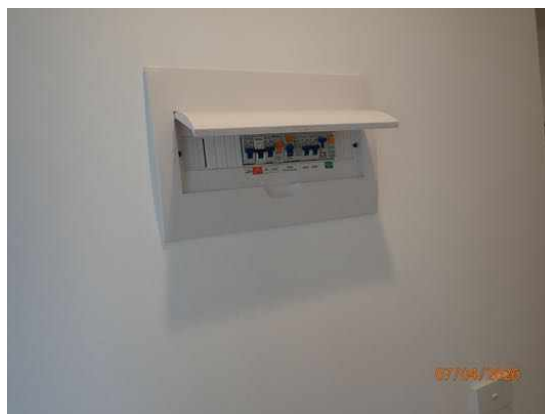
Finding: Electrical Switch Box

Information: All electric wiring, meter boxes and appliances need to be checked by a licensed Electrician ensuring any work completed as part of a renovation or extension has been issued with a Certificate of electrical Safety (CES). The checking of any electrical items is out side the scope of this inspection.

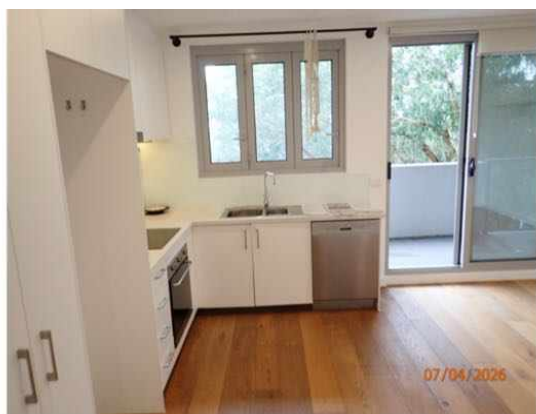
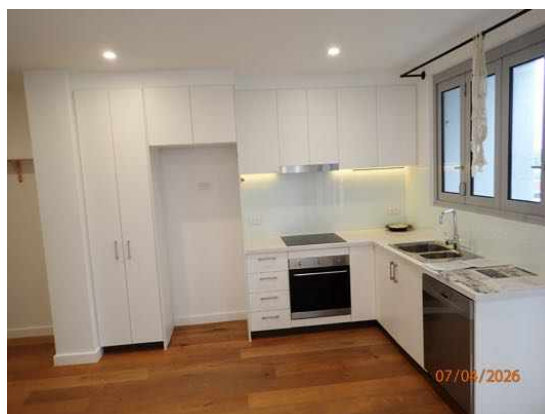
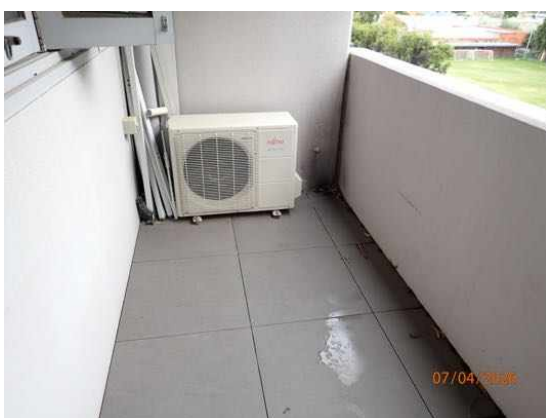
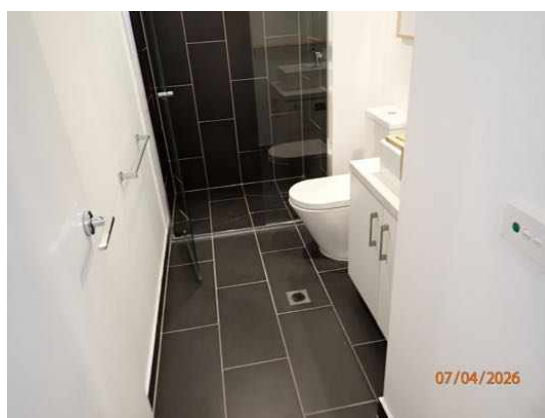
Building: Main Building
Location: All Internal Areas
Finding: Additional Photos - Obstructions and Limitations
Information: These photographs are an indication of the obstructions and limitations which impeded full inspection of the property at the time of inspection. These obstructions can hide an array of defects and should be removed to allow full inspection to be carried out. A re-inspection is recommended once the areas are made accessible.
