Building and Timber Pest Inspection Report

Inspection Date: Wed, 11 Mar 2026

Property Address: 16 Panorama Parade, Moruya NSW 2537,
Australia

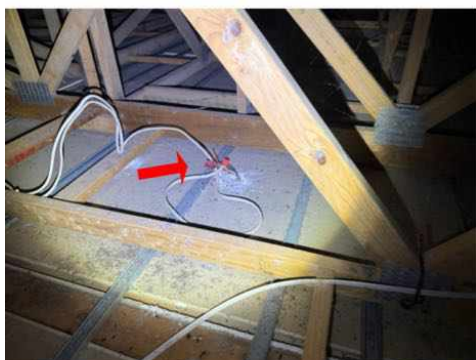
Building:	Building 1
Location:	Roof Cavity - left middle
Finding:	Electrical cables missing a junction box
Information:	The electrical fitting in this roof area was found to be missing a junction box at the time of inspection.

This missing fitting and loose cables does expose electrical works, and may create a safety hazard if there is potential contact with persons in the area.

A Licensed electrician should be appointed to rectify these areas immediately.

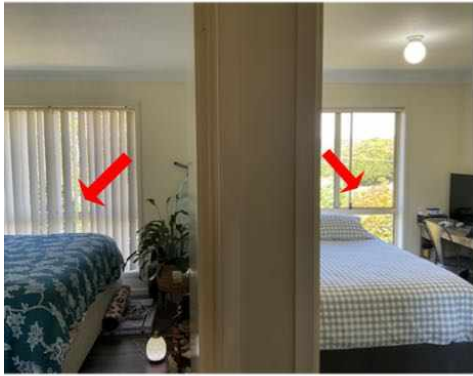
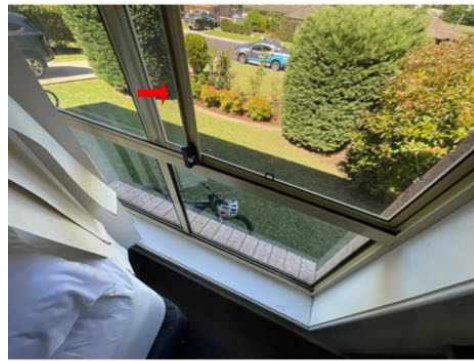
Finding 1.02

Building:	Building 1
Location:	Bedrooms
Finding:	Window opening restrictors missing.
Information:	The Building Code of Australia rules require all openable windows (where the internal floor is more than 2m above the ground outside) in residential rooms to be fitted with a suitable screen or restrictor. There are inexpensive and easy to fit devices. Windows located 1.7m above the floor level do not require protection.

Window restrictors are required where people who are vulnerable to the risk of falling have access to windows. This means all windows above ground level which do not have another fall prevention safety measure in place, such as a balcony or balustrade should have a restrictor.

These need to be added urgently for the safety of all persons.

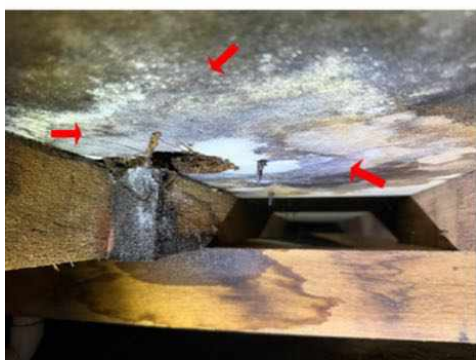
Finding 2.01

Building: Building 1
 Location: Bathrooms and laundry
 Finding: Waterproofing membrane and flooring damage
 Information: Internal Water Proofing Membranes, are crucial in preventing water ingress into the property.

It appears this membrane has failed causing major flooring damage requiring replacement.

Quotes should be sought before purchase from bathroom renovation companies to replace the damaged flooring and waterproofing membrane.

These replacements costs are likely be substantial.

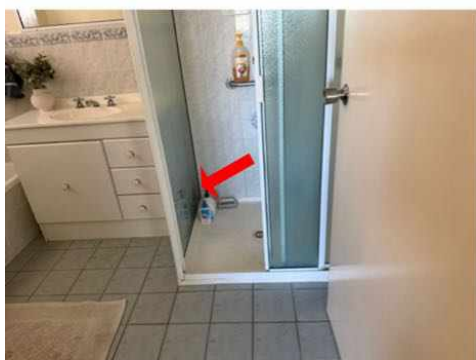
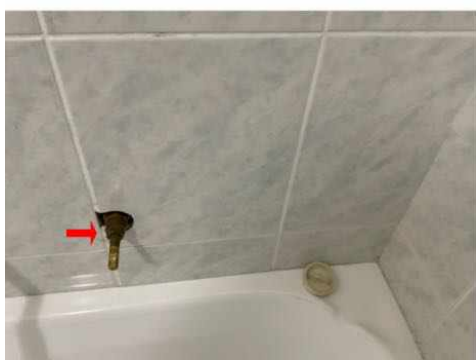
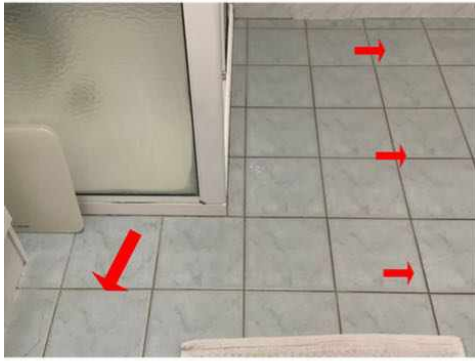
Building: Building 1
Location: Bathroom
Finding: Shower screen leaking and other bathroom defects.
Information: Leaking was evident to the left shower screening at the time of inspection. It is suspected that the leaking has occurred as a result missing sealant. Leaking from the shower , where left unattended, is likely to lead to water damage to adjoining flooring and walls. Such damage can lead to water damage and necessitate extensive remedial works being required. Appointment of a sealant expert is required to repair or replace this missing sealant. Such works should be performed as soon as possible to ensure that no further damage occurs.

- a missing bath tap handle (still working)
- a cracked shower tap handle
- approx ten cracked floor tiles and one cracked shower lower wall tile were evident.

A full bathroom renovation is likely to be required.

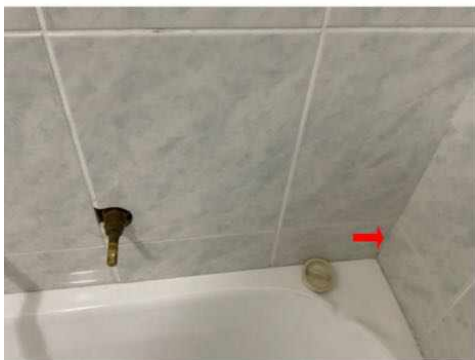
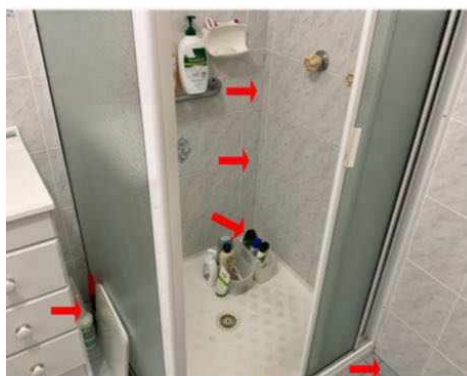
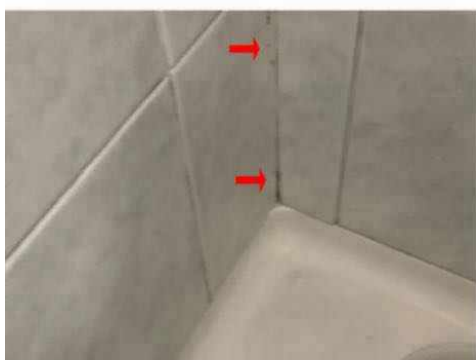
Finding 3.03

Building:	Building 1
Location:	Bathroom
Finding:	Sealant and grouting - Missing or damaged
Information:	It was noted on inspection that sealant or grout is degraded to these pictured wet areas.

Different materials and floor areas move at different rates, generally causing cracking to grout or sealant at this point. A flexible sealant is required to allow for expected expansion and contraction, while keeping the joint water tight and protective of all associated building materials.

Flexible and mould resistant materials should be applied to affected areas to prevent any subsequent water damage that is likely to occur. Regular maintenance and replacement of damage or missing or damaged sealant and grout is highly recommended to the wet areas, as this is a regular wear and tear defect. Sealant and grouting in areas that come into regular contact with water should be maintained for the long term care of your property.

A sealant specialist or tiling contractor should be appointed to complete these works as soon as possible

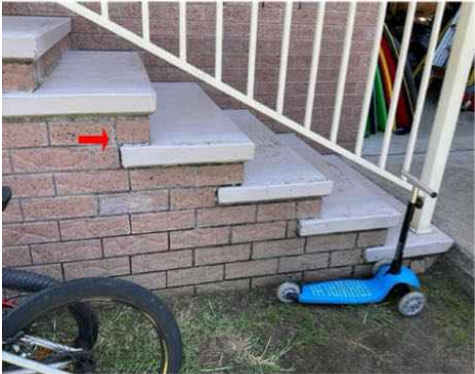
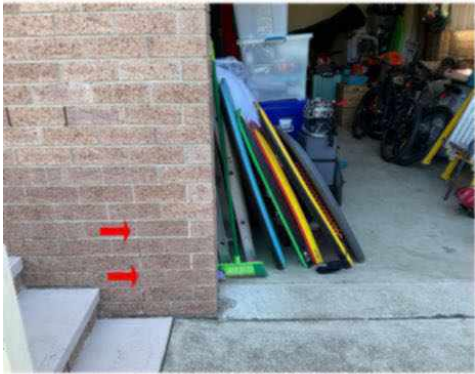
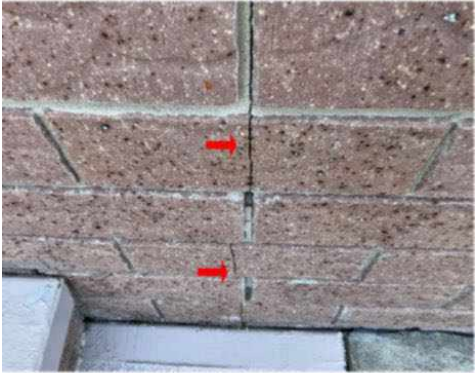
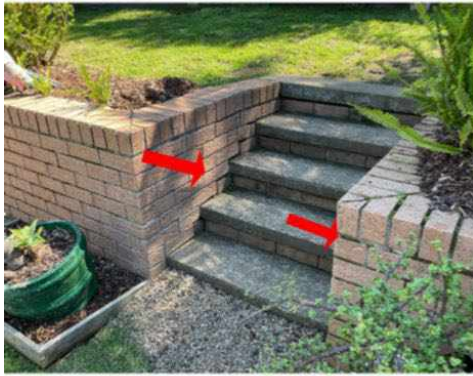
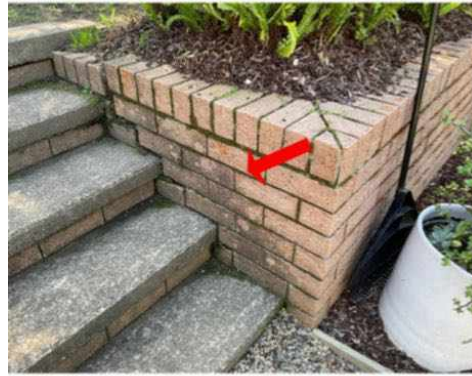
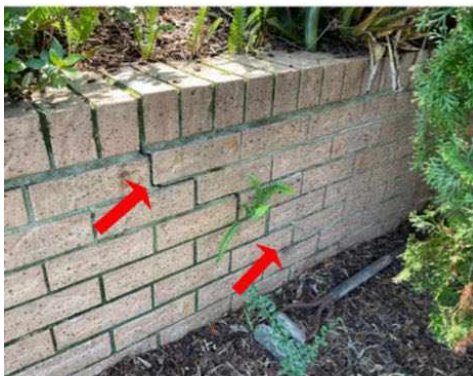
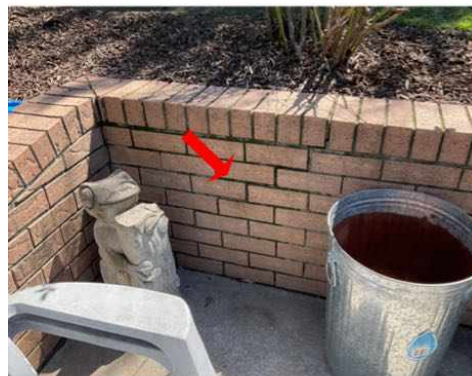
Finding 3.04

Building:	Building 1
Location:	Exterior front house and rear yard walls
Finding:	Step cracking to brickwork (minor under 5mm)
Information:	Step cracking was identified to the brickwork in three areas of the right front walls and 4 areas of the rear yard small retaining walls at the time of inspection.

Step cracking, which is similar to other forms of cracking, has a variety of possible causes. However, the most common is the subsidence of adjacent footings.

Step cracking is a relatively common defect, and is most likely to occur adjacent to windows, doors and other openings. Mortar failure in the gaps between affected bricks indicates the stresses and tensions affecting the wall.

The rear yard step cracking either side of the rear steps in the 790mm wall, is over 5mm, however, due to it having no bearing on the house, this is mentioned in this report as a minor defect. Adding drainage behind these rear retaining wall areas will likely stop movement of these

If step cracking is extensive or severe (over 5mm) the client is advised to consult a structural engineer. The pictured minor house step cracking can be used as a warning sign to address factors causing stress to the wall, which can include the effect of water leaks, soil erosion, or even the presence of reactive soils in the surrounding

area.

These areas should be monitored annually and if any house wall cracking exceeds 5mm, a structural engineers advice is required. These cracks are currently 1-3mm.

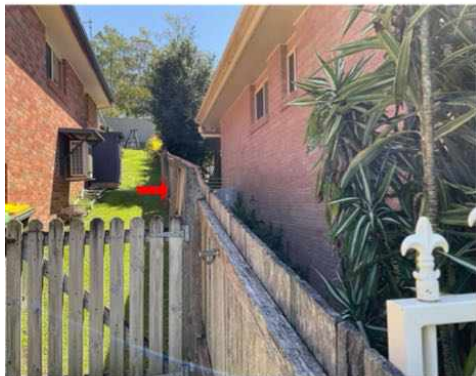
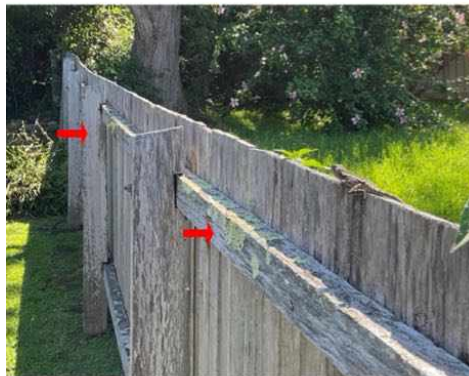
Finding: Fences damaged - leaning
 Information: Evidence of damage to the pictured left and right fences was identified at the time of the inspection. The likely cause of this fence leaning is not enough concrete used in the post footings. If left unmanaged this fence may deteriorate further. It is suggest a fencing contractor be engaged for rectification when convenient.

The cost of repairing fences is often shared between neighbours.

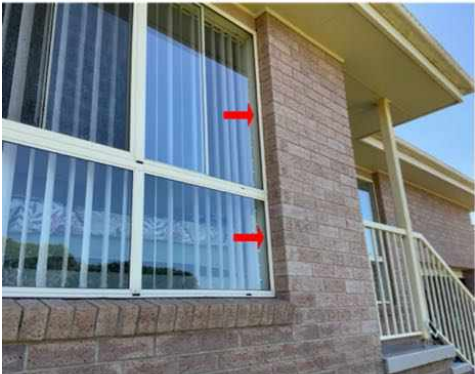
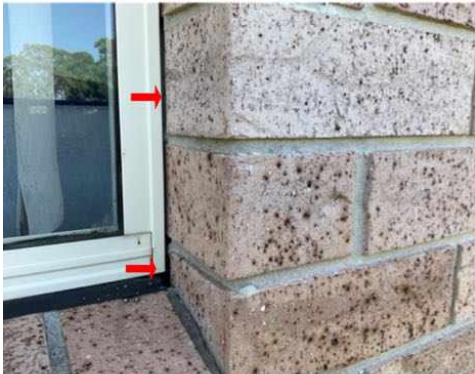
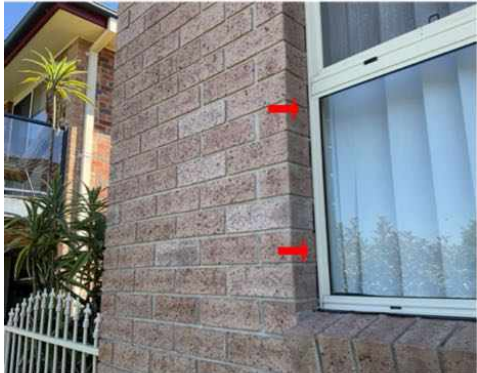
Building: Building 1
Location: Some window areas
Finding: Sealant (external) - Missing.
Information: It was noted on inspection that areas of external sealant was missing to small areas of the external walls.

Flexible sealants should be applied to these affected areas to prevent any subsequent water damage that is likely to occur.

A sealant specialist or skilled handy person should be appointed to complete these works as soon as possible

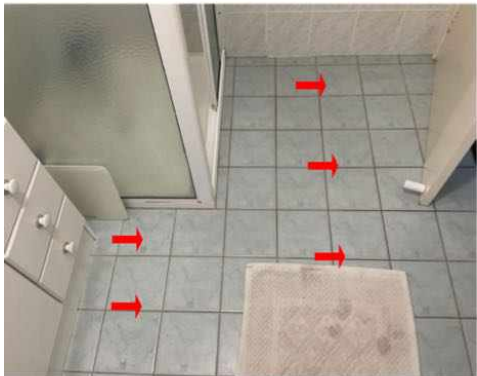
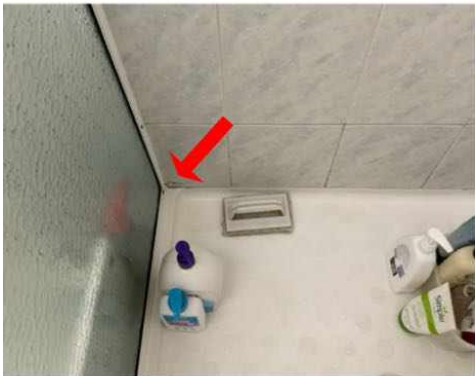
Finding 3.10

Building: Building 1
Location: Bathroom, laundry
Finding: Tiles cracked
Information: Cracked tiles were evident in these pictured areas at the time of inspection. It is suspected that this cracking has occurred as a result of minor settlement.

Cracked tiles throughout the household detract from the overall appearance of the affected areas. In wet areas of kitchens and laundrys, it can lead to water damage of adjoining walls and floors.

Replacement of cracked tiles is recommended as soon as possible. A tiling contractor may be appointed to perform these works. Where cracks become more numerous, contact a licensed building inspector for further investigation.

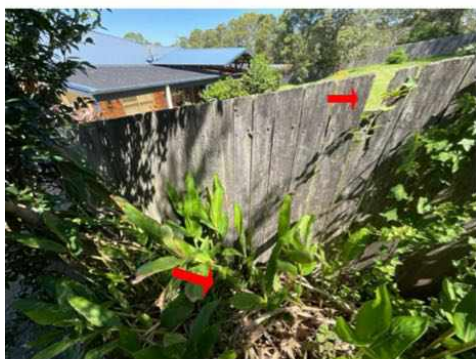
Finding 3.11

Building:	Building 1
Location:	Fence and subfloor areas
Finding:	Wood rot under bathroom and small fence areas
Information:	These pictured areas shows evidence of wood rot. Wood rot, also known as Fungal Decay, occurs when timbers and other cellulose building materials are exposed to damp conditions on an ongoing basis. This could be the result of exposure to weathering over a prolonged period of time, or the attraction of excessive moisture from other abutting building materials.

Early intervention and regular maintenance, particularly of exterior timbers, will prolong the useful life of these building elements. Prior to any works being performed, the cause of the moisture that has created the visible wood rot should be identified and addressed in a suitable manner. Replacement of affected timbers may then be a necessary step in protecting surrounding building elements from such deterioration.

A qualified carpenter or registered builder may also be required to replace affected building materials.

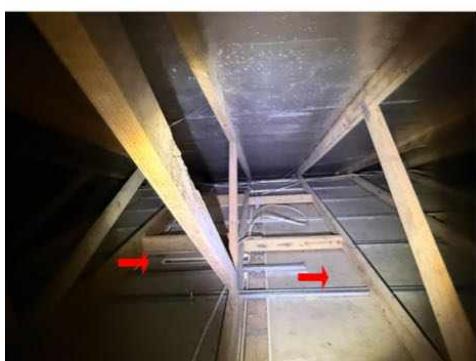
Finding 3.12

Building:	Building 1
Location:	All Roof cavity areas
Finding:	Insulation - Missing
Information:	Upon inspection of the roof void it was noted that insulation is not present (sarking was fitted and in good condition).

Insufficient insulation will result in a comparatively higher cost to heat and cool a property as there is a lack of Insulation (or uneven coverage of insulation) which works as a barrier to heat transfer. This helps to keep out unwanted heat in summer and preserves warmth inside your home in winter. It can also help soundproof your home from unwanted airborne noise transfer.

Where insulation is absent, the area does not meet current Australian Standards. Installation of adequate insulation is required and should be conducted as soon as possible.

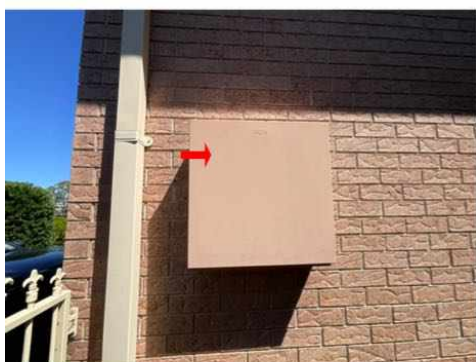
Building:	Building 1
Location:	Meter Box
Finding:	Termite Management System - no evidence of a chemical installation
Information:	The application of a post-construction chemical termite barrier is highly recommended for all properties. Such barriers are highly effective in preventing termite attack on any timber building elements throughout the property.

A durable notice should be placed in the switchboard unit to indicate current termite barriers. At the time of inspection, no durable notice was evident and it appeared as though no chemical termite management system has been installed, with no evidence to suggest preventative works taking place since the property was built.

The client may consider gaining further advice from a pest controller as to the costs and procedures involved with a 'chemical' application. It is recommended that obtaining such advice be a short-term priority.

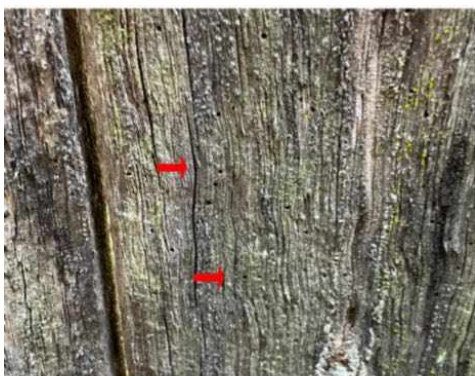
The other commonly known borer the Anobium borer is more likely to attack floorboards and may cause severe structural damage to flooring areas.

As no live wood borer activity was identified treatment is not required at this time. Replacement of affected timbers may be considered by the client for superficial reasons.
