Building and Timber Pest Inspection Report

Inspection Date: Thu, 22 Jan 2026

Property Address: 16 Torwood Street, Warrimoo NSW 2774

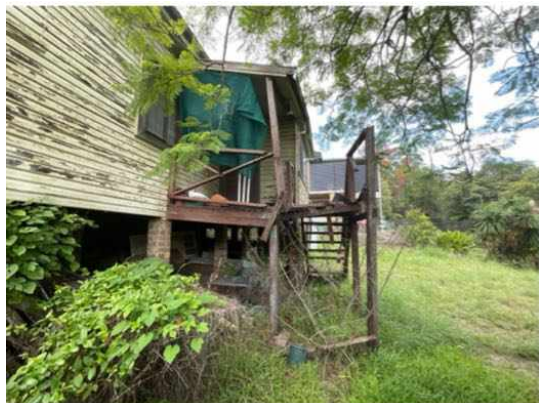
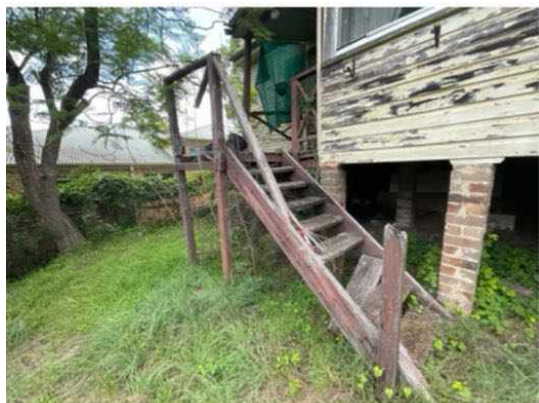
Building:	Main Building
Location:	Balcony
Finding:	Safety Hazard – Rear Balcony, Stairs and Veranda Roof Structure
Information:	Observation:

The rear balcony and associated stairs have collapsed due to advanced timber decay, resulting in a significant loss of structural integrity. The balcony balustrades (balusters) and stair components are damaged, missing, and assessed as being beyond economical repair.

In addition, the roof covering above the veranda is sagging noticeably. This condition appears to be directly related to deterioration and damage to the supporting post, which is no longer providing adequate structural support to the roof framing above.

The collapsed balcony and stairs present an immediate and serious safety hazard, with a high risk of injury due to potential falls or further structural failure. The compromised veranda support post significantly increases the risk of additional roof movement, partial collapse, or progressive damage to the roof structure and covering. These conditions represent a substantial risk to occupants, visitors, and contractors accessing the area.

Urgent action is required. It is strongly recommended that the affected area be restricted from use immediately. A suitably qualified and licensed builder should be engaged without delay to remove the failed balcony, stairs, balustrades, and damaged support post, and to design and construct compliant replacement structures. The veranda roof structure and roof covering should be thoroughly assessed and repaired or rebuilt as necessary to restore structural stability and ensure compliance with current safety and building standards.

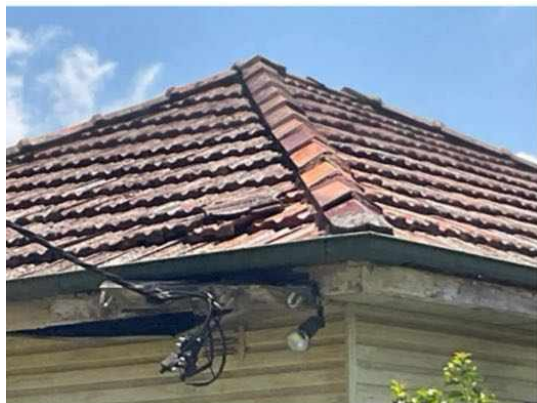
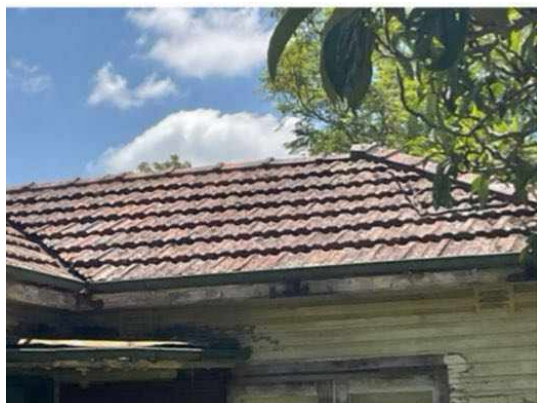
The roof tiles were observed to be in generally poor condition. Dislodged tiles were noted, along with isolated areas of damage and wear consistent with age, weather exposure, and a lack of ongoing maintenance.

Loose and displaced tiles were observed, and tile alignment appeared inconsistent in several areas. Minor deterioration to bedding mortar at ridge and hip cappings was also noted.

Valley irons were observed to be in poor condition, with signs of deterioration.

Evidence of active roof leaks was noted at the time of inspection. Water damage and staining were observed to internal ceilings in some areas.

Overall, the roof covering and associated components were assessed as being in poor condition at the time of inspection. Evidence of active leaks and lack of maintenance was noted.

The tiled roof covering was assessed as being in poor condition, with active leaks observed at the time of inspection. Maintenance and repair works are required to ensure continued weather resistance. Access limitations applied due to roof height and pitch, and the inspection was limited to areas that could be viewed safely.

It is recommended that a licensed roofing contractor carry out a comprehensive assessment of the roof covering, drainage components, and leak sources.

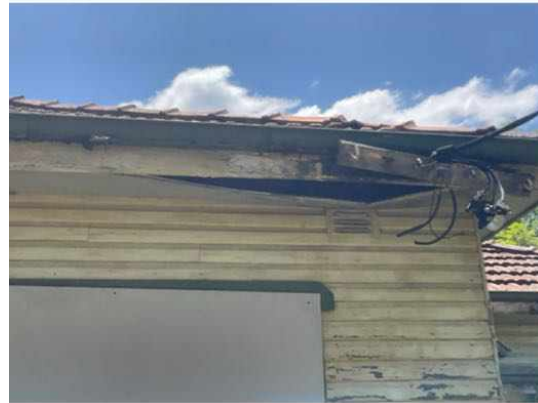
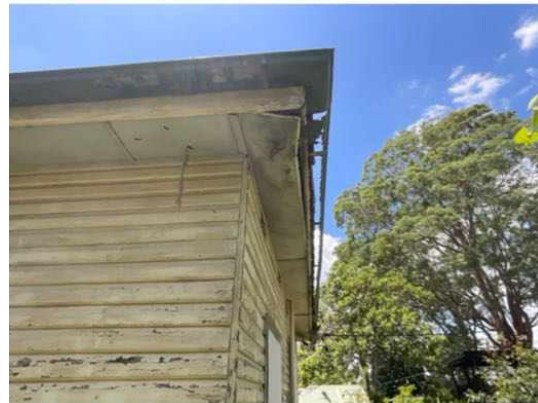
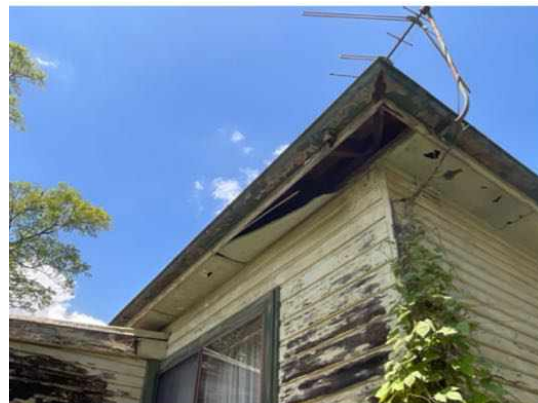
Finding 2.03

Building:	Main Building
Location:	All Areas
Finding:	Major Defect – Damaged Eaves
Information:	Observation:

Sagging, damaged, and missing sections of eaves were observed at multiple locations around the perimeter of the property. The eaves lining appears to be in generally poor condition, with signs of deterioration, loss of support, and failure of fixings. Based on the extent and consistency of the defects noted, the eaves are considered not serviceable and are likely to require full or substantial replacement rather than isolated repairs.

Eaves form an integral component of the building envelope by assisting in the control of rainwater runoff, protecting external wall surfaces, and limiting moisture exposure to roof framing and wall junctions. The observed sagging and damage may indicate prolonged moisture exposure, material degradation, or structural fatigue. If left unrectified, these defects increase the risk of water ingress into roof and wall cavities, accelerated timber decay, potential pest entry, and progressive deformation of the roofline. Ongoing deterioration may also lead to increased repair costs and reduced durability of adjoining building elements.

Rectification works are required. It is recommended that a suitably qualified and licensed carpenter or builder be engaged to further assess the extent of damage and carry out necessary repairs or replacement of the affected eaves. All works should ensure the eaves are correctly aligned, securely fixed, and reinstated in accordance with current building standards to restore effective weather protection and prevent further deterioration.

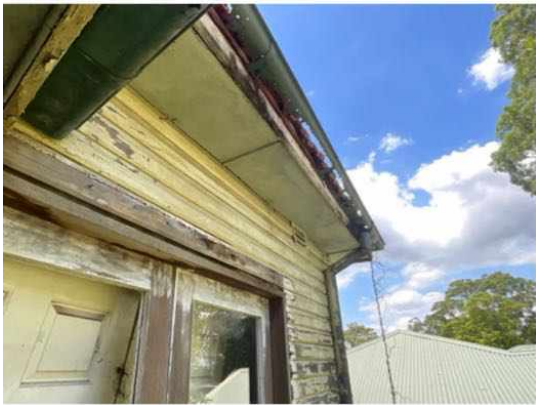
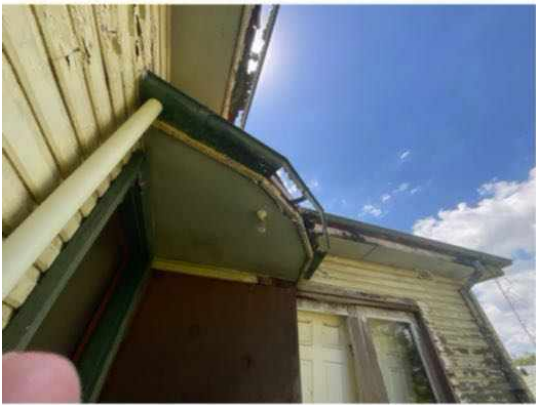
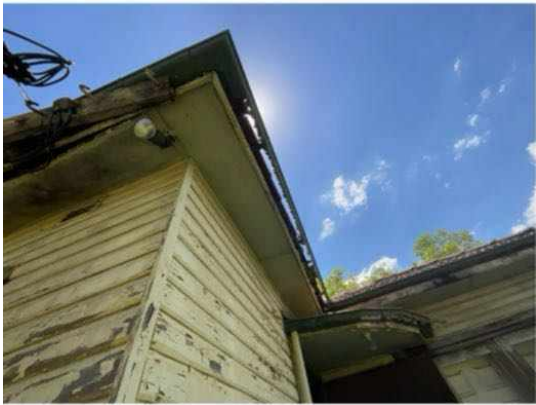
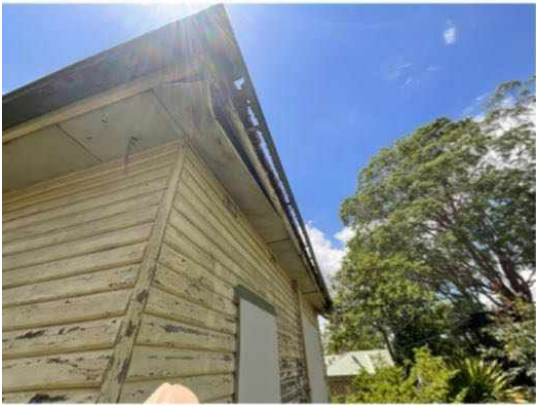
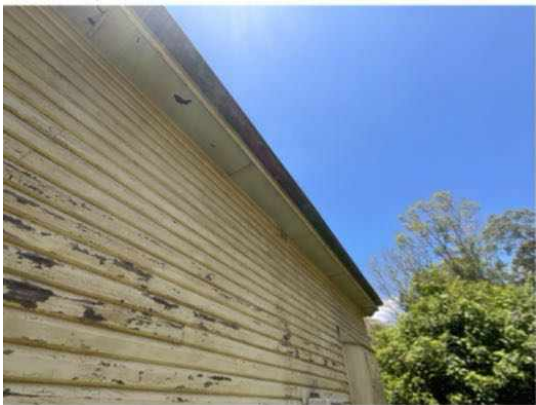
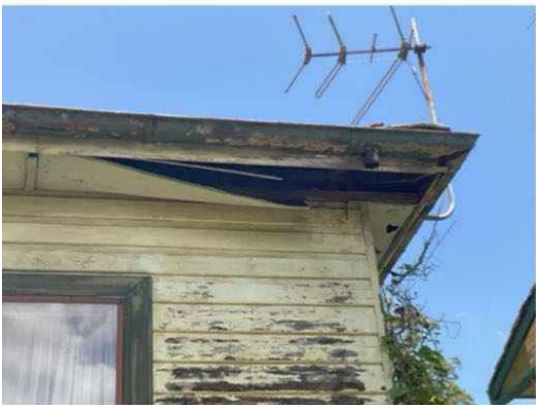
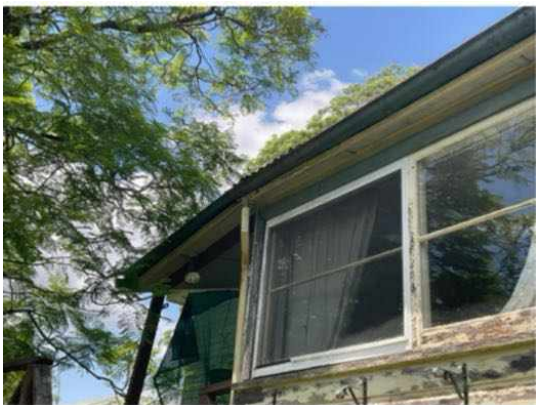
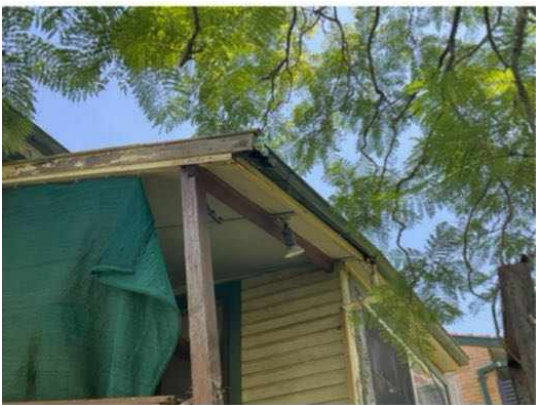
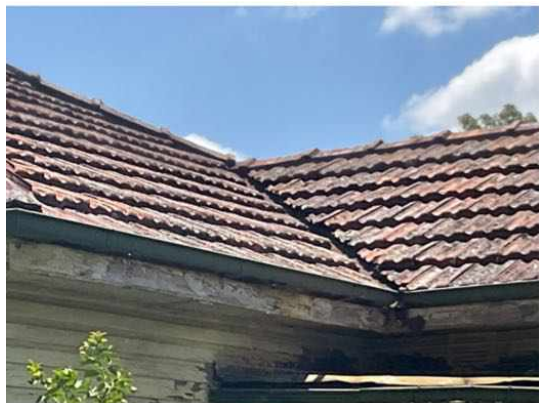
**Finding 2.04**

Location: All Areas
Finding: Major Defect – Roof Plumbing (Gutters, Downpipes and Valley Iron)
Information: Observation:

The roof plumbing system was observed to be in poor condition throughout the property. Significant rusting, deterioration, and missing sections were noted to gutters and downpipes, with several downpipes either not serviceable or not connected to the stormwater drainage system. Corrosion was also observed to valley iron in areas, indicating prolonged exposure to moisture and ineffective drainage.

The extent of deterioration suggests long-term lack of maintenance, which is consistent with the property reportedly being vacant for an extended period (approximately 20 years). Blocked or poorly functioning gutters have likely resulted in prolonged pooling or standing water, accelerating deterioration of the roof plumbing components.

Defective roof plumbing compromises the effective collection and discharge of rainwater from the roof. Where gutters, downpipes, and valley irons are rusted, leaking, or disconnected, water may overflow or discharge uncontrolled around the building perimeter or into roof cavities.

This condition increases the risk of secondary moisture-related defects, including dampness to subfloor areas, deterioration of brickwork and mortar joints, and an increased likelihood of timber decay or pest activity. Ongoing exposure to uncontrolled moisture may result in progressive damage to the building structure and increased rectification costs if not addressed.

Prompt rectification is strongly recommended. A suitably licensed roofing plumber should be engaged to carry out a comprehensive assessment of the roof plumbing system, including gutters, downpipes, and valley irons. Based on the extent of deterioration observed, replacement of affected components is likely to be required to restore effective stormwater drainage. All remedial works should be completed in accordance with current building standards to prevent further moisture-related damage to the property.

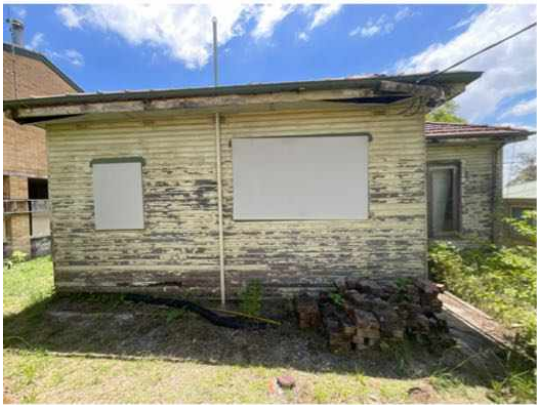
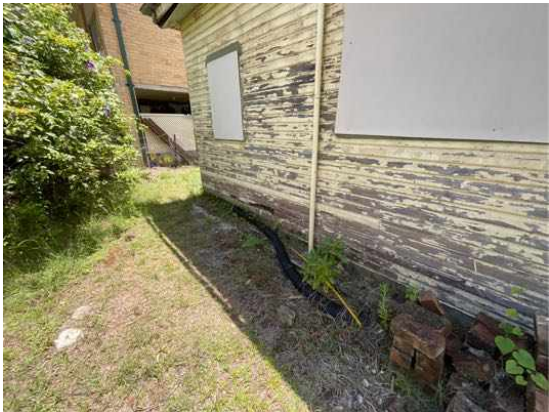
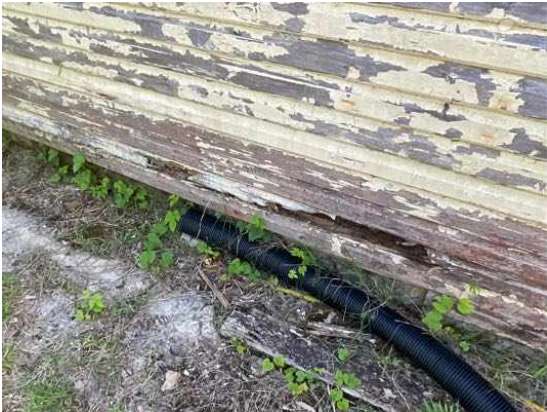
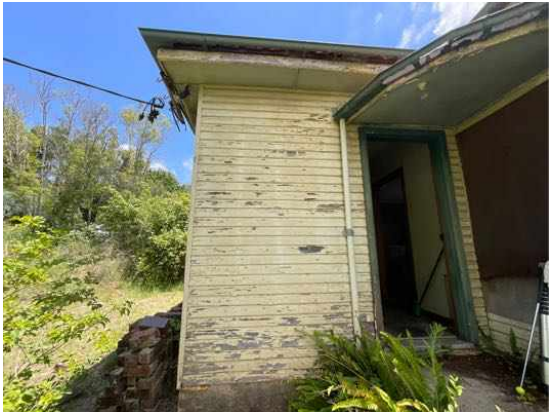
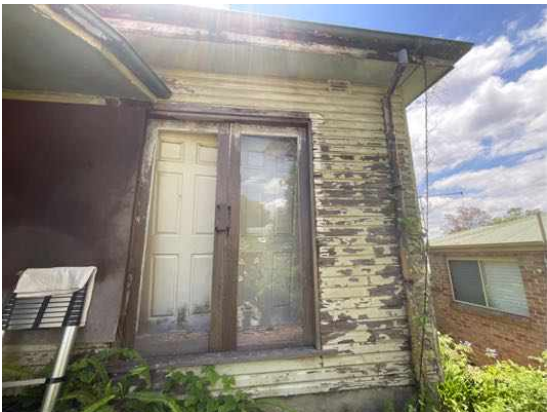
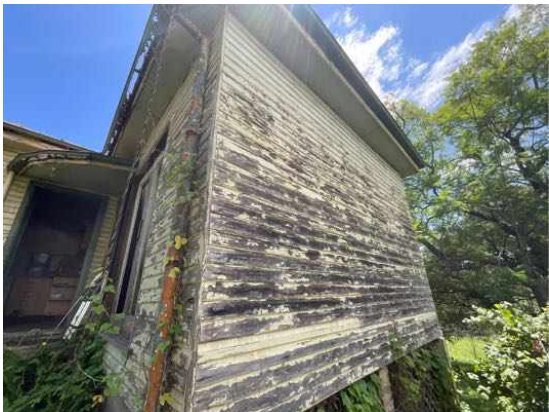
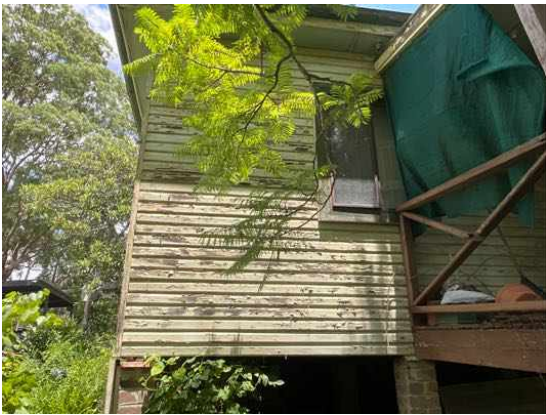
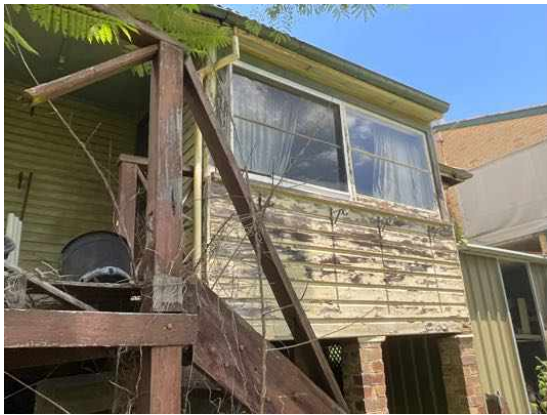
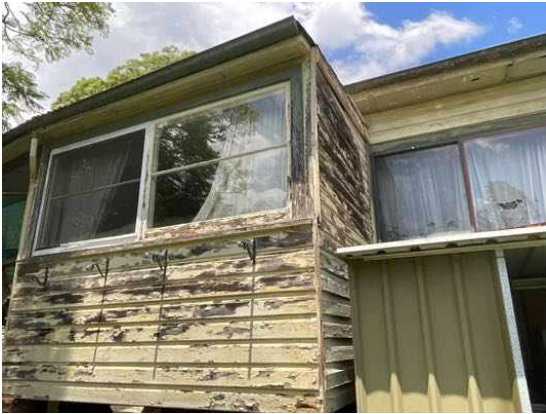
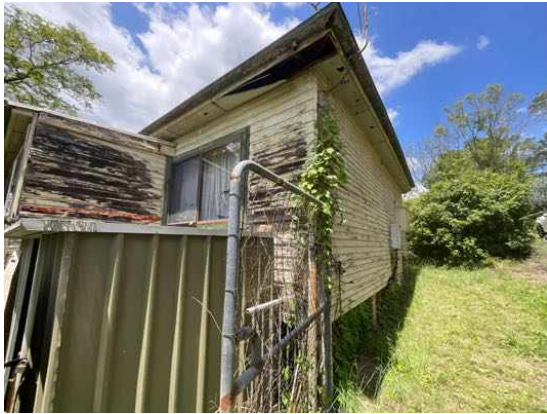
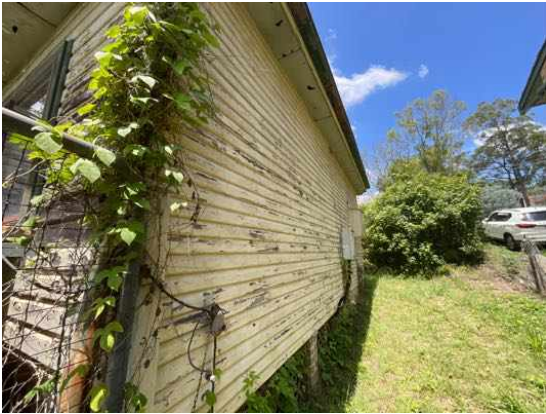
Finding 2.05

Building:	Main Building
Location:	All External Areas
Finding:	Major Defect – External Wall Cladding (Weatherboards)
Information:	Observation:

The property shows clear evidence of long-term neglect. The external paintwork has deteriorated extensively and is peeling in numerous locations. As a result, the external weatherboards have been exposed to prolonged weather conditions. Several sections of the weatherboards exhibit signs of fungal decay (wood rot), indicating advanced deterioration of the timber material.

The extent and distribution of the damage suggests that the deterioration has occurred over a prolonged period and is consistent with a lack of ongoing maintenance. This condition aligns with the property reportedly having been vacant for an extended duration (approximately 20 years).

repair or replace all weatherboards that have deteriorated beyond practical repair, using appropriately pre-treated replacement materials.

Following carpentry works, all exposed and untreated timber surfaces should be promptly sealed and painted by a suitably qualified painting contractor or competent handyman to reinstate effective weather protection and prevent further moisture ingress. Ongoing maintenance of external coatings is strongly advised to preserve the condition of the external wall cladding and reduce the risk of future deterioration.

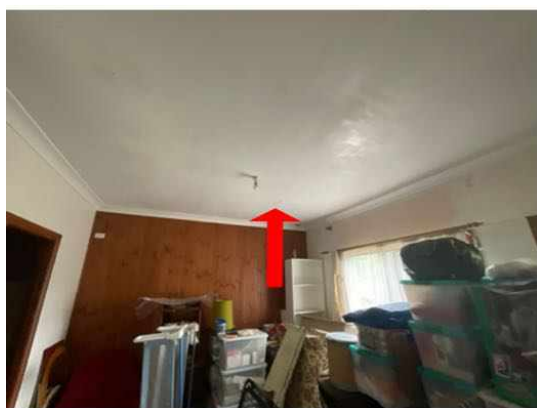
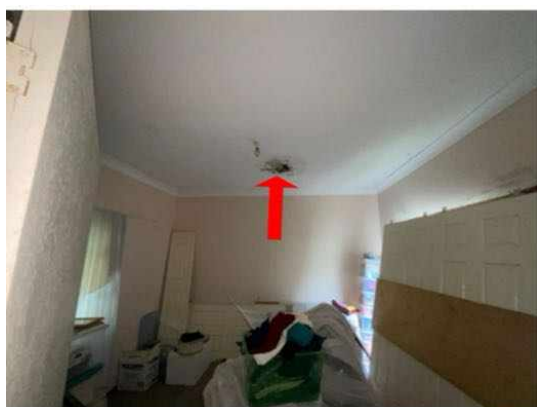
Finding 2.06

Building: Main Building
Location: Living Room & Bedroom
Finding: Major Defect – Ceiling Lining Water Damage
Information: Observation:

Immediate action is recommended to identify and rectify the source of the roof leak. A licensed roofing contractor should be engaged to inspect the roof covering and perform all necessary repair works to stop further water ingress. Following the repair of the leak, a suitably qualified plasterer and painter should assess the ceiling linings to determine whether minor patching and repainting or full replacement of affected sections is required. Where additional structural damage to ceiling supports or roof framing is suspected, a licensed carpenter or builder should also be consulted to ensure all damage is appropriately rectified.

Ongoing monitoring is advised to confirm that all water entry has been addressed and that no further deterioration occurs.

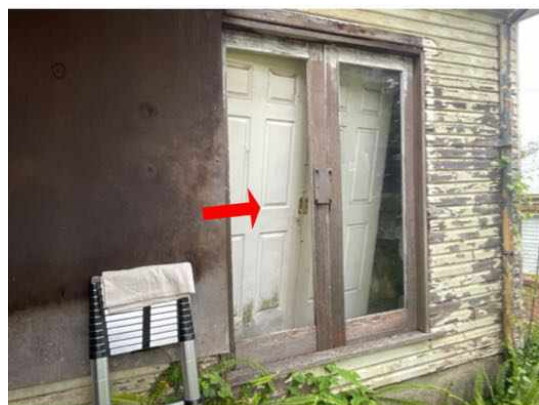
Finding 3.02

Building: Main Building
 Location: Front Elevation
 Finding: External Front Door – Missing Glass Panel
 Information: Observation:

It is recommended that the missing glass panel be replaced promptly by a suitably qualified tradesperson. The replacement glazing should comply with current safety glazing requirements and be adequately sealed to restore the door's weather resistance and prevent potential water damage.

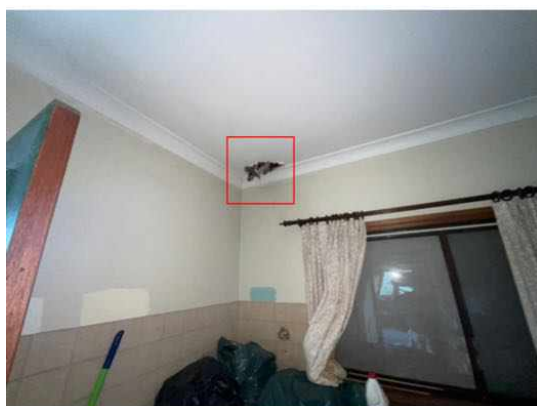
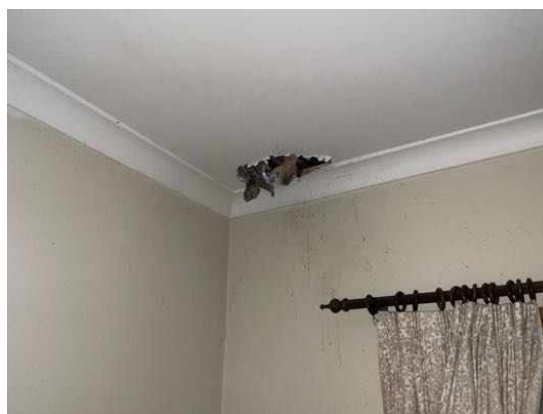
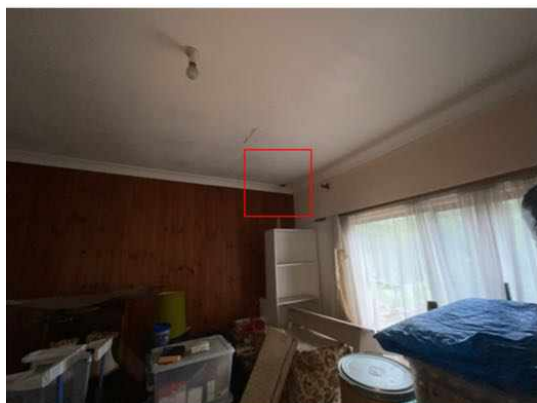
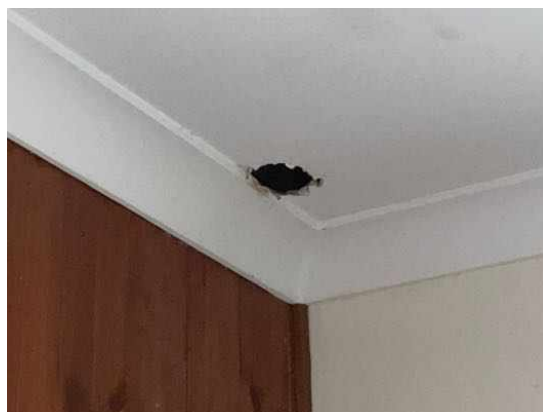
Finding 3.05

Building:	Main Building
Location:	Living Room & Bedroom
Finding:	Ceiling – Animal Damage (Suspected Possum Activity).
Information:	Observation:

It is recommended that the damaged ceiling areas be repaired to reinstate the integrity and appearance of the linings. Minor damage may be rectified by maintenance to surface finishes, such as filling, patching, sanding, and repainting. Where damage is more extensive, replacement of affected ceiling sections may be required. Prior to repairs, consideration should be given to engaging a licensed pest or wildlife professional to confirm and address any ongoing animal activity. Repair works can typically be carried out by a qualified plasterer or general tradesperson at the discretion of the client.

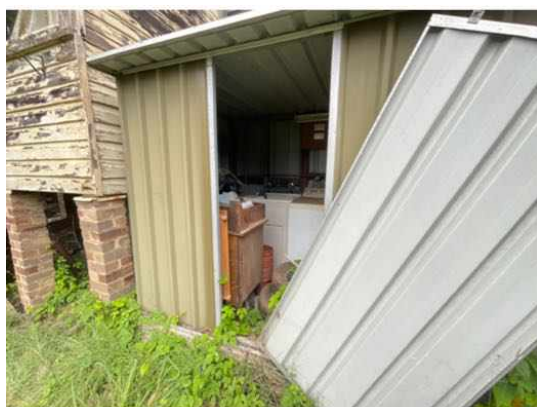
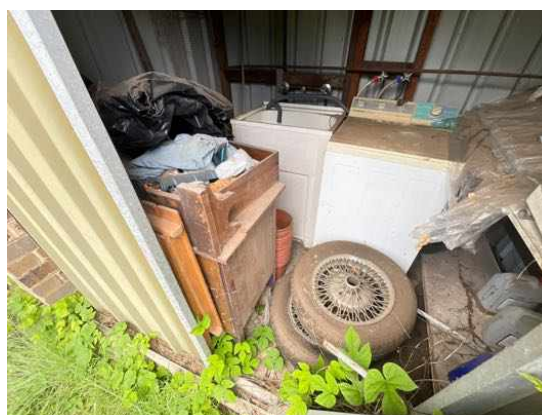
Building: Main Building
 Location: All Areas
 Finding: Water service - Disconnected.
 Information: Important Limitation – Plumbing Fixtures Not Tested

It is strongly advised that these obstructions be removed to enable a complete inspection of the affected areas. Once access is granted, a re-inspection—particularly of tap fittings and drainage components—is recommended to ensure no concealed defects or leaks are present.
