Building and Timber Pest Inspection Report

Inspection Date: Thu, 26 Mar 2026

Property Address: u9/601 Elgar Rd, Mont Albert North VIC
3129

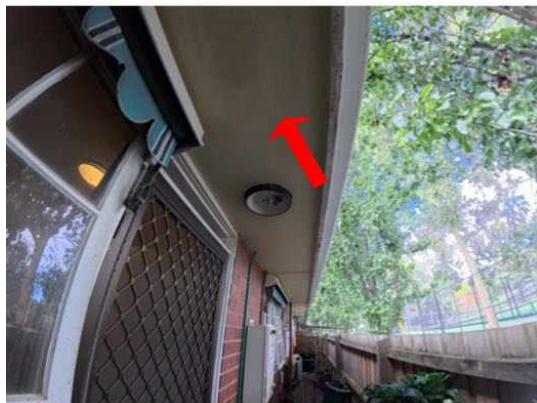
Building:	Main Building
Location:	Roof Eave Sheets
Finding:	Asbestos - Suspected ACM Identified on Site (Roof Eave sheets)
Information:	Reporting on Asbestos is outside the Scope of this Report. This suspected defect is highlighted as a caution only. We suspect, based on our experience in the building industry, that there is a higher risk of the identified building element containing asbestos.

As Asbestos Reporting is outside the scope of this report, we advise that you consider a separate Asbestos Inspection and Condition Audit, which can include the taking of samples for definitive confirmation of the presence of Asbestos.

In the interim, the client is advised to act with caution, especially when considering any damage to building materials general wear and tear renovations extensions demolition and general maintenance activities due to the suspected presence of Asbestos.

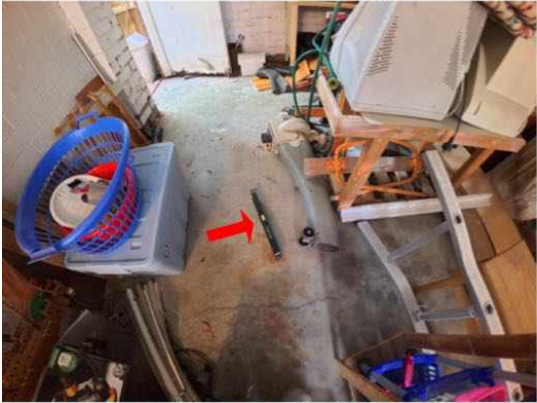
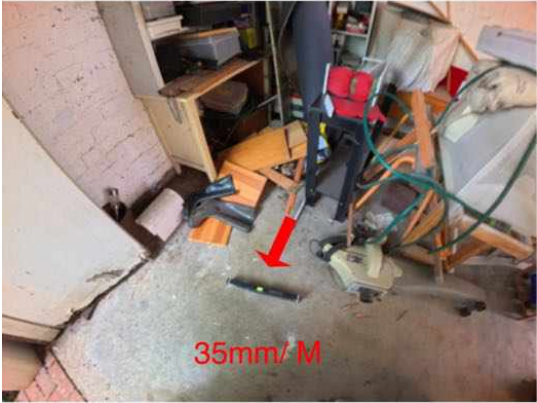
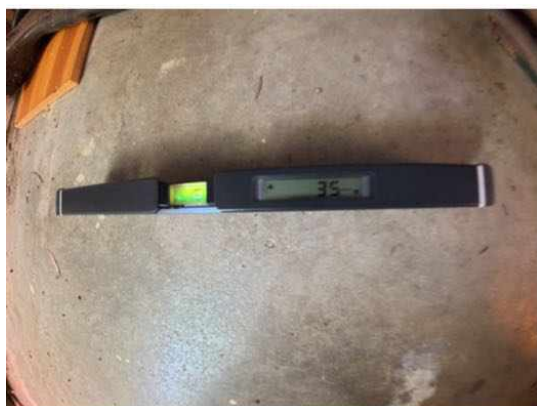
Building:	Main Building
Location:	Garage
Finding:	Brick Wall – Stepped Cracking Observed (3–10mm)
Information:	At the time of inspection, stepped cracking was observed in the brick wall, with crack widths ranging approximately from 3mm up to 10mm. This type of cracking typically follows the mortar joints and is commonly associated with foundation movement, footing settlement, or differential movement within the structure.

Cracks of this magnitude are considered significant and may indicate ongoing structural movement rather than superficial or cosmetic issues. Potential contributing factors may include reactive soil conditions, moisture variation, inadequate footing support, or poor site drainage.

If left unaddressed, such cracking may lead to further structural movement, widening of cracks, water ingress, and potential compromise of the building's integrity.

Building: Main Building
 Location: Garage
 Finding: Garage Floor – Severe Unevenness
 Information: At the time of inspection, the garage concrete floor was observed to be severely uneven, with an estimated slope of approximately 35mm per metre, which is considered excessive and beyond acceptable construction tolerances.

This condition may be associated with foundation movement, slab settlement, poor workmanship, or subgrade failure. In some cases, it may also indicate ongoing structural movement affecting the slab.

If left unaddressed, this may result in water drainage issues, trip hazards, progressive cracking, and potential impact on adjacent structural elements.

It is strongly recommended that the owner engage a qualified structural engineer to assess the extent and cause of the cracking. Remedial works may include foundation stabilisation (e.g. underpinning), crack repair, and improvement of site drainage conditions. Ongoing monitoring is also advised to determine whether movement is active.

It is recommended that the owner engage a qualified structural engineer or builder to assess the cause of the unevenness. Remedial works may include re-leveling, grinding, or structural rectification depending on severity.

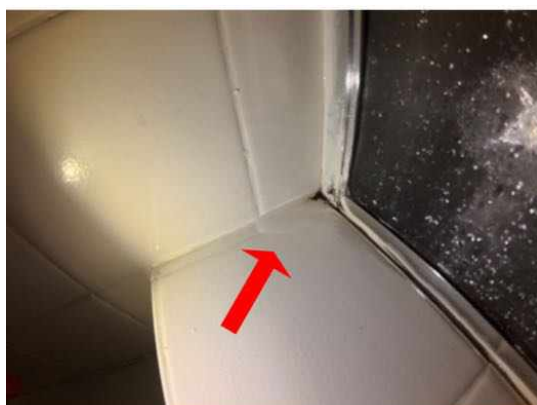
Finding 2.03

Building:	Main Building
Location:	Bathroom
Finding:	Bathroom – Shower Area Water Leaking Around Shower Screen
Information:	During the inspection, active signs of water leakage were observed around the shower screen perimeter within the bathroom.

Moisture readings taken around the shower screen frame and adjoining wall junctions indicated elevated levels compared to unaffected areas.

This condition was recorded at the time of inspection as a waterproofing defect.

The leakage was identified along the base and vertical frame of the shower screen, particularly where the shower glass frame meets the tiled floor and wall junctions.

Water traces and mild staining were noted on the external floor tiles immediately outside the shower enclosure.

This condition is likely caused by failed or deteriorated silicone sealant, gaps between screen junctions, or inadequate drainage within the shower base.

- Damage to the waterproof membrane;
- Water staining or swelling of adjoining walls and skirting;
- Growth of mould and mildew; and
- Deterioration of structural materials in concealed areas.

This condition is classified as a Major Defect under AS 4349.1 Clause 3.2, and does not comply with AS 3740 Clause 2.4 – Continuity of Waterproofing

It is recommended that the owner engages a licensed plumber or waterproofing specialist to:

- Inspect and identify the leakage source;
- Remove and replace all deteriorated or failed silicone sealant around the shower screen;
- Check the integrity of the waterproof membrane and floor gradient; and
- Rectify any tiling or drainage issues to ensure full waterproofing compliance.

Until repairs are completed, water usage in this shower should be minimised to prevent further leakage or hidden water damage.

All remedial works must comply with AS 3740 and AS 3958.1 standards.

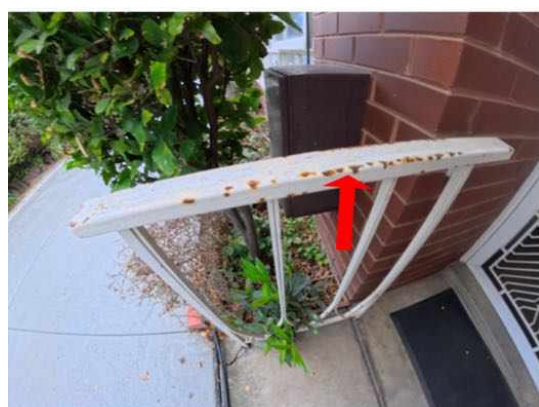
Finding 3.01

Building:	Main Building
Location:	Entry
Finding:	Metal Handrail – Corrosion/Rusting Observed
Information:	At the time of inspection, the metal handrail was observed to have visible signs of rust and corrosion. This condition is typically associated with exposure to moisture, weathering, or deterioration of protective coatings over time.

While the current extent of corrosion appears to be surface-level, if left untreated, it may lead to progressive material deterioration, reduced structural integrity, and potential safety concerns.

It is recommended that the owner engage a qualified tradesperson to treat the affected areas, which may include removal of rust, application of anti-corrosion treatment, and repainting or recoating. Severely affected sections may require repair or replacement to ensure durability and safety.

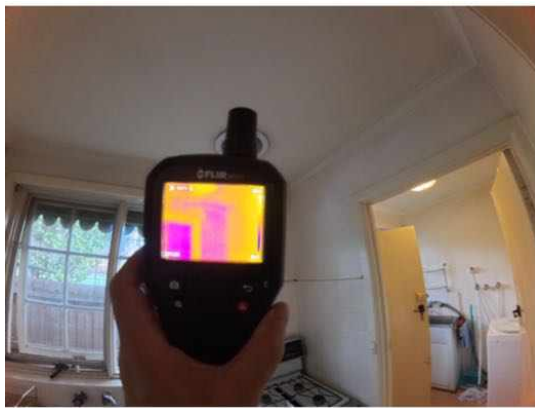
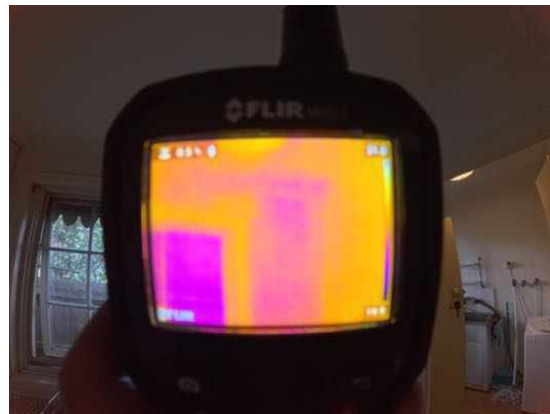
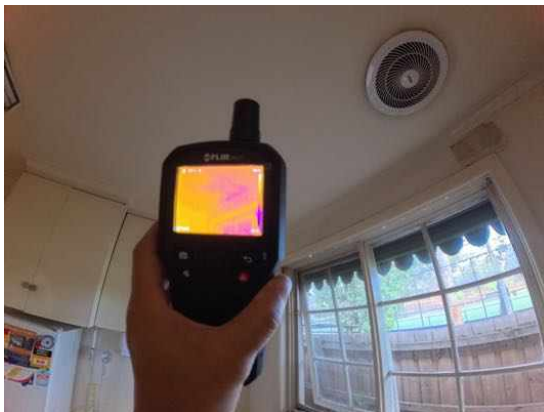
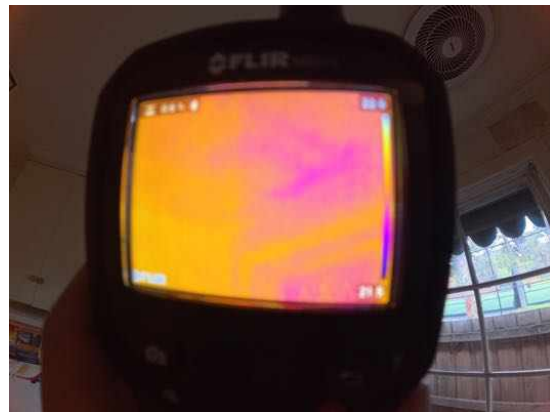
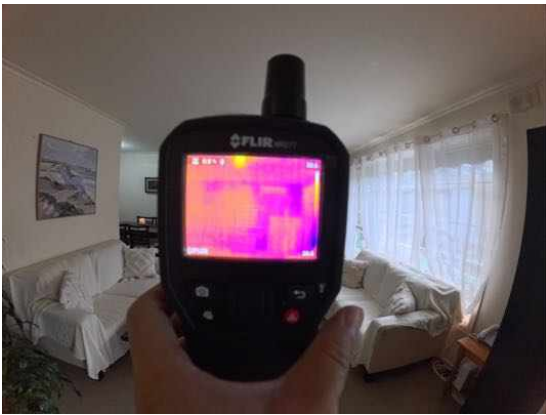
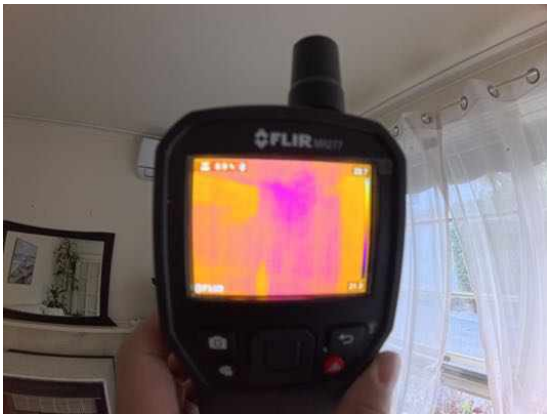
Finding 3.02

Building:	Main Building
Location:	All Internal Areas
Finding:	Ceiling – Moisture Testing (Minor Moisture Detected)
Information:	At the time of inspection, moisture testing to the ceiling area identified minor elevated

moisture readings. While no active leakage was directly observed, the presence of moisture indicates possible water ingress.

Based on the overall site observations, including accumulation of leaves and debris within the roof gutter system, there is a strong likelihood that blocked gutters may have caused water backflow (overflow), allowing moisture to enter the ceiling space.

If left unaddressed, this condition may lead to water staining, deterioration of ceiling materials, mould growth, and potential damage to internal building elements.

It is recommended that the owner engage a qualified roof plumber or contractor to clean the gutters, ensure proper drainage, and inspect the roof and gutter system for any defects. Ongoing monitoring of the ceiling area is also advised to confirm whether moisture levels stabilise after rectification.

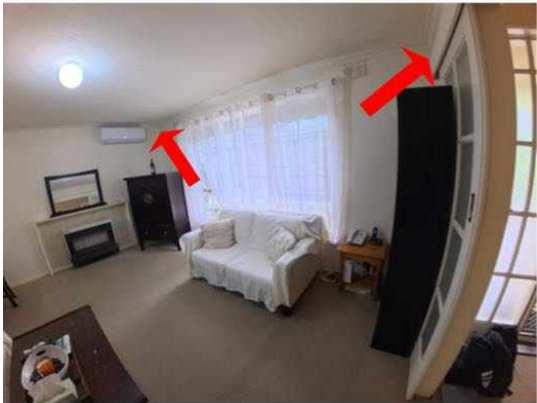
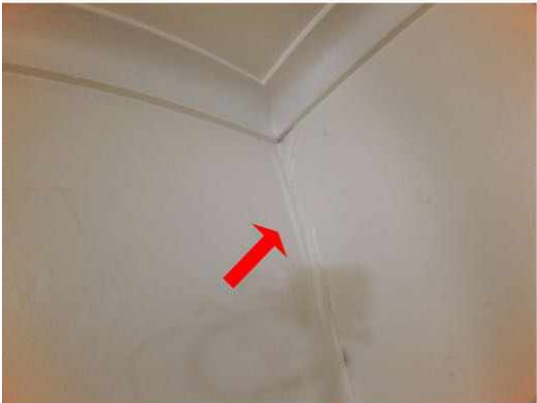
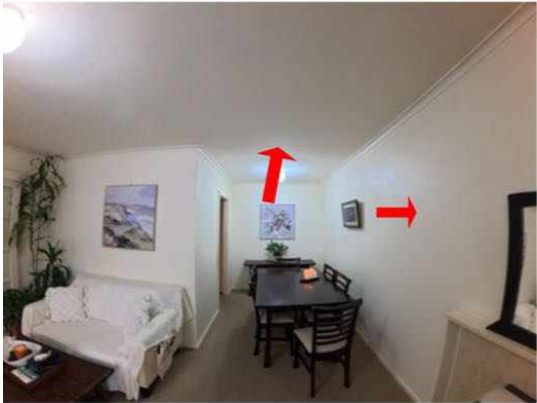
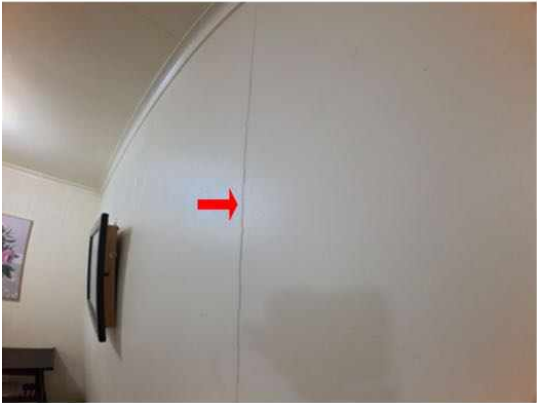
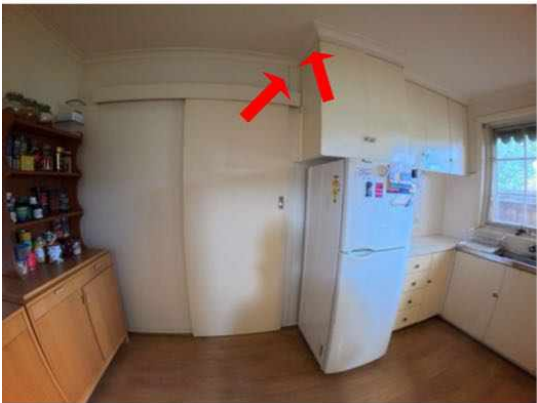
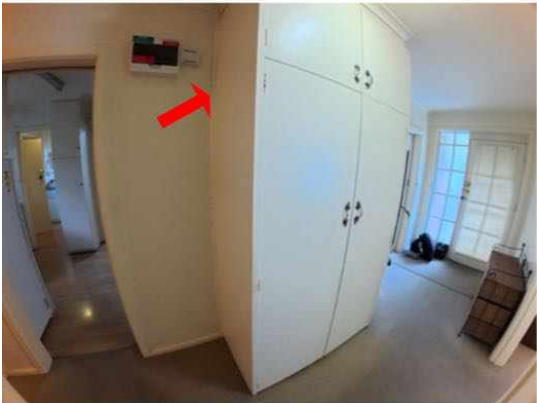
Finding 3.03

Building: Main Building
Location: All Internal Areas
Finding: Wall & Ceiling – Multiple Cracks Observed (Minor 1–3mm)
Information: At the time of inspection, multiple minor cracks (approximately 1–3mm in width) were observed to the wall and ceiling surfaces. Such cracking is commonly associated with building movement, material expansion and contraction, or minor settlement.

Based on site observations, it is possible that water ingress into the ceiling space (potentially due to gutter overflow/backflow) and/or additional loading from solar panel installation on the roof may have contributed to the observed cracking.

While the cracks are currently considered minor in nature, ongoing contributing factors may lead to further cracking, surface deterioration, or movement of building elements over time.

It is recommended that the owner monitor the affected areas. If cracks widen, extend, or become more numerous, further assessment by a qualified builder or structural professional is advised. Any identified water ingress issues should also be addressed to prevent ongoing damage.

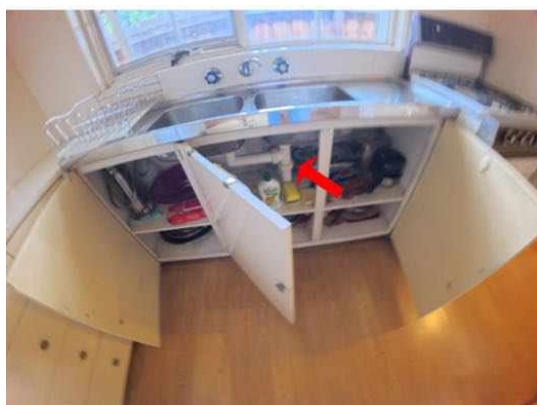
Finding 3.04

Building: Main Building
 Location: Kitchen
 Finding: Kitchen Sink – Water Leakage Observed

Information: At the time of inspection, a water leak was observed at the kitchen sink area, with moisture accumulation inside the cabinet beneath the sink. The leak is likely due to loose pipe connections, deteriorated sealant, or aging plumbing components.

If not addressed promptly, this condition may lead to material deterioration (swelling, warping, or decay of cabinetry and surrounding finishes), mould and bacterial growth, potential electrical hazards if moisture reaches nearby outlets, and increased risk of pest activity.

It is recommended that the owner engage a licensed plumber to inspect and repair the leak. Damaged components should be replaced or resealed where necessary. Consideration may also be given to installing moisture barriers or waterproof liners within the cabinet to reduce the risk of future damage.

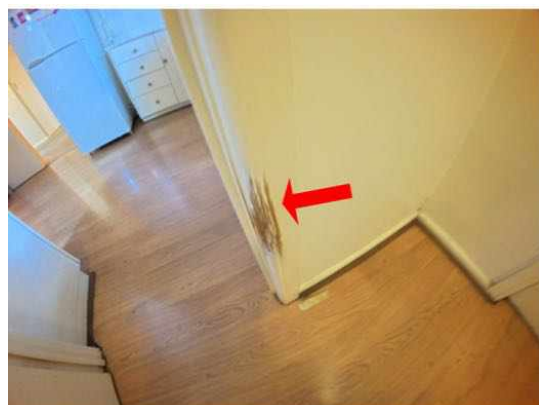
Finding 3.05

Building: Main Building
 Location: Laundry
 Finding: Internal Wall Finishes – Scratches and Dents (General Wear and Tear)
 Information: During the inspection, scratches and dents were observed on the internal wall surfaces of the property.

The defects were noted in multiple areas throughout the dwelling, including common living areas and hallways, which are typically subject to regular use and contact.

The scratches and dents appear consistent with general wear and tear from everyday use rather than structural or workmanship issues.

It is recommended that the owner engages a qualified painter or plasterer to carry out minor surface preparation and touch-up painting where necessary.

This maintenance work will help restore the wall finish appearance and maintain the property in good condition.

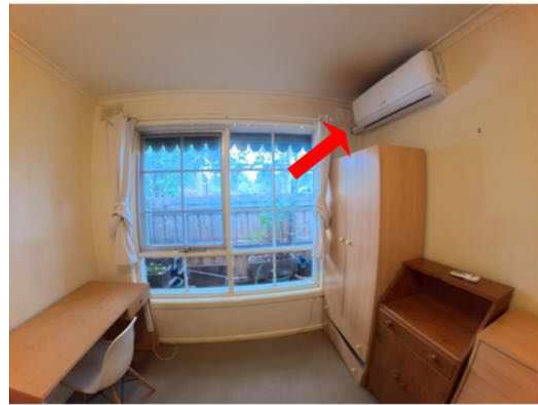
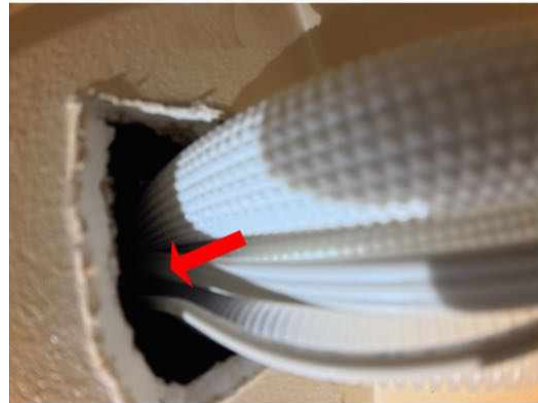
Finding 3.06

Building:	Main Building
Location:	Bedroom
Finding:	Wall Penetration – Not Sealed (Air Conditioning Pipe)
Information:	At the time of inspection, an air conditioning pipe penetration through the plaster wall was observed to be not properly sealed, with visible gaps around the opening.

Unsealed penetrations may allow air leakage, moisture ingress, dust accumulation, and potential pest entry into the wall cavity. Over time, this may lead to material deterioration, reduced energy efficiency, and possible internal damage within concealed areas.

It is recommended that the owner engage a qualified tradesperson to properly seal the penetration using appropriate materials to ensure a complete and durable finish.

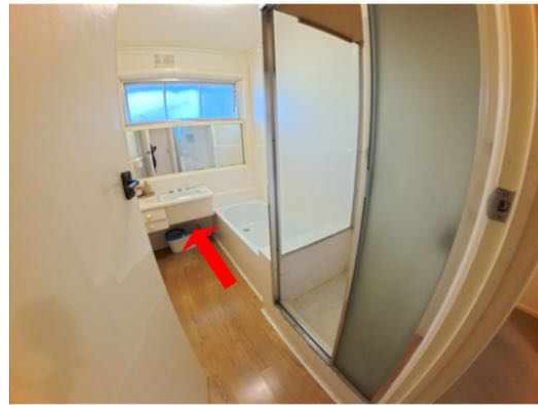
Finding 3.07

Building: Main Building
 Location: Bathroom
 Finding: Bathroom Basin – Water Leakage Observed
 Information: At the time of inspection, water leakage was observed from the bathroom basin pipework, likely originating from pipe connections, trap fittings, or deteriorated seals.

Ongoing leakage may result in moisture accumulation within the cabinet or surrounding areas, which can lead to material deterioration, mould growth, and potential damage to adjacent building elements if left unaddressed.

It is recommended that the owner engage a licensed plumber to inspect and repair the leaking pipework, and to replace any defective components to prevent further water damage.

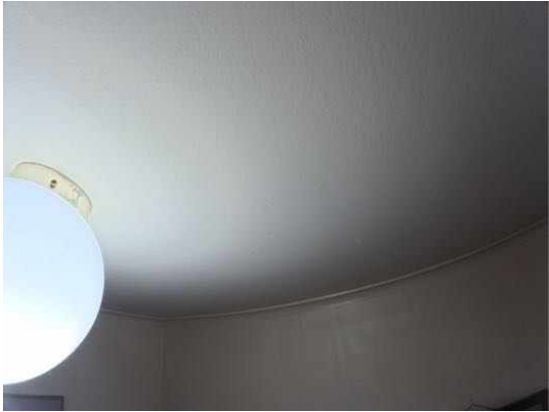
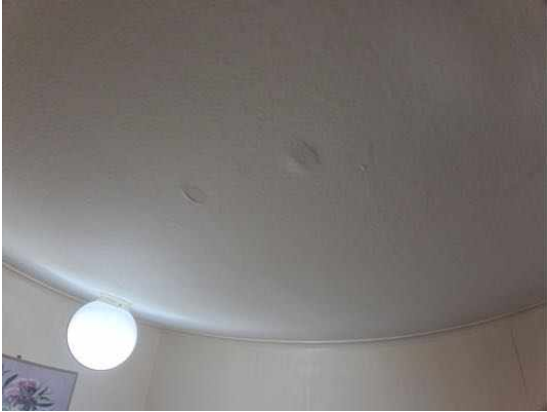
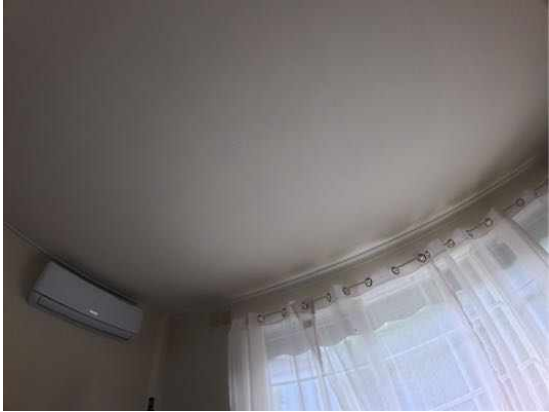
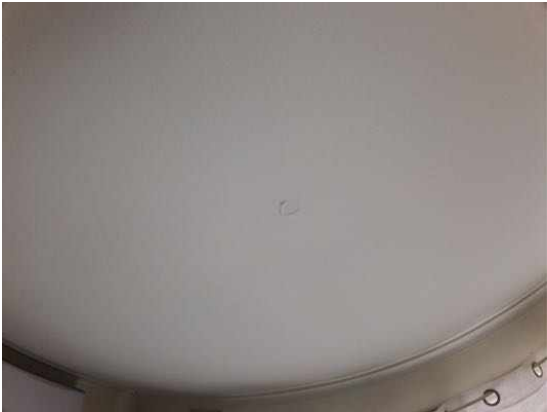
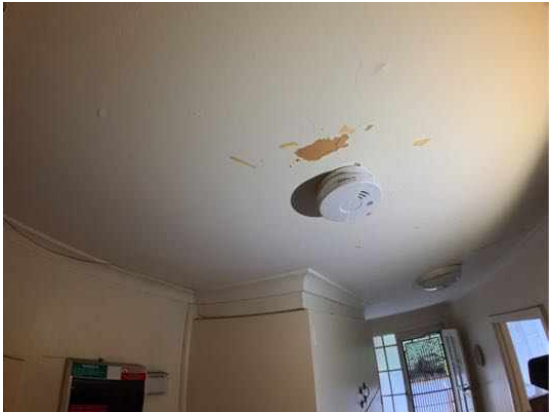
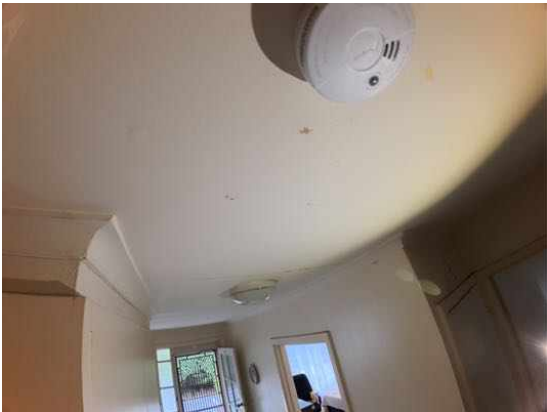
Finding 3.08

Information: At the time of inspection, nails are found popping out of the plasterboard, nails and screws are held by the friction between them and the surface that they are applied to. Over time, the nails and screws can back out, which is often a result of general ageing and deterioration of the building structure.

If left unmanaged, internal wall and ceiling sheeting may become loose and unstable, increasing the rate of deterioration of these building elements and creating potential for the development of secondary defects.

Re-fastening of popped nails will help to maintain the stability of these, and associated, building elements. Such minor works will also help to improve the appearance of the affected area and secure the linings. These works should be performed by a qualified carpenter or plasterer at client discretion.

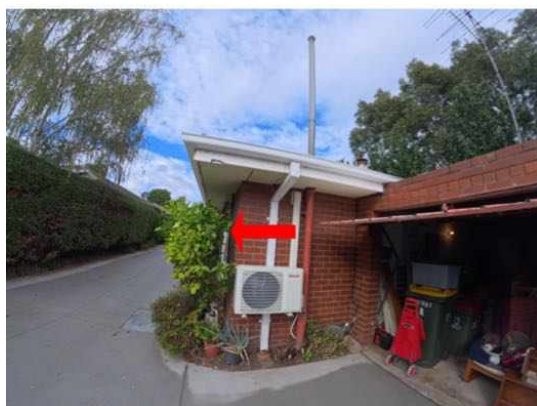
Building: Main Building
Location: All External Areas
Finding: Bridging - Vegetation
Information: Where vegetation obstructs inspection of building elements, also known as bridging as it provides a bridging point for the access of termites, full inspection can not be achieved. Consequently moisture or dampness may be present and the areas becomes conducive to termite activity. Plants against or very close to buildings provide cover, shade and can provide an environment that is attractive to termite infestation.

The removal of any such materials that may be conducive to termite activity should be carried out as soon as possible and arrange re inspection to minimize the risk of termite attack.

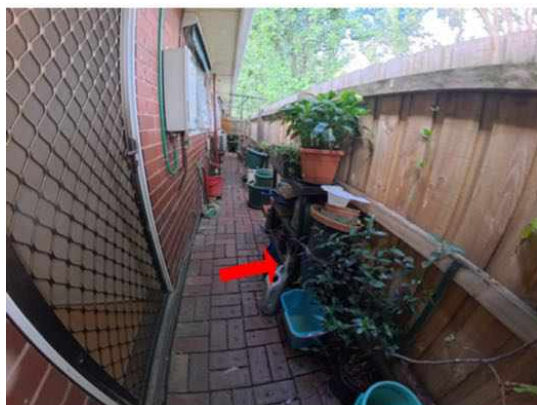
Building:	Yard
Location:	Back Yard / Subfloor
Finding:	Stored Items - Conducive to Timber Pest food sources
Information:	At the time of inspection, the following condition was observed: stored items were present within the garden.

The presence of stored materials can obstruct inspection access and create concealed conditions that are conducive to timber pest activity.

Stored items may retain moisture and restrict ventilation, increasing the likelihood of timber decay, mould growth, and termite infestations. In accordance with AS 4349.3, such conditions are classified as conducive to timber pest activity and may conceal existing infestations.

It is recommended that all stored items be removed from the garden to allow adequate ventilation, inspection access, and to reduce conditions conducive to timber pest activity.

The property owner should remove these stored items before further timber pest activity and damage occur, and engage a licensed Timber Pest Management company to implement appropriate pest management and control measures.

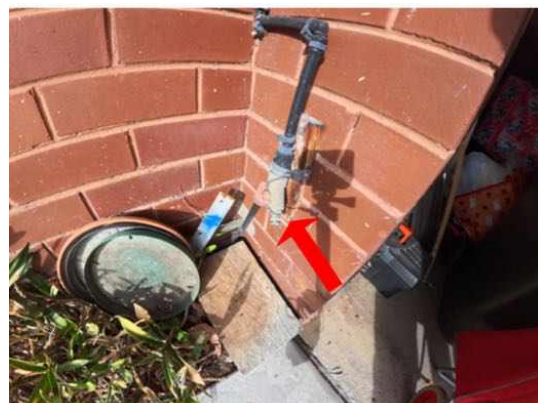
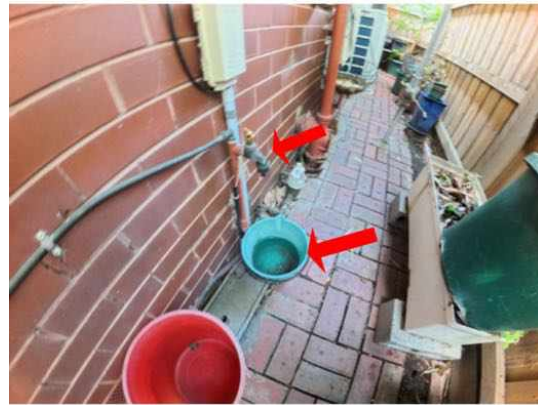
Finding 6.04

Building:	Yard
Location:	Yard - Front
Finding:	Garden Water Tap and Drain Misalignment
Information:	During the inspection, it was observed that the outdoor water tap is not properly aligned with the adjacent ground drain. As a result, discharged water does not flow directly into the drainage point and may instead accumulate around the base of the tap, creating localized damp conditions.

This installation issue reduces drainage efficiency and may lead to persistent moisture in the surrounding area. Prolonged water pooling can create a slip hazard, increase the likelihood of soil saturation near the building perimeter, and potentially contribute to moisture migration toward foundations. Ongoing damp conditions may also create an environment conducive to termite and timber pest activity, particularly where nearby timber elements or subfloor areas are present.

It is recommended that a licensed plumber be engaged to assess and rectify the installation. Rectification may involve repositioning the tap, adjusting the drainage alignment, improving surface fall, or installing an appropriate drainage or diversion system to ensure effective water discharge and minimise associated risks.

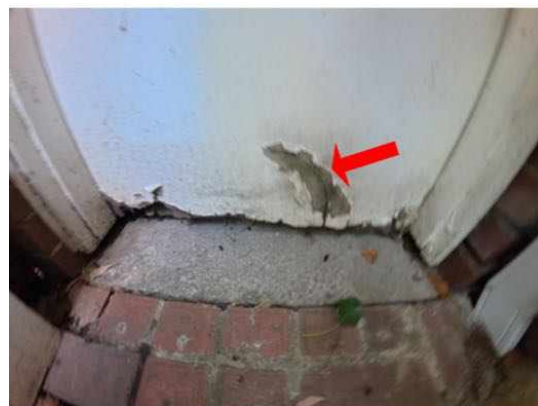
Finding 7.01

Building: Yard
 Location: Sub-floor Entry Gate, Timber Fence
 Finding: Fungal decay - absent at the time of inspection
 Information: At the time of inspection, no evidence of fungal decay was observed within the accessible areas inspected.

No visible signs of timber softening, discolouration, moisture-related deterioration, or fungal growth were identified during the inspection.

No further action is required at this stage.

Ongoing monitoring and routine maintenance are recommended to minimise the risk of future moisture-related fungal decay.
