Building Inspection Report

Inspection Date: Wed, 25 Mar 2026

Property Address: 6/181 Riversdale Rd, Hawthorn VIC 3122,
Australia

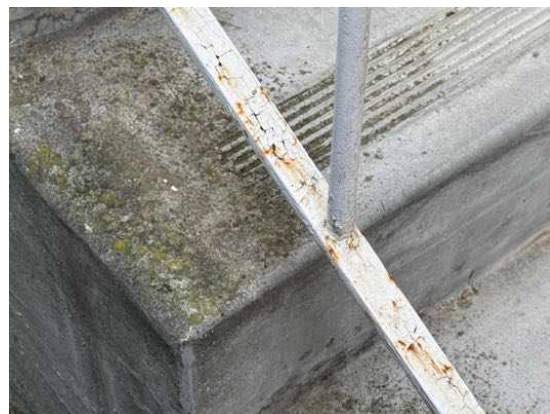
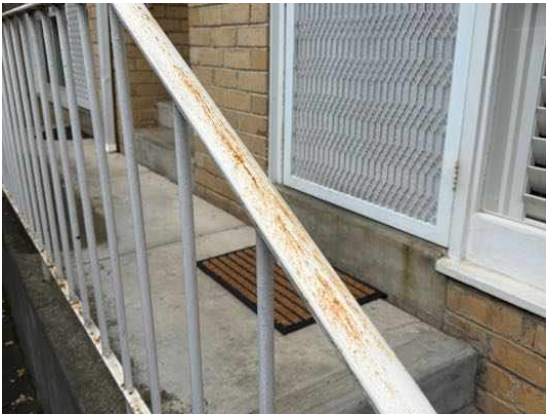
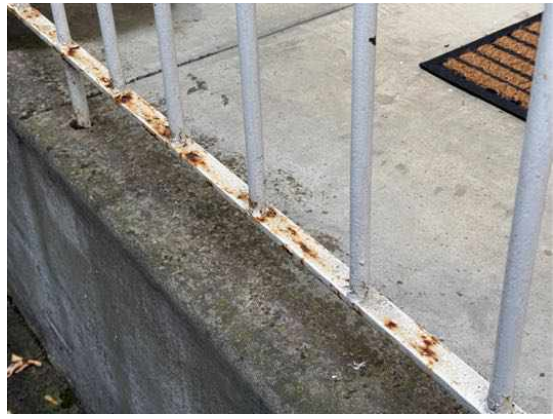
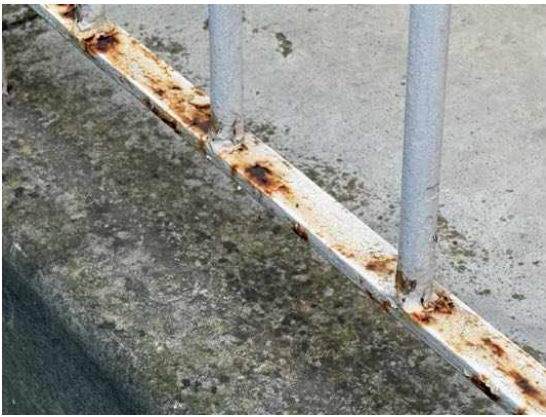
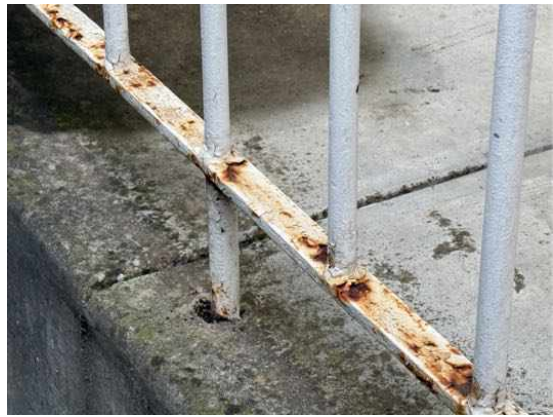
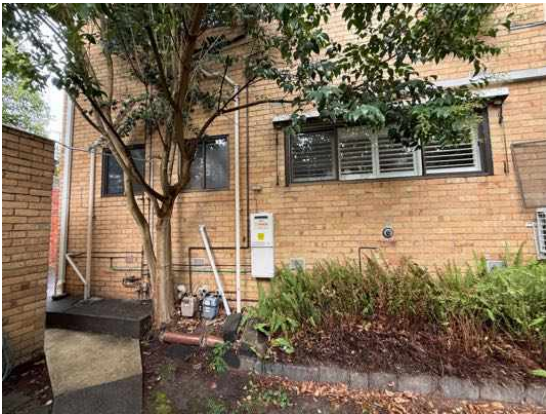
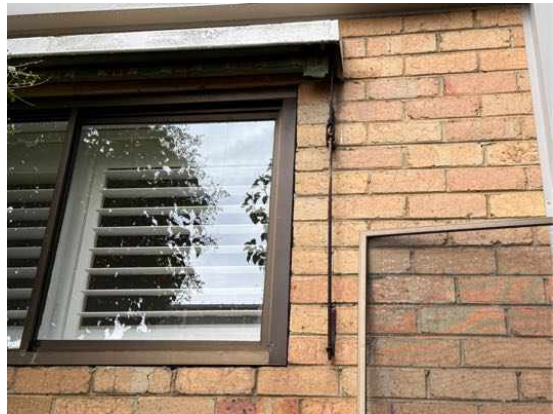
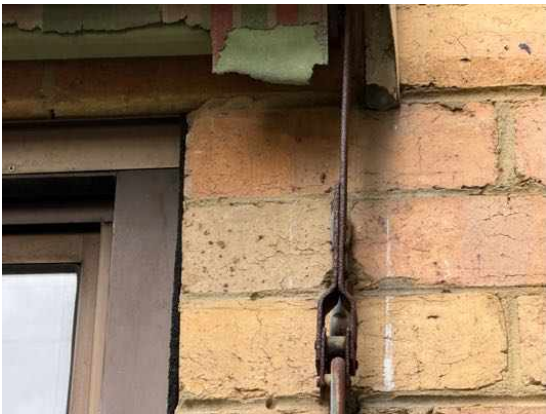
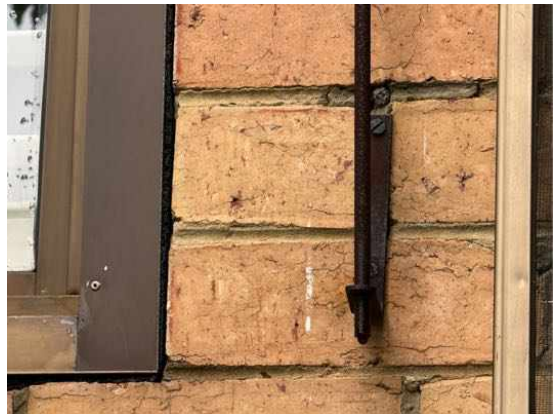
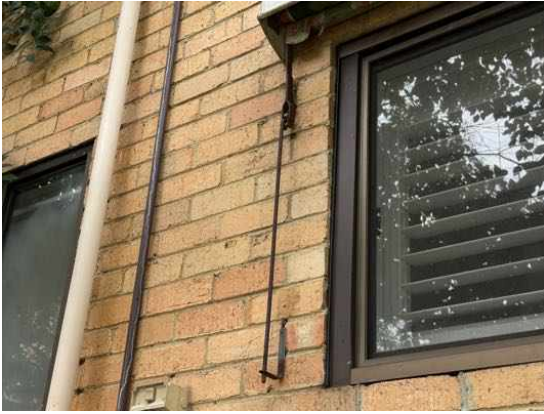
Defects 3.01

Building:	Building 1
Location:	All Areas > All Areas
Finding:	Building element - Rusted or corroded
Information:	Some exterior building elements and materials that show evidence of rusting and corrosion, has likely developed as a result of excessive exposure to moisture, harsh weather conditions and or inadequate coatings. A surface that is found to be rusted provides no protection to the underlying iron, the deteriorating condition is likely to worsen if not addressed and left unmanaged, it is therefore recommended that the relevant tradespersons remove as much rust as possible, clean and re-paint these areas.

Where possible, the use of galvanized (treated) metals or aluminium coated metals aid in rust prevention, as does regular general maintenance. Rust formation can be controlled with coatings, such as paint, that isolate the iron from the environment. Rusting and corrosion should be managed by ideally removing or limiting the affected surface from exposure to moisture and harsh weather conditions. A qualified painter or other relevant tradespersons may be appointed to paint affected areas and a qualified carpenter to replace any building elements that have been severely affected by rust or water damage.

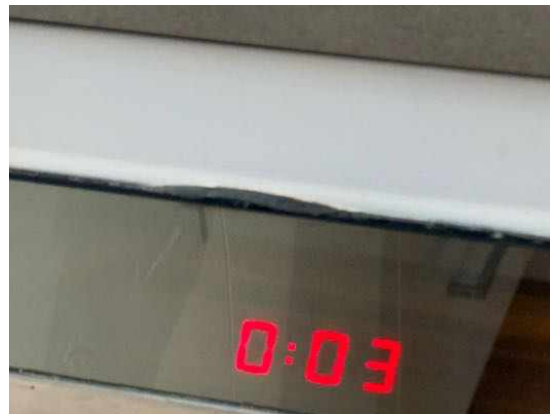
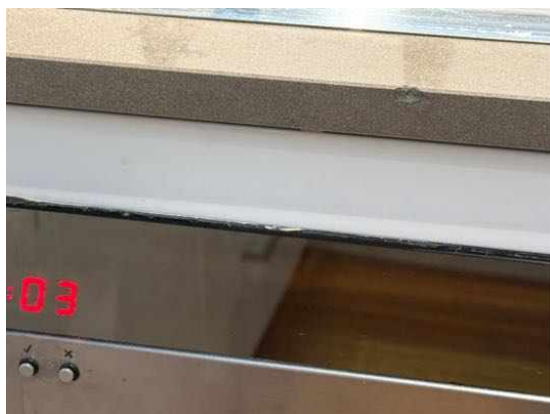
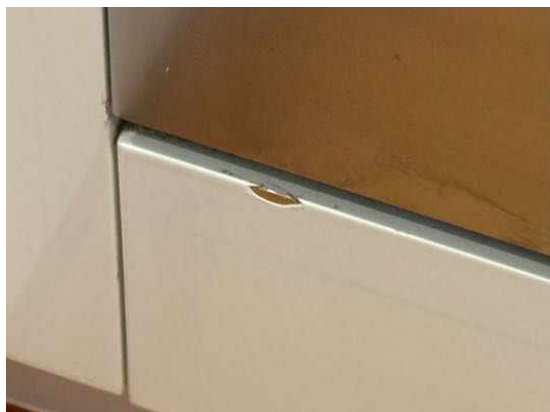
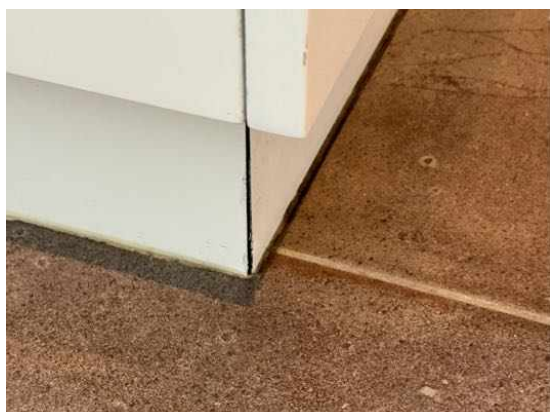
Defects 3.02

Building: Building 1
 Location: Kitchen > All Areas
 Finding: Kitchen cabinetry
 Information: The kitchen cabinetry showed signs of some minor damage. Some maintenance, remedial work or repair may be required to ensure further deterioration does not continue any further. These defects may detract from the overall looks of the cabinetry, in most cases it does not necessarily affect the operational state of the cabinetry.

To improve the operation of these affected cabinets, cabinet doors or drawers, a qualified cabinet maker or carpenter may be appointed to rejuvenate rectify or repair any cabinetry as deemed to be necessary. Such works should be completed at discretion of the client.

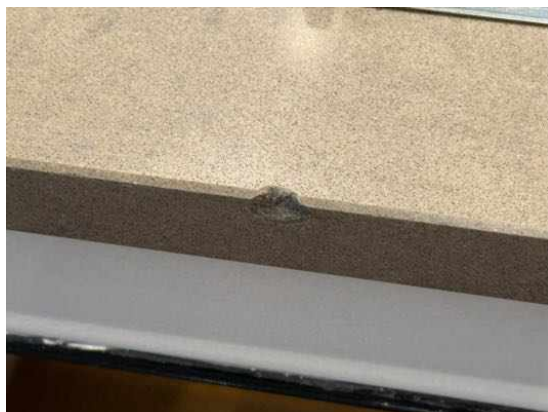
Defects 3.03

Building:	Building 1
Location:	Kitchen > All Areas
Finding:	Chip to kitchen bench top.
Information:	Although this chip is noticeable, it is only considered to be an appearance defect, and usually will not indicate any overall bench top damage. Generally, the cause of a bench top chips are accidental impacts. Chips of this nature can generally be repaired by the relevant tradespersons or bench-top installers. Such works should be performed by a qualified bench top installers. Monitoring of all chips should be conducted periodically to ensure no further damage is occurring.

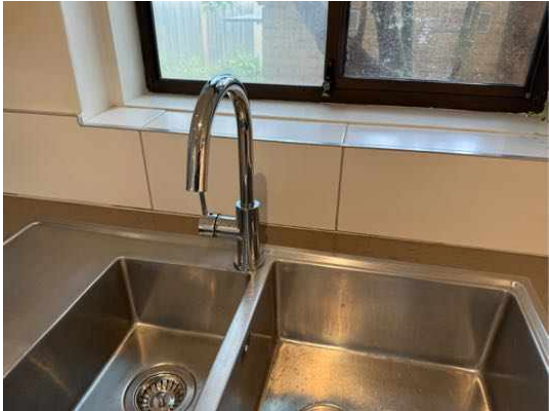
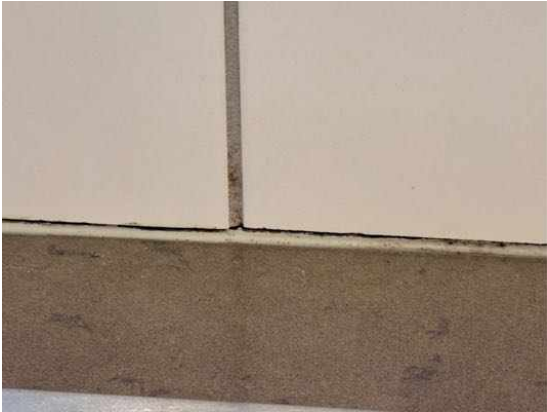
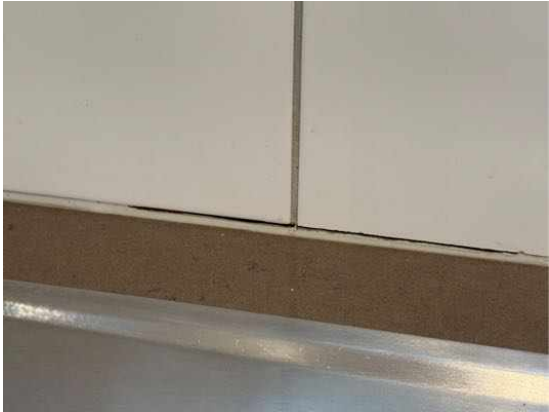
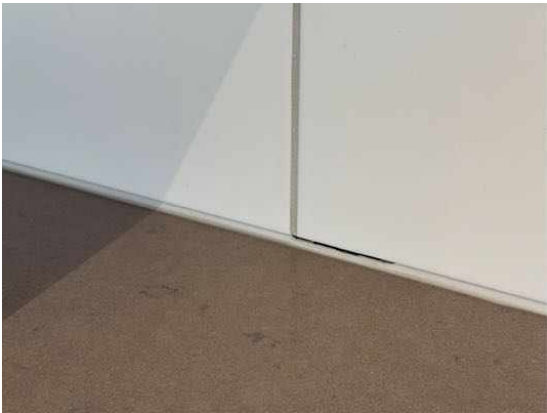
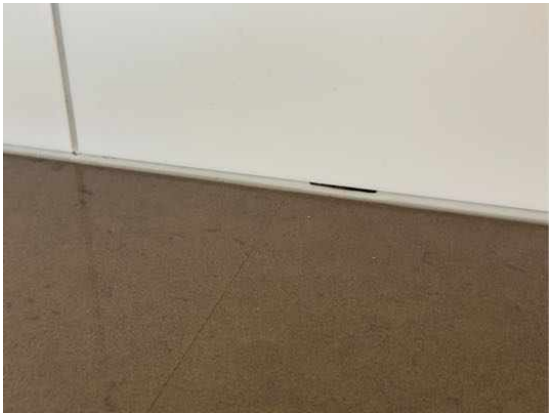
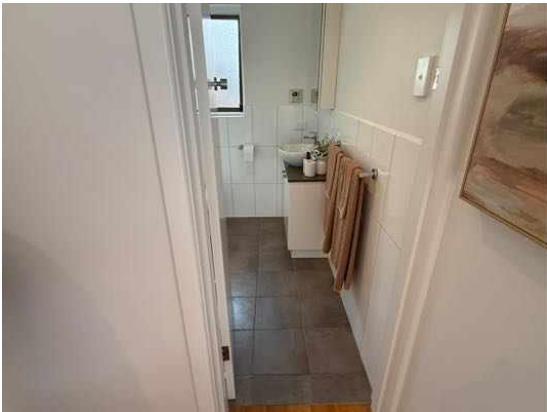
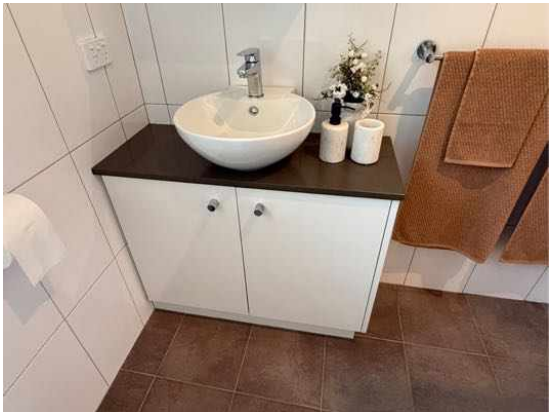
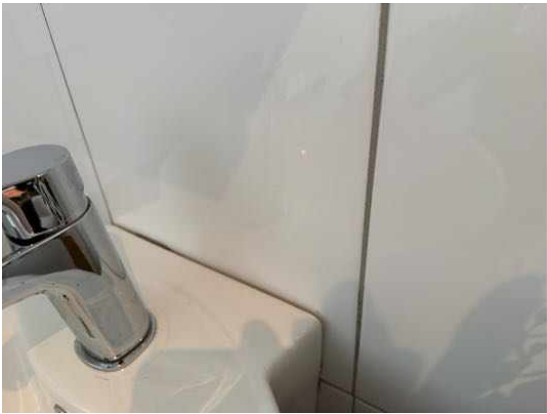
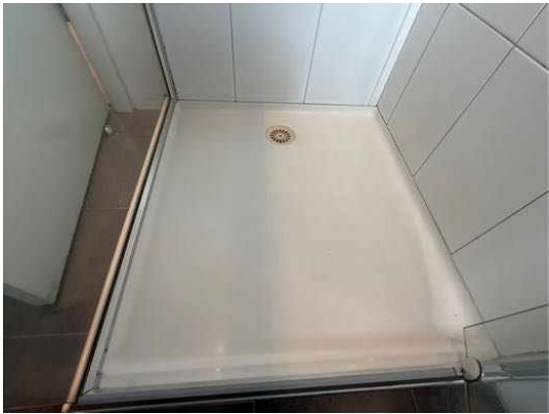
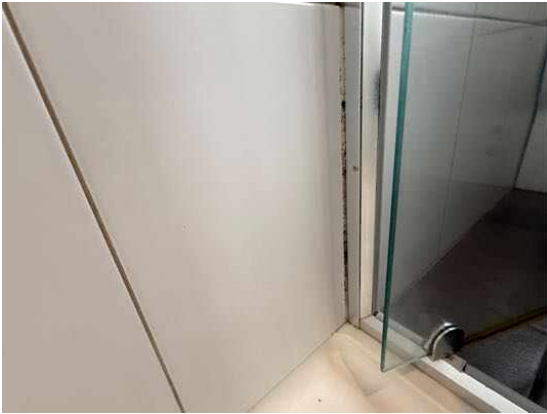
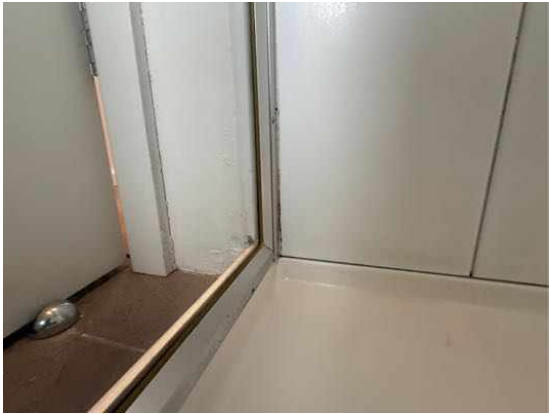
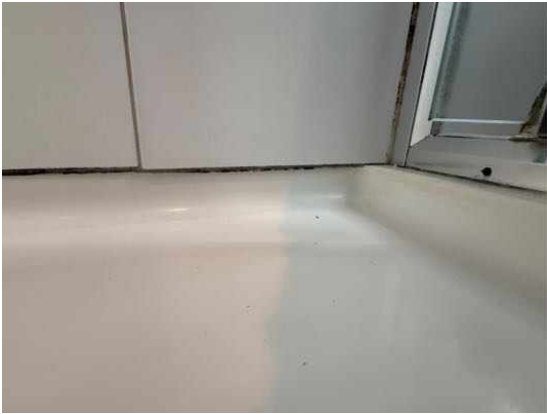
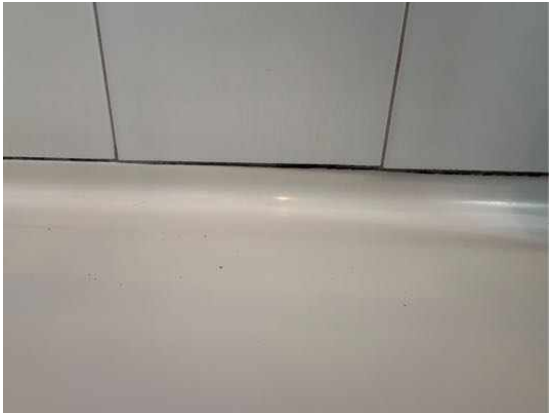
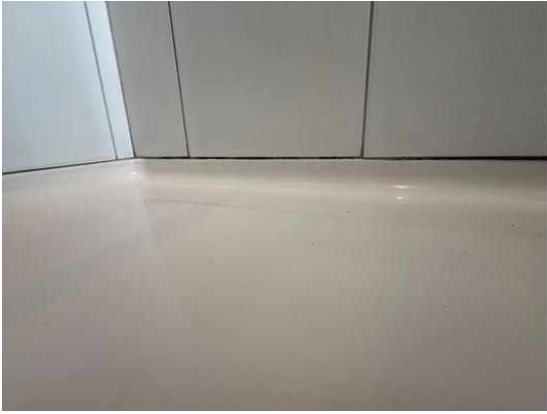
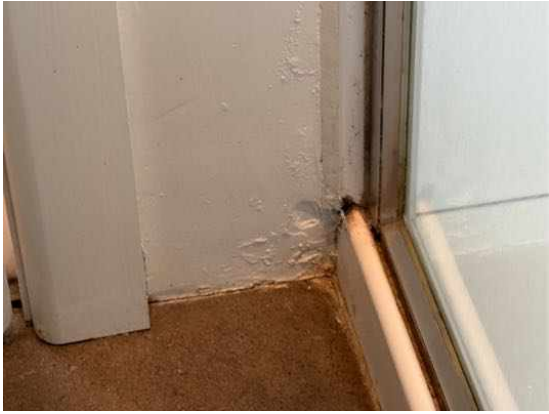
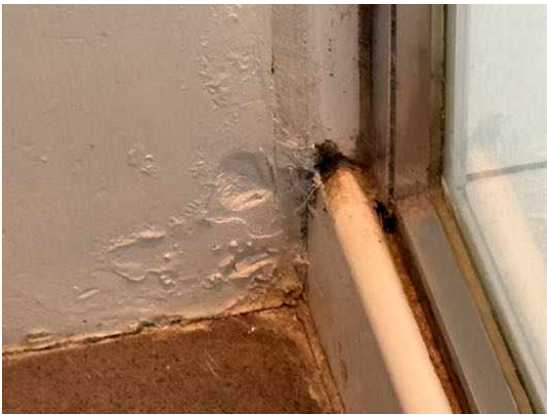
Defects 3.04

Building:	Building 1
Location:	Bathroom > All Areas
Finding:	Grout and sealant maintenance
Information:	It was observed that grout and sealant in the tiled shower alcove and in the bathroom and kitchen areas requires some maintenance to ensure these areas remain watertight at all times. Grout and sealant were observed to have been either deteriorated, dislodged or missing, in these types of wet areas if not rectified and maintained adequately it is highly likely that these areas will have accelerated damage and deterioration to the substrate as well as more serious secondary defects to the adjoining floor and wall structures.

Regular maintenance and replacement of grout to any holes or damaged sealant is highly recommended to the wet areas, as this is a regular wear and tear defect. Sealant and grouting in areas that come into regular contact with water should be maintained for the long term care of your property. Different materials on the walls and floor areas move at different rates, generally causing cracking to grout or sealant at these points. A flexible sealant is required to allow for expected expansion and contraction, while keeping the joint water tight and protective of all associated building structures and materials. Flexible and mould resistant materials should be applied to affected areas to prevent any subsequent water damage that is likely to occur if left unmanaged. A sealant specialist or tiling contractor should be appointed to complete these works immediately or as soon as possible.

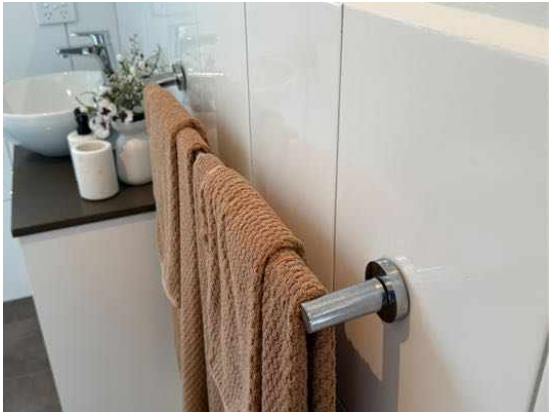
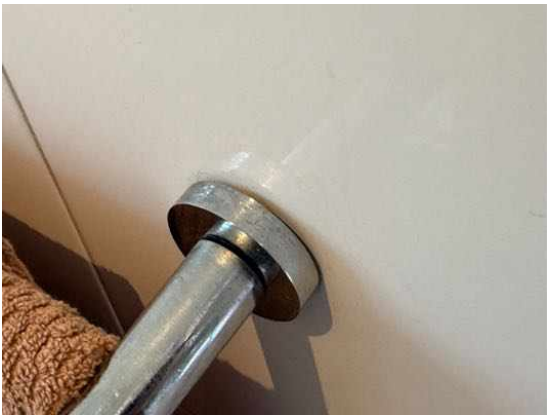
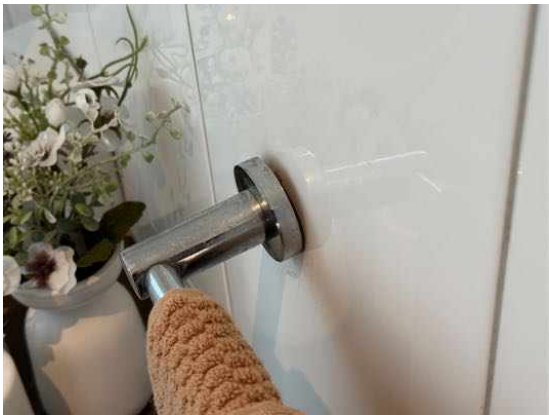
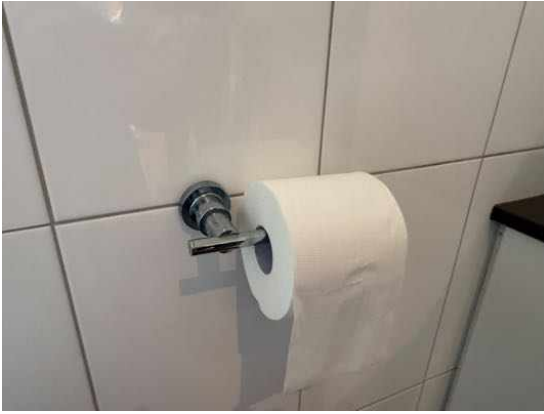
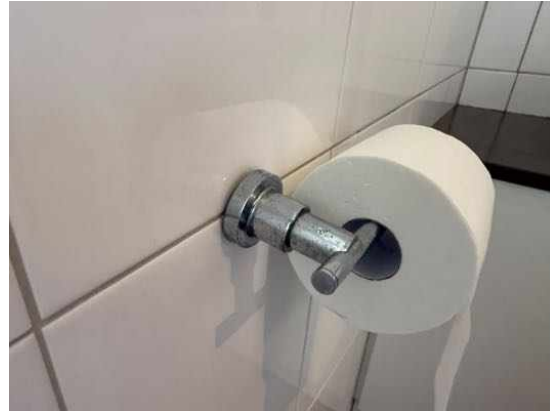
Defects 3.05

Building: Building 1
Location: Bathroom > All Areas
Finding: Bathroom towel rail - toilet roll holder loose
Information: Bathroom towel rail and toilet roll holder were observed to be loose and may require maintenance to be good, this occurs generally due to substandard installation or poor trade practices. A qualified carpenter should be appointed to repair or replace the affected towel rails, at the clients discretion.

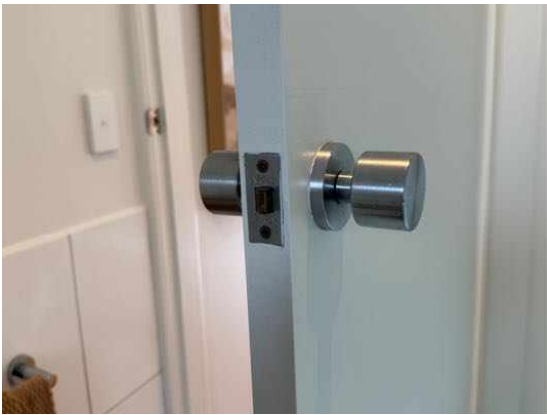
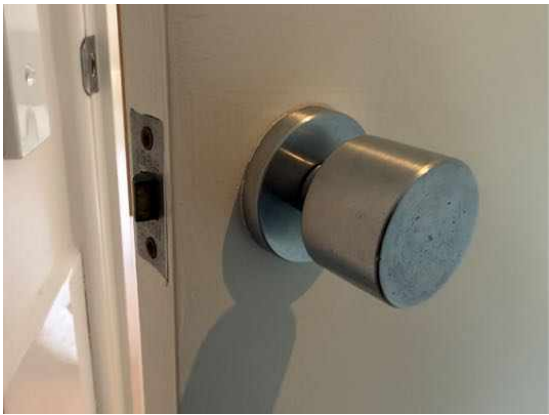
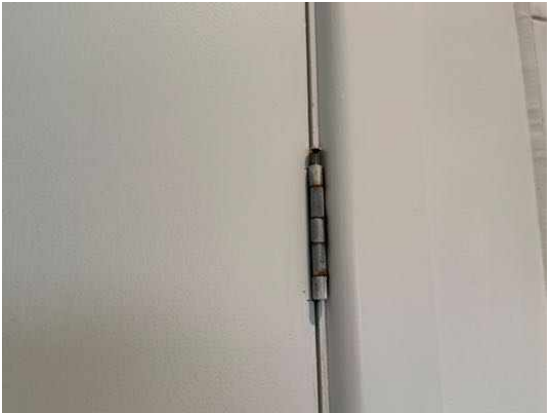
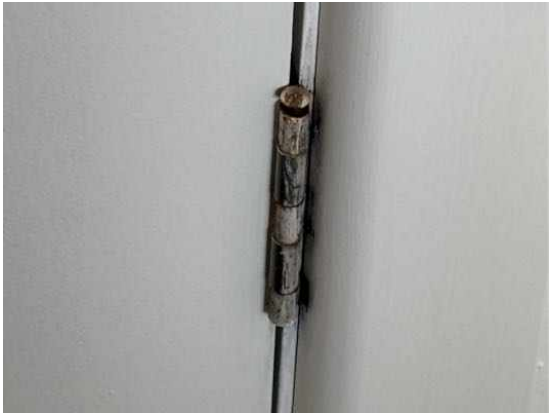
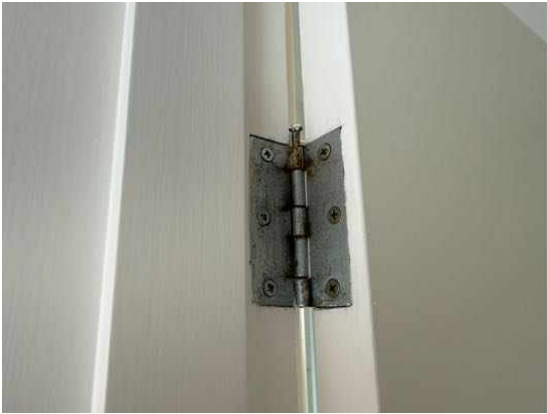
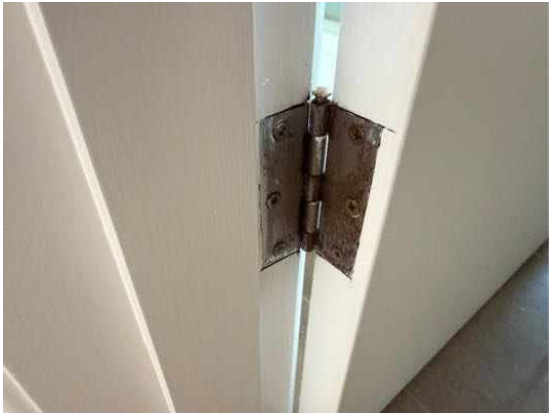
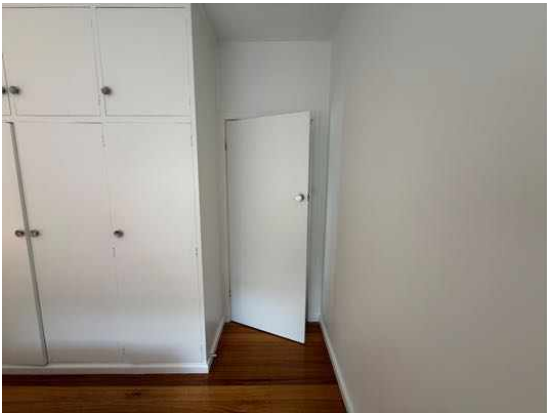
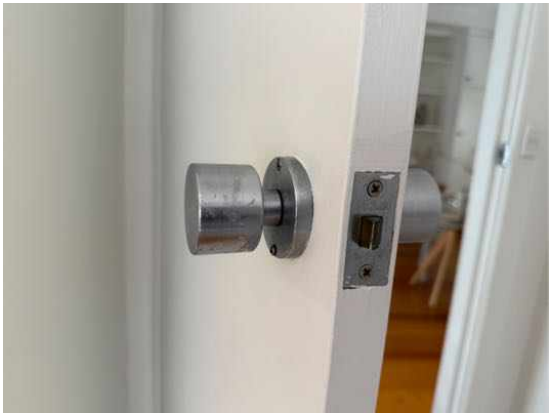
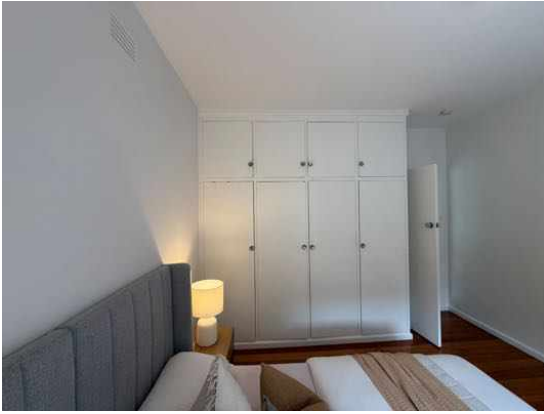
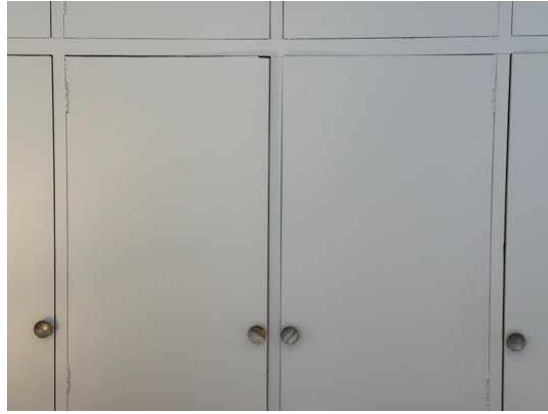
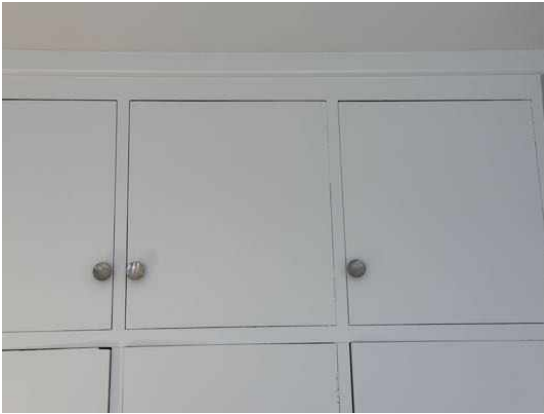
Defects 3.06

Building: Building 1
 Location: Bedroom > All Areas
 Finding: Door handles
 Information: Bathroom and the bedroom door handles were too stiff and will either require new door handles the correct maintenance to make good. There is a high possibility that occupants will get stuck in these rooms if not repaired properly and immediately. When door handles are found to be hard to operate, this will make it difficult for occupants to safely egress the interior areas. All doors should be rectified to ensure they operate easily during standard operation. These doors and door hardware defects may inhibit a safe and timely egress in the case of an emergency.

Some of these doors require immediate attention to ensure their functionality is not compromised, they are suspected to create secondary defects and damage to the associated door frames if left unmanaged. The wardrobe doors are also aged, damaged and deteriorated and may cause secondary defects from deteriorated hinges. A qualified carpenter should be appointed to perform minor rectification works at the clients discretion.

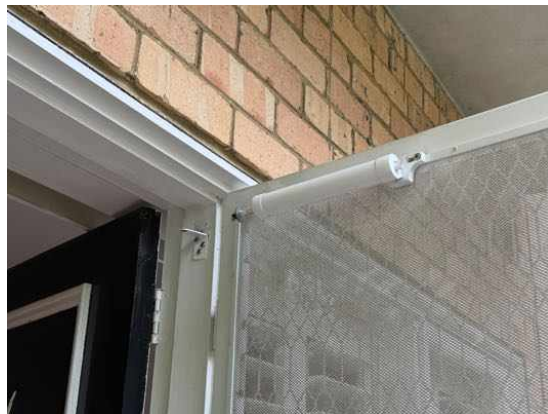
Defects 3.07

Building: Building 1
Location: Front wire door > All Areas
Finding: Front flywire door closer
Information: At the time of the inspection the front flywire door closer appeared to be broken and not fitted, this may need to be rectified or replaced to make good.

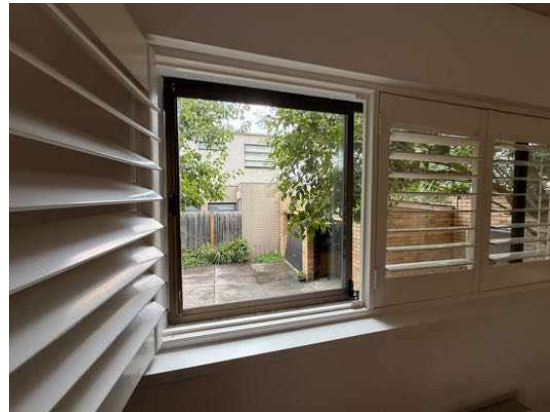
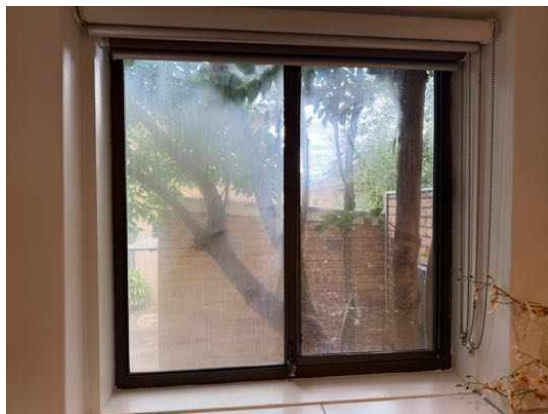
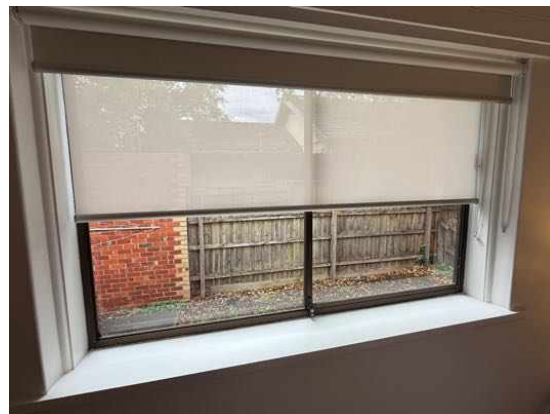
Defects 3.08

Some flyscreens were found to be missing to the windows throughout the home at the time of inspection. Whether the flyscreens have not been installed or have been removed for maintenance and or painting purposes, this missing building element detracts from the operational state of the window. Where not replaced, missing flyscreens allow pest and insect ingress into the adjoining room/s. It is advised that all missing building elements be installed or replaced in order to ensure the full function of all building structures. A qualified carpenter may be appointed to replace flyscreens at the discretion of the client.

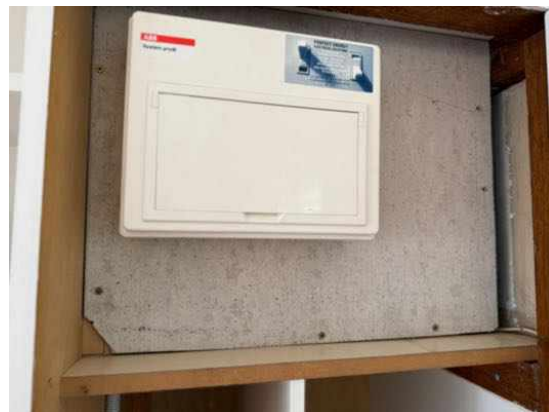
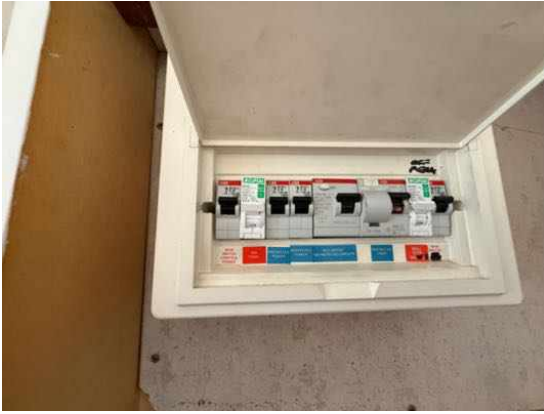
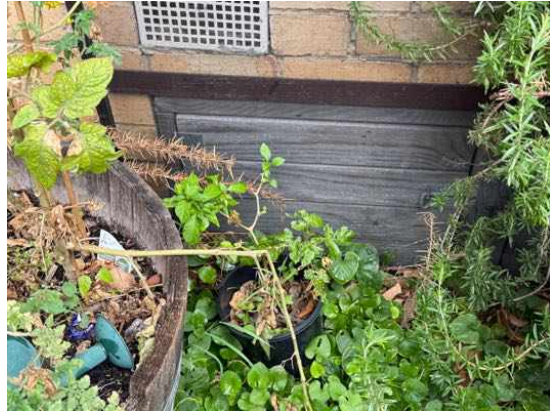
Building: Building 1
 Location: All Areas > All Areas
 Finding: Termite Management System - no evidence of a chemical installation or durable notice
 Information: At the time of the inspection no application of a chemical termite barrier or durable notice was observed. Such barriers are highly effective and highly recommended for all properties in preventing termite attack on any timber building elements throughout the property.

A durable notice should be placed in the switchboard unit or in the another accessible area to indicate current termite barriers. At the time of inspection, no evidence to suggest preventative works taking place. The client may consider gaining further advice from builders or a pest controller and as to the costs and procedures involved with this application. It is recommended that obtaining such advice be a short-term priority.
