Building and Timber Pest Inspection Report

Inspection Date: Wed, 4 Feb 2026

Property Address: 6309/1 Morton St, Parramatta NSW 2150,
Australia

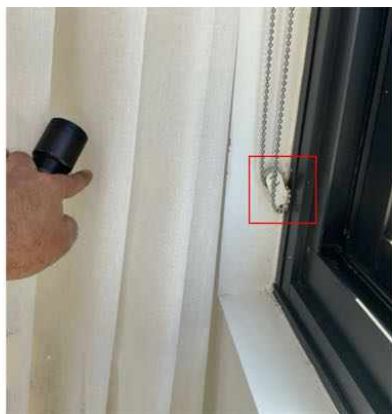
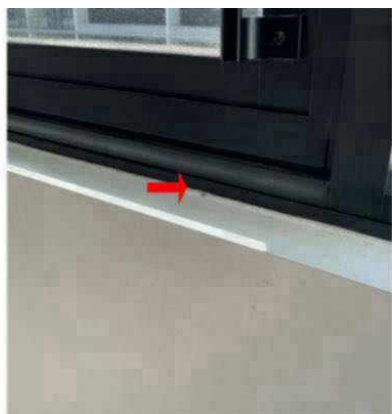
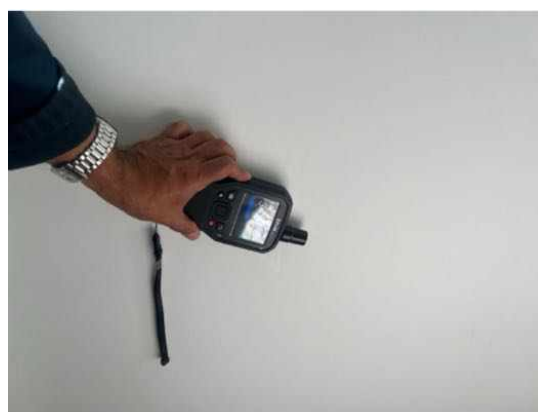
Finding 3.01

Building: Main Building

Location: Bedroom 2

Finding: Minor Mould Growth and elevated moisture

Information: Minor mould growth was observed to the internal window reveal, with elevated moisture readings recorded below the window at the time of inspection. No visible material deterioration was observed. This condition is commonly associated with condensation, limited ventilation, and external environmental influences such as weather exposure and temperature differentials across the building envelope. The exact cause could not be confirmed due to the non-invasive nature of the inspection. Cleaning, improved ventilation, and ongoing monitoring are recommended, with further investigation advised if the condition persists.

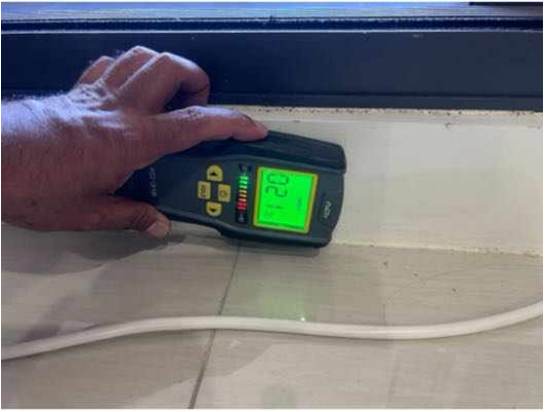
Finding 3.02

Building:	Main Building
Location:	Balcony
Finding:	Elevated moisture and minor mould growth
Information:	Elevated moisture readings were recorded to the tiled floor surfaces and adjacent wall bases when tested using a non-invasive (pinless) moisture meter, and minor mould growth was observed at the base of the sliding door. No visible evidence of moisture ingress, tile debonding, grout deterioration, staining, or material damage was observed at the time of inspection. The elevated readings may be associated with environmental factors such as condensation, limited ventilation, or moisture migration through tiled finishes, however, the exact cause could not be confirmed due to the

non-invasive nature of the inspection. Ongoing monitoring is recommended, with further investigation by a strata-appointed waterproofing contractor if the condition persists.

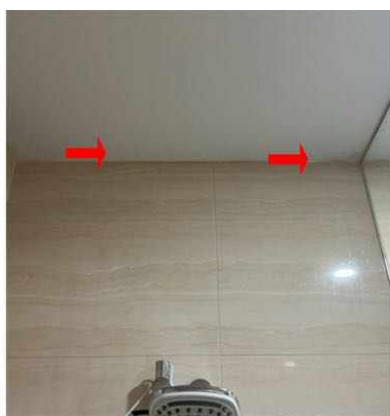
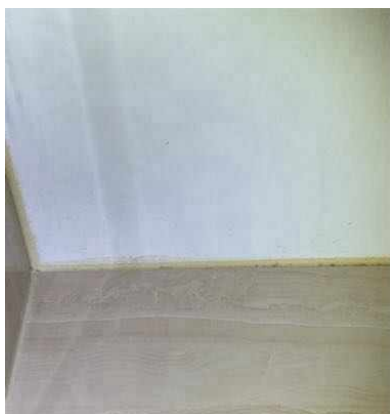
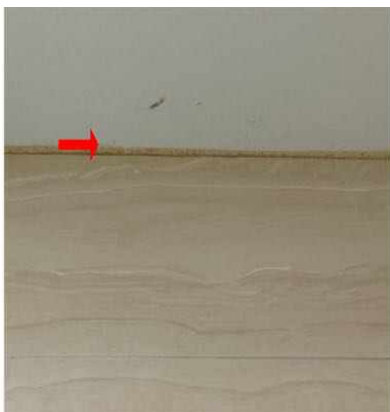
Finding 3.03

Building: Main Building

Location: Bathrooms

Finding: Water Staining - Humidity or Ventilation

Information: The ceiling surface shows peeling paint and water staining on the walls faint commonly consistent with humidity-related staining, often found in bathroom or wet areas with insufficient ventilation. While there is no visible sagging or major water damage, the pattern suggests prolonged moisture exposure, possibly due to steam accumulation or minor condensation issues. According to AS 4349.1–2007 (Appendix C), this would be classified as a minor defect unless further deterioration or active leaks are found. Recommend improving mechanical or natural ventilation, cleaning the surface with mould treatment, and monitoring for recurrence.

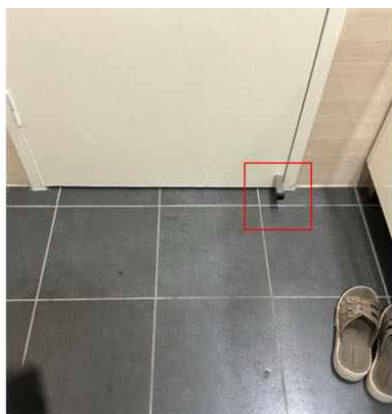
Finding 3.04

Building:	Main Building
Location:	Ensuite
Finding:	Wet-Area Door Jambs – Moisture Staining / Decay
Information:	Minor moisture staining and early signs of deterioration were observed at the base of the wet-area door jamb and architraves. This is commonly due to water splashing or moisture tracking from the bathroom floor into adjacent joinery. At the time of inspection, the condition appears superficial and non-structural, consistent with general wear typical of wet-area use.

It is recommended that the door junctions be resealed with a suitable moisture-resistant sealant and that ventilation and drainage within the bathroom be maintained to reduce further dampness.

For information only — further inspection by a licensed carpenter or waterproofing contractor is recommended to confirm the extent of deterioration and verify whether remedial sealing or minor replacement works are warranted.

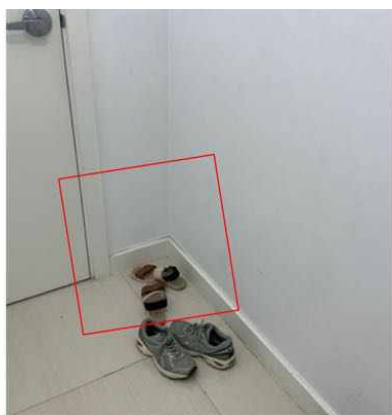
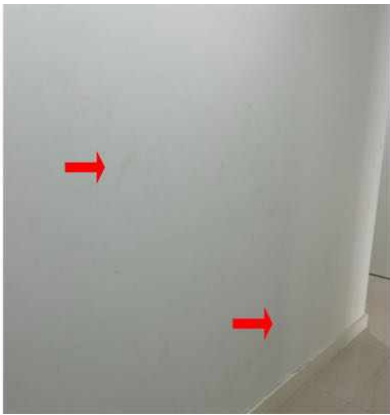
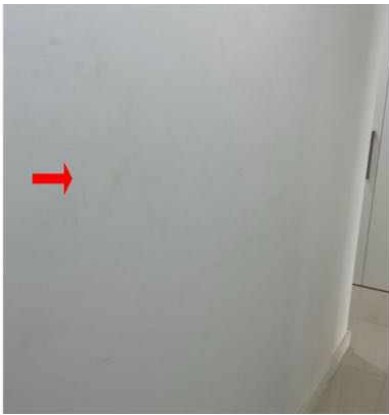
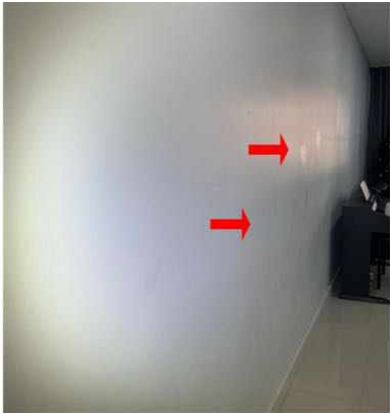
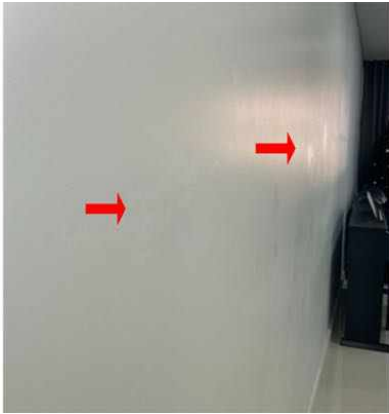
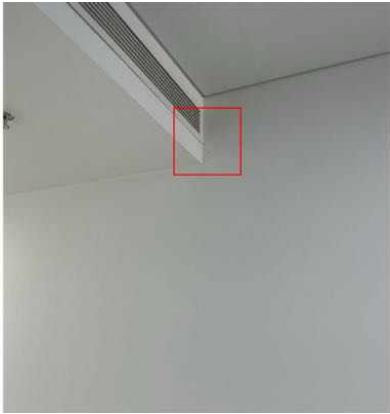
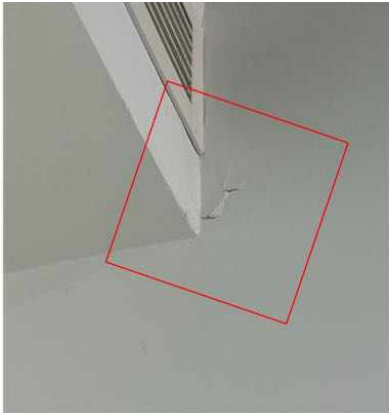
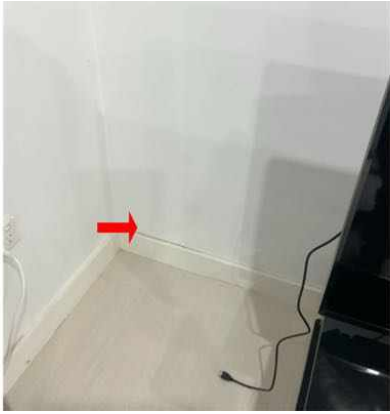
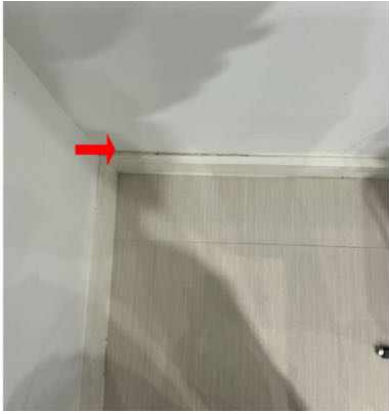
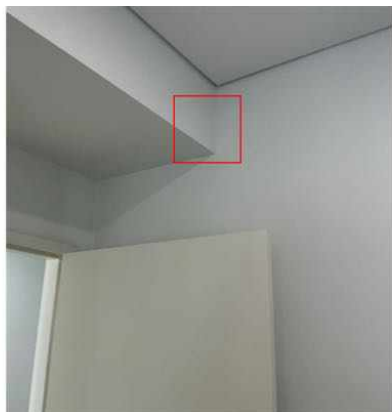
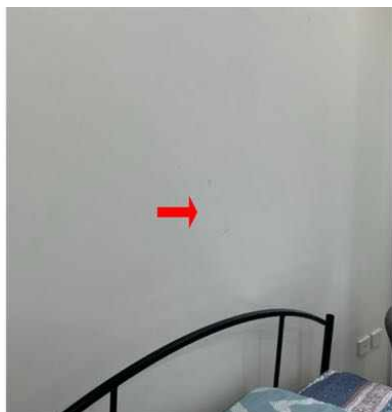
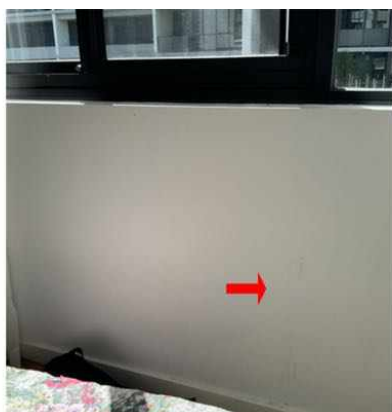
Finding 3.05

Building:	Main Building
Location:	All Internal Areas
Finding:	Paint finish and hairline cracking
Information:	The paint finish in this area was identified as being incomplete at the time of inspection including some hairline minor cracking.

Whilst incomplete or missing paint finish is generally an appearance defect, it can also lead to the development of secondary building defects over time. Incomplete areas of paint finish expose the area to moisture, potentially accelerating the deterioration of underlying building materials.

Incomplete paint finishes should be sanded back, filled, leveled and painted, as applicable. Where inadequate or missing paint protection has led to the deterioration of the associated building element, repair and/or replacement of this building element may be required.

A painting contractor should be appointed as soon as possible to perform necessary works to aid the appearance of the affected area and to ensure the area is protected against further deterioration. Alternatively, the homeowner following manufacturer instructions may perform these works.

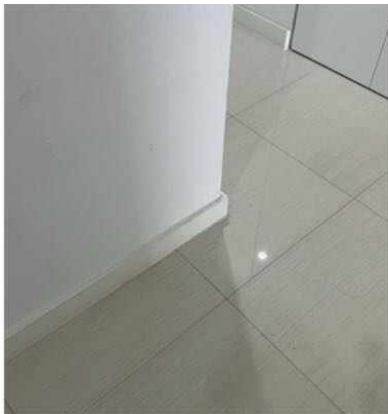
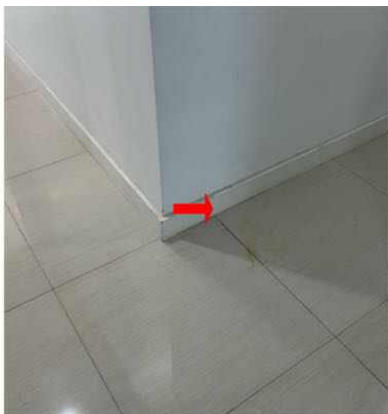
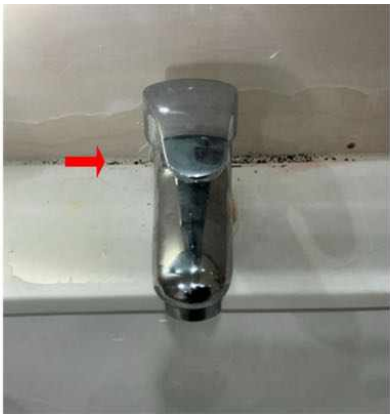
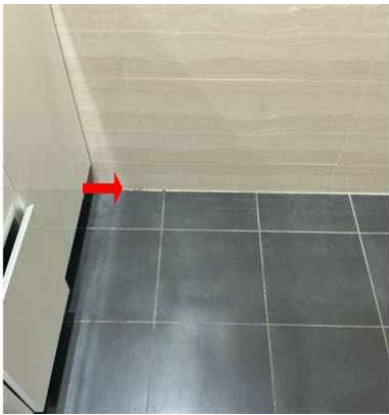
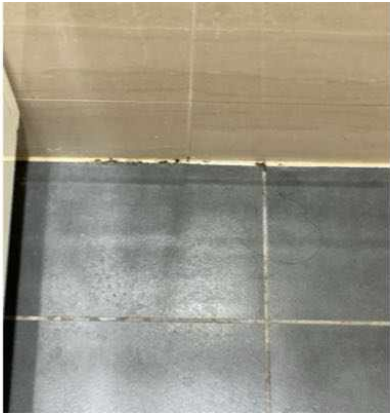
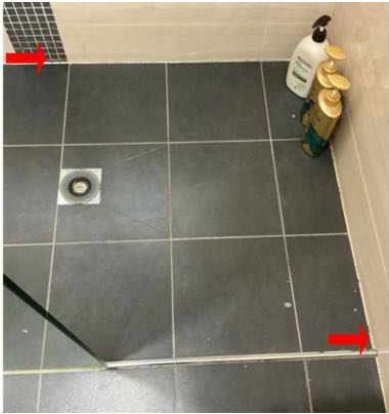
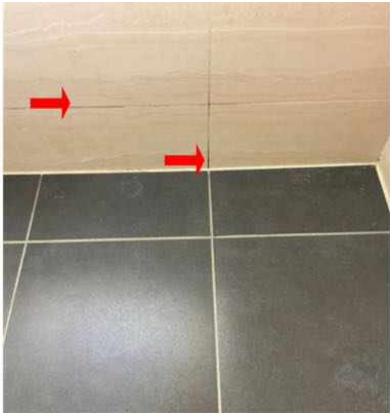
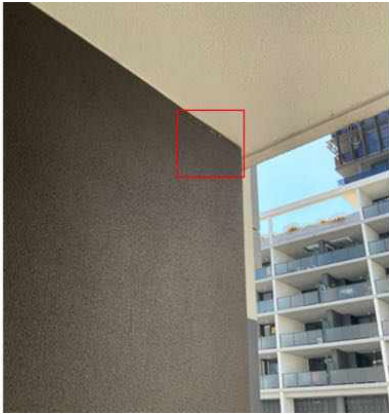
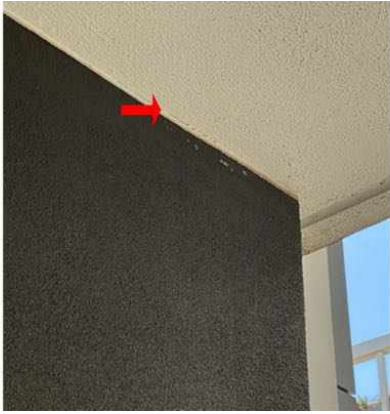
Finding 3.06

Building:	Main Building
Location:	All Internal Areas
Finding:	Sealant and grouting - Missing or degraded
Information:	It was noted on inspection that sealant or grout is degraded. There is also evidence of poor workmanship and excessive use of sealant. Silicone should never be used as a first line of defence against waterproofing. Further inspection by a licensed waterproofing contractor is highly recommend

Different materials and floor areas move at different rates, generally causing cracking to grout or sealant at this point. A flexible sealant is required to allow for expected expansion and contraction, while keeping the joint water tight and protective of all

associated building materials.

There appears to be excessive mould to the sealant and grout which will likely require scraping out and replacement.

Flexible and mould resistant materials should be applied to affected areas to prevent any subsequent water damage that is likely to occur. Regular maintenance and replacement of damage or missing or damaged sealant and grout is highly recommended to the wet areas, as this is a regular wear and tear defect. Sealant and grouting in areas that come into regular contact with water should be maintained for the long term care of your property.

A sealant specialist or tiling contractor should be appointed to complete these works as soon as possible

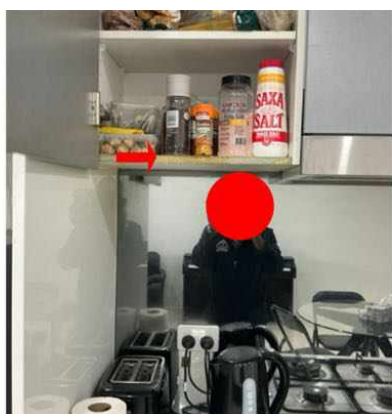
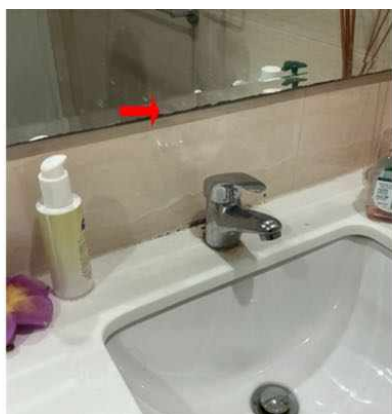
Finding 3.07

Building:	Main Building
Location:	All Internal Areas
Finding:	Building element - Damaged - Cabinet trim missing kitchen , bathrooms mirror desilvering , vanity drawer water damage bathroom ,
Information:	Breakage occurs generally when the building materials have either aged and decayed, or as a result of damage (accidental or deliberate).

Repair and/or replacement of broken elements is advised to ensure that additional secondary defects do not arise as a consequence. Such works are necessary, as all building elements play a key role in the operation and function of the overall structure and its performance.

A relevant tradesperson should be appointed to repair or replace the affected building element prior to any subsequent damage being caused.

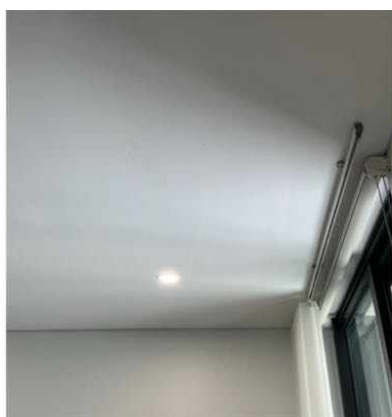
Finding 3.08

Building:	Main Building
Location:	Bedroom - Master
Finding:	Ceiling nails - Popping
Information:	Numerous popped nails were identified in the internal ceiling at the time of inspection. Nails and screws hold simply by the friction between them and the surface they are applied to. Over time, the nails and screws can back out, which is often a result of

general ageing and deterioration of the building structure.

If left unmanaged, the ceiling sheets may become loose and unstable, increasing the rate of deterioration of the internal ceiling and creating potential for the development of secondary defects.

Re-fastening of popped nails will help to maintain the stability of the internal ceiling and associated building elements. Such minor works will also help to improve the appearance of the affected area and secure the ceiling sheets, so as to prevent the onset of ceiling sagging. These works should be performed by a qualified carpenter or plasterer at client discretion.

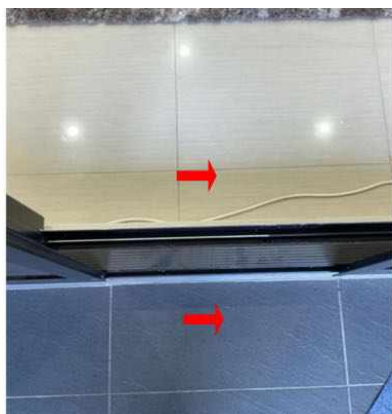
Noted Item

Building:	Main Building
Location:	Balcony
Finding:	Balcony Floor Level Differential
Information:	The balcony finished surface appears to be close to, or at the same level as, the internal floor. Standard construction practice requires a step-down of approximately 50 mm unless a fully engineered threshold drainage system is provided. No such drainage features were visible during inspection. This configuration increases the risk of water ingress. Confirmation of the balcony waterproofing detail through strata/building management is recommended.
