Building and Timber Pest Inspection Report

Inspection Date: Wed, 25 Mar 2026

Property Address: 14 Helen St, Drouin VIC 3818, Australia

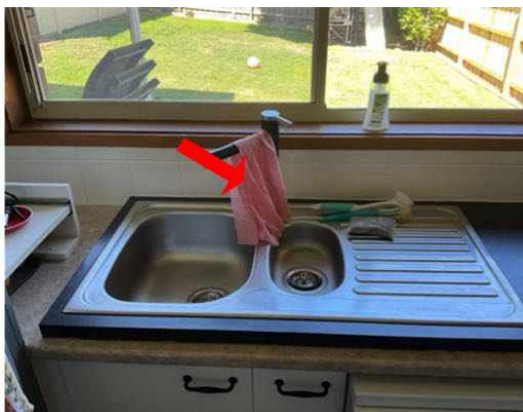
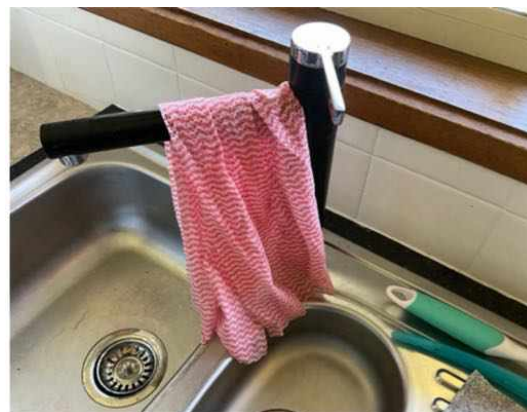
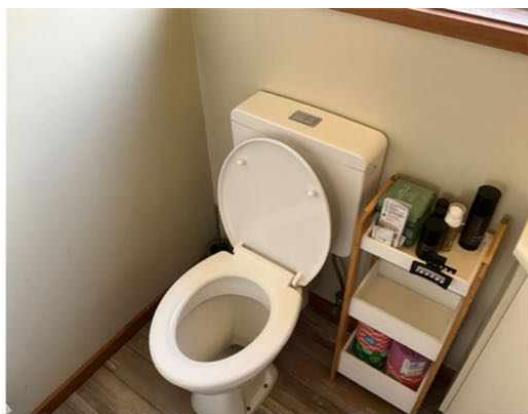
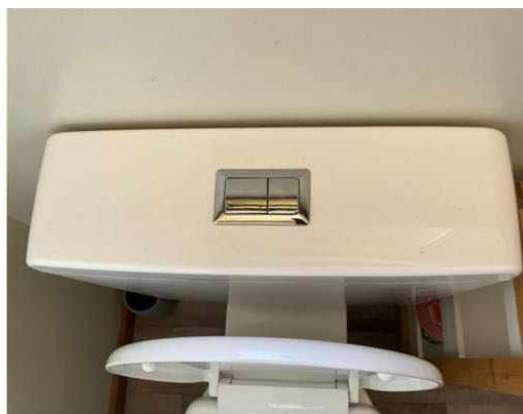
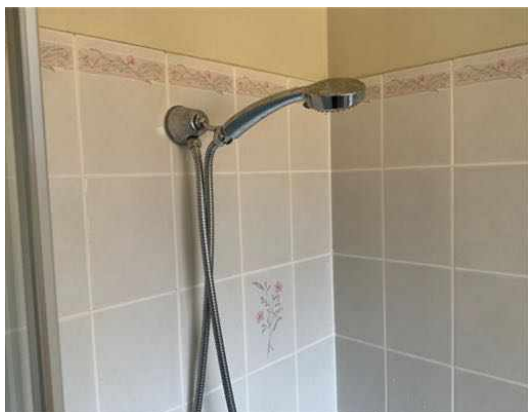
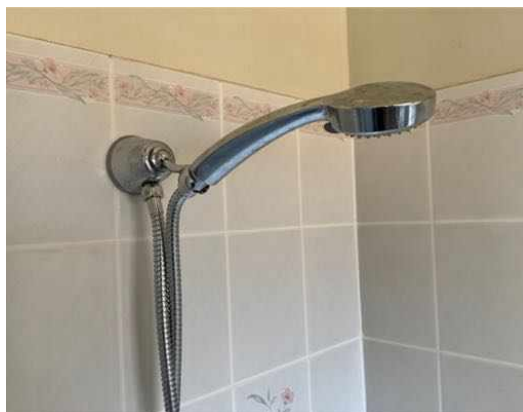
Finding 3.01

Information: Water hammer was observed affecting multiple plumbing fixtures, including taps and toilet flush systems. Water hammer is a pressure surge that occurs when water flow is suddenly stopped or redirected within the plumbing system. This is commonly associated with high water pressure, worn or poorly maintained fittings, or inadequate pipe support. The condition is typically identified by a noticeable banging or knocking noise during operation of taps or flushing of toilets.

Although generally considered a minor defect, ongoing water hammer can lead to deterioration of tapware, loosening of pipe connections, and potential water damage to surrounding building elements over time if left unaddressed.

It is recommended that a licensed plumber be engaged to assess the plumbing system, regulate water pressure if required, and repair or replace any affected fixtures. If any associated water damage to cabinetry or surrounding materials is identified, a qualified carpenter or cabinet maker may also be required to carry out remedial works.

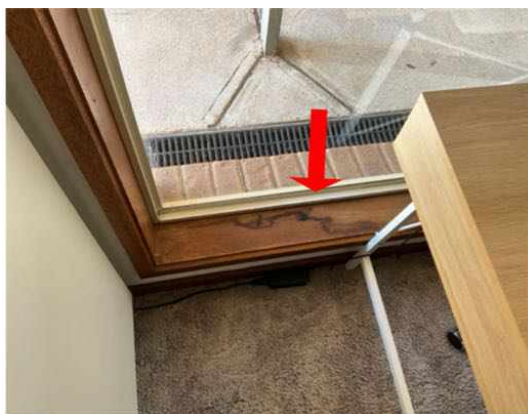
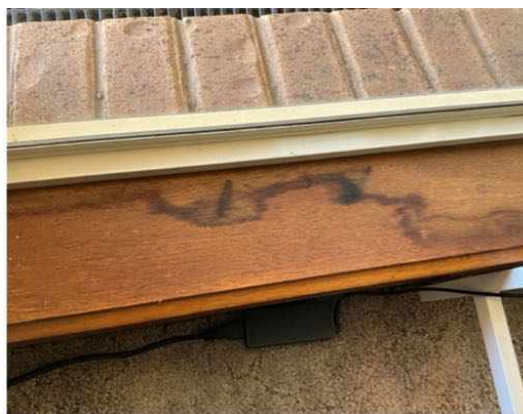
Finding 3.02

Building:	Main Building
Location:	All Internal Areas
Finding:	Weathered Timber Window Sills
Information:	The timber window sills were observed to be weathered, with visible signs of surface degradation. This condition is typically caused by prolonged exposure to sun, rain, and varying temperatures over time. Inadequate maintenance, such as infrequent painting or sealing, can accelerate the weathering process and leave the timber unprotected against the elements.

If left untreated, the deterioration may worsen, potentially leading to timber rot, water ingress into the wall structure, or even pest activity. Over time, this can compromise the structural integrity of the sill and affect the surrounding window frame, possibly resulting in more extensive repairs.

It is recommended that the weathered timber be sanded back to sound material, sealed, and repainted with a suitable exterior-grade protective coating. Any sections showing signs of rot or softness should be replaced. Regular maintenance will help extend the lifespan of the sill and protect the building envelope from further damage.

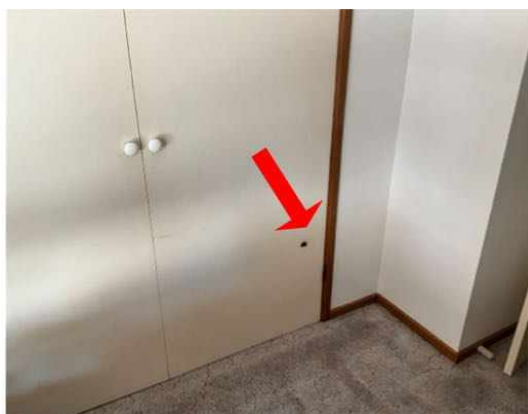
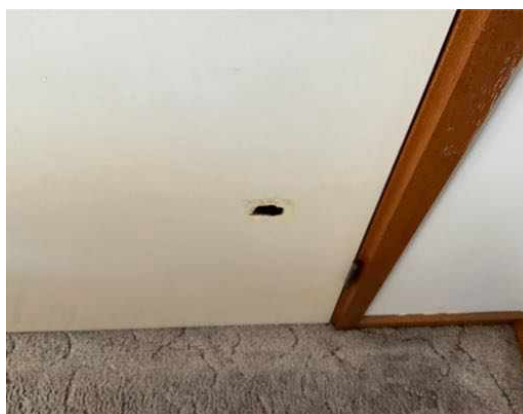
Finding 3.03

Building:	Main Building
Location:	Bedroom
Finding:	Robe Door Damage
Information:	Minor impact damage was observed to the robe door during the inspection. This is likely the result of accidental force or collision, causing localised surface damage to the door.

While the defect is considered minor and does not currently affect the overall functionality of the door, continued use without repair may lead to further deterioration and affect the appearance.

It is recommended that a handyman or qualified tradesperson be engaged to repair or rectify the damaged section of the robe door as required

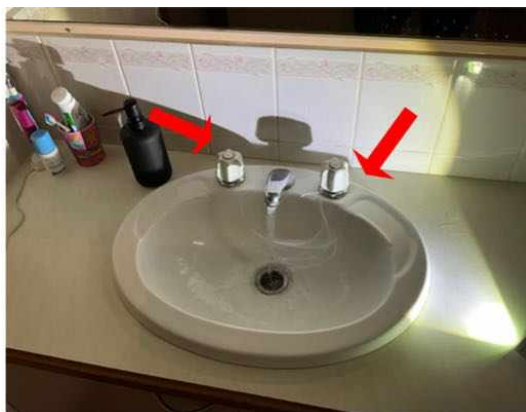
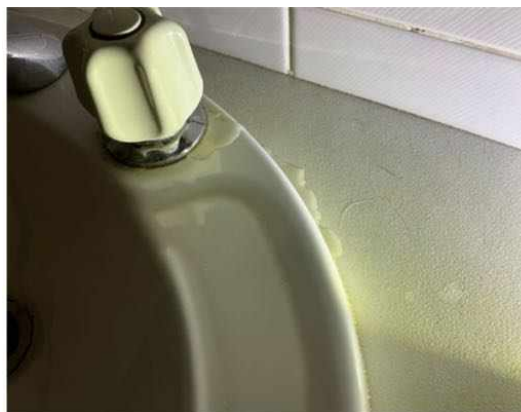
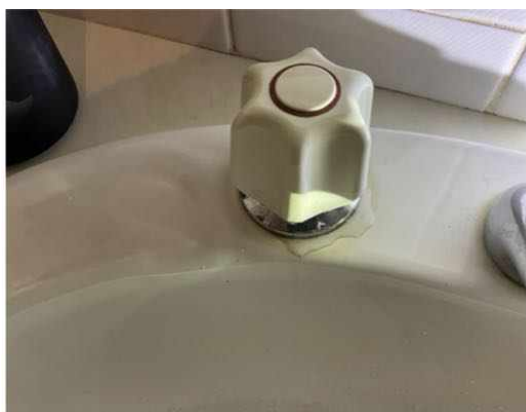
Finding 3.04

Building:	Main Building
Location:	Bathroom
Finding:	Leaking Tap with Noise
Information:	A tap was observed to be leaking and producing noise during operation. The issue is likely due to worn internal components such as washers or cartridges, and may also

If left unaddressed, the leak may lead to unnecessary water wastage, increased utility costs, and potential deterioration of surrounding building elements. The associated noise may also indicate ongoing stress within the plumbing system, which could contribute to further wear over time.

It is recommended that a licensed plumber be engaged to inspect the tap, replace any faulty components, and carry out necessary repairs to rectify both the leakage and noise.

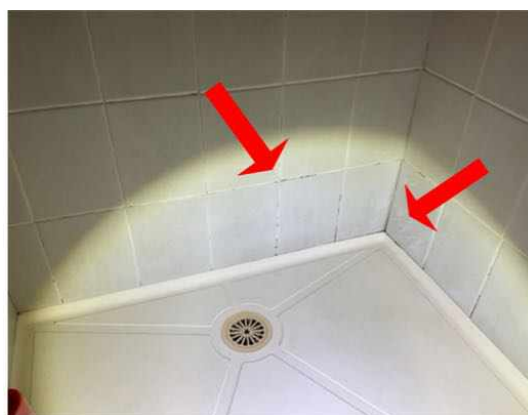
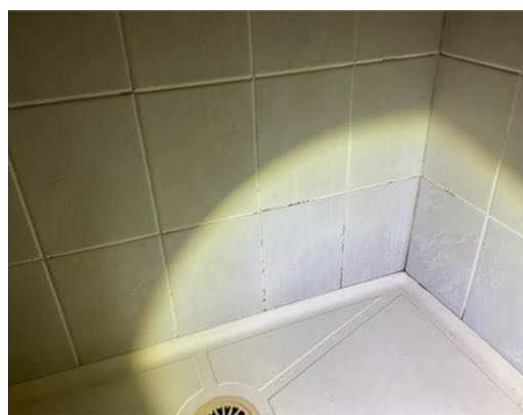
Finding 3.05

Building:	Main Building
Location:	Bathroom
Finding:	Mould suspected - Shower
Information:	Suspected mould growth was noted in the shower area during the inspection. This is likely the result of excessive moisture and humidity commonly associated with wet areas, combined with inadequate ventilation or poor drainage. The persistent presence of water and damp conditions creates an environment conducive to mould development, especially if regular cleaning and drying practices are not maintained.

with respiratory conditions, allergies, or sensitivities. Additionally, prolonged exposure to moisture can damage surrounding materials, such as grout, tiles, and underlying structures, leading to deterioration and costly repairs. In severe cases, mould growth may spread beyond the immediate area, affecting other parts of the building.

To address the issue, a qualified environmental health inspector or mould specialist should confirm the presence of mould and assess its extent. Minor mould growth can typically be cleaned using appropriate cleaning agents by the homeowner or a professional cleaning contractor. If materials are severely affected, a licensed builder or carpenter may be required to replace damaged elements. It is recommended to address this issue promptly and ensure proper ventilation and moisture control in the shower area to prevent recurrence.

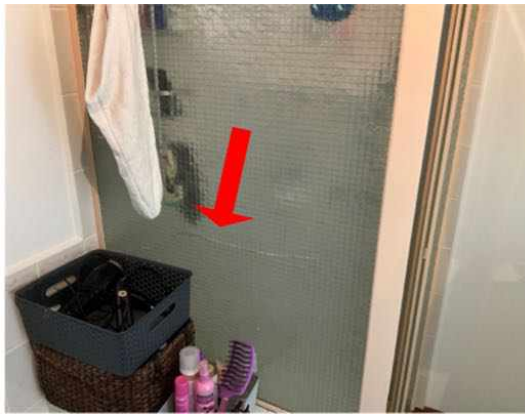
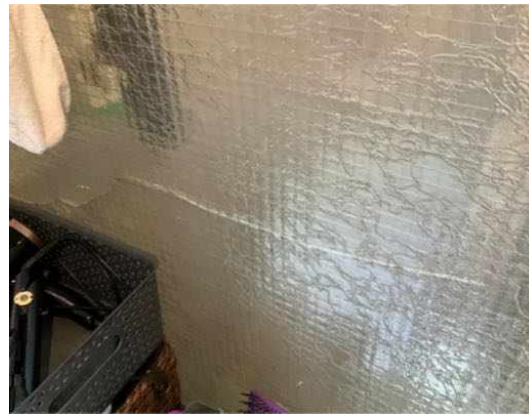
Finding 3.06

Building:	Main Building
Location:	Bathroom
Finding:	Cracked Shower Screen Glass
Information:	Cracking was observed in the shower screen glass during the inspection. This is likely due to impact damage, stress on the glass panel, or material fatigue over time.

Cracked glass poses a safety risk as it may shatter unexpectedly, potentially causing injury. The integrity of the shower screen is compromised and the condition may worsen with continued use.

It is recommended that a licensed glazier be engaged to replace the damaged shower screen glass. The shower should be used with caution until the issue is rectified.

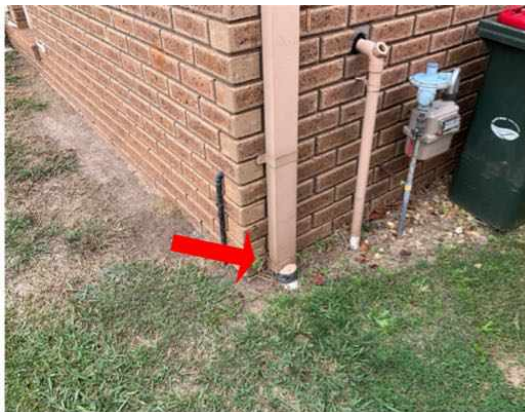
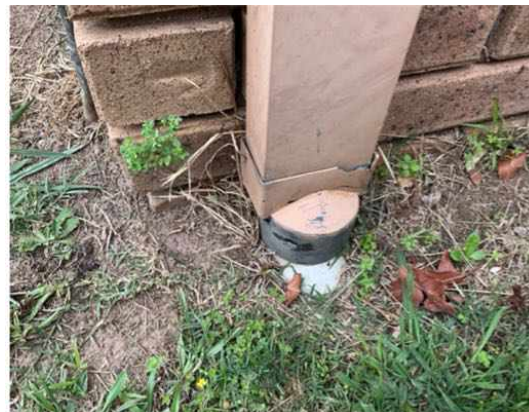
Finding 3.07

Building:	Main Building
Location:	All External Areas
Finding:	Downpipe Base Damage
Information:	Minor damage was observed to the base of a downpipe during the inspection. This is likely due to impact, general wear and tear, or exposure to external elements over time.

While the defect is considered minor, damaged sections at the base may affect the efficient discharge of water and could contribute to localised damp conditions if left unaddressed.

It is recommended that a handyman or licensed plumber be engaged to repair or replace the affected section of the downpipe to ensure proper stormwater drainage.

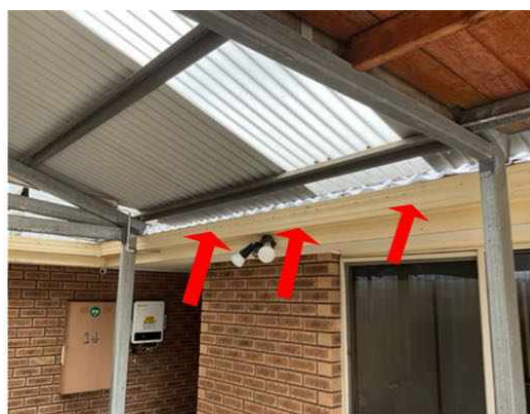
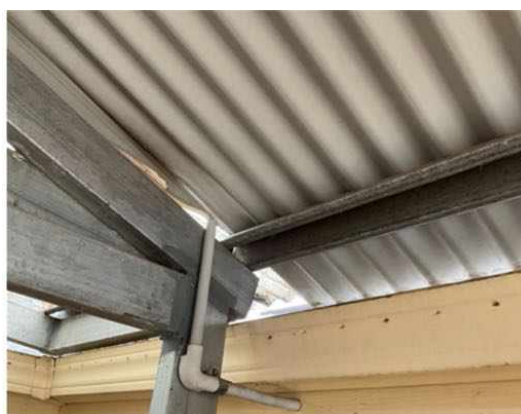
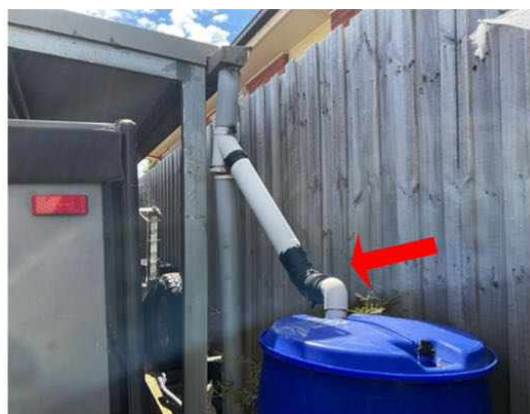
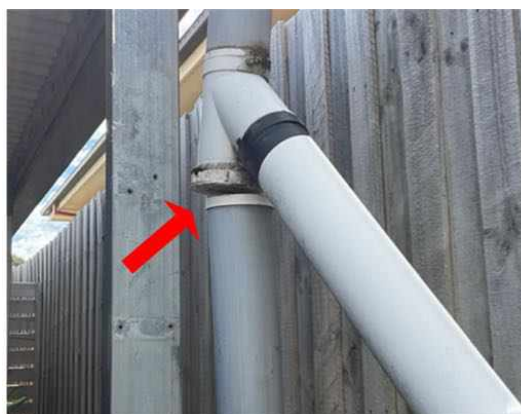
Finding 3.08

Building:	Main Building
Location:	Carport
Finding:	Carport Roof Lacking Gutters
Information:	The carport roof was observed to be constructed without gutters, resulting in rainwater discharging directly onto the adjoining existing roof surface. This

This condition may lead to excessive water flow over the existing roof, increasing the risk of water ingress, accelerated deterioration of roofing materials, and potential moisture-related issues within the structure over time.

It is recommended that a registered builder or licensed plumber be engaged to assess the installation and install appropriate guttering and stormwater connections to ensure compliant and effective drainage. Further investigation may be required to confirm compliance with relevant standards and regulations.

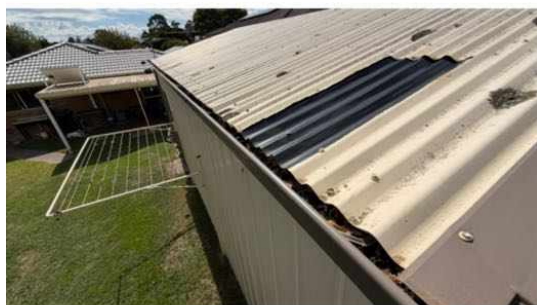
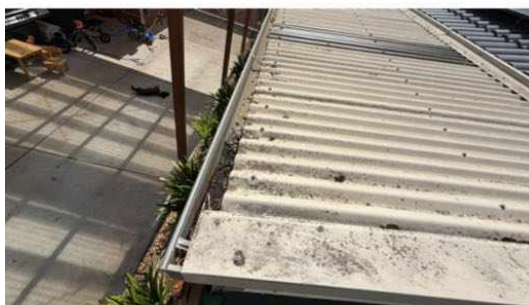
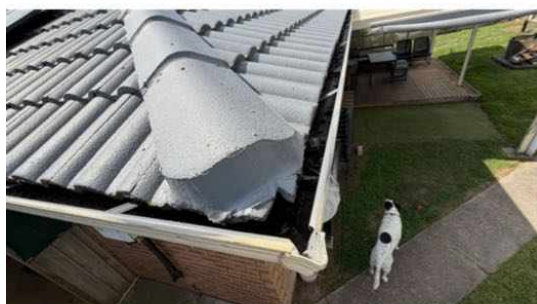
Finding 3.09

Building:	Main Building
Location:	Roof Exterior
Finding:	Gutters - Partially Blocked
Information:	Roof plumbing structures, such as guttering and downpipes, should be free of all debris to prevent blockages. Blockages of the guttering and downpipes will lead to pooling and accumulated water overflows, which is likely to subsequently flood eaves and exterior walls.

Blocked gutters are likely to lead to high levels of moisture in the affected areas. Such moisture will not only cause rust and decay of the associated building materials, but can also provide conditions that are conducive to termite and timber pest activity.

Blockages in gutters should therefore be removed immediately to ensure dry conditions are maintained.

Consult a Licensed Plumber for further specific advice on remedial works that may be required. In the interim, it is highly advised that blocked gutters be removed by the homeowner or a general handyman as a matter of urgency.

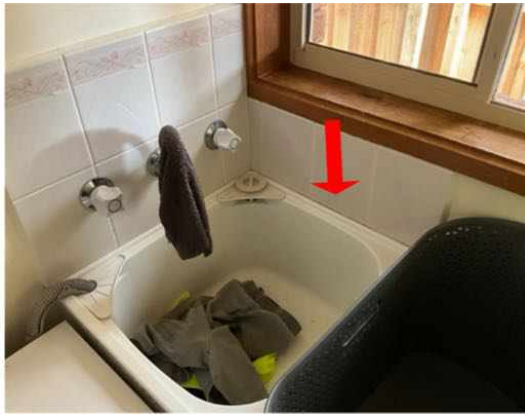
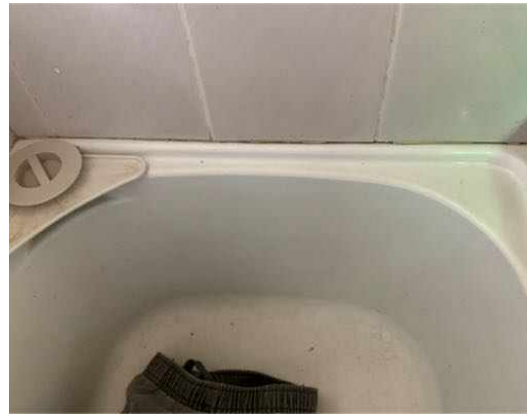
Finding 3.10

Building:	Main Building
Location:	Laundry
Finding:	Grout - Deteriorated
Information:	Grout was found deteriorated in this area. Grout is used to protect gaps and crevices in building materials to ensure that they are water-tight and prevent water penetration to the associated structures.

Where grout is missing or deteriorated, a tiling contractor should be appointed immediately to apply grout and re-apply any silicone where necessary. Failure to do so

is likely to lead to water damage to the surrounding area.

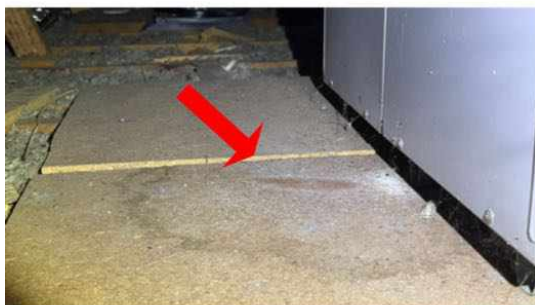
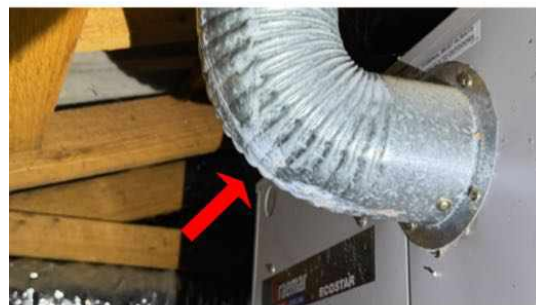
Finding 3.11

Building:	Main Building
Location:	Roof Void
Finding:	Water Staining to Flue Pipe
Information:	Water staining was observed on the flue pipe and on the surrounding surfaces beneath it during the inspection. This may be indicative of a current or previous water leak, potentially originating from roof plumbing, flashing defects, or condensation around the flue penetration.

If the issue is ongoing, it may lead to further moisture-related damage, deterioration of surrounding materials, and potential mould growth over time.

It is recommended that a licensed plumber or roofing contractor be engaged to inspect the area, identify the source of moisture, and carry out necessary repairs. The affected area should be monitored, and further investigation may be required if the issue persists.

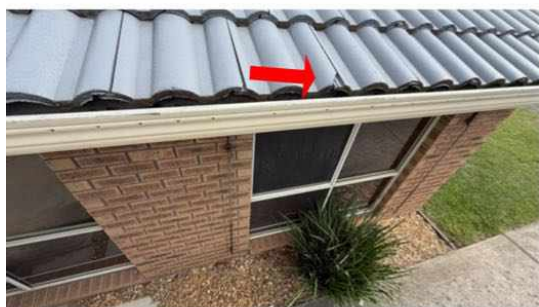
Finding 3.12

Location: Roof Exterior
 Finding: Roof tile - Broken
 Information: Upon inspection of the exterior roof covering, broken roofing tile was identified. Broken and friable roof tiles are generally the result of ageing and weathering of what is essentially a porous material.

If left to further deteriorate, broken and brittle roof tiles are likely to lead to water penetration via the roof into the ceiling space, causing secondary damage to ceiling linings, insulation and roof structures. Broken roof tiles are also likely to detract from the effectiveness of the roof drainage system, creating potential for secondary damage to the exterior roof covering and roof plumbing.

Replacement of broken tiles is required and should be performed by a roofing contractor as soon as possible.

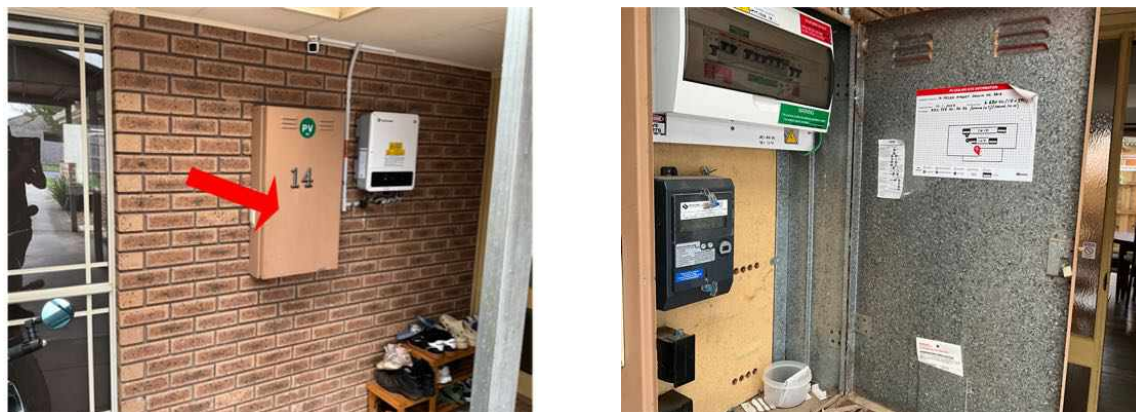
Building: Main Building
 Location: Meter Box
 Finding: Termite Management System - no evidence of a chemical installation
 Information: The application of a post-construction chemical termite barrier is highly recommended for all properties, particularly if live termite activity has been found on the site previously. Such barriers are highly effective in preventing termite attack on any timber

The client may consider gaining further advice from a pest controller as to the costs and procedures involved with this application. It is recommended that obtaining such advice be a short-term priority.

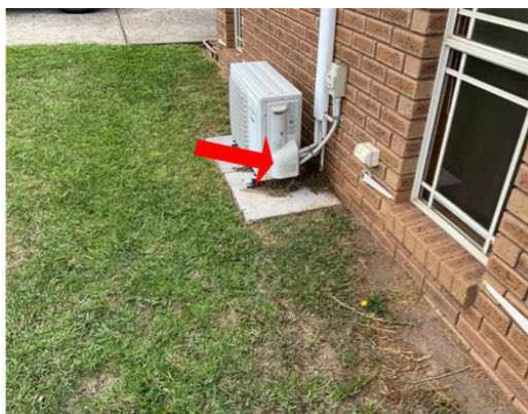
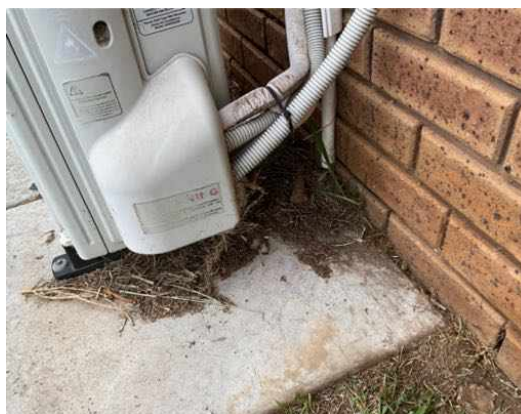
Finding 6.02

Building:	Main Building
Location:	All External Areas
Finding:	Air conditioner - Disconnected overflow
Information:	The Air Conditioner (A/C) overflow was found to be disconnected from storm water drainage and is creating excessive moisture in the surrounding area.

Such leaking creates an environment which is conducive to an array of defects, including water damage to associated building elements and the attraction of termite or timber pest infestation.

It is highly recommended that a licensed plumber be appointed to connect the A/C overflow in order to prevent such an environment from being created. These minor works should be carried out as soon as possible.

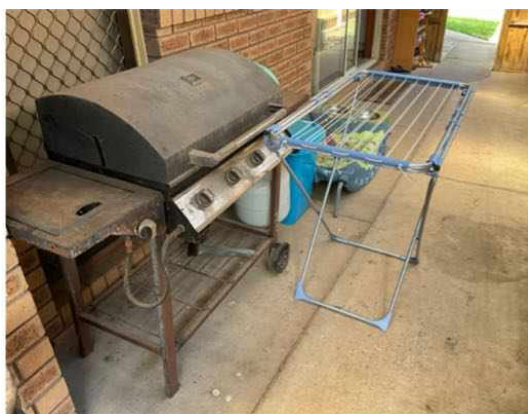
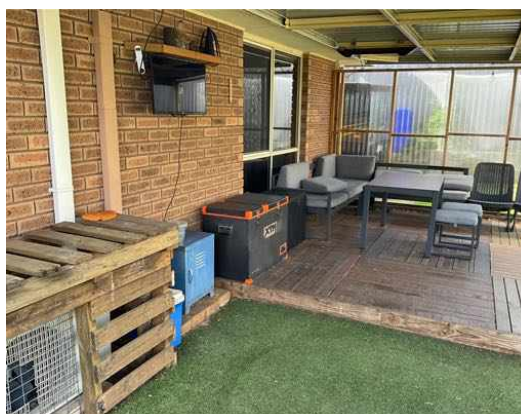
Finding 6.03

Building:	Main Building
Location:	All External Areas
Finding:	Bridging - Attachments to Buildings
Information:	Bridging occurs when items against a building provide a concealed entry point for termites into the building or by passing around a termite management system.

Building attachments of this nature need to be frequently inspected for termite activity by a qualified inspector.

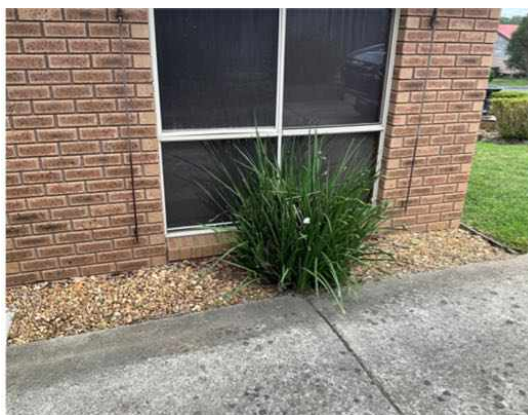
Finding 6.04

Building:	Main Building
Location:	All External Areas
Finding:	Garden Beds - Conditions Conducive to Termites
Information:	Garden beds were found to be evident in the garden area. These garden beds can include untreated timber, and with a combination of moisture from watering hosing

can make conditions conducive to termite activity and termite ingress.

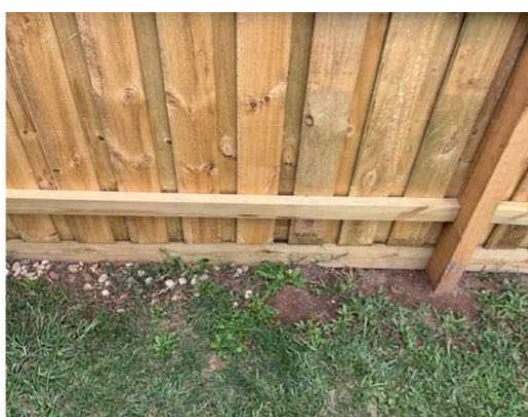
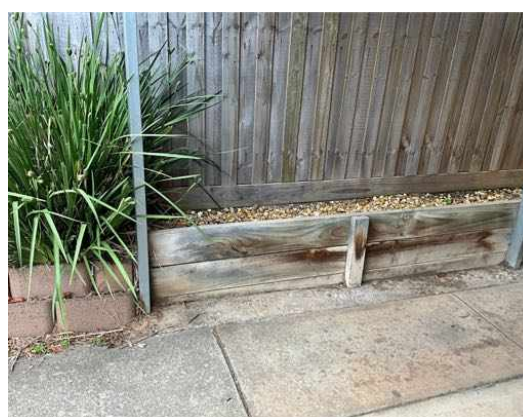
Finding 6.05

Building:	Main Building
Location:	All External Areas
Finding:	Building materials in direct ground contact - conducive to termites
Information:	Where timber elements are in direct contact with the ground and consequently moisture or dampness they become conducive to termite activity. Whether timber is used as a building element part of a fencing structure or stored as an unused item they can provide an environment that is attractive to termite infestation.

When met with excessive moisture timber begins to decay and develop wood rot. Any timbers that are in direct contact with external grounds especially if left untreated or non-durable also provide ingress for subterranean termites into that particular element.

The removal of any such materials that may be conducive to termite activity should be removed as soon as possible to minimise the risk of termite attack.

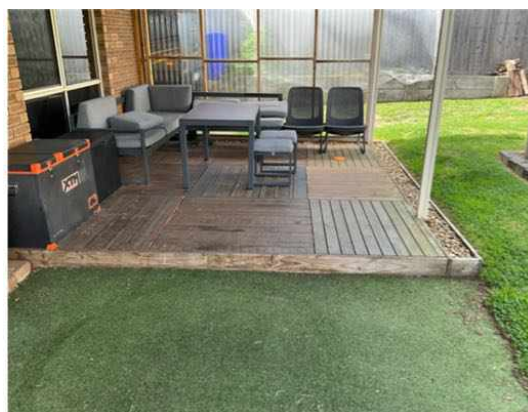
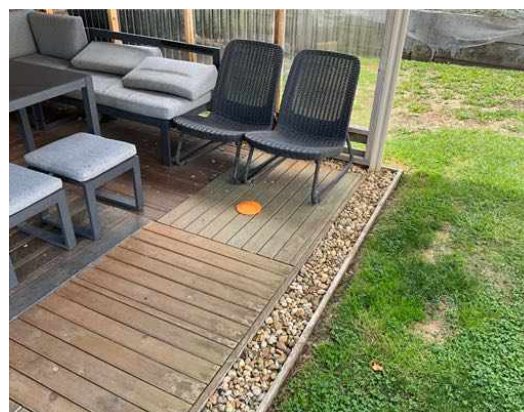
Finding 6.06

Finding: Ground level deck - conducive to moisture and timber decay
 Information: The ground level deck can be conducive to timber pest infestation due to its close proximity to the soil. Without proper precautions, the moisture in the soil can create an ideal environment for timber decay and other termites to thrive. Regular inspection and treatment can help prevent infestation and protect the decks structural integrity.

An invasive inspection of the area is recommended to determine further actions.

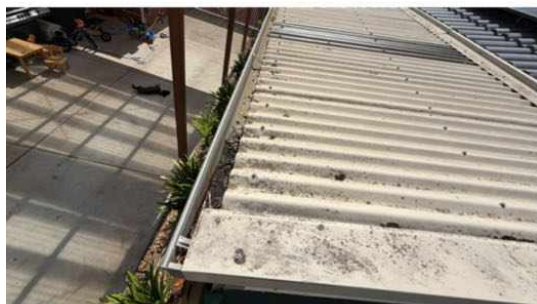
Finding 6.07

Building: Main Building
 Location: Roof Exterior
 Finding: Gutters - Partially Blocked - Timber Pest Risk
 Information: During the inspection, debris accumulation was noted in the guttering and downpipes. Blocked gutters can cause water to pool and overflow, leading to excessive moisture around eaves, fascia boards, and exterior walls. Where gutter guards are installed, regular maintenance is essential to remove any debris that may settle on top or filter through. Prolonged exposure to moisture in these areas creates conditions conducive to timber decay and potential termite or timber pest activity.

Excess moisture resulting from blocked gutters can accelerate timber deterioration, increasing the risk of fungal decay and attracting timber pests such as termites. Moisture-damaged timber is highly susceptible to infestation, as pests are drawn to damp and softened wood. If left unaddressed, this issue can lead to structural weakening and costly remediation work.

It is strongly recommended that all blockages in the gutters and downpipes be cleared immediately to maintain dry conditions and reduce the risk of timber pest activity. Homeowners or a general handyperson can perform routine cleaning; however, a licensed plumber should be consulted for further assessment and any necessary remedial work. Ongoing gutter maintenance is crucial in preventing future moisture-related timber issues.

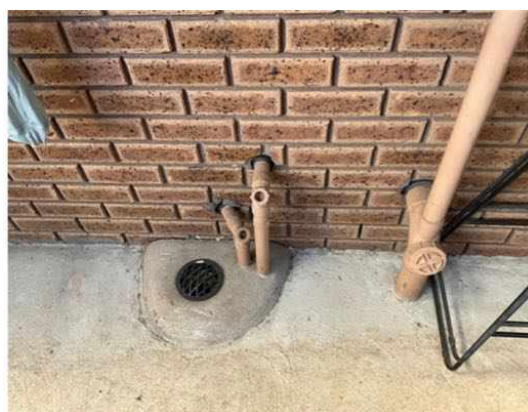
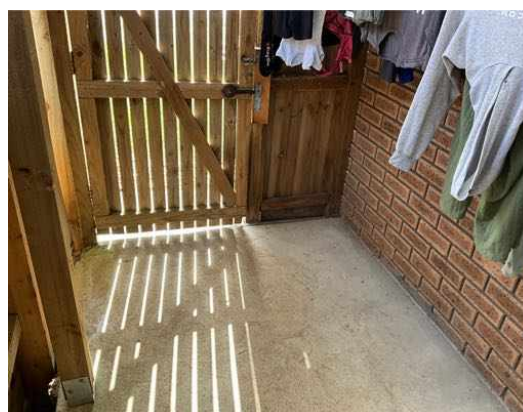
Finding 6.08

Building: Main Building
 Location: All External Areas
 Finding: Slab Edge - Exposure
 Information: An inspection zone of at least 75mm in relation to the exposed slab edge, between the bottom brick and the perimeter pavement, is required. This inspection zone should be maintained in order to force termites into the open where they can be detected more readily during regular inspections. The slab edge should not be concealed by anything that may prevent inspection of the area, including render, landscaping, soil, turf, paving, concrete cladding or other structures.

Where the slab edge cannot be properly inspected, it is highly recommended that termite or timber pest inspections be carried out every 6-12 months to aid protection of the property against infestation.

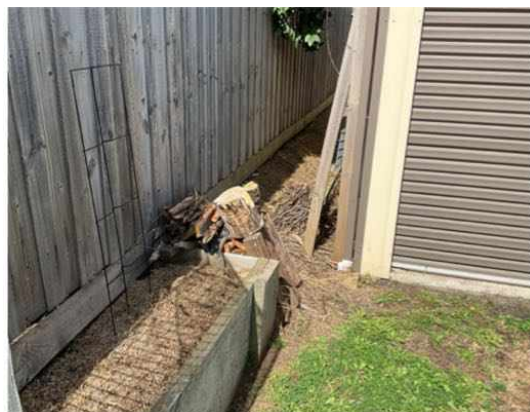
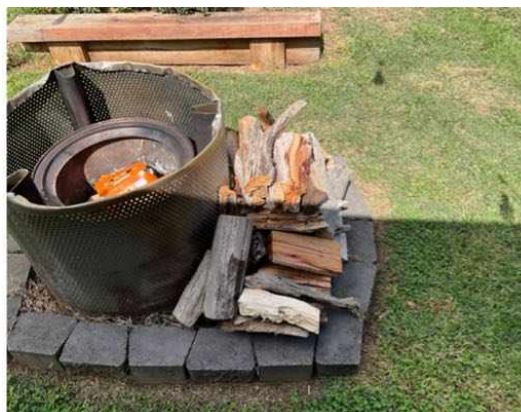
Finding 6.09

Finding: Stored timbers - external area
Information: The storing of timbers in the external property increases the risk of termite activity being present. As they are likely to come into contact with weather conditions or excessive moisture wood rot is likely to develop on timbers that are not treated.

It is highly recommended that any stored timbers be immediately removed from areas in which they may attract any termite / timber pest attack. Minimisation of risk / prevention of termite attack is far more adequate than dealing with the presence of termite activity.

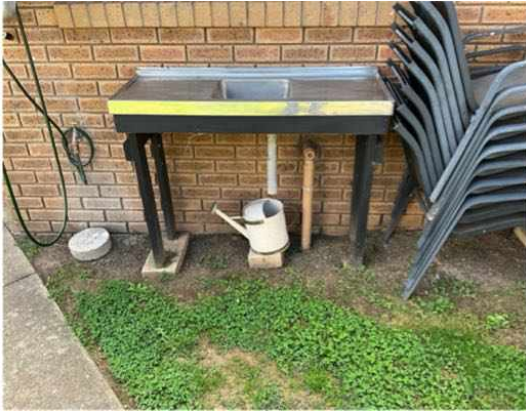
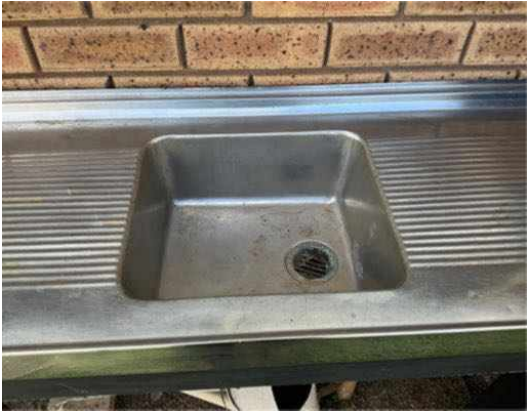
Noted Item

Building: Main Building
 Location: Exterior walls - rear
 Finding: External Sink Incomplete Installation
 Information: An external sink was observed without a tap connection and lacking a drainage outlet during the inspection. This indicates that the installation is incomplete or non-functional.

In its current state, the sink cannot be used and may allow water to accumulate if connected improperly in the future, potentially leading to localised dampness or unsanitary conditions.

It is recommended that a licensed plumber be engaged to complete the installation, including provision of a suitable tap connection and compliant drainage to the stormwater or sewer system as required.
