Building and Timber Pest Inspection Report

Inspection Date: Tue, 17 Mar 2026

Property Address: 24 Alinta Promenade, Jordan Springs NSW
2747

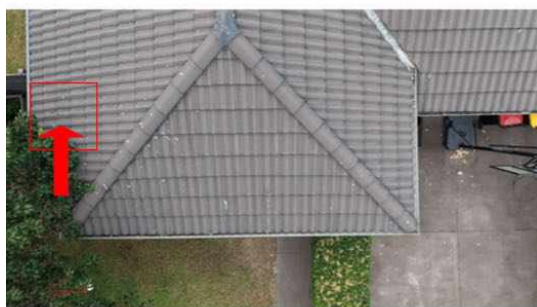
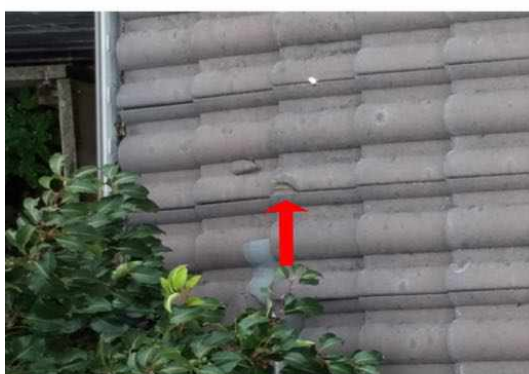
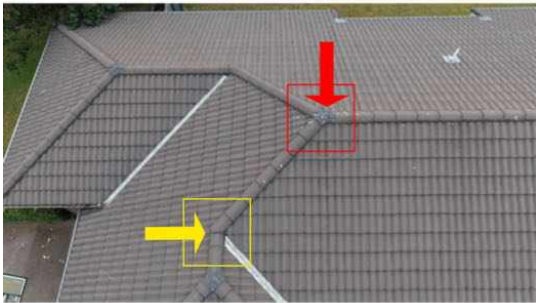
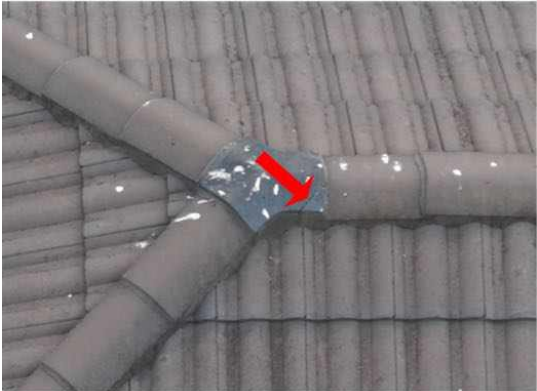
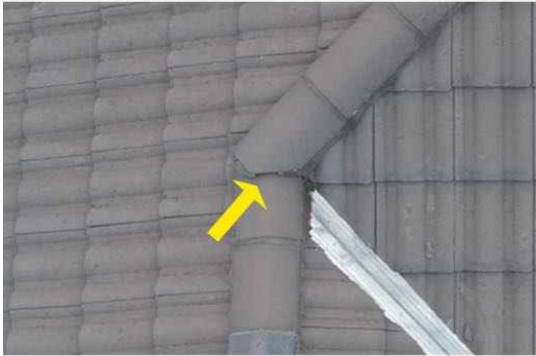
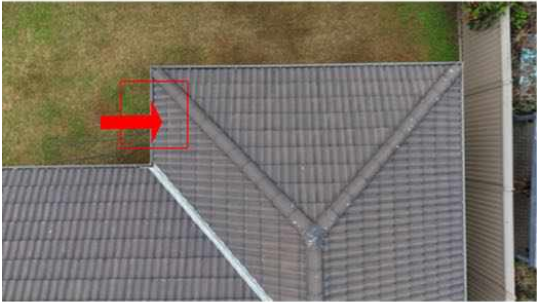
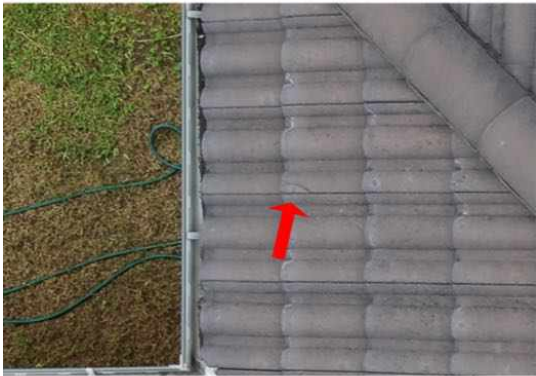
Roof tiles were generally adequately fixed and aligned, with no loose or displaced tiles observed at the time of inspection. Localised chipped tiles and wear to some crown capping were noted.

Ridge and hip cappings were generally intact, with bedding and pointing in serviceable condition overall. However, localised cracking and minor deterioration of mortar bedding and pointing were observed.

The concrete tiled roof covering was observed to be in generally sound condition, with no evidence of active leaks at the time of inspection. The overall installation appears serviceable; however, minor defects were identified, including localised tile damage and deterioration to ridge capping mortar.

Maintenance works, including replacement of damaged tiles, repointing of ridge and hip cappings, and routine cleaning of gutters and valleys, are recommended to maintain the roof's weatherproofing performance and extend its serviceable life.

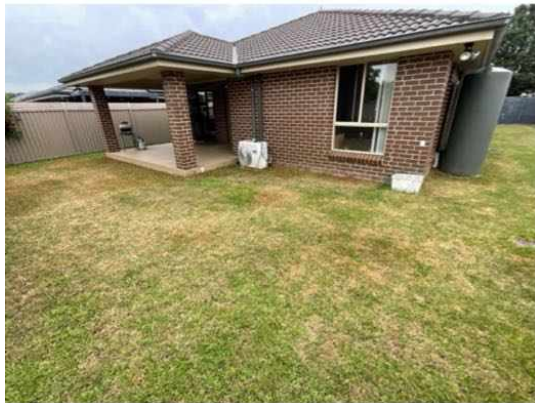
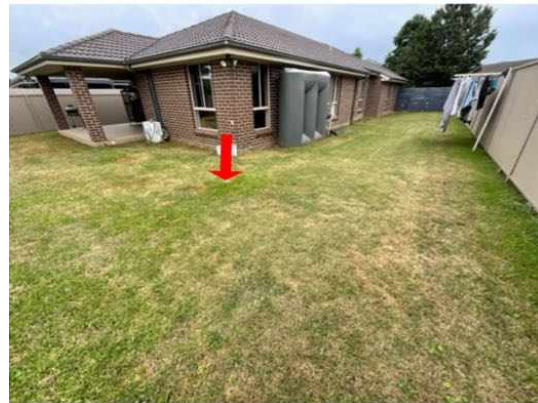
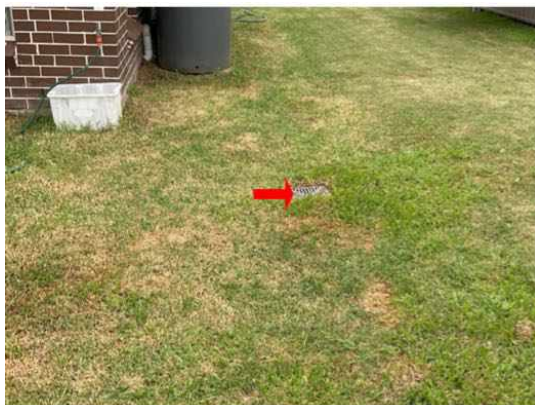
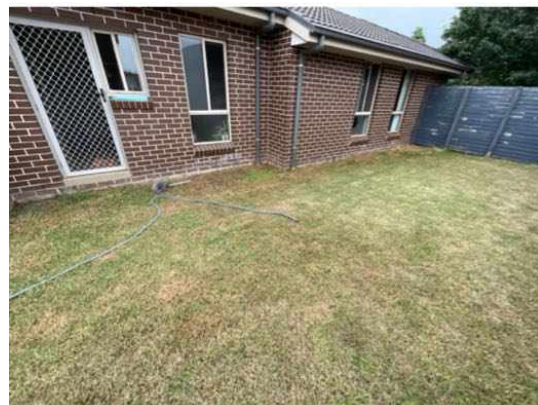
Finding 3.02

Building: Main Building
Location: All External Areas
Finding: Inadequate Site Drainage / Ground Levels Sloping Toward Dwelling.
Information: Observation:

Ground levels at the front of the property were observed to slope toward the house, rather than away from it as required for effective surface water drainage. A surface drain has been installed to collect runoff; however, this arrangement is not effective due to incorrect slope or fall.

from the structure, with finished ground levels falling at least 50–75 mm over the first metre away from the building. The current configuration, where the drainage point is positioned too high, increases the risk of moisture pooling around the house, foundation movement, or dampness to subfloor and wall areas.

If left unrectified, poor site drainage may result in water ponding near footings or slab edges, potentially leading to structural settlement, moisture damage, or rising damp issues over time.

It is recommended that a landscape contractor in consultation with a licensed plumber review the site grading and surface drainage layout. Works should be undertaken to ensure all surface water drains away from the building, and that drainage points are rectified.

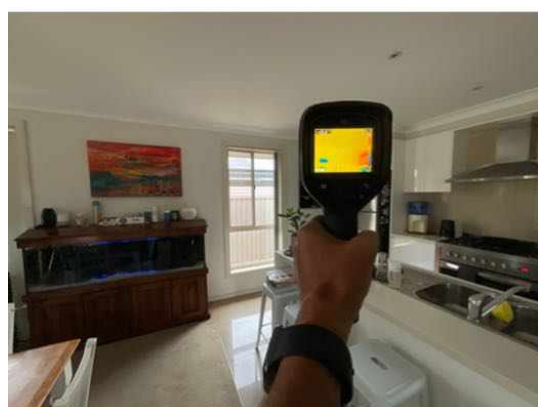
Termites release heat in the form of carbon dioxide and build mud tubes with high moisture content, which can create irregular heat patterns on surfaces such as walls, ceilings, and floors.

At the time of the inspection, no abnormalities indicating live termite activity were observed. However, it's important to note that various factors—such as obstructions, ambient temperature, and wall material/thickness—can impact the accuracy of thermal readings. In cases where surfaces are visually restricted or obstructed, a comprehensive thermal scan may not always be feasible.

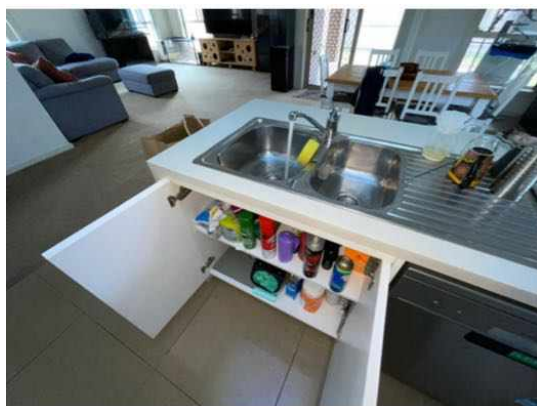
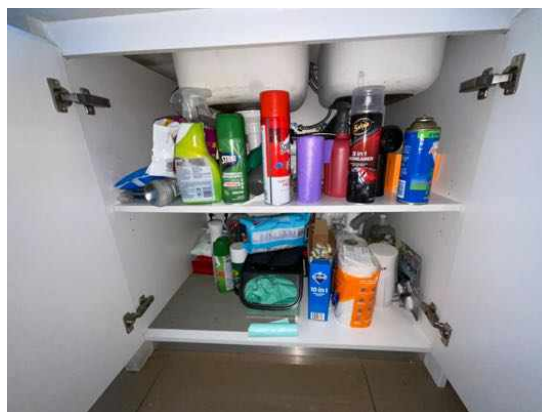
Building: Main Building
Location: Kitchen
Finding: Kitchen Sink – Overall Condition & Recommendations.
Information: Observations:

- Further monitoring and testing are recommended once the tap(s) are in constant use, to identify any drainage issues or signs of slow leaks not evident during the limited inspection.
- It is recommended that the stored items beneath the sink be removed to allow for a full re-inspection of the plumbing and cabinetry, ensuring no concealed defects are present.

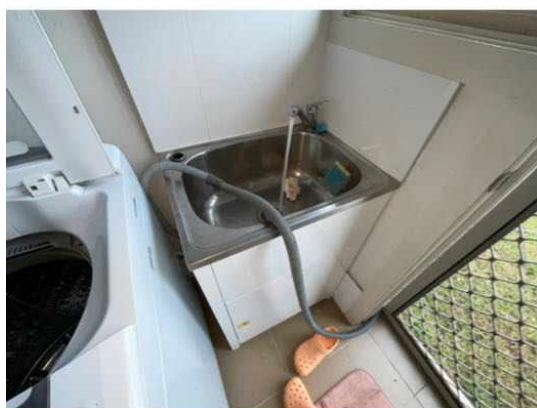
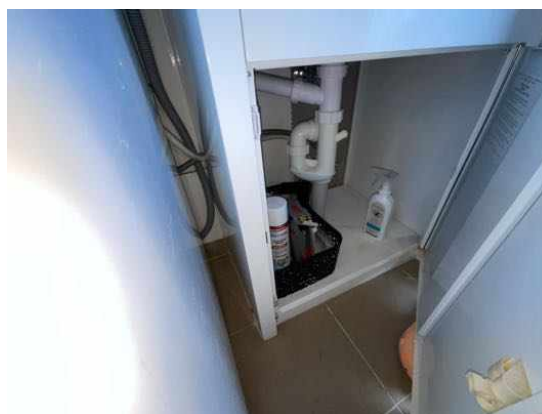
Building: Main Building
 Location: Laundry
 Finding: Laundry - Taps/Plumbing/Drainage.
 Information: Observation: Laundry Tub – Taps, Plumbing, and Cabinetry

- Further monitoring or testing is recommended once the taps are placed into regular use, to ensure no leaks develop over time and that the drainage system continues to perform adequately.
- Sealant and grouting in wet areas should be maintained as part of the long-term care and upkeep of the property.

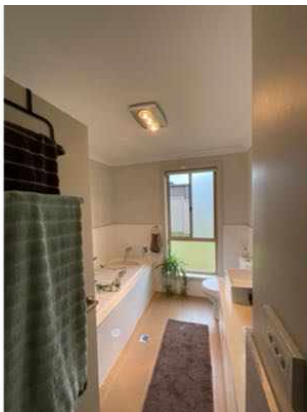
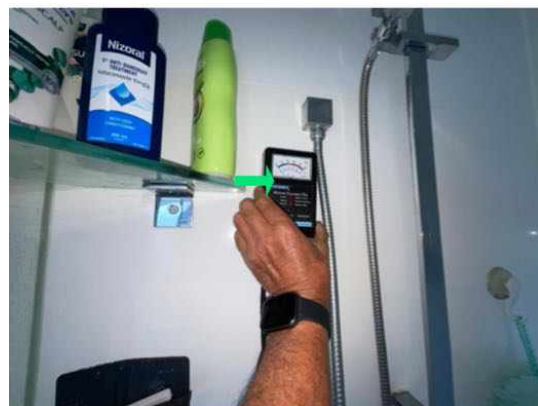
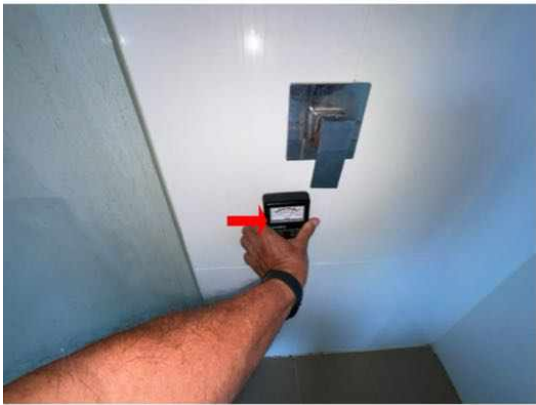
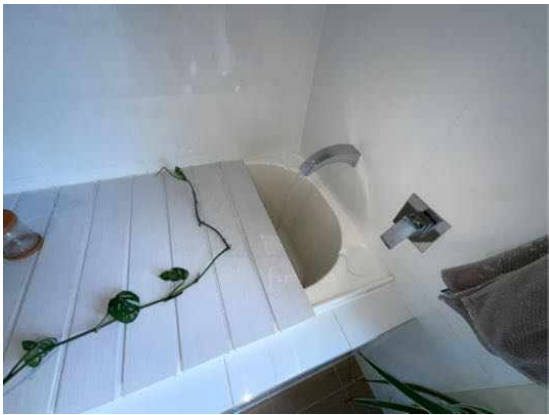
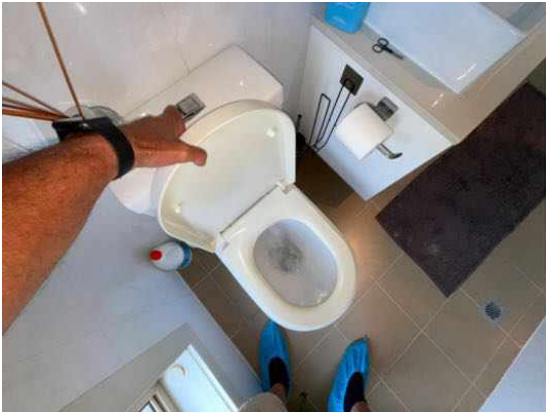
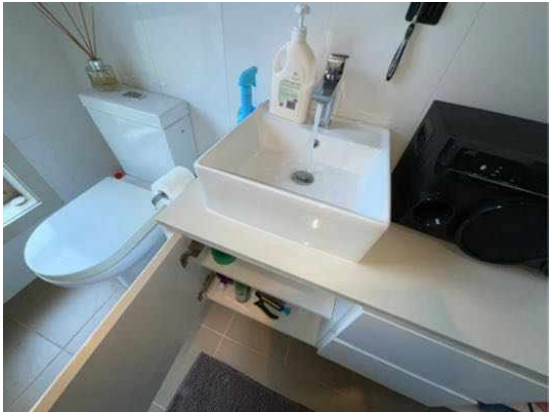
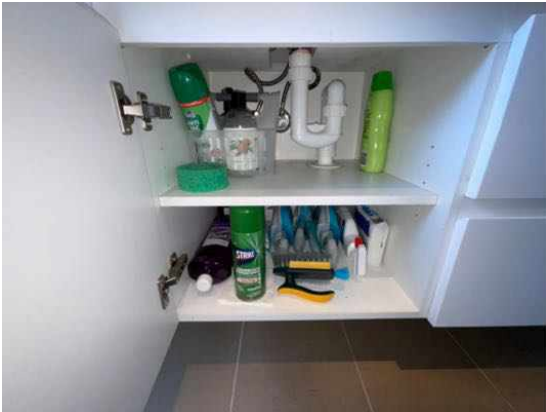
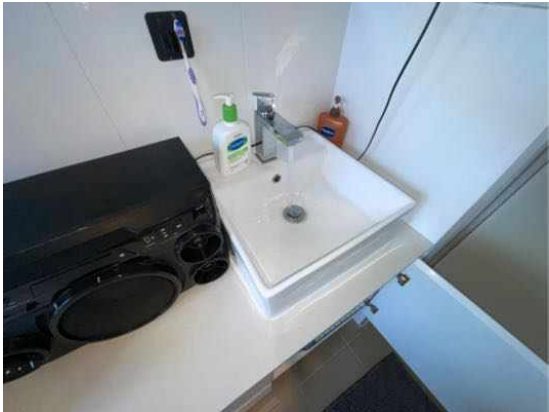
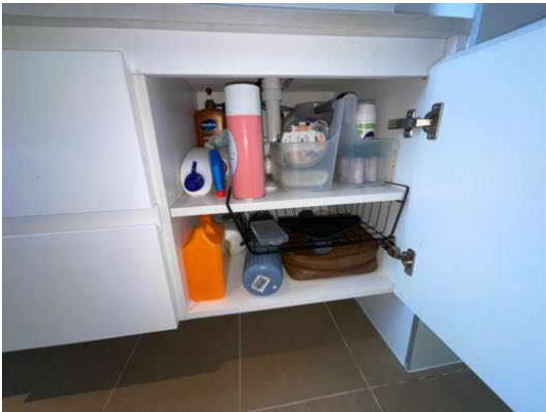
Building: Main Building
Location: Bathroom
Finding: Wet Areas - Bathroom(s) - Overall Condition & Recommendations.
Information: Overall Condition & Recommendations

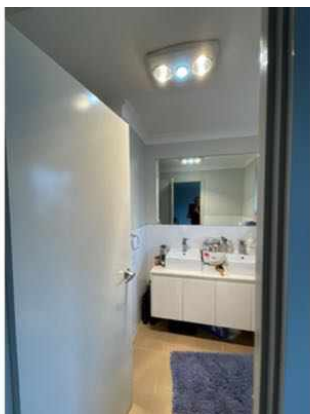
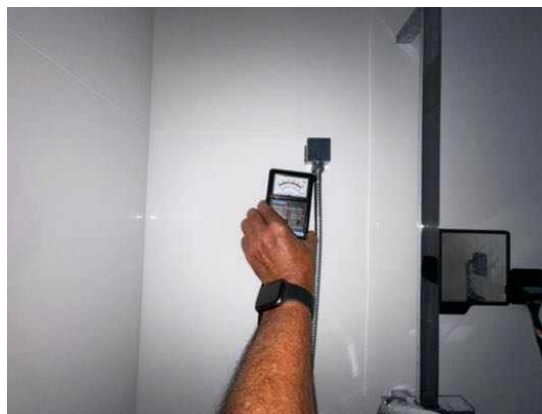
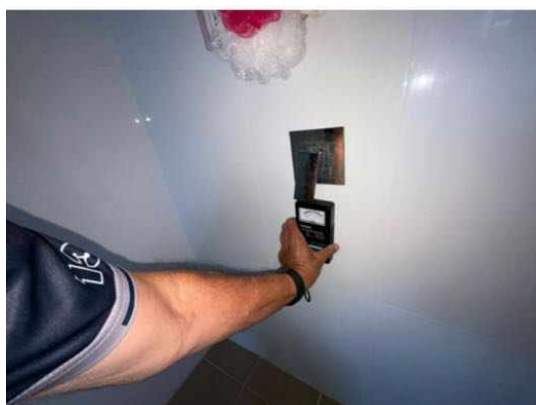
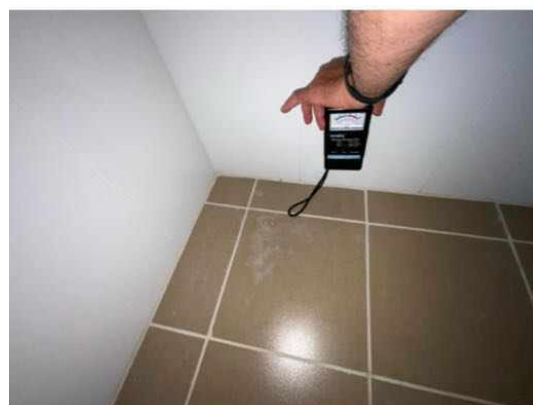
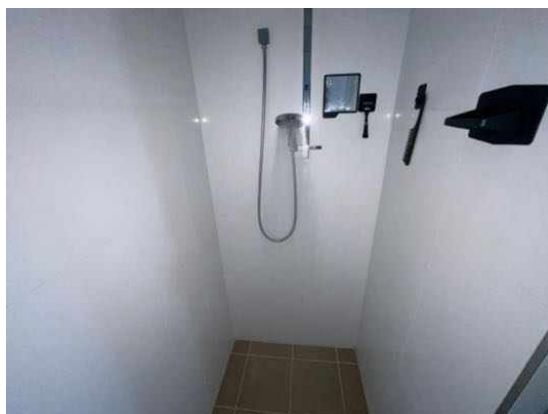
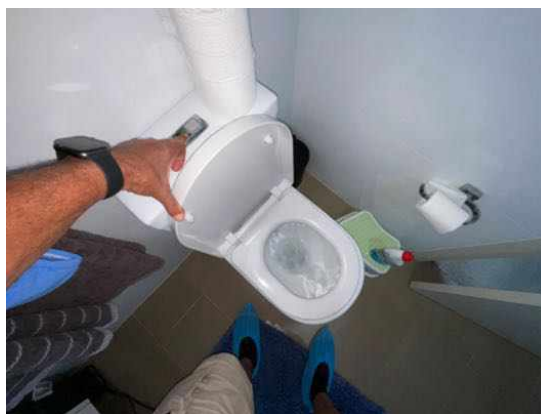
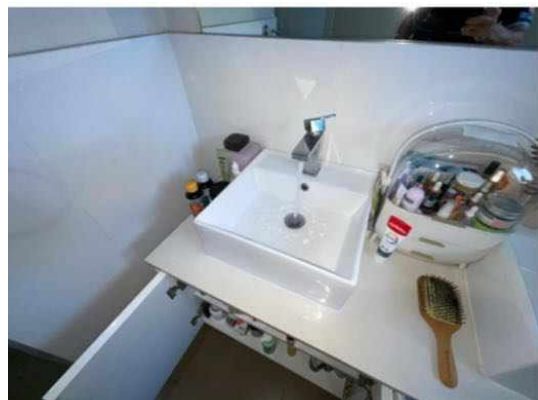
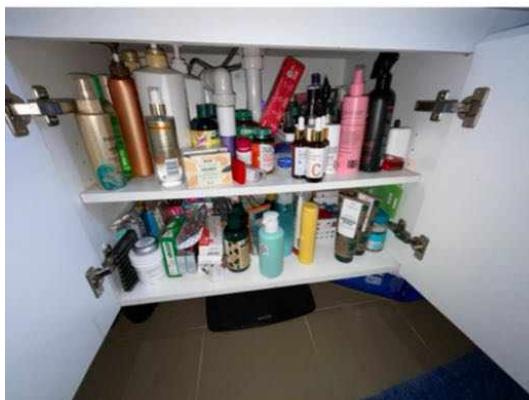
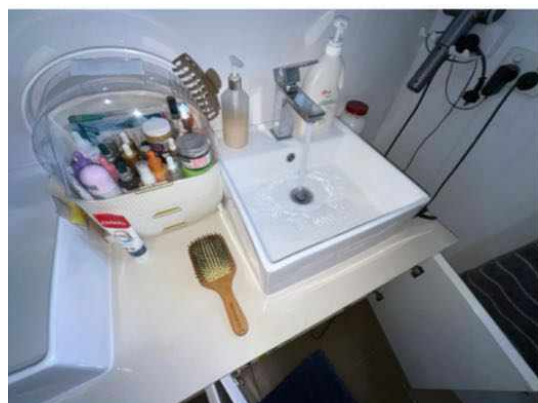
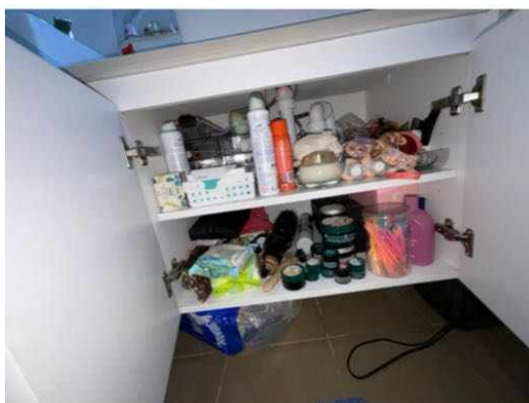
Building: Main Building
Location: Ensuite
Finding: Wet Areas - Bathroom(s) - Overall Condition & Recommendations.
Information: Overall Condition & Recommendations

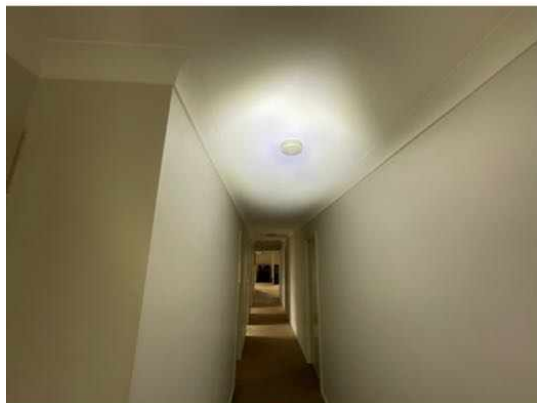
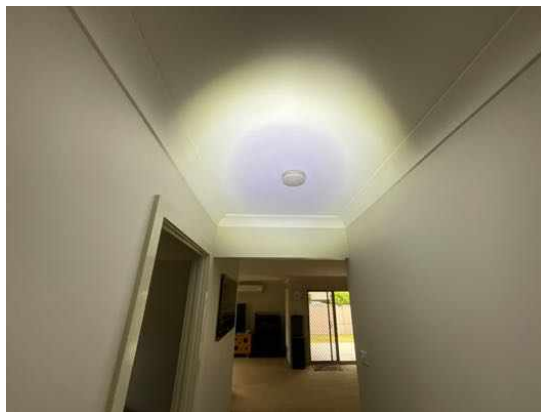
Building:	Main Building
Location:	All Areas
Finding:	Smoke Detectors / Alarms.
Information:	Reporting on the presence, type, location, or compliance of smoke detectors or alarms, including hard-wired smoke detection systems and their legislative requirements, is outside the scope of this inspection report.

- All smoke detectors be tested monthly by the homeowner.
- All systems comply with the requirements of AS 3786 and any applicable state-based legislation.
