# Building and Timber Pest Inspection Report

Inspection Date: Fri, 6 Mar 2026

Property Address: 7 Karoola St, Busby NSW 2168, Australia

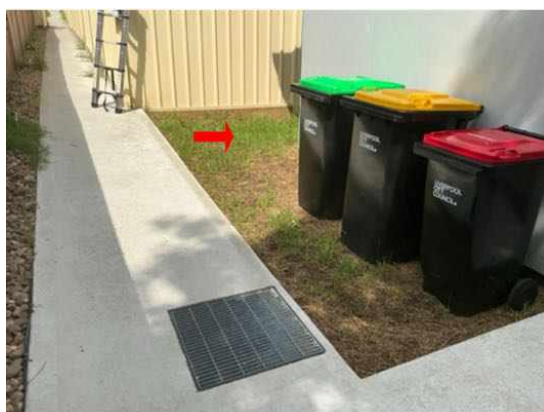
Location:	Granny Flat
Finding:	Site drainage - Inadequate
Information:	The site drainage was found to be inadequate at the time of inspection, creating potential for subsequent water damage to associated building elements.

It is important that water does not lie against the base of walls; surrounding paths and ground levels should be sloped to drain water away from walls. Downpipes should not discharge stormwater onto lower walls or plinths. Stormwater should be carried away by large, regularly cleaned drains. Ground levels may need to be lowered to expose a buried DPC.

Where site drainage is inadequate, installation of an Agricultural (Aggie) Drain may be required. A qualified plumber should be appointed to further inspect the property and perform any remedial works as necessary. Water damage and secondary defects are likely to occur if left unmanaged.

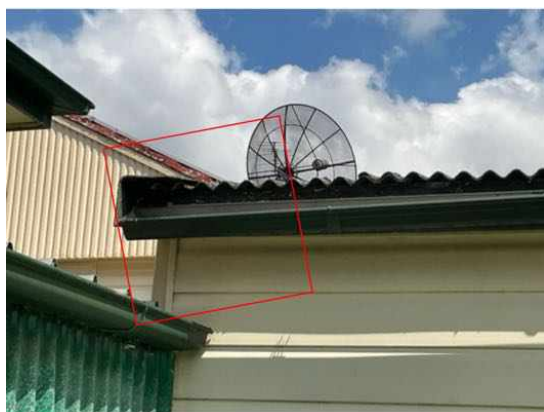
Building:	Main Building
Location:	Garage
Finding:	Gutter/Fascia Damaged/Deteriorated
Information:	Breakage and deterioration occurs generally when either the metal/timber has aged and decayed with excessive moisture, or as a result of damage (accidental or deliberate).

Repair and/or replacement of the gutter is advised to ensure that additional secondary defects do not arise as a consequence. Such works are necessary, as all building elements play a key role in the operation and function of the overall structure and its performance.

A licensed roof plumber should be appointed immediately to repair or replace the damaged gutter prior to any subsequent damage being caused.

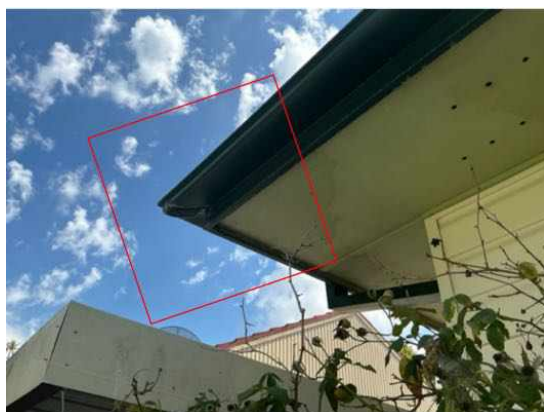
### Finding 3.08

Building:	Main Building
Location:	Exterior walls - left side
Finding:	Water leak - External (suspected)
Information:	A suspected water leak was found in this area at the time of inspection. Whilst it was

not leaking at the time of inspection there were blatant signs of water ingress. Water leaks can be detrimental to surrounding building elements; their potential causes include damage to plumbing fittings and fixtures, through to water damage and deterioration of associated building elements, as depicted in the attached photographs.

Rust, corrosion, decay and water damage are potential outcomes where a minor water leak is left unattended. More serious defects may also result, such as electrical hazards, or water damage to structural building elements.

In extreme cases, structural damage may develop due to a prolonged water leak.

It is highly advised that internal water leaks be addressed by a licensed plumber as a matter of relative urgency.

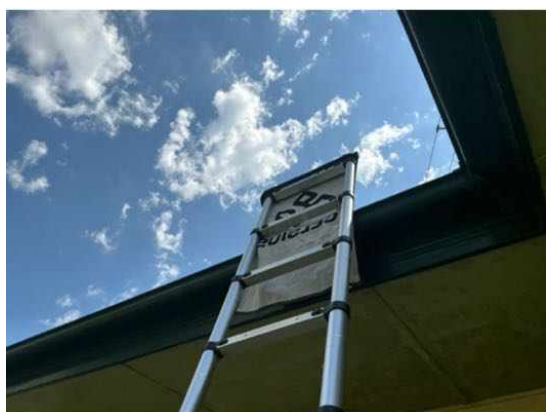
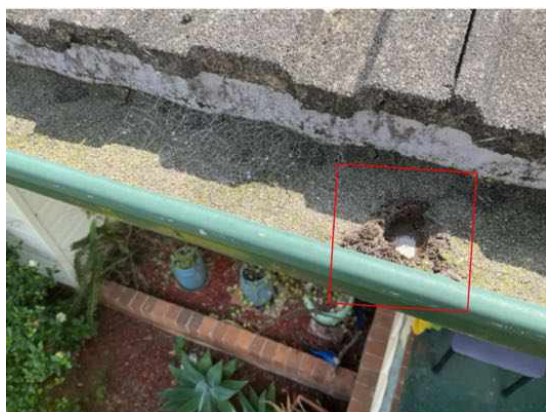
### Finding 3.09

Building:	Main Building
Location:	Roof Exterior
Finding:	Gutters - Debris
Information:	Roof plumbing structures, such as guttering and downpipes, should be free of all debris to prevent blockages. Blockages in the guttering and downpipes will lead to pooling and accumulated water overflow, which is likely to flood the eaves and exterior walls.

In addition to blockages, leftover materials in the gutters could also cause damage. These materials, if not cleared, may contribute to rust, decay, and further deterioration of the building materials. Over time, moisture buildup caused by blockages and debris can also create conditions which could lead to additional structural issues.

Blockages and debris should be removed immediately to ensure dry conditions are maintained.

It is recommended to consult a licensed plumber for specific advice on any necessary remedial works. In the interim, it is strongly advised that a general handyman clear the building material as a matter of urgency to prevent further damage.

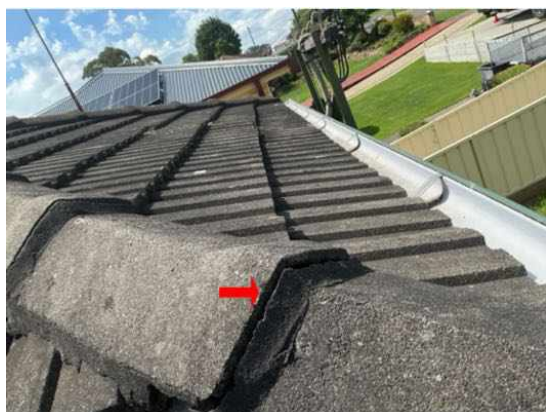
### Finding 3.10

Building:	Main Building
Location:	Roof Exterior
Finding:	Roof tiles - Weathered
Information:	Upon inspection of the exterior roofing, the majority of roof tiles were considered to be in a fair condition. While weathering of the tiles is consistent with the age of the property, maintenance works are required.

Isolated areas of mortar have come loose on the ridges and minor cracking is also present. Re-pointing and re-sealing may be considered as an interim solution by

Where left unmanaged, deteriorating roof tiles are likely to lead to a number of secondary defects, including minor water leaks and weather exposure to internal roofing structures.

Consultation with a roofing contractor is highly advised to gain advice on cost of remedial works that may be required in the short to medium term. Remedial works are likely to increase the longevity of the exterior roofing structure.

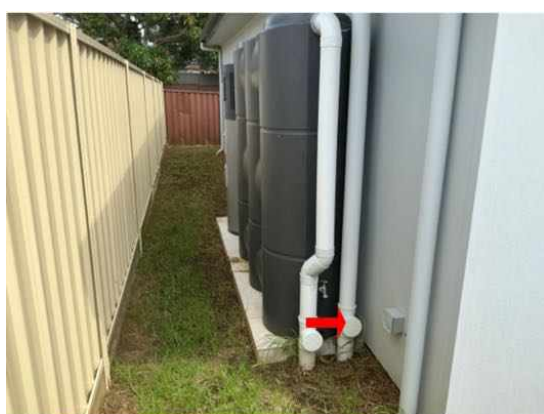
Building:	Main Building
Location:	All External Areas
Finding:	Bridging or Obstruction - Air Conditioner, Hot Water Tank
Information:	Bridging of termite barriers is a significant concern, as it occurs when termites bypass the intended protective barrier or inspection zone, often through the construction of Mud tunnels or by finding a passage that allows them to traverse the barrier undetected. This bridging comprises the effectiveness of the termite protection system and increases the risk of termite infestation entering the property in a concealed or undetectable manner, which can lead to potentially severe damage overtime.

During the inspection it was noted that certain obstructions such as an air

conditioning unit, hot water unit, storage shed, or various stored goods, impeded the clear visual inspection of the external walls and weep holes in the affected area. These obstructions create blindspots that prevent a thorough assessment of the termite barrier and the condition of the wall surfaces. The presence of such obstructions can limit the ability to detect early signs of termite activity or breaches in the protective barrier, thereby increasing the likelihood of undetected termite intrusion.

To mitigate risk it is strongly recommended that all obstructions be moved away from the external walls and weep holes to allow for a comprehensive visual inspection. This step will ensure that both current and future inspections can be conducted thoroughly, enabling the detection of any termite activity, potential bridging, or breaches in the barrier. Maintaining clear access to these areas is crucial for the continued effectiveness of the termite management system and for safeguarding the property from potential damage.

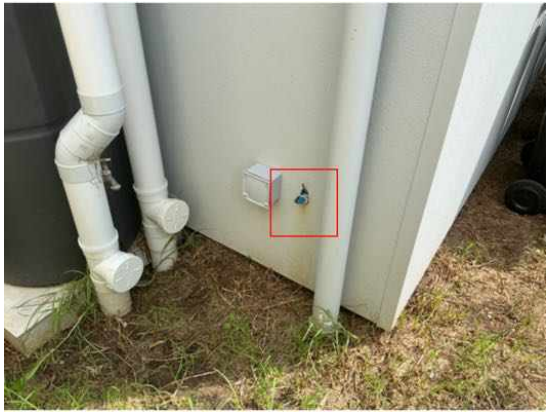
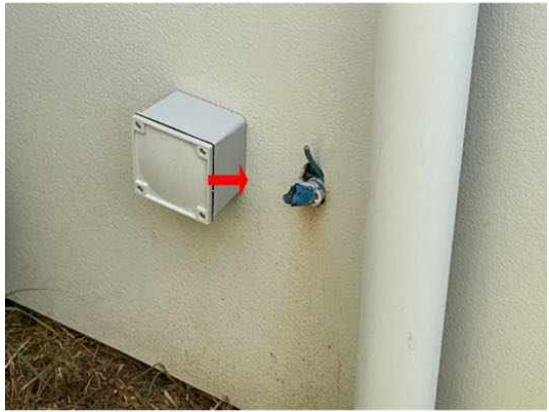
Building: Main Building  
Location: Granny Flat  
Finding: Exposed Electrical Cables  
Information: Exposed electrical wiring was identified during the inspection. This presents a potential safety hazard, including risks of electric shock, fire, or accidental contact.

It is strongly recommended that a licensed electrician be engaged as a matter of urgency to inspect, investigate, and carry out any necessary rectification works to ensure compliance with current electrical safety standards.

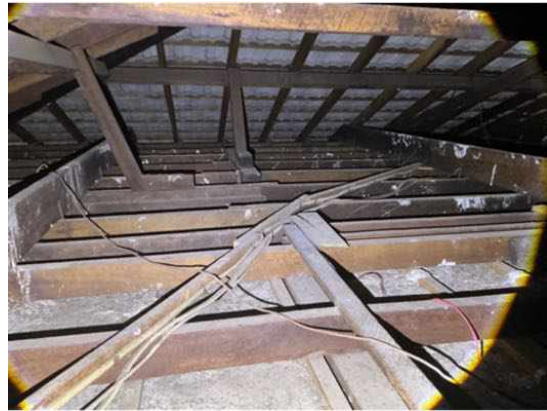
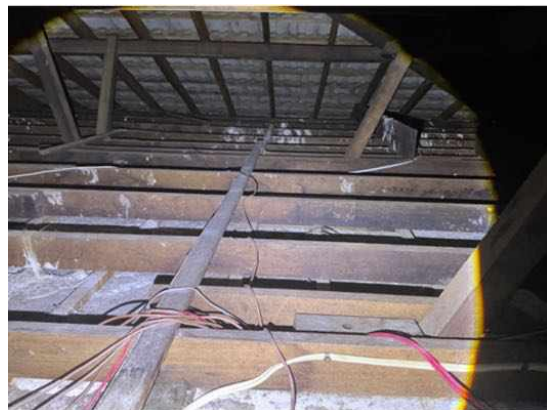
Building: Main Building  
 Location: Roof Void  
 Finding: Insulation - Inadequate  
 Information: Upon inspection of the roof void it was noted that there is a lack of adequate insulation.

Insufficient insulation will result in a comparatively higher cost to heat and cool a property as there is a lack of Insulation (or uneven coverage of insulation) which works as a barrier to heat transfer. This helps to keep out unwanted heat in summer and preserves warmth inside your home in winter. It can also help soundproof your home from unwanted airborne noise transfer.
