Building and Timber Pest Inspection Report

Inspection Date: Tue, 10 Mar 2026

Property Address: 13A Leicester St, West Richmond SA 5033,
Australia

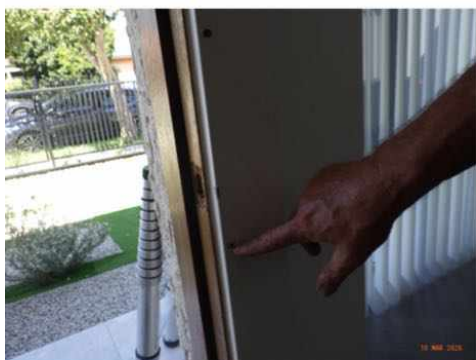
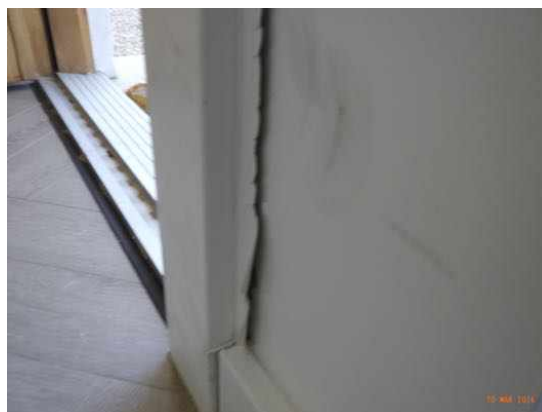
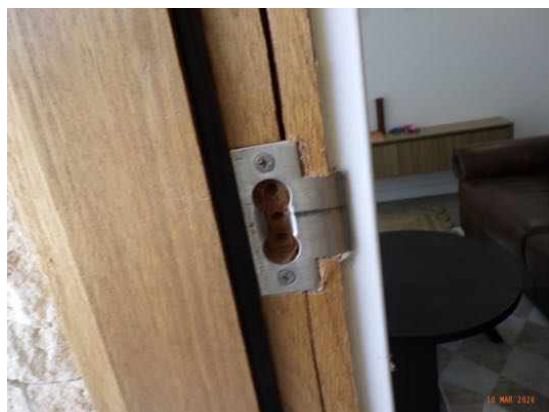
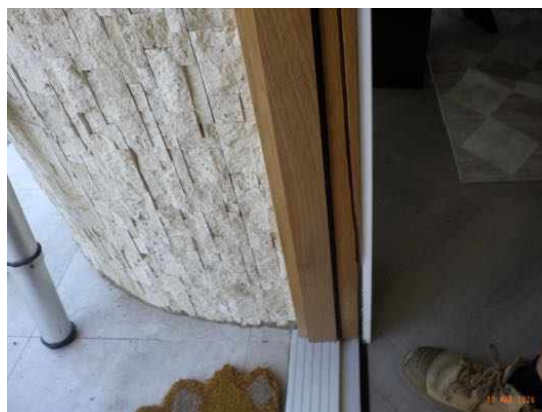
Finding 1.01

Building: Building 1
Location: Entry
Finding: Door frame - damaged
Information: Damage was evident above the front door frame likely due to break in.

Damaged elements should be replaced to ensure the safety of the property and until repaired the security of the dwelling cannot be assured.

A licensed carpenter should be appointed immediately to make relevant repairs to the area to restore safety and functionality.

It was noted by the client that the door frame and associated damage is to be repaired by the vendor prior to settlement.

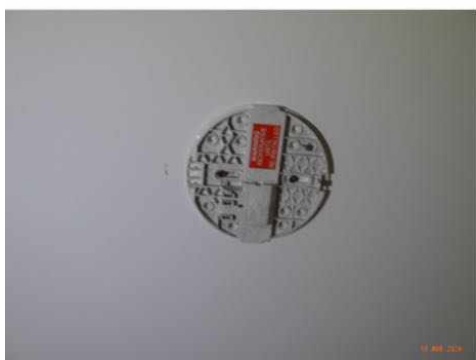
Finding 1.02

Location:	All Internal Areas
Finding:	Smoke Detectors and Alarms
Information:	Reporting on Smoke Detectors or Alarms, including hard wired smoke detection systems and their legislative requirements, is outside the Scope of this Report.

Please note that this defect is highlighted as a caution only. We suspect, based on our experience in the building industry, that the absence of smoke detectors, or their poor condition, should be addressed as a matter of urgency to improve occupant safety.

Further Inspection and/or advice is necessary to provide advice on the sufficiency, type and location of smoke detectors, and to test the functionality of all devices.

Always ensure sufficient working and suitable smoke detectors are installed prior to occupying any building. Additionally, it is advised that all smoke detectors be tested by the homeowner on a monthly basis.

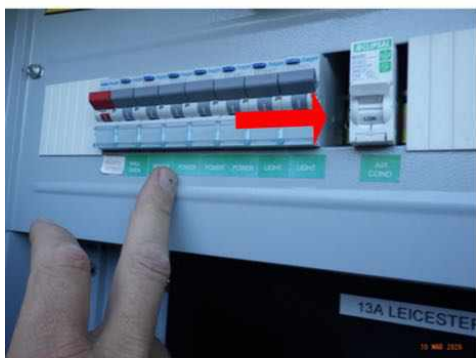
Finding 1.03

Building:	Building 1
Location:	Electrical Switchboard
Finding:	Electrical switchboard gaps
Information:	A cover plate is missing to the electrical switchboard.

This could represent a serious safety hazard and should be addressed immediately as there is potentially live circuitry exposed

As there is live electricity in the area it is recommended to have the cover plate fitted to the area immediately.

A licensed Electrician should be appointed to install these basic cover caps

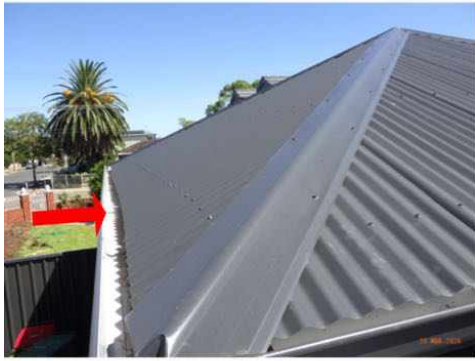
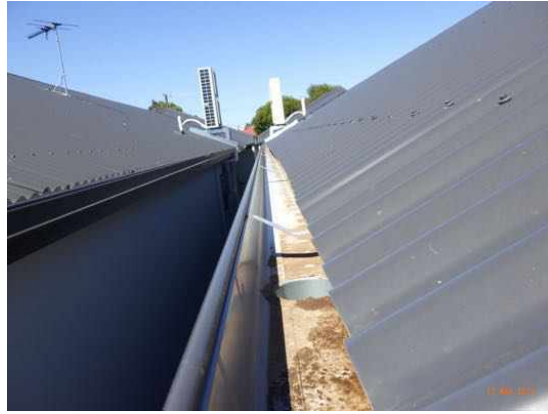
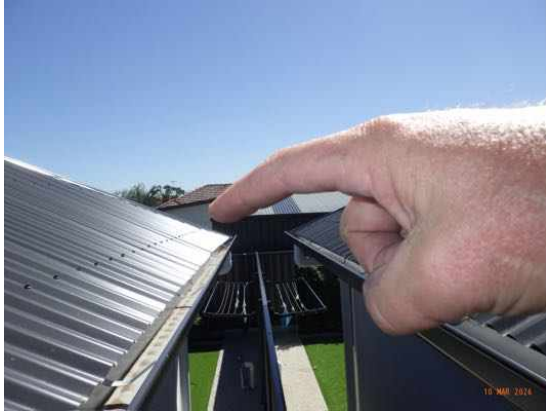
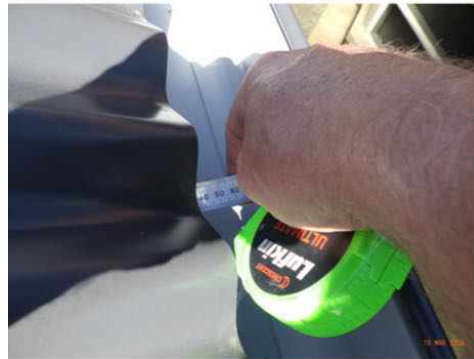
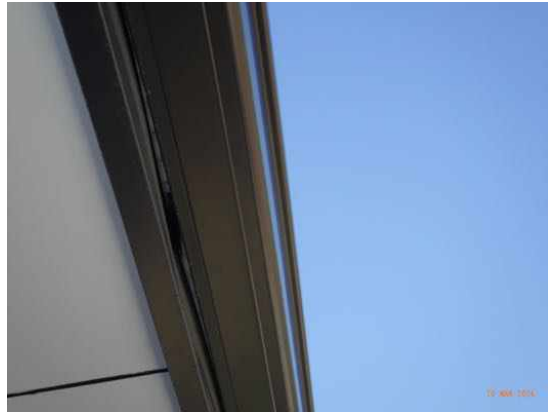
Finding 3.01

Building:	Building 1
Location:	Roof Exterior
Finding:	Exterior roof - Insufficient overhang
Information:	It was identified that there is insufficient overhang of the roofing into the guttering which is likely leading to water making its way behind the gutter which has in turn damaging the fascia which could also lead to an array of secondary related building defects.

Such defects are likely to include material deterioration, leaks and/or corrosion of associated building materials.

Over time, if this defect is not addressed further building defects will develop.

If leaking becomes apparent then consultation with a roofing plumber would be required regarding repair works.

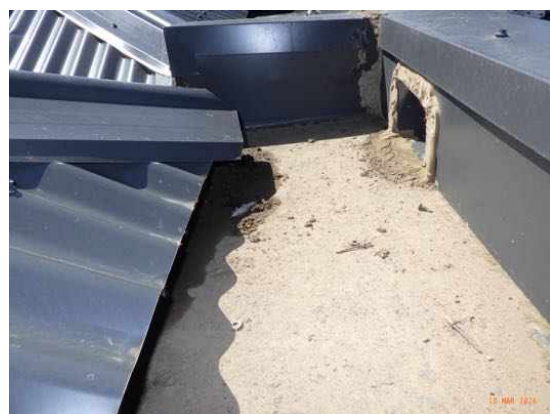
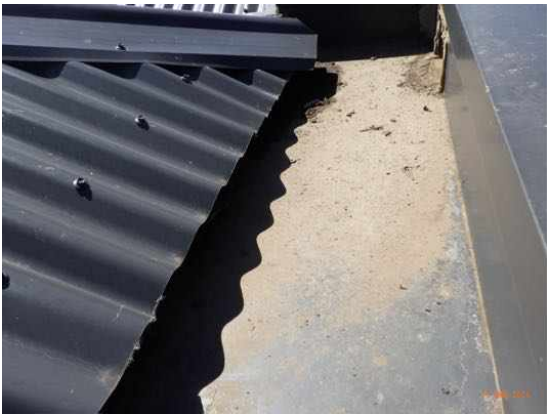
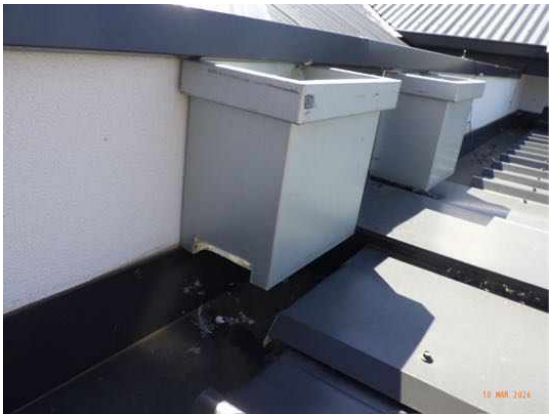
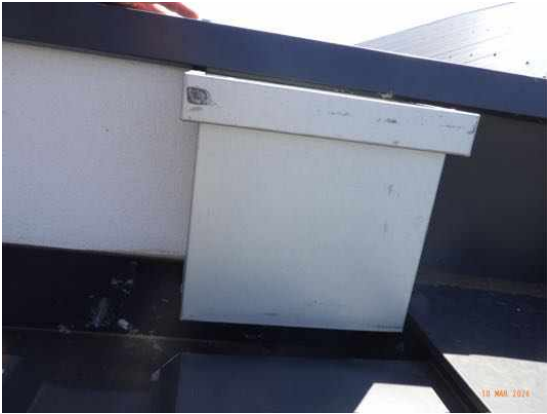
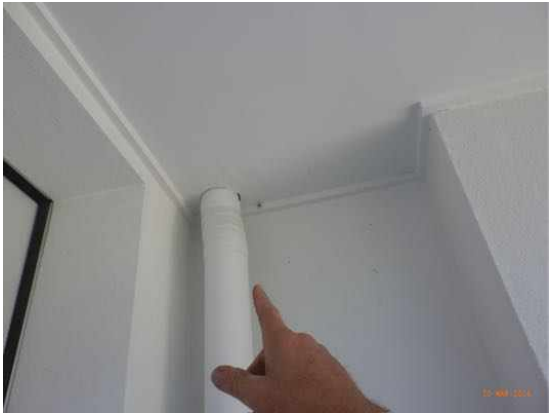
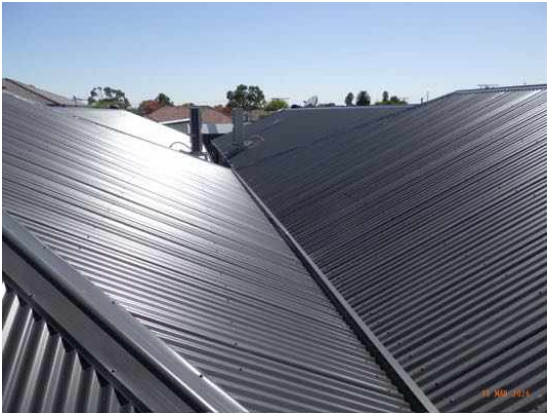
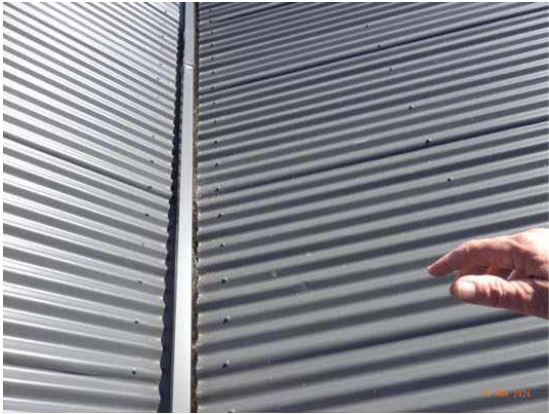
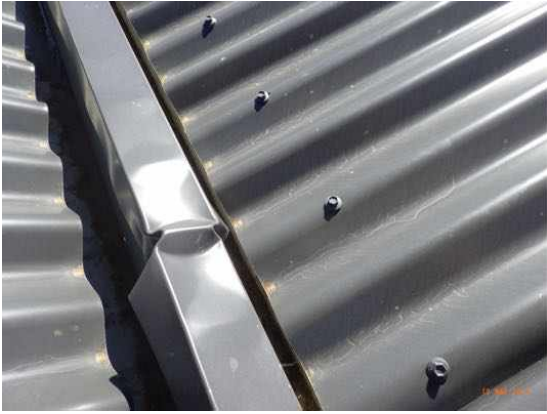
Finding 3.02

Building: Building 1
 Location: Roof Exterior
 Finding: Box gutters non compliant pre purchase.
 Information: It was noted that compliance issues exist with the box gutter system on the roof, main issues being

(b)Gutters discharge, Box gutters to discharge at the downstream end without change of direction (i.e. not to the side).

Monitoring the areas recommended and should issues arise then a licensed roofer should be appointed to give advice quotation and make repairs to ensure no leaks in the future.

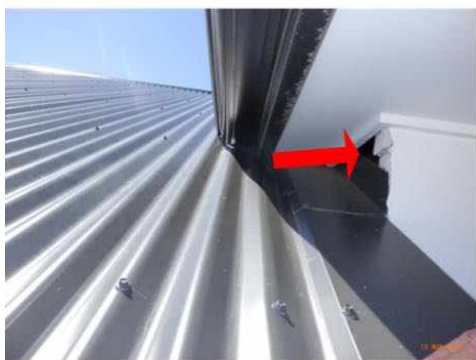
Finding 3.03

Building: Building 1
 Location: Roof Exterior
 Finding: External walls - Holes
 Information: Significant holes were identified around pipe penetrations in this wall section. It is suspected that the installation of this pipework was completed to a substandard level of workmanship or is incomplete.

Gaps and holes around pipework makes the area susceptible to insect and vermin ingress, as well as allowing water penetration to the cavity wall. As such, associated building elements are likely to deteriorate at an accelerated rate, and major implications are expected if holes around the pipework are left unmanaged.

All excessive holes, gaps or cracks should be adequately filled by a suitable sealant or trimmings as soon as possible to prevent any further damage. Such works may be conducted by a general handyperson or licensed plumber.

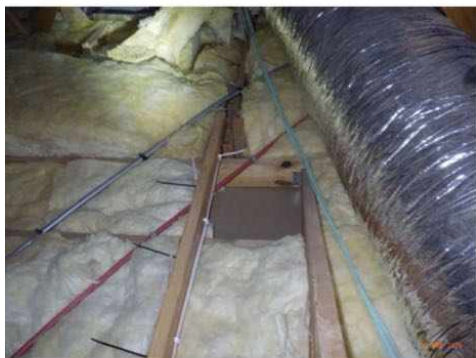
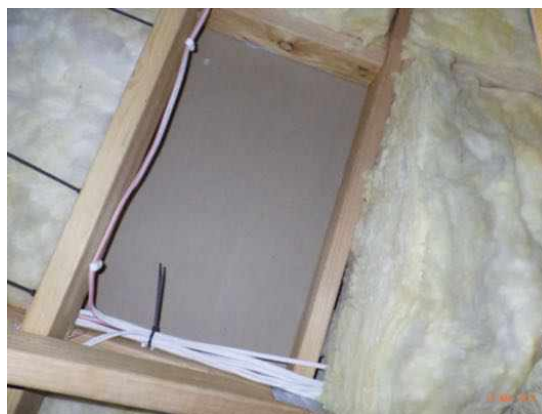
Finding 3.04

Building: Building 1
 Location: Roof Void
 Finding: Insulation - Moved PPBI
 Information: Upon inspection of the roof void it was noted that insulation has been moved likely by trades people and not replaced.

Insufficient insulation will result in a comparatively higher cost to heat and cool a property as there is a lack of Insulation (or uneven coverage of insulation) which works as a barrier to heat transfer. This helps to keep out unwanted heat in summer and preserves warmth inside your home in winter. It can also help soundproof your home from unwanted airborne noise transfer.

Where insulation is absent, the area does not meet current Australian Standards. Replacement of adequate insulation is required and should be conducted as soon as possible.

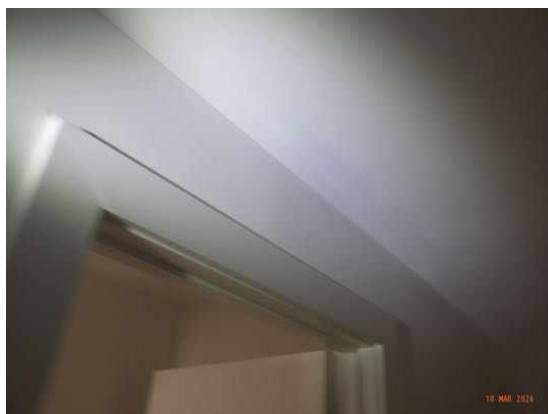
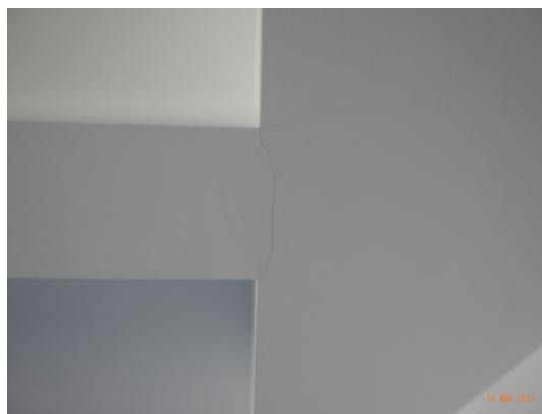
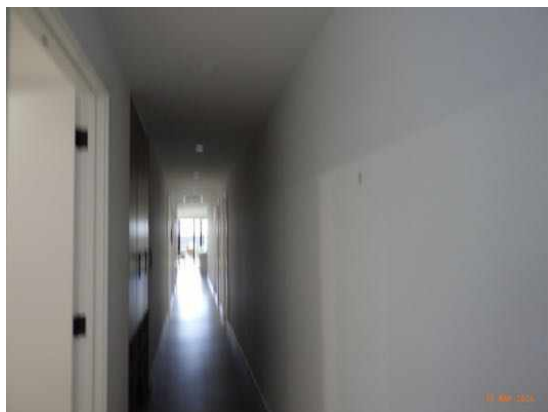
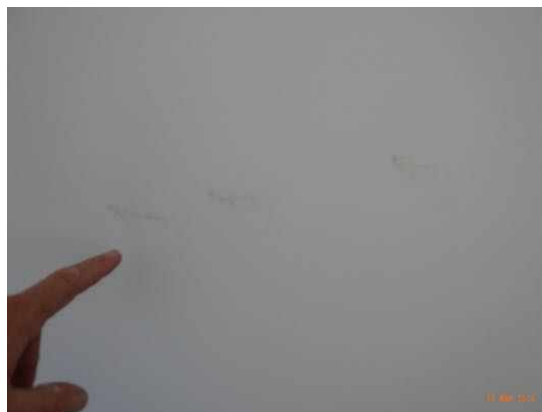
Finding 3.05

Building:	Building 1
Location:	All Internal Areas
Finding:	Cracking - Damage Category 0 - Hairline (less than 1mm)
Information:	Hairline cracks are very minor in nature and generally are only ever an appearance defect. While such cracking may be noticeable in some cases, it is quite common and does not indicate any structural damage.

These hairline cracks are likely exacerbated by the fact that no expansion joints or articulation joints have been provided to the long run of Plasterboard flowing down the hallway.

Cracking of this nature can generally be repaired with minor sanding, filling and/or repainting. Such works should be performed by a qualified painter or a qualified plasterer. The installation of articulation joints could help prevent further movement in the future.

Monitoring of all cracking should be conducted frequently. Always contact a building inspector should cracks widen, lengthen, or become more numerous.

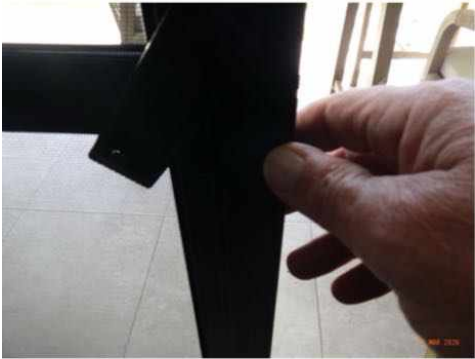
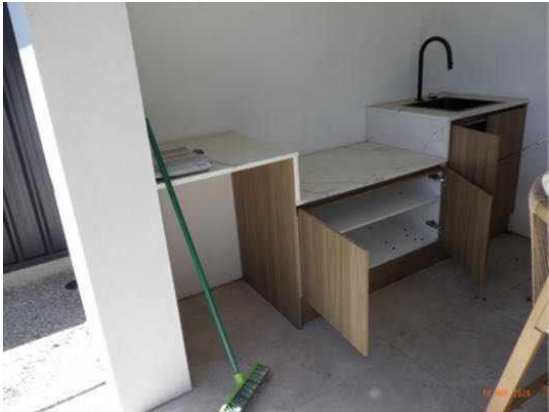
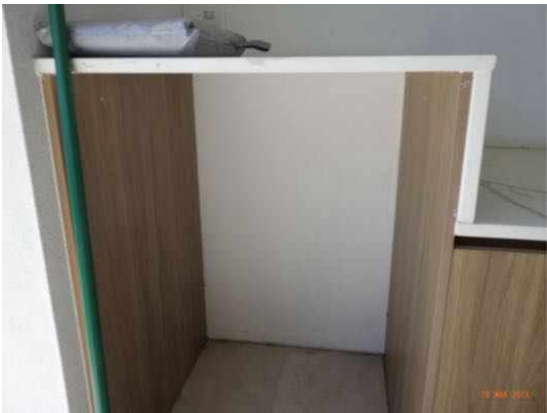
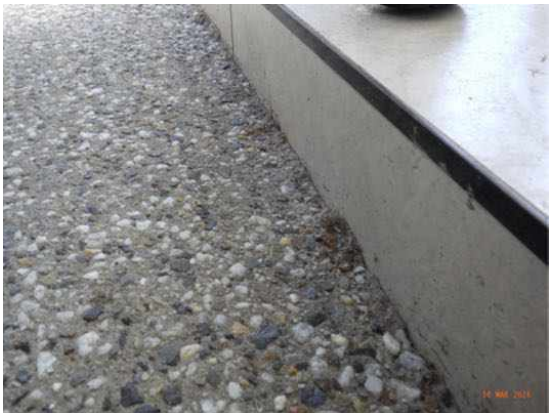
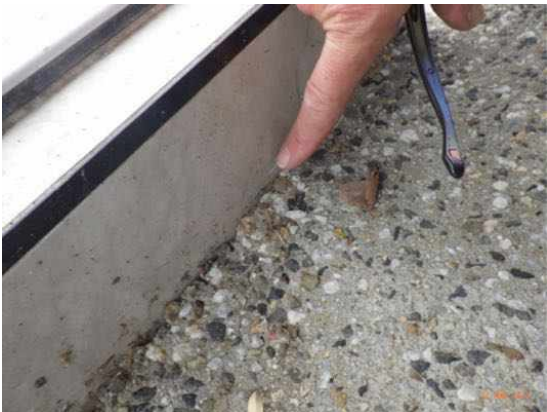
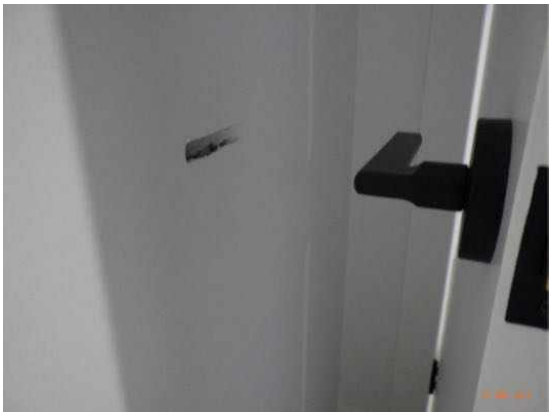
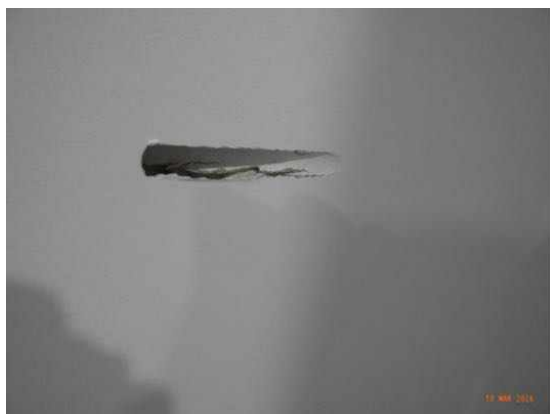
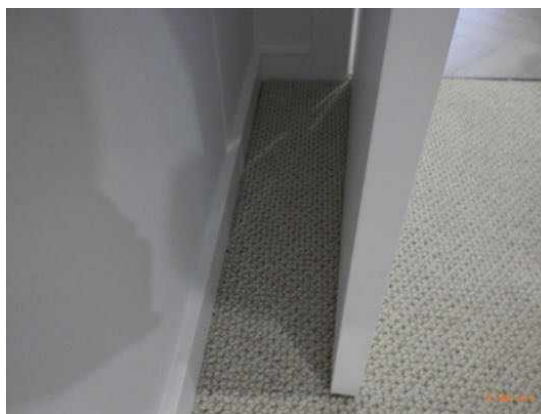
Finding 3.06

Building:	Building 1
Location:	All Areas
Finding:	Minor defects present
Information:	Minor defects were evident throughout the dwelling at the time of inspection, which are consistent with normal wear and tear and considered appropriate for a property of this age.

These defects are typical of ongoing material ageing, settlement, and general use over time, and include, but are not limited to:

- Screen door handle loose
- Service holes required to outdoor kitchen
- Tiling buried in concrete pavement around perimeter of dwelling.
- Door stops missing
- Hole in wall due to missing door stops

While these defects are not considered structurally significant at present, they should be addressed as part of routine and ongoing property maintenance to prevent further deterioration. Repairs and maintenance works should be carried out by appropriately

licensed and qualified tradespeople to ensure the continued serviceability and longevity of the dwelling.

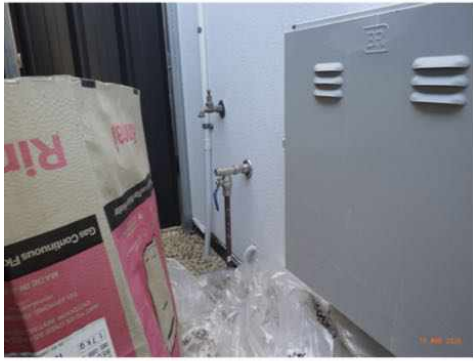
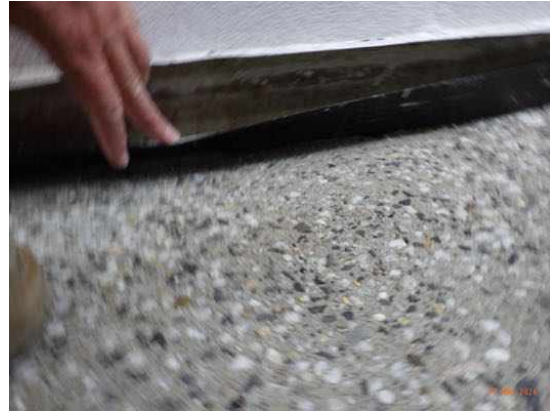
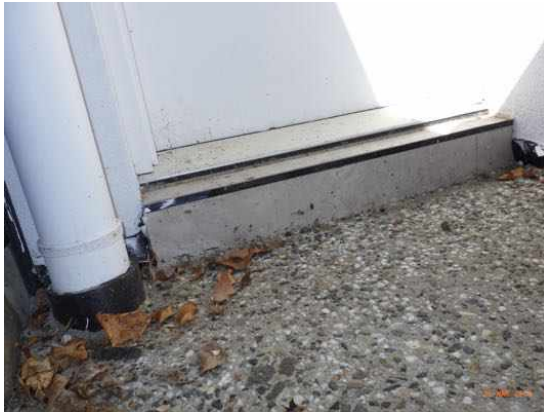
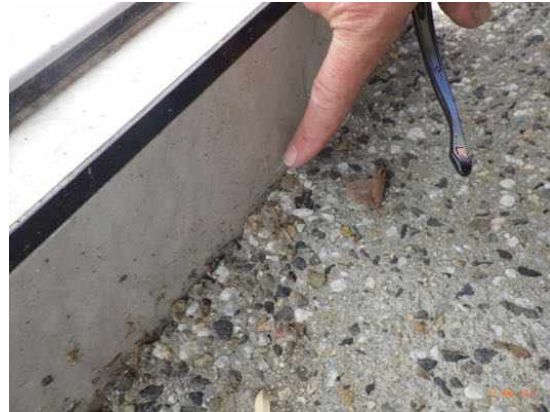
There has been a damp proof membrane installed at the junction of the perimeter of pavement to house. This should be cut down to pavement level to allow the slab edge to breathe and create a visual barrier to inspect for termites.

Membrane should be cut down to perimeter pavement level immediately to allow full inspection of the slab edge.

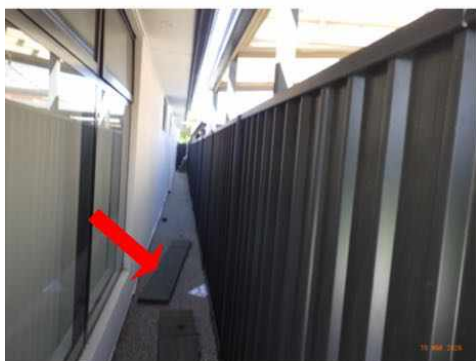
Finding 6.02

Building:	Building 1
Location:	All External Areas
Finding:	Untreated or non-durable timbers in a hazardous environment
Information:	To reduce the risk of timber pest attack it is essential that timber used in a hazardous environment (e.g. in direct contact with the ground or frequently exposed to damp conditions) is of sufficient durability and/or is adequately preservative treated. Additionally any timber lying around or timber stumps should be removed.

Untreated timbers in direct contact with the ground are likely to develop severe wood rot and/or fungal decay if left unattended creating attraction for subterranean termites to infest the timbers from surrounding areas.

If untreated or non-durable timbers are found to be in a hazardous environment it is highly advised that replacement of these building elements be performed as soon as possible to aid the protection of the property against termite / timber pest attack. Failing this close monitoring is recommended in an attempt to identify termite infestation at an early stage.

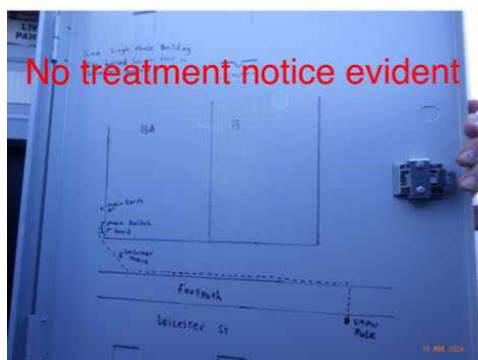
Finding 6.03

Building:	Building 1
Location:	All Areas
Finding:	Termite Management System - no evidence of a chemical installation
Information:	The application of a post-construction chemical termite barrier is highly recommended for all properties, particularly if live termite activity has been found on the site previously. Such barriers are highly effective in preventing termite attack on any timber building elements throughout the property.

At the time of inspection, it appeared as though no termite management system has been installed, with no evidence to suggest preventative works taking place.

The client may consider gaining further advice from a pest controller as to the costs and procedures involved with this application. It is recommended that obtaining such advice be a short-term priority.

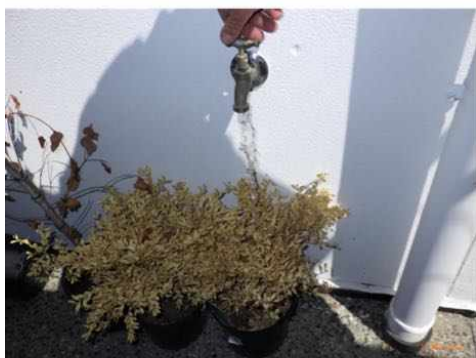
Finding 6.04

Building:	Building 1
Location:	All External Areas
Finding:	Air conditioner and or external tap - No drainage
Information:	Moisture around the perimeter of the building should be minimised to ensure that the area is kept dry and stable which in turn reduces the risk of water damage and termite infestation.

There appears to be no drainage points set up to the air conditioning unit, and or the external tap. While this is not a legal requirement it is recommended to reduce the risk of moisture related issues and the creation of an environment conducive to termite activity.

It is recommended that a licensed plumber be appointed to set up drainage in order to prevent such an environment from being created.
