# Building and Timber Pest Inspection Report

Inspection Date: Tue, 17 Mar 2026

Property Address: 2/126 Somers Ave, Macleod VIC 3085,  
Australia

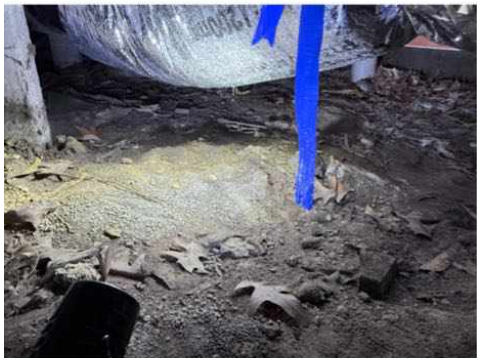
Building:	Main Building
Location:	Subfloor
Finding:	Minor Leak from Bath Tub Drain (Subfloor Area)
Information:	During the water test, a minor leak was observed from the bath tub drain connection within the subfloor area. Evidence of minor moisture staining and dripping was noted; however, no significant timber decay or structural wood rot was evident at the time of inspection.

Although the issue currently appears minor, ongoing leakage can introduce excessive moisture into the subfloor environment, which may lead to timber deterioration, mould growth, subsidence issues or deterioration of surrounding materials over time.

It is recommended that a licensed plumber inspect and rectify the leaking drain connection as soon as practicable to prevent further moisture ingress and potential future damage to the subfloor structure.

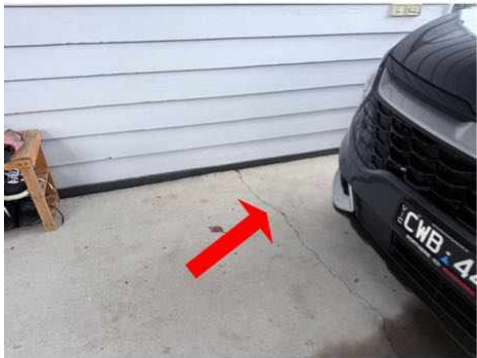
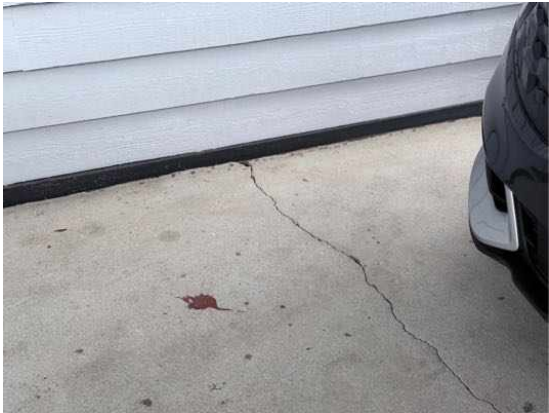
**Finding 3.02**

Building: Main Building  
Location: Driveway  
Finding: Cracking - External Concrete Paving Damage Category 1 - Fine (less than 2mm)  
Information: Fine cracks were identified in external concrete paving. Although fine cracks are quite noticeable, they are often only considered to be an appearance defect, and usually do not indicate any structural damage. To be considered a Category 1 or fine crack, the crack is found to be less than 2mm in width.

Generally the cause of a hairline crack in existing concrete paving such as driveways and pathways is indicative of the expansion and contraction of the concrete. Such causes are generally due to environmental factors, such as moisture levels, weather conditions, root systems of nearby trees or the soil types on which they are laid.

Fine cracks may also be due to poor original installation of the concrete. Factors such as poor compaction of the sub surface and/or inadequate reinforcing of the slab may create cracking and other secondary defects.

Monitoring of all cracking should be conducted frequently. Always contact a building inspector should cracks widen, lengthen, or become more numerous.

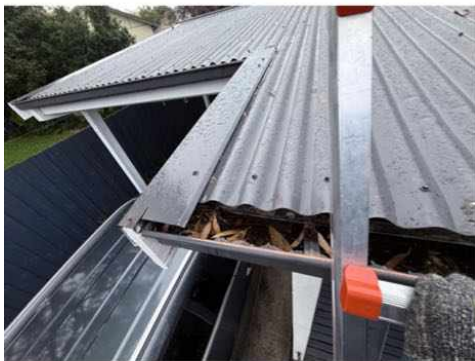
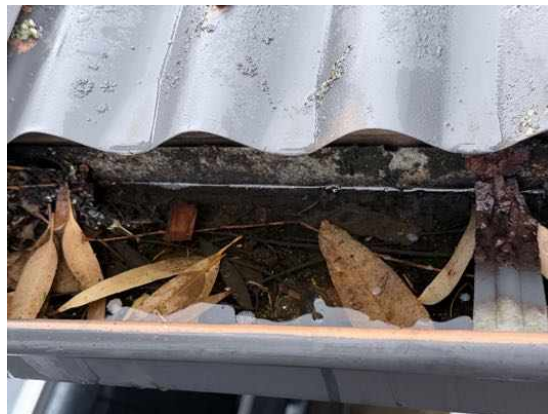
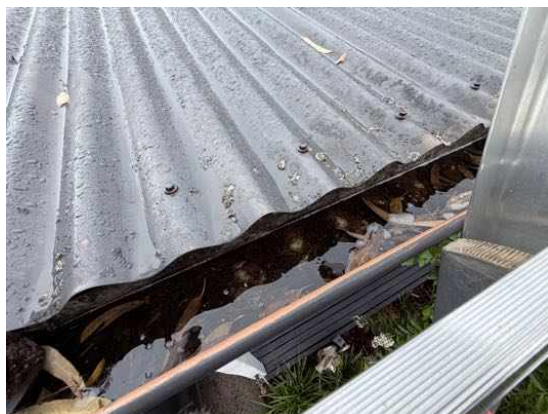
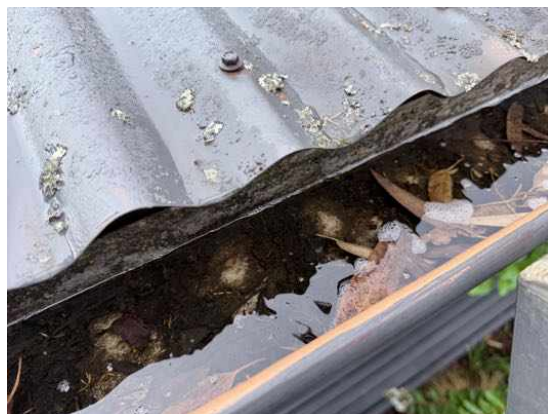
**Finding 3.03**

Building: Main Building  
Location: Roof Exterior  
Finding: Gutters - Water pooling  
Information: Water was found to be pooling in sections of the roof guttering. This is generally a secondary defect caused by blocked or partially blocked gutters. Such blockages and subsequent water pooling are likely to lead to rust and water damage to associated structures if left unattended.

Any areas of guttering that shows evidence of water pooling should be checked for partial or full blockages and any secondary damage that may have occurred as a result. Depending on the extent of the damage, building elements may require repair and/or replacement to ensure adequate roof drainage and function of exterior plumbing system.

A roofing plumber should be appointed as soon as possible to rectify this issue. It is highly advised that all gutters be maintained on a frequent basis to ensure the condition of roof plumbing.

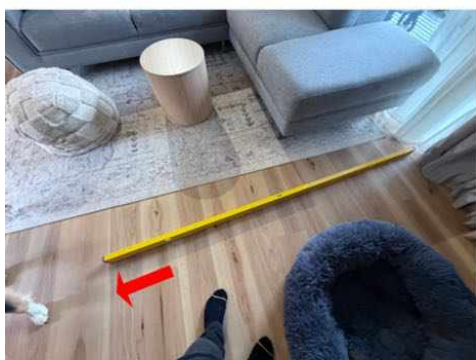
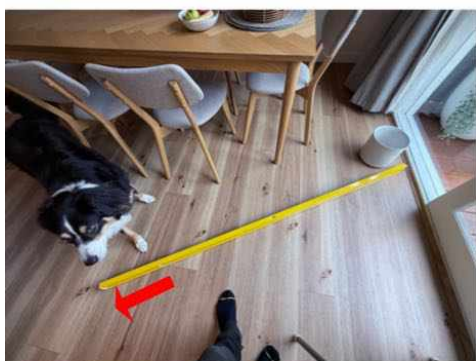
Finding 3.04

Building: Main Building  
Location: Some Internal Areas  
Finding: Subsidence- minor  
Information: It is suspected that the subfloor structure might have been affected by movement of the foundations, often referred to as sinking or subsidence.

General subsidence is usually initiated by changes in soil moisture content. The most critical factor is identifying the specific causes, and identifying if this is a recurring or ongoing problem, or one that has been resolved by previous works in the past. Max deviation is at 10-12 mm in 2 m distance.

Subsidence can have complex and varying causes, which will influence the required remedial works. If secondary defects like door binding, cracks around the cornices, or gaps between walls & flooring are evident. It will be advised to begin by consulting a structural engineer to determine the required scope of works. This generally includes some form of underpinning, as well as addressing the underlying cause.

A Registered Builder specialising in re-stumping would then generally carry out works as advised by an Engineer.

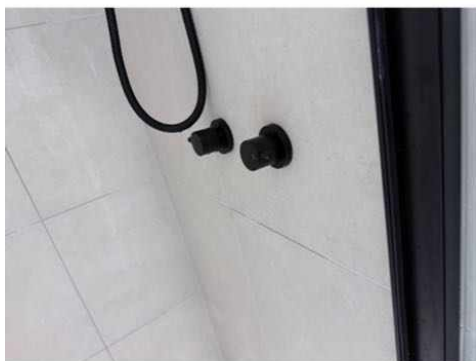
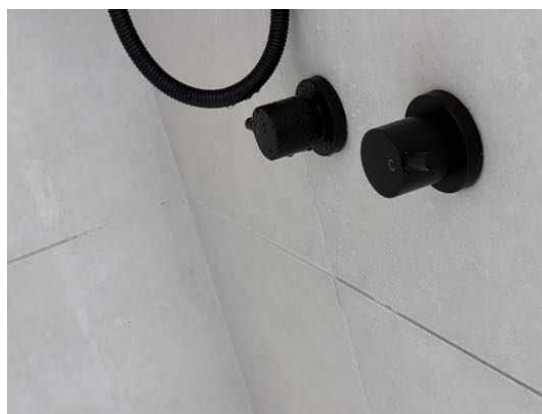
### Finding 3.05

Information: This tap shows indications consistent with minor water hammer (a pressure surge that can occur when water flow is stopped suddenly). This is a relatively common issue in plumbing fixtures and is often noticed as a faint banging or knocking noise during tap operation. It may be influenced by factors such as slightly elevated water pressure, worn tap washers, or the absence/ineffectiveness of pipe restraints.

At the time of inspection, this issue appears minor, however if left unmanaged it may contribute to gradual wear of tap components and, in some cases, loosen plumbing connections over time.

Recommendation: A licensed plumber may be engaged at the owner's discretion to inspect the fitting and undertake minor remedial works if required (e.g., tap servicing, pressure check, installation of a water hammer arrestor). Ongoing monitoring is recommended, particularly if the noise increases or leakage becomes evident.

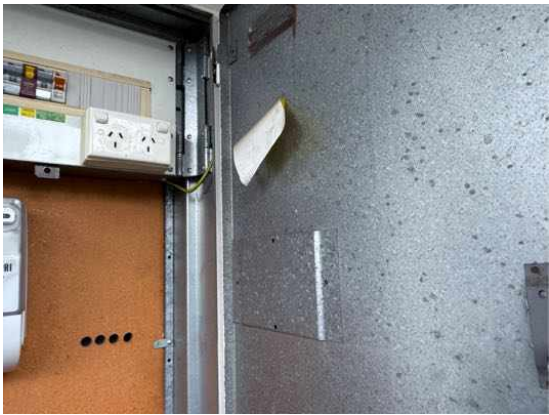
Building:	Main Building
Location:	Meter Box
Finding:	Termite Management System - no evidence of a chemical installation
Information:	The application of a post-construction chemical termite barrier is highly recommended for all properties, particularly if live termite activity has been found on the site previously. Such barriers are highly effective in preventing termite attack on any timber building elements throughout the property.

A durable notice should be placed in the switchboard unit to indicate current termite barriers. At the time of inspection, it appeared as though no termite management system has been installed, with no evidence to suggest preventative works taking place.

The client may consider gaining further advice from a pest controller as to the costs and procedures involved with this application. It is recommended that obtaining such advice be a short-term priority.

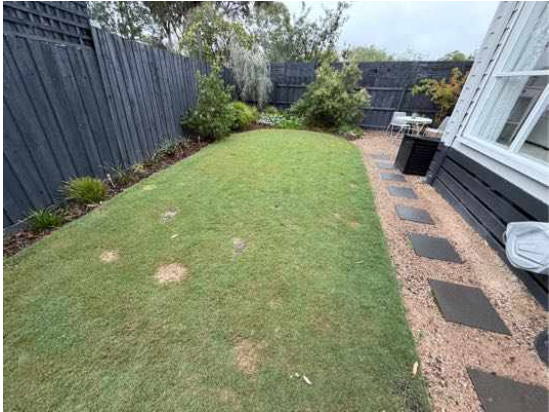
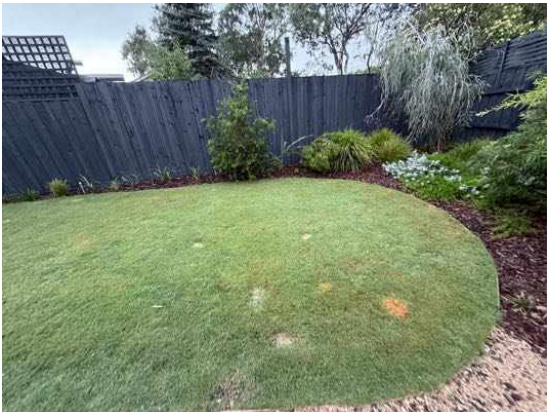
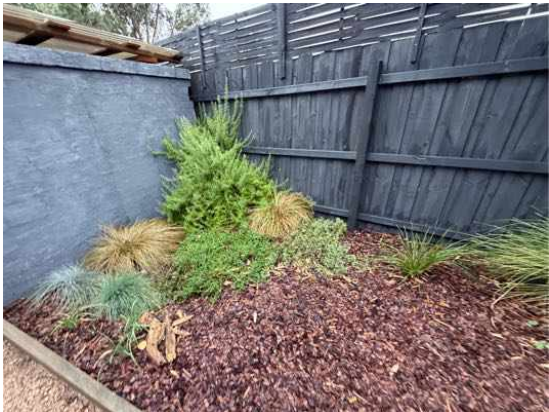
**Finding 6.02**

Building: Main Building  
 Location: All External Areas  
 Finding: Garden Bed/ Mulch - Conditions Conducive to Termites  
 Information: Mulch were found around the property. These areas can include untreated timber, and with a combination of moisture from watering hosing can make conditions conducive to termite activity and termite ingress.

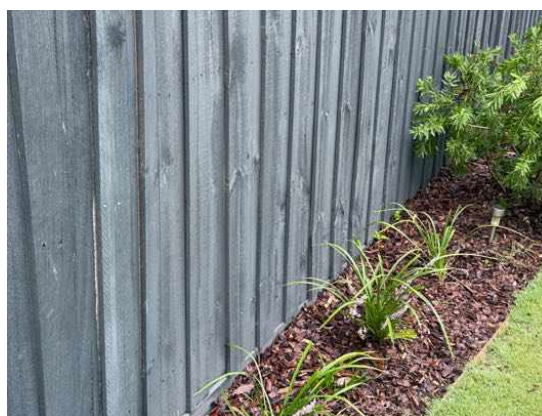
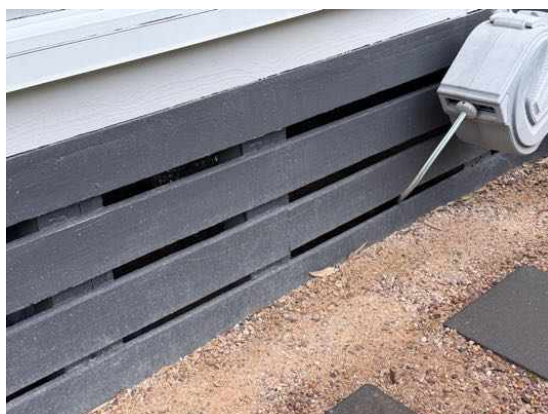
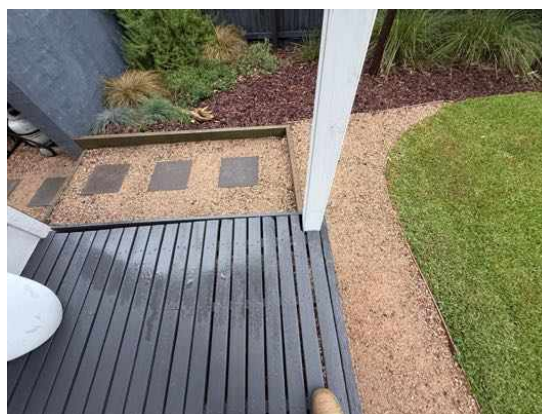
**Finding 6.03**

Location: All External Areas  
 Finding: In ground contact  
 Information: Any timbers in direct ground contact provide opportunity for concealed termite entry and are likely to be subject to premature rot and decay as the soil retains moisture or damp conditions against the timbers.

Remove untreated timber that is in direct contact with external grounds. Consider replacement with more durable materials i.e. treated timber or non timber elements. Frequent pest inspections are advised to readily identify any termite activity in these areas.

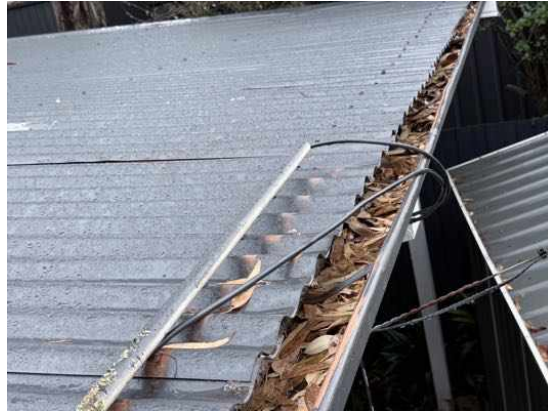
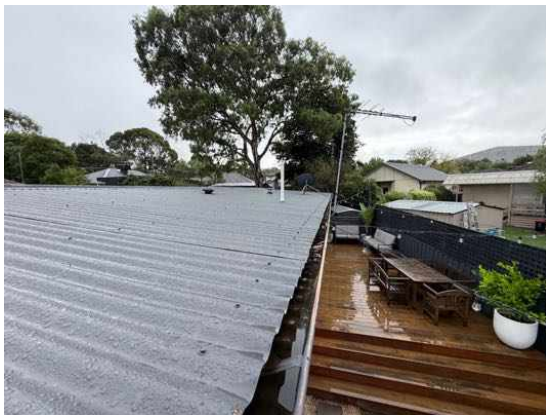
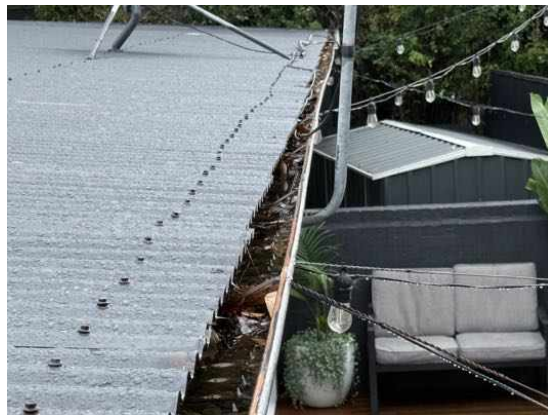
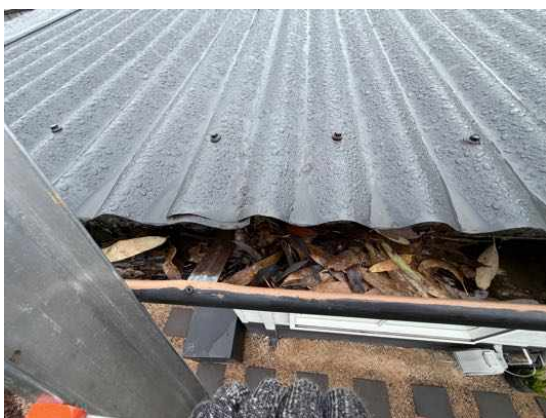
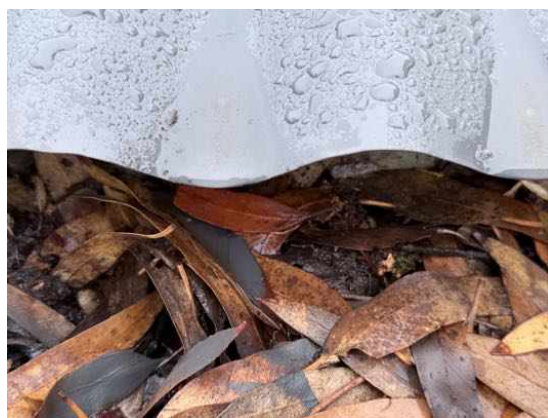
### Finding 6.04

Building: Main Building  
 Location: Roof Exterior  
 Finding: Gutters - Blocked  
 Information: Roof plumbing structures, such as guttering and downpipes, should be free of all debris to prevent blockages. Blockages of the guttering and downpipes will lead to pooling and accumulated water overflows, which is likely to subsequently flood eaves and exterior walls.

Blocked gutters are likely to lead to high levels of moisture in the affected areas. Such moisture will not only cause rust and decay of the associated building materials, but can also provide conditions that are conducive to termite and timber pest activity. Blockages in gutters should therefore be removed immediately to ensure dry conditions are maintained.

Consult a Licensed Plumber for further specific advice on remedial works that may be required. In the interim, it is highly advised that blocked gutters be removed by the homeowner or a general handyperson as a matter of urgency.

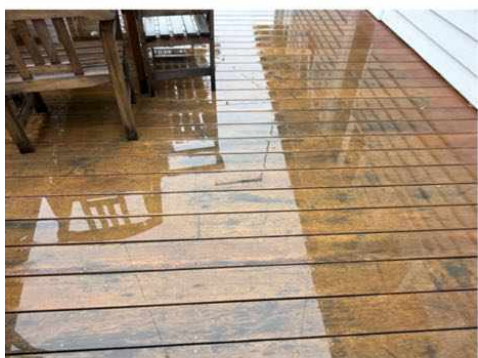
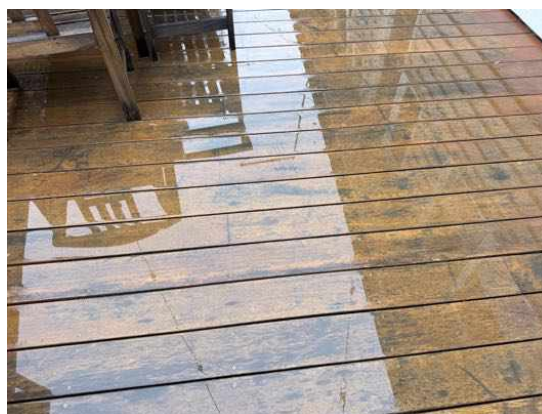
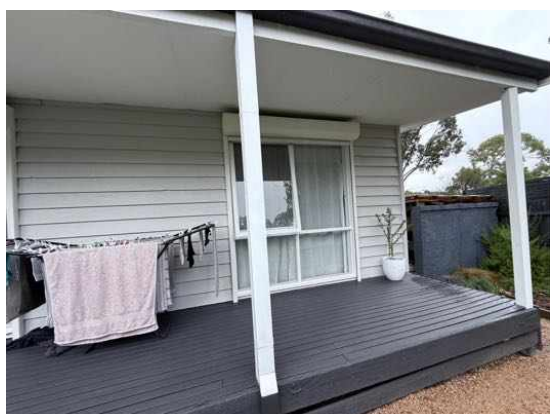
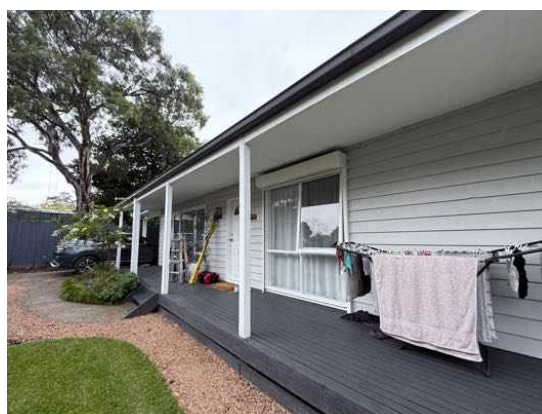
### Finding 6.05

Building: Main Building  
 Location: All External Areas  
 Finding: Timber deck- High conducive condition.  
 Information: We are unable to inspect under the timber deck if its in close proximity to the ground.

Where we are unable to inspect timber structures, decks and subfloor areas the risk of undetected termite activity is rated as extremely High.

We strongly recommend the purchaser prioritise a termite treatment by a Licensed Pest Controller to protect and maintain the asset as it is a timber structure.

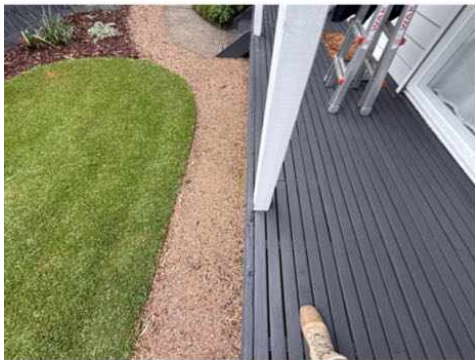
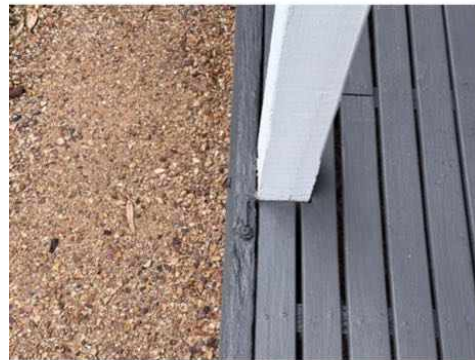
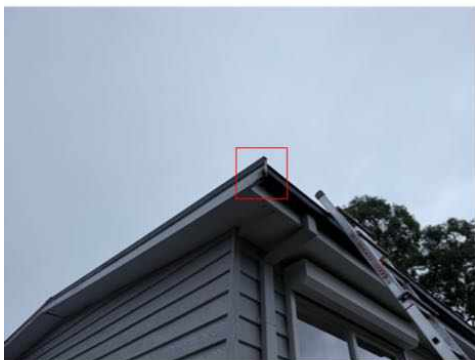
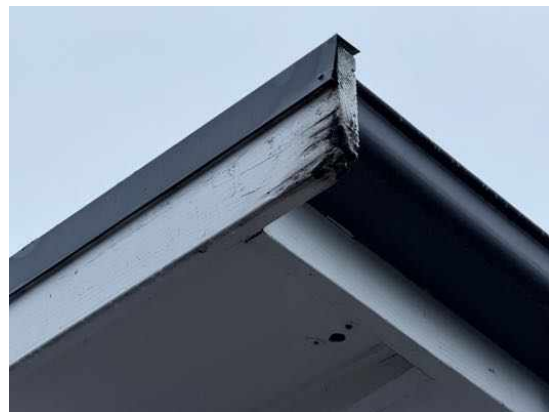
### Finding 7.01

Building: Main Building  
 Location: All External Areas  
 Finding: Wood rot  
 Information: These building elements shows evidence of wood rot. Wood rot, also known as Fungal Decay, occurs when timbers and other cellulose building materials are exposed to damp conditions on an ongoing basis. This could be the result of exposure to weathering over a prolonged period of time, or the attraction of excessive moisture

Wood rot is often associated with general damp problems and is evidenced by a 'musty' smell or mould and mildew occurring on surfaces. If left unmanaged, damp conditions can lead to further health problems and the decay of timbers will continue.

Early intervention and regular maintenance, particularly of exterior timbers, will prolong the useful life of these building elements. Prior to any works being performed, the cause of the moisture that has created the visible wood rot should be identified and addressed in a suitable manner. Replacement of affected timbers may then be a necessary step in protecting surrounding building elements from such deterioration.

A qualified plumber may be appointed to assess the cause of excessive moisture and to provide advice on any remedial works as required. A qualified carpenter or registered builder may also be required to replace affected building materials.
