Building and Timber Pest Inspection Report

Inspection Date: Fri, 20 Feb 2026

Property Address: 99 Gilbert St, Tumbarumba NSW 2653,
Australia

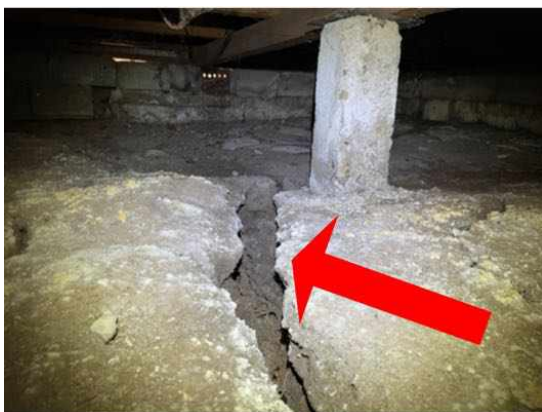
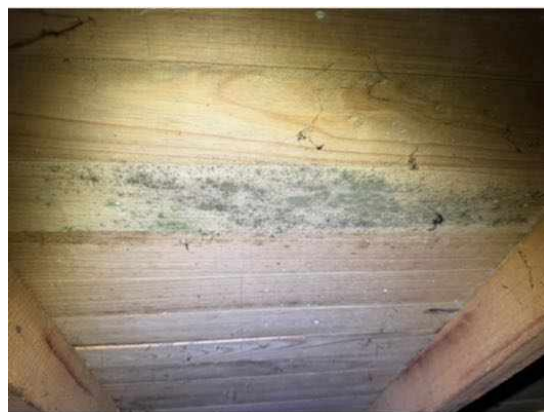
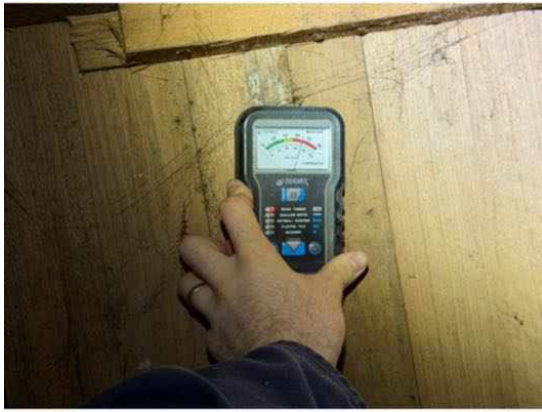
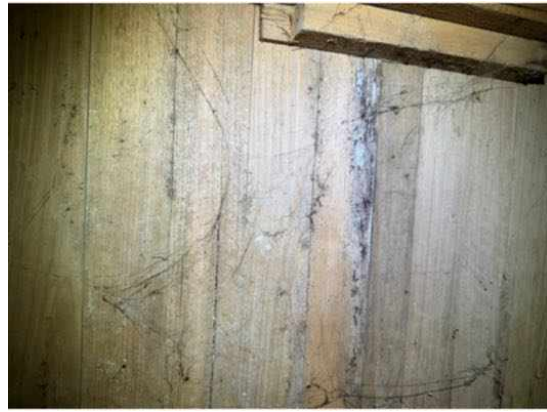
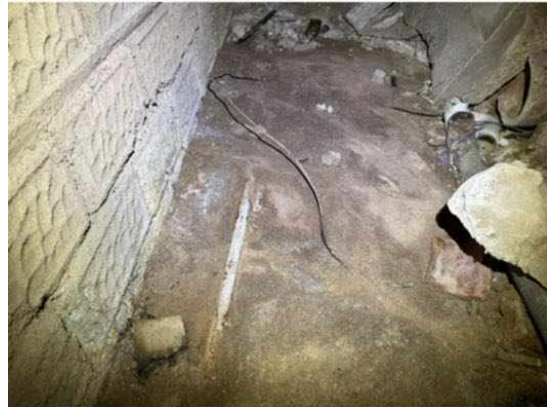
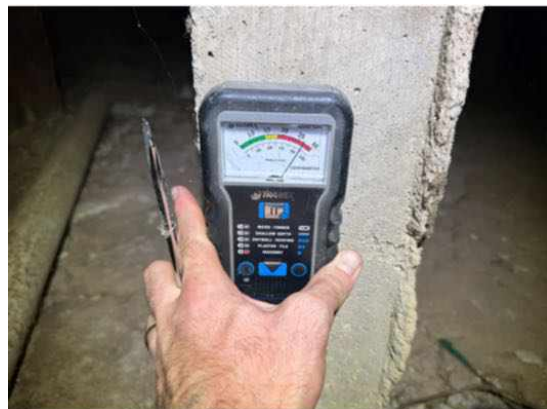
Building: Main Building
Location: Subfloor
Finding: Subfloor & Stumps - Moist Conditions & Mould
Information: Moist conditions and mould growth were evident in areas of the sub floor and the stumps at the time of inspection. Causes of this defect can be attributed to water pooling against the property, insufficient ventilation, and/or associated leaking.

Where moist conditions are in the subfloor, this creates areas conducive to timber pest activity, and can lead to deterioration of the stumps overtime.

Consultation with a licensed plumber specialising in drainage is advised promptly, to provide further advice and remedial works where necessary. It is also advised that a mould remediation specialist and subfloor ventilation specialist be engaged, to provide further advice.

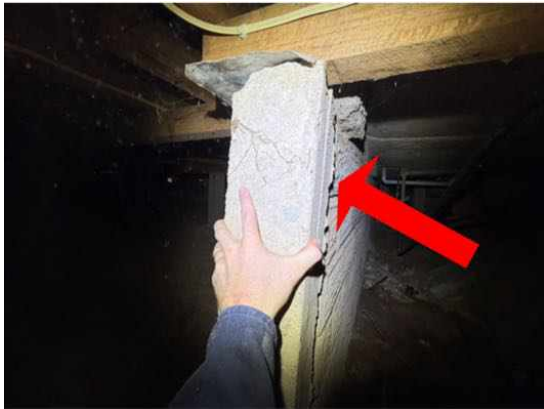
Finding 3.02

Building:	Main Building
Location:	Subfloor
Finding:	Subfloor pier - Insufficient support
Information:	It was noted that a pier, at but not limited to the bathroom area in the subfloor was wobbly and loose. Recommend engaging a registered builder in the short term, to provide remedial works, to ensure the pier is sufficiently fixed & secure, to avoid the development of secondary building defects.

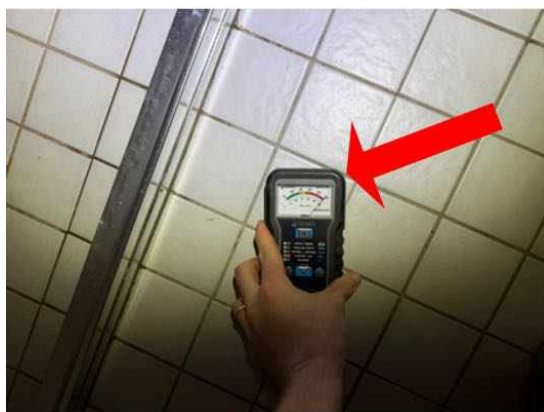
Finding 3.05

Building: Main Building
 Location: Bathroom
 Finding: Bathroom - High Moisture In Floor
 Information: Evidence of high moisture was identified to the bathroom floor. Causes of high moisture in the flooring could be attributed poor or deteriorated water proofing, insufficient fall to the associated drains and/or insufficient use of preventative measures such as bath mats.

The client should take preventative measures such as using a bath mat, to minimise the amount of water pooling on the floor. Should further moisture in the flooring become apparent, the client should engage a licensed tiling contractor and/or plumber

promptly, for further evaluation and remedial works where necessary.

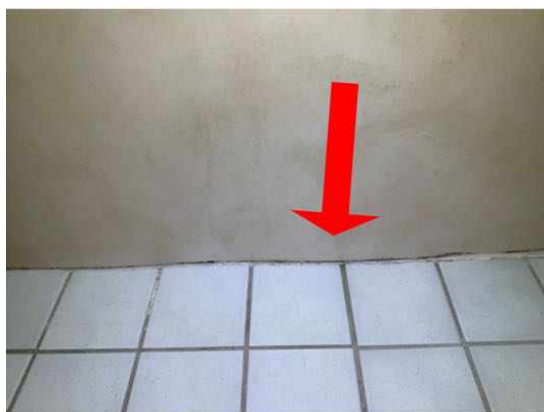
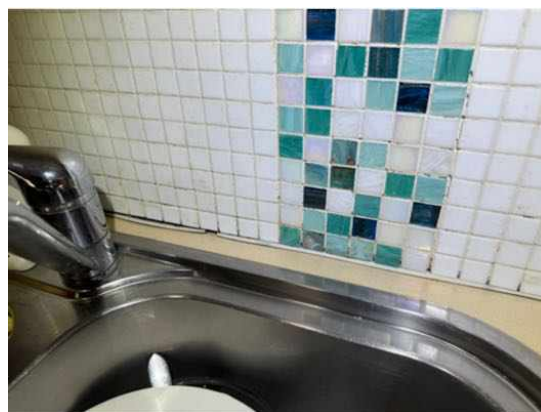
Finding 3.06

Building:	Main Building
Location:	Tiled Areas
Finding:	Sealant and grouting - deteriorated or missing
Information:	It appears that the sealant and grout is not present or has deteriorated, in some tiled areas. Sealant and grouting in areas that come into regular contact with water should be maintained for the long term care of your property.

A sealant specialist or tiling contractor should be appointed to complete these minor works, to prevent the potential development of secondary building defects overtime.

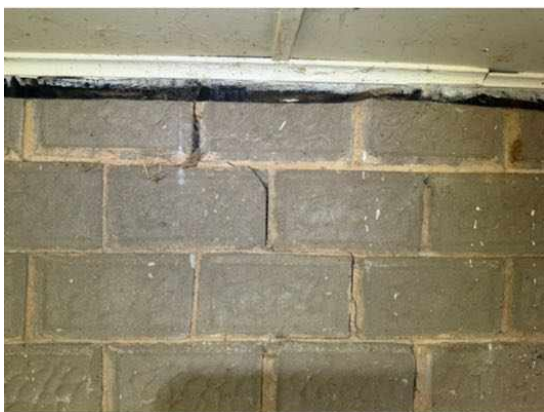
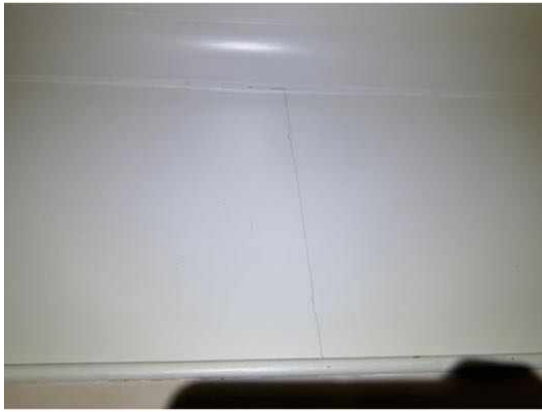
Building:	Main Building
Location:	All Internal Areas
Finding:	Cracking - External & Internal
Information:	Cracking was identified to some areas of the brickwork and internal wall linings at the time of inspection. Cracking has a variety of possible causes, however, the most common is general movement of adjacent footings and/or expansion / contraction of building materials.

Cracking is a relatively common defect, and is most likely to occur adjacent to windows, doors and other openings.

The client should monitor the cracking. Should the cracking lengthen, widen or become more numerous, the client should consult with a structural engineer promptly to provide further advice.

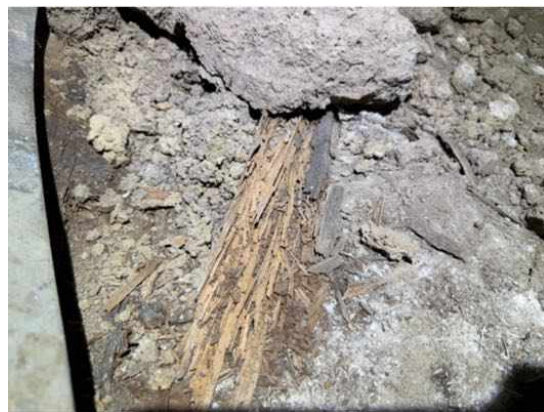
Building: Main Building
Location: Subfloor, Shed, Fence Post
Finding: Evidence of termite workings & damage
Information: Although no live termite activity was identified at the time of inspection, previous termite damage was identified at, but not limited to, areas of the shed framing, fence post and timber debris in the subfloor.

The client should engage a licensed pest controller promptly, to provide further advice regarding installation of a termite treatment.

6 monthly ongoing termite inspections, conducted by a qualified termite inspector, are also recommended

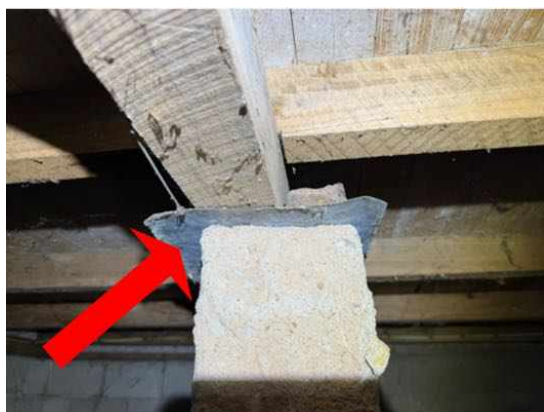
Building:	Main Building
Location:	Subfloor
Finding:	Ant caps - Inadequate
Information:	It was found that the ant caps that have been installed are inadequate. Ant caps are designed to easily identify termite or pest ingress from stumps to the adjoining bearers.

Where ant caps are inadequate, this poses as an obstruction to the inspection and frequent monitoring of these areas should be carried out in order to identify any early signs of termite workings. Recommend engaging a licensed carpenter to install adequate ant caps to the subfloor.

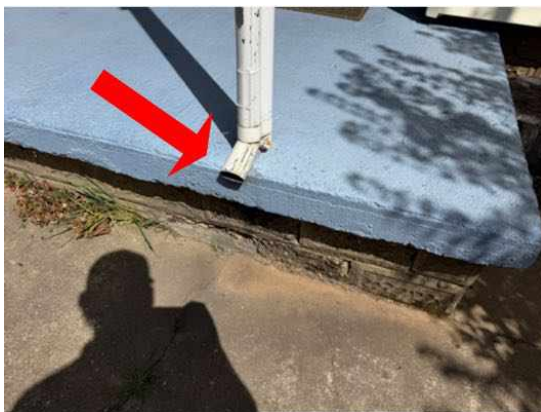
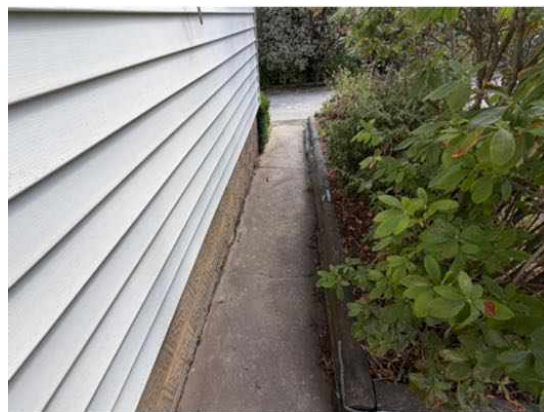
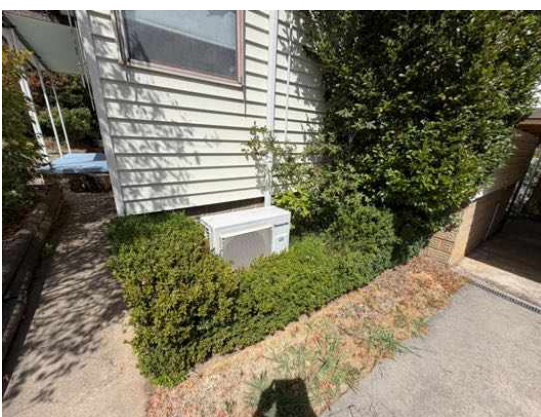
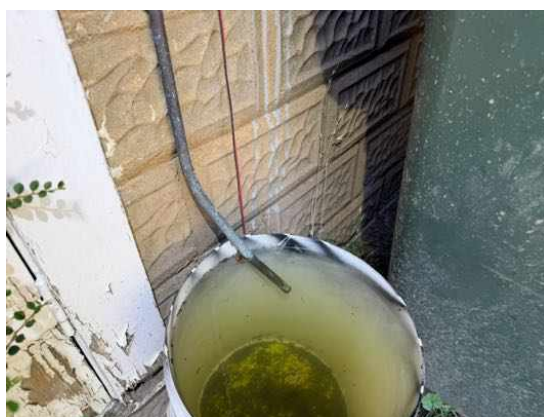
Finding 6.04

Building:	Main Building
Location:	All external areas, Down-pipe
Finding:	Potential Water pooling - against property
Information:	It appears that there are potential areas around the perimeter of the property that could be susceptible to water pooling. A disconnected down-pipe was noted at, but not limited to the front elevation.

Where insufficient site drainage and insufficient drainage of taps, roof plumbing, hot water system & aircon overflows are present, water pooling is likely to occur, and can create areas conducive to timber pests and potential damage to the subfloor structure overtime, if neglected.

Recommend consulting with a licensed plumber in the short term to further assess and provide remedial advice.

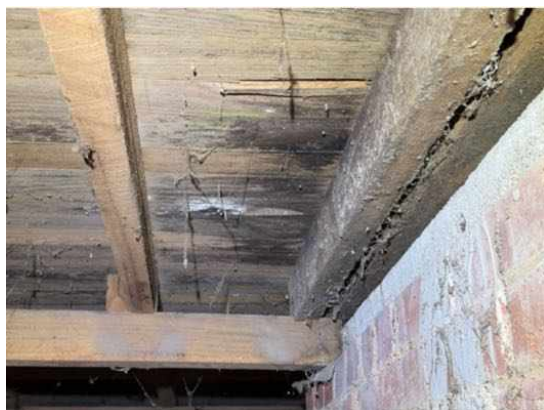
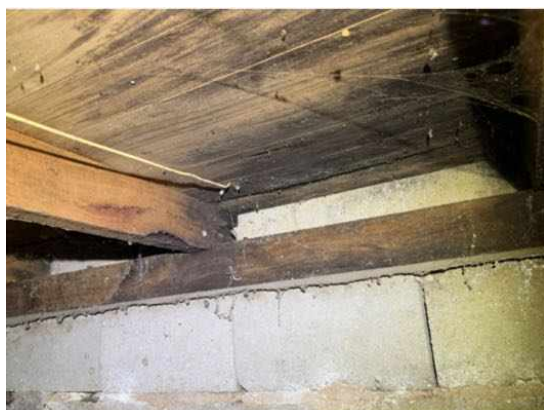
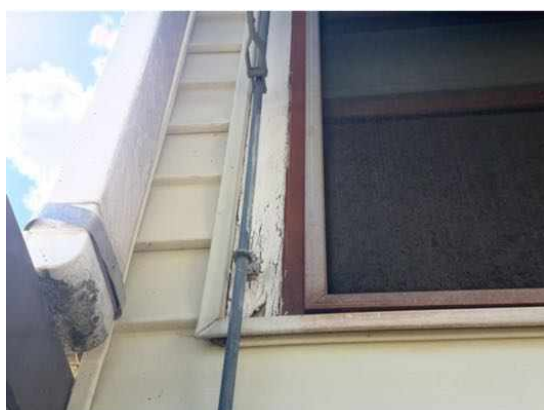
Finding 7.01

Building: Main Building
Location: Windows, Fascias, Subfloor, Carport & Shed Framing
Finding: Fungal decay & weathering
Information: Areas of fungal decay (wood rot) & weathering were identified at but not limited to some window frames, fascia's, shed & carport framing and some subfloor timbers. For areas of fungal decay, the client can engage a licensed carpenter at their discretion to replace affected materials.

For areas of general weathering, it is advised the client engage a licensed painter to apply protective sealant or coating to areas of weathered external timbers.

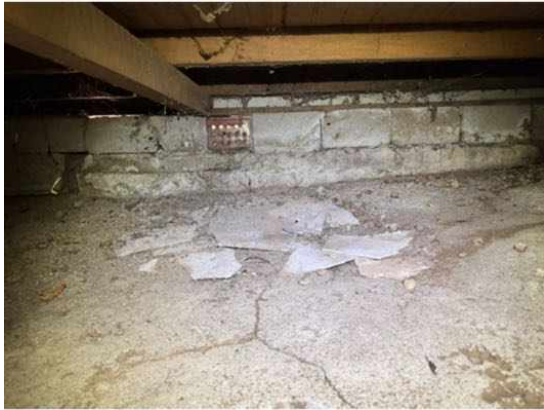
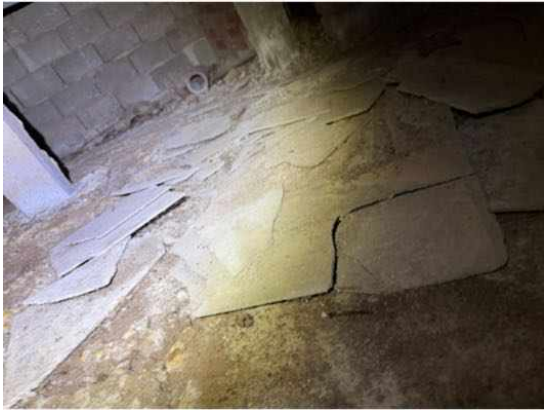
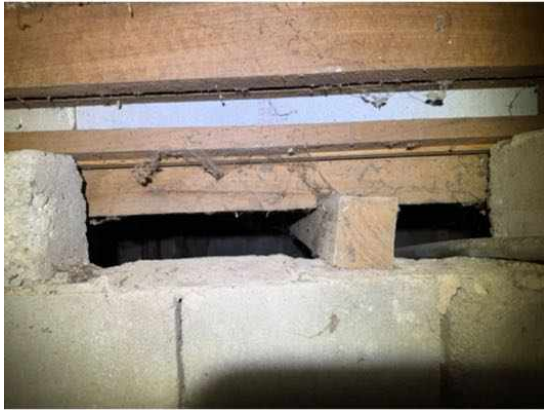
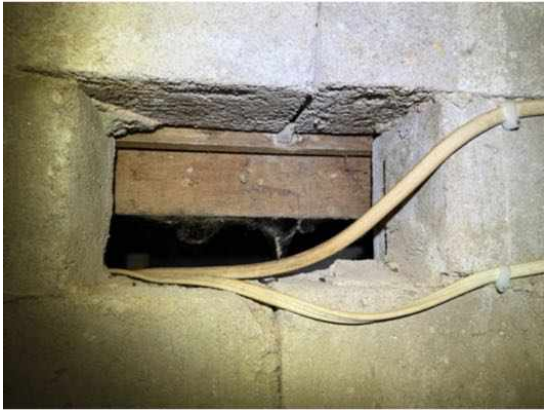
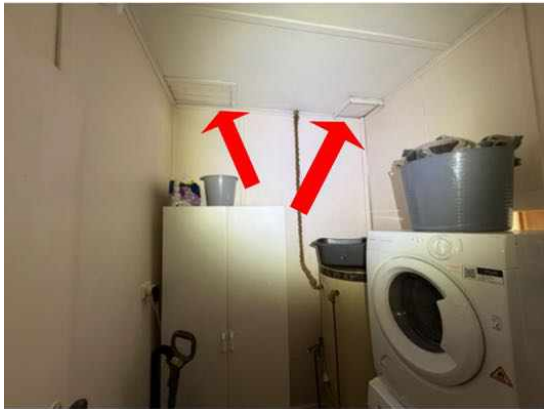
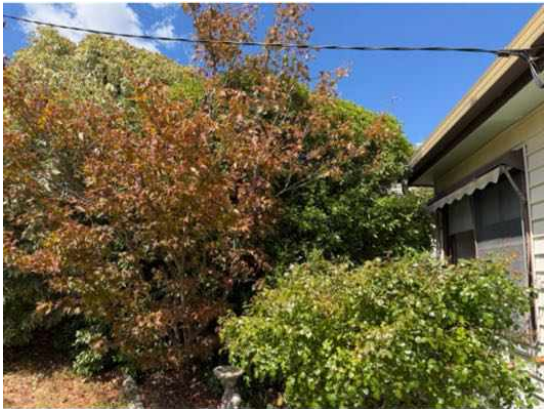
Building: Main Building
Location: All Areas
Finding: Additional Photos - Obstructions and Limitations
Information: These photographs are an indication of the obstructions and limitations which impeded full inspection of the property at the time of inspection. These obstructions can hide an array of defects and should be removed to allow full inspection to be carried out. A re-inspection is recommended once the areas are made accessible.

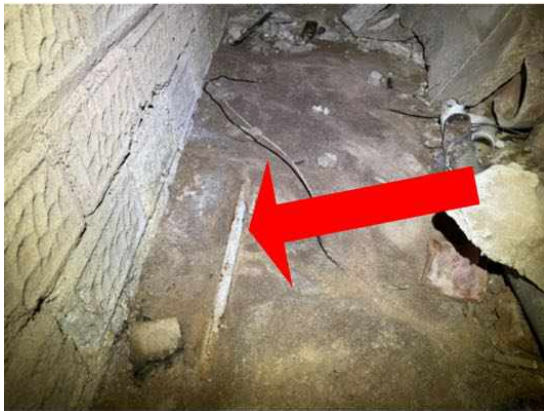
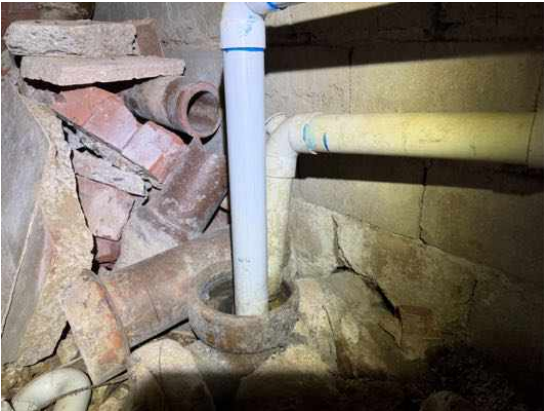
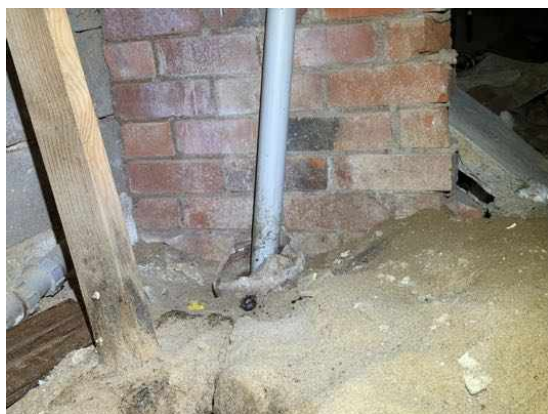
Building: Main Building
Location: Subfloor
Finding: Plumbing - Poor Workmanship & Rust
Information: Some of the plumbing in the subfloor appears to be of poor workmanship. It appears areas of rusted pipework were also present. Recommend consulting with a licensed plumber to provide further advice and remedial works where necessary. A separate plumbing inspection may also be considered by the client.

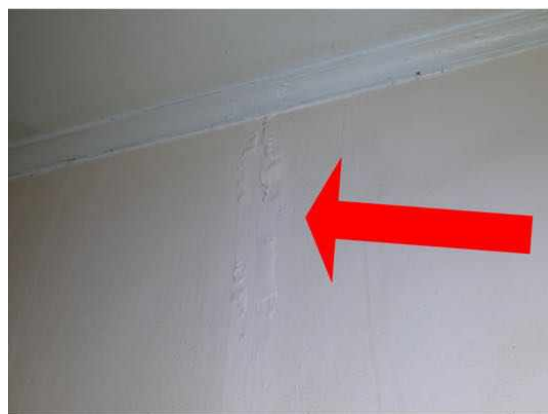
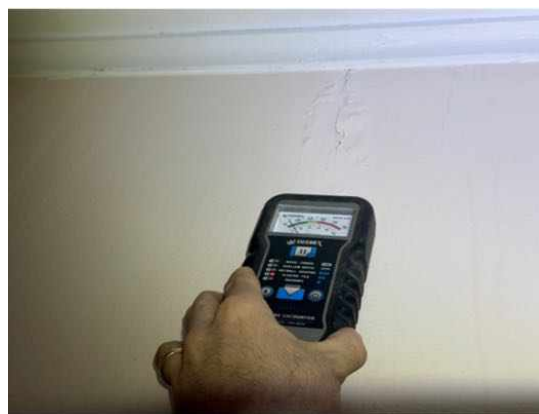
Building: Main Building
 Location: Bedroom Wall
 Finding: Water Staining Present
 Information: It appears that water staining was present at but not limited to, the rear bedroom wall. Potential causes of leaking include deteriorated roof cladding or damaged plumbing fittings and fixtures. No high moisture was evident in the area at the time of inspection.

Recommend that the client monitor the area and engage a licensed roof plumber promptly, should the leak persist or return.

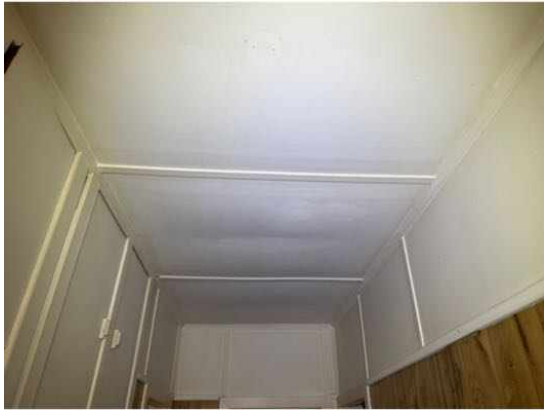
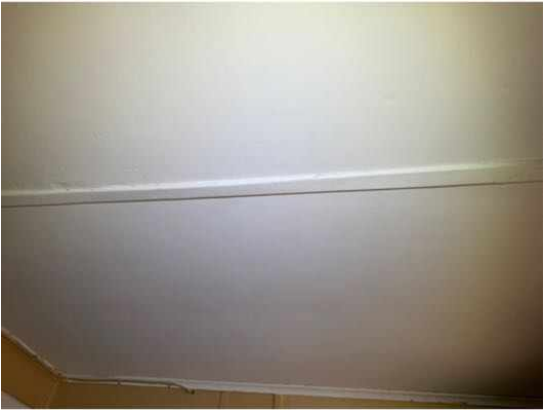
Building: Main Building
 Location: Hallway, Extension
 Finding: Ceiling - Sagging
 Information: Sections of the ceilings at but not limited to, the hallway and extension ceiling were found to be slightly sagging. Causes of ceiling sagging include fixings (e.g. nails or glue) that have become loose and require re-fixing. Recommend that the client monitor the sagging.

Should the sagging develop, a licensed plasterer and/or licensed carpenter should be

engaged to provide maintenance works where necessary.
