# Building and Timber Pest Inspection Report

Inspection Date: Mon, 9 Mar 2026

Property Address: 93/370 Gainsborough Dr, Pimpama QLD  
4209, Australia

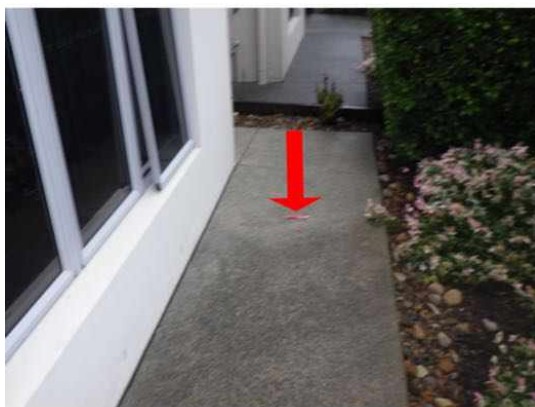
#### Finding 3.01

Building: Main Building  
Location: Driveway > Ground Level  
Finding: Cracking in concrete slab - Category 1  
Information: Minor cracking coded as Category 0 - 1 was identified in the driveway and footpaths concrete slab. A Category 1 crack is described as a fine but noticeable crack, with the slab at an otherwise reasonable level.

To be considered Category 1, the approximate width of the crack is less than 1.0mm, or a less than 10mm change in offset when a 3m straight edge is placed over the defect.

Category 1 cracks should be monitored for a period of 12 months. At the end of the monitoring period, identified cracks that are rated greater than Category 2 are considered defects, and require rectification.

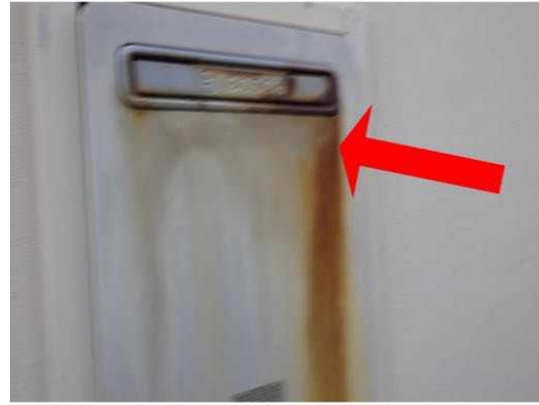
### Finding 3.02

Building: Main Building  
 Location: Exterior walls - right side > Centre Right  
 Finding: Gas System - Cover Plates  
 Information: At the time of inspection the front cover plate to the gas instant hot water unit showed signs of surface rust or rusting.

The cover plate should be in good condition to prevent moisture from penetrating the gas unit systems protective shell.

It is recommended a plumber is contacted regarding replacement of the front cover plates. Alternatively a licensed painter could be engaged to treat or seal the rusted area with an approved protective coating.

NOTE - The gas system cover plate replacement or maintenance may be the responsibility of the buildings body corporate managers.

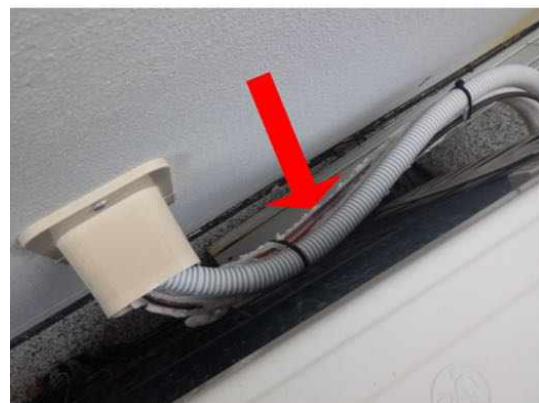
### Finding 3.03

Building: Main Building  
 Location: Exterior walls - right side > Centre Right  
 Finding: Pipework - Insulation deteriorated  
 Information: At the time of inspection sections of the air conditioning unit pipe work insulation showed evidence of damage and deterioration. It is suspected that this deterioration has developed as a result of excessive exposure to weather, including UV exposure in daylight. Deteriorated insulation reduces the effectiveness of the material in helping to maintain the desired temperature and work most efficiently.

If left in an exposed position, it is likely that the deterioration will continue and worsen over time, potentially resulting in secondary building defects as well as a further loss in insulating properties.

Some areas of replacement of pipe insulation is likely to be required. Further preventative measures to remove or protect the material from future exposure are also advisable. Consultation with a licensed air conditioning installer is advised to gain quotes for the repair and/or replacement of deteriorated insulation.

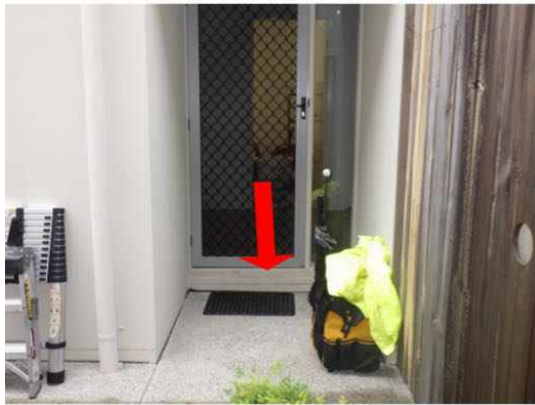
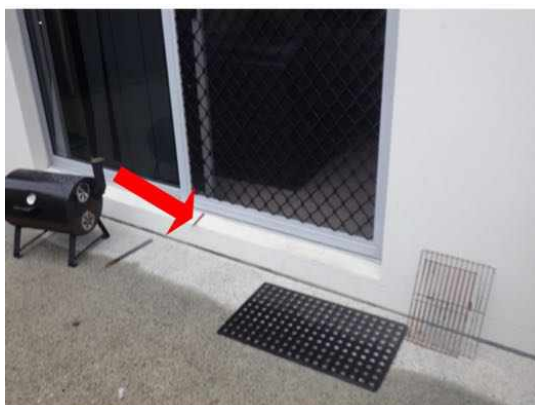
### Finding 3.04

Building: Main Building  
 Location: Exterior walls - right side & rear. > Existing

Finding: Cracks to External render - Category 1

Information: It has been observed that fine cracking and/or superficial damage to external window and door sill rendered surfaces has occurred (as per example photos). The degree of damage falls within Category 1, described as fine cracks that do not need repair and which are less than 1.0mm in width limit.

A qualified solid plasterer could be consulted for further advice.

Always contact your building inspector should cracks widen, lengthen, or become more numerous.

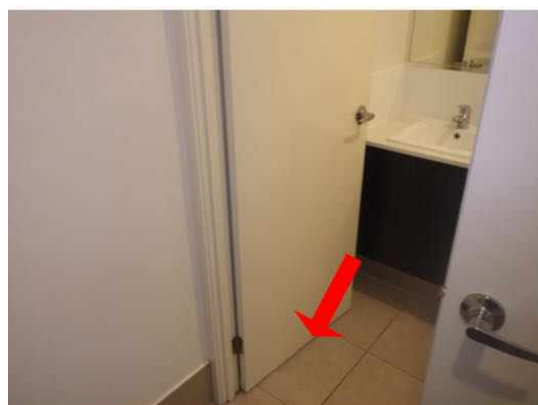
### Finding 3.05

Building: Main Building  
 Location: Powder Room > Front  
 Finding: Damaged Door  
 Information: The door leading into the powder room has suffered damage to the bottom edge.

Damage occurs generally when the building materials have aged and decayed, but in this instance the damage appears to be the result of exposure to moisture, possibly from the bottom and/or top edges of the door not being sealed with a suitable paint or sealant at the time of construction.

A qualified carpenter or general handyman could be appointed to repair/replace the door at the clients discretion.

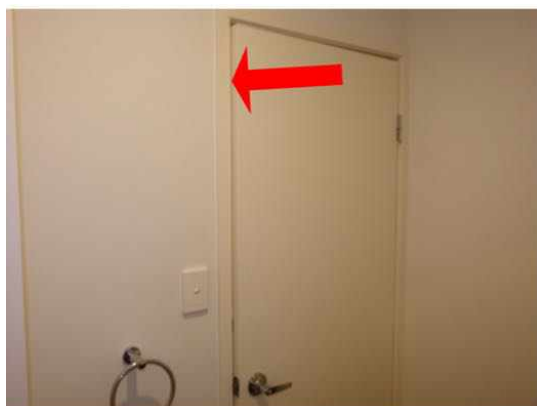
### Finding 3.06

Building: Main Building  
 Location: Powder Room > Front  
 Finding: Door - Binding/Jamming  
 Information: Binding and/or jamming of the powder room door on the door frame was evident during standard operation. This defect inhibits the functionality of affected door as well as creating potential for secondary defects to associated building elements, such as damage to the door framing.

A door that binds to the associated door frame or sill may have several causes, such as poor installation of the door or deteriorated hinges.

A qualified carpenter or general handyperson could be appointed to perform minor rectification works at client discretion.

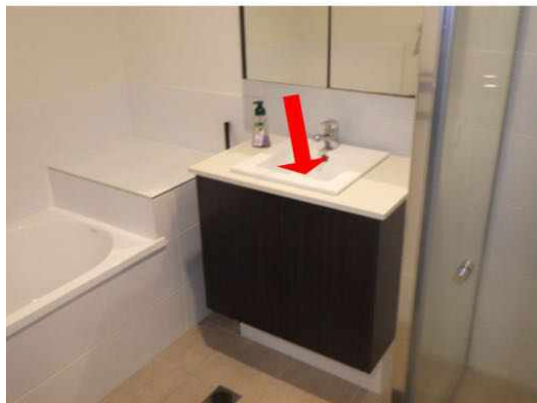
Building: Main Building  
 Location: Bathroom > Centre,Rear  
 Finding: Basin - Pop up waste stiff.  
 Information: The bathroom basin pop up waste was stiff to operate at the time of inspection. It is advised that maintenance is carried out on the waste so as it functions as intended.

A handyman could be appointed to perform any remedial works where required.

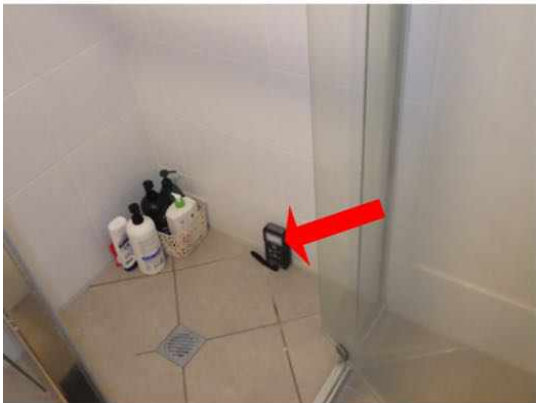
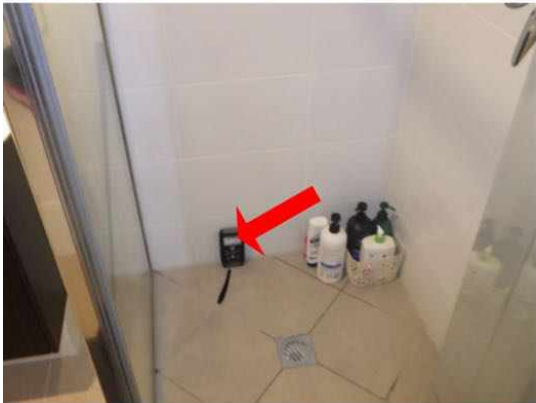
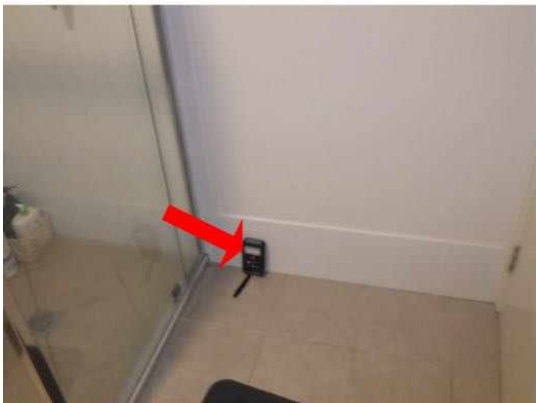
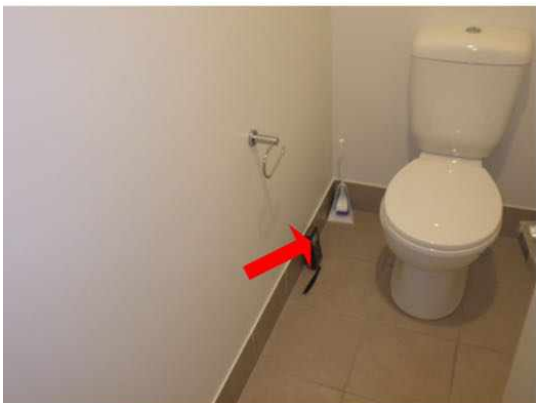
### Finding 3.09

Building: Main Building  
 Location: Bathroom > Rear Right  
 Finding: Shower - Monitor  
 Information: Elevated moisture level readings were recorded to the lower 300mm of wall to the bathroom shower alcove at the time of inspection. There was no elevated moisture level readings around the tap area, and no elevated readings transferring outside the shower cubicle or to the other side of the wall in the areas where moisture readings were able to be obtained. Both sealant and grout appear in good condition at present.

This defect is quite common, and is suspected to have been caused by moisture permeating or leaching through the grouting and perhaps gaps in the sealant.

Monitoring the area is advised and if any visual signs of excessive moisture appear (peeling paint, mould) then consultation with a qualified plumber or bathroom specialist would be advised to identify the cause of damp and to perform remedial works as required.

Always ensure that sealant and grout is in good condition to prevent any moisture issues occurring in the future.

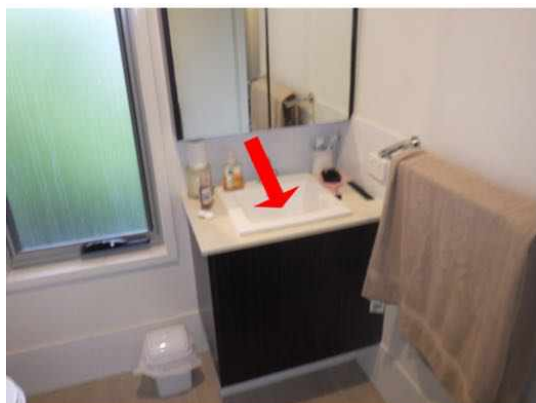
Finding 3.10

Building: Main Building  
 Location: Ensuite > Front Right  
 Finding: Basin - Pop up waste stiff.  
 Information: The ensuite basin pop up waste was stiff to operate at the time of inspection. It is advised that maintenance is carried out on the waste so as it functions as intended.

A handyman could be appointed to perform any remedial works where required.

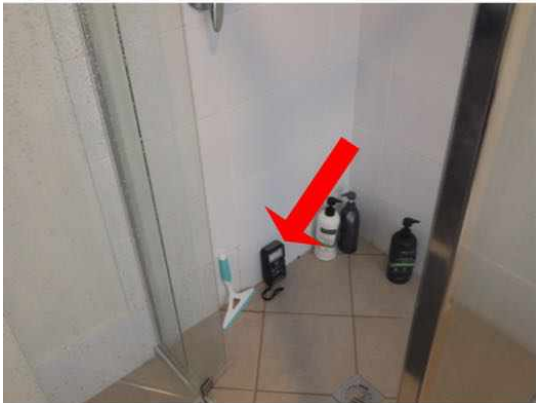
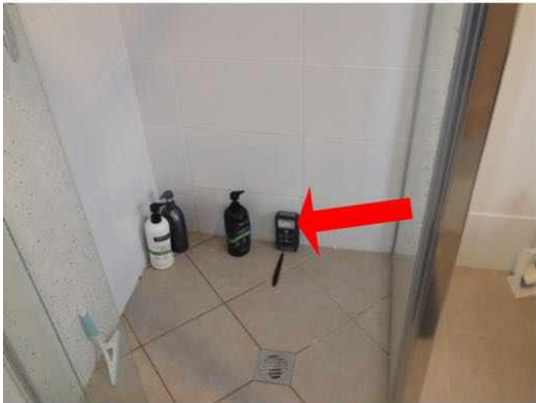
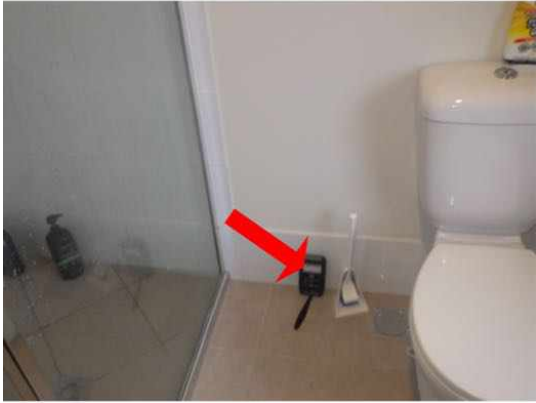
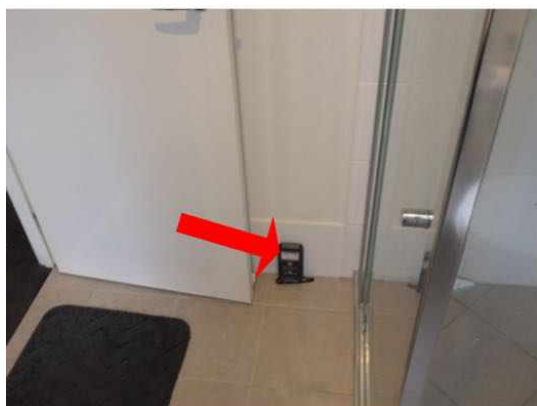
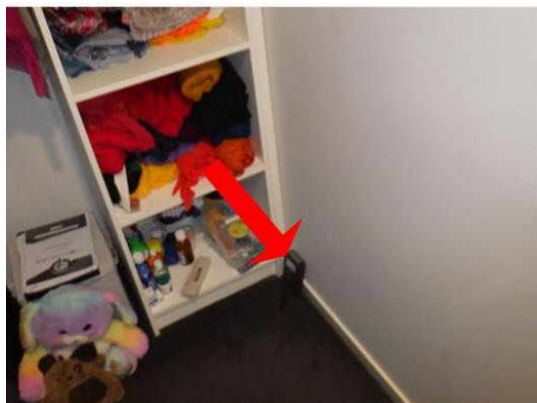
### Finding 3.11

Building: Main Building  
 Location: Ensuite > Rear Left  
 Finding: Shower - Monitor  
 Information: Elevated moisture level readings were recorded to the lower 300mm of wall to the ensuite shower alcove at the time of inspection. There was no elevated moisture level readings around the tap area, and no elevated readings transferring outside the shower cubicle or to the other side of the wall in the areas where moisture readings were able to be obtained. Both sealant and grout appear in good condition at present.

This defect is quite common, and is suspected to have been caused by moisture permeating or leaching through the grouting and perhaps gaps in the sealant.

Monitoring the area is advised and if any visual signs of excessive moisture appear (peeling paint, mould) then consultation with a qualified plumber or bathroom specialist would be advised to identify the cause of damp and to perform remedial works as required.

Always ensure that sealant and grout is in good condition to prevent any moisture issues occurring in the future.

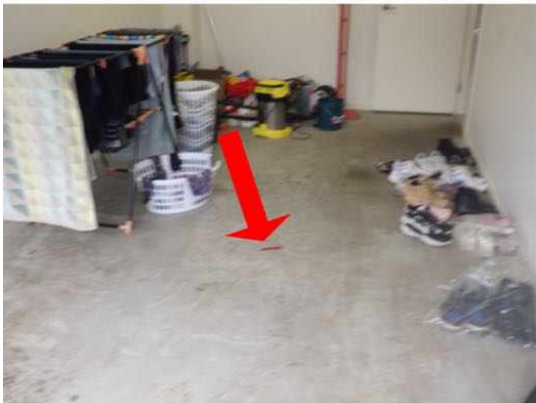
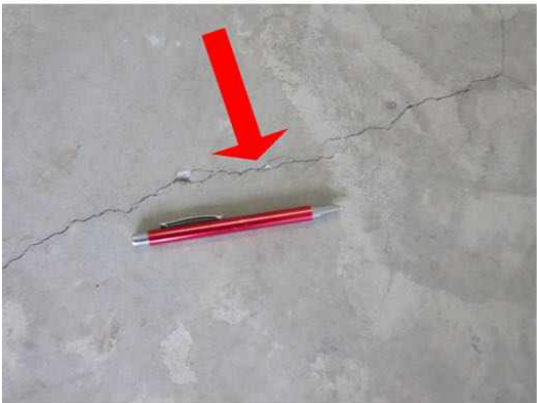
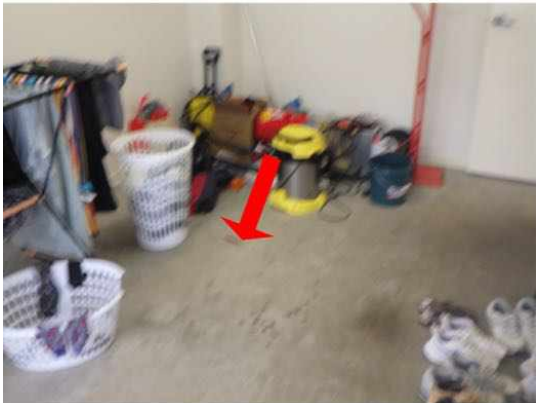
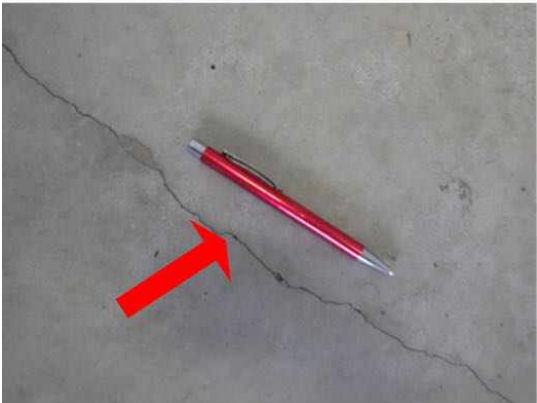
### Finding 3.12

Building:	Main Building
Location:	Garage > Ground Level
Finding:	Cracking in concrete slab - Category 1
Information:	Cracking coded as Category 1 was identified in the garage floor concrete slab (as per example photos). A Category 1 crack is described as a fine but noticeable crack, with the slab at an otherwise reasonable level.

To be considered Category 1, the approximate width of the crack is less than 1.0mm, or a less than 10mm change in offset when a 3m straight edge is placed over the defect.

Category 1 cracks should be monitored for a period of 12 months. At the end of the monitoring period, identified cracks that are rated greater than Category 2 are considered defects, and require rectification.

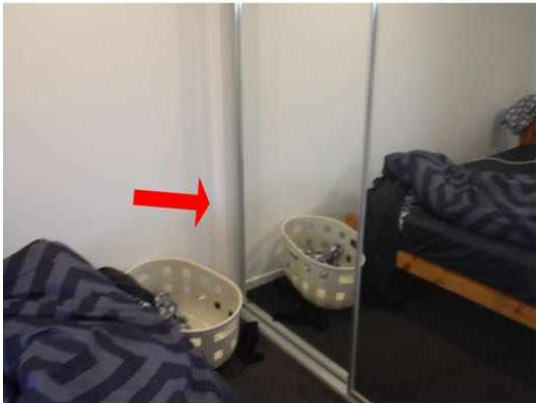
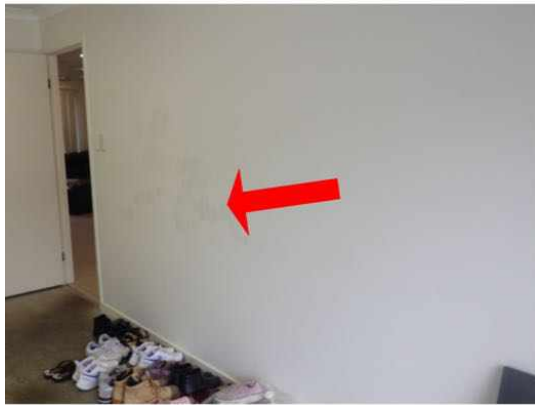
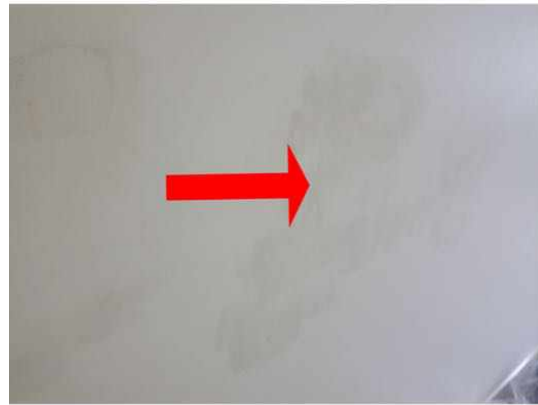
**Finding 3.13**

Building: Main Building  
Location: Internal Areas > Existing  
Finding: Wear and Tear  
Information: At the time of inspection the building interior showed signs of minor cracking and/or scuffing to wall surfaces (as per example photos).

The level of damage appears consistent with general deterioration and/or wear and tear.

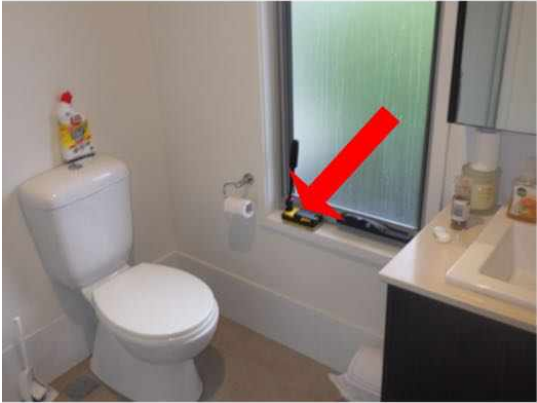
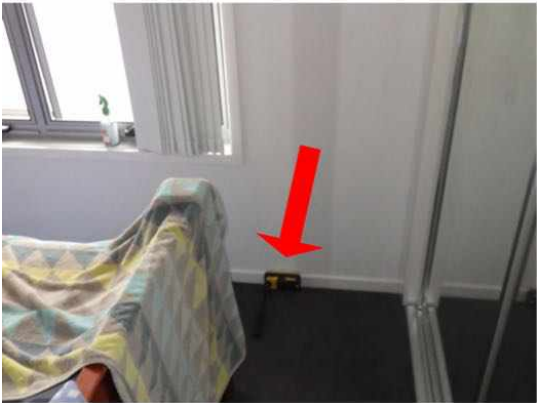
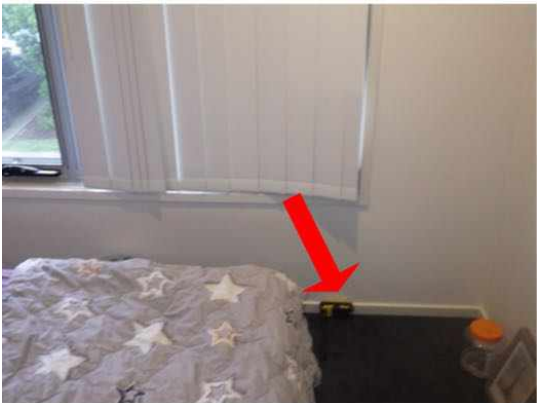
Building: Main Building  
Location: Internal Areas > Existing  
Finding: Termitracker  
Information: The termitracker was positioned randomly to internal wall, timber skirting and window frame areas checking for signs of termite activity.

No activity was recorded at the time of inspection.

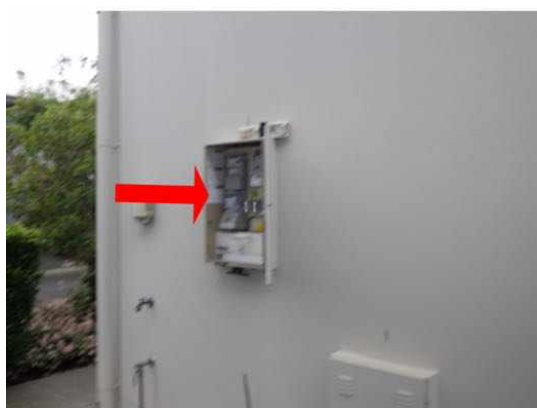
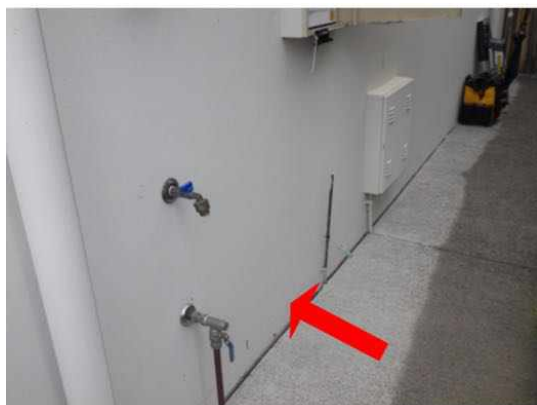
In this instance evidence of a previously installed physical barrier was observed, along with a durable notice inside the electrical meter box.

No evidence of regular or annual inspections was found.

Where a Termite Management System has been identified you should refer to the type of barrier date of installation warranty conditions and any documentation provided by a past owner or possibly the buildings body corporate managers.
