# Building and Timber Pest Inspection Report

Inspection Date: Wed, 21 Jan 2026

Property Address: 4 Wentworth St, Palmers Island NSW 2463,  
Australia

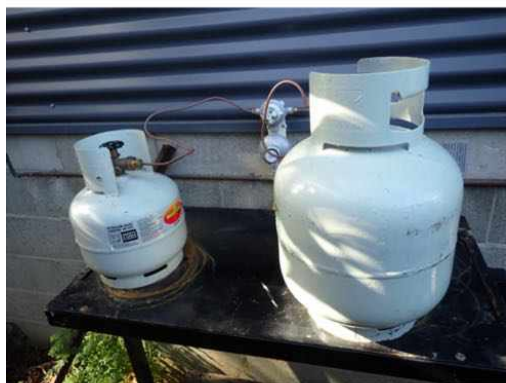
#### Finding 1.01

Building:	Main Building
Location:	Left hand elevation
Finding:	Gas Bottles – Not Secured and Non-Compliant
Information:	The gas bottles were found to be unsecured at the time of inspection and are considered non-compliant. This presents a potential safety risk and does not meet current installation requirements. It is recommended that a suitably qualified gas fitter or licensed tradesperson secure and rectify the installation as deemed necessary to achieve compliance and improve safety.

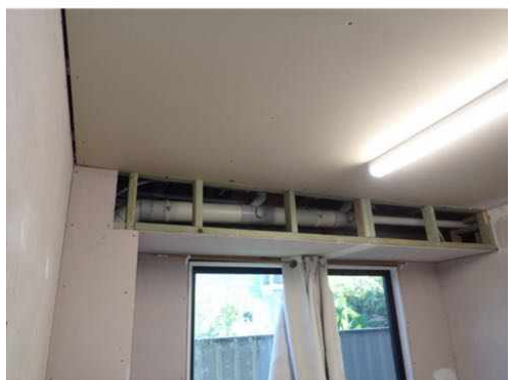
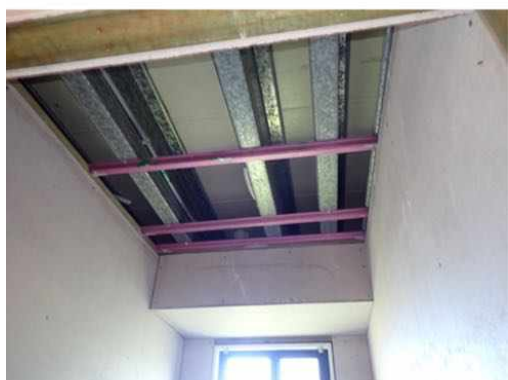
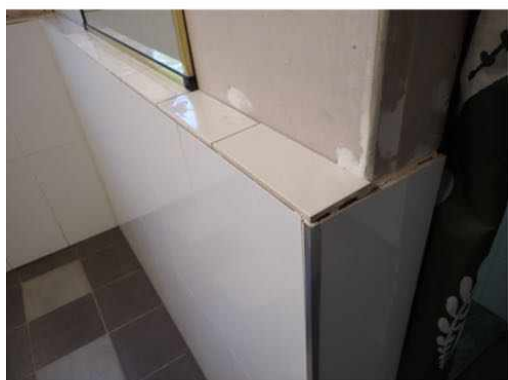
#### Finding 2.01

Building:	Main Building
Location:	Laundry
Finding:	Ground Floor Bathroom/Laundry – Unfinished Works
Information:	The ground floor bathroom/laundry was found to be unfinished at the time of inspection. This includes incomplete fixtures and finishes, which may affect functionality and compliance. It is recommended that a suitably qualified tradesperson complete the remaining works as deemed necessary to bring the area to an acceptable standard.

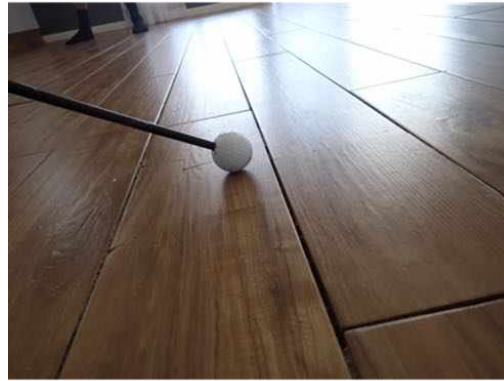
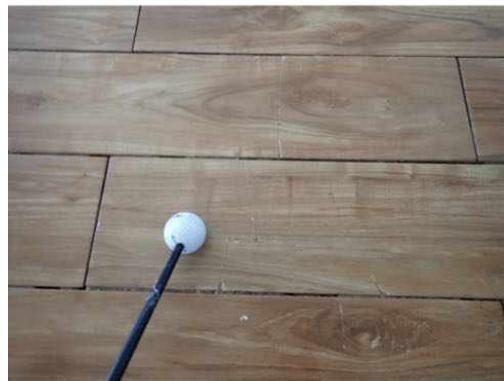
## Finding 2.02

Building:	Main Building
Location:	Top floor tiled area
Finding:	Top Floor – Floor Tiles in Poor Condition
Information:	The floor tiles to the top floor were found to be in poor condition at the time of inspection and require replacement. This may be due to age-related deterioration, poor installation, or issues with the underlying substrate. It is recommended that a suitably qualified tiler remove the tiles, assess the substrate, and carry out repairs or replacement as deemed necessary before re-tiling to ensure a suitable finish.

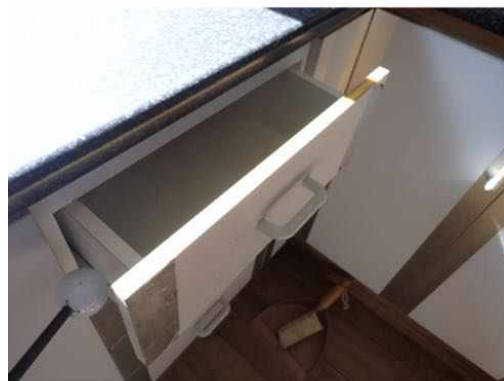
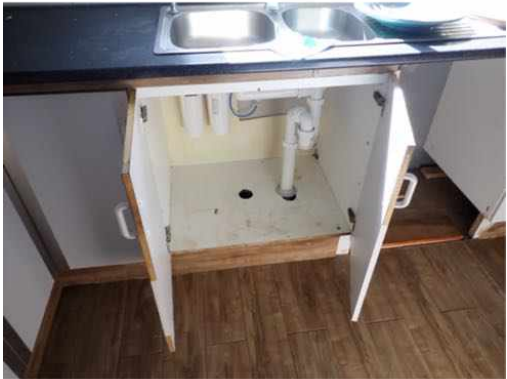
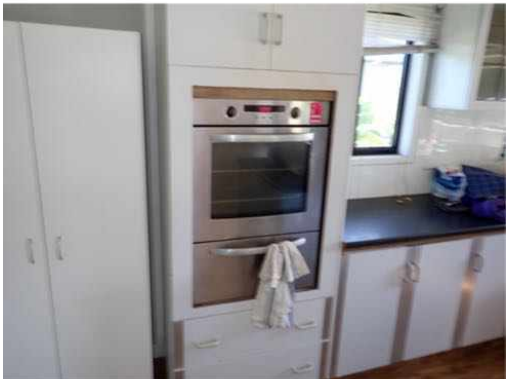
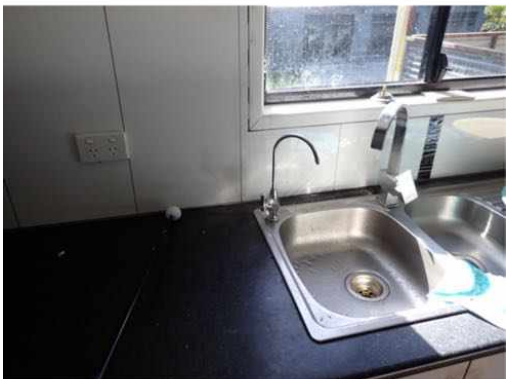
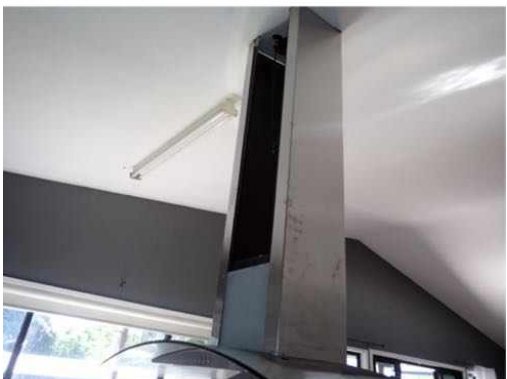
### Finding 2.03

Building:	Main Building
Location:	Kitchen
Finding:	Kitchen – Poor Condition Due to Incomplete Installation and Lack of Maintenance
Information:	The kitchen was found to be in poor condition at the time of inspection due to poor and incomplete installation and a lack of general maintenance, although it was functional. If left unaddressed, the condition may continue to deteriorate over time. It is recommended that a suitably qualified tradesperson carry out repairs, completion works, and general maintenance as deemed necessary to improve the overall condition and longevity of the kitchen.

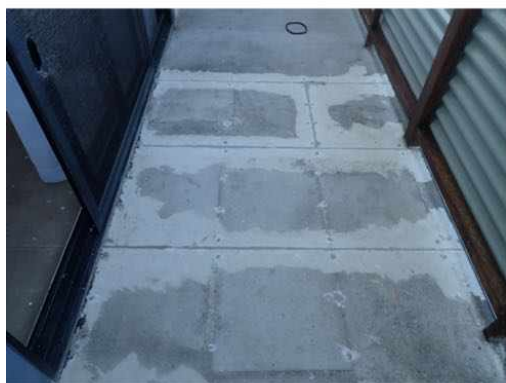
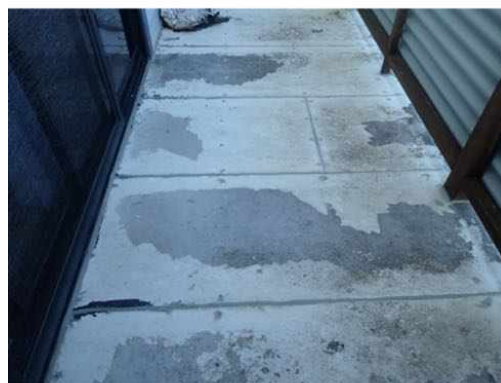
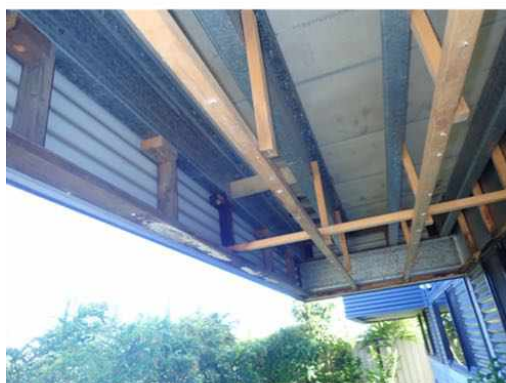
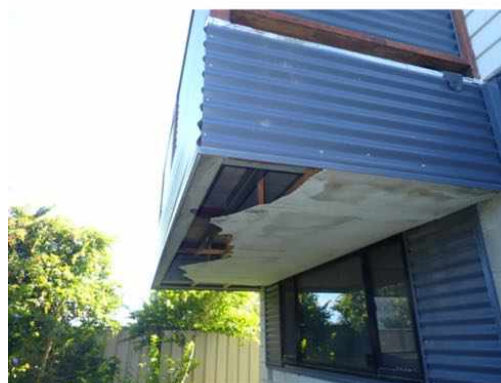
Finding 2.04

Building:	Main Building
Location:	Bedroom balcony's
Finding:	Bedroom Balconies – Inadequate Waterproofing Causing Damage Below
Information:	A lack of effective waterproofing to the bedroom balconies was identified at the time of inspection, which has resulted in damage to the timber framework and internal linings below the balconies. This indicates ongoing moisture penetration. If left unaddressed, further deterioration and potential further structural issues may occur. It is recommended that a suitably qualified builder or waterproofing specialist assess the balconies, rectify the waterproofing, and repair the damaged timber and linings as deemed necessary.

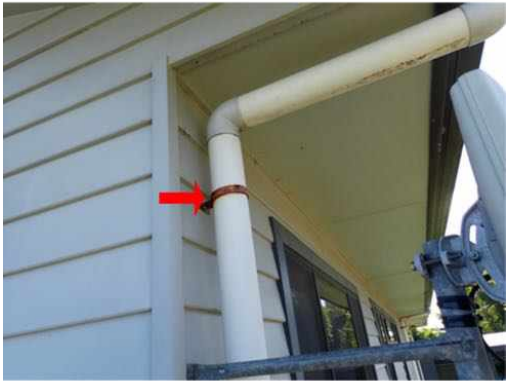
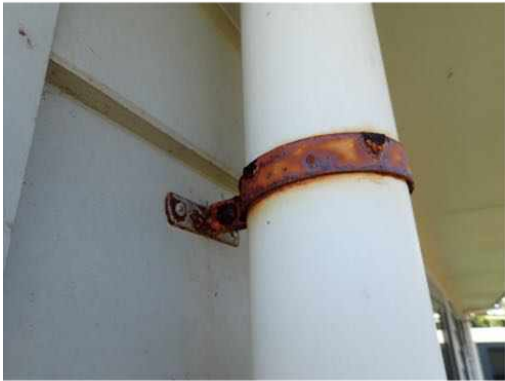
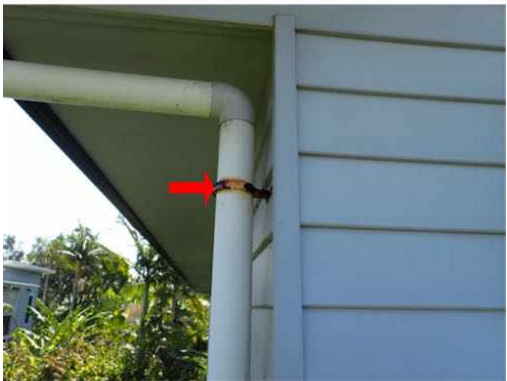
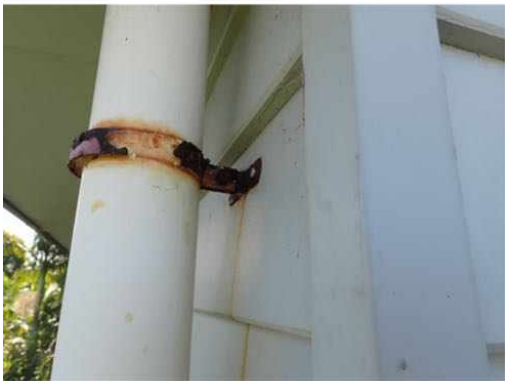
## Finding 2.05

Building:	Main Building
Location:	Down pipes
Finding:	Downpipe Brackets – Rusted and Require Replacement
Information:	Rust was identified to the downpipe brackets at the time of inspection, indicating age-related deterioration. If left unaddressed, the brackets may fail and affect the stability of the downpipe. It is recommended that a suitably qualified tradesperson replace the affected brackets as deemed necessary to ensure the downpipe is adequately supported.

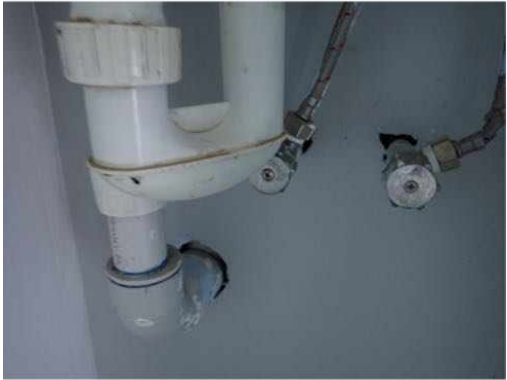
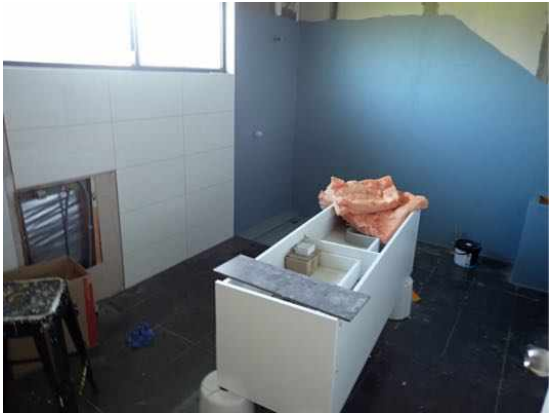
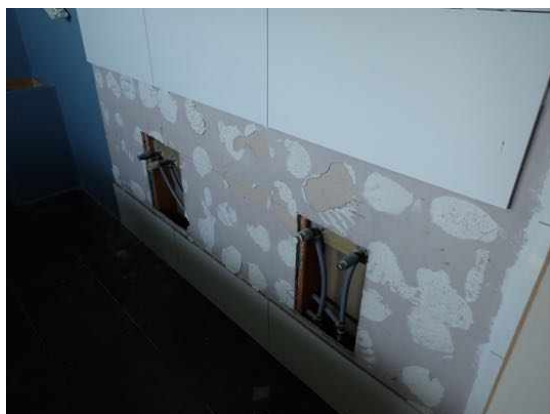
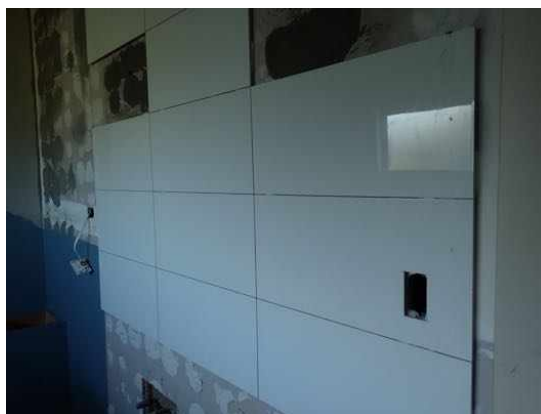
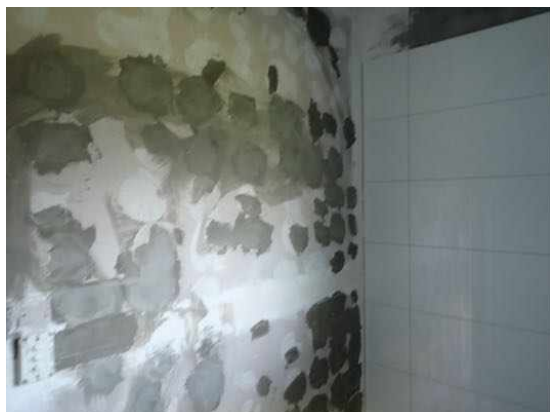
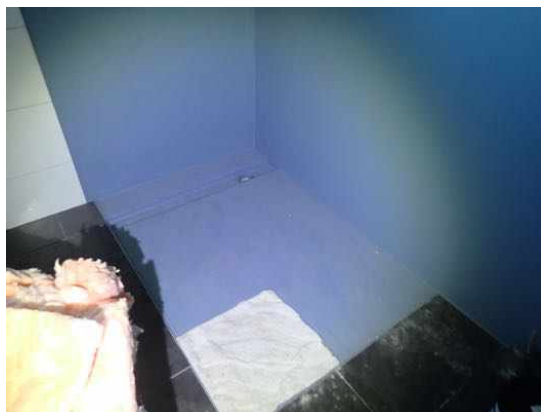
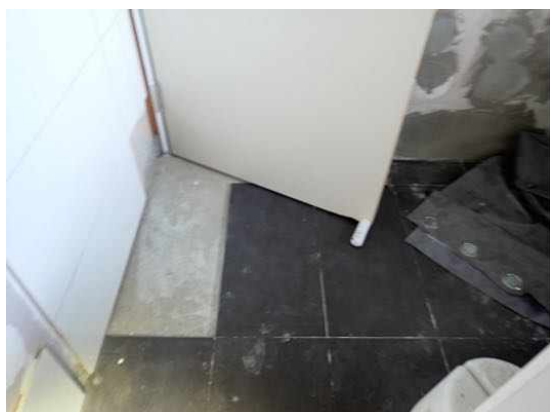
**Finding 2.06**

Building: Main Building  
Location: Bathroom  
Finding: Ground Floor Bathroom – Unfinished Works  
Information: The main bathroom was found to be unfinished at the time of inspection. This includes incomplete fixtures and finishes, which may affect functionality and compliance. It is recommended that a suitably qualified tradesperson complete the remaining works as deemed necessary to bring the area to an acceptable standard.

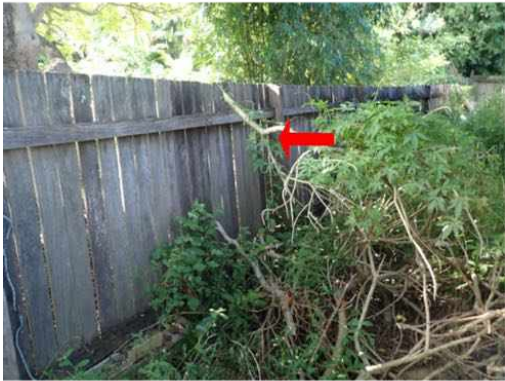
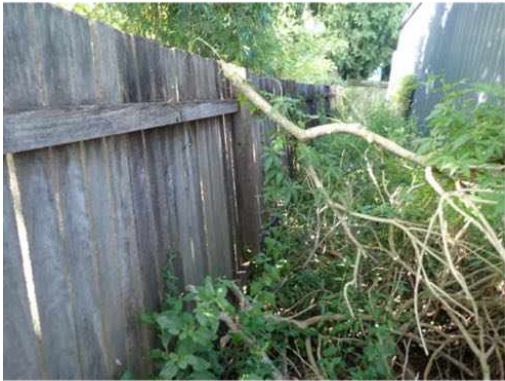
**Finding 2.08**

Building: Main Building  
Location: Rear boundary  
Finding: Rear Boundary Timber Fence – Poor Condition  
Information: The rear boundary timber fence was found to be in poor condition at the time of inspection. This is likely due to age-related deterioration and weather exposure. If left unaddressed, further deterioration and loss of stability may occur. It is recommended that a suitably qualified fencing contractor or tradesperson repair or replace the fence as deemed necessary.

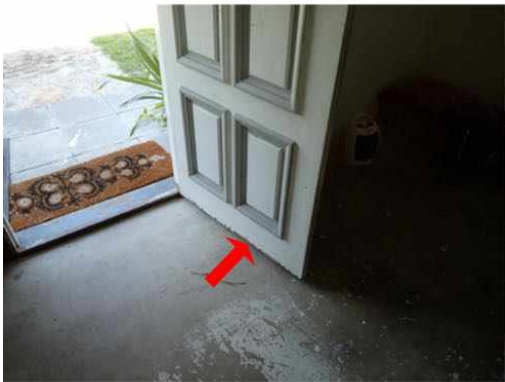
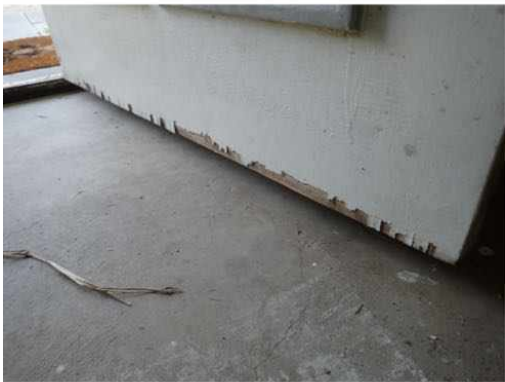
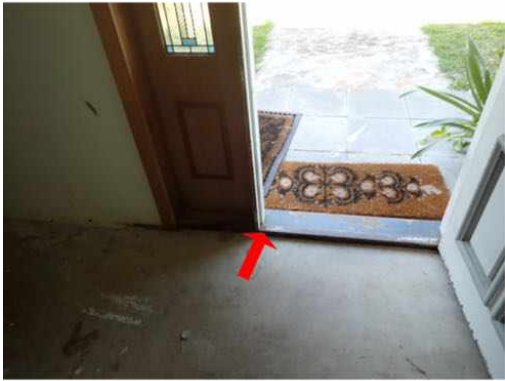
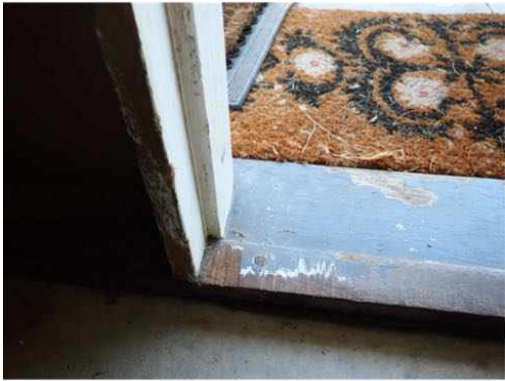
#### Finding 3.01

Building: Main Building  
Location: All Areas  
Finding: Internal Doors – Generally in Need of Repair and Maintenance  
Information: The doors throughout the building were found to be generally in need of repair and maintenance at the time of inspection. This may include adjustment, repair of hardware, painting or general servicing due to unfinished works, poor installation and age-related wear and tear. It is recommended that a suitably qualified carpenter or general handyman carry out repairs and maintenance as deemed necessary to restore proper operation and condition.

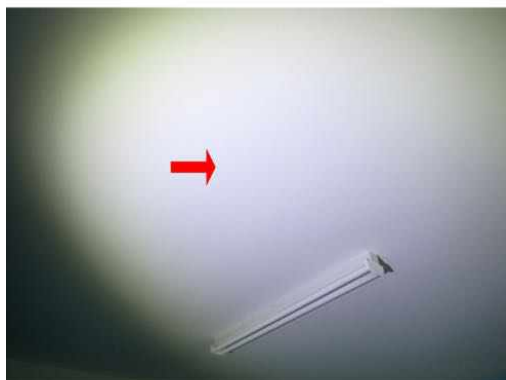
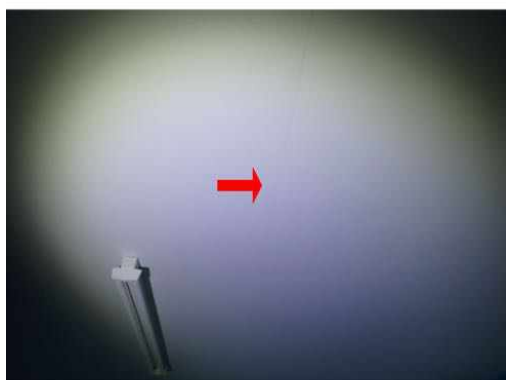
Finding 3.03

Building:	Main Building
Location:	Ground floor concrete slab
Finding:	Ground Floor Ceiling – Minor Cracks to Plaster
Information:	Minor cracks were identified in the ground floor ceiling plaster at the time of inspection. These may be related to poor installation, minor movement, or shrinkage of materials. While not considered structurally significant, it is recommended that the cracks be repaired and monitored as deemed necessary by a suitably qualified tradesperson to maintain the ceiling finish.

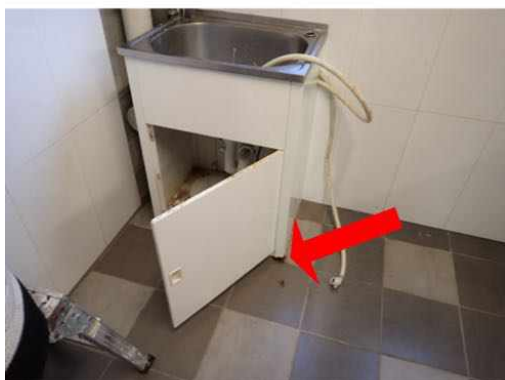
### Finding 3.04

Building:	Main Building
Location:	Laundry
Finding:	Laundry Tub Cabinet – Rust to Bottom Section
Information:	Rust was identified to the bottom of the laundry tub cabinet at the time of inspection. This is likely due to prolonged exposure to moisture. If left unaddressed, the corrosion may continue to deteriorate the cabinet. It is recommended that a suitably qualified tradesperson repair, treat, or replace the affected cabinet as deemed necessary to prevent further deterioration.

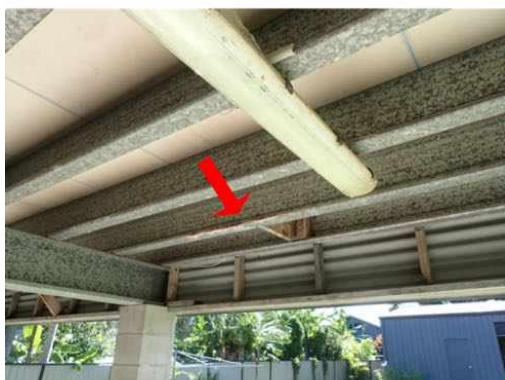
### Finding 3.05

Building:	Main Building
Location:	Carport
Finding:	Carport – Surface Rust to Steel Floor Joist
Information:	Surface rust was identified to a steel floor joist within the carport at the time of inspection. This is consistent with age-related deterioration and exposure to moisture. While the rust appeared to be superficial, ongoing corrosion may occur if left unaddressed. It is recommended that a suitably qualified tradesperson clean, treat, and protect the affected steelwork as deemed necessary to prevent further deterioration.

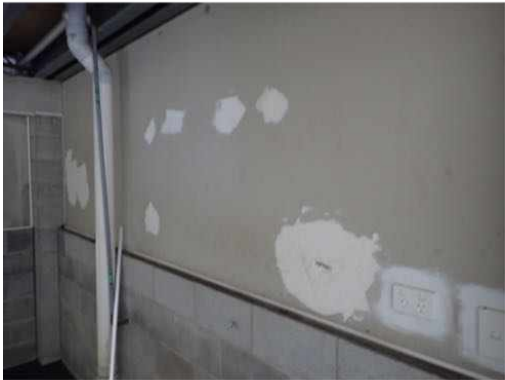
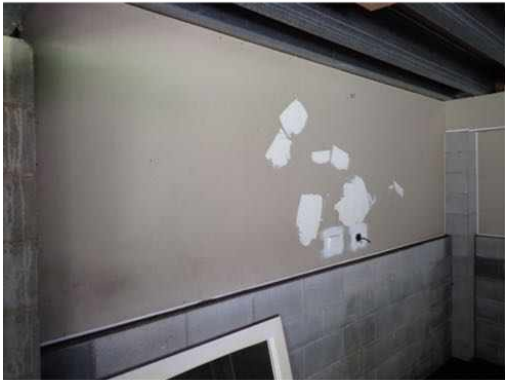
### Finding 3.06

Building:	Main Building
Location:	Carport
Finding:	Carport – Unfinished Works
Information:	Unfinished works were identified to the carport at the time of inspection. This includes incomplete construction of finishing items that may affect functionality and appearance. It is recommended that a suitably qualified tradesperson complete the remaining works as deemed necessary to bring the carport to an acceptable standard.

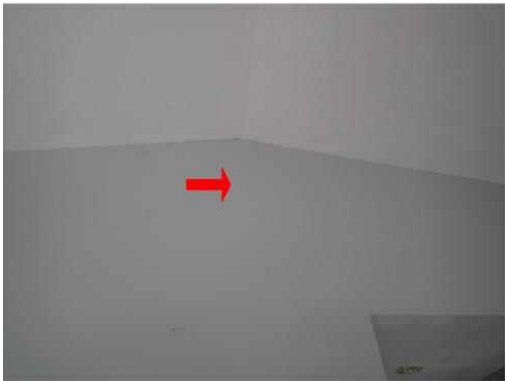
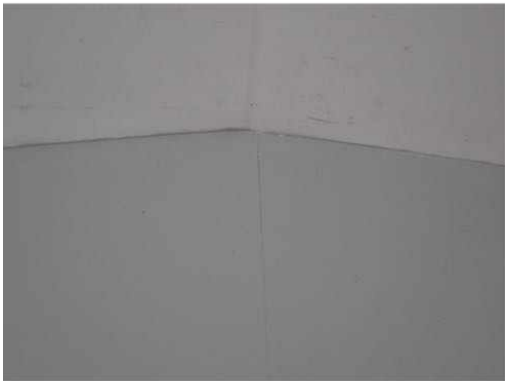
**Finding 3.07**

Building: Main Building  
Location: Living room  
Finding: Living Room – Minor Cracking to Internal Cladding  
Information: Minor cracking was identified to the internal cladding in the living room at the time of inspection. This appears consistent with minor movement and age-related wear. While not considered structurally significant, it is recommended that the affected areas be repaired and monitored as deemed necessary by a suitably qualified tradesperson to maintain the condition of the internal finishes.

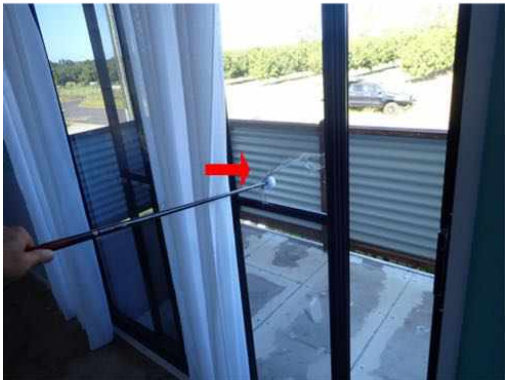
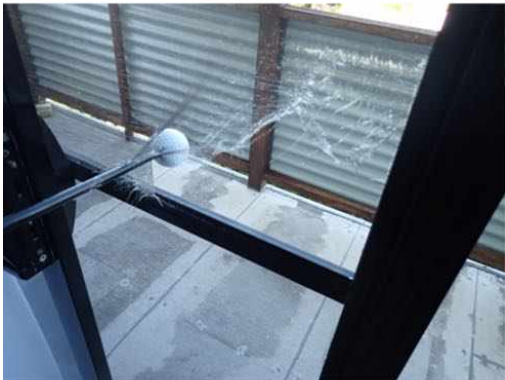
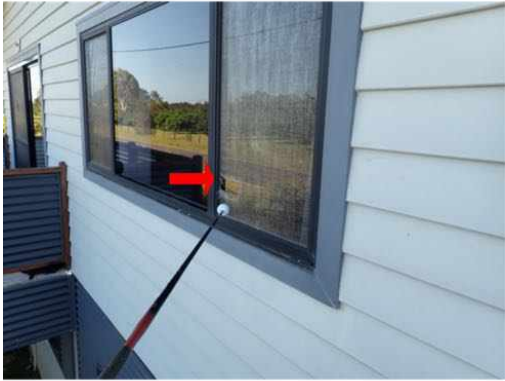
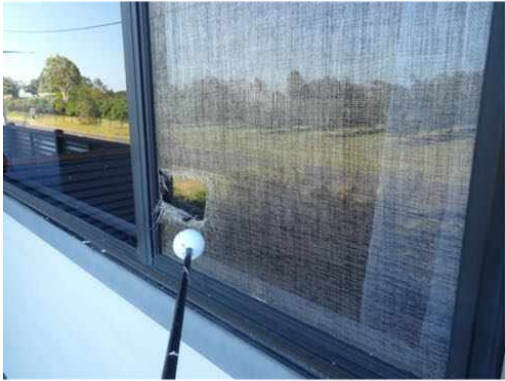
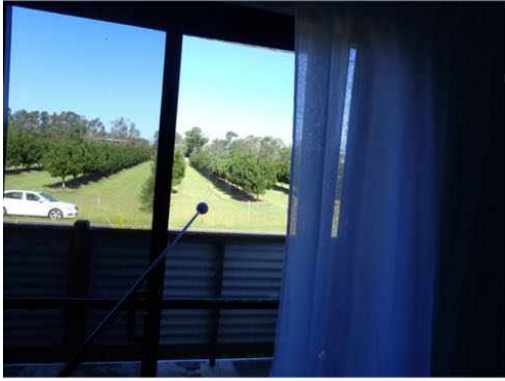
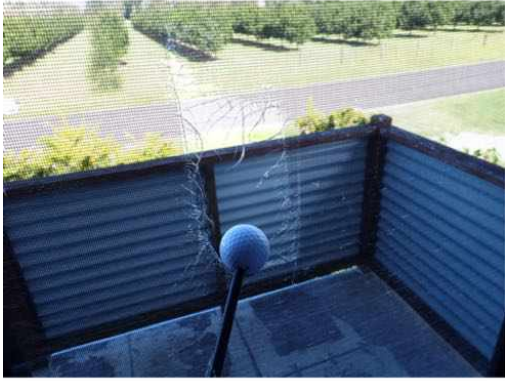
**Finding 3.09**

Building: Main Building  
Location: Bedrooms  
Finding: Bedroom sliding doors and window – Damaged Fly Screens  
Information: Damaged fly screens were identified to the bedroom windows and sliding doors at the time of inspection. This may reduce their effectiveness in keeping insects out and affect usability. It is recommended that a suitably qualified tradesperson repair or replace the affected fly screens as deemed necessary.

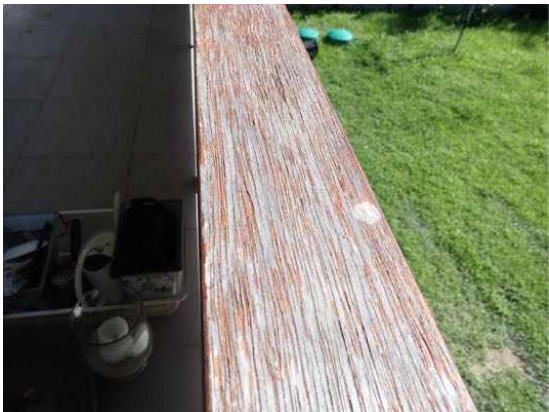
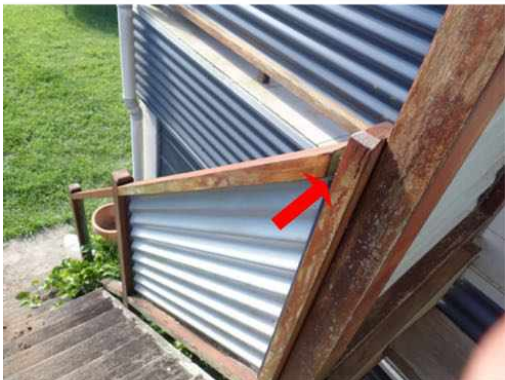
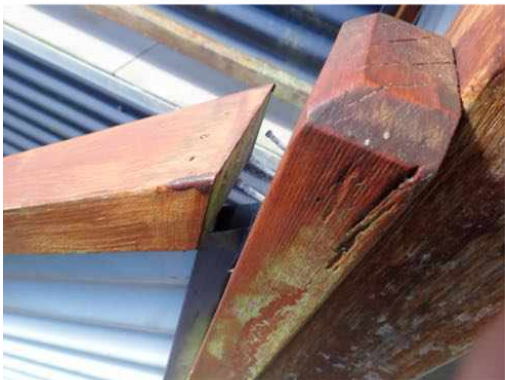
**Finding 3.10**

Building: Main Building  
Location: Balustrades, stair handrails and stairs  
Finding: Balustrades, Stairs and Handrails – Fair Condition, Maintenance Required  
Information: The balustrades, stairs, and stair handrails were found to be in fair condition at the time of inspection, however general maintenance and minor repair works are required. This is consistent with age-related wear and use. It is recommended that a suitably qualified tradesperson carry out maintenance and minor repairs as deemed necessary to maintain safety and serviceability.

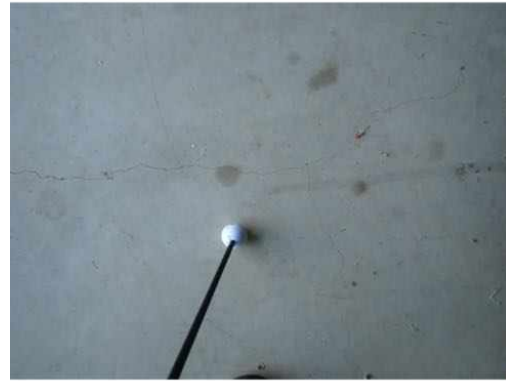
**Finding 3.11**

Building: Main Building  
 Location: Shed  
 Finding: Garage Concrete Slab – Several Minor Cracks  
 Information: Several minor cracks were identified in the garage concrete slab at the time of inspection. These appear consistent with general shrinkage and age-related movement. While not considered structurally significant, it is recommended that the cracks be monitored and repaired as deemed necessary by a suitably qualified tradesperson to help prevent further deterioration.

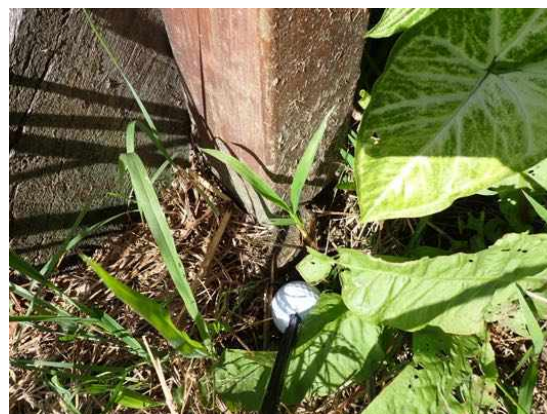
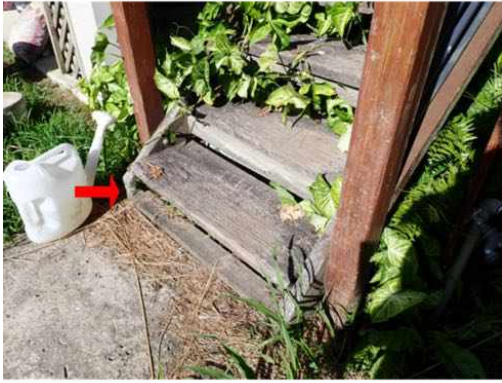
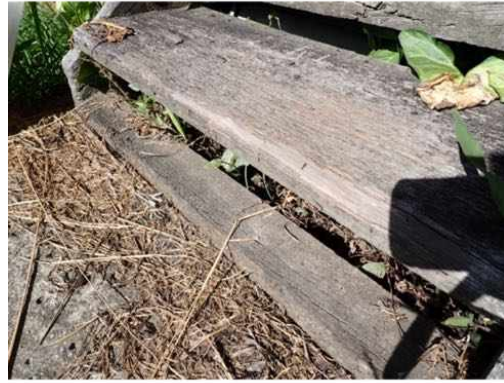
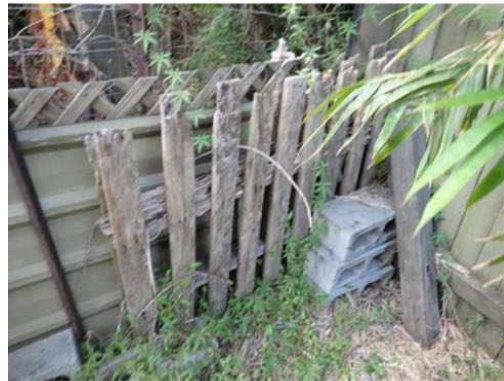
### Finding 6.01

Building:	Main Building
Location:	Rear boundary and rear stairs
Finding:	Timber in Contact with Ground – Conditions Conducive to Termite Attack
Information:	Timber elements were identified in direct contact with the ground at the time of inspection, creating conditions that are conducive to termite attack. This may increase the risk of concealed termite activity and timber damage. It is recommended that a suitably qualified tradesperson rectify the timber-to-ground contact and that a licensed timber pest technician be consulted to provide appropriate termite management measures as deemed necessary.

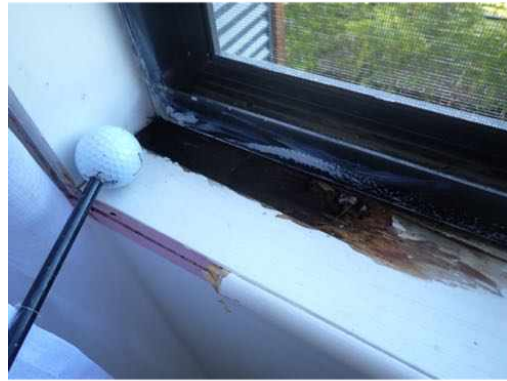
### Finding 7.01

Building:	Main Building
Location:	Bedroom
Finding:	Bedroom Window Frame – Wood Rot Identified
Information:	Wood rot was identified to the bedroom window frame at the time of inspection. This is likely due to prolonged moisture exposure. If left unaddressed, the deterioration may worsen and affect the integrity of the window. It is recommended that a suitably qualified carpenter repair or replace the affected timber and address the source of moisture as deemed necessary.

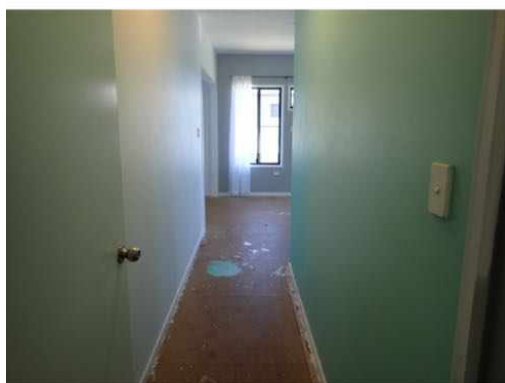
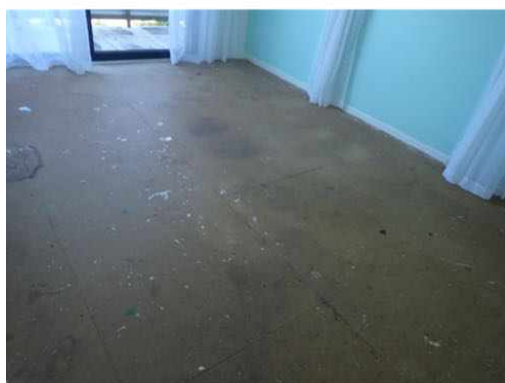
Building:	Main Building
Location:	Bedrooms
Finding:	Bedrooms – Missing Floor Coverings
Information:	Floor coverings were missing in the bedrooms at the time of inspection. This leaves the underlying floor exposed and may affect comfort and durability. It is recommended that a suitably qualified flooring contractor install appropriate floor coverings as deemed necessary to complete the rooms.

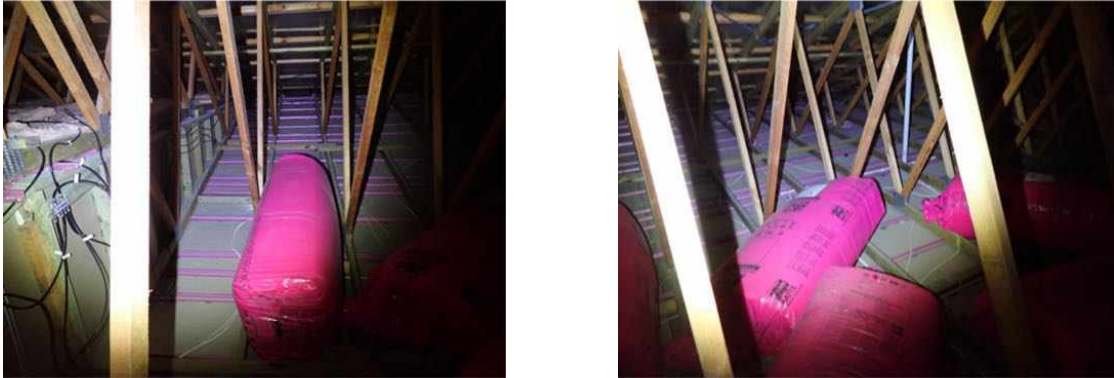
Building:	Main Building
Location:	Ceiling space
Finding:	Ceiling Insulation – Battens Not Installed to Part of Ceiling Space
Information:	Ceiling insulation battens were not installed to approximately half of the ceiling space at the time of inspection. This may affect the support and performance of the insulation and could lead to sagging or reduced thermal efficiency. It is recommended

that a suitably qualified tradesperson install appropriate insulation battens to the affected areas as deemed necessary to ensure the insulation is correctly supported and effective.

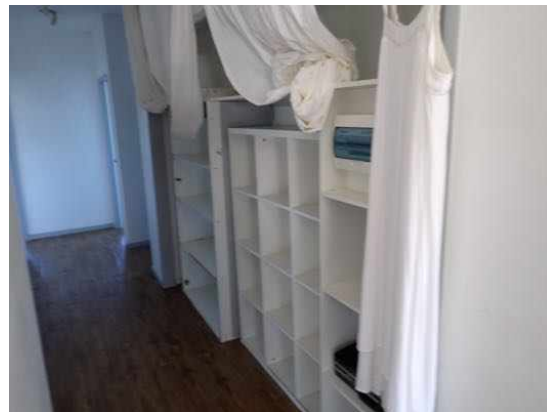
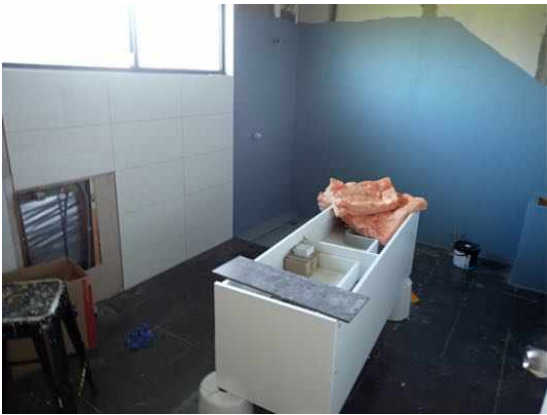
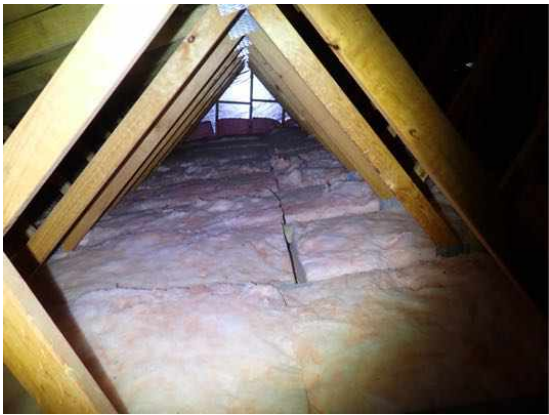
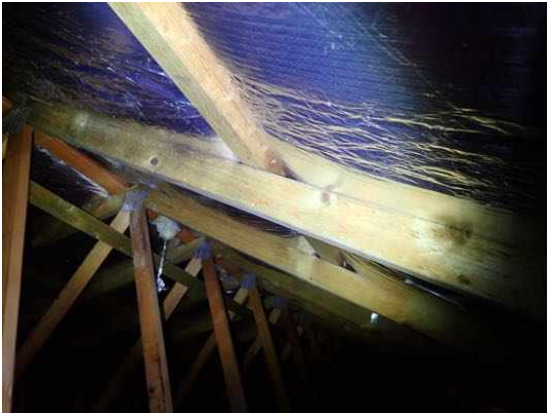
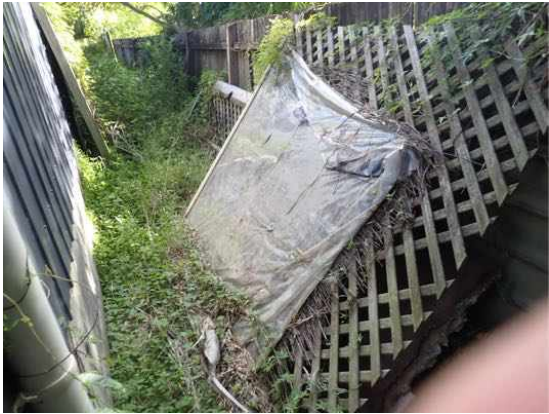
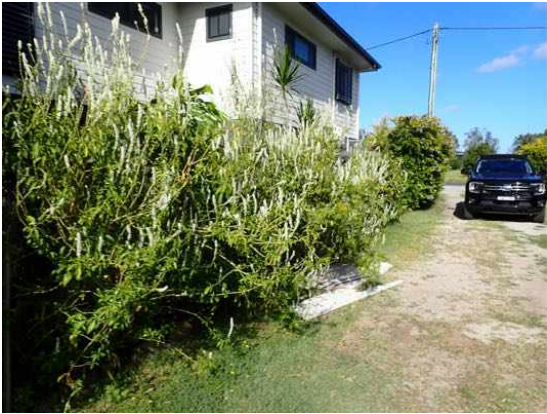
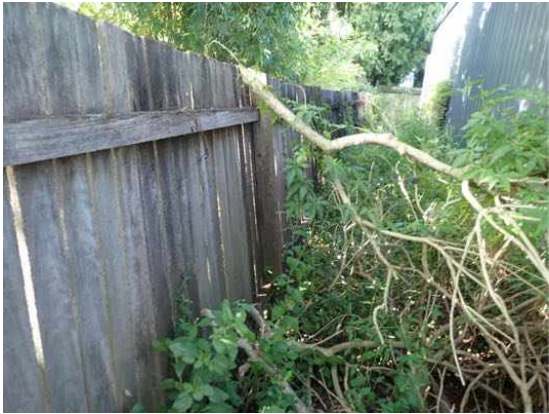
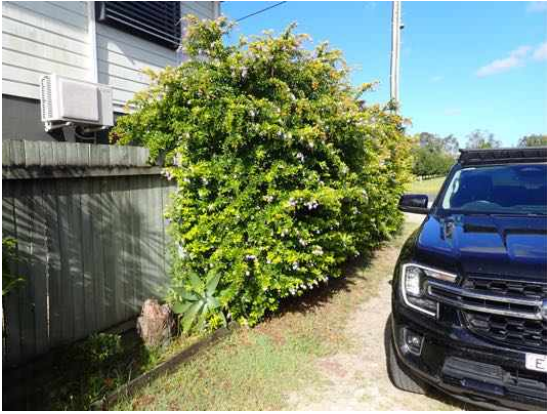
Information: These photographs are an indication of the obstructions and limitations which impeded full inspection of the area at the time of inspection. These obstructions can hide an array of defects and should be removed to allow full inspection to be carried out. A re-inspection is recommended once the areas are made accessible.

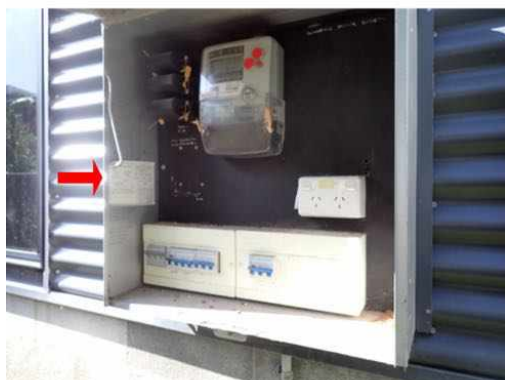
Building:	Main Building
Location:	Electrical meter box
Finding:	Evidence of a previous termite management system was identified
Information:	There are a number of factors which indicate the presence of a previously installed or applied termite barrier. The most common are a durable notice (to the inside of your meter box) observable physical barriers installed to building perimeter and in ground reticulation systems.
