# Building and Timber Pest Inspection Report

Inspection Date: Mon, 16 Feb 2026

Property Address: 42 Crackenback St, Thurgoona NSW 2640,  
Australia

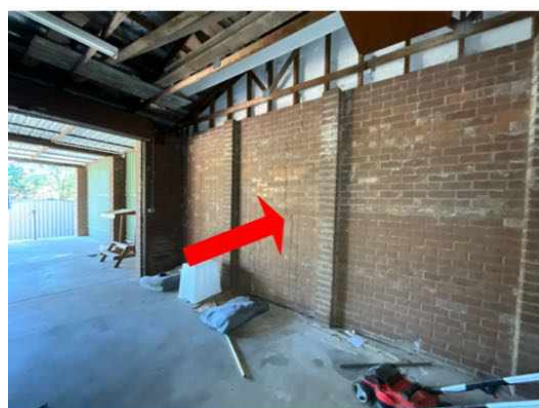
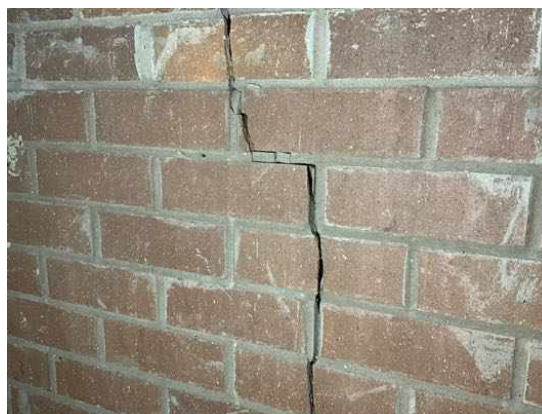
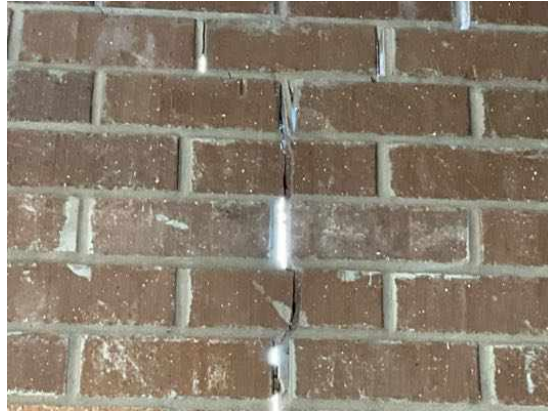
Building: Building 1  
Location: Garage  
Finding: Brickwork - Cracking [Repair required]  
Information: Major cracking was identified to the brickwork in this area. Cracks of this type are likely to have been caused by minor expected movement of building elements, but may also have a structural cause that is more significant.

A crack of this size may be repaired by extensive filling. Additionally, further remedial works to associated building elements, such as eave sheeting or external door frames, is likely to be required.

A qualified bricklayer should be contacted immediately to estimate and perform repair and restoration works. Consultation with a structural engineer may be required where structural instability is found to be the underlying cause of the cracking.

Always contact a building inspector should cracks widen, lengthen, or become more numerous.

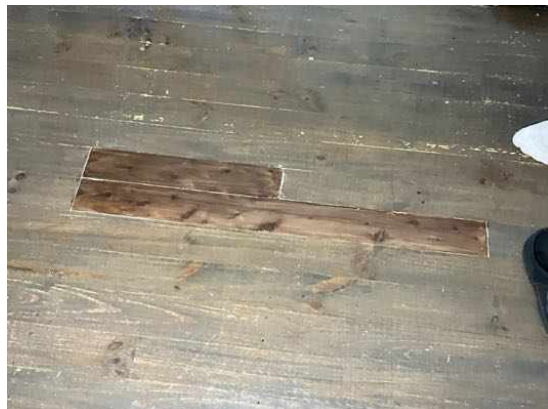
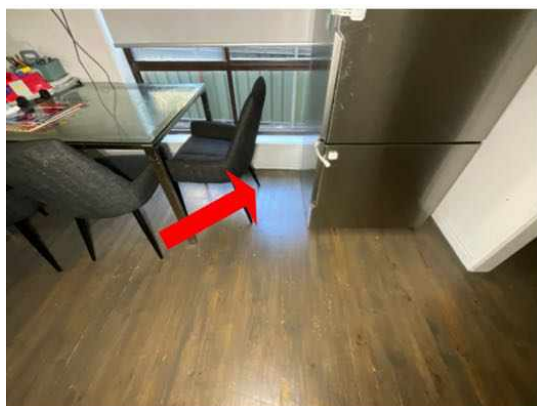
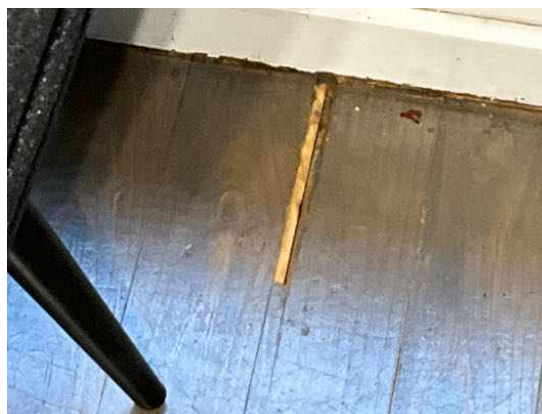
### Finding 3.01

Bouncy floors generally indicate that the floorboards or the subfloor structures are coming loose from the joists that they are installed on. Bouncy flooring may also be the result of gaps between flooring and stumps or joist structures, which require packing.

The client is advised to seek quotations for required repairs from a Registered Builder specialising in re-stumping. The potential resolution may range from packing gaps in subfloor structures through to replacement of subfloors stumps and refixing of flooring.

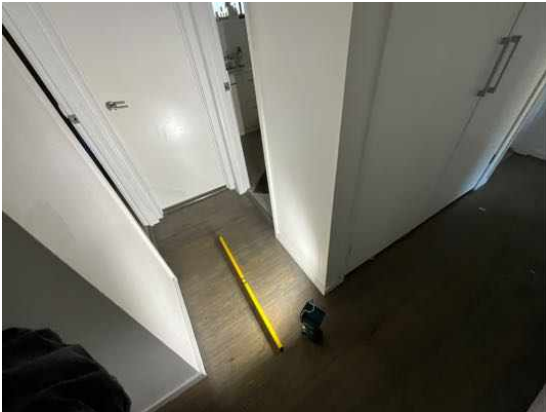
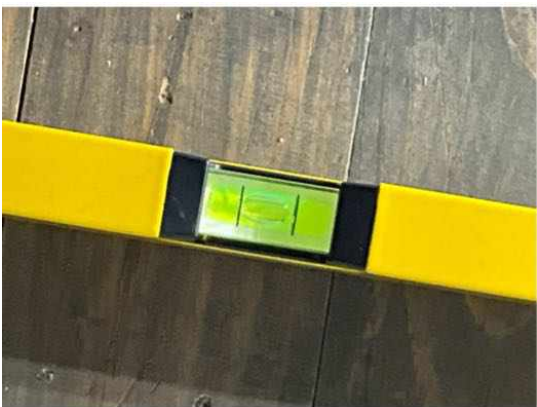
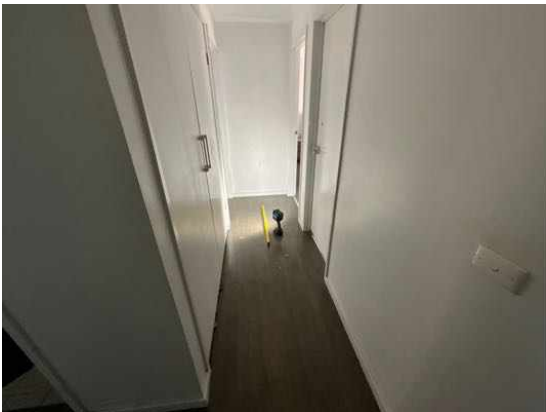
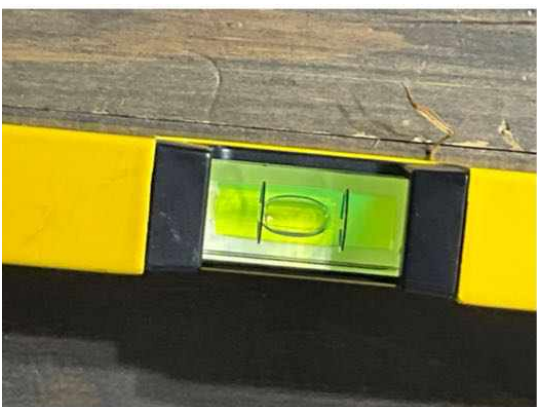
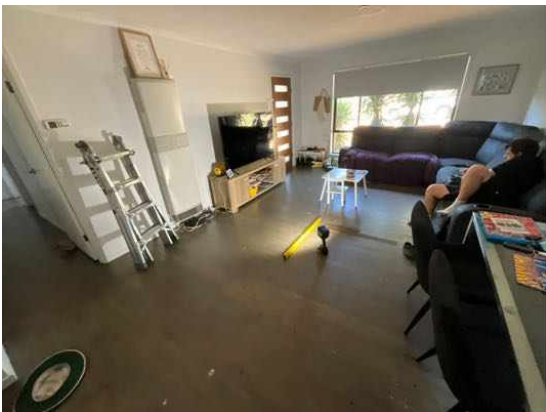
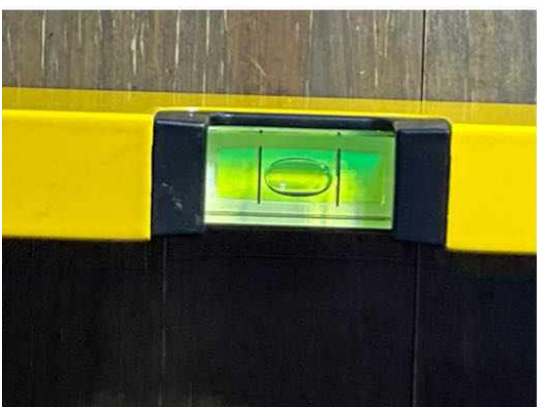
### Finding 3.02

Building:	Building 1
Location:	All Internal Areas
Finding:	Flooring - slightly uneven
Information:	The internal flooring in this area is out of level and uneven. Uneven flooring is likely to indicate minor defects such as expected movement of the foundations of the property, but may also indicate subsidence of the associated subfloor stumps.

It is advised that the flooring be closely monitored to identify any further movement. Where flooring remains relatively unchanged for an extended period of time (i.e. several months), it is likely that this defect has been caused by expected movement of the foundations of the property.

However, where flooring is increasingly uneven, potentially invasive inspection of the subfloor structures and stumps in this area is required. In this case, works to repair are likely to be required, and would be carried out by a registered builder specialising in re-stumping.

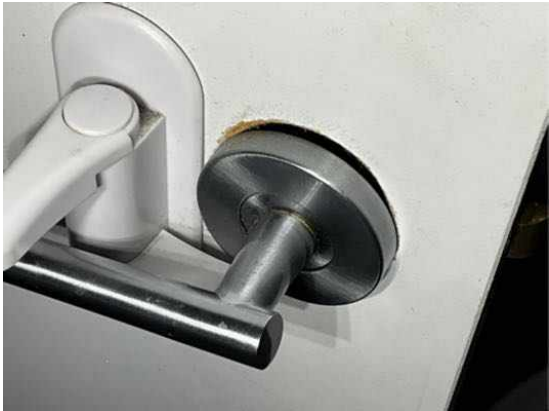
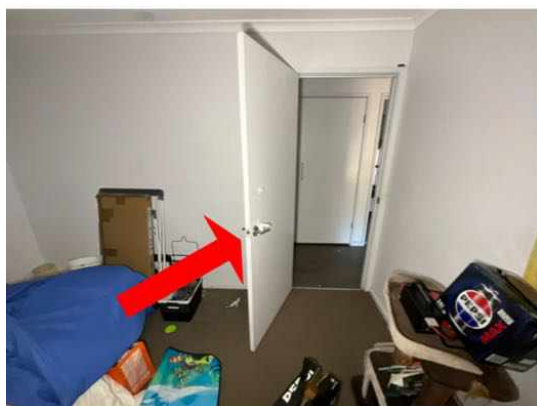
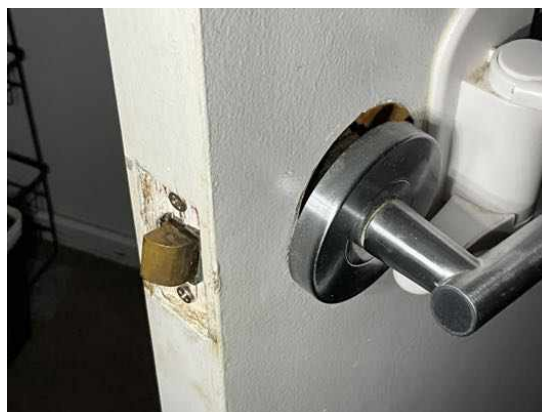
**Finding 3.04**

Building: Building 1  
Location: Laundry, bed 3  
Finding: Door handle- Poor operation  
Information: The door handle/ catch in this area was found to be faulty during the visual inspection. This is most probably because of a lack of maintenance or wear and tear over time.

A general Handy person or lock specialist should be contacted to make needed repairs at the discretion of the owner and restore full function.

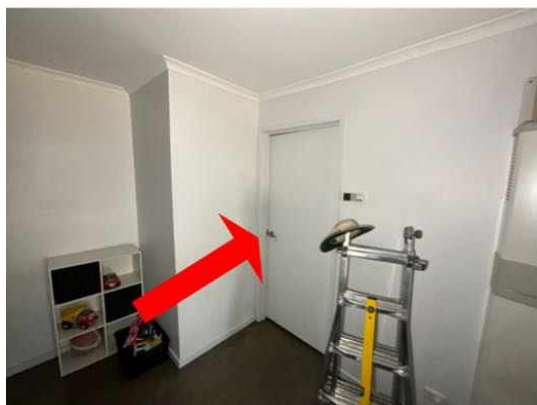
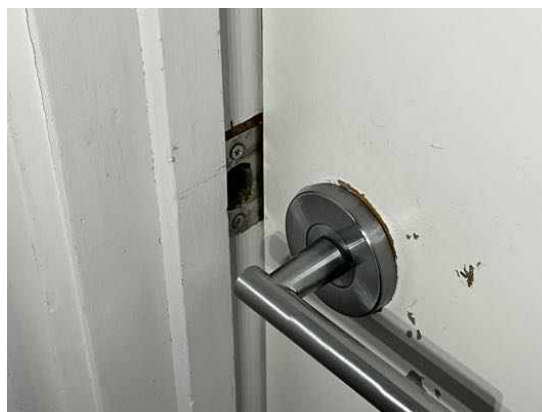
### Finding 3.05

This is a common defect and is expected in a property of this age, whether being due to substandard installation or general deterioration of the door hardware.

Readjustment of the striker plate is recommended at client discretion. Works such as these can be completed by a general handyman or qualified carpenter.

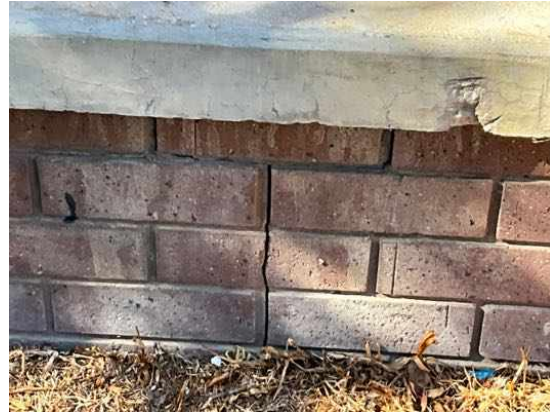
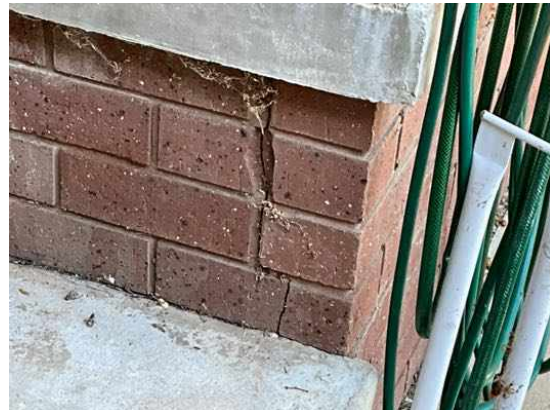
### Finding 3.06

Finding: Brickwork - Cracking noticeable

Information: There were several cracks and or crack repairs evident to external brickwork.

Noticeable cracks are a common occurrence in external brickwork and are a likely result of age expected building movement, general expansion, and/or contraction of building materials in different weather conditions. Noticeable cracks in brickwork may

develop if left unattended, with potential for necessitating major remedial works or replacement of the brickwork.

It is highly advised that a qualified bricklayer be appointed to provide necessary works to cracked brickwork to prevent any further damage. Such works should be conducted as soon as possible.

Always monitor these cracks and contact a building inspector should cracks widen, lengthen, or become more numerous.

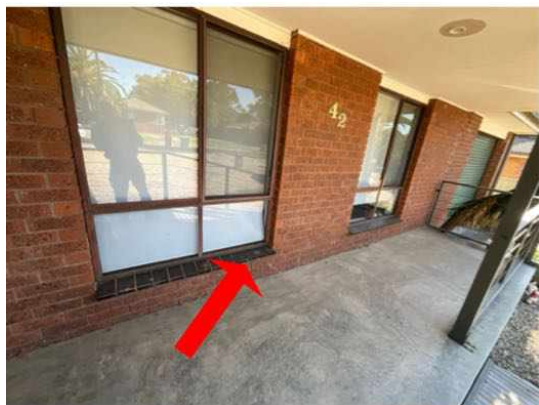
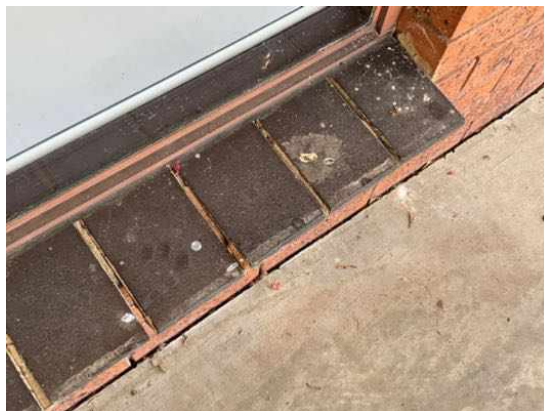
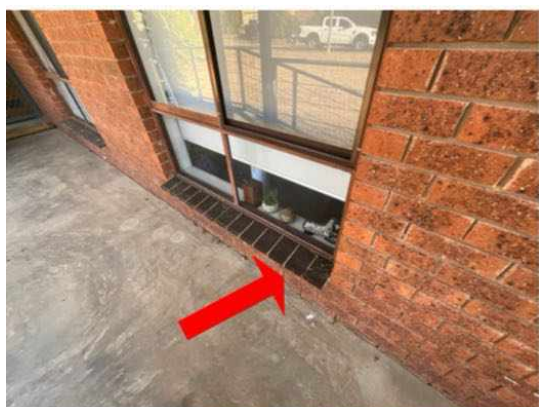
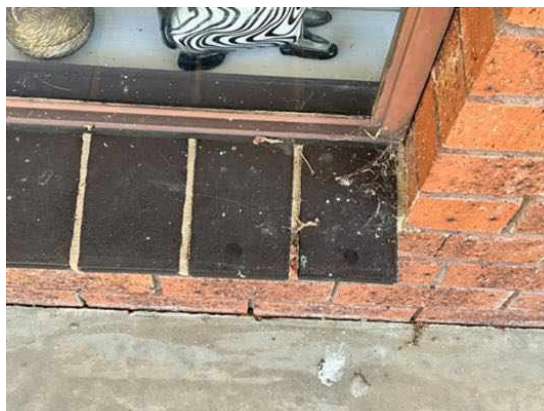
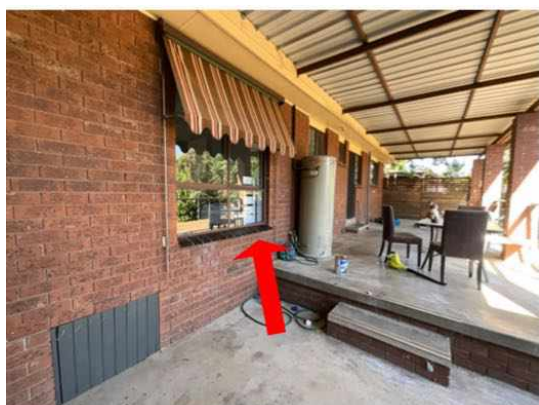
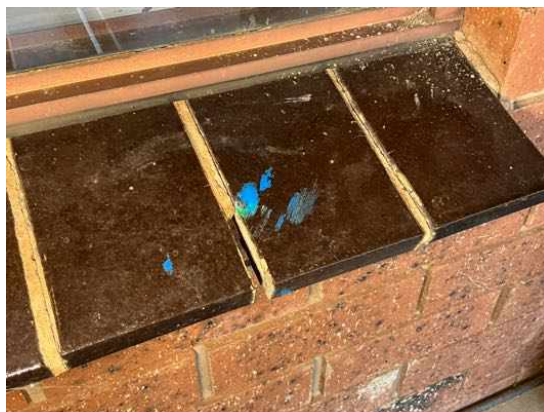
### Finding 3.07

Building:	Building 1
Location:	Front windows, some rear windows
Finding:	Brickwork - Deteriorated mortar
Information:	Mortar, or 'bedding', is the material which fills joints and intersections between bricks in masonry walls and structures. Sections of mortar in this brickwork were identified as having deteriorated, which is generally expected for a property of this age and condition.

Mortar may deteriorate as a result of age of building materials, minor movement of bricks, or frequent exposure to weathering. Mortar should be replaced to ensure that bricks remain in their intended location and to prevent gaps, which would allow water

or moisture ingress and secondary damage as a result.

Mortar deterioration can be addressed by a bricklayer where areas of deterioration are localised and easily accessible. Alternatively, appointment of a registered builder is advised, to repoint large areas of decaying mortar. Where secondary structural defects have become evident, consultation with a structural engineer may be required.

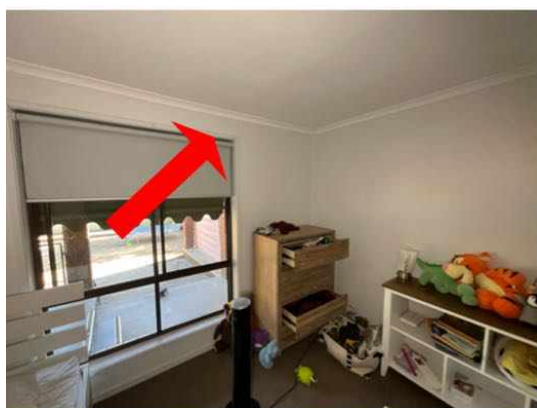
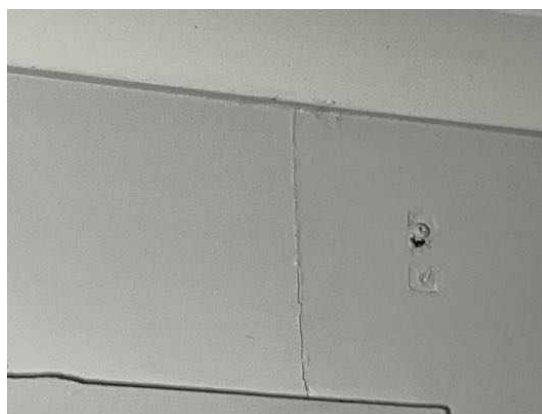
### Finding 3.08

Building:	Building 1
Location:	Bedroom 2
Finding:	Cracking - Damage Category 1 - Fine (up to 1mm)

**Information:** Although fine cracks are quite noticeable, they are often only considered to be an appearance defect, and usually do not indicate any structural damage. Generally, the cause of a fine crack is indicative of a separation between building materials and finishes (e.g. paint, plaster, etc.) along joins.

Cracking of this nature can generally be repaired with minor sanding, filling and/or repainting. Such works should be performed by a qualified painter or a general handyman.

Monitoring of all cracking should be conducted frequently. Always contact a building inspector should cracks widen, lengthen, or become more numerous.

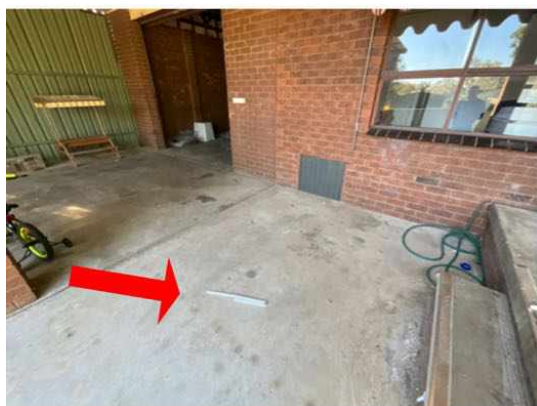
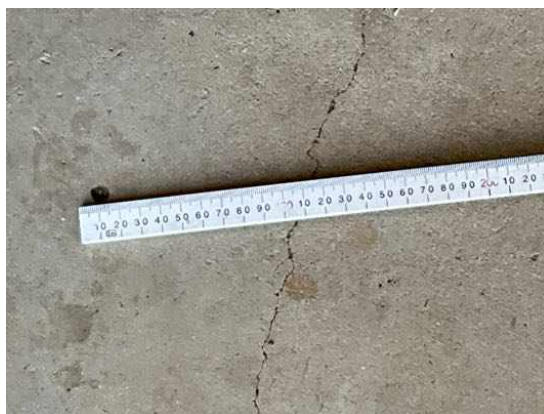
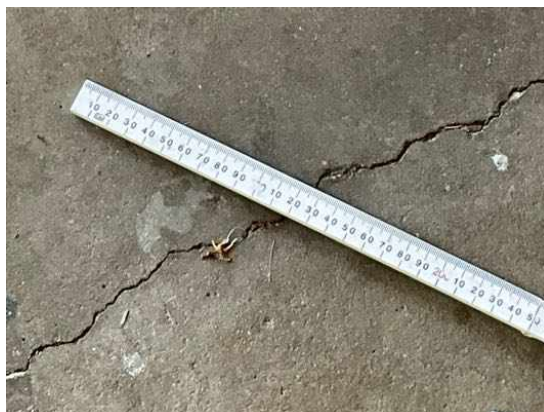
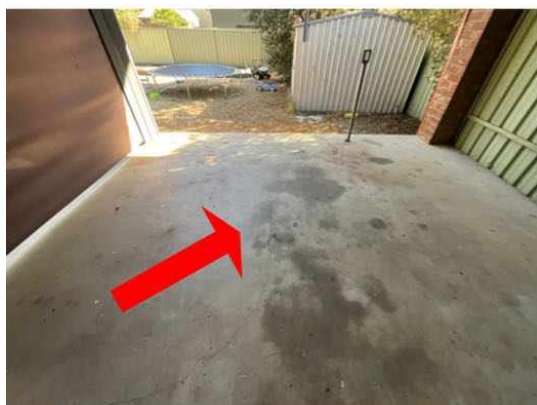
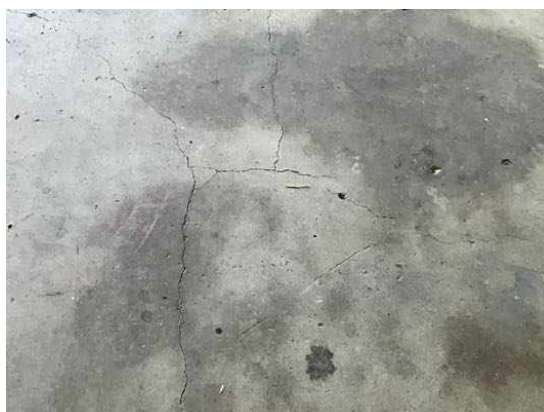
### Finding 3.09

**Building:** Building 1  
**Location:** Carport area  
**Finding:** Cracking - External Concrete Paving Damage Category 1 - Fine (less than 2mm)  
**Information:** Fine cracks were identified in external concrete paving. Although fine cracks are quite noticeable, they are often only considered to be an appearance defect, and usually do not indicate any structural damage. To be considered a Category 1 or fine crack, the crack is found to be less than 2mm in width.

Generally the cause of a hairline crack in existing concrete paving such as driveways and pathways is indicative of the expansion and contraction of the concrete. Such causes are generally due to environmental factors, such as moisture levels, weather conditions, root systems of nearby trees or the soil types on which they are laid.

Fine cracks may also be due to poor original installation of the concrete. Factors such as poor compaction of the sub surface and/or inadequate reinforcing of the slab may create cracking and other secondary defects.

Monitoring of all cracking should be conducted frequently. Always contact a building inspector should cracks widen, lengthen, or become more numerous.

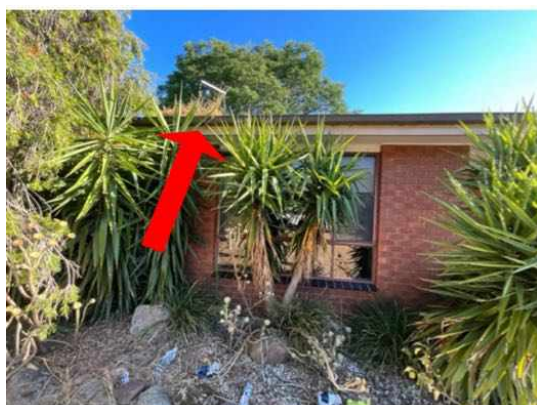
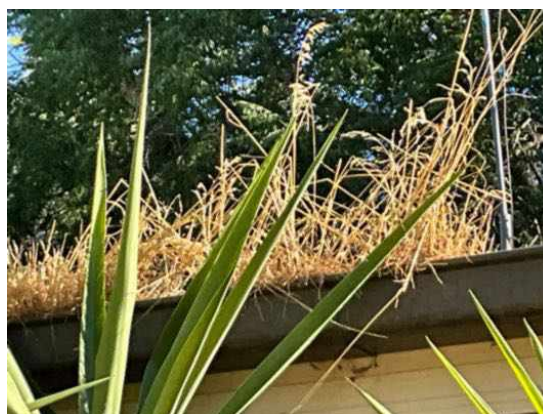
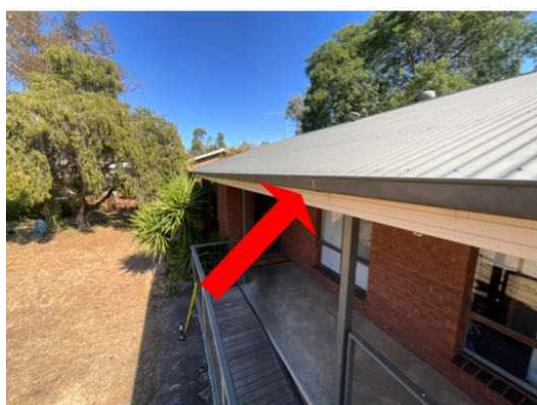
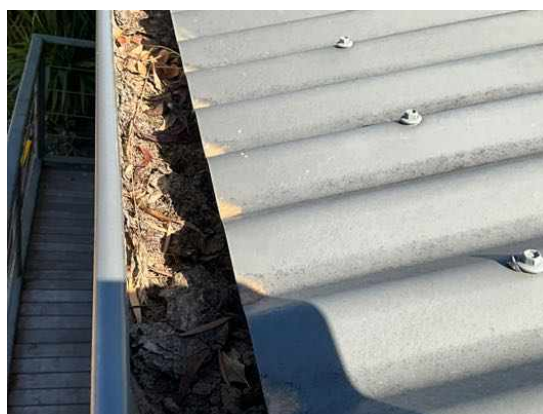
Blocked gutters are likely to lead to high levels of moisture in the affected areas. Such moisture will not only cause rust and decay of the associated building materials, but can also provide conditions that are conducive to termite and timber pest activity. Blockages in gutters should therefore be removed immediately to ensure dry conditions are maintained.

Consult a Licensed Plumber for further specific advice on remedial works that may be required. In the interim, it is highly advised that blocked gutters be removed by the homeowner or a general handyman as a matter of urgency.

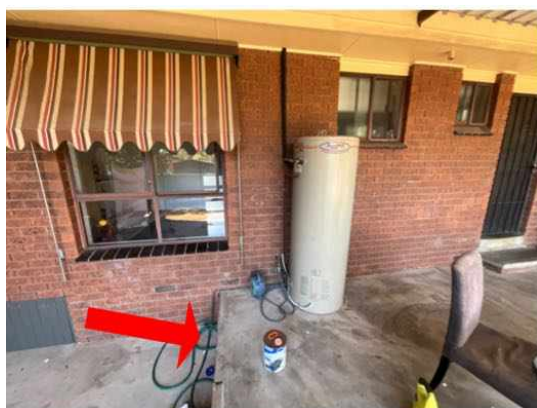
### Finding 6.02

Building: Building 1  
 Location: Verandah  
 Finding: HWS Overflow - Not Connected

Information: The Hot Water System (HWS) overflow was found to be disconnected from storm water drainage and is creating excessive moisture in the surrounding area.

These damp conditions can lead to secondary defects such as rot, rust or corrosion of associated building elements, the formation of fungal decay, or even the creation of potential slip hazards. When coupled with poor site drainage, pooling of water may also attract termite activity to this area.

It is highly recommended that a licensed plumber be appointed to connect the HWS overflow in order to prevent such an environment from being created. These minor works should be carried out as soon as possible.

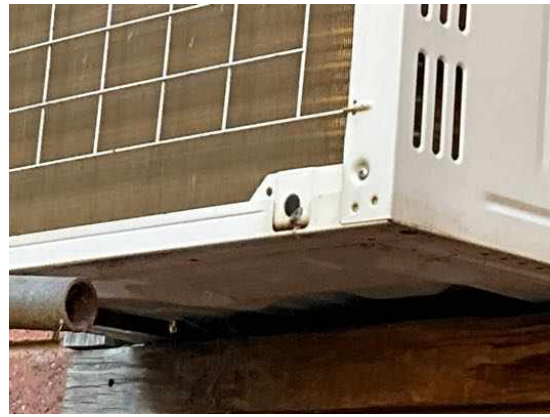
### Finding 6.03

Building: Building 1  
 Location: Yard - Side  
 Finding: Air conditioner - Disconnected overflow  
 Information: The Air Conditioner (A/C) overflow was found to be disconnected from storm water drainage and is creating excessive moisture in the surrounding area.

Such leaking creates an environment which is conducive to an array of defects, including water damage to associated building elements and the attraction of termite or timber pest infestation.

It is highly recommended that a licensed plumber be appointed to connect the A/C overflow in order to prevent such an environment from being created. These minor works should be carried out as soon as possible.

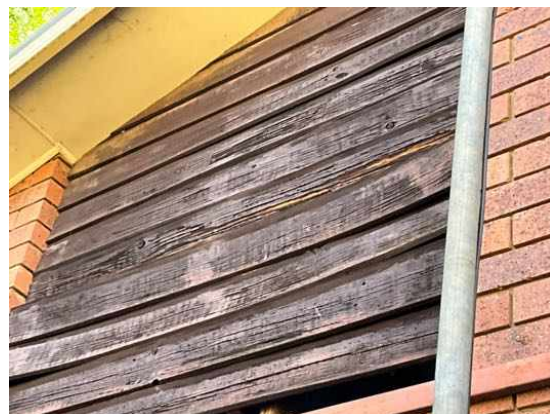
### Finding 6.04

Building: Building 1  
 Location: Yard - Side  
 Finding: Timber - exposed to weather  
 Information: External timbers that are frequently exposed to harsh weather conditions require adequate protection in order to maintain their condition. Where timbers have not been painted or treated adequately, general deterioration is likely to occur at an accelerated rate.

If left unattended, replacement of these timbers is likely to be necessary in the short-term future. Adequate treatment of these timbers is required as soon as possible by a painting contractor or general handyman.

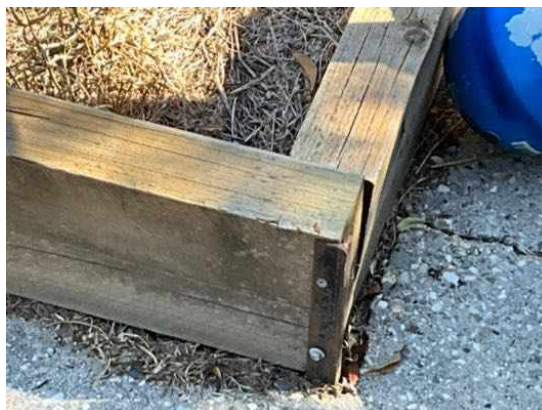
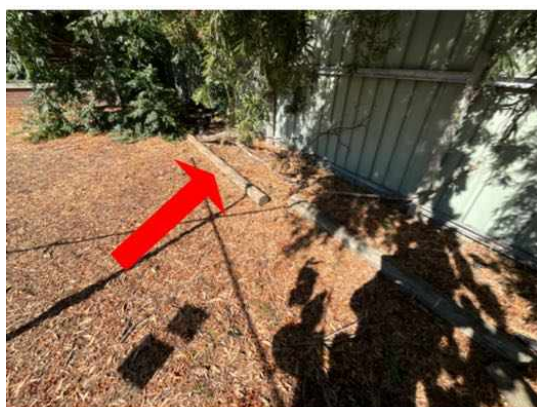
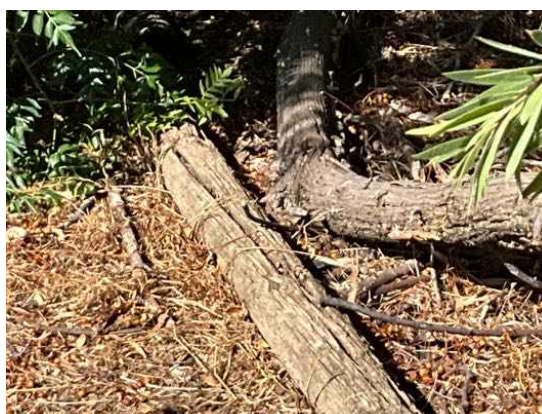
### Finding 6.05

Building: Building 1  
 Location: Yard - Back  
 Finding: Untreated or non-durable timbers in a hazardous environment  
 Information: To reduce the risk of timber pest attack it is essential that timber used in a hazardous environment (e.g. in direct contact with the ground or frequently exposed to damp conditions) is of sufficient durability and/or is adequately preservative treated.

Untreated timbers in direct contact with the ground are likely to develop severe wood rot and/or fungal decay if left unattended creating attraction for subterranean termites to infest the timbers from surrounding areas.

If untreated or non-durable timbers are found to be in a hazardous environment it is highly advised that replacement of these building elements be performed as soon as possible to aid the protection of the property against termite / timber pest attack.

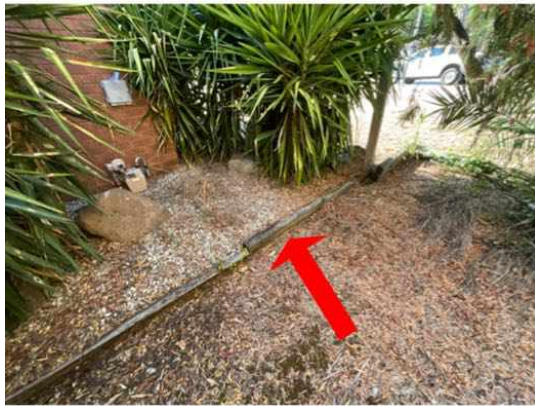
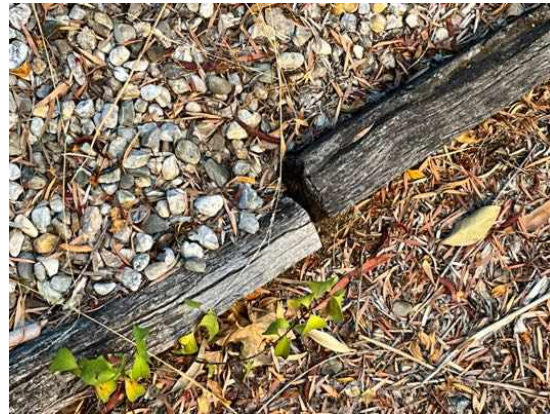
### Finding 6.06

Building:	Building 1
Location:	Yard - Front
Finding:	Untreated or non-durable timbers in a hazardous environment
Information:	To reduce the risk of timber pest attack it is essential that timber used in a hazardous environment (e.g. in direct contact with the ground or frequently exposed to damp conditions) is of sufficient durability and/or is adequately preservative treated.

Untreated timbers in direct contact with the ground are likely to develop severe wood rot and/or fungal decay if left unattended creating attraction for subterranean termites to infest the timbers from surrounding areas.

If untreated or non-durable timbers are found to be in a hazardous environment it is highly advised that replacement of these building elements be performed as soon as possible to aid the protection of the property against termite / timber pest attack.

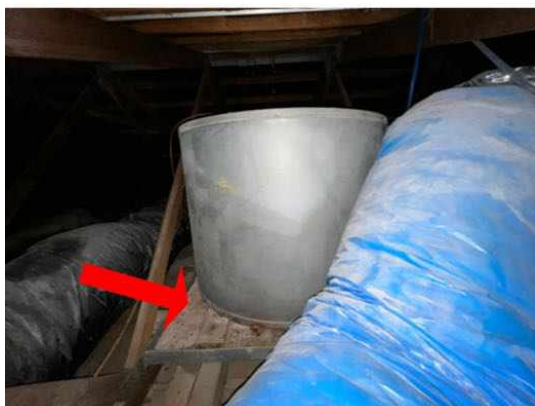
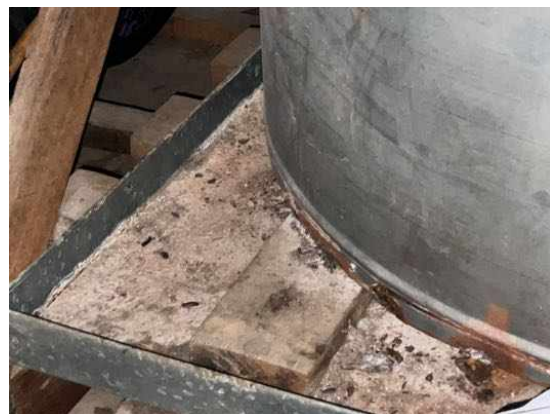
### Finding 6.07

Building: Building 1  
 Location: Roof Void  
 Finding: Gravity-Fed HWS - Disconnected  
 Information: It was noted at the time of inspection that a disconnected gravity-fed hot water system (HWS) remains in this area.

Despite this plumbing structure being unused, it is likely to be storing residual water, and is therefore susceptible to rust and corrosion. If allowed to continue, rust and corrosion is likely to lead to damage to adjoining building elements, and may also make the area susceptible to termite or timber pest activity.

While it is a costly exercise to remove the disused gravity-fed HWS, it is advisable in the short-term future to prevent any further damage to the area. Further consultation with a licensed plumber is required to gain further advice on removal of the structure.

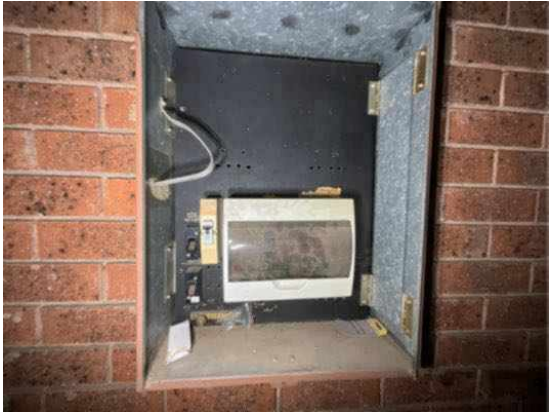
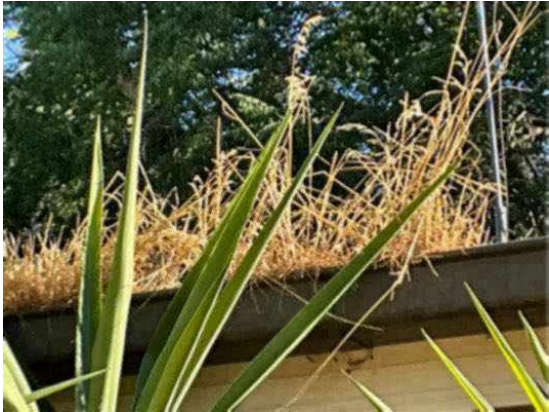
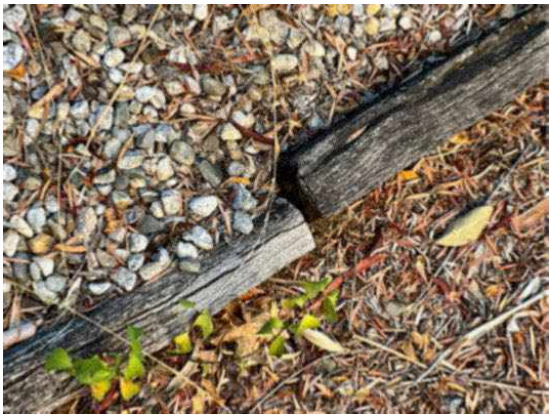
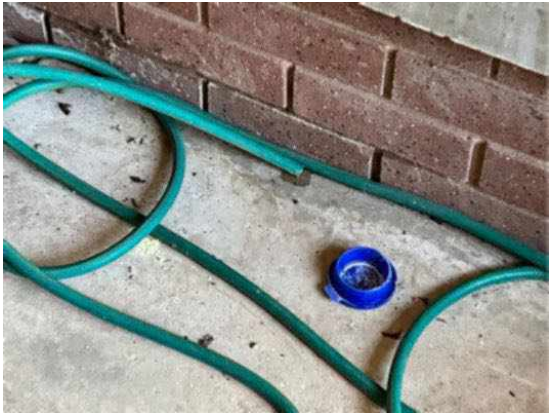
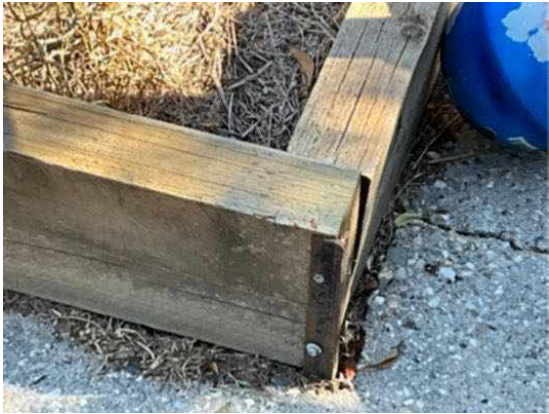
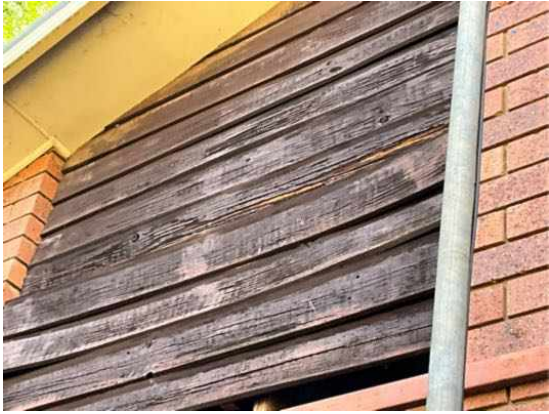
### Finding 6.08

Finding: Termite Management System - no evidence of a chemical installation  
Information: The application of a post-construction chemical termite barrier is highly recommended for all properties, particularly if live termite activity has been found on the site previously. Such barriers are highly effective in preventing termite attack on any timber building elements throughout the property.

A durable notice should be placed in the switchboard unit to indicate current termite barriers. At the time of inspection, it appeared as though no termite management system has been installed, with no evidence to suggest preventative works taking place.

The client may consider gaining further advice from a pest controller as to the costs and procedures involved with this application. It is recommended that obtaining such advice be a short-term priority.

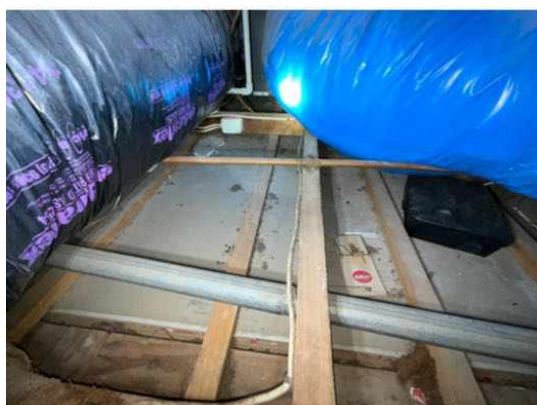
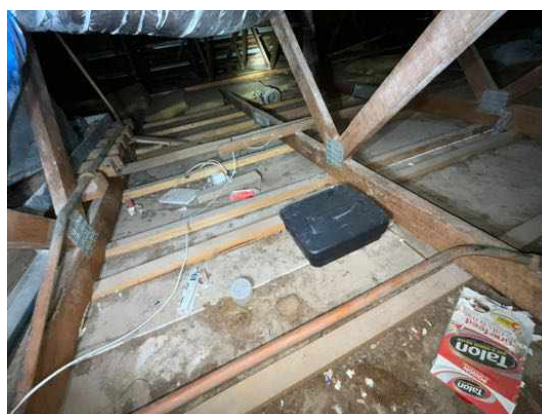
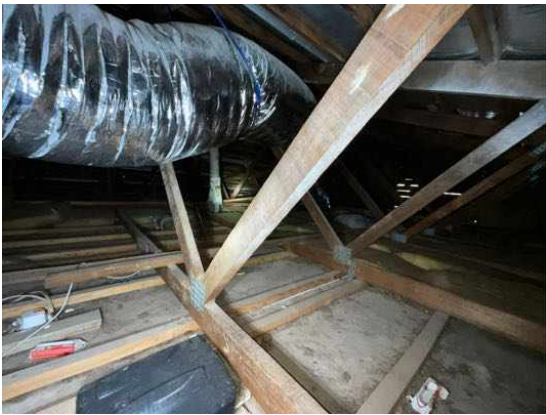
Building:	Building 1
Location:	Roof Void
Finding:	Insulation - Inadequate
Information:	Upon inspection of the roof void it was noted that there is a lack of adequate insulation.

The level of insulation in the property does not meet current Australian Standards. Installation of adequate insulation is required and should be conducted as soon as possible.

Caution should be exercised when accessing the roof void. Do not attempt to stand on the framework to the underside of the trusses and be aware there is a potential for electric shock if contact is made with exposed or faulty electrical wiring.

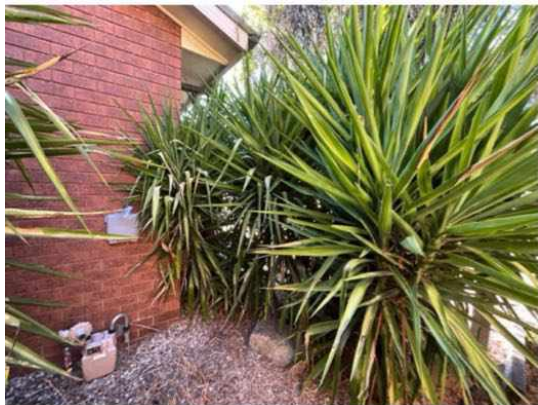
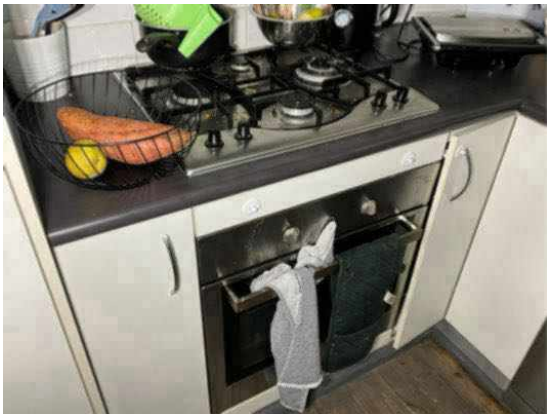
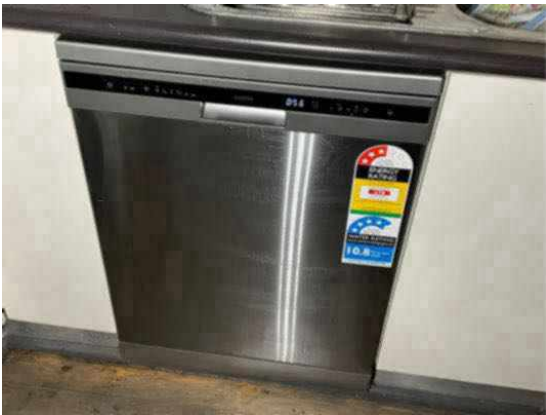
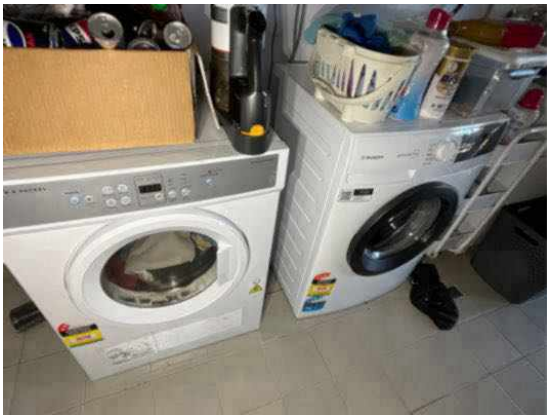
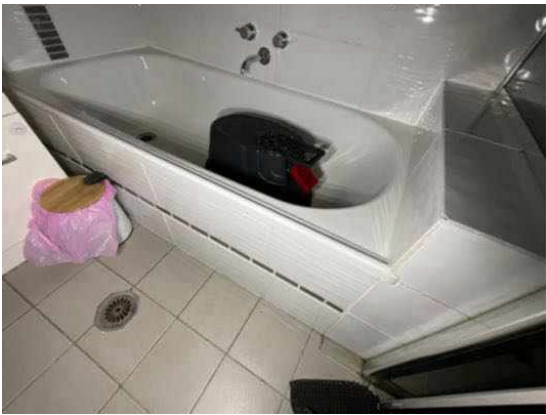
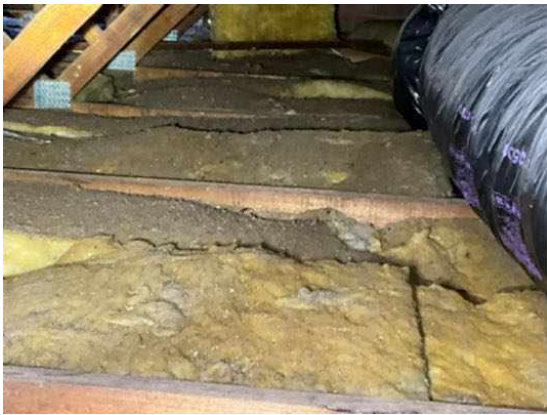
Building: Building 1  
Location: All Areas  
Finding: Additional Photos - Obstructions and Limitations  
Information: These photographs are an indication of the obstructions and limitations which impeded full inspection of the property at the time of inspection. These obstructions can hide an array of defects and should be removed to allow full inspection to be carried out. A re-inspection is recommended once the areas are made accessible.
