Building and Timber Pest Inspection Report

Inspection Date: Wed, 8 Apr 2026

Property Address: 9 Helens Way, Langwarrin VIC 3910,
Australia

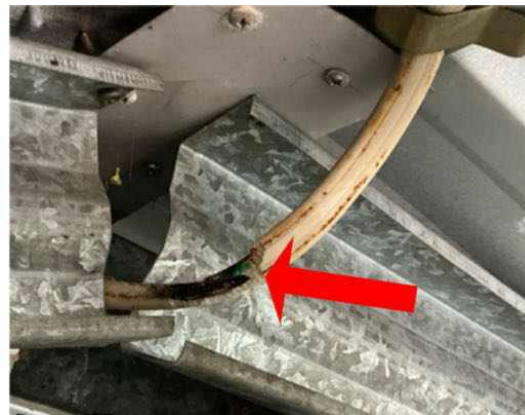
Finding 1.01

Building:	Main Building
Location:	Shed
Finding:	Electrical wires- missing conduit
Information:	The electrical wires to the shed have insufficient or missing conduit. Exposed electrical wiring represents a potential safety hazard for personal contact. Contact a licensed electrician urgently for further inspection investigation and rectification.

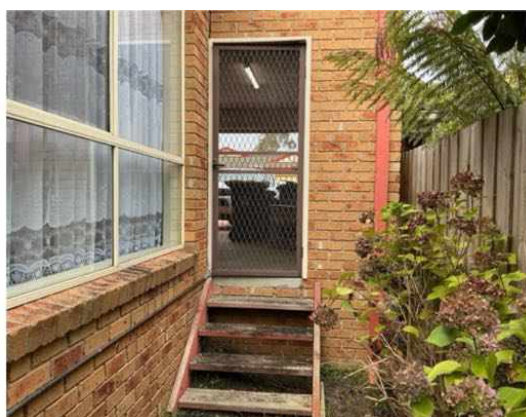
Finding 1.02

Building:	Main Building
Location:	Yard - Back
Finding:	No landing installed
Information:	At the time of the inspection, it was observed that the exit from the garage is fitted with an outward opening door that leads immediately to a set of descending steps. There is no intermediate landing provided between the door threshold and the stairway.

It is recommended that a registered builder be engaged as soon as possible to install a compliant landing at the garage exit to provide a safe transition between the doorway and the stairway. Additionally, consideration should be given to door swing direction or the installation.

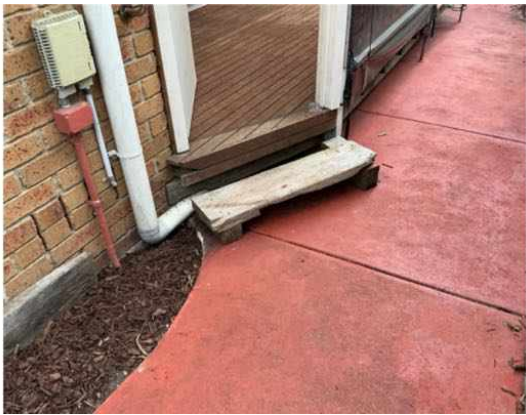
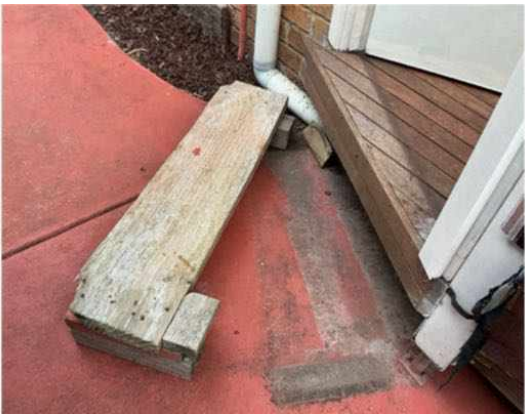
Finding 1.03

Building:	Main Building
Location:	Exterior walls - right side
Finding:	Step not securely fixed
Information:	During inspection of the patio area, a temporary step was observed at the doorway which was not secured, fixed or anchored to the ground surface.

This condition presents a significant safety hazard as the step may shift, tilt or slip underload when in use. Such instability increases the risks of trip slips and falls for occupants entering or exiting the doorway. The hazard is further exacerbated in wet or uneven conditions where movement of the step may be less predictable.

It is recommended to engage a licensed builder to remove the temporary step and replaced with a properly constructed and permanently fixed step the complies with relevant building standards as soon as possible to reduce the risk of personal injury.

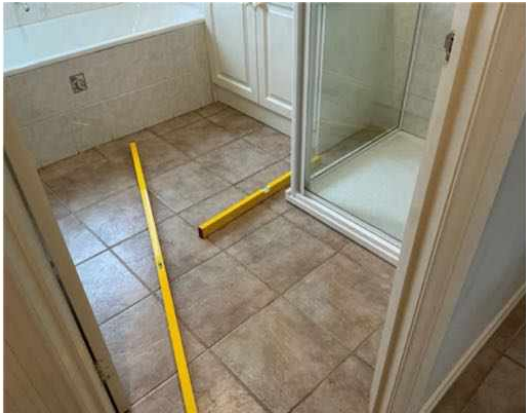
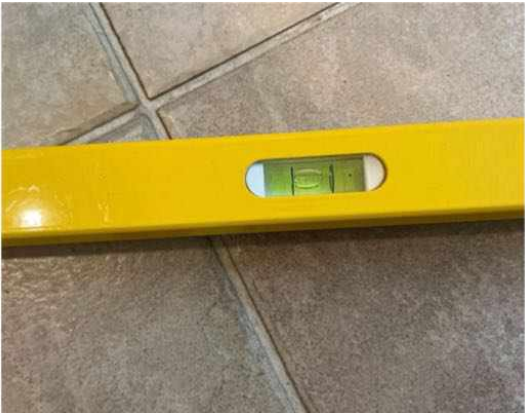
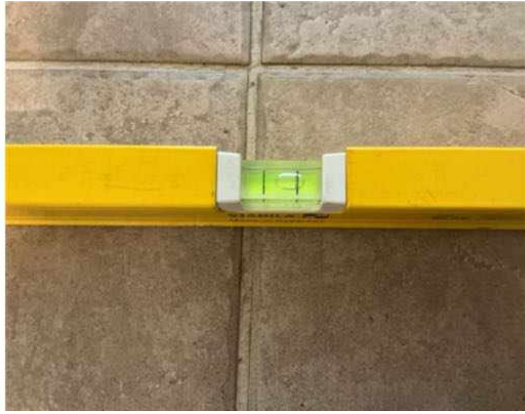
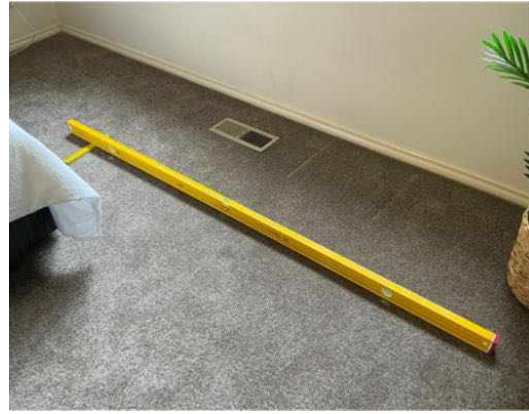
Finding 2.01

Building: Main Building
Location: Bathroom, bedroom 2 and hallway
Finding: Floors - Uneven/ out of level
Information: The internal flooring to these areas is out of level and uneven. Based on preliminary assessment, it is suspected that this unevenness is primarily due to the movement of the foundations supporting the building. This type of movement could be due to soil subsidence, settlement, or shifts in the foundations/footings.

It is recommended to engage a qualified structural engineer to conduct a thorough examination of the foundational support system to provide appropriate advice and recommendations to reduce the risk of further deterioration as a matter of urgency.

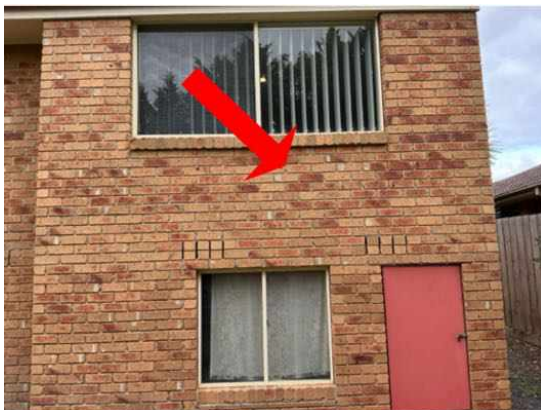
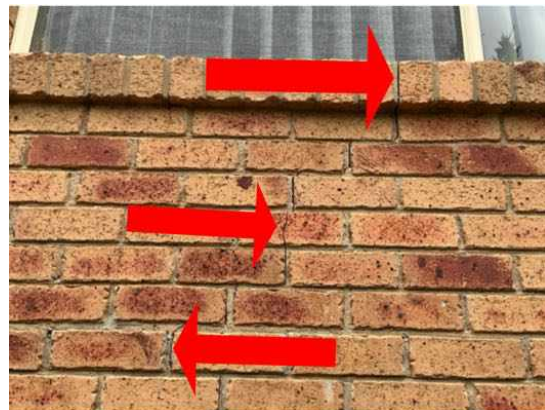
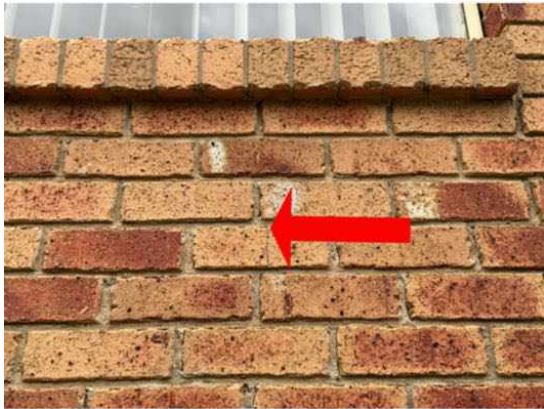
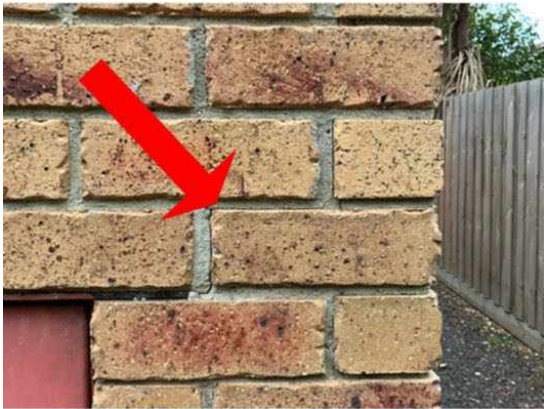
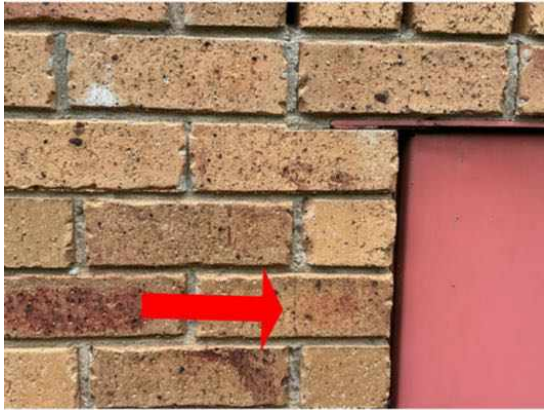
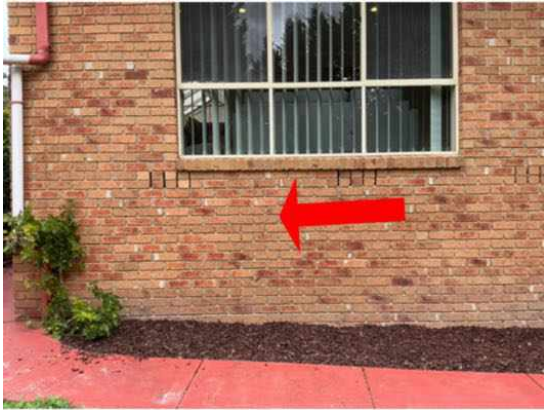
Finding 2.02

Building: Main Building
 Location: Exterior walls - rear
 Finding: Damage to Masonry Walls (Cracks)- Category 2
 Information: It has been observed that damage to the rear masonry walls caused by movement of slabs, footings, or other causes, has occurred. The degree of damage falls within Category 2, described as noticeable cracks which are easily filled. Such cracking may cause doors and/or windows to stick slightly, and are generally less than 5mm in width.

Damage of this category is required to be monitored for a period of 12 months, after which time a crack rated at Category 2 or above is considered a defect requiring rectification, such as minor repairs and repointing. Always contact your building inspector should cracks widen, lengthen, or grow more numerous.

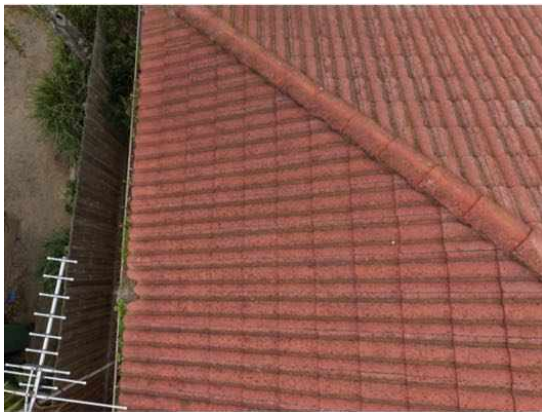
Finding 3.01

Blocked gutters are likely to lead to high levels of moisture in the affected areas. Such moisture will not only cause rust and decay of the associated building materials, but can also provide conditions that are conducive to termite and timber pest activity. Blockages in gutters should therefore be removed immediately to ensure dry conditions are maintained.

Consult a Licensed Plumber for further specific advice on remedial works that may be required. In the interim, it is highly advised that blocked gutters be removed by the homeowner or a general handyperson as a matter of urgency.

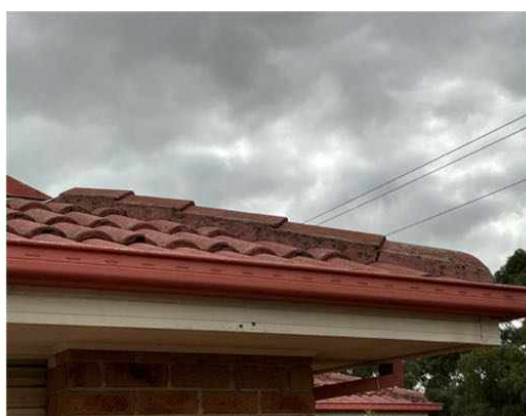
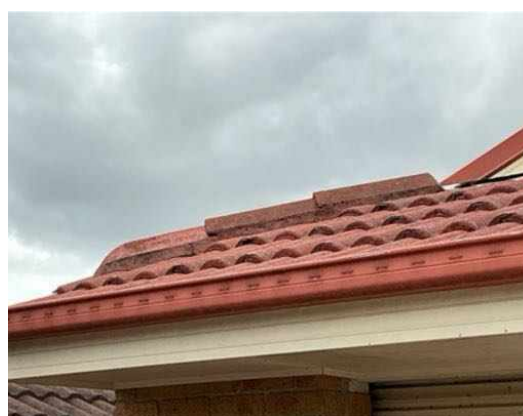
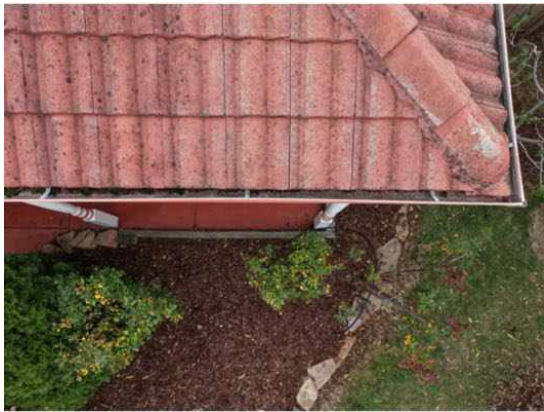
Finding 3.02

Building:	Main Building
Location:	Roof Exterior
Finding:	Roof tile mortar deterioration and cracking
Information:	Cracking and deterioration was observed in the ridge and hip tile mortar bedding. The mortar has separated in several areas, with visible gaps forming between ridge tiles and the underlying bedding. This condition indicates age-related degradation and exposure to the elements, which has caused the mortar to become brittle and lose its bonding integrity.

Compromised mortar may lead to further deterioration, potentially allowing water ingress and structural damage to the roof structure below.

Recommend engaging a qualified roofing contractor to carry out repointing or full re-bedding of affected ridge and hip tiles as necessary. All deteriorated mortar should be removed and replaced with new flexible roof bedding compound in accordance with current Australian Standards (AS 2050).

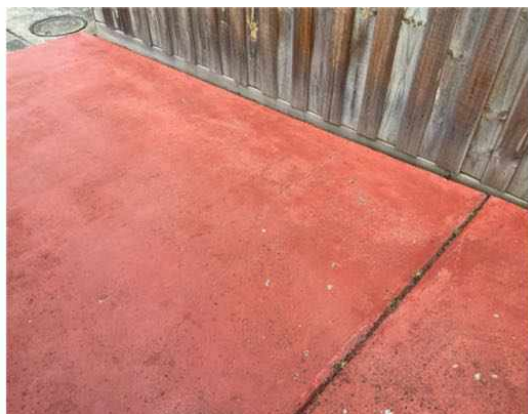
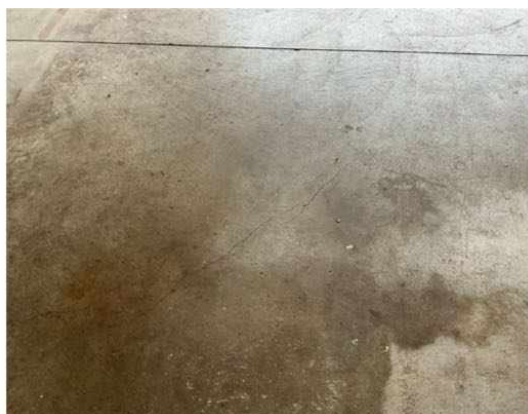
Finding 3.03

Building: Main Building
 Location: Driveway/garage/pathway
 Finding: Driveway/garage/pathway Cracking
 Information: Cracks were identified in the driveway, garage and pathway concrete paving. Although cracks are quite noticeable, they are often only considered to be an appearance defect, and usually do not indicate any structural damage.

Generally the cause of the cracks in existing concrete paving such as driveways and pathways is indicative of the expansion and contraction of the concrete. Such causes are generally due to environmental factors, such as moisture levels, weather conditions, root systems of nearby trees or the soil types on which they are laid.

Cracks may also be due to poor original installation of the concrete. Factors such as poor compaction of the sub surface and/or inadequate reinforcing of the slab may create cracking and other secondary defects.

Monitoring of all cracking should be conducted frequently. Always contact a building inspector should cracks widen, lengthen, or become more numerous.

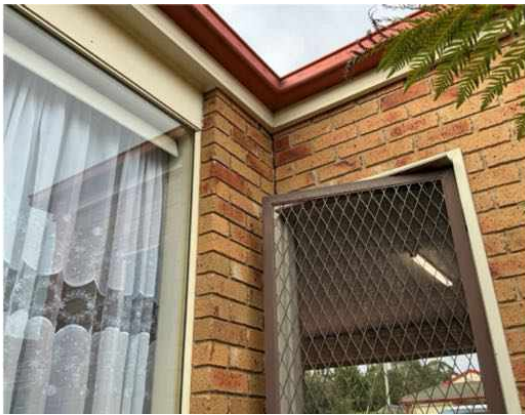
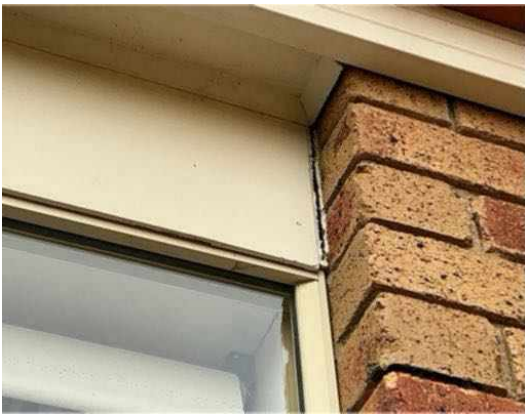
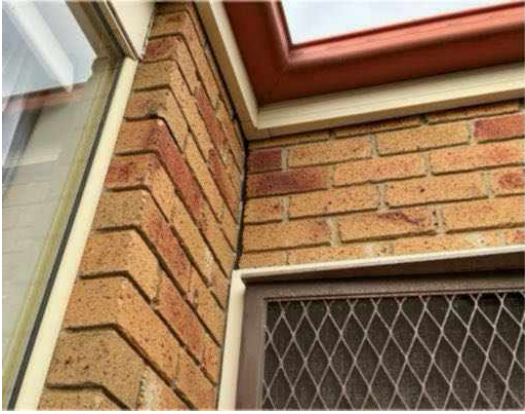
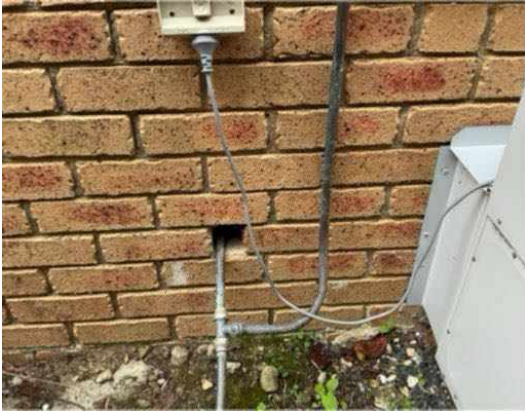
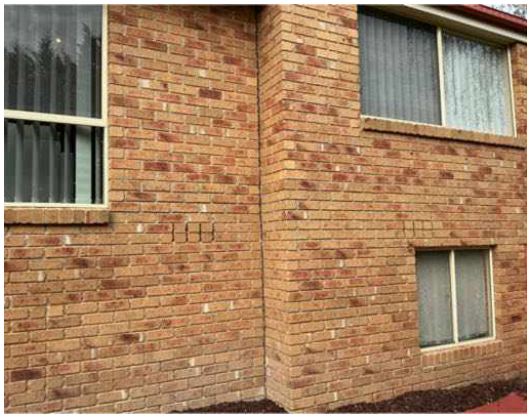
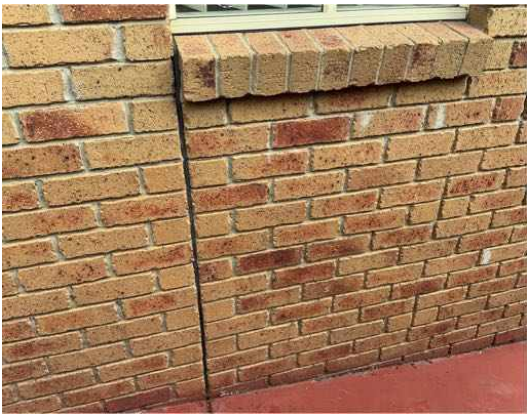
Finding 3.04

Building:	Main Building
Location:	Exterior walls
Finding:	A few gaps to the exterior walls/windows
Information:	A few gaps were noticed to some of the exterior walls/windows to the building. These gaps can let in water, drafts, and pests. Overtime moisture ingress may cause damage to internal walls, mould growth, or structural issues. Gaps also reduce the energy efficiency of the property. Recommend engaging a caulker to seal gaps with an exterior grade flexible sealant that is UV and weather resistant to reduce the risk of pest/water penetration to the building as soon as possible.

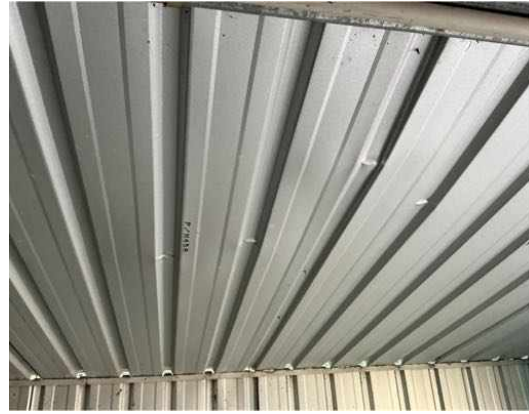
Finding 3.05

Building: Main Building
Location: Yard - Back
Finding: Rust and damage to shed
Information: Rust and damage to parts of the shed. Recommend repair/replacement by a handyman or carpenter to reduce the risk of future deterioration at the owners discretion.

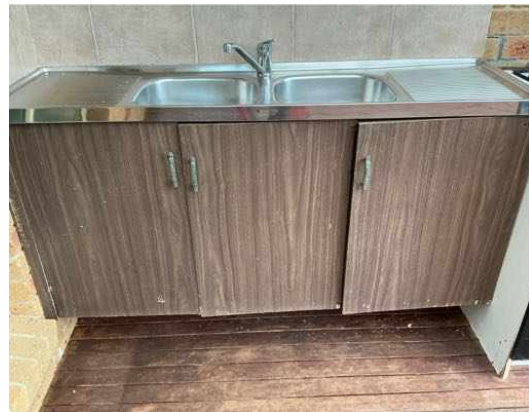
Finding 3.06

Building:	Main Building
Location:	Patio
Finding:	Cabinets need adjustment
Information:	On inspection it was noticed that the patio cabinets do not shut or open correctly and require maintenance or adjustment. Recommend engaging a cabinet maker to adjust/maintain to reduce the risk of further deterioration at the owners discretion.

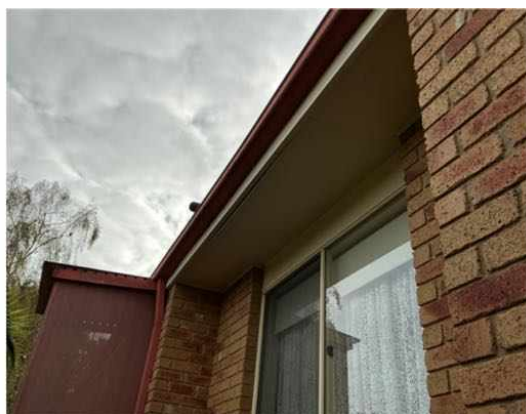
Finding 3.07

Building:	Main Building
Location:	Exterior walls - left side
Finding:	Eaves sagging
Information:	Parts of the left side eaves are sagging. Recommend engaging a carpenter to repair as necessary to reduce the risk of further deterioration as soon as possible.

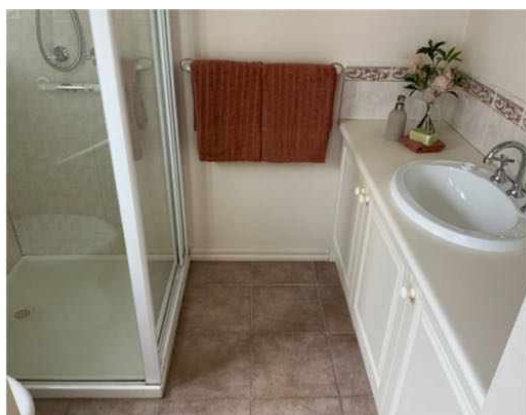
Finding 3.08

Building:	Main Building
Location:	Ensuite - Master
Finding:	Bathroom Sealant and grouting - Missing or damaged
Information:	It was noted on inspection that sealant or grout is degraded to the tiled shower alcove and or other areas of the bathroom.

Different materials and floor areas move at different rates, generally causing cracking to grout or sealant at this point. A flexible sealant is required to allow for expected expansion and contraction, while keeping the joint water tight and protective of all associated building materials.

Flexible and mould resistant materials should be applied to affected areas to prevent any subsequent water damage that is likely to occur. Regular maintenance and replacement of damage or missing or damaged sealant and grout is highly recommended to the wet areas, as this is a regular wear and tear defect. Sealant and grouting in areas that come into regular contact with water should be maintained for the long term care of your property.

A sealant specialist or tiling contractor should be appointed to complete these works as soon as possible

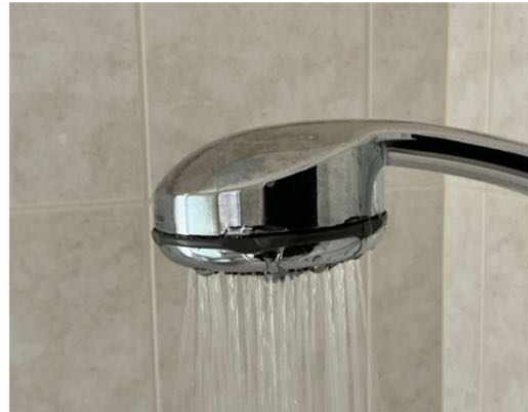
Finding: Ensuite Shower head is dripping/leaking

Information: The shower head to the ensuite bathroom is loose and dripping/leaking. This can

often happen over time with deterioration or if the shower head is loose and needs tightening. Recommend engaging a plumber to repair/replace the shower head to reduce the risk of further deterioration and water leaks as soon as possible.

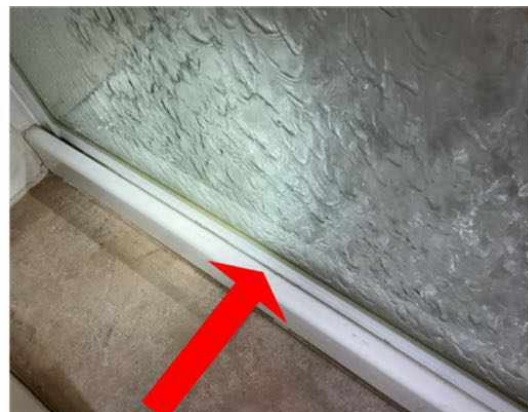
Finding 3.11

Building:	Main Building
Location:	Bathroom
Finding:	Bathroom-Shower screen leaking
Information:	Leaking was evident to the shower screen at the time of inspection. It is suspected that the leaking has occurred as a result of deteriorated or missing caulking to the shower or general ageing of the building elements.

Leaking from the shower where left unattended, is likely to lead to water damage to adjoining flooring and walls. Such damage can lead to water damage and necessitate extensive remedial works being required. Active water leaks may also create an environment that is susceptible to the formation and development of mould.

Appointment of a caulking contractor is required to repair or replace the caulking to the shower area. Such works should be performed as soon as possible to ensure that no further damage occurs.

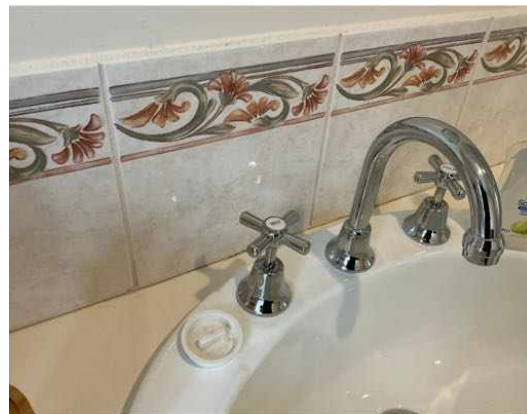
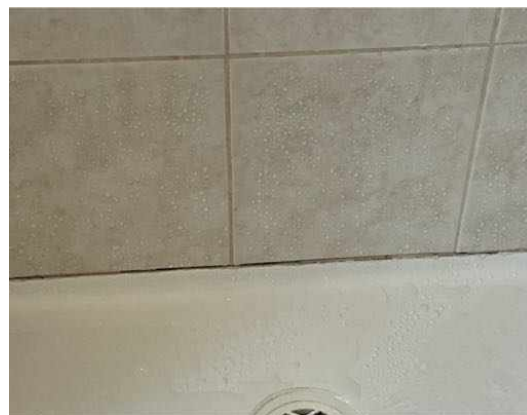
Finding 3.12

Building: Main Building
Location: Bathroom
Finding: Bathroom Sealant and grouting - Missing or damaged
Information: It was noted on inspection that sealant or grout is degraded to the tiled shower alcove and or other areas of the bathroom.

Different materials and floor areas move at different rates, generally causing cracking to grout or sealant at this point. A flexible sealant is required to allow for expected expansion and contraction, while keeping the joint water tight and protective of all associated building materials.

Flexible and mould resistant materials should be applied to affected areas to prevent any subsequent water damage that is likely to occur. Regular maintenance and replacement of damage or missing or damaged sealant and grout is highly recommended to the wet areas, as this is a regular wear and tear defect. Sealant and grouting in areas that come into regular contact with water should be maintained for the long term care of your property.

A sealant specialist or tiling contractor should be appointed to complete these works as soon as possible

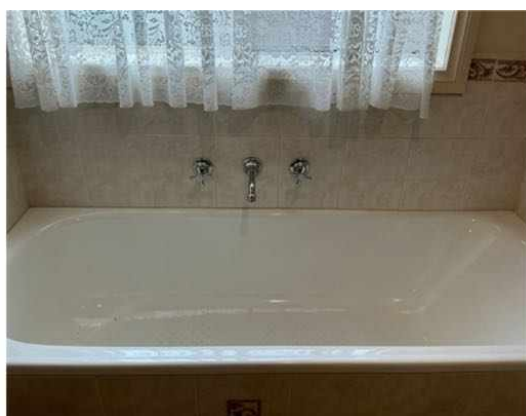
Finding 3.13

Building: Main Building
 Location: Bathroom
 Finding: Spout - Leaking bathroom
 Information: The spout in the bathroom was found to be leaking at the time of inspection. This is a common defect that is consistent with general ageing of the building element. However, it may be indicative of substandard plumbing workmanship if the spout is relatively new.

While this defect only seems minor, if left unmanaged, it is likely to result in the development of rust, water damage and/or extensive water usage.

It is advised that a handyman or licensed plumber be appointed to perform remedial works on the affected tap. Such works should be performed prior to the development of secondary defects to ensure adequate functionality of all associated building elements.

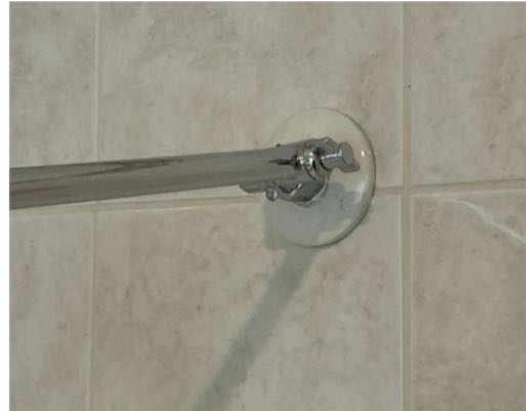
Finding 3.14

Building: Main Building
 Location: Bathroom
 Finding: Shower head is dripping/leaking
 Information: The shower head to the bathroom is loose and dripping/leaking. This can often happen over time with deterioration or if the shower head is loose and needs tightening. Recommend engaging a plumber to repair/replace the shower head to reduce the risk of further deterioration and water leaks as soon as possible.

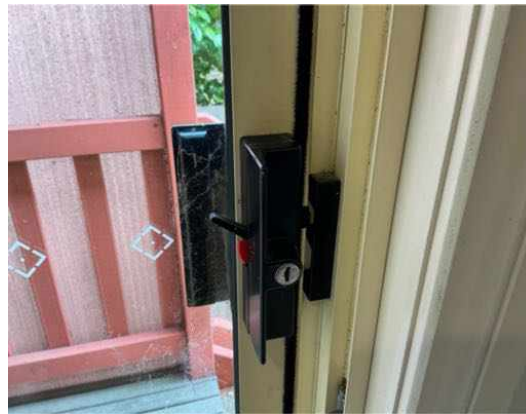
Finding 3.15

Finding: Door - Loose handle laundry

Information: The door handle to the laundry was found to be loose at the time of inspection. Looseness occurs generally when the building materials have aged and decayed, but may be indicative of impact damage (accidental or deliberate).

Repair of the loose door handle is advised to improve the operational state of the associated door.

A qualified carpenter or general handyman should be appointed to repair/replace the door handle at the client's discretion.

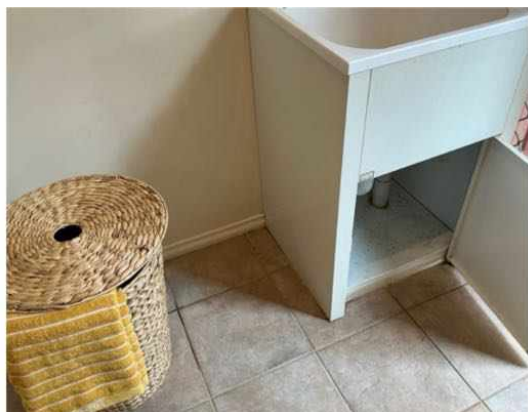
Finding 3.16

Finding: Cracked tiles-laundry

Information: Cracking/damage to the tiles was evident to the laundry at the time of inspection. It is suspected that this cracking has occurred as a result of minor settlement/shrinkage or impact damage.

Cracked tiles to the household detract from the overall appearance of the affected areas however it is unlikely to create or lead to any secondary defects.

While not considered a matter of urgency, replacement of cracked tiles is recommended at the clients discretion. A tiling contractor may be appointed to perform these works. Where cracks become more numerous, contact a licensed building inspector for further investigation.

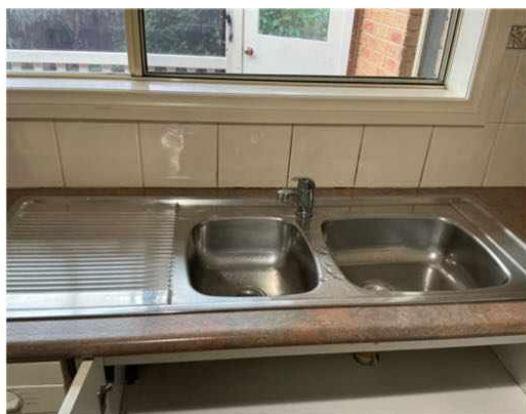
Finding 3.17

Building:	Main Building
Location:	Kitchen
Finding:	Kitchen Sealant and grouting - Missing or damaged
Information:	It was noted on inspection that sealant or grout is degraded to the kitchen splash back and or other areas of the kitchen.

Different materials and floor areas move at different rates, generally causing cracking to grout or sealant at this point. A flexible sealant is required to allow for expected expansion and contraction, while keeping the joint water tight and protective of all associated building materials.

There appears to be excessive mould to the sealant and grout which will likely require scraping out and replacement.

Flexible and mould resistant materials should be applied to affected areas to prevent any subsequent water damage that is likely to occur. Regular maintenance and replacement of damage or missing or damaged sealant and grout is highly recommended to the wet areas, as this is a regular wear and tear defect. Sealant and grouting in areas that come into regular contact with water should be maintained for the long term care of your property.

A sealant specialist or tiling contractor should be appointed to complete these works as soon as possible

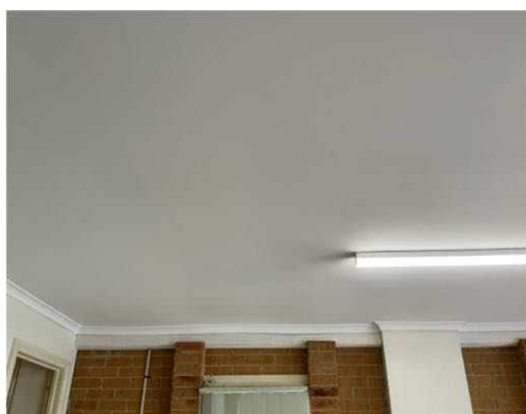
Finding 3.18

Building:	Main Building
Location:	Garage
Finding:	Ceiling - Sagging garage.
Information:	Sections of the garage ceiling were found to be sagging at the time of inspection with a part at risk of collapse. It is recommended to keep this area clear until the ceiling has been repaired for personal safety. Sagging to the fixed ceiling structure generally indicates that the building materials/fixings (e.g. nails or glue) have become loose and require reattachment. This is quite a common defect in garages of this age. It is suspected that internal plaster is used where wet board plasterboard should be used and it gets affected by the moisture and condensation in the air. There is normally no insulation in the garage ceiling allowing the moisture to accelerate the deterioration.

Where sagging is evident repairs such as re-gluing or replacing of ceiling sheets, may be required. Such works may be performed by relevant tradespeople, such as plasterers and painters.

The appropriate action should be taken by the client straight away to ensure that any potential further damage is limited.

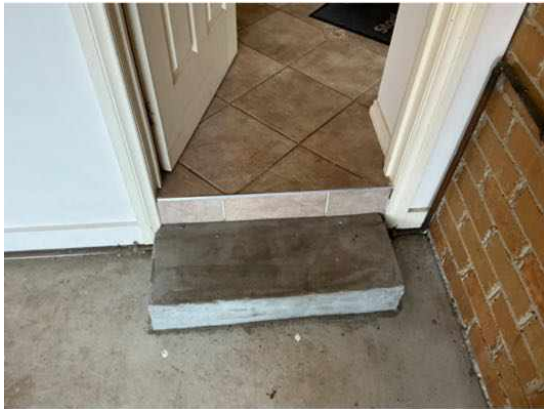
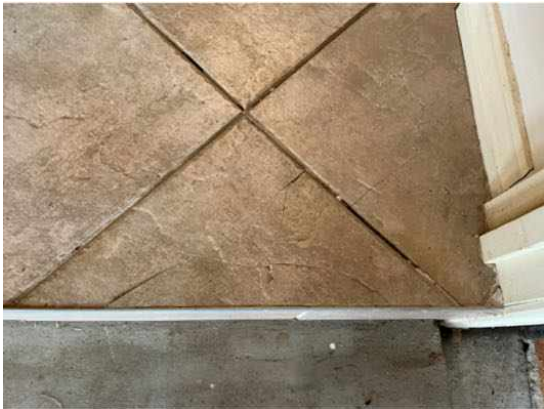
Finding: Garage entry Cracked tiles

Information: Two cracked tiles was evident to the garage entry at the time of inspection. It is suspected that this cracking has occurred as a result of minor settlement of the building or accidental impact damage.

While not considered a matter of urgency, replacement of cracked tiles is recommended as soon as possible. A tiling contractor may be appointed to perform these works. Where cracks become more numerous, contact a licensed building inspector for further investigation.

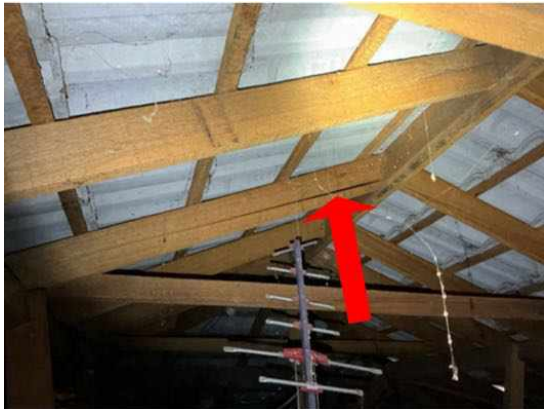
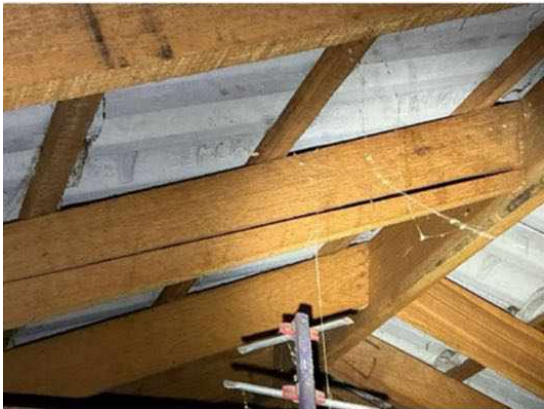
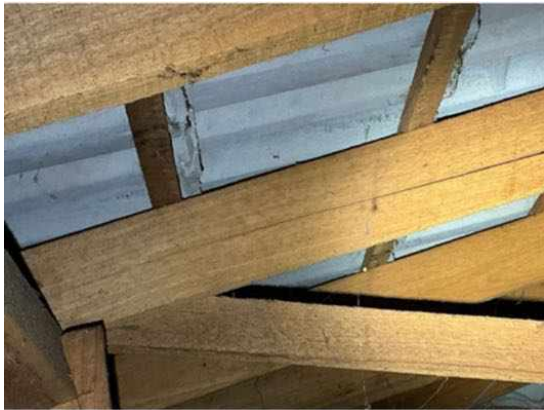
Finding 3.21

Building: Main Building
Location: Roof Void
Finding: Rafter split
Information: On inspection of the roof space it was noted that one of the rafters has split. Recommend engaging a carpenter to install additional roof framing support to reduce the risk of further deterioration as soon as possible.

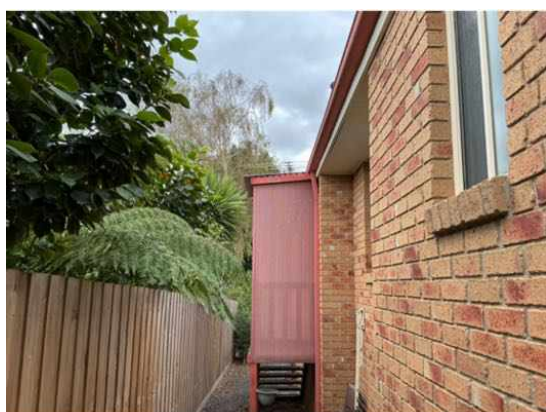
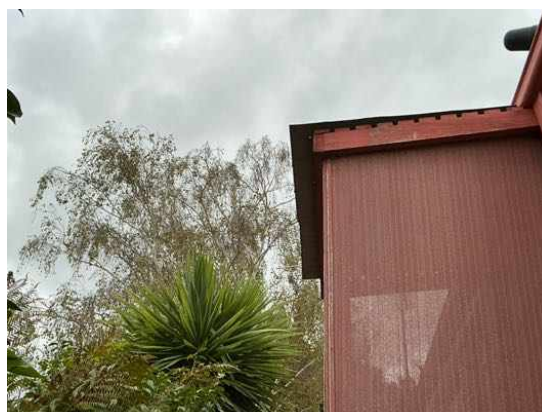
Finding 6.01

Building:	Main Building
Location:	Roof Exterior
Finding:	No gutters or down pipes installed
Information:	No gutters or down pipes installed to the side patio roof. Where plumbing doesn't drain adequately, the area at the apse perimeter can become excessively damp, potentially creating an environment that is susceptible to rust and corrosion of surrounding building elements as well as attracting termites and other pests. Recommend engaging a plumber to install gutters and down pipes to reduce the risk of footing movement and other moisture related issues as soon as possible.

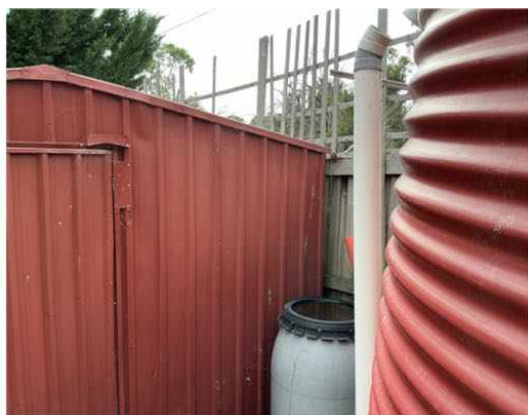
Finding 6.05

Building:	Main Building
Location:	Shed
Finding:	No gutters or down pipes installed
Information:	No gutters or down pipes installed to parts of the shed roof. Where plumbing doesn't drain adequately, the area at the apse perimeter can become excessively damp, potentially creating an environment that is susceptible to rust and corrosion of surrounding building elements as well as attracting termites and other pests. Recommend engaging a plumber to install gutters and down pipes to reduce the risk of footing movement and other moisture related issues as soon as possible.

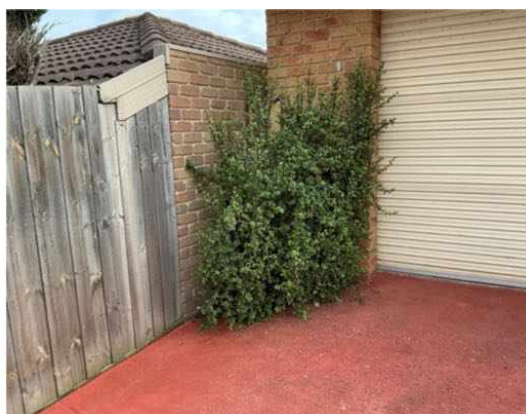
Finding 6.10

These garden beds can include untreated timber, and with a combination of moisture from watering hosing can make conditions conducive to termite activity and termite ingress.
