Building and Timber Pest Inspection Report

Inspection Date: Tue, 24 Mar 2026

Property Address: 17 Greendale Road, Wallacia NSW 2745

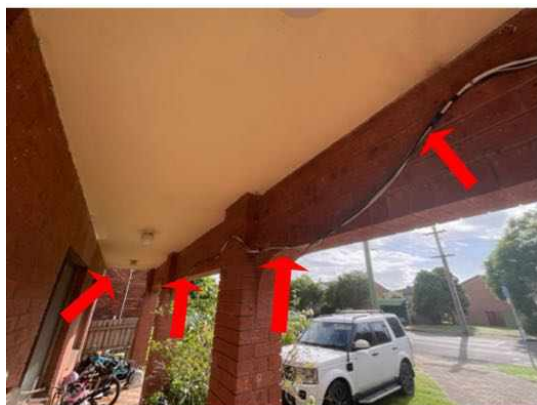
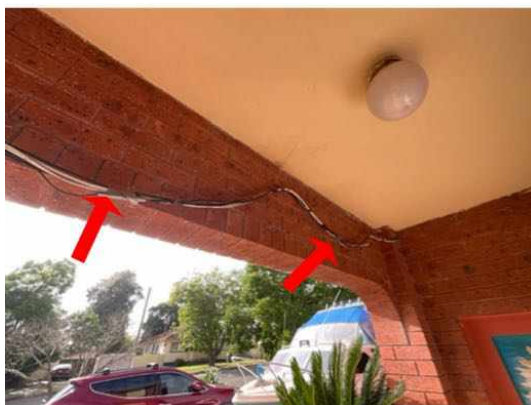
Exposed or substandard electrical wiring presents a safety hazard. Wiring that is not suitably enclosed is susceptible to mechanical damage over time and increases the risk of electric shock, short-circuiting, or potential fire hazards. There is also a risk of inadvertent contact by occupants or persons accessing the area, which may result in injury. The condition does not align with accepted electrical safety standards and good trade practice.

It is strongly recommended that a suitably licensed electrician be engaged as a matter of urgency to further inspect the installation and carry out the necessary repairs. Works should include the installation of appropriate conduit or replacement of the wiring to ensure it is adequately protected, compliant, and safe for ongoing use. Further investigation may be required to confirm that no additional electrical defects are present.

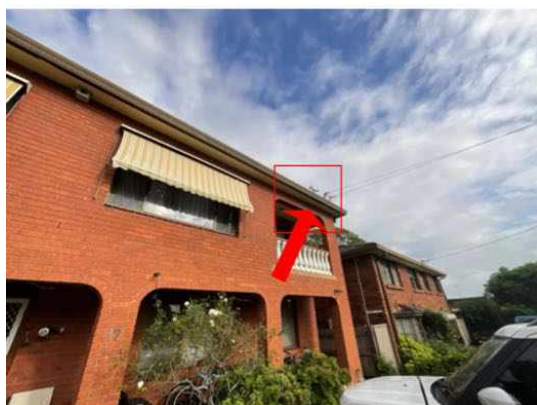
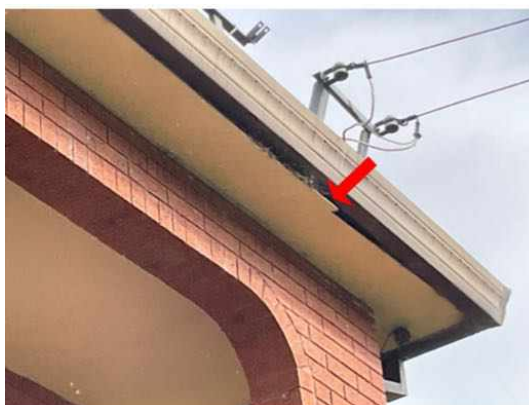
- Eaves play a vital role in diverting water away from the building and shielding external walls and structural elements from excessive moisture exposure.
- Sagging may indicate moisture damage, structural fatigue, or failure of fixings, and if left unaddressed, can lead to water ingress, timber deterioration, or further deformation of the roofline.

- Minor rectification works are recommended. A qualified carpenter or general handyman should be appointed to reinstate and secure the eaves to ensure proper function and alignment.
- Early maintenance will help prevent more costly repairs from developing over time.

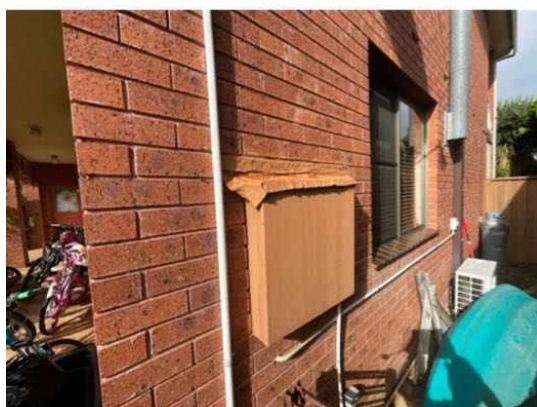
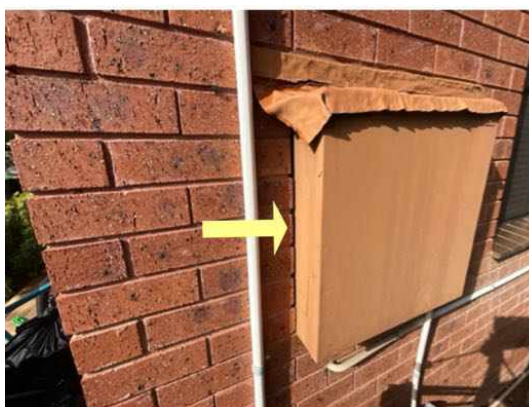
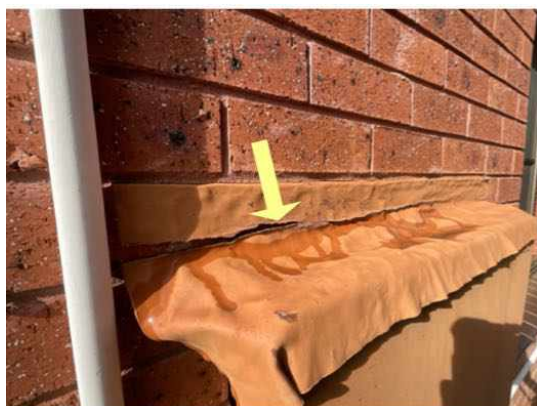
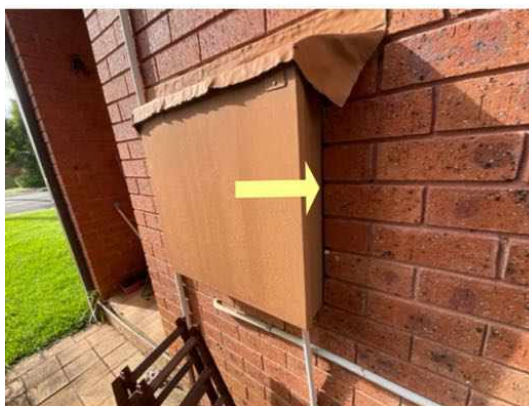
Finding 3.02

Building: Main Building
Location: Exterior walls - right side
Finding: Minor Defect – Electrical Meter Box Sealing & Flashing
Information:

At the time of inspection, sealant was noted to be missing along sections of the perimeter of the electrical meter box. In addition, the lead flashing installed above the meter box was observed to be severely cracked and deteriorated. These conditions were identified via visual inspection of accessible areas only.

The absence of adequate sealing and the compromised condition of the flashing increase the likelihood of water ingress into and around the meter box enclosure. Over time, this may contribute to deterioration of surrounding materials, corrosion or damage to electrical components, and potential moisture-related issues within adjacent wall elements. While no active moisture ingress was confirmed at the time of inspection, the condition represents a maintenance-related defect that may worsen if left unaddressed.

It is recommended that a suitably qualified tradesperson carry out repairs, including the application of appropriate flexible, weather-resistant sealant to the meter box perimeter and replacement or repair of the damaged lead flashing. Works should ensure the area is adequately sealed against moisture entry and remains durable for ongoing exposure. Further assessment by a licensed electrician may be considered if any concerns arise regarding the condition of internal electrical components.

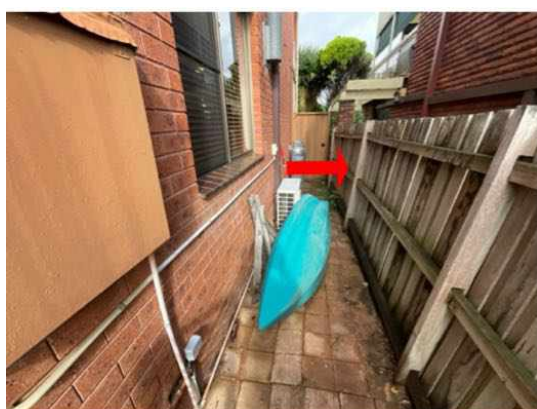
Finding 3.03

Building: Yard
 Location: Fencing - Right
 Finding: Fencing – Fair Condition and Maintenance.
 Information: Findings:

- At the time of inspection, the timber fencing to the property was observed to be in a deteriorated condition.
- This deterioration is typical of fences of similar age and exposure, and is often caused by a combination of factors including:
 - Prolonged exposure to weather conditions (sun, rain, wind)
 - Timber rot, rusted fixings, and general wear and tear
- In some cases, poor installation or inadequate maintenance can also contribute to accelerated deterioration.

- If left unattended, further deterioration and structural instability of the fencing is likely.
- Compromised fencing may affect property security, privacy, and aesthetic appeal.
- Based on visual assessment, repairs to several sections are likely necessary.

The existing timber fencing shows clear signs of age-related deterioration. To prevent further damage and maintain property security and presentation, timely repair or replacement should be considered. The involvement of a qualified fencing contractor is advised to ensure appropriate and lasting outcomes.

It is recommended that the client engage a licensed fencing contractor to:

- Assess the full extent of damage and deterioration

- Provide advice on whether targeted repairs or complete replacement is more appropriate
- Undertake rectification works in accordance with local standards and property requirements

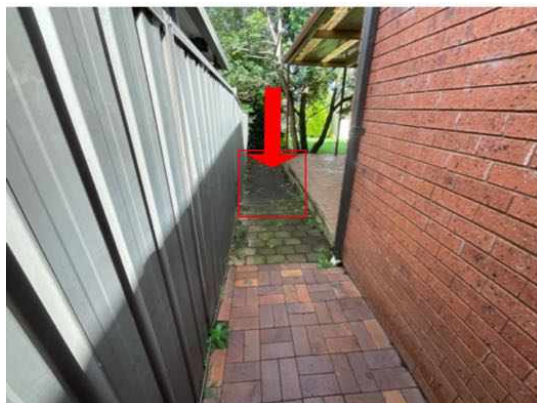
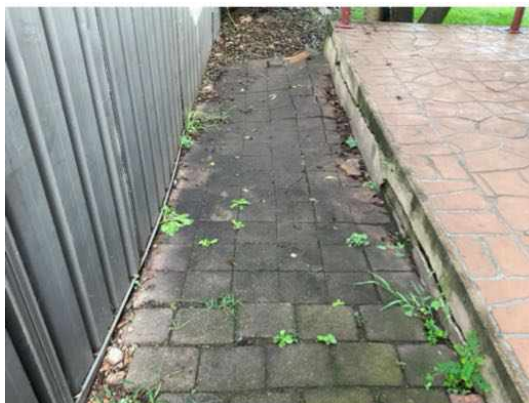
Finding 3.04

Building:	Yard
Location:	Exterior - left side
Finding:	Minor Defect – Uneven External Paving.
Information:	Observation:

Sections of the external paved areas were observed to be uneven, with noticeable height variations between adjoining pavers. This condition is consistent with possible substandard installation, minor ground movement, or settlement of the underlying base. Assessment was limited to visual inspection of accessible areas only.

Uneven paving presents a trip hazard, particularly in commonly used pedestrian areas and during low visibility or wet conditions. In addition, irregular surface levels may adversely affect drainage, allowing water to pond or track toward the dwelling, which may contribute to moisture-related issues and ongoing surface deterioration if not addressed.

It is recommended that the affected areas be rectified by a suitably qualified paving contractor. Works should include lifting and re-laying the pavers, with attention to proper base preparation, compaction, and grading to achieve a level, stable surface with adequate drainage. Prompt maintenance is advised to reduce safety risks and prevent further deterioration.

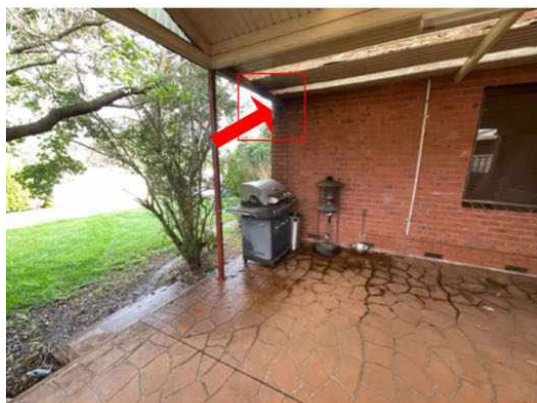
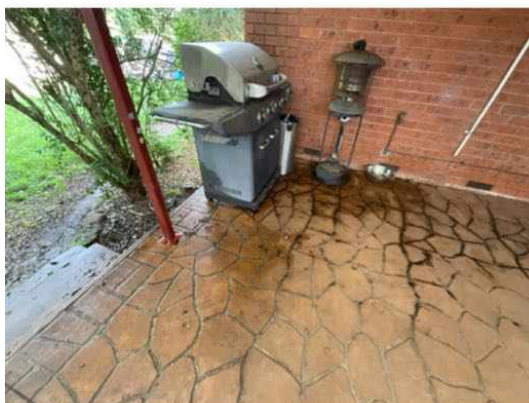
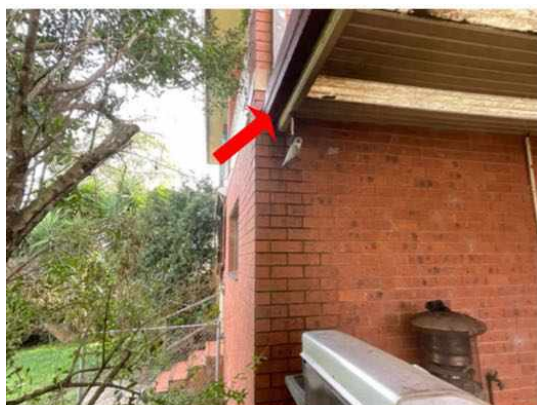
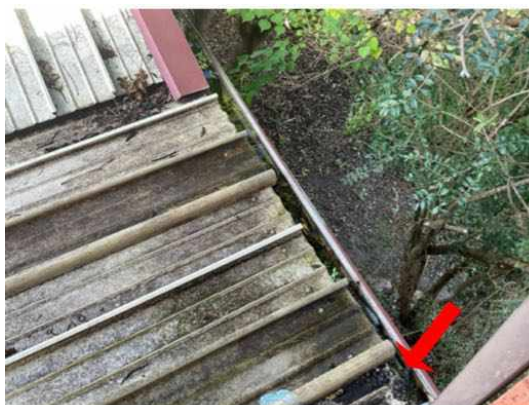
Finding 3.05

Building:	Yard
Location:	Exterior - rear
Finding:	Roof Plumbing – Blocked Gutters and Downpipes.
Information:	Observation

Roof plumbing elements, including the guttering and downpipe systems, were observed to contain accumulated debris at the time of inspection. These components are designed to maintain continuous and unobstructed water flow from the roof to the stormwater discharge system. Any obstruction in these systems compromises their intended performance.

- **Water Pooling and Overflow:** Debris prevents effective water discharge, resulting in water pooling within the gutters. This can force water to overflow the gutter edges, potentially flooding eaves, external walls, and adjacent structural elements.
- **Elevated Moisture Levels:** Prolonged pooling of water increases moisture levels in surrounding building components. Excess moisture accelerates the deterioration of metal components through rust and corrosion and contributes to the decay of timber elements.
- **Termite and Timber Pest Risk:** Damp conditions are a known attractant for termites

and other timber pests. Blocked gutters can inadvertently create moisture-rich environments conducive to pest activity and subsequent structural damage.

Failure to address these issues promptly may result in secondary and potentially costly defects to roof framing, soffits, cladding, and internal finishes.

- All debris should be removed from gutters and downpipes immediately to restore proper drainage performance.
- Homeowners or a suitably competent handyperson may carry out basic cleaning works as an interim measure.
- A licensed plumber should be engaged to undertake a full assessment of the roof plumbing system, confirm whether any components have been damaged due to sustained moisture exposure, and provide recommendations for required remedial works.
- Where gutter guard is installed, a routine maintenance program should be implemented to ensure debris does not accumulate and impede the system's operation.

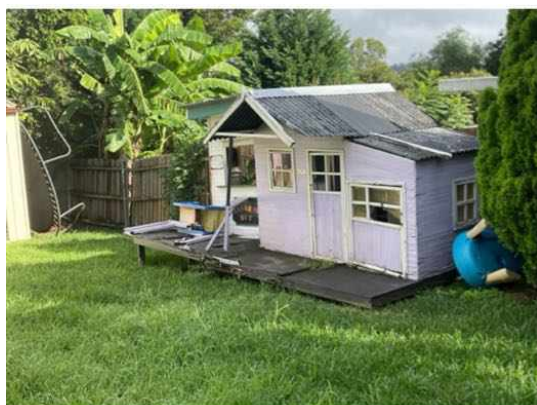
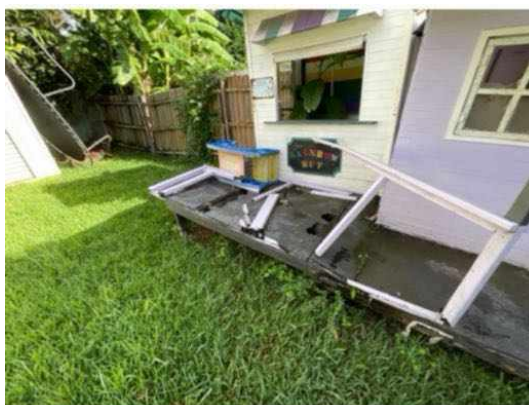
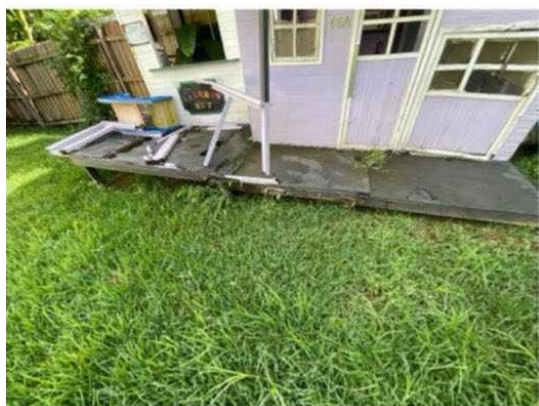
Finding 3.06

Building: Yard
Location: Exterior - rear
Finding: Defect – Deteriorated Children’s Playhouse (External Structure)
Information:

A children’s playhouse located on the property was observed to be in a poor and significantly deteriorated condition at the time of inspection. Extensive timber decay was evident to structural and non-structural elements, including framing and cladding components. The structure appeared weathered, unstable, and not maintained. This assessment was based on a visual inspection only and no invasive testing was carried out.

The advanced level of timber decay compromises the structural integrity of the playhouse, rendering it unsafe for use. There is an increased risk of collapse, splintering, or failure of components, which presents a safety hazard, particularly for children. In addition, decaying timber can create conditions conducive to timber pest activity, including termites, and may increase the likelihood of attracting such pests to the surrounding area or dwelling.

It is recommended that the playhouse be decommissioned and removed from the site. Removal should be carried out in a safe manner, and all associated debris disposed of appropriately. Following removal, consideration may be given to inspecting the surrounding area for any signs of timber pest activity.

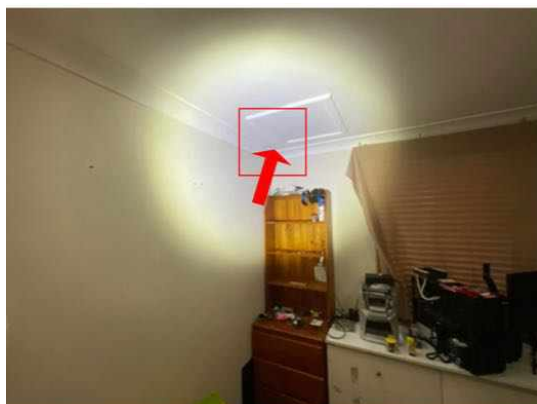
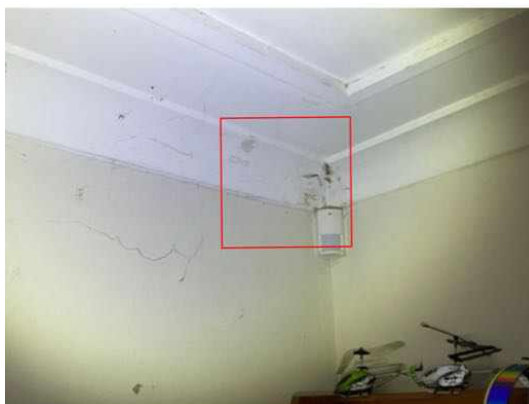
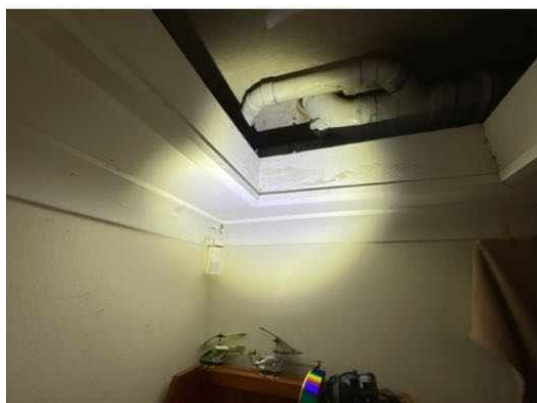
Finding 3.07

Building:	Shed
Location:	Bedroom > Ground Level
Finding:	Minor Defect – Ceiling Water Staining
Information:	Observation:

Water staining was noted to ceiling linings within the inspected area(s) at the time of inspection. The staining presented as discoloured and patchy areas, consistent with previous moisture ingress. Inspection of the adjacent void via with the access hatch did not reveal any active leaks at the time of assessment. Plumbing drainage pipes servicing the upstairs bathroom are located in this vicinity and appear to have been the likely source of a past leak; these were observed to be dry at the time of inspection. This assessment was based on a visual inspection only.

Ceiling staining typically indicates prior moisture exposure and may be associated with plumbing failures. Although no active moisture was detected at the time of inspection, previous water ingress can contribute to deterioration of building materials, including corrosion of metal components, timber degradation, and damage to ceiling linings and finishes. There is also potential for mould development where moisture has been present. If the source of the leak has not been fully rectified, there remains a risk of recurrence and further damage.

Where the staining appears dry and no active leak is evident, repairs to the affected ceiling surfaces, including patching and repainting, may be undertaken at the client's discretion once it has been confirmed that the source of the moisture ingress has been adequately rectified. Should any signs of ongoing or recurring moisture become evident, it is recommended that a suitably qualified plumber be engaged to investigate and address the source of the leak.

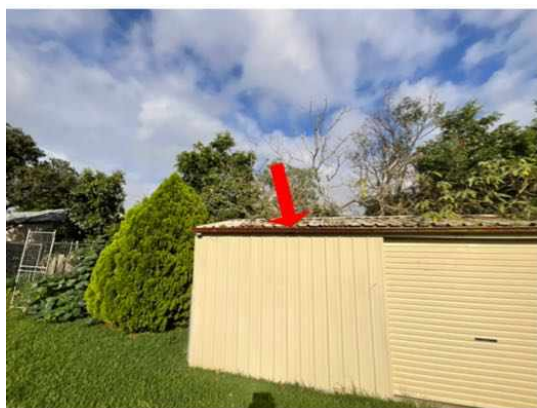
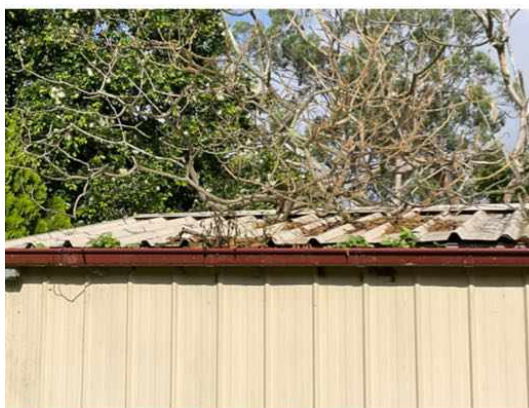
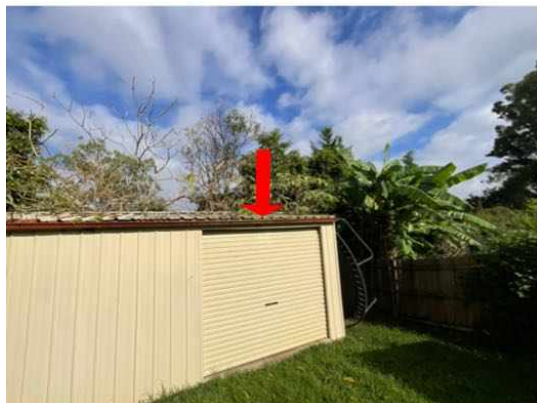
Finding 3.08

Building:	Shed
Location:	Roof Exterior
Finding:	Roof Plumbing – Blocked Gutters and Downpipes.
Information:	Observation

Roof plumbing elements, including the guttering and downpipe systems, were observed to contain accumulated debris at the time of inspection. These components are designed to maintain continuous and unobstructed water flow from the roof to the stormwater discharge system. Any obstruction in these systems compromises their intended performance.

- Elevated Moisture Levels: Prolonged pooling of water increases moisture levels in surrounding building components. Excess moisture accelerates the deterioration of metal components through rust and corrosion and contributes to the decay of timber elements.

Failure to address these issues promptly may result in secondary and potentially costly defects to roof framing, soffits, cladding, and internal finishes.

- All debris should be removed from gutters and downpipes immediately to restore proper drainage performance.
- Homeowners or a suitably competent handyperson may carry out basic cleaning works as an interim measure.
- A licensed plumber should be engaged to undertake a full assessment of the roof plumbing system, confirm whether any components have been damaged due to sustained moisture exposure, and provide recommendations for required remedial works.
- Where gutter guard is installed, a routine maintenance program should be implemented to ensure debris does not accumulate and impede the system's operation.

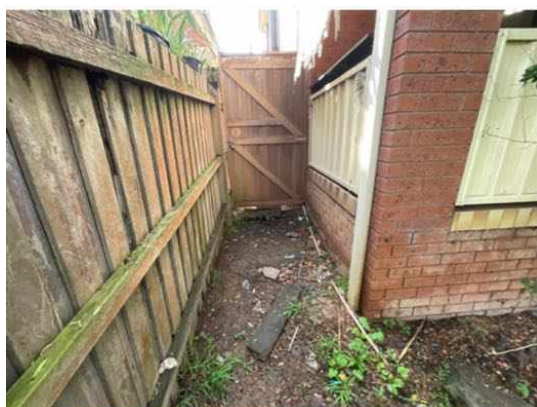
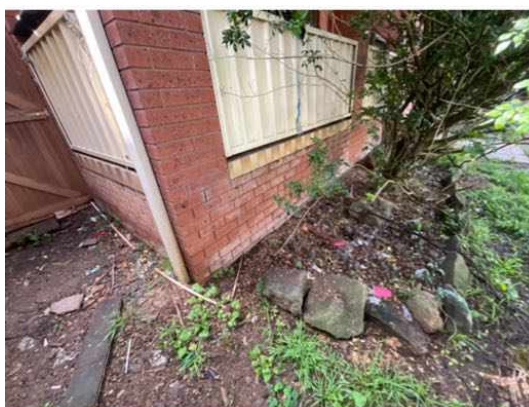
Finding 3.09

Building: Yard
 Location: Exterior - rear
 Finding: Defect – Below Average Site Drainage
 Information:

Site drainage in the inspected areas appears to be below average, with no surface drains observed at the time of inspection. Ground surfaces and paved areas adjacent to the building do not appear to be adequately graded to facilitate effective surface water runoff.

- Water should not be allowed to accumulate against the base of external walls or around the perimeter of the dwelling.
- Prolonged moisture exposure can contribute to:
 - Dampness and structural deterioration
 - Movement of footings or erosion of subsoils

- Conditions that are conducive to timber pest activity, including termites, which are attracted to moist environments
- Best practice site drainage includes:
 - Paved surfaces falling away from the building by at least 25mm over the first metre
 - Bare ground sloping away by at least 50mm over the first metre

Failure to meet these minimum drainage falls increases the risk of water ingress, foundation issues, and secondary building defects.

- A licensed plumber and/or landscaping contractor should be engaged to:
 - Evaluate the current site grading and surface runoff conditions
 - Install or upgrade surface water drainage (e.g. strip drains, spoon drains, grated channels) as required
 - Improve grading around the building to ensure water flows away from the structure

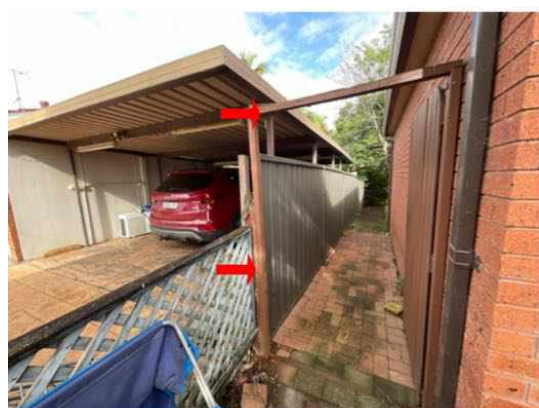
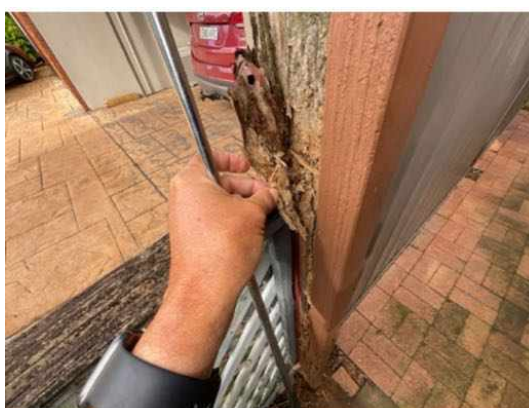
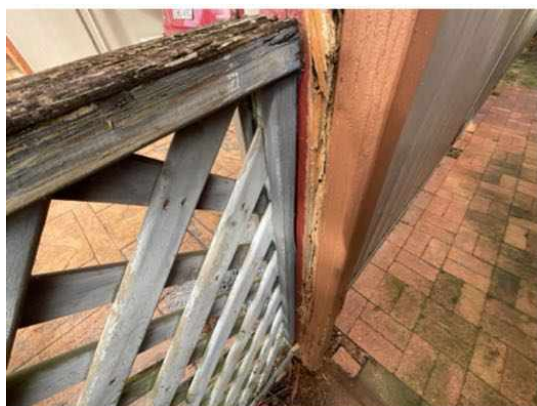
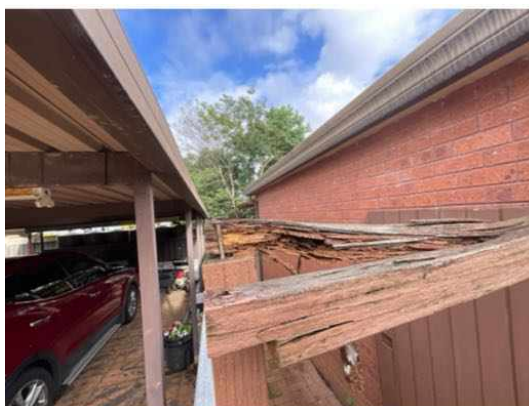
Visible evidence of termite workings was identified in the landscaping timbers at the time of inspection. The workings appeared inactive, with no live termites observed during the inspection. Evidence included typical indicators such as mudding and timber damage. This assessment was based on a visual, non-invasive inspection only.

Inactive termite workings indicate that termite activity has occurred previously; however, this does not confirm that the risk has been eliminated. Termites may still be active in the surrounding area or within concealed sections of the property. There remains a risk of re-infestation or ongoing concealed activity, which may result in further timber damage if not appropriately managed. It is not possible to conclusively determine the current status of termite activity without further invasive investigation and ongoing monitoring.

It is recommended that the affected landscaping timbers be removed and disposed of to eliminate a potential source of attraction and harbourage for termites. The client should also seek clarification from the current owner regarding any previous termite treatments or management measures undertaken.

A comprehensive timber pest inspection by a licensed pest control specialist is strongly recommended, along with the implementation of a regular inspection and maintenance program to monitor and manage future risk.

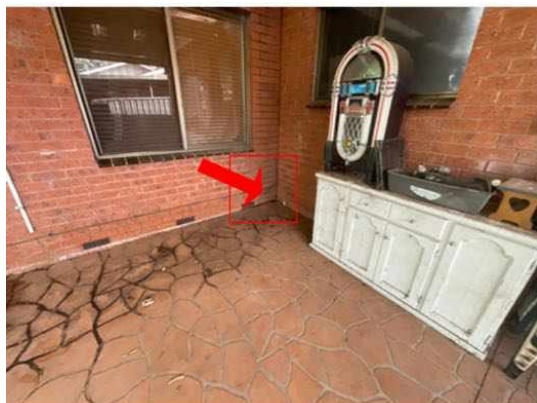
Finding 6.01

Building:	Main Building
Location:	Exterior walls
Finding:	Plumbing and/or yard drainage - Conducive conditions..
Information:	Observation: Drainage Issues Around Property

It is highly recommended that all overflows from the HWS and air conditioning units be redirected away from the building, preferably via fixed drainage or extension piping, to prevent water accumulation near the structure.

These minor corrective works should be undertaken promptly to minimise the risk of both termite ingress and potential structural damage due to ongoing moisture exposure.

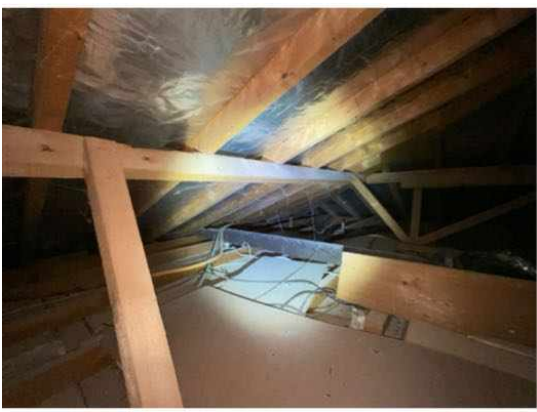
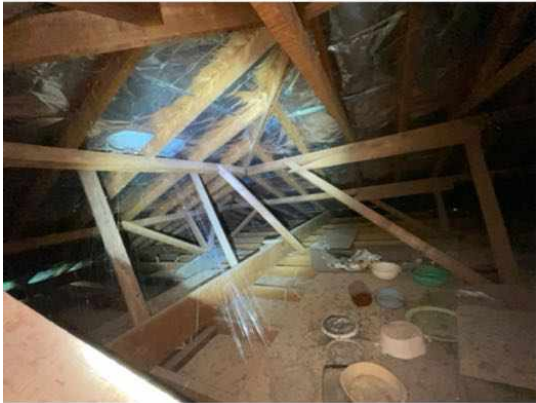
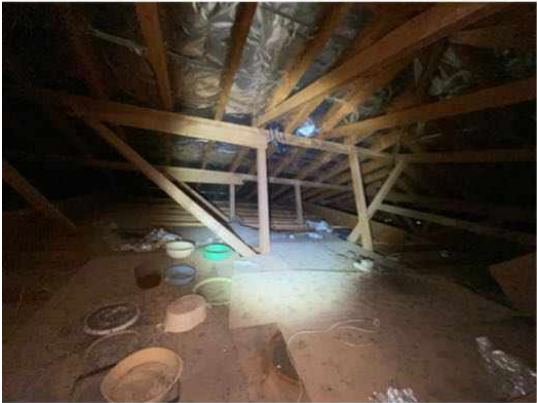
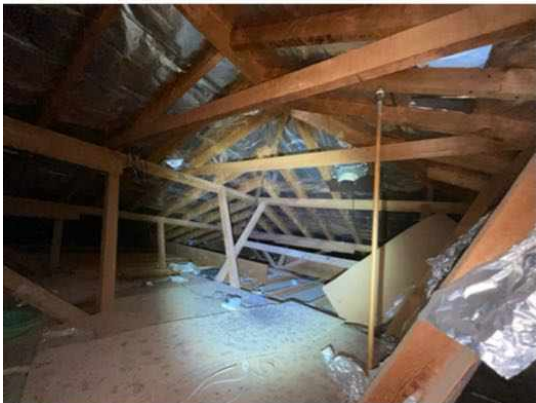
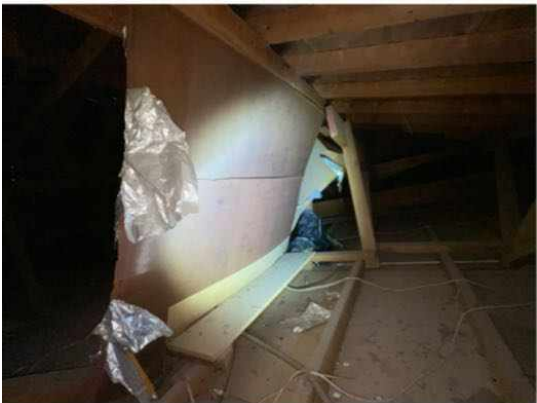
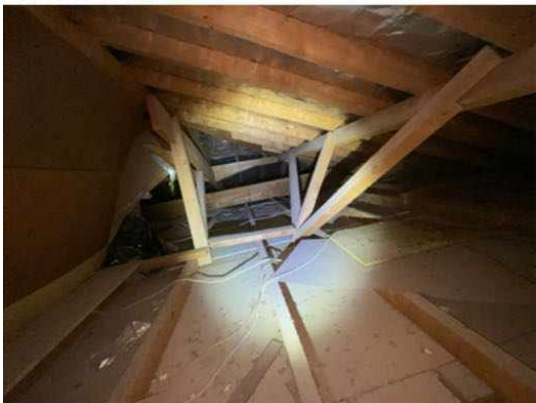
The roof void was generally found to be in sound condition within the areas inspected. Notwithstanding this, restricted access and obstructions limited the scope of inspection, and concealed defects may exist that were not identifiable at the time of assessment.
