# Building and Timber Pest Inspection Report

Inspection Date: Thu, 9 Apr 2026

Property Address: 60 Fraser Ave, Kellyville NSW 2155,  
Australia

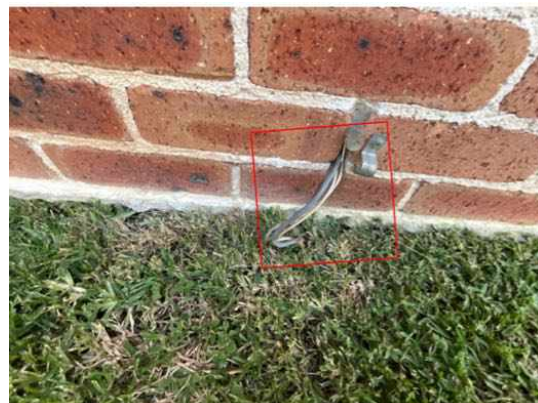
Building:	Main Building
Location:	Exterior walls - left side
Finding:	Conduit - Missing
Information:	A conduit has not been installed to exterior wires in this area. This is a safety measure that is aimed at protecting the wires and preventing any personal injury that may result if wires are squashed or damaged.

Without a conduit providing adequate protection, external wiring is likely to become damaged and deteriorated over time, creating an electrical safety hazard. Damage to the wiring is also likely to result in the associated elements losing function.

A qualified electrician should be contacted immediately to install a conduit around the wires and provide any further advice on additional works that may be required to increase the safety of the wiring and its surrounding area.

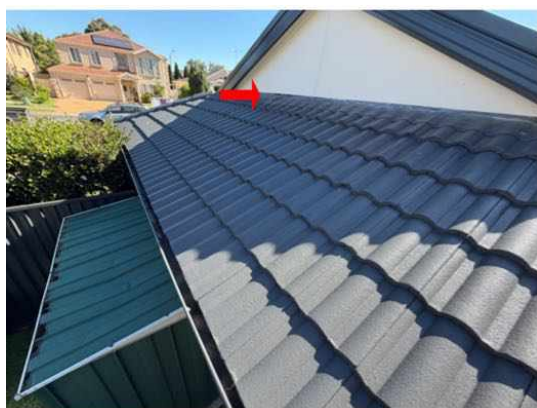
Building:	Main Building
Location:	LHS gable
Finding:	Roof plumbing - Flashing inadequate
Information:	Some sections of the roof are missing or have inadequate roof flashings. Flashings are

Flashings that are not installed adequately or are missing are likely to result in water penetration to the interior of the property, as well as creating excessively damp conditions against the exterior surfaces and around the base perimeter of the building.

Premature ageing and secondary building defects are imminent where roof plumbing is missing or inadequately installed. Additionally, water pooling also creates an environment that is susceptible to termite and pest infestation.

A roofing plumber should be appointed as soon as possible to install relevant roof plumbing materials, ensuring that no further damage is sustained.

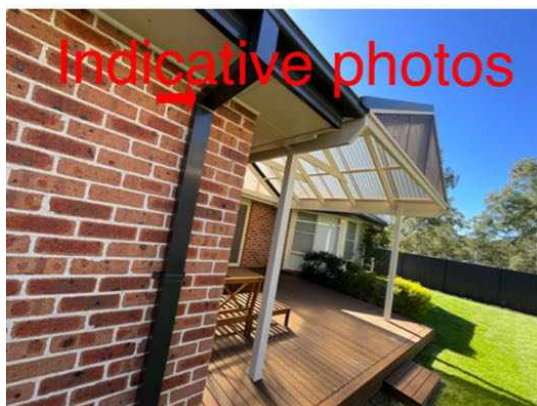
### Finding 3.02

Building:	Main Building
Location:	Multiple areas of roof plumbing
Finding:	Water leak - External
Information:	Water leaks were found to be present to exterior plumbing work. Leaks are generally caused by deterioration of the plumbing elements over time, due to exposure to weather conditions, but may have also been caused by minor impact damage.

Such leaking creates damp conditions in the affected area, causing potential for water pooling and subsequent water damage if left unattended. These conditions may also attract termite attack, particularly if the area is subject to minimal levels of sun throughout daylight hours.

It is highly advised that a licensed plumber be appointed to rectify any water leaks that may be present. Areas of repair and replacement of plumbing fittings and fixtures may be required and, as such, a quotation should be sought.

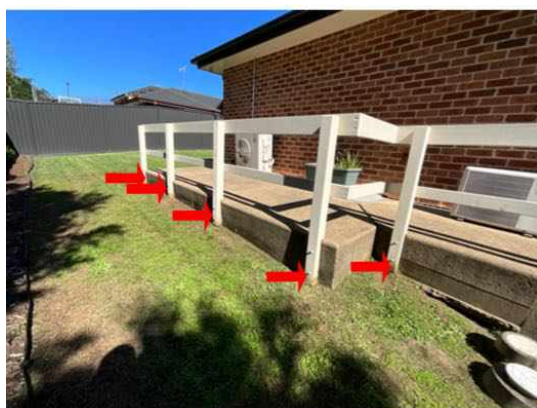
Building: Main Building  
 Location: Balustrades  
 Finding: Untreated or non-durable timbers in a hazardous environment

Information: To reduce the risk of timber pest attack it is essential that timber used in a hazardous environment (e.g. in direct contact with the ground or frequently exposed to damp conditions) is of sufficient durability and/or is adequately preservative treated.

Untreated timbers in direct contact with the ground are likely to develop severe wood rot and/or fungal decay if left unattended creating attraction for subterranean termites to infest the timbers from surrounding areas.

If untreated or non-durable timbers are found to be in a hazardous environment it is highly advised that replacement of these building elements be performed as soon as possible to aid the protection of the property against termite / timber pest attack.

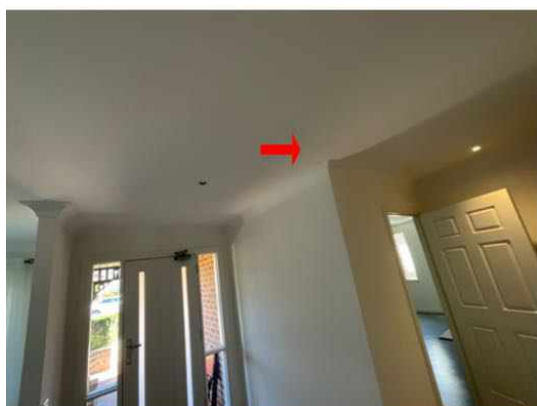
Building:	Main Building
Location:	Multiple areas
Finding:	Cracking - Damage Category 0 - Hairline (less than 1mm)
Information:	Hairline cracks are very minor in nature and generally are only ever an appearance defect. While such cracking may be noticeable in some cases, it is quite common and does not indicate any structural damage.

Cracking of this nature can generally be repaired with minor sanding, filling and/or repainting. Such works should be performed by a qualified painter or a general handyman.

Monitoring of all cracking should be conducted frequently. Always contact a building inspector should cracks widen, lengthen, or become more numerous.

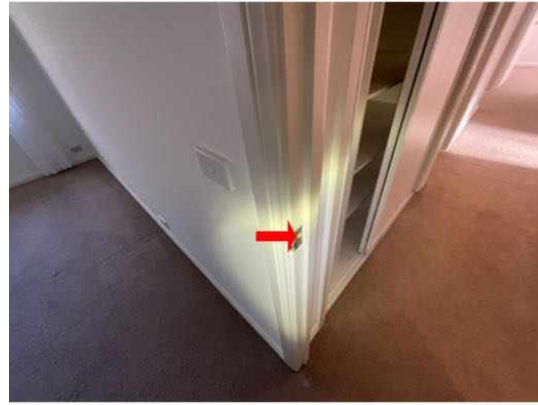
### Finding 3.07

Building:	Main Building
Location:	Multiple areas
Finding:	Door - Striker plate misaligned
Information:	The striker plate to this door appears to have become misaligned and has consequently resulted in the door's operation being compromised.

This is a common defect and is expected in a property of this age, whether being due to substandard installation or general deterioration of the door hardware.

Readjustment of the striker plate is recommended at client discretion. Works such as these can be completed by a general handyman or qualified carpenter.

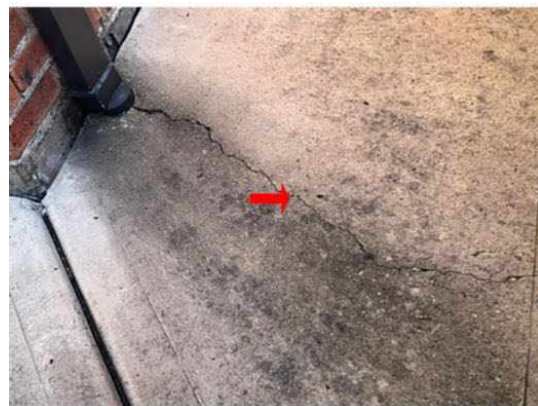
### Finding 3.08

Building:	Main Building
Location:	Backyard
Finding:	Cracking - External Concrete Paving Damage Category 1 - Fine (less than 2mm)
Information:	Fine cracks were identified in external concrete paving. Although fine cracks are quite noticeable, they are often only considered to be an appearance defect, and usually do not indicate any structural damage. To be considered a Category 1 or fine crack, the crack is found to be less than 2mm in width.

Generally the cause of a hairline crack in existing concrete paving such as driveways and pathways is indicative of the expansion and contraction of the concrete. Such causes are generally due to environmental factors, such as moisture levels, weather conditions, root systems of nearby trees or the soil types on which they are laid.

Fine cracks may also be due to poor original installation of the concrete. Factors such as poor compaction of the sub surface and/or inadequate reinforcing of the slab may create cracking and other secondary defects.

Monitoring of all cracking should be conducted frequently. Always contact a building inspector should cracks widen, lengthen, or become more numerous.

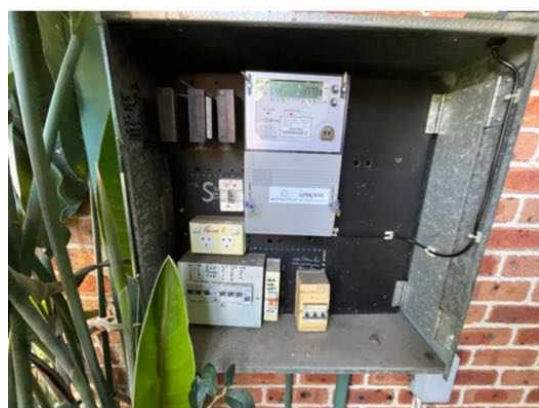
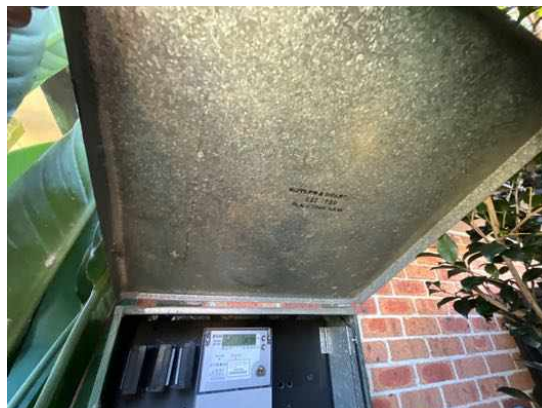
Building:	Main Building
Location:	Meterbox
Finding:	Termite Management System - no evidence of installation
Information:	The application of a post-construction chemical termite barrier is highly recommended for all properties, particularly if live termite activity has been found on the site previously. Such barriers are highly effective in preventing termite attack on any timber building elements throughout the property.

A durable notice should be placed in the switchboard unit to indicate current termite barriers. At the time of inspection, it appeared as though no termite management system has been installed, with no evidence to suggest preventative works taking place.

The client may consider gaining further advice from a pest controller as to the costs and procedures involved with this application. It is recommended that obtaining such advice be a short-term priority.

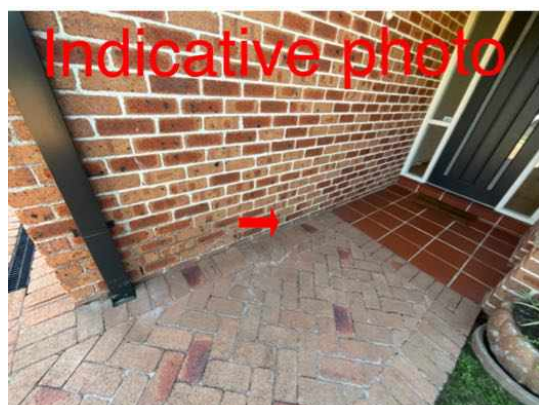
### Finding 6.04

Building:	Main Building
Location:	Slab penetrations
Finding:	Service penetrations
Information:	Services into home can allow for concealed termite entry without additional or adequate termite protection.

concrete edge should not be concealed by render, tiles, cladding, flashings, adjoining structures, paving, soil, turf or landscaping etc. Where this is the case you should arrange to have the slab edge exposed for inspection. Concealed termite entry may already be taking place but could not be detected at the time of the inspection. This may have resulted in concealed timber damage. Does the slab edge inspection zone fully comply?

Not able to comment. A very high proportion of termite attacks are over the edge of both Infill and other concrete slabs types. Covering the edge of a concrete slab makes concealed termite entry easy. Infill slab type construction has an even higher risk of concealed termite ingress as the slab edge is concealed due to the construction design and cannot be exposed. The type of slab may only be determined by assessment of the construction plans by a qualified person e.g. Builder, Architect. Construction Plans may be obtainable by your local Council or Builder. Termite activity and or damage may be present in concealed timbers of the building. We strongly recommend frequent regular inspections in accordance with AS 3660.2. Where the slab edge is not fully exposed or the slab is an infill slab or the slab type cannot be determined then we strongly recommend inspections every 3 to 6 months in accordance with AS 3660.2 or AS 4349.3.

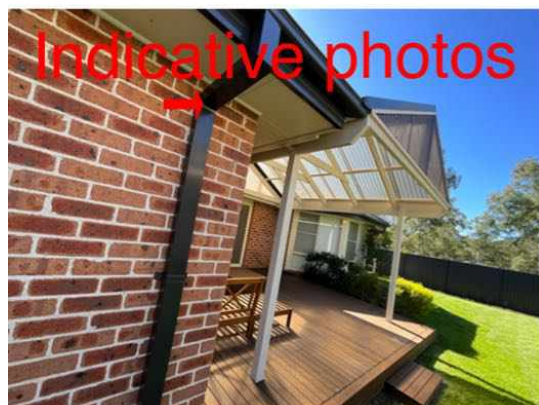
### Finding 6.06

Building:	Main Building
Location:	Multiple areas of roof plumbing
Finding:	Water leak - External
Information:	Water leaks were found to be present to exterior plumbing work. Leaks are generally caused by deterioration of the plumbing elements over time, due to exposure to weather conditions, but may have also been caused by minor impact damage.

Such leaking creates damp conditions in the affected area, causing potential for water pooling and subsequent water damage if left unattended. These conditions may also attract termite attack, particularly if the area is subject to minimal levels of sun throughout daylight hours.

It is highly advised that a licensed plumber be appointed to rectify any water leaks that may be present. Areas of repair and replacement of plumbing fittings and fixtures may be required and, as such, a quotation should be sought.

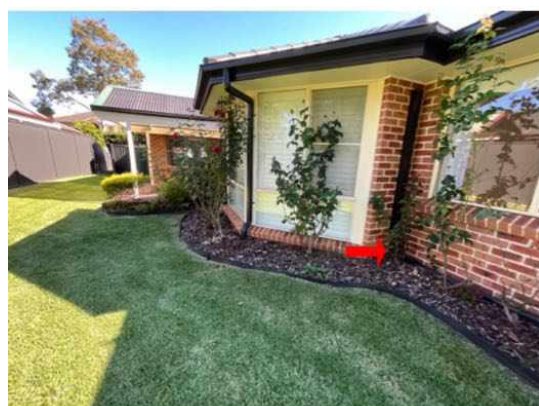
### Finding 6.07

Building: Main Building  
 Location: Multiple areas  
 Finding: Overflow - Not plumbed for drainage  
 Information: The overflow is not plumbed or connected to suitable drainage, which can result in the surrounding area becoming excessively damp.

These damp conditions can lead to secondary defects such as rot, rust or corrosion of associated building elements, the formation of fungal decay, or even the creation of potential slip hazards. When coupled with poor site drainage, pooling of water may also attract termite activity to this area.

It is highly recommended that a licensed plumber be appointed to install adequate drainage to the overflow. These works will ensure that the area remains dry and free of any secondary defects.

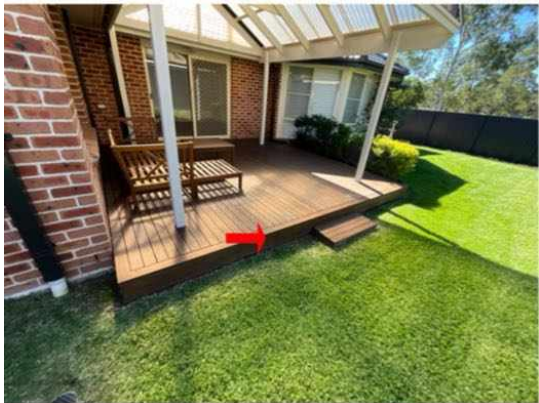
### Finding 6.08

Building:	Main Building
Location:	Fencing & Landscaping
Finding:	Building materials in direct ground contact - conducive to termites
Information:	Where timber elements are in direct contact with the ground and consequently moisture or dampness they become conducive to termite activity. Whether timber is used as a building element part of a fencing structure or stored as an unused item they can provide an environment that is attractive to termite infestation.

When met with excessive moisture timber begins to decay and develop wood rot. Any timbers that are in direct contact with external grounds especially if left untreated or non-durable also provide ingress for subterranean termites into that particular element.

The removal of any such materials that may be conducive to termite activity should be removed as soon as possible to minimise the risk of termite attack.

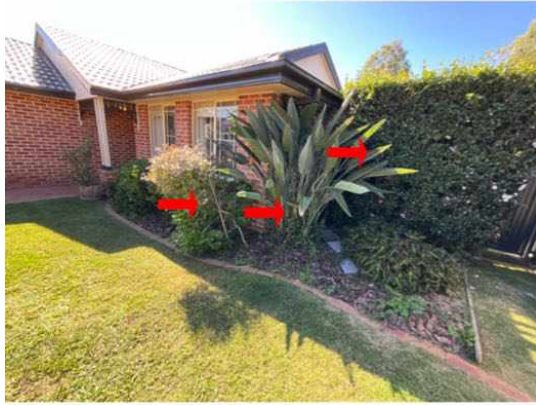
Building: Main Building  
 Location: Vegetation

Finding: Vegetation - Abutting property  
 Information: Vegetation against external wall may have an invasive root system. If there are weak points in the brick work or concrete slab, it is possible for the roots to gain entry into these areas. Once the roots have gained entry, it is possible for termites to gain concealed entry via these roots. It is recommended to remove the vegetation and root system where possible.

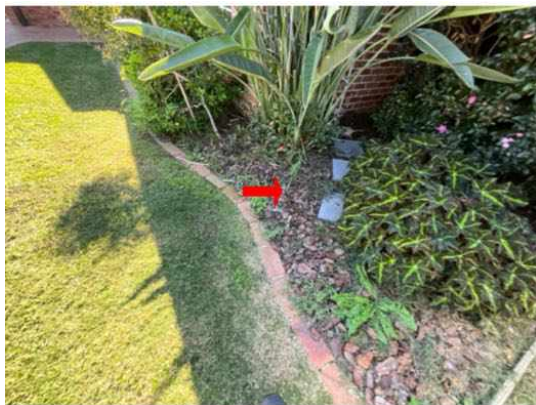
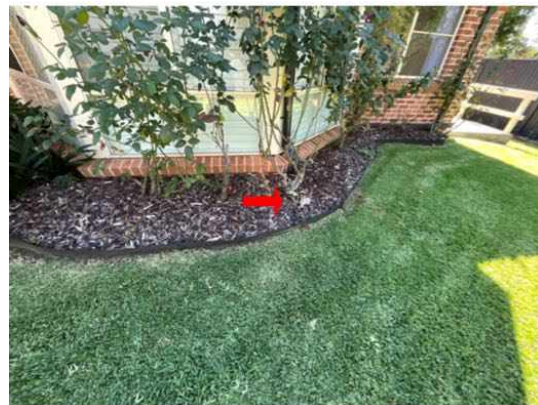
### Finding 6.11

Building: Main Building  
 Location: Garden beds  
 Finding: Garden Beds  
 Information: Garden beds were found to be evident in the garden area. These garden beds can include untreated timber, and with a combination of moisture from watering hosing can make conditions conducive to termite activity and termite ingress.

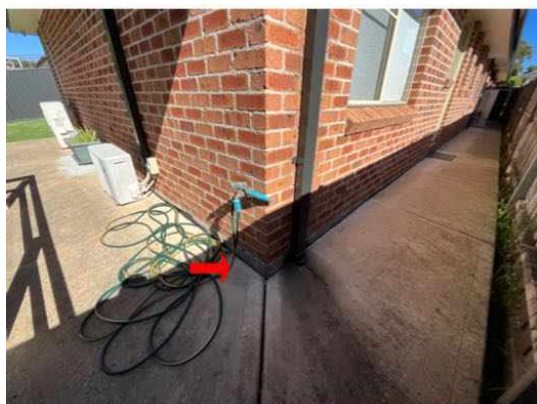
### Finding 6.12

Building: Main Building  
 Location: External tap  
 Finding: Tap - No drain  
 Information: The external tap in this area was noted to have no drain at the time of inspection.

This keeps the surrounding surfaces damp while using the tap, which becomes conducive to termite activity.

A licensed plumber must be appointed to ensure an appropriate drain is installed.

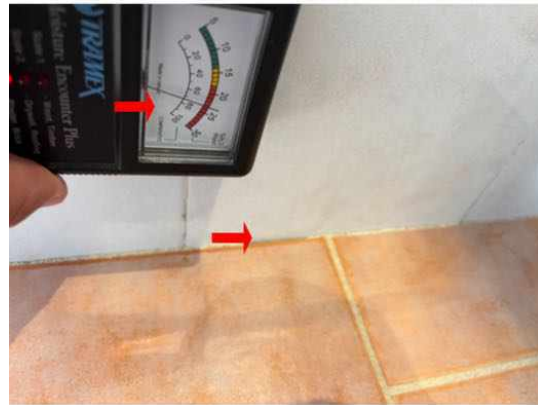
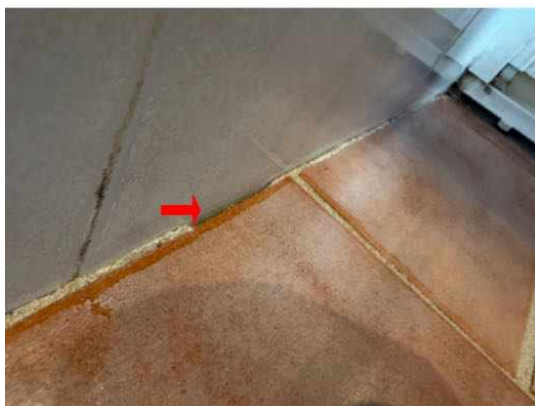
### Finding 6.13

Building:	Main Building
Location:	Ensuite
Finding:	Shower damp - Sealant and grout
Information:	Damp is evident to the lower 400mm of wall to the shower alcove. This defect is quite common, and is suspected to have been caused by moisture permeating or leaching through the grouting and sealant in this area, which shows evidence of deterioration. Leaking pipes within the wall is also a possible cause however this seems unlikely in this instance as there is no moisture build up around the taps or transferring to the other side of the wall. There appears to be no sealant around the tap spindles which may be a small contributing factor.

Damp (or structural damp) refers to the presence of unwanted moisture in the structure of a building, either as the result of intrusion from outside, or condensation from within the structure. In the shower area, internal water leaks, degraded materials or other sources of excessive moisture are generally the cause of damp.

Unmanaged damp in the shower recess is likely to facilitate the formation and development of mould and fungi growth, decaying associated building materials and compromising their structural integrity of associated elements. It is important to address damp conditions, as the World Health Organisation notes that excess moisture leads - on almost all indoor materials - to growth of microbes such as moulds, fungi and bacteria, which subsequently emit spores and other matter into the indoor air. Exposure to these contaminants is associated with a wide range of respiratory and other health-related problems. Damp conditions also create a conducive environment for termite infestation.

Consultation with a bathroom sealant specialist is advised immediately to identify the cause of damp and to perform remedial works as required.

Always ensure that sealant and grout is in good condition to prevent any moisture issues occurring in the future.
