# Building and Timber Pest Inspection Report

Inspection Date: Thu, 26 Mar 2026

Property Address: 30 George Street, Springwood NSW 2777

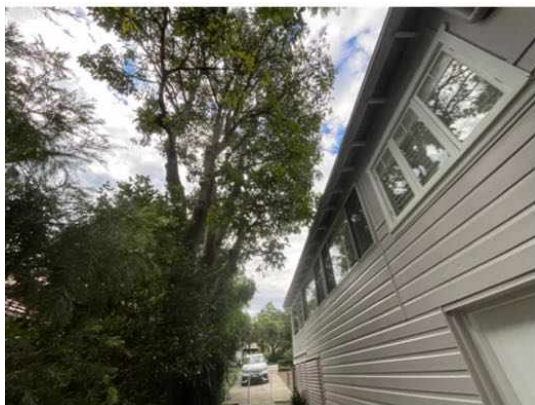
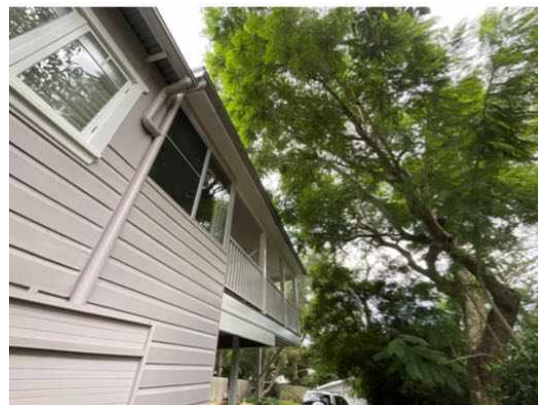
Gutters are a critical part of the building's management of storm water and rain. It is therefore important that they be kept clear to prevent secondary damage to associated building elements, including exterior and interior walls, ceiling linings and any adjoining building elements. Where gutters are blocked, pooling of rainwater is likely to occur, fast-tracking rust and corrosion of the roof plumbing elements.

It is highly advised that all overhanging tree branches be removed as soon as possible to prevent any further damage. Repair and/or replacement of sections of damaged guttering may also be required where the extent of the damage necessitates.

Such works should be performed by the homeowner; however, appointment of a landscape contractor or an arborist may be required. Consultation with a licensed roof plumber is required where guttering has been damaged.

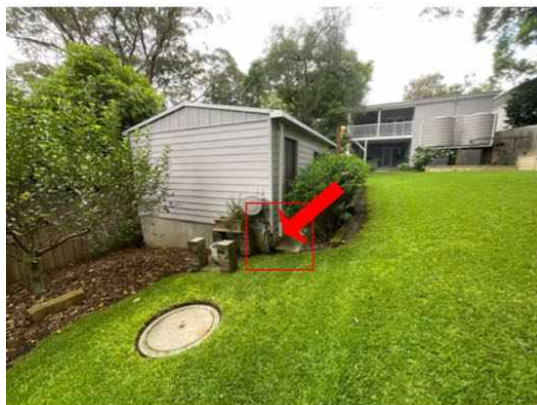
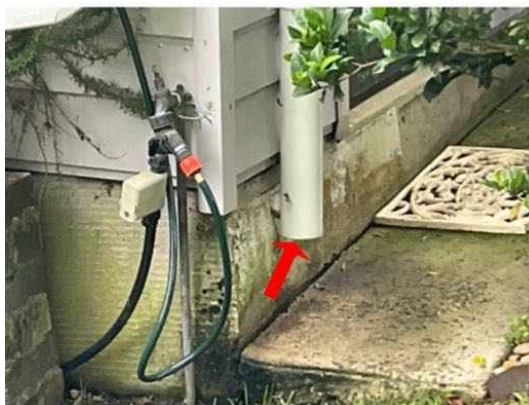
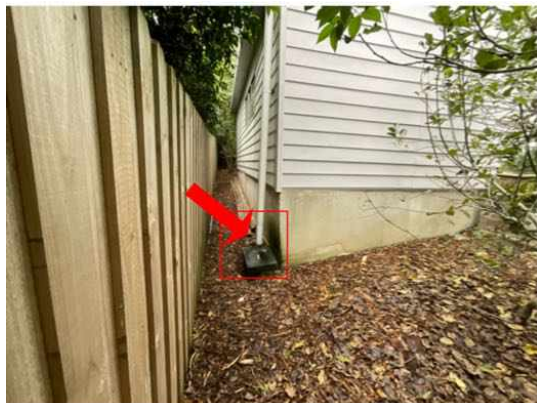
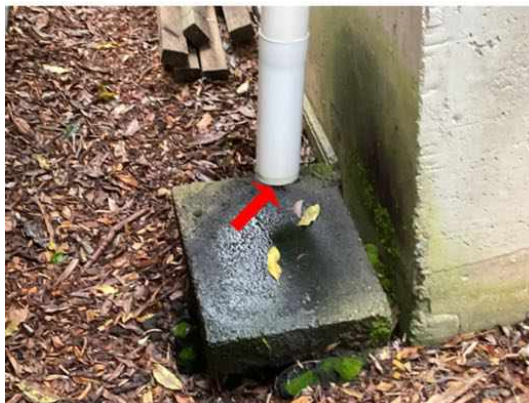
### Finding 3.02

Building: Garage  
Location: Roof Exterior  
Finding: Downpipe - Unconnected.  
Information: Observation:

A section of roof plumbing was found where the downpipe is not connected to the stormwater drainage system.

Excessive moisture from uncontrolled roof runoff can create conditions that promote termite activity and timber decay.

- Gutters and downpipes were in serviceable condition with no active leaks noted.
- Downpipes to the garage are not connected to the stormwater drainage system.

It is advised that a licensed plumber be engaged to:

- Inspect the affected roof plumbing area, and
- Connect the downpipe to a compliant stormwater drainage system, or alternatively, install appropriate drainage measures to manage water flow and mitigate potential property damage or pest risks.

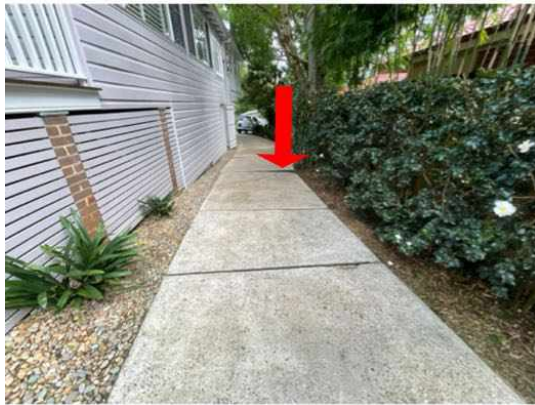
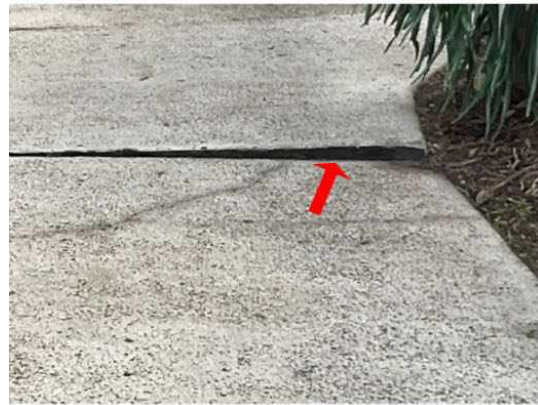
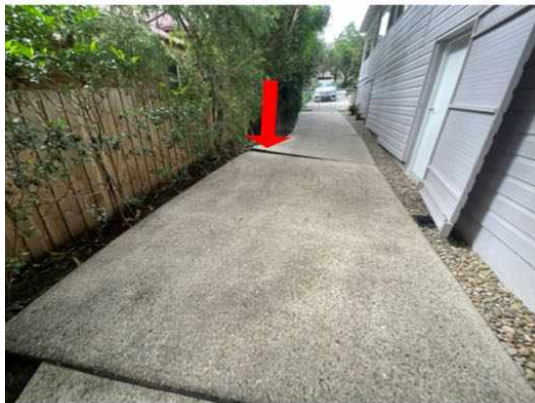
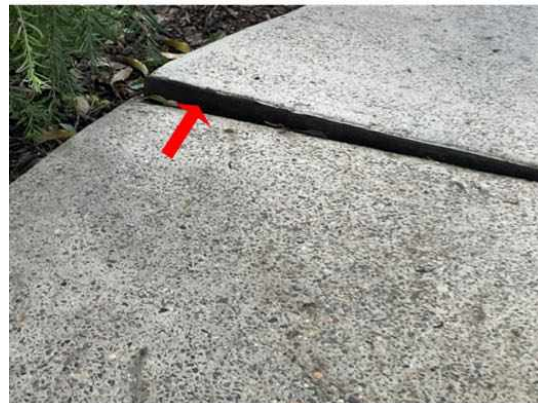
### Finding 3.03

Building:	Yard
Location:	Driveway
Finding:	Paving - Uneven.
Information:	Sections of the external paved area were observed to be uneven and irregular, with noticeable height variations between adjoining pavers. This condition appears consistent with either rough or substandard installation practices, possible soil movement, or settlement of the underlying base material over time.

Uneven paving poses a significant trip and fall hazard, particularly in areas of regular pedestrian use such as paths, patios, or entryways. The risk of personal injury increases if individuals are unaware of the uneven surface or during periods of low visibility or wet conditions. From a safety perspective, this issue requires timely attention to ensure compliance with general building and accessibility standards.

In addition to safety concerns, uneven paved areas can also negatively affect surface drainage. Poorly graded or uneven sections may allow water to pond or flow back toward the building's foundation, contributing to moisture accumulation, potential dampness issues, and premature surface deterioration. Over time, these conditions can lead to further instability of the paving and may necessitate more extensive repair works.

It is recommended that the affected sections be re-laid or re-paved to achieve an even and stable finish. Works should include assessment and correction of the underlying substrate to prevent recurrence of movement or settlement. Ensuring appropriate compaction, grading, and drainage will improve both the functionality and longevity of the surface.

A qualified concreter or paving specialist should be consulted to inspect the area, determine the extent of remediation required, and carry out the necessary works in accordance with relevant building and safety standards. Prompt rectification will help eliminate potential safety hazards and preserve the overall condition and presentation of the property.

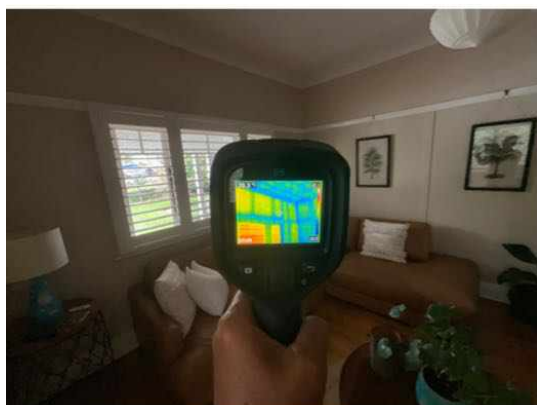
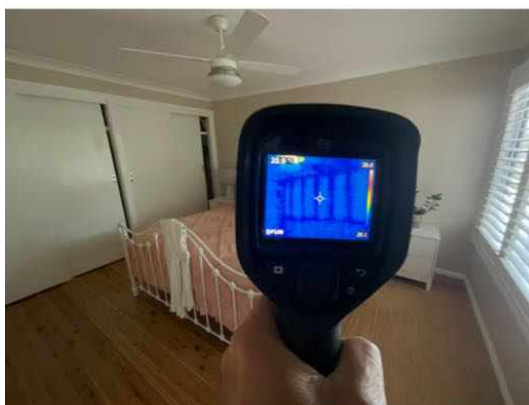
Termites release heat in the form of carbon dioxide and build mud tubes with high moisture content, which can create irregular heat patterns on surfaces such as walls, ceilings, and floors.

At the time of the inspection, no abnormalities indicating live termite activity were observed. However, it's important to note that various factors—such as obstructions, ambient temperature, and wall material/thickness—can impact the accuracy of thermal readings. In cases where surfaces are visually restricted or obstructed, a comprehensive thermal scan may not always be feasible.

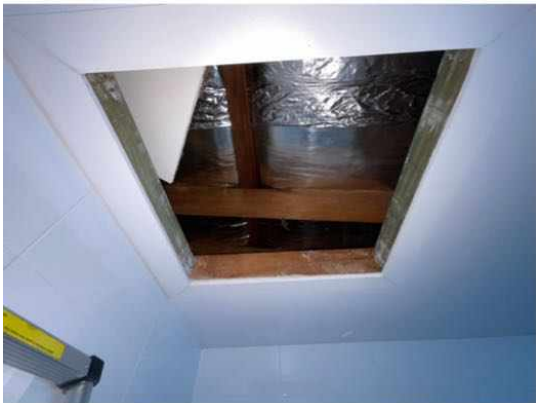
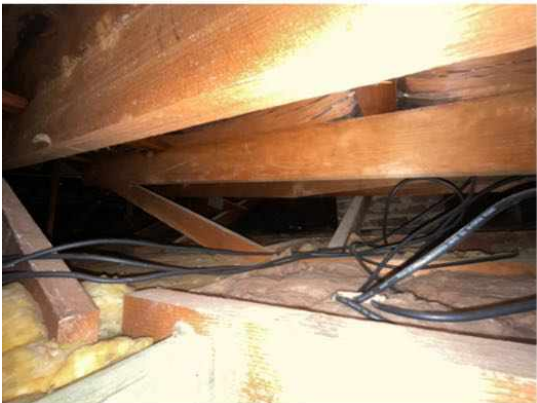
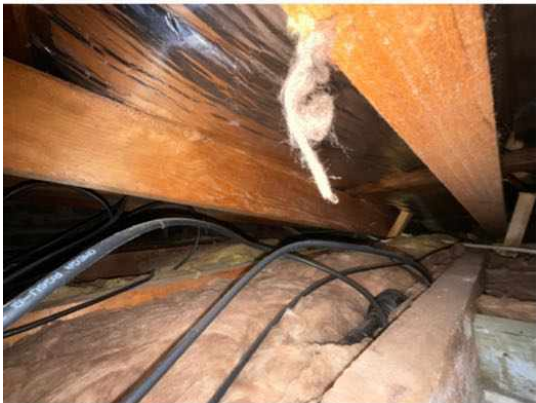
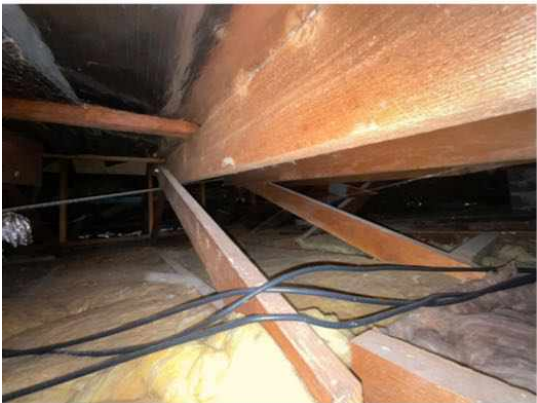
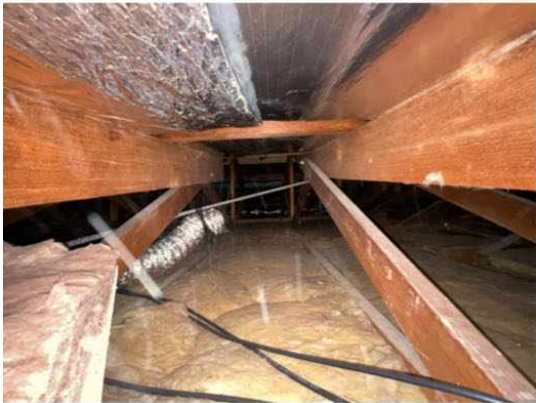
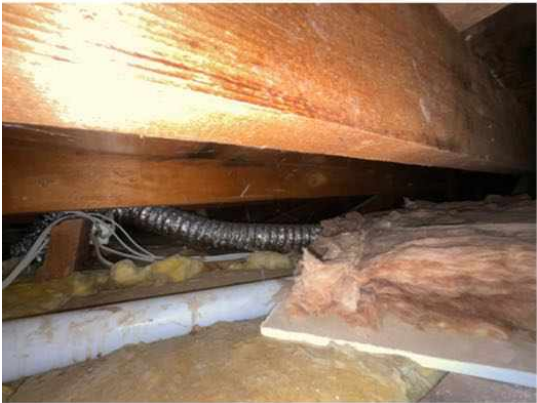
- Insulation in the roof void and subfloor may conceal termite activity or damage.
- No access to roof void areas due to placement of hatch at lower pitch, insufficient clearance.
- Full access is required to allow for a more comprehensive assessment and as recommended the area(s) re-inspected.

Recommendation:

Installation of an additional manhole is recommended to facilitate a re-inspection and enable a more thorough assessment of the roof void in the future. This will help ensure that all structural elements and concealed areas are properly evaluated.

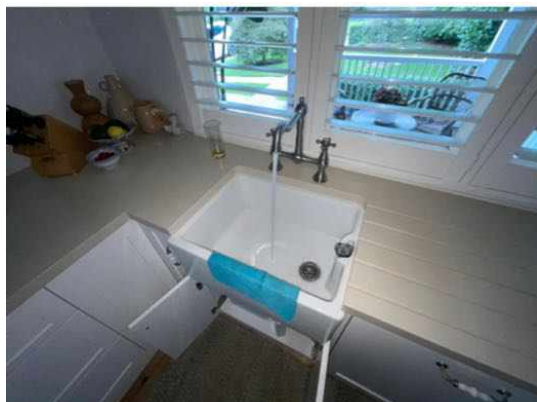
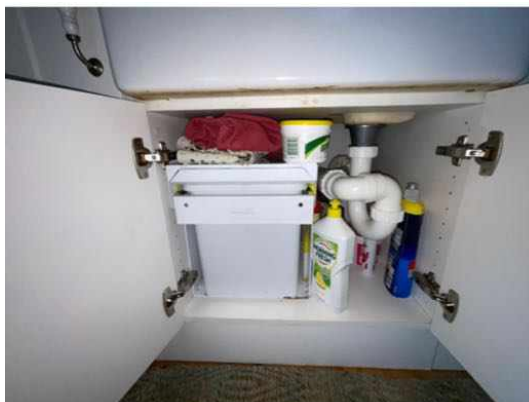
Building: Main Building  
Location: Kitchen

Recommendations:

- Further monitoring and testing are recommended once the tap(s) are in constant use, to identify any drainage issues or signs of slow leaks not evident during the limited inspection.
- It is recommended that the stored items beneath the sink be removed to allow for a full re-inspection of the plumbing and cabinetry, ensuring no concealed defects are present.
