Building Inspection Report

Inspection Date: Mon, 9 Mar 2026

Property Address: 56 Kingloch Parade, Wantirna VIC 3152,
Australia

This is a follow-up inspection report to the previous inspection carried out in December 2025. Unfortunately, several items identified in the previous report remain unrectified or have not been rectified to an acceptable standard at the time of this inspection.

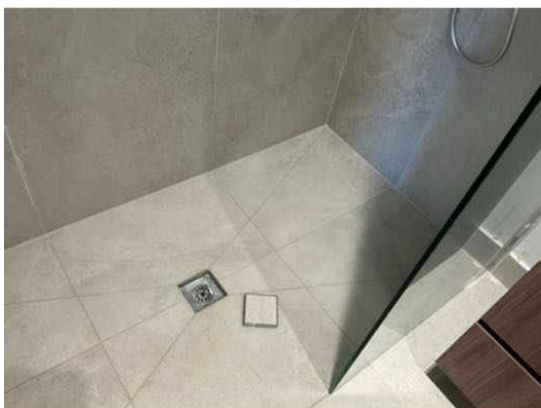
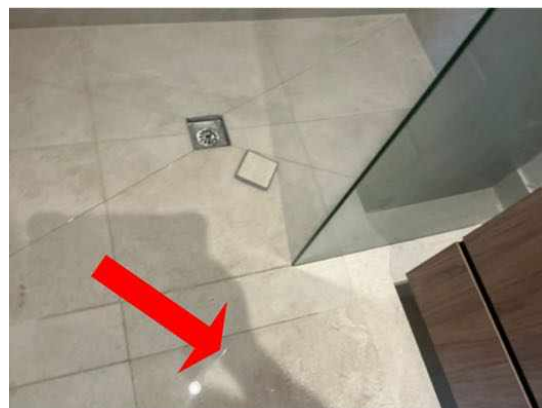
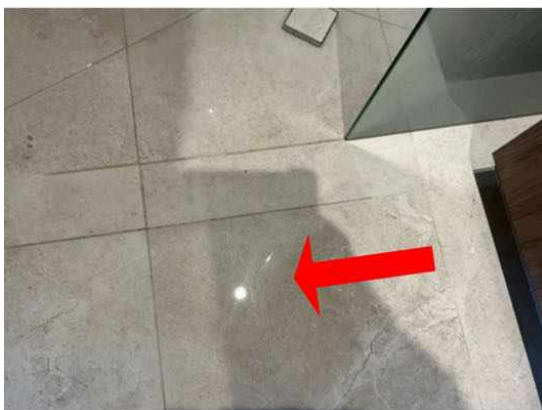
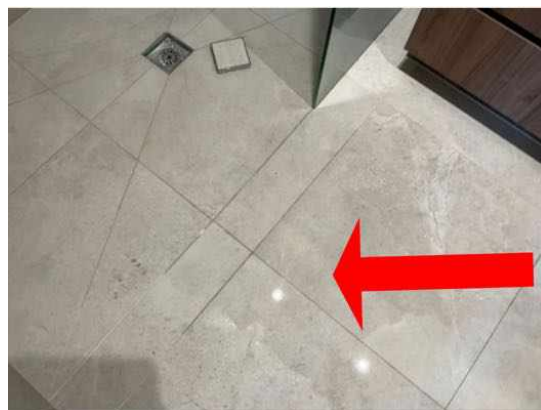
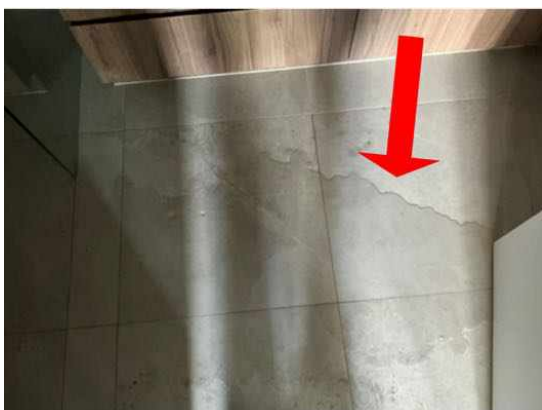
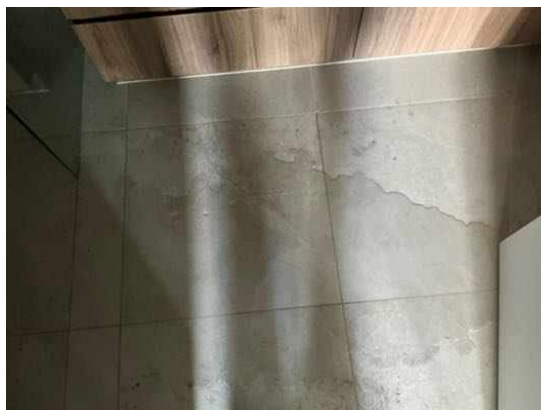
Defects 3.01

Building: Main Building
Location: Ensuite - Master
Finding: Water Escaping from Shower Area
Information:

At the time of inspection, the shower was operated for approximately 15 minutes, after which water was observed escaping beyond the shower area and spreading onto the surrounding bathroom floor. The shower appears to have a level entry (hobless) design, and no visible water-retention detail was noted at the shower opening.

If water is not adequately contained within the shower area, ongoing use may allow moisture to regularly spread across the bathroom floor, which may increase the risk of moisture-related deterioration to adjacent finishes.

It is recommended that a registered builder or qualified waterproofing specialist assess the floor falls, shower screen configuration, and waterproofing/water-retention detailing to ensure the shower effectively contains water and functions as intended.

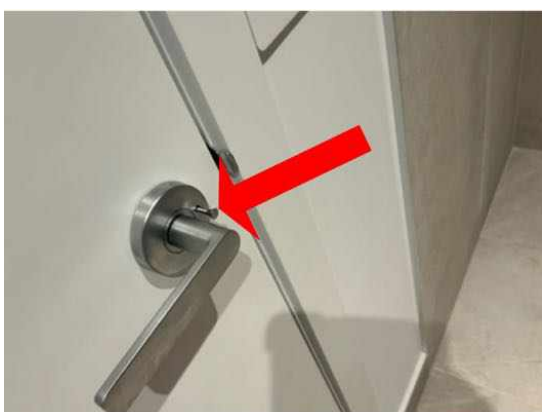
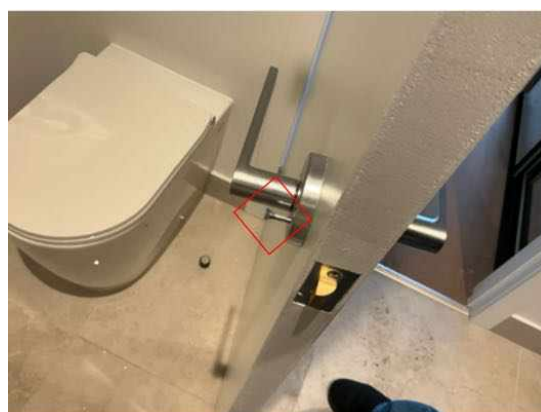
Defects 3.02

Building: Main Building
Location: Ensuite - Master
Finding: Ensuite Bathroom Door Lock – stiff
Information: The door lock to the master ensuite is stiff to press and does not operate as intended; the builder is to return and rectify.

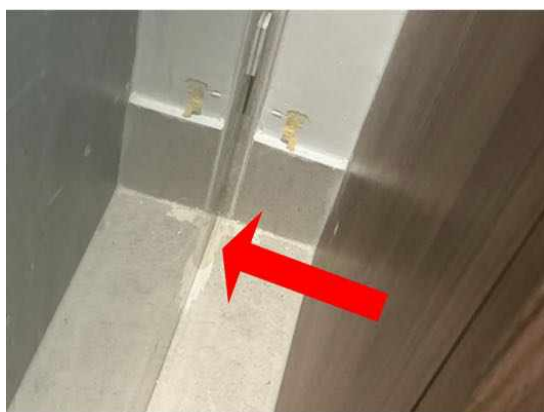
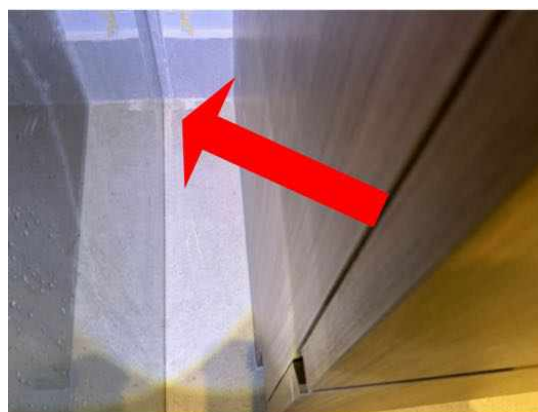
Defects 3.03

Building: Main Building
Location: Ensuite - Master

Finding: Shower screen - Leaking
 Information: Leaking was evident to the downstairs shower screen at the time of inspection. It is suspected that the leaking has occurred as a result of missing caulking to the shower.

Leaking from the shower where left unattended, is likely to lead to water damage to adjoining flooring and walls. Such damage can lead to water damage and necessitate extensive remedial works being required. Active water leaks may also create an environment that is susceptible to the formation and development of mould.

Appointment of a caulking contractor is required to repair or replace the caulking to the shower area. Such works should be performed as soon as possible to ensure that no further damage occurs.

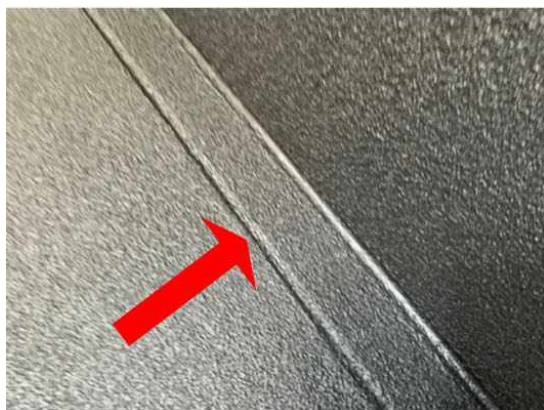
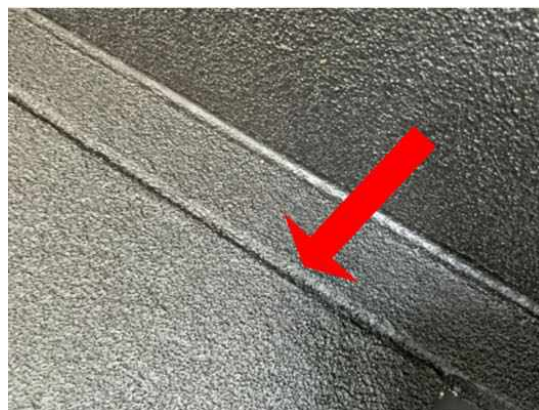
Defects 3.04

Building: Main Building
 Location: Balcony
 Finding: Rendered Over Expansion Joint
 Information: The external expansion joint at the balcony has been rendered over, obstructing the intended movement allowance of the joint. Expansion joints are designed to accommodate natural movement within the structure due to thermal expansion and contraction, and obstructing them may compromise this functionality.

When these joints are covered by rigid finishes such as render, the ability of the structure to move freely is reduced. This can lead to cracking in the render or adjacent building elements over time, and may also contribute to moisture ingress if movement causes gaps or fractures in the render.

It is recommended that the rendered-over section be carefully removed to expose the expansion joint, and the joint reinstated with an appropriate flexible sealant or control joint system to ensure it continues to function as intended.

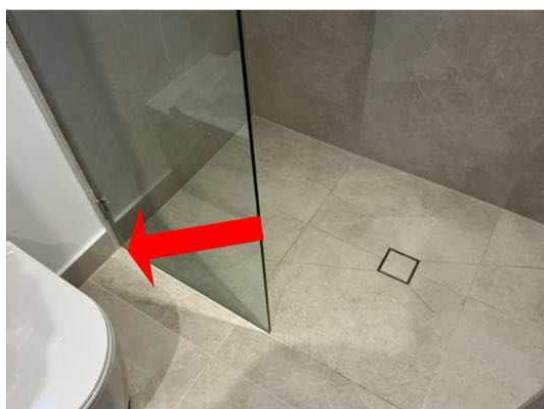
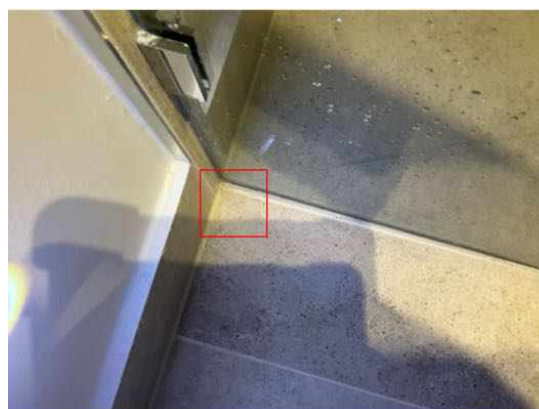
Defects 3.05

Building:	Main Building
Location:	Upstairs bathroom
Finding:	Shower screen - Leaking
Information:	Leaking was evident to the upstairs shower screen at the time of inspection. It is suspected that the leaking has occurred as a result of deteriorated or missing caulking to the shower or general ageing of the building elements.

Leaking from the shower where left unattended, is likely to lead to water damage to adjoining flooring and walls. Such damage can lead to water damage and necessitate extensive remedial works being required. Active water leaks may also create an environment that is susceptible to the formation and development of mould.

Appointment of a caulking contractor is required to repair or replace the caulking to the shower area. Such works should be performed as soon as possible to ensure that no further damage occurs.

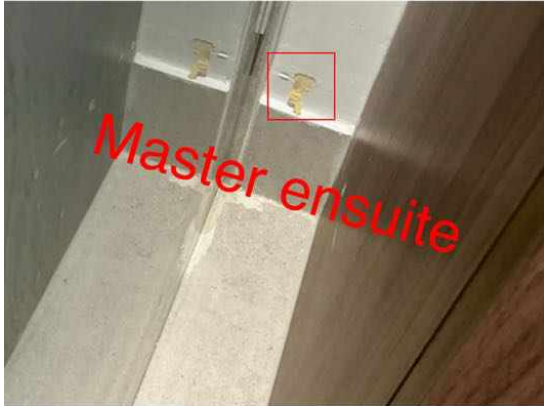
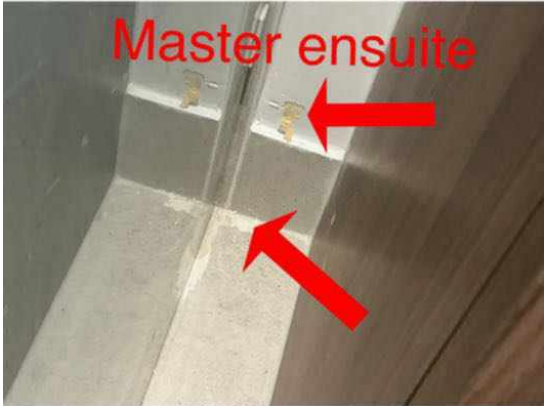
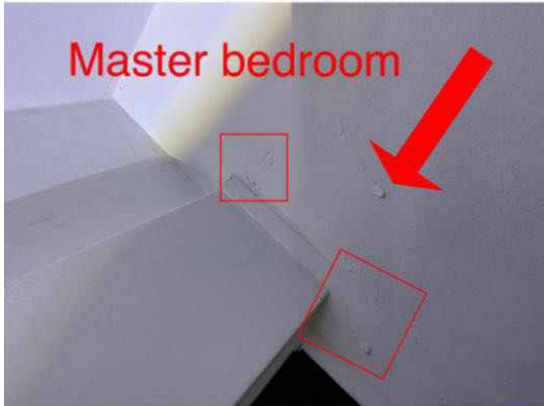
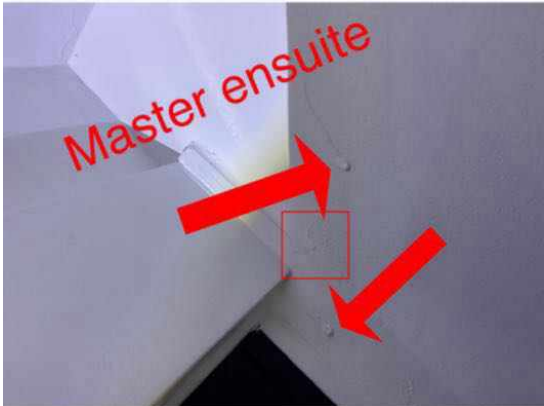
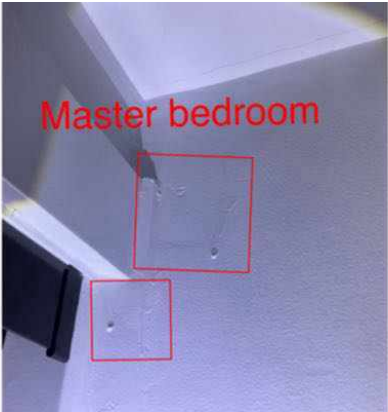
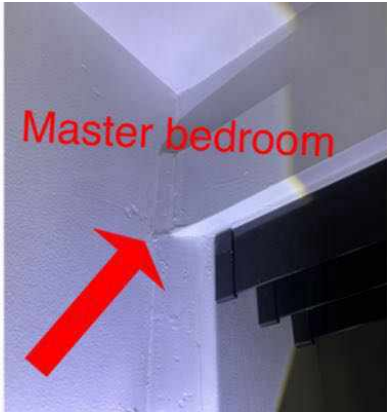
Defects 3.06

Building:	Main Building
Location:	All Internal Areas
Finding:	General Workmanship – Poor Finish

Information: The below photographs show examples of poor workmanship and substandard finishes identified in various areas throughout the dwelling.

The builder is to review all affected areas and carry out rectification works as required to bring the finishes up to an acceptable standard consistent with new construction.

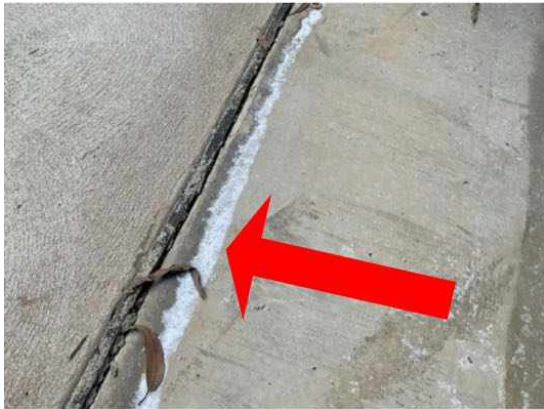
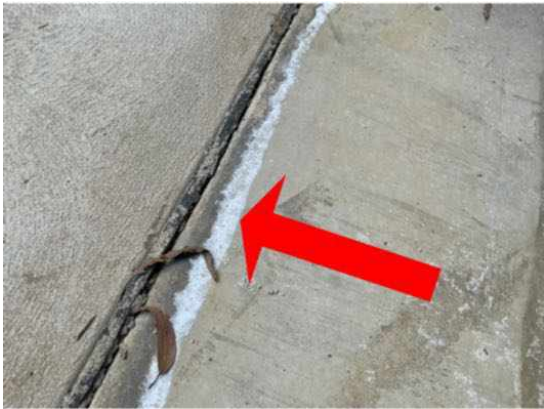
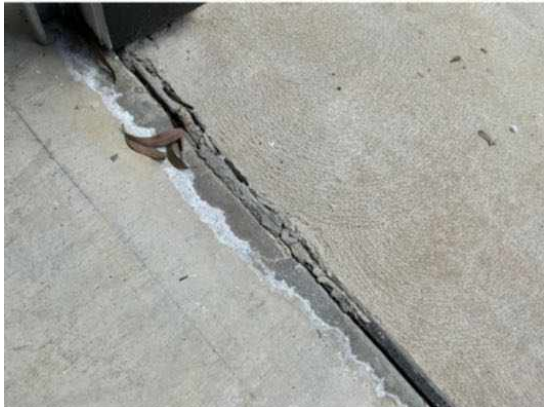
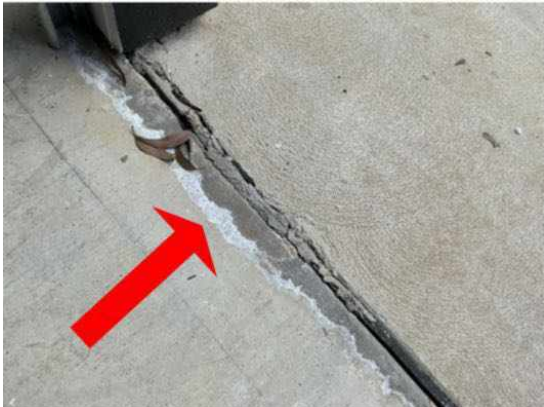
Defects 3.07

Building:	Main Building
Location:	Garage
Finding:	RISING DAMP – GARAGE SLAB EDGE (EXCESSIVE MOISTURE RECORDED)
Information:	Rising damp was identified to the slab edge within the garage. Excessive moisture levels were recorded using the moisture meter at the time of inspection, confirming the presence of elevated moisture within the slab edge area.

Prolonged moisture exposure can lead to deterioration of building elements in contact with the slab edge, deterioration of applied finishes, and creation of conducive conditions for timber pest activity and future moisture related defects. If left unrectified, the condition is likely to worsen over time.

It is recommended that a qualified plumber or moisture management specialist be engaged to investigate the cause of the moisture ingress and implement a suitable damp proofing solution to prevent moisture migration. The area should be monitored following rectification to ensure moisture levels return to acceptable levels.

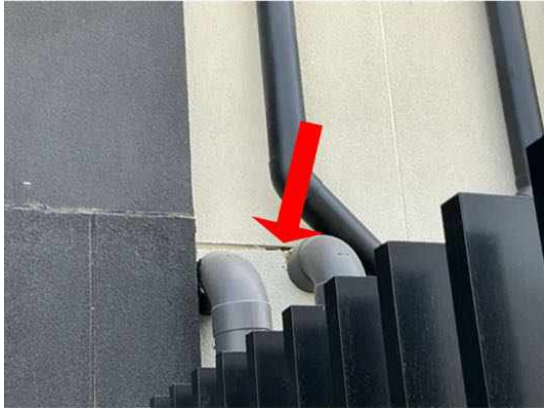
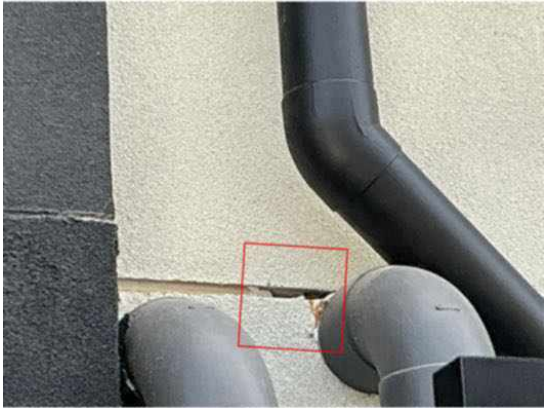
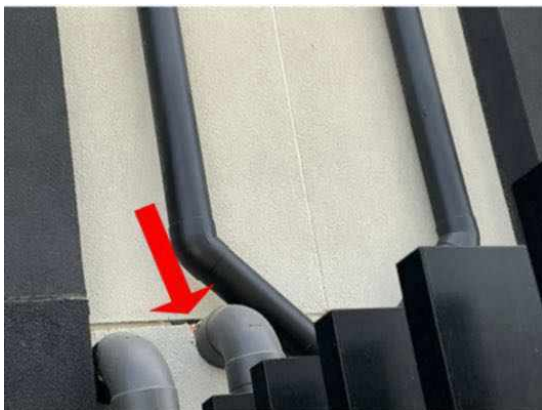
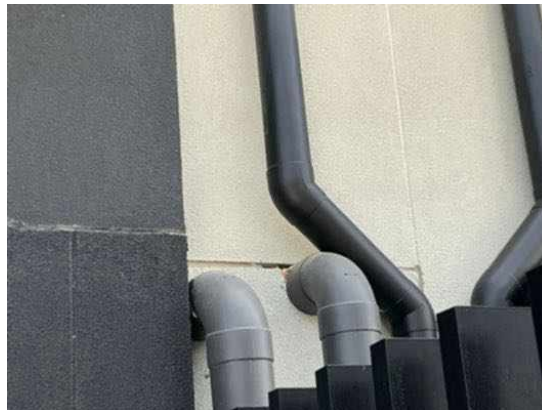
Defects 3.08

Building: Main Building
Location: Exterior walls - rear
Finding: Rear External Walls – Inconsistent Sealant Application
Information: At the time of inspection, the sealant/caulking application to the rear external walls was found to be inconsistent, with visible gaps present.

The builder is to engage a suitably qualified tradesperson to reapply and make good the sealant to all affected areas to ensure full coverage and reduce the risk of water ingress.

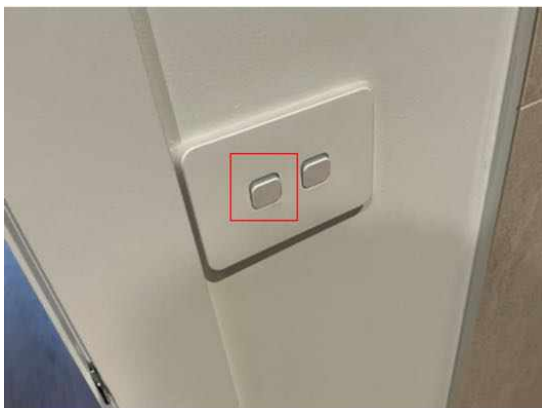
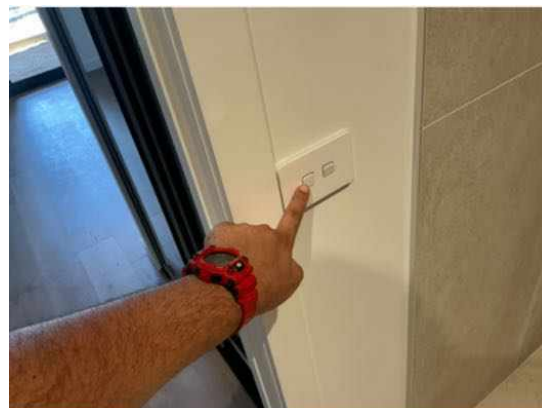
Defects 3.09

Building: Main Building
 Location: Ensuite - Master
 Finding: Stiff Light Switch – Master Ensuite Bathroom
 Information:

The light switch button in the master ensuite bathroom was stiff to press at the time of inspection; a licensed electrician should return to check and rectify.

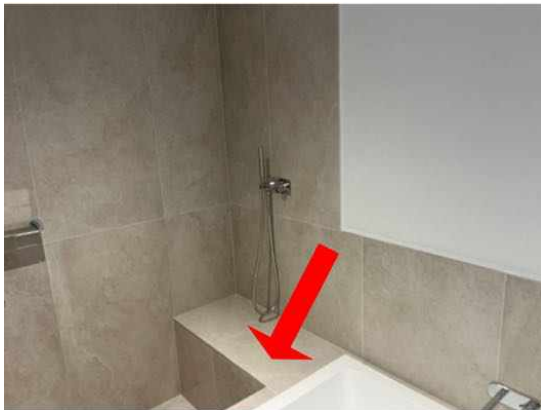
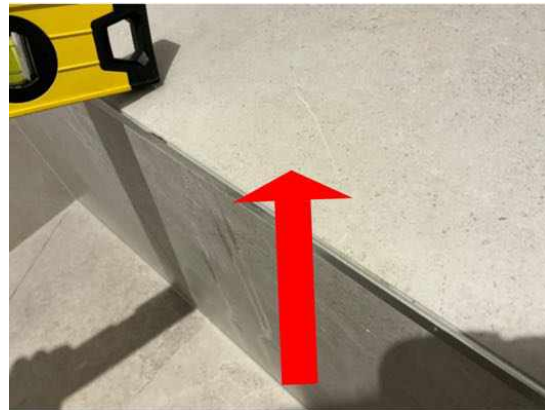
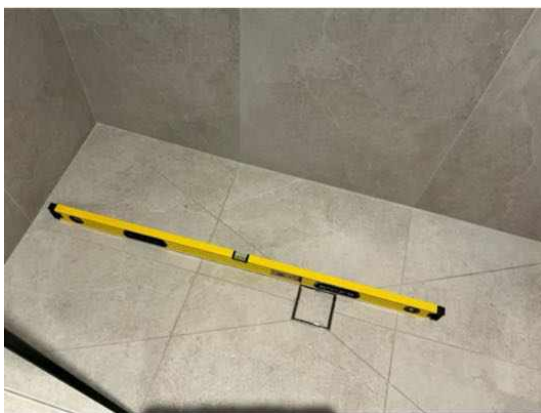
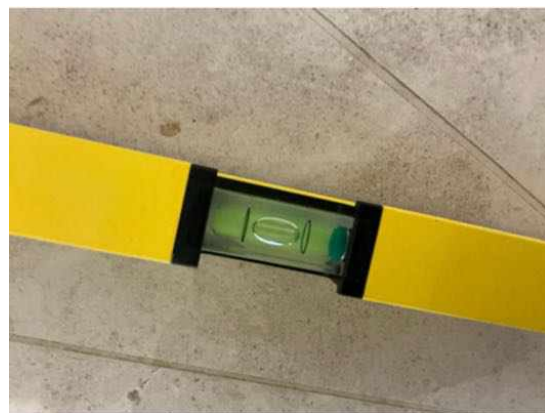
Defects 3.10

Building: Main Building
 Location: Bathroom upstairs
 Finding: Inadequate Falls to Upstairs Shower Base and Tiled Seat
 Information:

At the time of inspection, the upstairs shower was operated for approximately 15–20 minutes, after which water was observed pooling on the shower floor and on the adjacent tiled seat. This condition indicates that the surfaces appear to lack sufficient falls toward the floor waste, resulting in poor drainage.

If left unaddressed, ongoing water ponding may lead to persistent moisture within the shower area and may increase the likelihood of deterioration to finishes over time.

It is recommended that the builder return to reassess the falls within the shower area,

and where necessary engage a qualified tiler to rectify the tile falls to ensure effective drainage toward the waste.

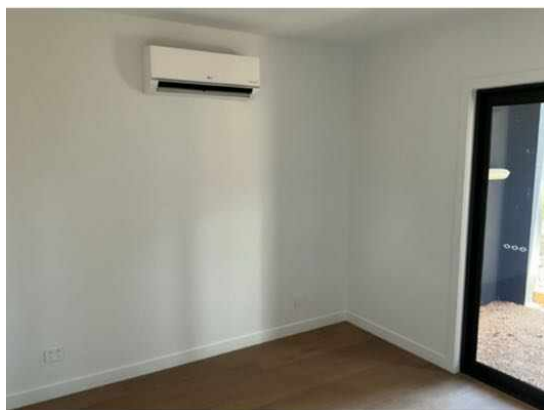
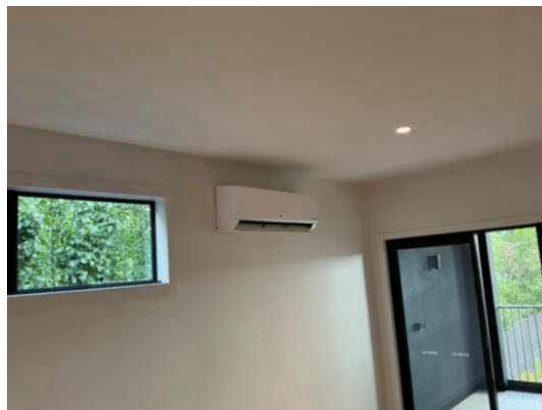
Defects 3.11

Building: Main Building
Location: All Internal Areas
Finding: Split System Air Conditioners – Operational
Information:

At the time of inspection, the split system air conditioning units located in the upstairs living area and the master bedroom downstairs were observed to be operational. The client should engage a licensed air conditioning specialist to inspect and confirm that the split system units are operating correctly.

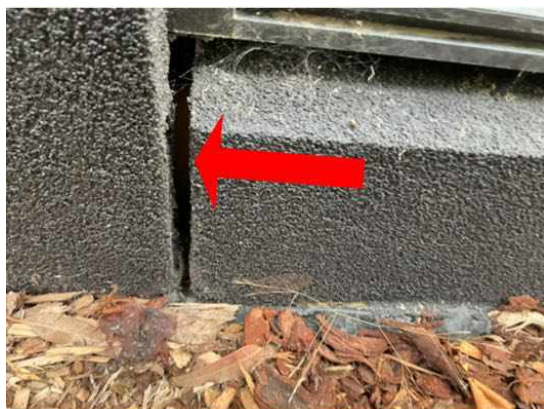
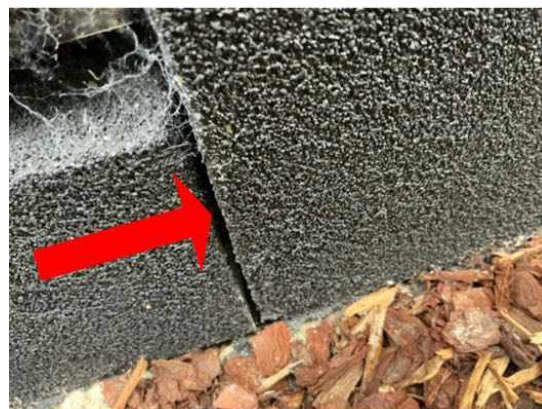
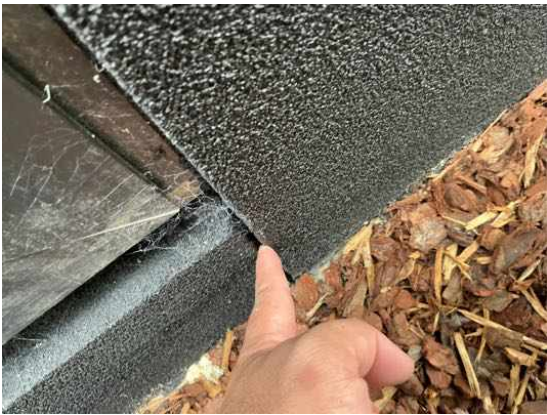
Defects 3.12

Building: Main Building
 Location: LHS exterior walls
 Finding: Cladding expansion joint - Seal missing.
 Information: During the inspection, it was noted that the seal for the Hebel expansion joint is missing on parts of the RHS exterior walls. Expansion joints in Hebel cladding are critical as they accommodate the natural movement of building materials caused by thermal expansion, contraction, and other environmental factors. The absence of a proper seal in these joints can lead to several issues:

- Water Penetration: Without a seal, water can penetrate the expansion joint, potentially leading to water damage within the wall cavity and interior spaces. This can result in dampness, mold growth, and deterioration of building materials.
- Energy Efficiency: Gaps in the expansion joints can affect the building's insulation properties, leading to increased energy consumption for heating and cooling.

To address this issue, it is recommended that a qualified handyman, caulking specialist, be engaged to inspect and reseal the expansion joint. This will help maintain the integrity, durability, and appearance of the brickwork, as well as prevent potential water ingress and structural problems.

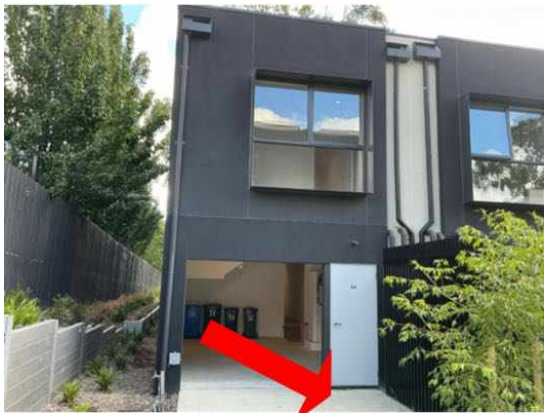
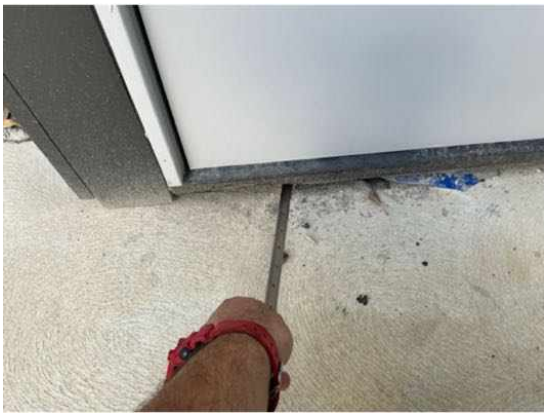
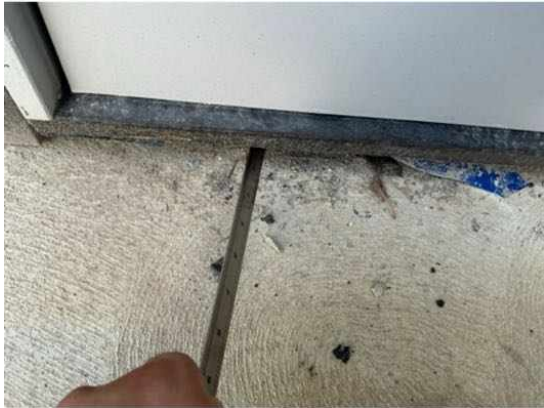
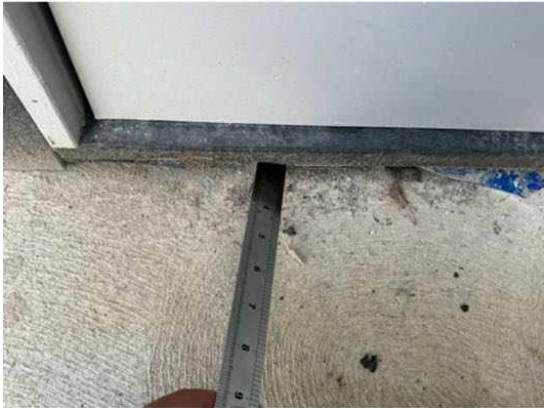
Defects 3.13

Building: Main Building
Location: Garage
Finding: Gap Under Rear Garage Access Door Seal
Information:

At the time of inspection, a large gap was observed beneath the rear garage access door, indicating that the bottom door seal has not been properly installed or finished. The builder is to return and rectify the door seal to ensure the gap is adequately sealed.

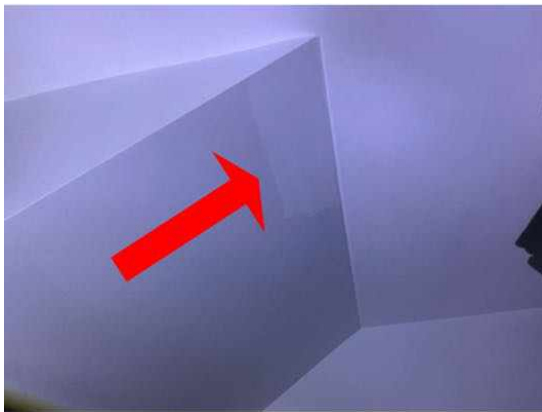
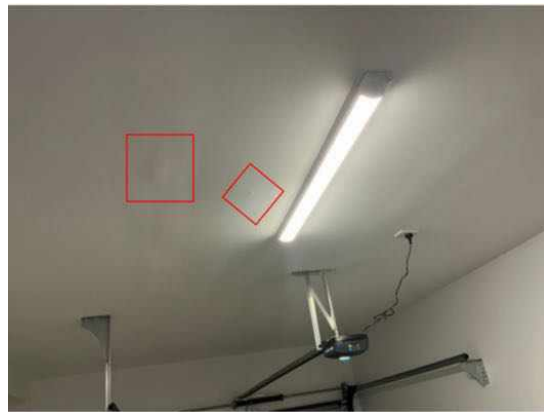
Defects 3.14

Building: Main Building
Location: Garage
Finding: Poor Paint Finishing – Garage Ceiling
Information:

At the time of inspection, the paint finishing to the garage ceiling was observed to be of poor quality, with patching areas clearly visible and standing out from the surrounding surface. The painter is to return and rectify the finishing to achieve a consistent and acceptable finish.
