Building and Timber Pest Inspection Report

Inspection Date: Wed, 18 Feb 2026

Property Address: 15 Kingsley Grove, Kingswood NSW 2747

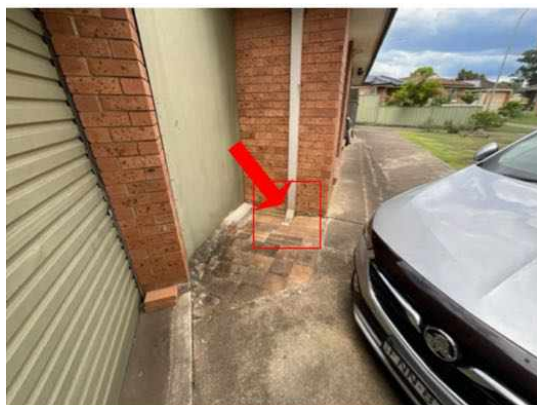
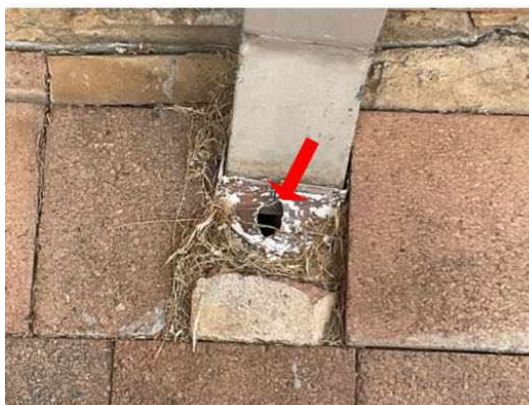
Building: Main Building
Location: Front Elevation
Finding: Downpipe - Damaged connection
Information: Observation:

- The roof plumbing (downpipe) in this location has been damaged and is not fully sealed.
- This may suggest an attempt to bypass a blocked stormwater drainage pipe or redirect water flow due to inadequate drainage performance.

- Poorly sealed or disconnected downpipes can result in:
 - Water pooling around the base of the building
 - Excessively damp conditions at the foundation or subfloor level
 - Increased risk of foundation movement, moisture ingress, or wood rot
- Water runoff may also be diverted to a neighbouring property, which is non-compliant with building codes and may create legal or council-related issues.

- Rectification is advised.
- A licensed plumber should be appointed to:
 - Inspect the area thoroughly
 - Assess the condition of the stormwater system

- Repair, replace or properly connect all downpipes to ensure compliant and effective drainage

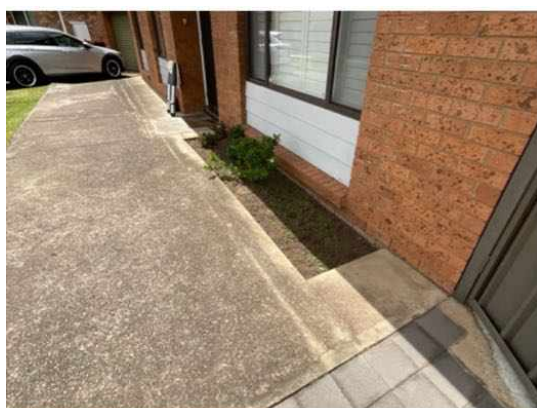
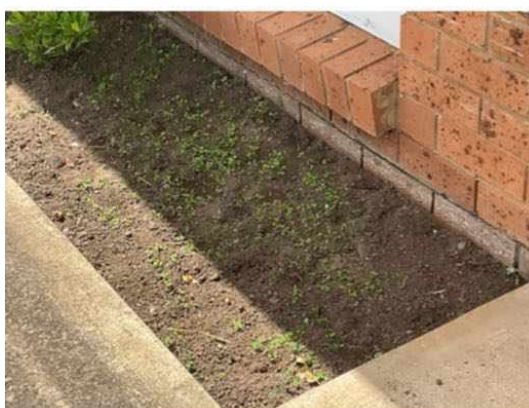
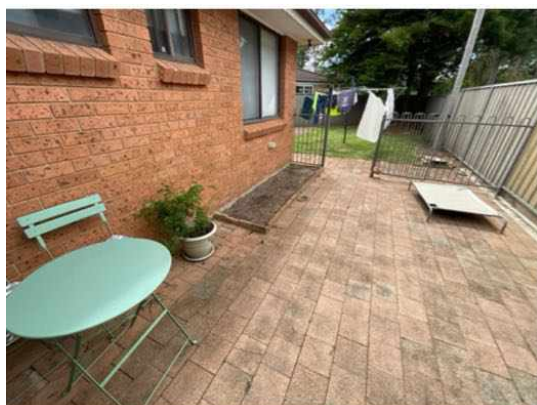
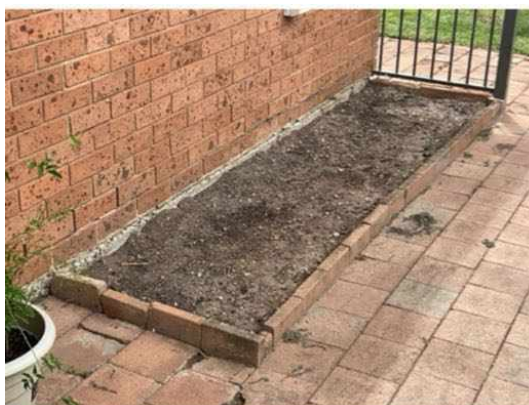
Finding 3.02

Building:	Main Building
Location:	Front & Rear Elevation
Finding:	Site/Yard drainage - Inadequate.
Information:	Defect / Observation – Inadequate Site Drainage

At the time of inspection, site drainage in this area was found to be inadequate, allowing water to pool against the base of the external walls.

Poor surface drainage can lead to moisture ingress and deterioration of materials at the base of walls, slab edge dampness, or foundation movement. Prolonged exposure to standing water may cause rising damp, efflorescence, or corrosion of embedded steel components. These conditions can lead to secondary structural or moisture-related defects if not rectified.

To prevent moisture-related damage, ground levels around the dwelling should:

- Provide a minimum 50 mm clearance between finished ground level and the bottom of cladding or wall weep holes (minimum 75 mm where paved and 100 mm where unpaved).
- Be graded to achieve a minimum fall of 1:20 (50 mm over 1 m) away from the building for at least 1 m.

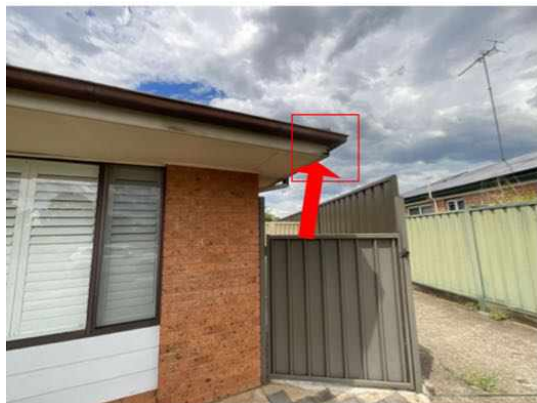
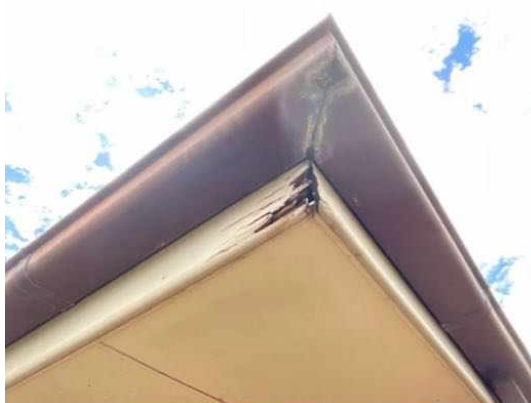
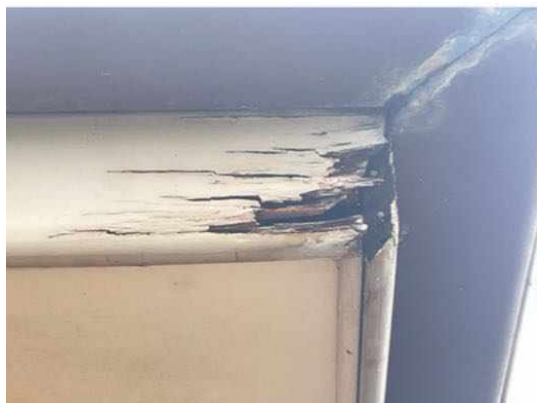
Finding 3.03

Building:	Main Building
Location:	Front Elevation
Finding:	Wood Rot – Fascias and/or Bargeboards.
Information:	Wood rot (Fungal Decay) was identified affecting fascias and/or bargeboards in this area. This condition typically occurs when timber or cellulose-based materials are exposed to persistent moisture over time.

It is likely that the wood rot has developed due to faults in the roof plumbing, leading

to excessive moisture in these areas. Additionally, frequent exposure to rain and weather makes fascias and bargeboards particularly vulnerable to deterioration when not properly maintained.

- Fascias and barges are exterior-facing and often take the brunt of water runoff from the roof.
- Ongoing exposure without adequate protection or drainage can lead to fungal decay, compromising their structural integrity.
- If left untreated, damage may spread to surrounding building elements.

- A qualified carpenter should be engaged to assess the extent of wood rot and carry out necessary repairs or replacements.
- Repaired or new timber should be properly sealed and painted to prevent future decay.
- A qualified painter may be required to complete repainting works and ensure long-term protection.

- Routine inspections and maintenance of roof plumbing and external timber elements are strongly recommended to prevent recurrence.

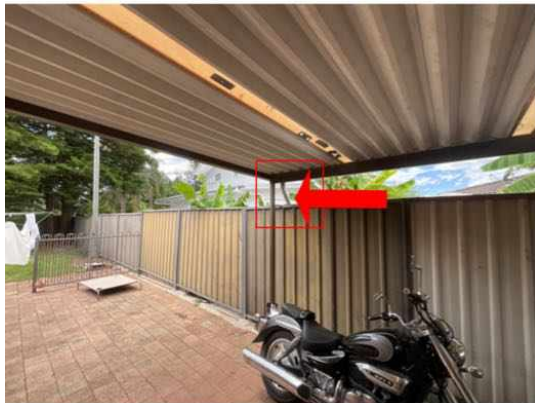
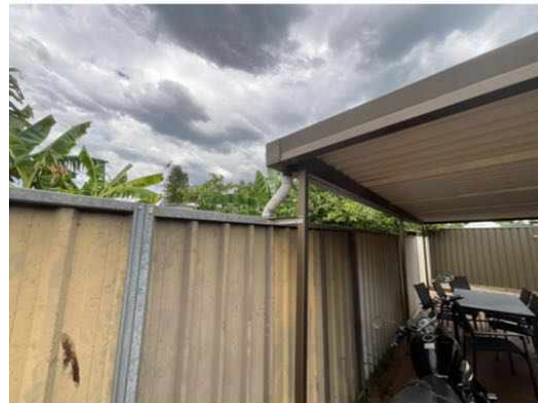
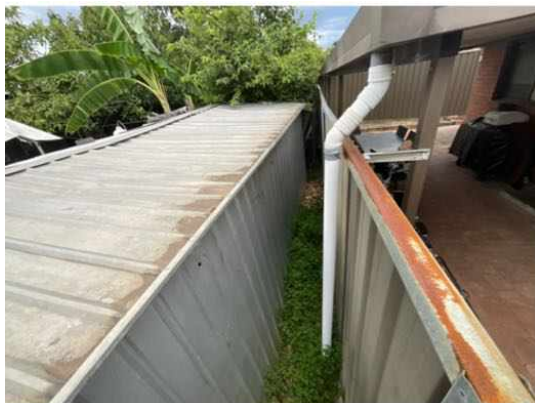
Finding 3.04

Building:	Main Building
Location:	Pergola
Finding:	Downpipe - Unconnected.
Information:	Observation:

A section of roof plumbing was found where the downpipe is not connected to the stormwater drainage system.

Excessive moisture from uncontrolled roof runoff can create conditions that promote termite activity and timber decay.

- Inspect the affected roof plumbing area, and
- Connect the downpipe to a compliant stormwater drainage system, or alternatively, install appropriate drainage measures to manage water flow and mitigate potential

property damage or pest risks.

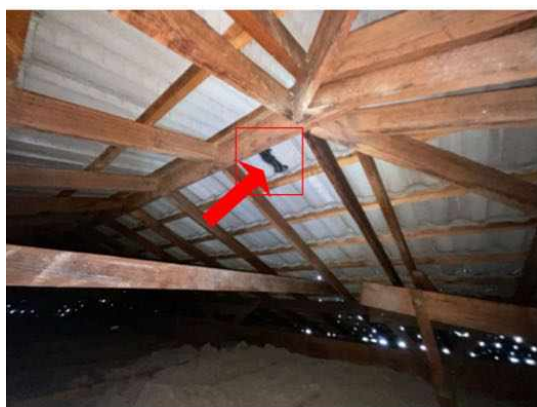
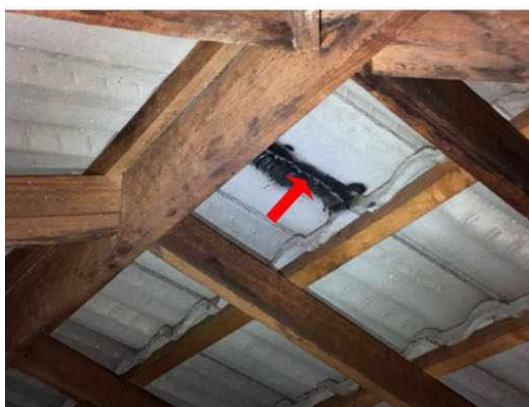
Finding 3.05

Building: Main Building
 Location: Roof Void
 Finding: Roof Void – Defective Roof Tile.
 Information: Observation:

A broken and/or cracked roof tile was observed from within the roof void at the time of inspection. The affected tile appears to have been previously repaired using a black sealant compound. The repair is considered temporary in nature and does not constitute a permanent or compliant rectification.

The defect was identified from below within the roof space; no removal of roof coverings was undertaken as part of this inspection.

Broken or cracked roof tiles compromise the integrity of the roof covering system and may permit water penetration into the roof cavity during rainfall events. Moisture ingress can result in:

Temporary sealant repairs are prone to deterioration over time due to thermal movement and weather exposure, increasing the likelihood of future leakage.

Engage a licensed roofing contractor to replace the damaged tile with a suitable matching tile to restore the integrity of the roof covering.

At the time of replacement, the contractor should also inspect adjacent tiles for movement or damage and confirm that no underlying sarking, battens, or support components have been adversely affected.

Ongoing monitoring of internal ceilings for signs of moisture staining is advised until permanent repairs are completed.

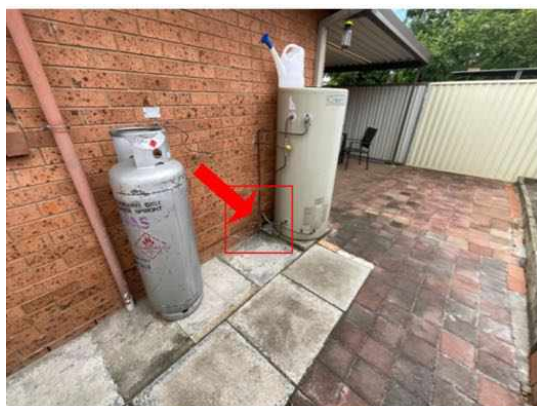
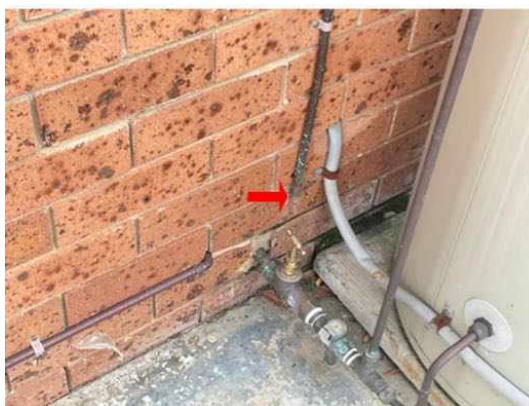
Building: Main Building
Location: All External Areas
Finding: Overflow Management – Risk of Termite Activity..
Information: Observation: Water Pooling from HWS and Air Conditioning Overflows

Water discharge from the Hot Water System (HWS) pressure relief valve and air conditioning unit overflows was observed discharging close to the base of the structure, contributing to water pooling around the building perimeter.

Persistent moisture near the foundation or subfloor area significantly increases the likelihood of termite activity. Termites are highly attracted to damp environments, and stagnant water near structural elements provides ideal conditions for foraging and infestation.

It is highly recommended that all overflows from the HWS and air conditioning units be redirected away from the building, preferably via fixed drainage or extension piping, to prevent water accumulation near the structure.

These minor corrective works should be undertaken promptly to minimise the risk of both termite ingress and potential structural damage due to ongoing moisture exposure.

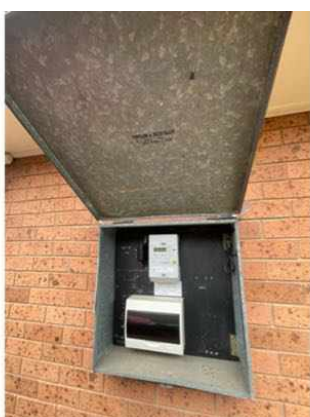
Building: Main Building
 Location: All Areas
 Finding: Termite Management System - Missing Durable Notice..
 Information: Observation: Missing Durable Notice for Termite Management System

Proper maintenance and documentation are essential to ensure continued protection. Without a visible durable notice, there is no clear indication of what system (if any) is in place, which may limit the effectiveness of future termite inspections and hinder warranty claims.
