Building and Timber Pest Inspection Report

Inspection Date: Fri, 27 Mar 2026

Property Address: 36 Slattery Pl, Pakenham VIC 3810,
Australia

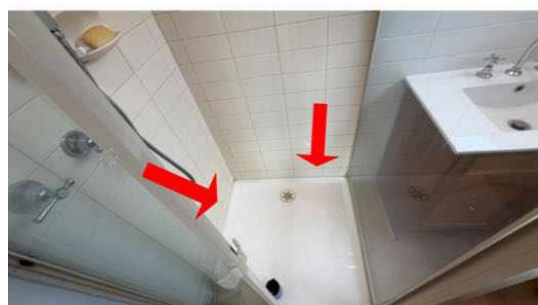
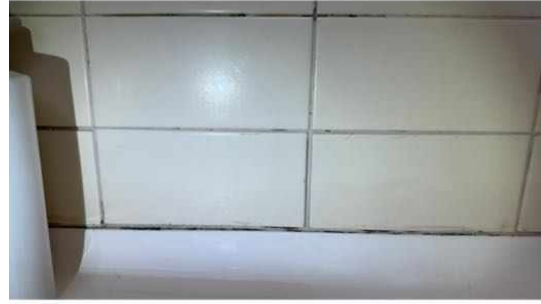
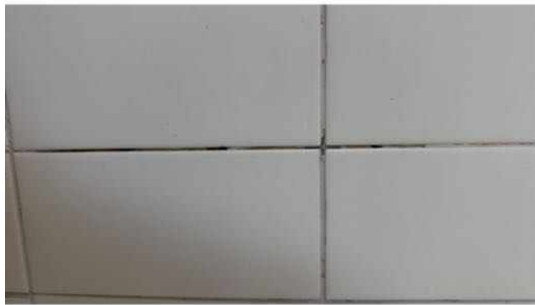
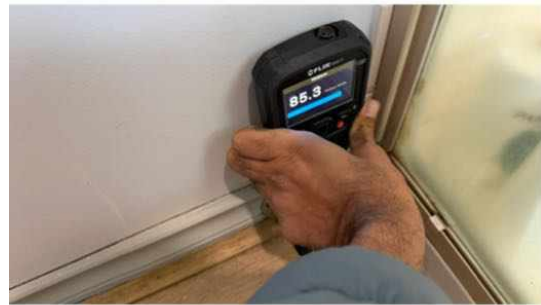
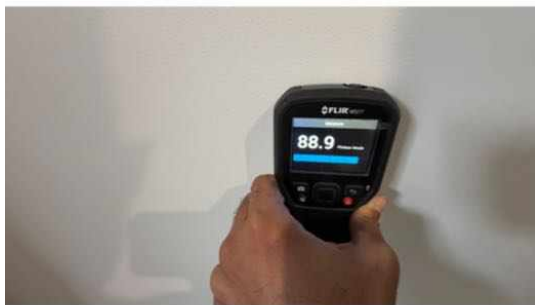
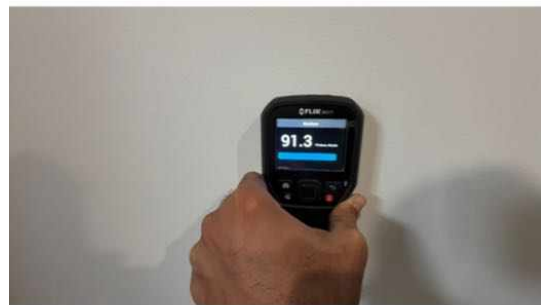
Finding: Shower Waterproofing Failure

Information: Cracked wall tile and deteriorated grout were observed in the shower area during the inspection. Elevated moisture levels were recorded on the adjacent plasterboard wall and to the backside of the shower area, indicating moisture ingress consistent with a likely failure of the waterproofing barrier. These conditions suggest that water is penetrating beyond the tiled surface and affecting surrounding building elements.

Failure of the waterproofing system can lead to concealed damage to structural timbers and wall linings, promote mould growth, and create conditions conducive to timber pest (termite) activity due to persistent dampness. If left unaddressed, this may result in significant deterioration of building components and costly repairs.

1. Cracked wall tile and deteriorated grout were observed in the shower area during the inspection. Elevated moisture levels were recorded on the adjacent plasterboard wall and to the backside of the shower area, indicating moisture ingress consistent with a likely failure of the waterproofing barrier. A registered plumber needs to be engaged as soon as possible.

It is highly recommended that a licensed plumber and a registered builder be engaged to carry out further investigation and necessary rectification works. An invasive inspection is strongly recommended to determine the full extent of damage, as this assessment is based on a visual, non-invasive inspection and concealed conditions could not be determined.

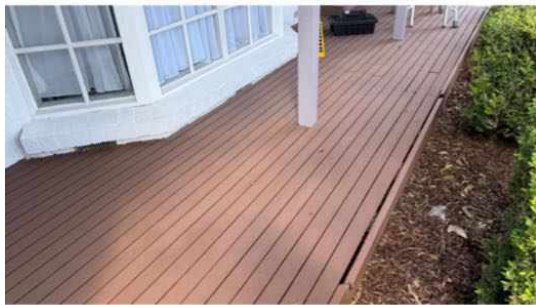
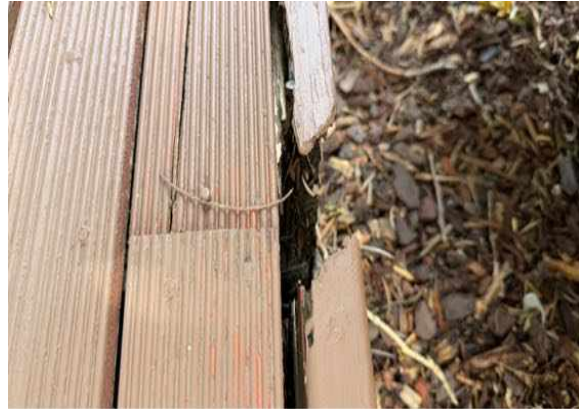
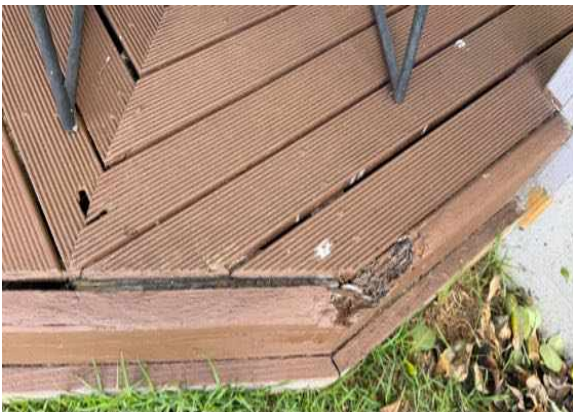
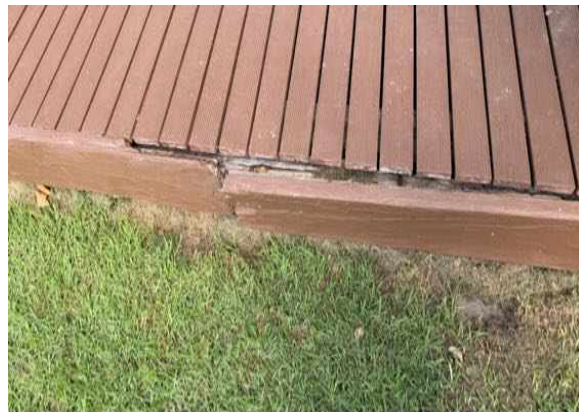
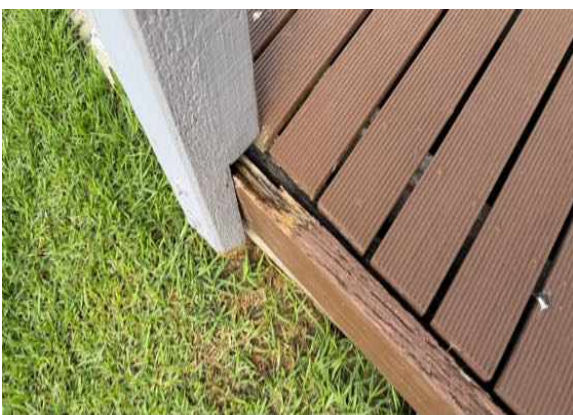
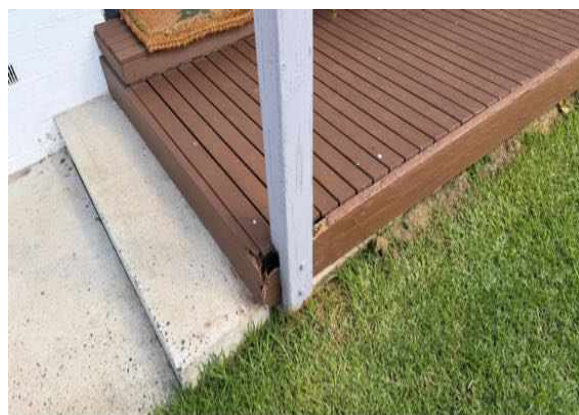
Finding 3.01

Building:	Main Building
Location:	Deck
Finding:	Deteriorated Timber Decking – Front and Rear
Information:	The timber decking to the front and rear areas was found to be deteriorated, with visible signs of wood rot. This condition is typically caused by prolonged exposure to moisture and weathering over time, leading to the breakdown of timber fibres.

Deteriorated and decayed timber can compromise the structural integrity of the decking and presents a safety hazard, particularly where load-bearing elements or walking surfaces are affected. There is an increased risk of timber failure, instability, or potential injury if the area continues to be used in its current condition.

It is recommended that a registered builder or a qualified handyman be engaged to assess the extent of the deterioration and carry out necessary repairs or replacement of affected timber components. The area should be used with caution until repairs are completed.

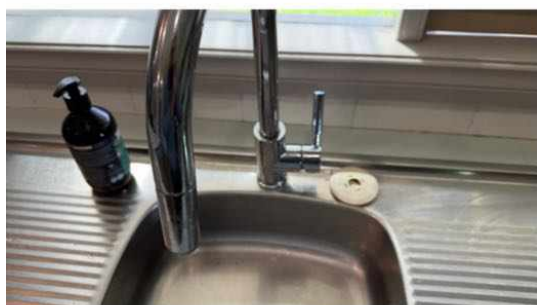
Finding 3.02

Building:	Main Building
Location:	All Internal Areas
Finding:	Tap - Water hammer
Information:	This tap shows evidence of water hammer being present. Water hammer, a pressure surge resulting when a fluid is forced to suddenly change direction, is a common defect in plumbing fittings, particularly those that are aged and not frequently maintained. Water hammer is generally caused by factors that create high water pressure in the affected plumbing fixture, usually evidenced by a faint banging noise during operation of the affected tap.

Although water hammer is generally considered to be a minor defect, subsequent damage such as erosion of tap hardware and/or water damage to associated building elements is likely to occur if left unmanaged.

A licensed plumber should be appointed as soon as possible to replace any affected tap hardware and perform any remedial works as necessary. Please be advised that the appointment of a cabinet maker or qualified carpenter may be necessary if water damage to associated building elements has occurred.

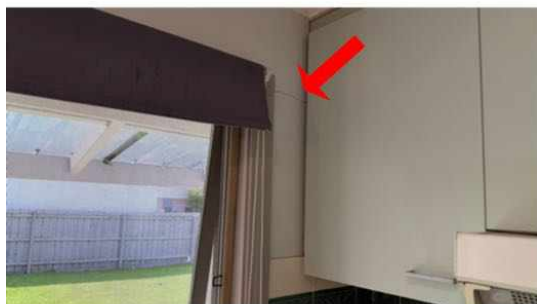
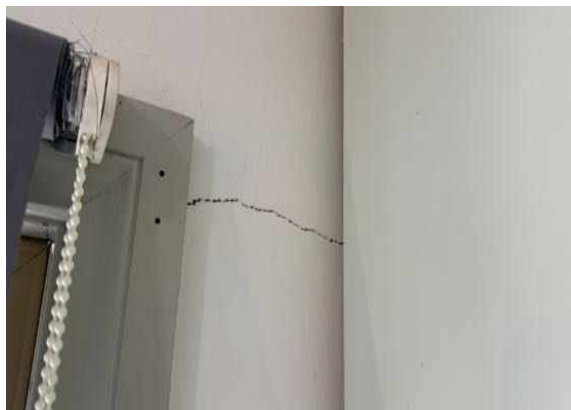
Finding 3.03

Building:	Main Building
Location:	Kitchen
Finding:	Cracking – Plasterboard Wall (Kitchen Window Area)
Information:	Cracking was observed to the plasterboard wall near the kitchen window during the inspection. The pattern and location of the crack indicate minor structural movement or settlement, which is relatively common over time.

While the crack appears minor at this stage, continued movement may result in further widening or additional cracking, potentially affecting the wall finish and surrounding elements.

It is recommended that the affected area be regularly monitored for any signs of progression. If the crack worsens or additional movement becomes evident, further

assessment by a registered builder is advised. Cosmetic repairs can be carried out as required.

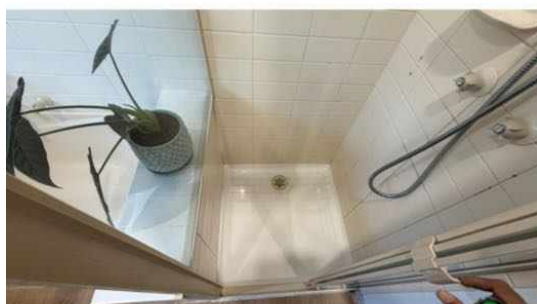
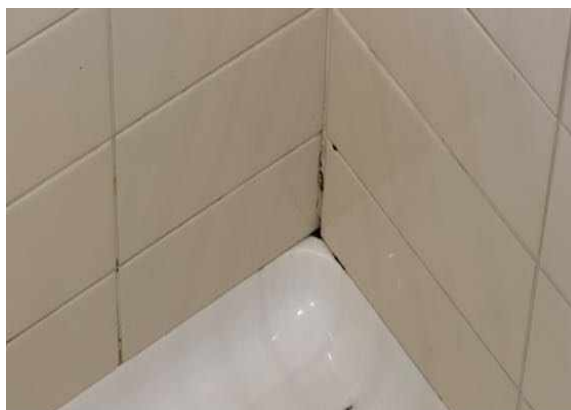
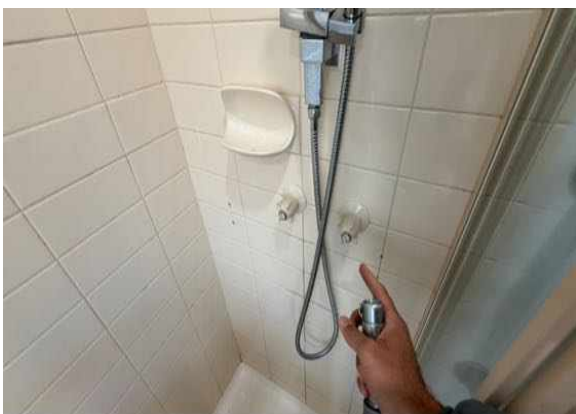
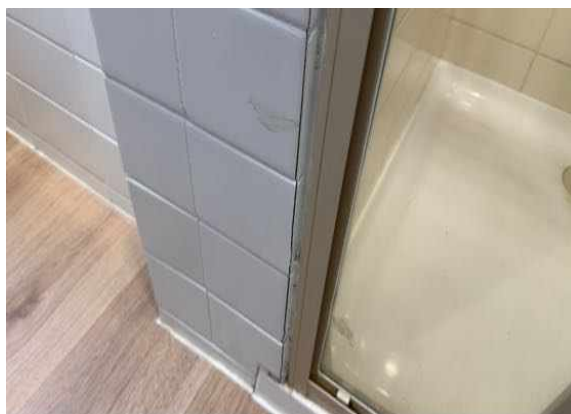
Finding 3.04

Building: Main Building
Location: Bathroom
Finding: Bathroom Defects – Deteriorated Grout and Shower Operation
Information: Deterioration of grout was observed in the bathroom tiled areas during the inspection. Additionally, the shower fittings were found to be hard to operate, likely due to wear, corrosion, or build-up within the tapware components.

Deteriorated grout can allow water to penetrate behind tiles, potentially leading to moisture-related issues over time. Difficulty in operating the shower fittings may worsen and could result in functional failure or minor leaks if left unaddressed.

It is recommended that the grout be repaired or regouted as required to maintain a watertight seal. The shower fittings should be inspected and serviced or replaced by a licensed plumber to ensure proper operation.

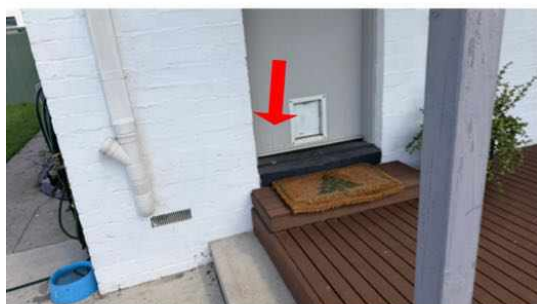
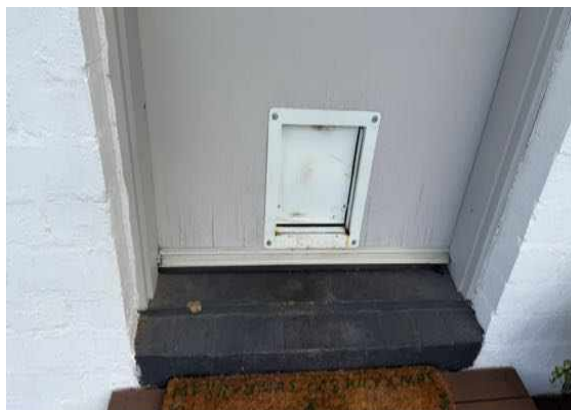
Finding 3.05

Information: The base of the laundry door was found to be weathered during the inspection. This condition is likely due to prolonged exposure to moisture and external weather elements, leading to deterioration of the timber.

Continued exposure may result in further degradation, including potential wood rot, swelling, or loss of structural integrity of the door base if left unaddressed.

It is recommended that the affected section be repaired or replaced as required. Protective sealing or painting should be applied to prevent further weather-related damage.

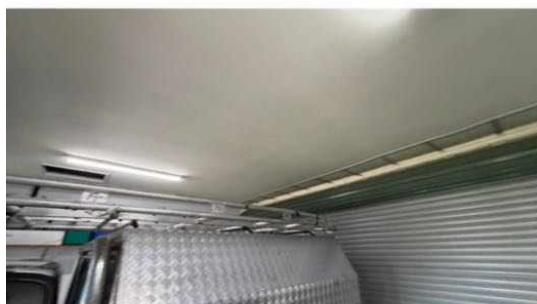
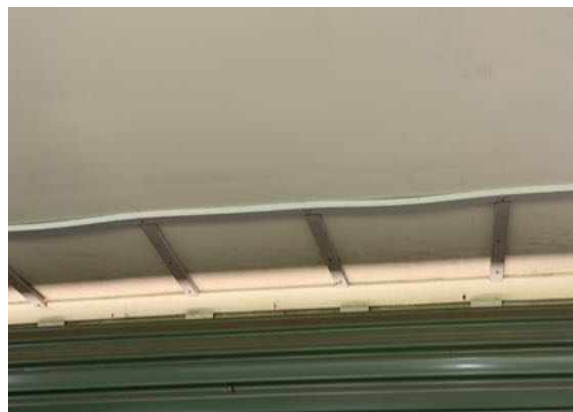
Finding 3.06

Information: Sagging of the ceiling was observed during the inspection. This condition is commonly associated with moisture exposure, deterioration of ceiling materials, or

loosening/failure of fixings over time.

A sagging ceiling may indicate underlying issues such as past or ongoing water ingress, and in some cases can pose a safety risk if sections become unstable or collapse. If left unaddressed, the condition is likely to worsen.

It is recommended that a registered builder be engaged to assess the extent of the sagging and identify the underlying cause. Repairs should be carried out as required, and any potential sources of moisture ingress should also be investigated and rectified.

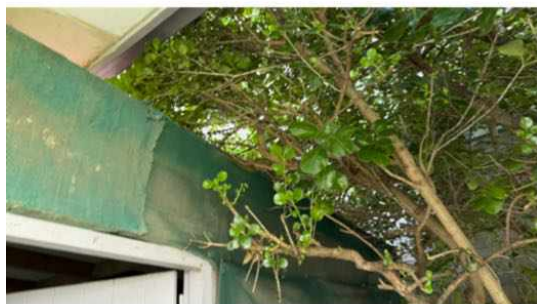
Gutters are a critical part of the building's management of storm water and rain. It is therefore important that they be kept clear to prevent secondary damage to associated building elements, including exterior and interior walls, ceiling linings and any adjoining building elements. Where gutters are blocked, pooling of rainwater is likely to occur, fast-tracking rust and corrosion of the roof plumbing elements.

It is highly advised that all overhanging tree branches be removed as soon as possible to prevent any further damage. Repair and/or replacement of sections of damaged guttering may also be required where the extent of the damage necessitates.

Such works should be performed by the homeowner; however, appointment of a landscape contractor or an arborist may be required. Consultation with a licensed roof plumber is required where guttering has been damaged.

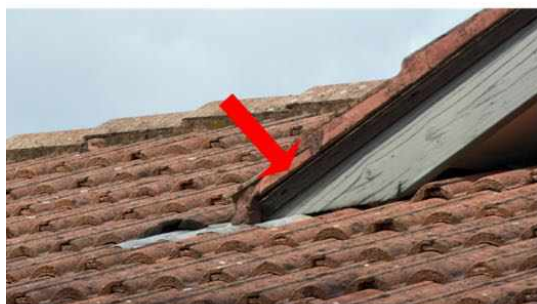
Finding 3.09

Building:	Main Building
Location:	Roof Exterior
Finding:	Exterior Timber Weathering and Roof Mortar Deterioration
Information:	The exterior timber elements were found to be weathered, and deterioration of mortar to roof tiles was observed during the inspection. The timber deterioration is likely due to prolonged exposure to weather conditions, while the mortar deterioration is typically associated with ageing, environmental exposure, and general wear over time.

Weathered timber may become susceptible to further decay, including wood rot, if not maintained. Deteriorated roof mortar can lead to loosening of roof tiles and may allow water ingress, particularly during adverse weather conditions.

It is recommended that the affected timber be repaired, treated, sealed, or replaced as required to prevent further deterioration. A licensed roofing contractor should be engaged to repair or re-point the deteriorated roof tile mortar and ensure the roof covering remains secure and weatherproof.

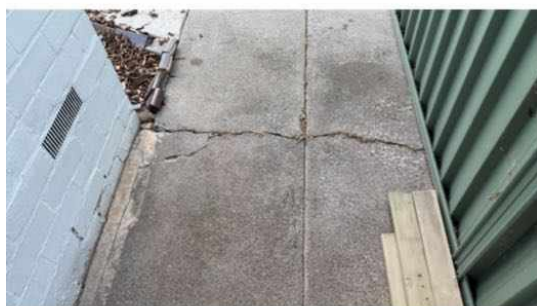
Finding 3.10

Finding: Cracking in Concrete Paving

Information: Cracks were identified in the concrete paving around the perimeter of the property. These cracks vary in size and may have occurred as a result of soil movement beneath the paving, which is often influenced by factors such as moisture changes, compaction issues, or natural settling over time. The extent and pattern of cracking suggest minor ground movement rather than structural failure at this stage.

If left unmonitored, such cracking can worsen over time, potentially leading to uneven surfaces that present trip hazards and reduce the visual appeal and functionality of the paved areas. Progressive cracking may also indicate ongoing ground movement, which could affect nearby structures or landscaping features if not addressed.

It is recommended that the affected areas be monitored periodically to determine whether the cracking is active or stable. If further movement or deterioration is observed, a registered builder or suitably qualified contractor should be engaged to assess the extent of the damage and undertake appropriate repairs or replacement in accordance with relevant standards and best practices.

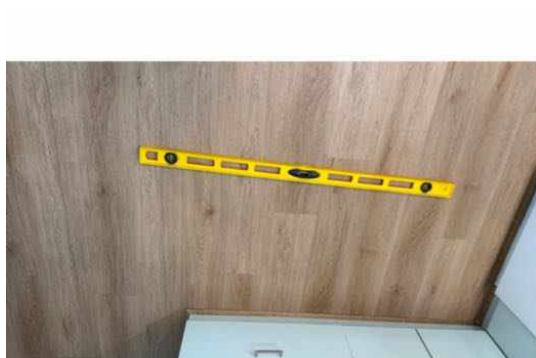
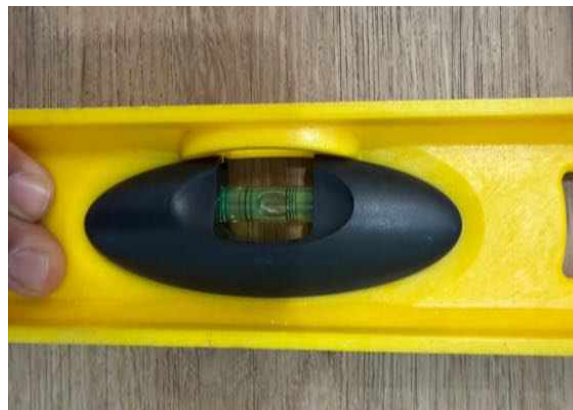
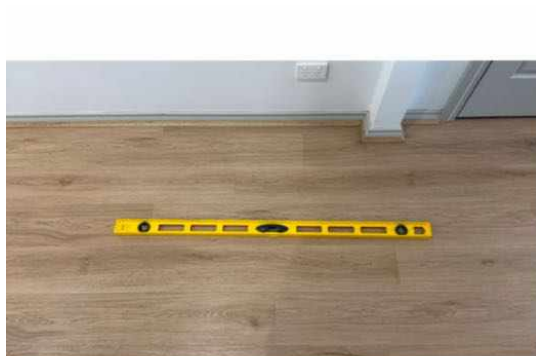
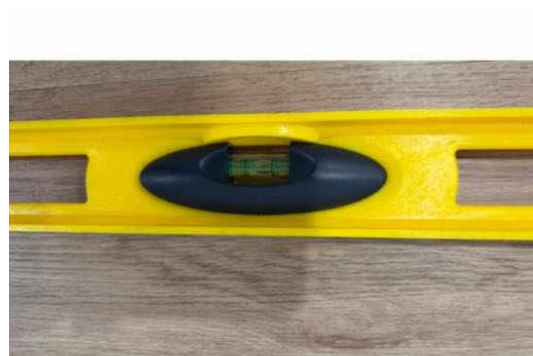
Building:	Main Building
Location:	All Areas
Finding:	Uneven Floor Levels – Minor Movement
Information:	Slightly uneven floor levels were observed during the inspection, which may indicate minor structural movement or settlement over time. Such conditions are relatively common in buildings and can result from natural ground movement or ageing of structural components.

At the time of inspection, the unevenness appears minor; however, continued movement may lead to further distortion, affecting floor finishes and adjoining building elements.

It is recommended that the area be monitored for any signs of progression. If the unevenness worsens or additional symptoms such as cracking or sticking doors/windows become evident, further assessment by a registered builder is advised.

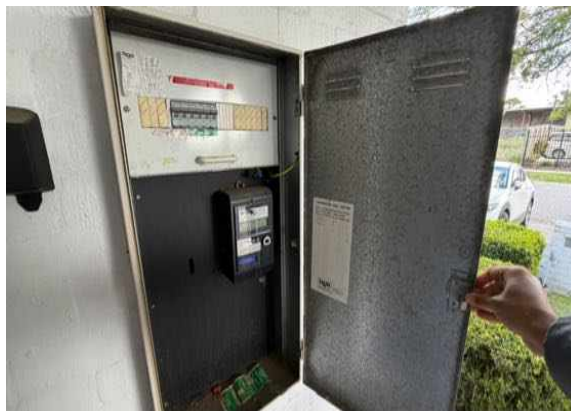
Building:	Main Building
Location:	Meter Box
Finding:	Termite Management System - no evidence of a chemical installation
Information:	The application of a post-construction chemical termite barrier is highly recommended for all properties, particularly if live termite activity has been found on the site previously. Such barriers are highly effective in preventing termite attack on any timber building elements throughout the property.

system has been installed, with no evidence to suggest preventative works taking place.

The client may consider gaining further advice from a pest controller as to the costs and procedures involved with this application. It is recommended that obtaining such advice be a short-term priority.

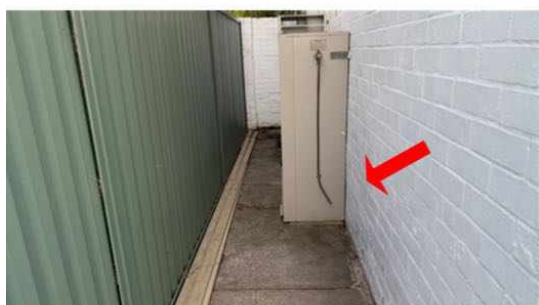
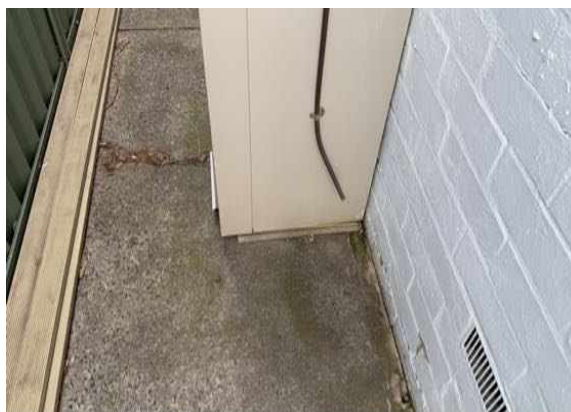
Finding 6.02

Building: Main Building
 Location: All External Areas
 Finding: HWS Overflow - Not Connected
 Information: The Hot Water System (HWS) overflow was found to be disconnected from storm water drainage and is creating excessive moisture in the surrounding area.

These damp conditions can lead to secondary defects such as rot, rust or corrosion of associated building elements, the formation of fungal decay, or even the creation of potential slip hazards. When coupled with poor site drainage, pooling of water may also attract termite activity to this area.

It is highly recommended that a licensed plumber be appointed to connect the HWS overflow in order to prevent such an environment from being created. These minor works should be carried out as soon as possible.

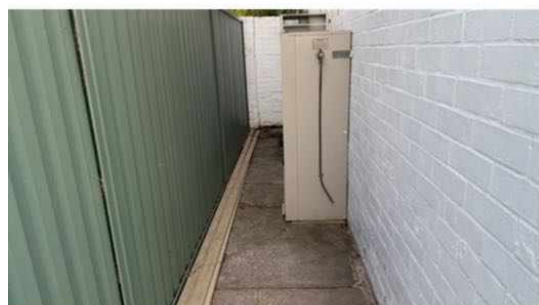
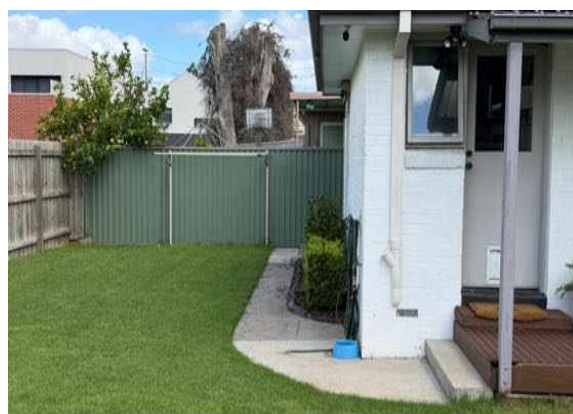
Finding 6.03

Building:	Main Building
Location:	All External Areas
Finding:	Bridging - Attachments to Buildings
Information:	Bridging occurs when items against a building provide a concealed entry point for termites into the building or by passing around a termite management system.

Where any part of an attachment to a building is not isolated and is not provided with a clear gap of not less than 25mm from the building, bridging occurs. Attachments to buildings such as hot water services, downpipes, verandahs, decks, steps, fences, service conduits are the like provide the opportunity for concealed entry.

Building attachments of this nature need to be frequently inspected for termite activity by a qualified inspector.

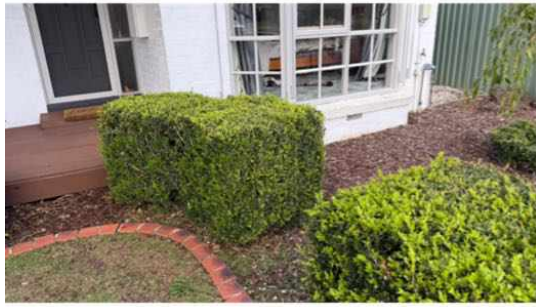
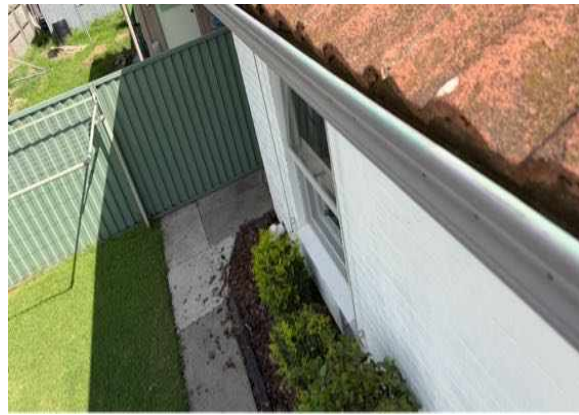
Finding 6.04

Building:	Main Building
Location:	All External Areas
Finding:	Garden Beds - Conditions Conducive to Termites
Information:	Garden beds were found to be evident in the garden area. These garden beds can include untreated timber, and with a combination of moisture from watering hosing can make conditions conducive to termite activity and termite ingress.

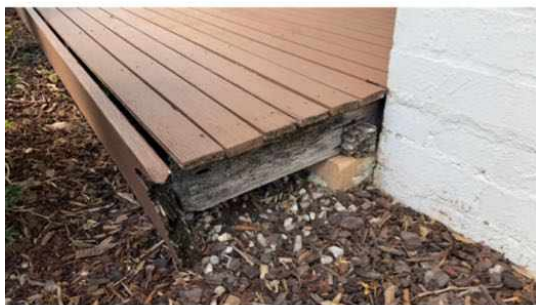
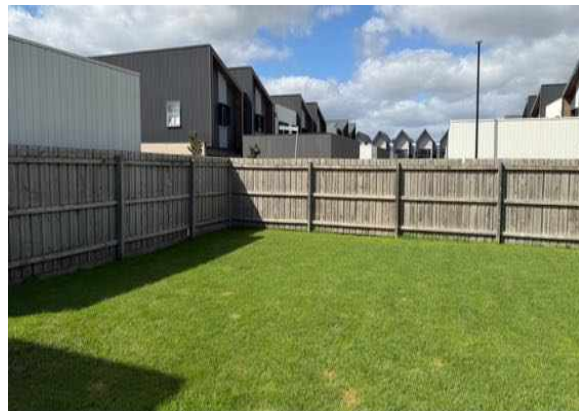
Finding 6.05

Building:	Main Building
Location:	All External Areas
Finding:	Building materials in direct ground contact - conducive to termites
Information:	Where timber elements are in direct contact with the ground and consequently moisture or dampness they become conducive to termite activity. Whether timber is used as a building element part of a fencing structure or stored as an unused item they can provide an environment that is attractive to termite infestation.

When met with excessive moisture timber begins to decay and develop wood rot. Any timbers that are in direct contact with external grounds especially if left untreated or non-durable also provide ingress for subterranean termites into that particular element.

The removal of any such materials that may be conducive to termite activity should be removed as soon as possible to minimise the risk of termite attack.

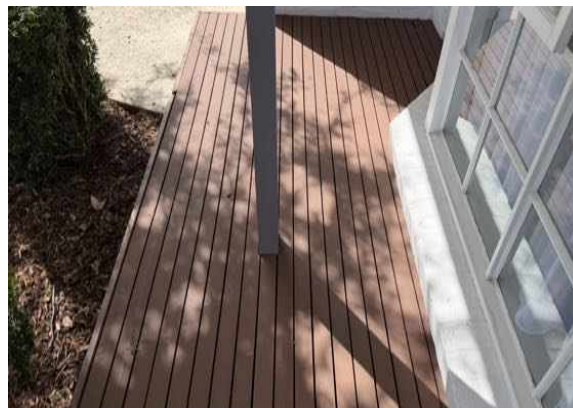
Finding 6.06

Building:	Main Building
Location:	All External Areas
Finding:	Ground level deck - conducive to moisture and timber decay
Information:	The ground level deck can be conducive to timber pest infestation due to its close

proximity to the soil. Without proper precautions, the moisture in the soil can create an ideal environment for timber decay and other termites to thrive. Regular inspection and treatment can help prevent infestation and protect the decks structural integrity.

An invasive inspection of the area is recommended to determine further actions.

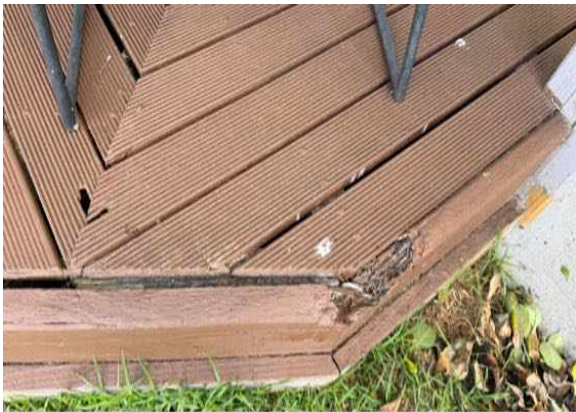
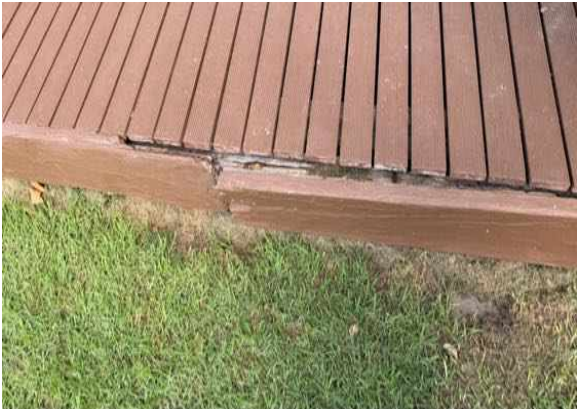
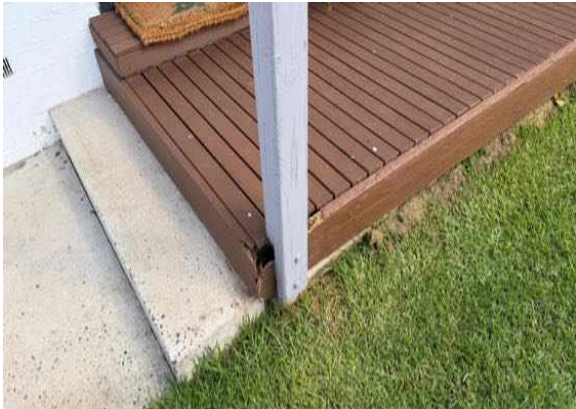
Finding 7.01

Building:	Main Building
Location:	Deck
Finding:	Wood rot - deck
Information:	This building element shows evidence of wood rot. Wood rot, also known as Fungal Decay, occurs when timbers and other cellulose building materials are exposed to damp conditions on an ongoing basis. This could be the result of exposure to weathering over a prolonged period of time.

Wood rot is often associated with general damp problems and is evidenced by a 'musty' smell or mould and mildew occurring on surfaces. If left unmanaged, damp conditions can lead to further health problems and the decay of timbers will continue.

Early intervention and regular maintenance, particularly of exterior timbers, will prolong the useful life of these building elements. Replacement of affected timbers may then be a necessary step in protecting surrounding building elements from such deterioration.

A qualified carpenter or a handy person may also be required to replace affected building materials.
