Building and Timber Pest Inspection Report

Inspection Date: Wed, 18 Mar 2026

Property Address: 7 Kurumba St, Kippa-Ring QLD 4021,
Australia

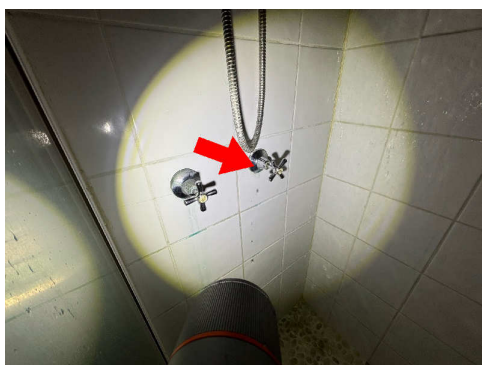
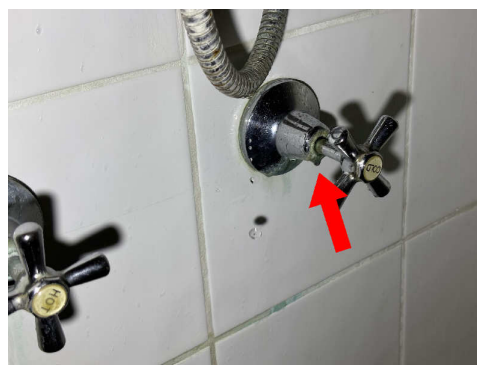
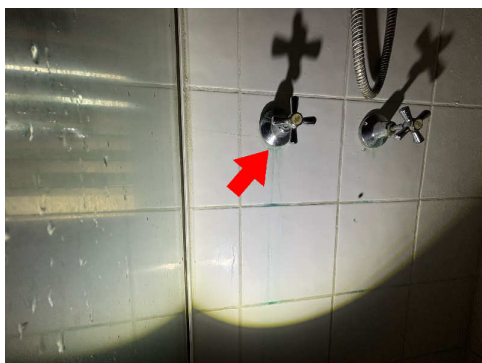
Finding: Family bathroom - shower taps leaking

Information: At the time of the inspection, it was noted that the hot and cold taps for the shower in the family bathroom were leaking when turned on. This may be due to general wear and tear.

A licensed plumber should be engaged to carry out this repair. This should be done as a short term priority.

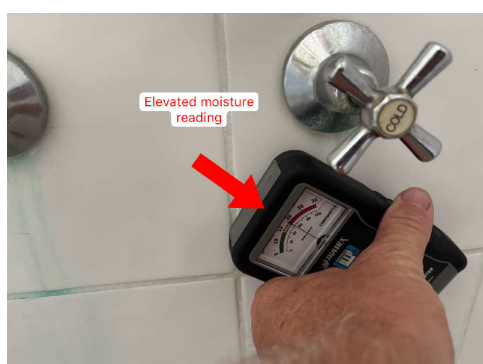
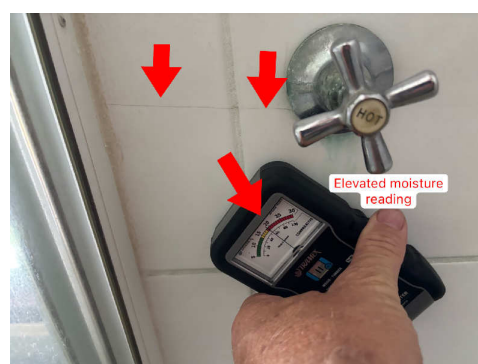
Finding 3.02

Finding: Family bathroom - elevated moisture readings to shower wall

Information: At the time of the inspection, it was noted that there were elevated moisture readings recorded beneath the shower taps. This may be due to the the taps leaking, allowing moisture to get behind the tiles. Two tiles near the hot water tap have hairline cracks to them.

Moisture behind the wall tiles may have a negative affect on the wall tile glue. This could result in loose tiles.

A bathroom specialist could be engaged to replace the grout and seal the floor and wall tiles in the shower cubicle. This will give longevity to the bathroom. This can be done at the clients discretion.

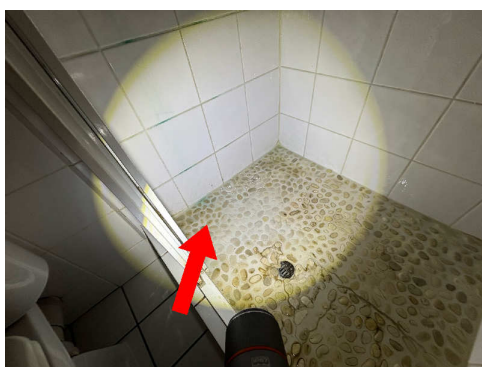
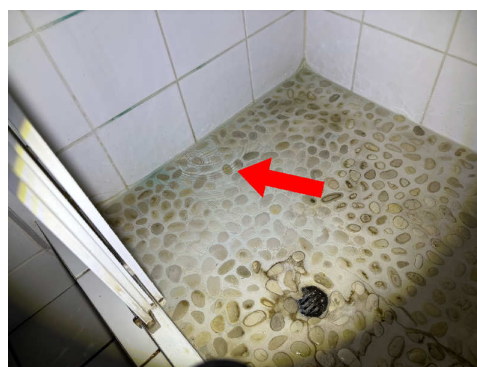
Finding 3.03

Information: At the time of the inspection, it was noted that the shower base in the family bathroom slopes toward the exterior wall and the drain is in the centre of the shower base. As a result, water pools against the wall and does not drain away effectively. There are several cracks in the grout around the pebbles. Traditionally, grout lines/gaps are not as large and this may be causing the cracks.

A bathroom specialist could be engaged to re-lay the shower base in order to get the correct falls to the drain. This could be done at the clients discretion.

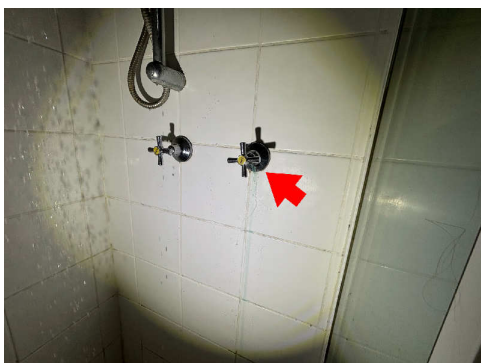
Finding 3.04

Finding: Ensuite - shower tap leaking

Information: At the time of the inspection, it was noted that the shower hot tap was leaking when turned on. A stain can be seen on the shower wall below the tap. This may be due to general wear and tear.

A licensed plumber should be engaged to carry out this repair. This should be done as a short term priority.

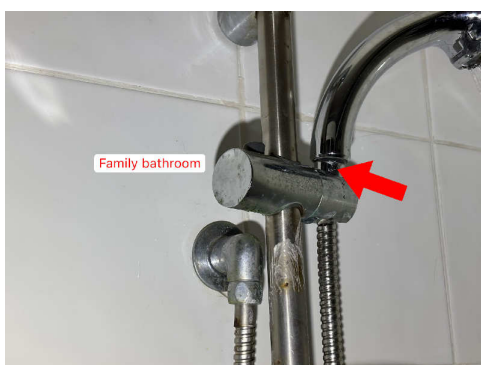
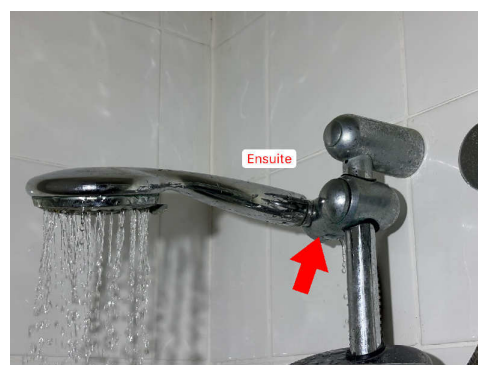
Finding 3.05

Finding: Bathrooms - shower heads leaking

Information: At the time of the inspection, it was noted that there was a leak from the shower heads in the bathrooms. The leak is coming from the hose to shower head connection. Hand tightening the hoses did not stop the leak.

A licensed plumber should be engaged to replace the shower heads and hoses. This can be done at the clients discretion.

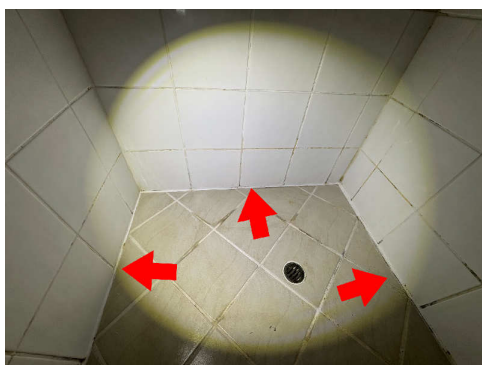
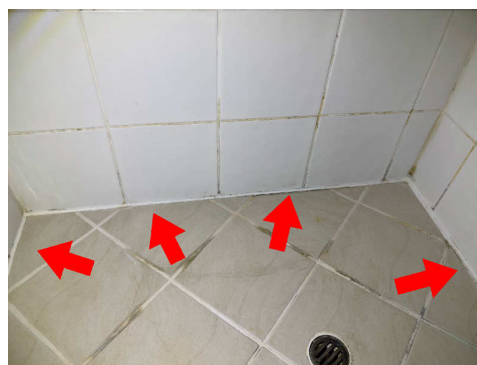
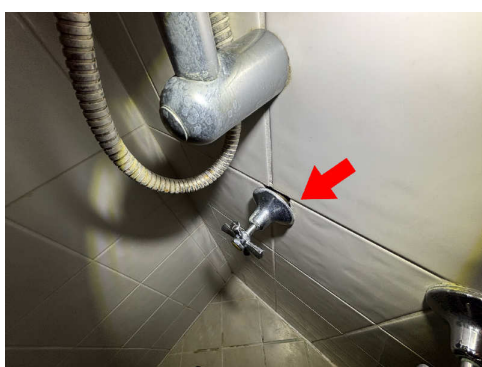
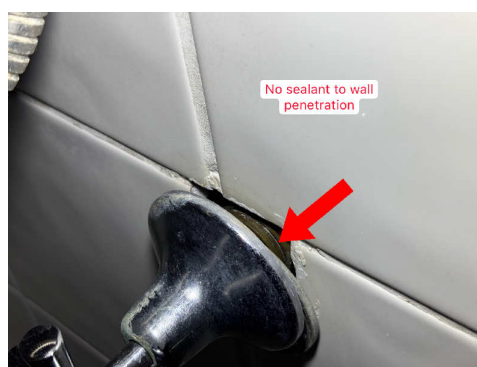
Finding 3.06

Finding: Ensuite - sealant deteriorating

Information: At the time of the inspection it was noticed that the sealant in the shower of the ensuite was deteriorating. It was also found that there was no sealant to the wall penetrations for the shower taps.

Sealant is used in tiled areas to prevent moisture from entering the wall cavity and causing damage to the building elements. A moist environment in the wall cavity may also be a conducive condition for termite activity.

If it is not addressed, damage to building elements will occur and would require invasive works to rectify any damage.

A building maintenance professional or sealant applicator should be appointed to replace all sealant as a matter of urgency.

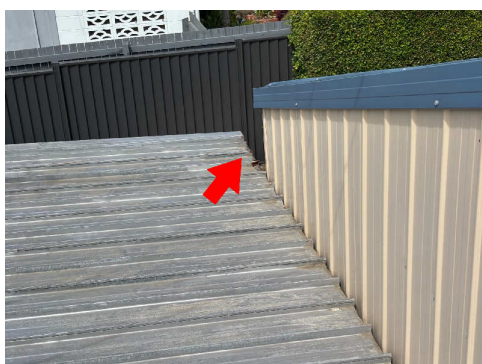
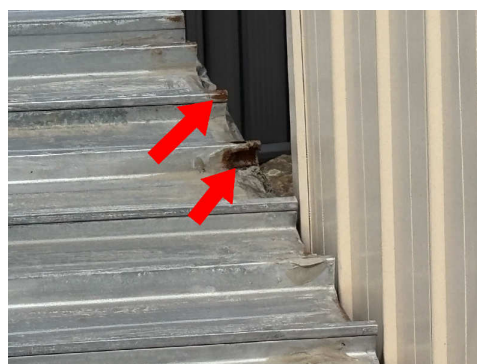
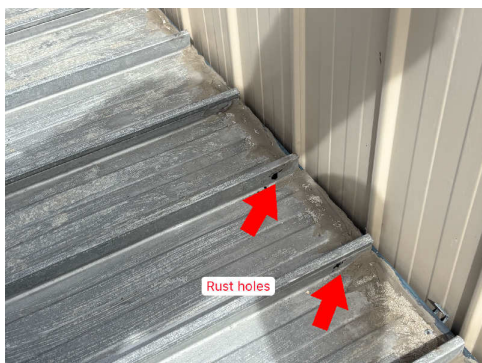
Finding 3.07

Finding: Roof sheeting - rusted

Information: At the time of the inspection, it was noted that there were several areas of rust on the outer edged of the roof sheeting over the study/entry area. It was also found that the roof sheets extend to the outer edge of the gutter and sealant has been applied to this junction.

The effectiveness of the gutter has been compromised. Moisture will now flow over the gutter and into the area between the garage/shed and the dwelling.

Excessive moisture next to the foundations creates a conducive environment for termite activity and can cause damage to the associated building materials.

A roofing contractor may be able to trim the front edge of the roof sheets to remove the rusted sections and restore functionality to the gutter. This should be done as a short term priority.

If the rust extends past the rear line of the gutter then the roof sheeting in this area will need to be replaced.

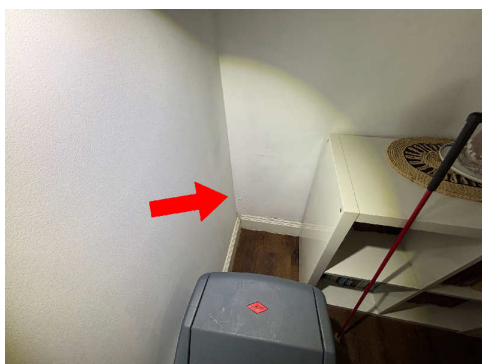
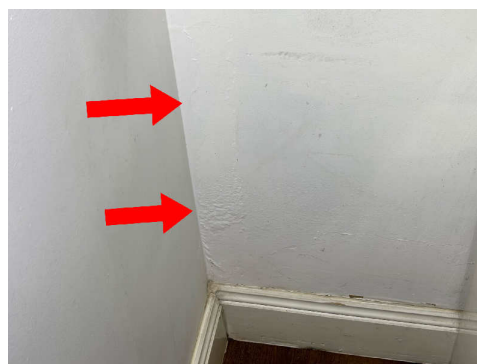
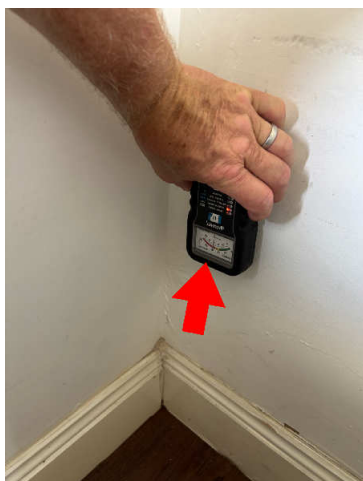
Finding 3.08

Finding: Bedroom 1 - evidence of moisture damage

Information: At the time of the inspection, it was noted that there was evidence of minor moisture damage to a section of the wall lining in bedroom 1. This is where the dwelling steps down at the rear. Elevated moisture readings were recorded in this area.

The client should monitor this area for any change in appearance to the wall lining. An invasive inspection may be required if further damage occurs.

A building maintenance professional or painting contractor could be engaged to carry out the necessary repairs to the wall lining. This can be done at the clients discretion.

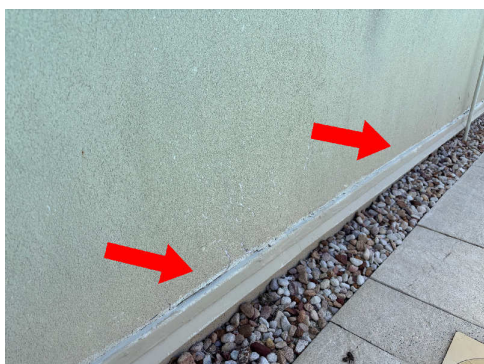
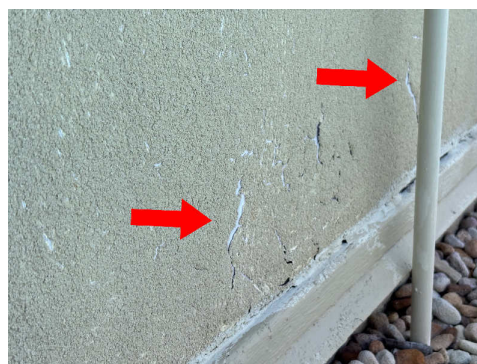
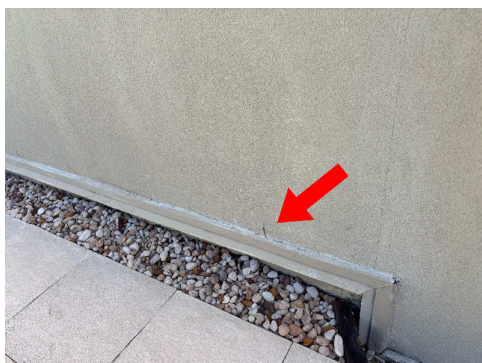
Finding 3.09

Information: At the time of the inspection, it was noted that several sections of the exterior render coat/paint was peeling or cracking. This may be due to the age of the materials and the quality of application. The render coat/paint does appear to be thinly applied.

A painting contractor could be engaged to paint the exterior of the dwelling. This can be done at the clients discretion.

Due to the age of the dwelling, it is recommended that the external cladding be tested for Asbestos Containing Materials prior to any work being carried out.

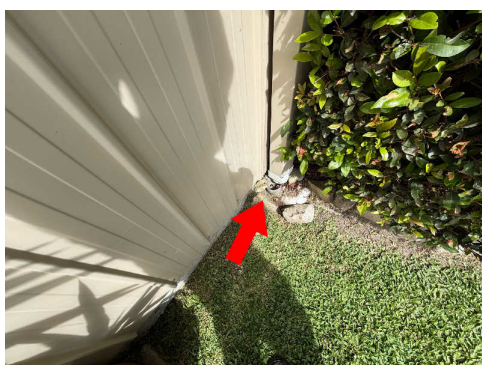
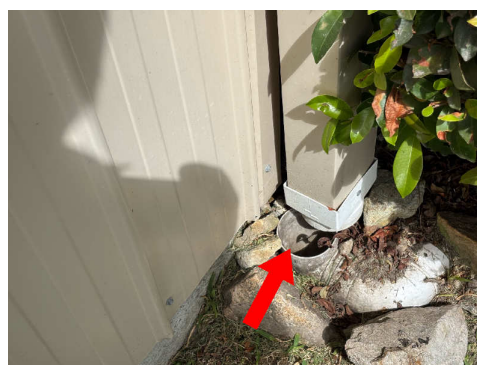
Finding 3.10

Information: At the time of the inspection, it was noted that the bottom section of the down pipe at the front of the garage/shed is disconnected.

This affects the functionality of the down pipe and allows water to escape near the foundation.

A licensed plumber should be engaged to carry out this repair. This should be done as a short term priority.

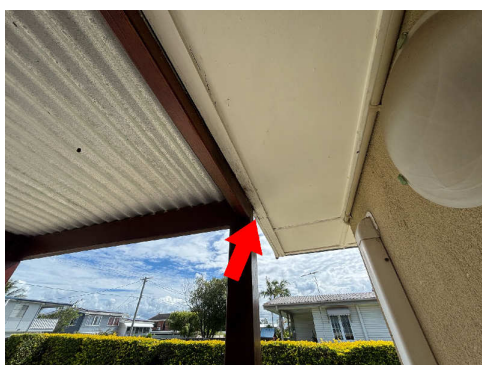
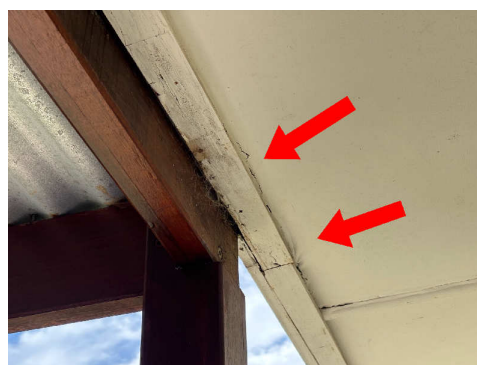
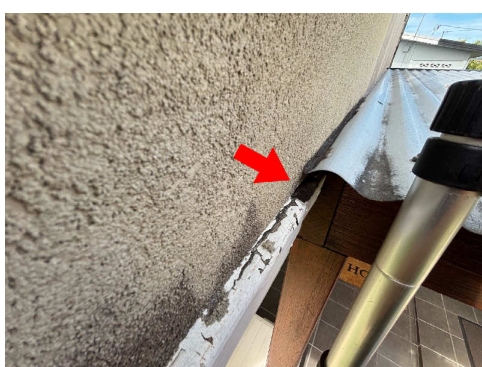
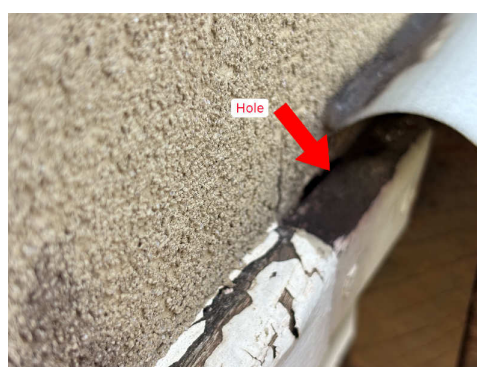
Finding 3.11

Finding: Entry eave - moisture damage

Information: At the time of the inspection, it was noted that there was evidence of moisture damage to the eave over the entry area. Moisture appears to be coming off the roof sheet and through the hole in the timber moulding and into the eave area.

A building maintenance professional should be engaged to seal the hole in the timber and carry out any necessary repairs to the eave. This should be done as a short term priority.

A gutter on this section of roof may be required in order to direct moisture away from the dwelling.

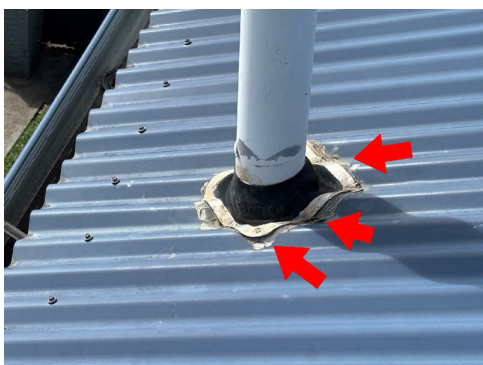
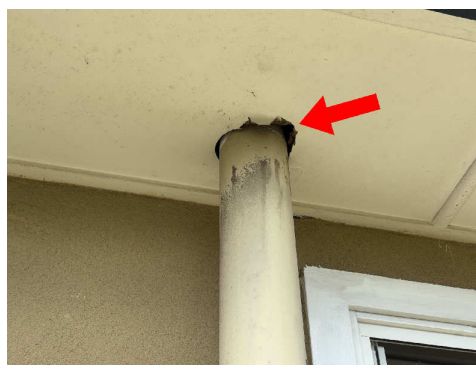
Finding 3.12

Finding: Eave - evidence of moisture damage

Information: At the time of the inspection, it was noted that there was evidence of moisture damage to the eave around the plumbing vent stack. The sealant around the flashing for the vent stack on the roof exterior is deteriorated and may allow moisture into the roof void above the eave.

A roof contractor or building maintenance professional should be engaged to replace the sealant to the flashing. This should be done as a short term priority.

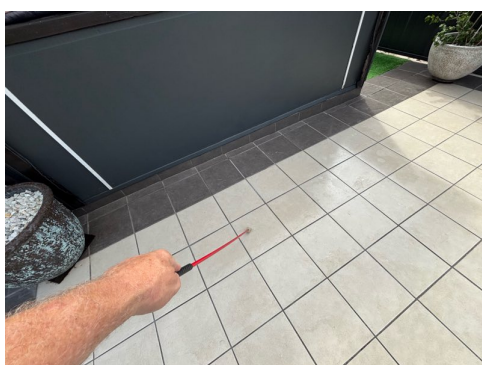
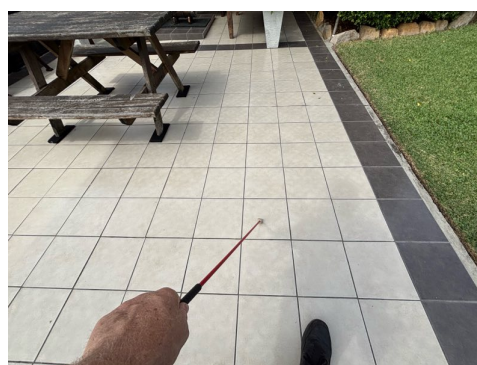
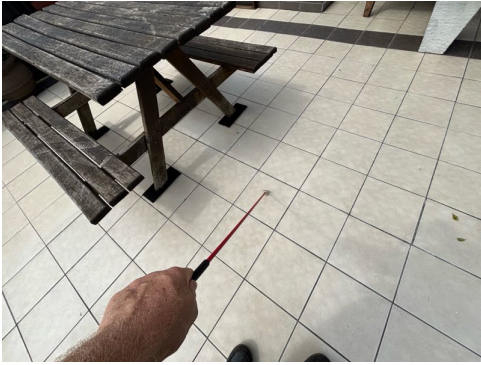
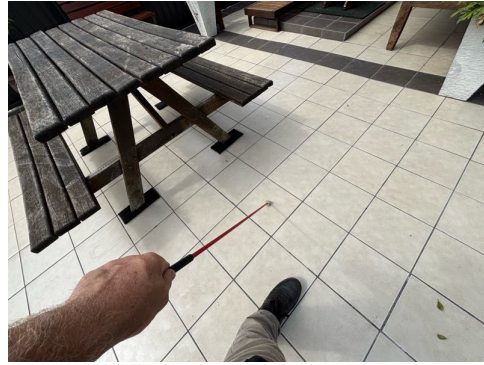
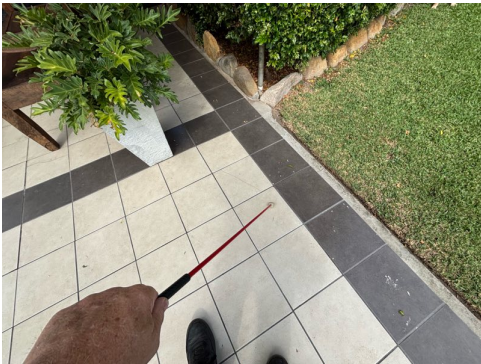
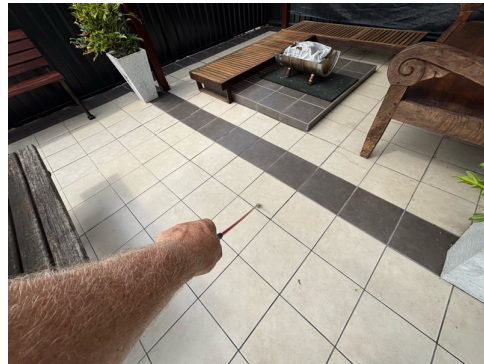
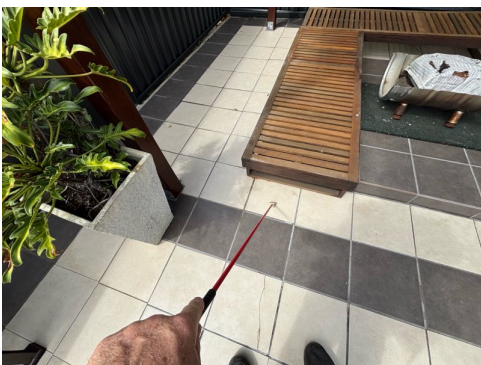
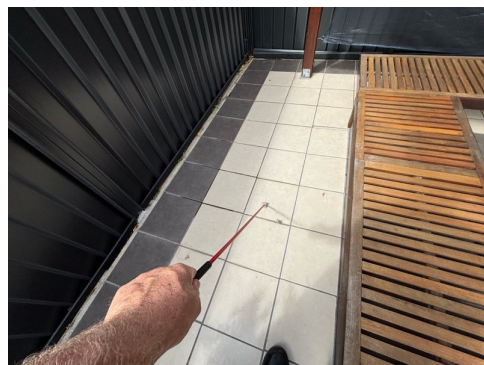
Finding 3.13

At the time of the inspection, it was noted that there were several drummy tiles on the rear patio area. Drummy tiles are easier to damage if an item is dropped on the affected areas.

The term 'drummy' refers to tiles that have become detached from their fixing, despite otherwise being in relatively good condition. Such defects are generally caused by physical or moisture damage to the area. Drummy tiled areas may also be a direct result of poor workmanship during the construction process.

Tiled areas may swell and shrink with changes in air humidity if the area has sustained moisture damage. Any exposure to moisture is capable of causing tiled areas to become drummy and/or cracked over a prolonged period of time. Drummy tiled areas generally require removal and replacement of affected tiles, with adequate sealant and grouting.

Specialist trades are available for these types of services. A registered builder may be required to undertake works if damage is extensive or if secondary building defects have resulted. Otherwise, it is advised that a tiling contractor be appointed to perform works as necessary. Immediate action is recommended to ensure that no further damage is sustained in the affected area.

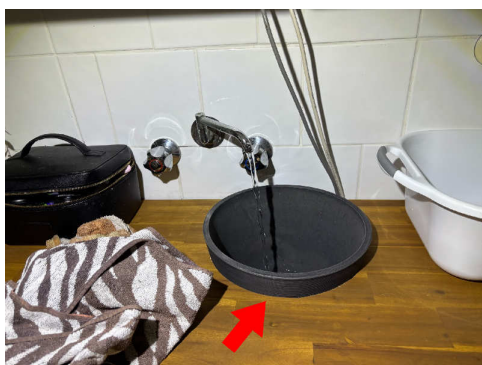
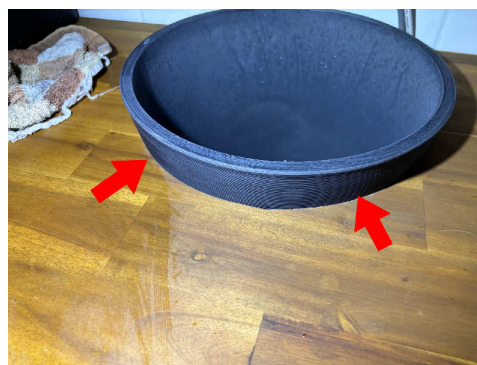
Finding 3.14

Finding:	Laundry basin- no sealant
Information:	At the time of the inspection, it was noted that there was no sealant around the laundry basin.
	Sealant is used in junctions to prevent moisture damaging the associated building materials, such as the timber benchtop in this instance.
	A building maintenance professional should be engaged to apply sealant to the basin and benchtop junction. This should be done as a short term priority.

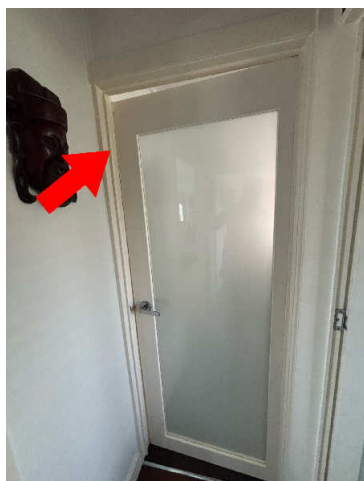
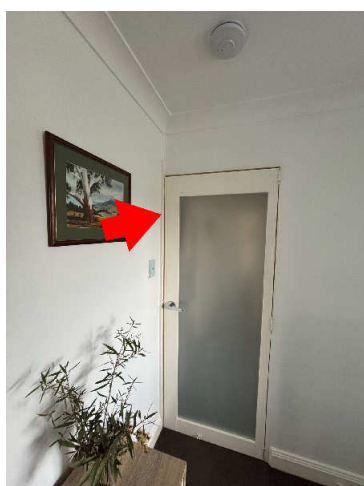
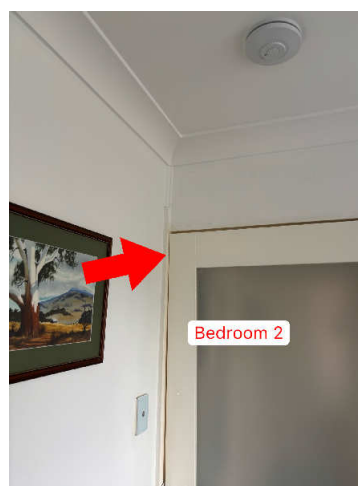
Finding 3.15

Building:	Main Building
Location:	All Internal Areas
Finding:	Doors - Binding during normal operation
Information:	At the time of the inspection, it was noted that the doors to bedroom 2 and 3 were binding during normal operation. This appears to be general wear and tear.
	For minor causes, a qualified carpenter or building maintenance professional should be appointed to perform minor rectification works at client discretion.

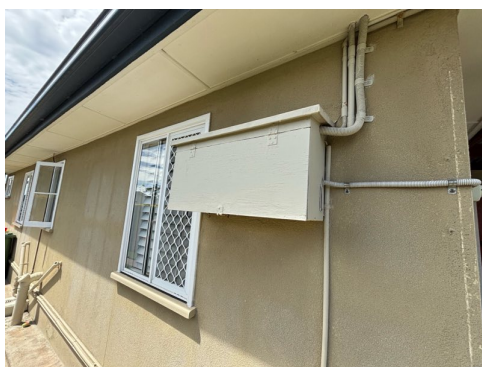
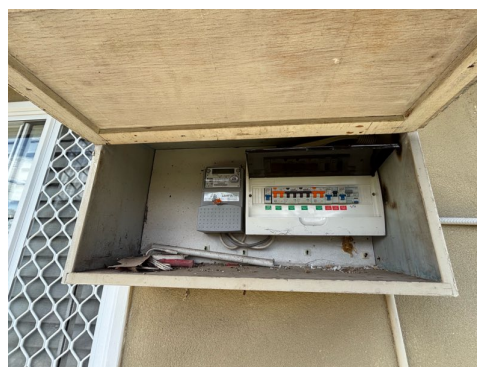
Information: At the time of the inspection, no evidence of a chemical termite management system was found. There is no durable notice in the meter box.

The application of a post-construction chemical termite barrier is highly recommended for all properties, particularly if live termite activity has been found on the site previously. Such barriers are highly effective in preventing termite attack on any timber building elements throughout the property.

A durable notice should be placed in the switchboard unit to indicate current termite barriers. At the time of inspection, it appeared as though no termite management system has been installed, with no evidence to suggest preventative works taking place.

The client may consider gaining further advice from a pest controller as to the costs and procedures involved with this application. It is recommended that obtaining such advice be a short-term priority.

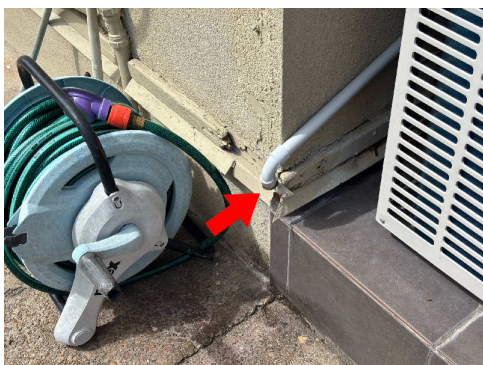
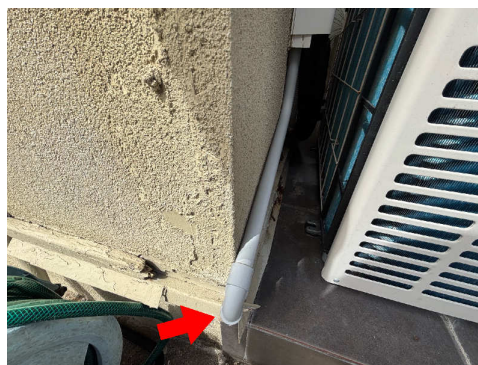
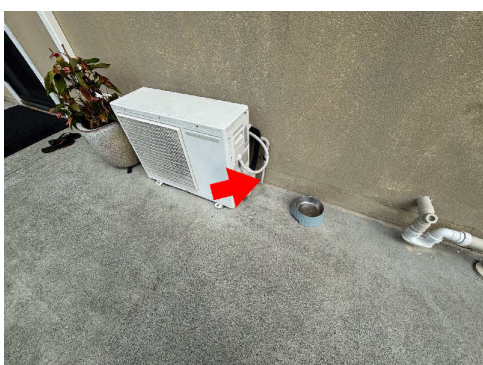
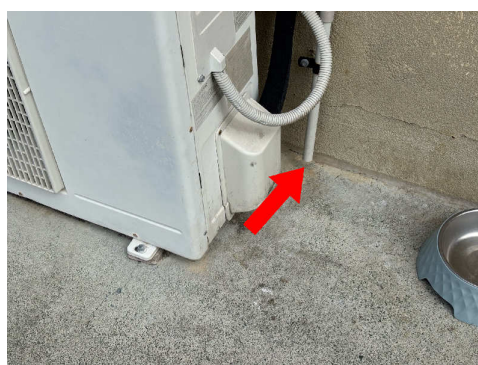
Finding 6.02

Building: Main Building
Location: All External Areas
Finding: Air conditioner - Disconnected overflows

At the time of the inspection, it was noted that the air conditioner drain overflows to all the units were not connected to the storm water drainage and as a result are draining next to the foundations of the dwelling.

Air conditioning overflows that are not connected to the storm water drainage and are draining near the foundation can create excessive moisture in the surrounding area.

Such leaking creates an environment which is conducive to an array of defects, including water damage to associated building elements and the attraction of termite or timber pest infestation.

It is highly recommended that a licensed plumber be appointed to connect the A/C overflow in order to prevent such an environment from being created. These minor works should be carried out as soon as possible.

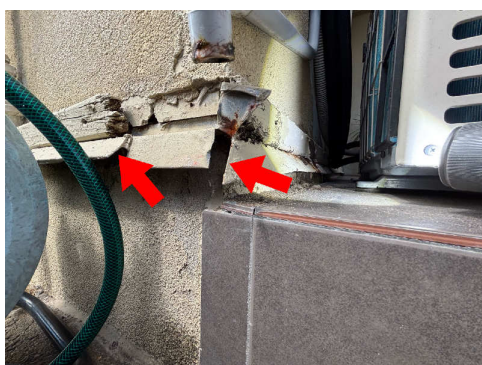
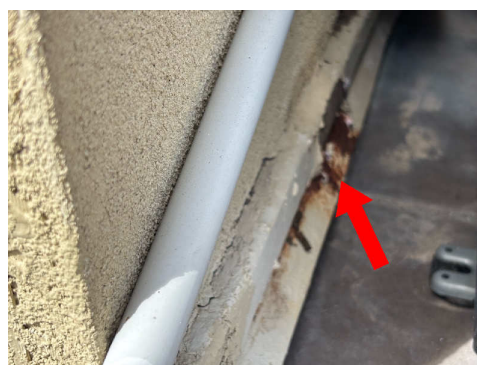
**Finding 6.03**

Location:	All External Areas
Finding:	Ant caps - damaged or modified
Information:	<p>At the time of the inspection, it was noted that a section of the ant caps in the have been damaged or modified. Generally, ant caps are installed to the intersection between the top of the stumps (or piers) and the timber sub structure or wall framing.</p> <p>Installed during the construction process, ant caps are designed to easily identify termite or pest ingress from stumps to the adjoining bearers.</p> <p>Where ant caps have been damaged or modified, frequent monitoring of these areas should be carried out in order to identify any signs of termite or timber pest workings.</p>

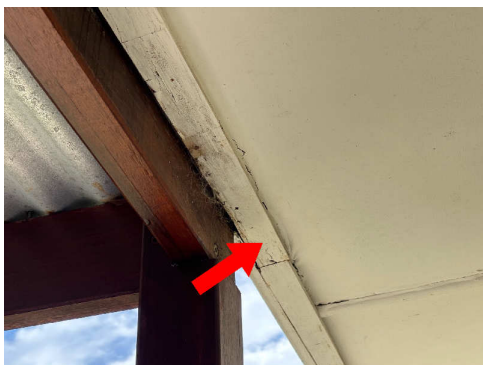
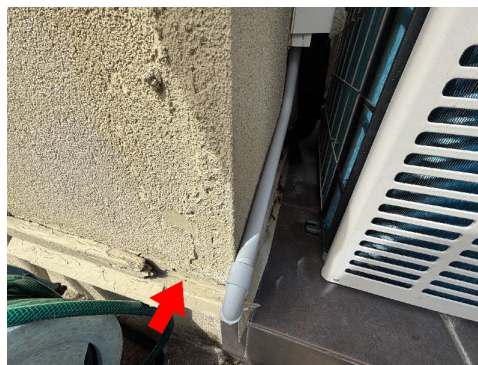
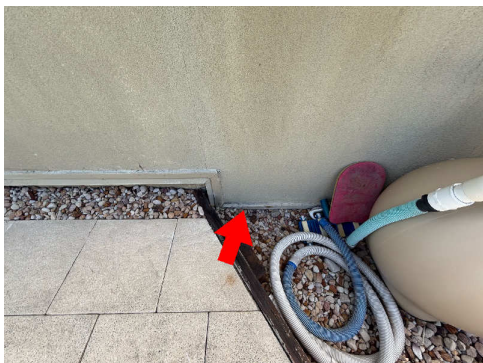
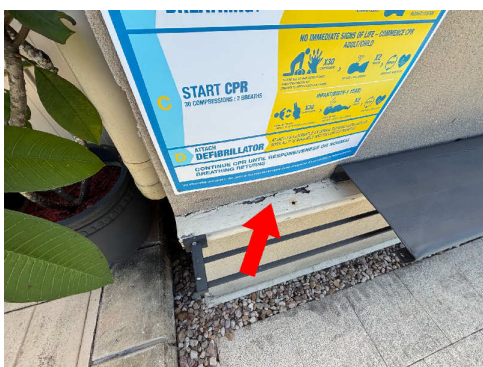
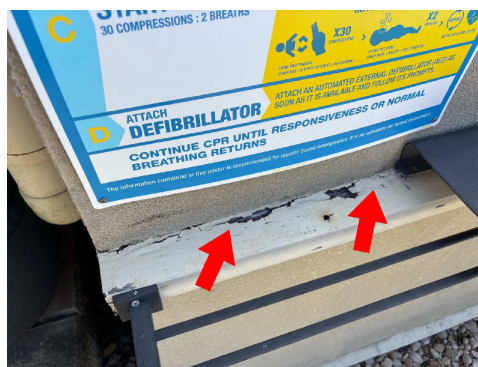
Finding 7.01

Building:	Main Building
Location:	All External Areas
Finding:	Wood rot

At the time of the inspection, it was noted that there were examples of wood rot to timber building elements found around the dwelling. Examples were found to timber mouldings above the ant cap, timber mouldings to the eave and the timber window sill in the pool area. This may be due to the age of the timber building elements and general weathering.

This building element shows evidence of wood rot. Wood rot, also known as Fungal Decay, occurs when timbers and other cellulose building materials are exposed to damp conditions on an ongoing basis.

Wood rot is often associated with general damp problems and is evidenced by a 'musty' smell or mould and mildew occurring on surfaces. If left unmanaged, damp conditions can lead to further health problems and the decay of timbers will continue.

Early intervention and regular maintenance, particularly of exterior timbers, will prolong the useful life of these building elements. Prior to any works being performed, the cause of the moisture that has created the visible wood rot should be identified and addressed in a suitable manner. Replacement of affected timbers may then be a necessary step in protecting surrounding building elements from such deterioration.

A qualified carpenter or registered builder may also be required to replace affected building materials.
