Building and Timber Pest Inspection Report

Inspection Date: Sat, 14 Feb 2026

Property Address: 36 Wallis St, Seymour VIC 3660, Australia

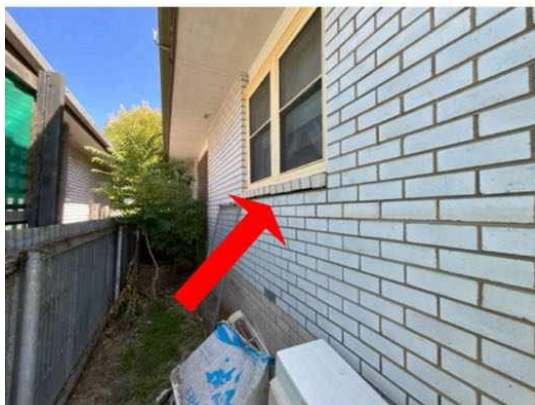
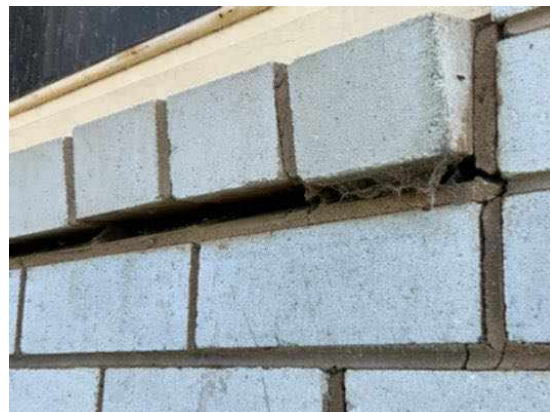
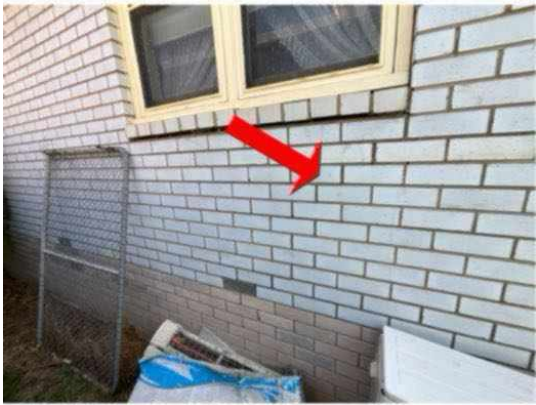
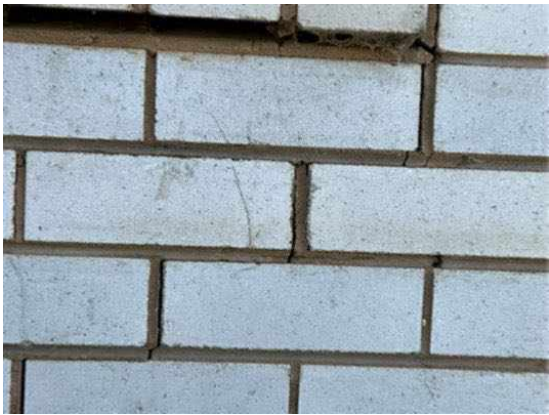
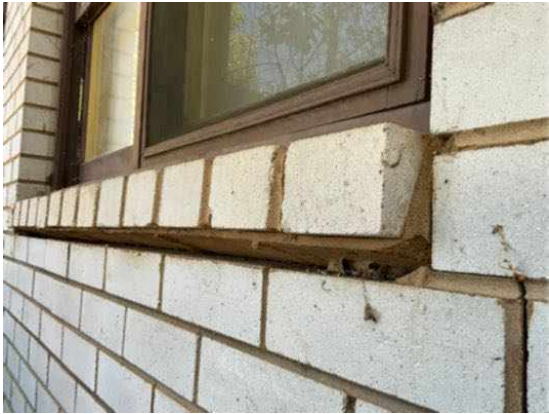
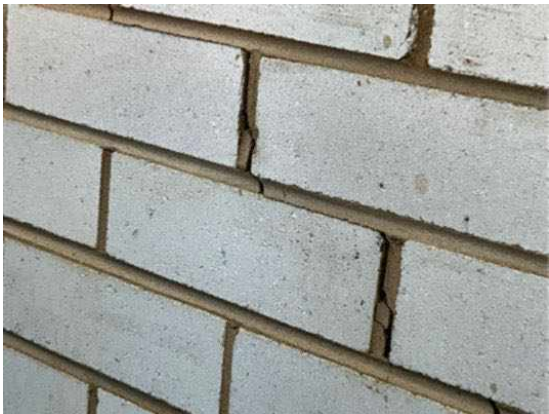
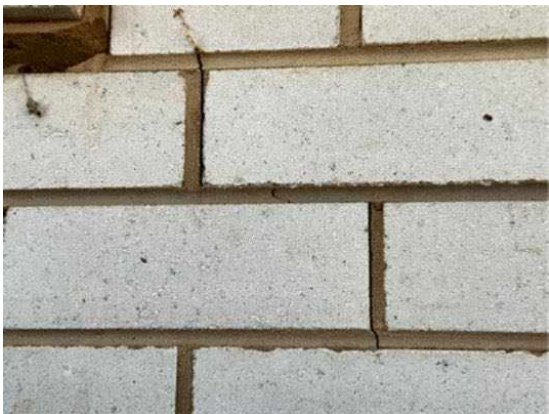
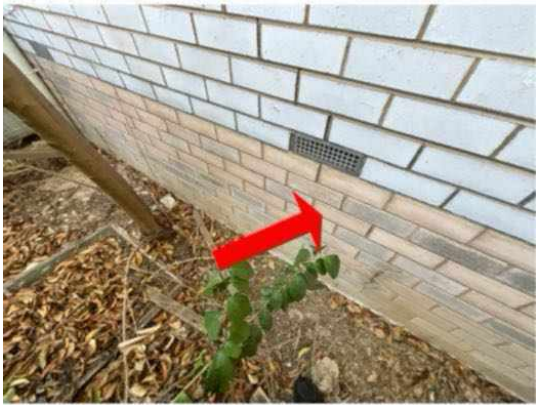
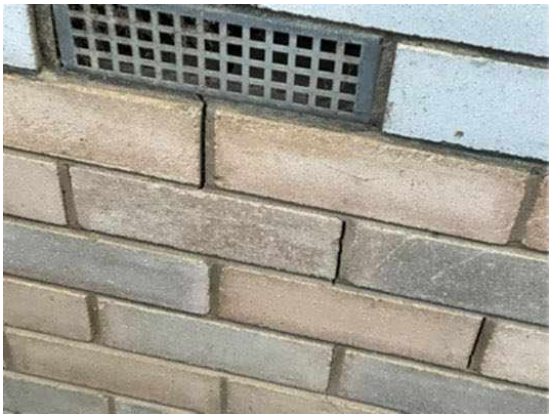
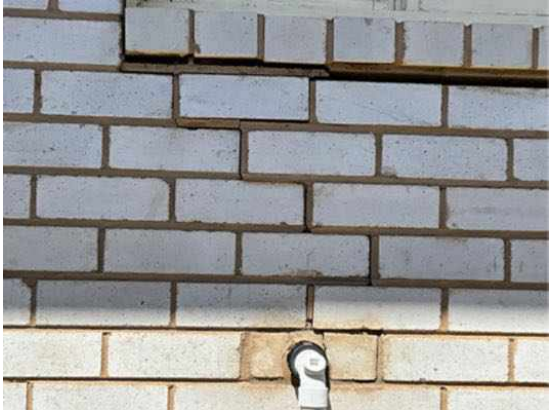
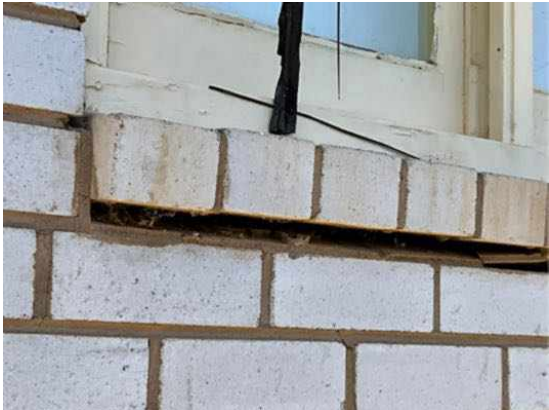
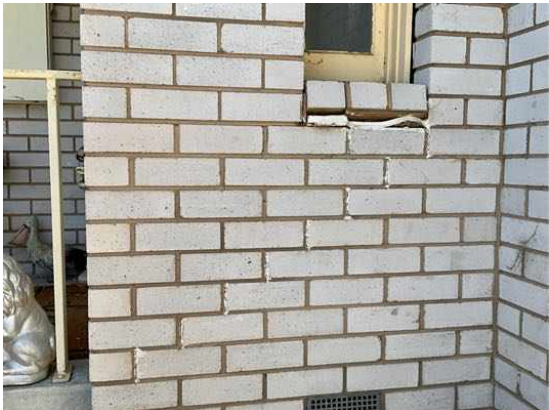
Finding 3.01

Building: Building 1
Location: Yard - Side, front, back
Finding: Brickwork - Step cracking
Information: Step cracking was identified to the brickwork in this area at the time of inspection. Step cracking, which is similar to other forms of cracking, has a variety of possible causes. However, the most common is the subsidence of adjacent footings.

Step cracking is a relatively common defect, and is most likely to occur adjacent to windows, doors and other openings. Mortar failure in the gaps between affected bricks indicates the stresses and tensions affecting the wall.

Where step cracking is extensive or severe, the client is advised to consult a structural engineer. Minor step cracking can be used as a warning sign to address factors causing stress to the wall, which can include the effect of surrounding trees, water leaks, soil erosion, or even the presence of reactive soils in the surrounding area.

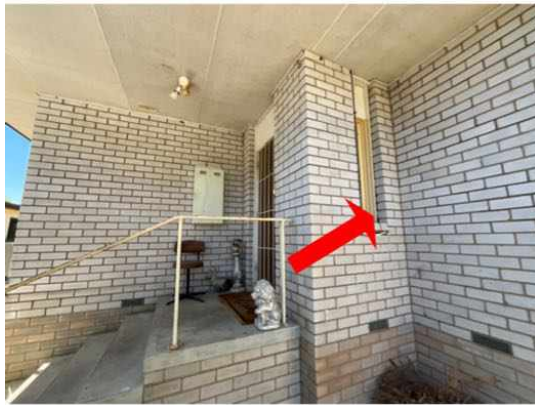
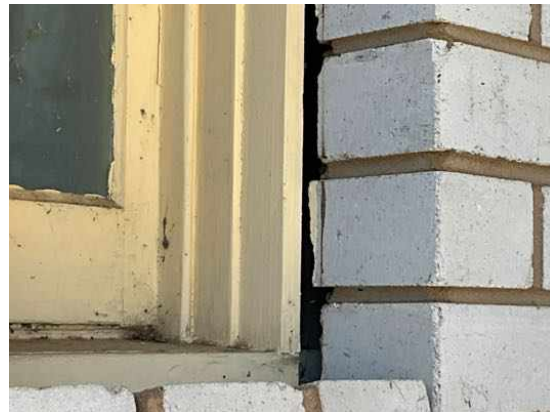
Finding 3.02

Building: Building 1
 Location: Front window
 Finding: Inadequate sealant/caulking
 Information: This area has a lack of effective Sealant or Grout. This may be allowing the ingress of water to the structure.

The presence of water encourages Termite attack, Mould and Fungal Decay.

A Caulker or General Handy person must be contacted soon to effect repairs and prevent possible deterioration.

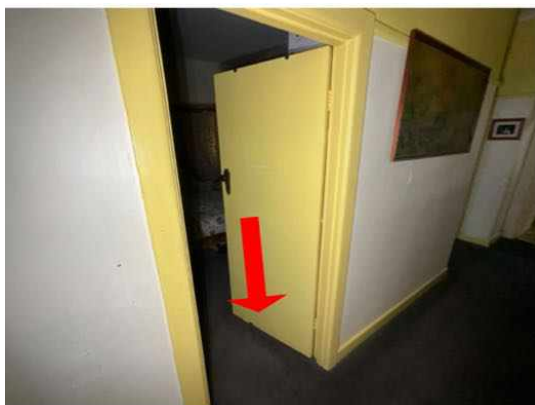
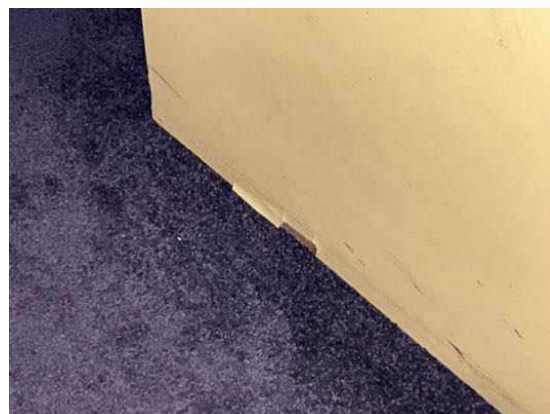
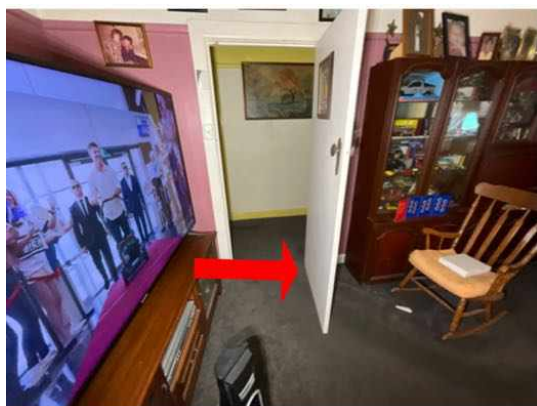
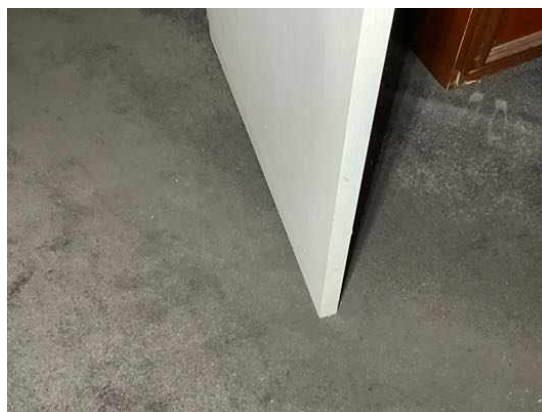
Finding 3.03

Building: Building 1
 Location: Bedroom 2, living
 Finding: Door- Binding/jamming
 Information: Binding and/or jamming of this door is evident during standard operation. This defect inhibits the functionality of the affected door as well as creating potential for secondary defects to associated building elements, such as damage to the floor covering.

A qualified carpenter or general handyperson should be appointed to perform minor rectification works at client discretion.

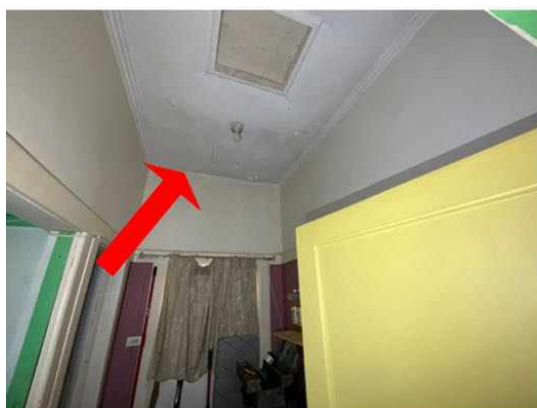
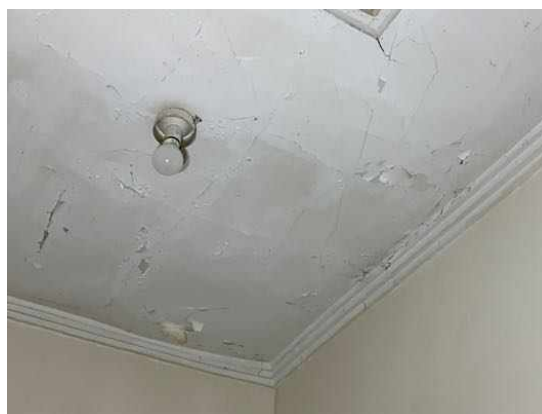
Finding 3.04

Building:	Building 1
Location:	Laundry
Finding:	Ceiling - Sagging
Information:	Sections of the ceiling were found to be sagging at the time of inspection. Sagging to the fixed ceiling structure generally indicates that the building materials have swollen, due to contact with water, or that fixings (e.g. nails or glue) have become loose and require reattachment.

In some cases, sagging ceiling linings may also indicate that there are structural issues, causing surfaces to warp, twist or sag. Where sagging appears to be major, appointment of a structural engineer is advised to further inspect the property and identify the source and rectification works required.

Where minor sagging is evident, comparatively minor works, such as re-gluing of ceiling sheets, may be required. Such works may be performed by relevant tradespeople, such as plasterers and painters. Where excessive moisture has caused the roofing structure to swell and sag, the source of the water leak should primarily be identified prior to any remedial works being performed.

The appropriate action should be taken by the client as soon as possible to ensure that any potential further damage is limited.

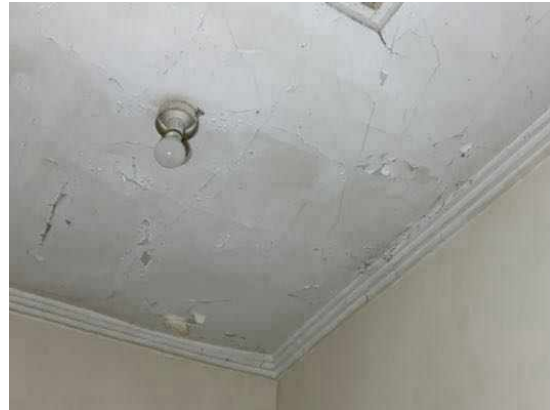
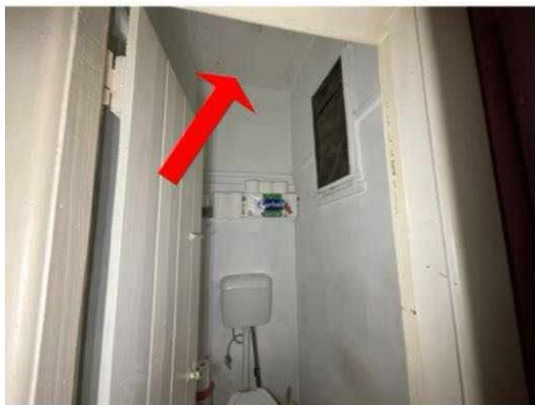
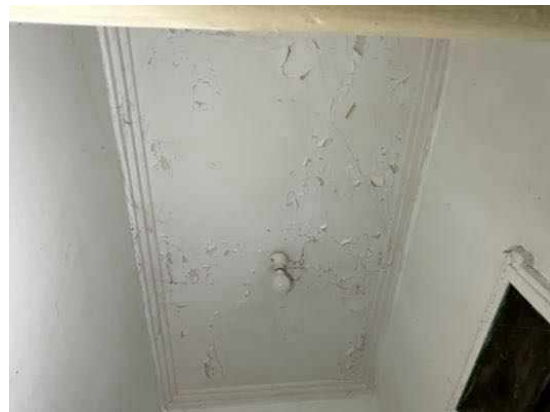
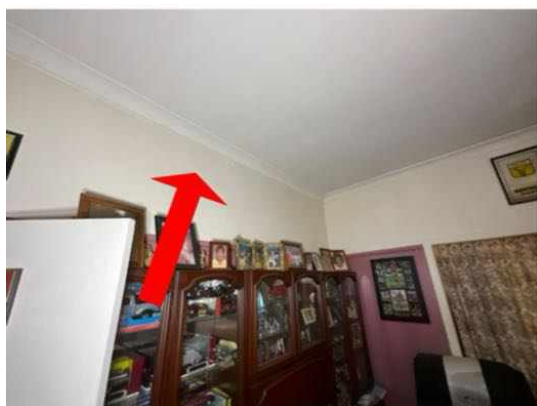
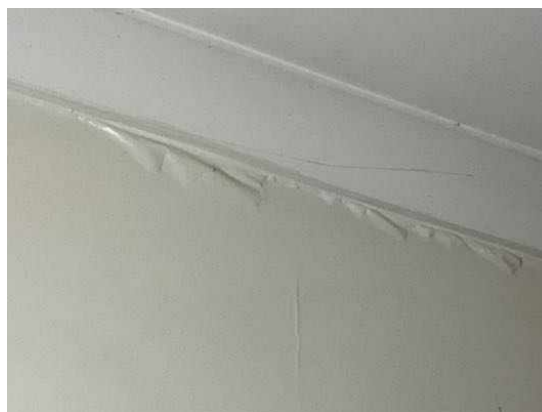
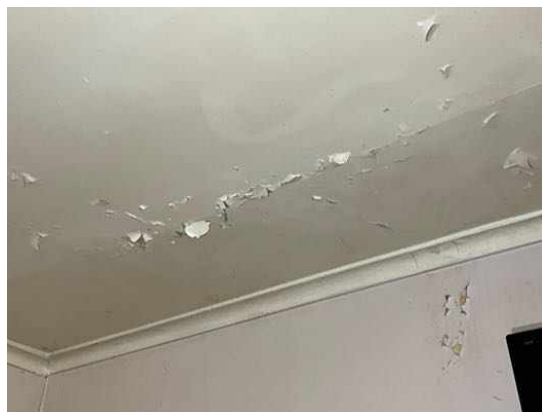
Finding 3.05

Building: Building 1
Location: Laundry, Wc, living, kitchen
Finding: Painted surface - Flaking
Information: Sections of paint in this area was found to have deteriorated. Paint flaking is generally an indication of excessive moisture in the area, that is currently hidden by the painted surface.

The presence of excessive moisture can have major implications on associated building elements if left unattended. While only seemingly minor at this stage, the damage cannot be determined due to the paint obstructing any further inspection of the damage.

A qualified Painter should be contacted at the Owner's discretion to re-paint the ceiling.

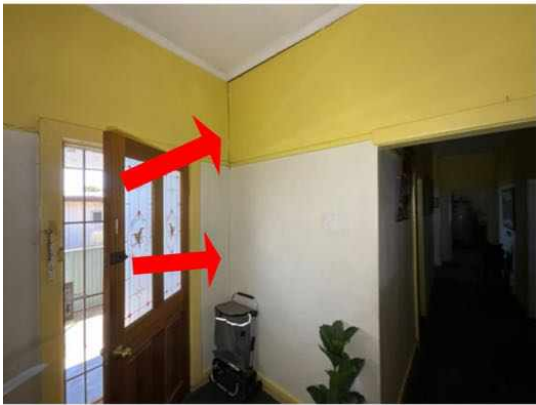
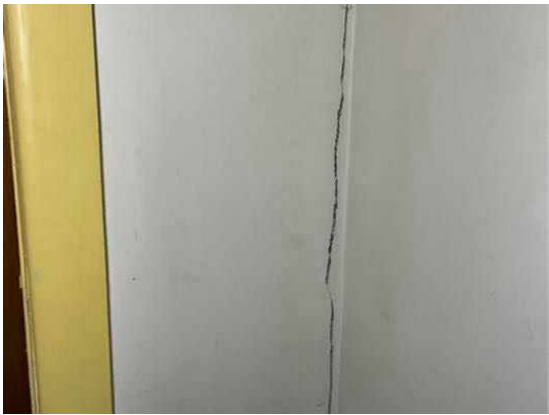
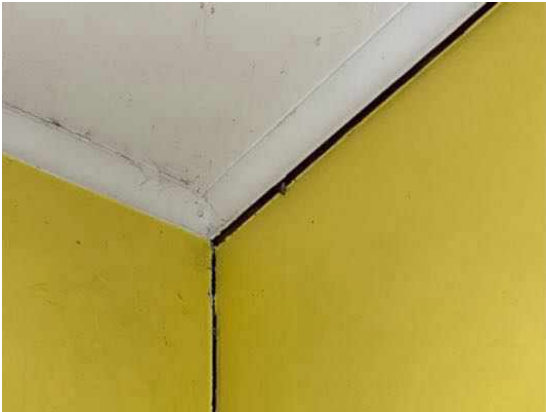
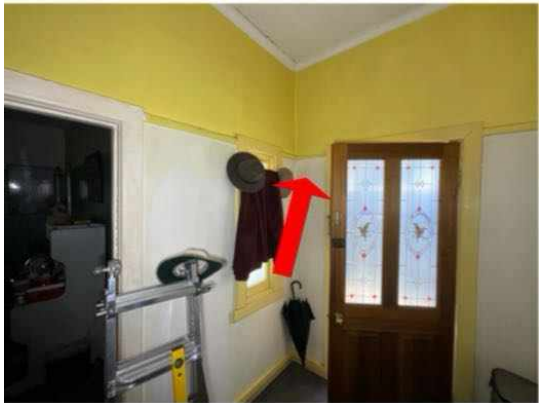
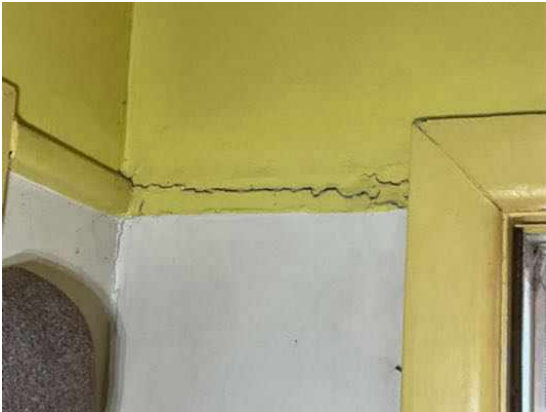
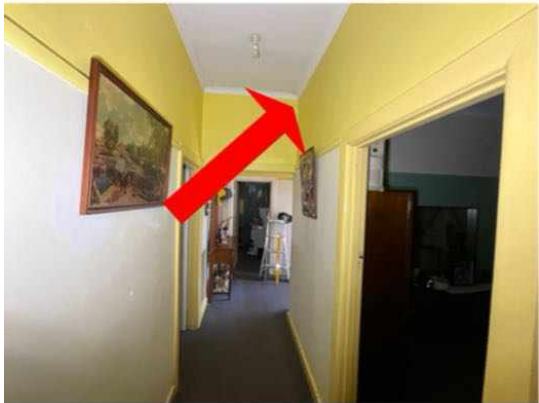
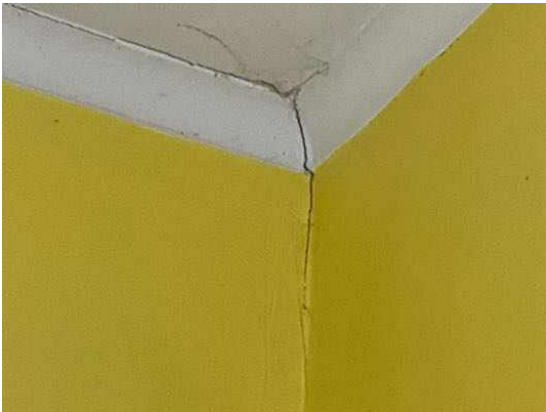
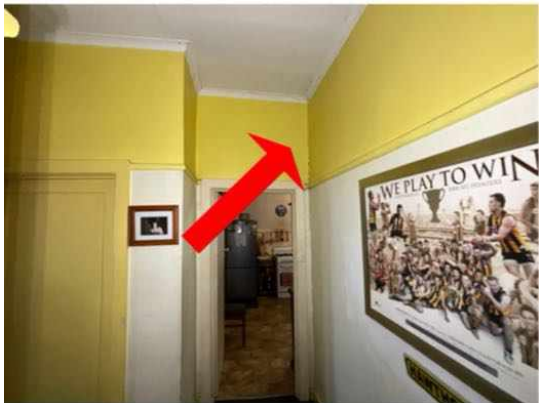
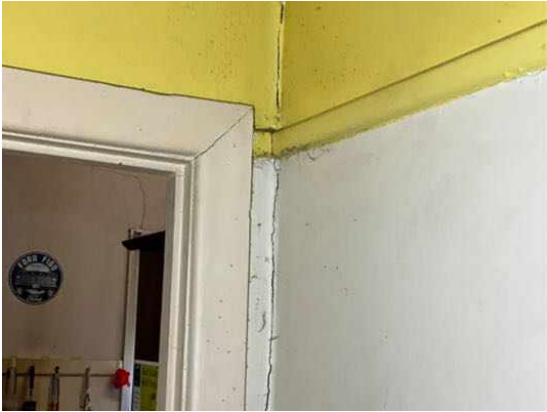
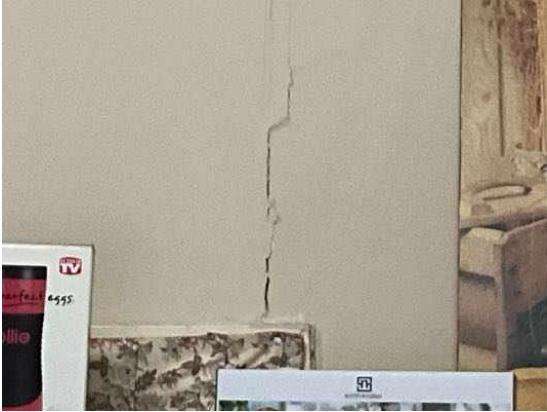
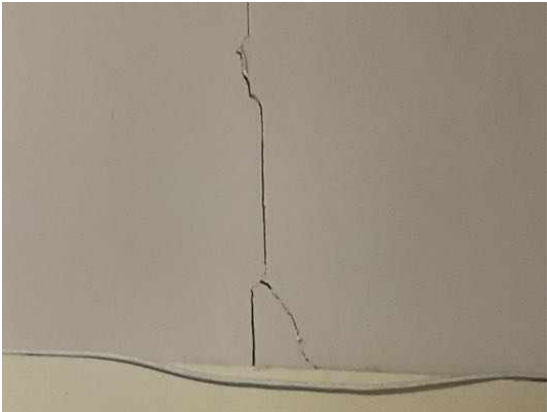
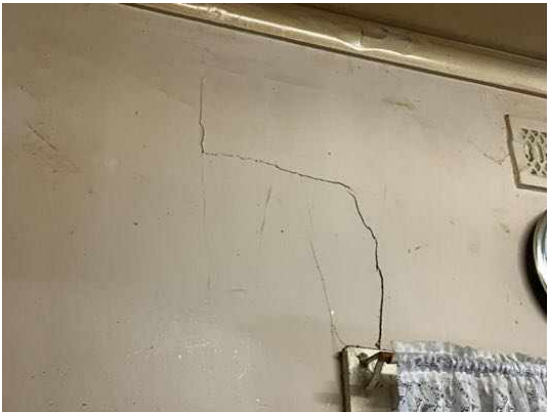
Finding 3.06

Building:	Building 1
Location:	Hall, kitchen
Finding:	Cracking - Damage Category 2 - Noticeable (up to 5mm)
Information:	Noticeable cracks are a common occurrence as a result of many primary defects. Such causes may include age, general wear and tear, expected building movement, general expansion/contraction of building materials in different weather conditions, and/or minor failings in the installation or application of building materials.

Noticeable cracks may result in minor sticking or jamming of associated doors and windows, which require easement. However, noticeable cracks are easily filled and repaired. A plasterer can be consulted to install an expansion joint at this point to allow for this movement during different weather conditions.

Monitoring of all cracking should be conducted frequently. Always contact a building inspector should cracks widen, lengthen, or become more numerous. Additionally, your building inspector should also be contacted if associated building elements such as doors and windows become more difficult to operate over time.

Relevant tradespeople, such as carpenters, painters and plasterers, should be appointed to perform remedial works, as deemed necessary.

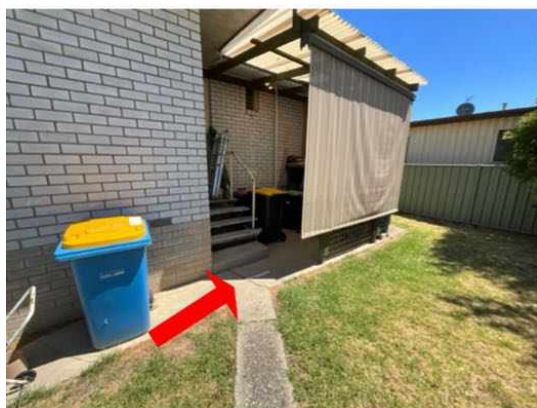
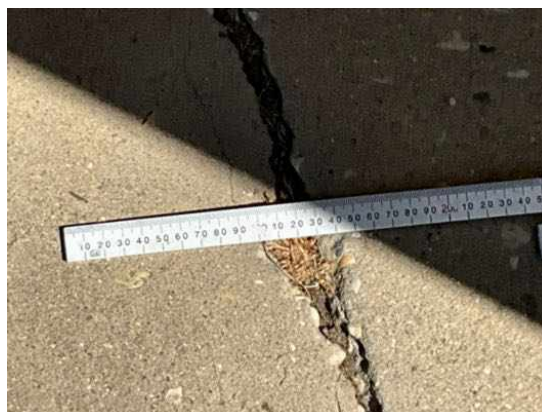
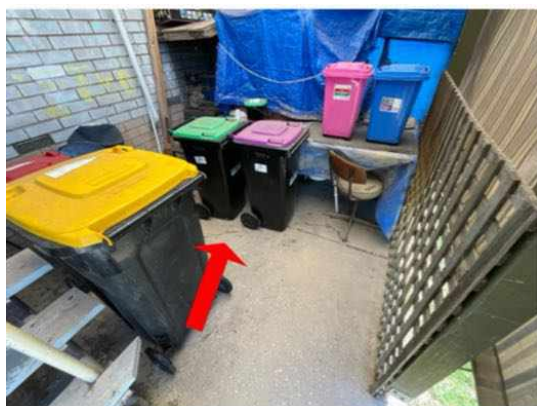
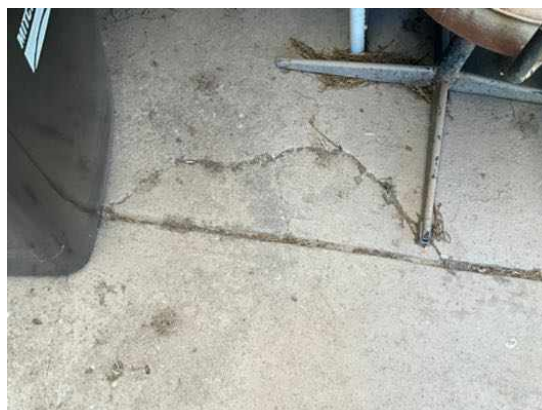
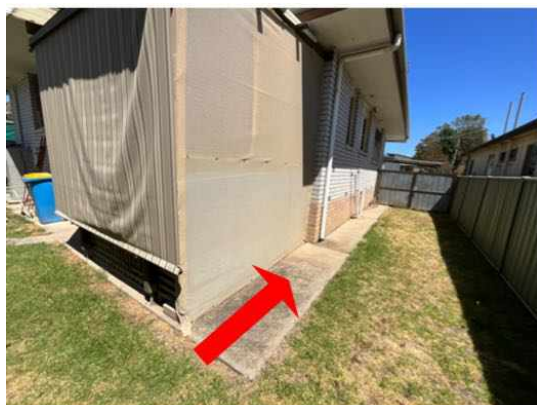
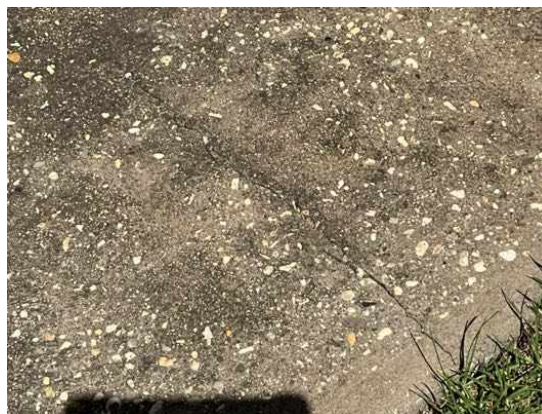
Finding 3.07

Building:	Building 1
Location:	Back door area
Finding:	Cracking - External Concrete Paving Damage Category 4 - Gaps in Slab (4mm - 10mm +)
Information:	Gaps in the slab were identified in external concrete paving. Gaps in the slab are significant and are likely to lead to the development of safety hazards and secondary defects if left unmanaged, such as the creation of a trip hazard.

General age and expected deterioration of the paved areas is a common cause of this type of cracking. However, expansion and contraction of the slab may also have occurred due to environmental factors. Such factors include variable moisture and weather conditions, the presence of trees and their roots having a settling or lifting affect on the soil, or the effect of load bearing, e.g. heavy vehicles over a sustained period of time.

Cracking to this degree may also be due to poor original installation of the concrete. Factors such as poor compaction of the sub surface and/or inadequate reinforcing of the slab may create cracking and other secondary defects. Gaps in the concrete paving may also have a more significant structural cause, such as subsidence of soils.

Where gaps in the concrete paving are adjacent to structural elements of the building, the advice of a Structural Engineer is advisable before undertaking repairs. Significant repair and likely replacement of the concrete paving is probable.

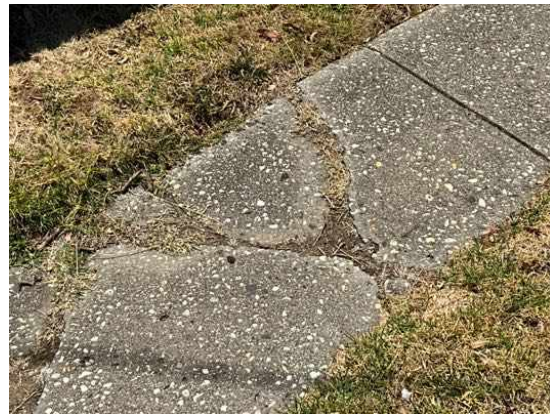
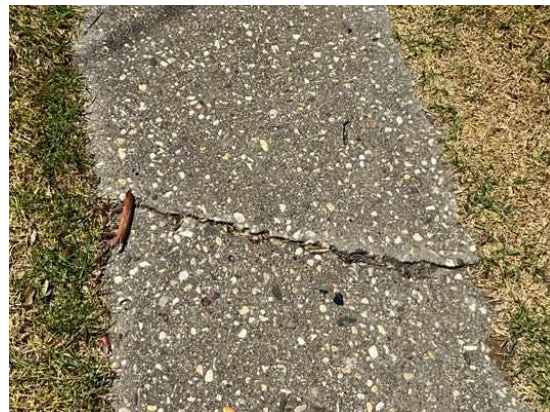
Finding 3.08

Building:	Building 1
Location:	Driveway
Finding:	Cracking - External Concrete Paving Damage Category 3 - Wide Cracks (2mm - 4mm)
Information:	Wide cracks were identified in external concrete paving. Wide cracks are significant and are likely to lead to the development of safety hazards and secondary defects if left unmanaged.

General age and expected deterioration of the paved areas is a common cause of this type of cracking. However, expansion and contraction of the slab may also have occurred due to environmental factors. Such factors include variable moisture and weather conditions, the presence of trees and their roots having a settling or lifting effect on the soil, or the effect of load bearing, e.g. heavy vehicles over a sustained period of time.

Cracking to this degree may also be due to poor original installation of the concrete. Factors such as poor compaction of the sub surface and/or inadequate reinforcing of the slab may create cracking and other secondary defects. Wide cracks may also have a more significant structural cause, such as subsidence of soils.

Where the crack is located adjacent to structural elements of the building, the advice of a Structural Engineer is advisable before undertaking repairs. Significant repair and likely replacement of the concrete paving is probable.

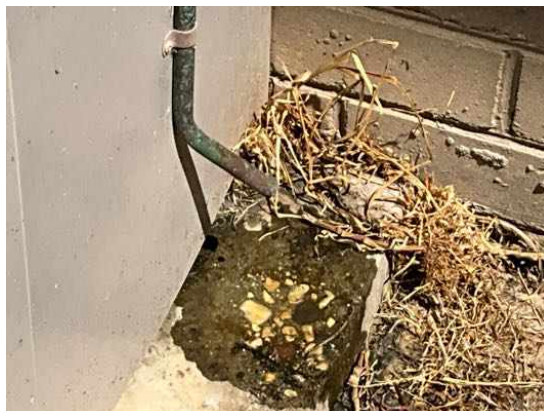
Finding 6.01

Building: Building 1
Location: Yard - Back
Finding: HWS Overflow - Not Connected
Information: The Hot Water System (HWS) overflow was found to be disconnected from storm water drainage and is creating excessive moisture in the surrounding area.

These damp conditions can lead to secondary defects such as rot, rust or corrosion of associated building elements, the formation of fungal decay, or even the creation of potential slip hazards. When coupled with poor site drainage, pooling of water may also attract termite activity to this area.

It is highly recommended that a licensed plumber be appointed to connect the HWS overflow in order to prevent such an environment from being created. These minor works should be carried out as soon as possible.

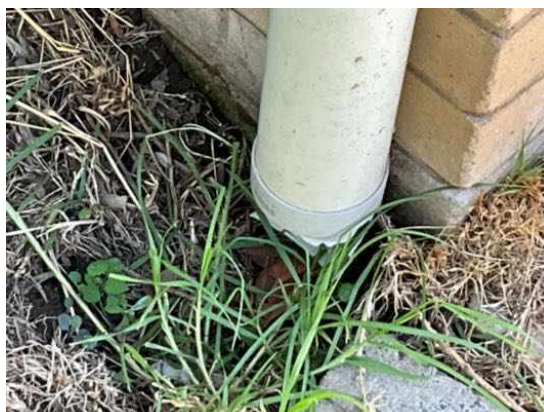
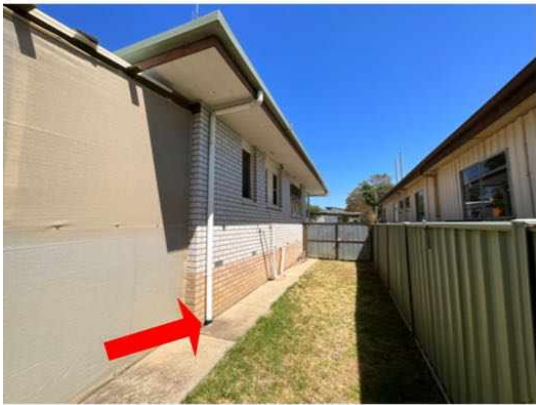
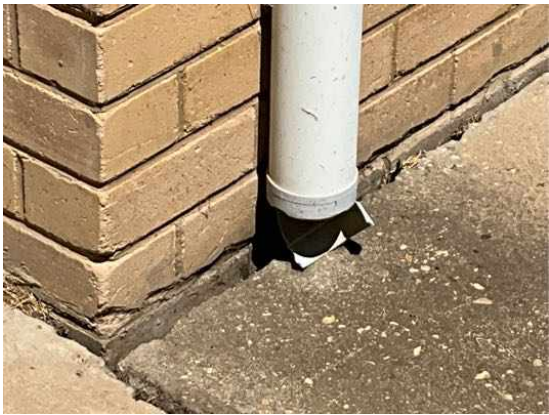
Finding 6.02

Building:	Building 1
Location:	Yard - Side, back
Finding:	Stormwater drain - Not connected
Information:	The roof plumbing is not adequately connected to stormwater drainage on the site. This disconnection negatively impacts the functional capacity of the roof plumbing.

Where roof plumbing doesn't drain adequately, the area at the base perimeter can become excessively damp, potentially creating an environment that is susceptible to rust and corrosion of surrounding building elements, as well as attracting termites and other pests.

It is highly recommended that a plumber be appointed to further inspect the area and to install adequate drainage equipment where necessary.

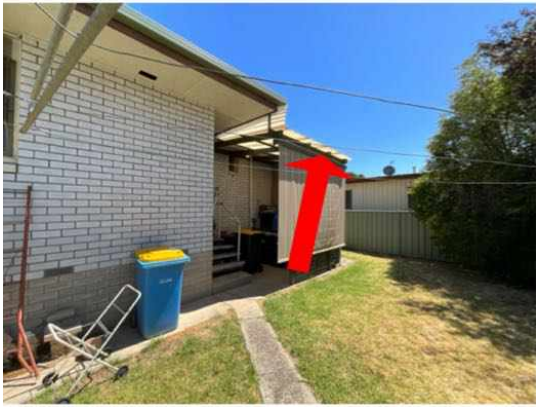
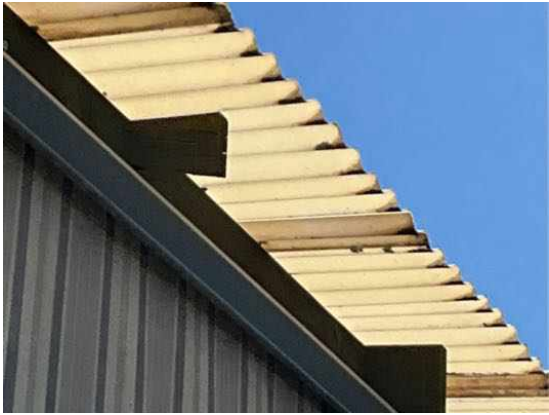
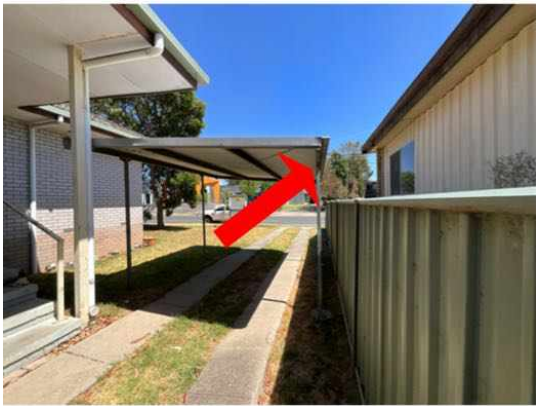
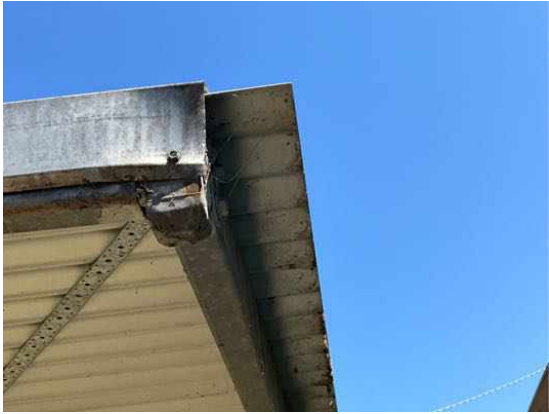
Finding 6.03

Building: Building 1
 Location: Yard - Back, carport
 Finding: Guttering Missing
 Information: The Guttering in this area was missing at the time of inspection. Guttering, Downpipes and Stormwater drainage are vital to protect the integrity of the structure and to prevent an environment conducive to Timber Pest attack.

A Plumber should be contacted as soon as possible to replace and connect to drainage the missing Guttering.

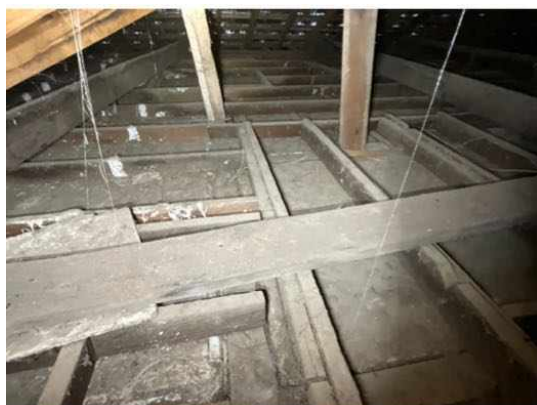
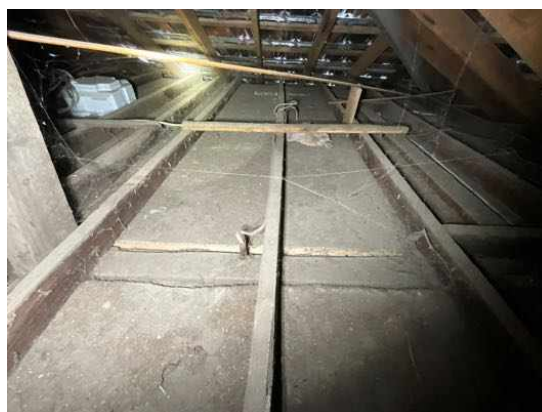
Building:	Building 1
Location:	Roof Void
Finding:	Insulation - Missing
Information:	Upon inspection of the roof void it was noted that insulation is not present.

Insufficient insulation will result in a comparatively higher cost to heat and cool a property as there is a lack of Insulation (or uneven coverage of insulation) which works as a barrier to heat transfer. This helps to keep out unwanted heat in summer and preserves warmth inside your home in winter. It can also help soundproof your home from unwanted airborne noise transfer.

Where insulation is absent, the area does not meet current Australian Standards. Installation of adequate insulation is required and should be conducted as soon as possible.

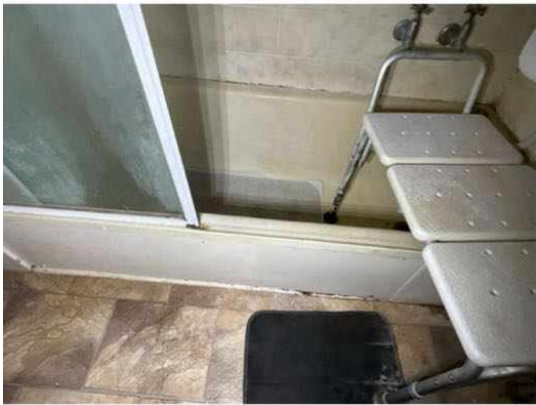
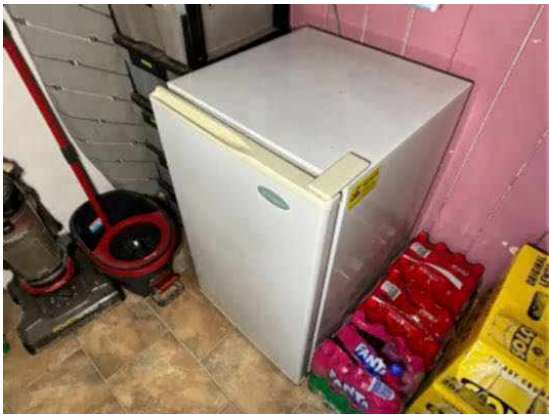
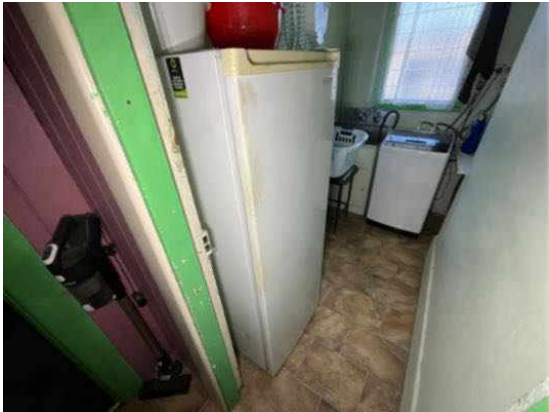
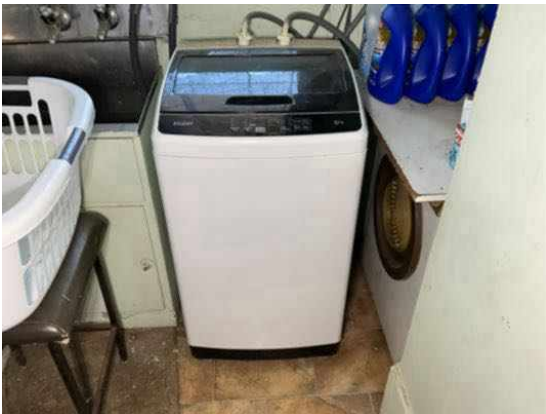
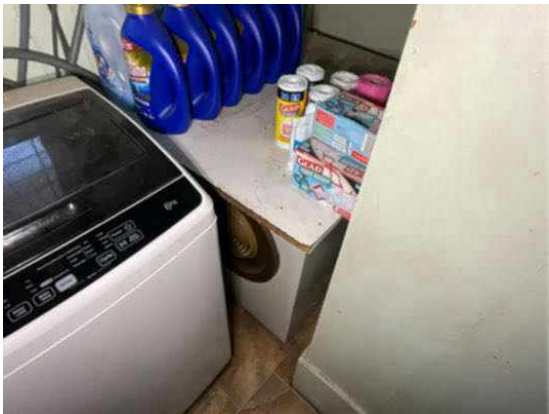
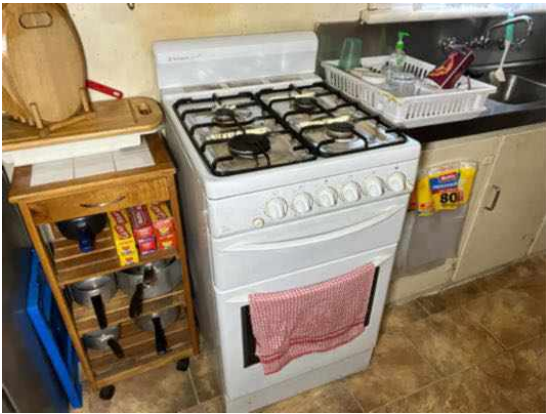
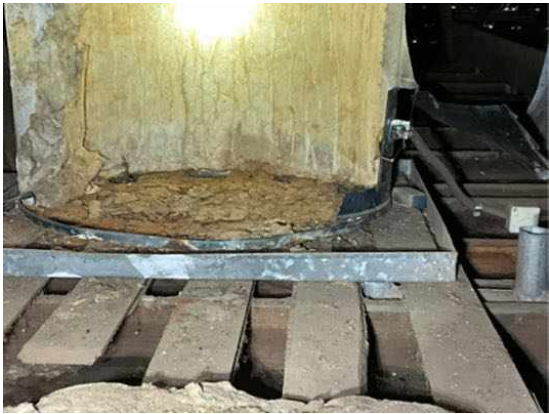
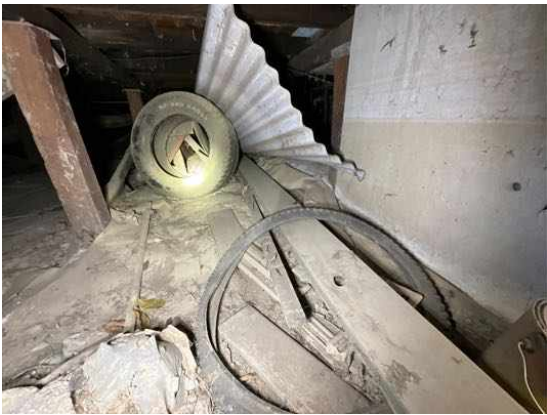
Building:	Building 1
Location:	All Areas
Finding:	Additional Photos - Obstructions and Limitations
Information:	These photographs are an indication of the obstructions and limitations which impeded full inspection of the property at the time of inspection. These obstructions can hide an array of defects and should be removed to allow full inspection to be carried out. A re-inspection is recommended once the areas are made accessible.
