Building Inspection Report

Inspection Date: Thu, 12 Feb 2026

Property Address: 22 Cavendish Ave, Blacktown NSW 2148,
Australia

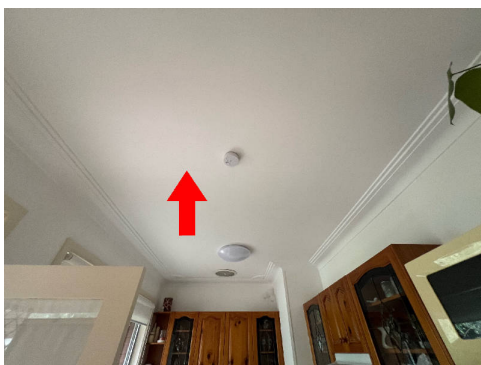
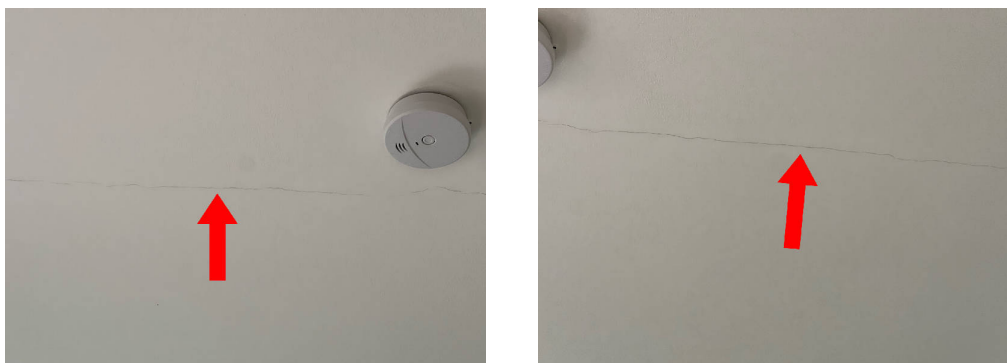
Defects 3.01

Finding: Ceiling – Hairline Cracking to Plasterboard

Information: Hairline cracking was observed to the plasterboard ceiling within the kitchen area, extending horizontally across the ceiling surface in proximity to the smoke alarm. The cracking appears fine and linear in nature and is consistent with minor movement or joint separation within the plasterboard lining. Such cracking commonly occurs due to normal building movement, minor structural settlement, or seasonal expansion and contraction of framing timbers.

At the time of inspection, the cracking appeared minor and did not display significant displacement, sagging, or evidence of active water staining. While currently considered a minor defect, if left unaddressed the cracking may widen over time and require more extensive rectification. It is recommended that a qualified plasterer assess and repair the affected area as required. Repairs can be undertaken as part of routine maintenance in the short to medium term, with ongoing monitoring for any signs of further movement.

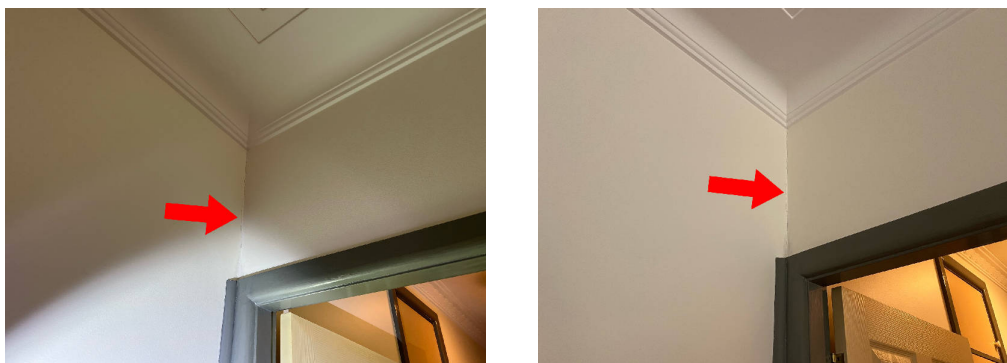
Defects 3.02

Finding: Vertical Corner Cracking Above Door Opening

Information: A vertical crack was observed to the internal wall lining at the corner junction above the door opening. The cracking extends from the cornice line downward along the wall junction and appears consistent with minor separation at the plasterboard joint. This type of cracking commonly occurs at stress points such as wall intersections and above openings, where differential movement, minor settlement, or thermal expansion and contraction can place stress on the plasterboard and jointing compound.

At the time of inspection, the cracking appeared fine and did not exhibit significant displacement, distortion to the door frame, or associated structural movement. The defect is considered minor in nature; however, if movement continues, the crack may widen over time. It is recommended that a qualified plasterer assess and repair the affected area as required. Repairs can generally be undertaken as part of routine maintenance in the short to medium term, with monitoring for any further movement or cracking.

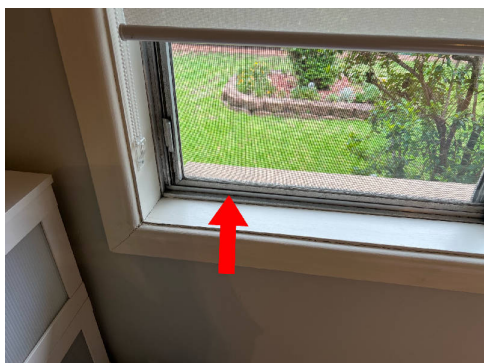
Defects 3.03

Information: The sliding window within the bedroom area was noted to be stiff during operation. Increased resistance was evident when attempting to open and close the sash, which may be attributable to debris accumulation within the track, minor distortion of the frame, worn rollers, or general age-related wear. No obvious signs of significant frame damage were observed at the time of inspection; however, dirt and debris were visible within the track which may be contributing to restricted movement.

Windows that do not operate smoothly can pose a safety concern, particularly where they may be required for ventilation or emergency egress. It is recommended that the window tracks be cleaned and the rollers and hardware inspected. If stiffness persists following cleaning and lubrication, further assessment and adjustment by a qualified window technician or carpenter is recommended. Rectification should be undertaken in the short term to ensure safe and functional operation.

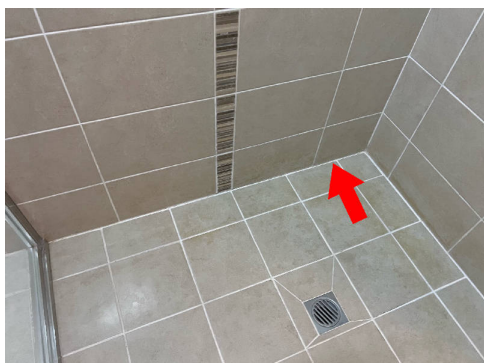
Defects 3.04

Finding: Deteriorated Sealant to Shower Wall and Floor Junction

Information: Sealant was observed to be deteriorated along the junction between the shower wall tiles and the floor tiles. This condition was evident at the base of the tiled wall within the shower area. Sealant at this junction is designed to prevent water from penetrating behind tiles and into the wall and floor substrates.

The absence of effective sealant increases the risk of water ingress, which can lead to moisture damage, deterioration of waterproofing membranes, and potential concealed damage over time. It is recommended that a suitably qualified tiler or bathroom repair specialist reapply appropriate waterproof sealant to this area in the short term to reduce the risk of ongoing moisture-related issues.

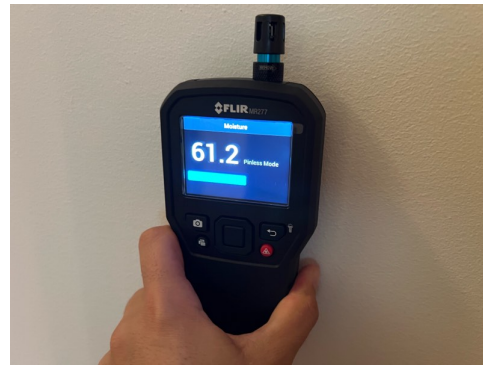
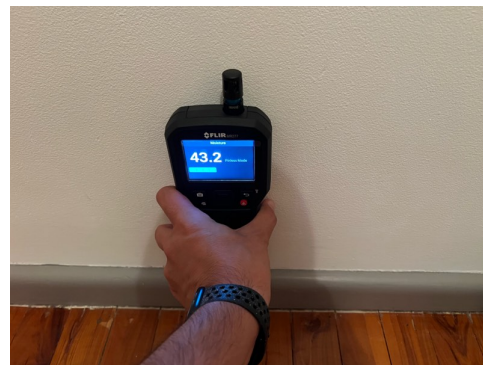
Defects 3.05

Finding: Internal Wall – Elevated Moisture Readings Adjacent to Shower

Information: Elevated moisture meter readings were recorded to the lower section of the internal wall adjacent to the shower recess. Readings in the medium to high range were obtained using a non-invasive moisture meter, indicating the likely presence of excess moisture within the wall lining or substrate. No invasive testing was undertaken; however, the readings are considered abnormal for a dry internal wall surface.

Elevated moisture in this location may be associated with shower recess waterproofing failure, leaking plumbing components, or deterioration of seals and grout. Prolonged moisture exposure can lead to damage of wall linings, deterioration of framing timbers, and potential mould growth if not addressed. It is recommended that a licensed plumber and/or bathroom specialist further investigate the source of moisture and carry out repairs as required. Rectification should be undertaken in the short term to prevent further damage.

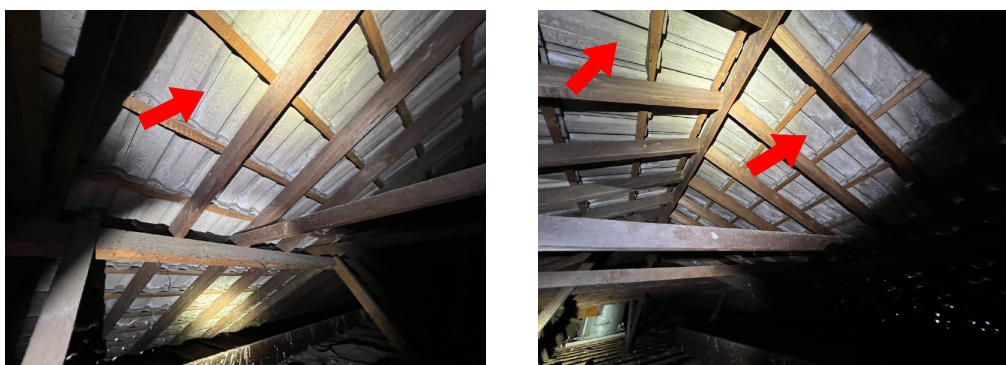
Defects 3.06

Building: Main Building
Location: Roof Void
Finding: No Sarking (Roof Underlay) Installed

Information: Within the roof space, the underside of the tiled roof covering was observed to be installed without sarking (roof underlay). The roof tiles are fixed directly to battens, with no moisture barrier present between the roof covering and the roof framing. While this may reflect common building practices at the time of construction, it does not align with current building standards and performance expectations.

The absence of sarking may increase the risk of wind-driven rain, dust, and debris entering the roof space, and may contribute to moisture exposure of roof timbers and insulation over time. Sarking also assists with condensation control and thermal performance, which may be reduced where it is not installed. This condition should be noted for future consideration, and advice from a qualified roofing contractor is recommended if roof upgrades or replacement works are undertaken.

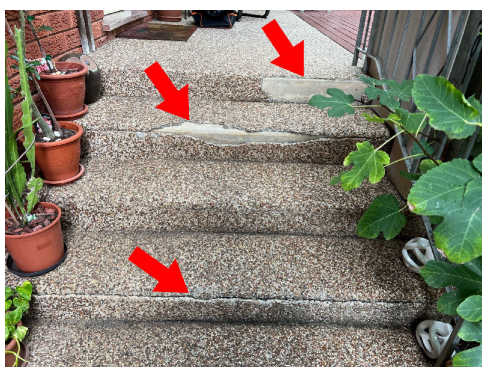
Defects 3.07

Building: Main Building
Location: Rear Elevation
Finding: External Stairs – Deteriorated Concrete and Spalling to Treads

Information: Deterioration and surface spalling were observed to the external concrete stairs at the front entry. Sections of the exposed aggregate finish have broken away from the stair treads and risers, with areas of underlying concrete visible. Localised cracking was also noted to the riser at the landing. The damage appears consistent with age-related wear, weather exposure, and possible moisture ingress contributing to breakdown of the surface finish.

The deterioration has resulted in uneven tread surfaces which may present a trip hazard and may continue to worsen if left unaddressed. Ongoing exposure to the elements may lead to further delamination of the aggregate topping and progressive deterioration of the underlying concrete substrate. It is recommended that a qualified concreter or builder assess the stairs and carry out repairs as required. Rectification should be undertaken in the short term to ensure safe access and to prevent further deterioration.

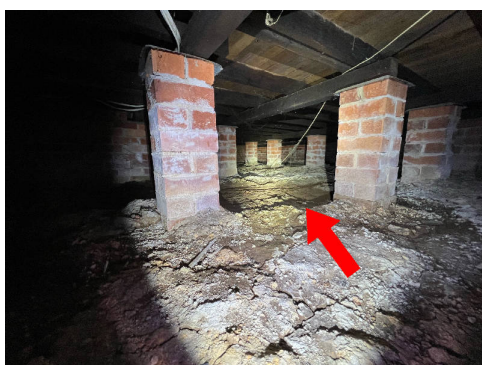
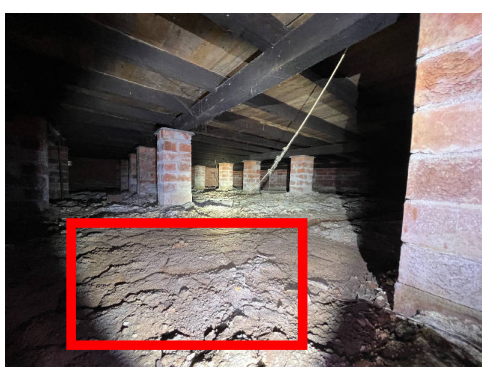
Defects 3.08

Building: Main Building
Location: Subfloor
Finding: Localised Moisture to Ground Surface

Localised areas of damp ground were observed within the subfloor space. Sections of the soil surface displayed visible moisture and cracking consistent with fluctuating moisture levels. The brick piers and visible timbers appeared serviceable at the time of inspection; however, elevated ground moisture was noted in some areas.

Excess moisture within a subfloor can contribute to increased humidity, potential timber deterioration, and may create conditions conducive to fungal decay or termite activity if not adequately managed. The moisture observed may be associated with poor drainage, inadequate subfloor ventilation, or seasonal ground conditions. It is recommended that surface drainage around the dwelling be reviewed and that subfloor ventilation be maintained to assist with moisture control. Monitoring is advised, and further assessment by a suitably qualified contractor should be undertaken if moisture levels persist or increase.

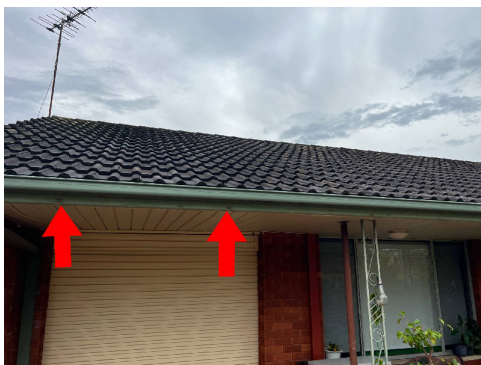
**Defects 3.09**

Finding: Fascia wood rot

Information: Sections of the fascia board were noted to be affected by timber rot and deterioration. The damage appears to be associated with prolonged exposure to moisture, likely from roof or gutter overflows in this area. Rotting timber can weaken structural integrity, compromise the support for gutters, and provide entry points for pests.

If left untreated, the decay may spread to adjoining timber elements and result in more extensive repairs being required. It is recommended that the affected sections be removed and replaced with new, treated timber, and that the source of moisture ingress (such as leaking or overflowing gutters) be identified and rectified.

Repairs should be carried out by a licensed carpenter or builder, with further inspection of roof plumbing by a roof plumber if leaks are contributing to the issue.

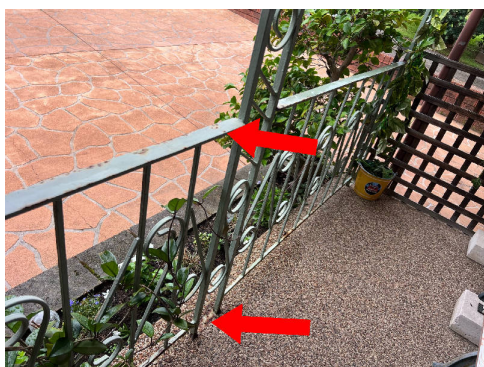
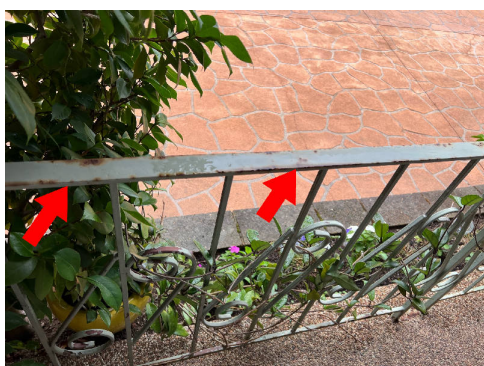
Defects 3.10

Finding: Corrosion to Metal Balustrade Base

Information: Corrosion was observed to the metal balustrade at the front porch, particularly at the base connection where the railing is fixed to the concrete surface. Paint breakdown and surface rusting were noted around the base plate and fixings.

While currently assessed as a minor defect, corrosion at balustrade base connections can progress over time if not treated, particularly where exposed to weather and moisture. Ongoing deterioration may lead to weakening of the railing and potential safety concerns if left unaddressed. It is recommended that the affected areas be cleaned, treated for corrosion, and recoated with a suitable protective finish. Repair or replacement of sections may be required if deterioration advances.

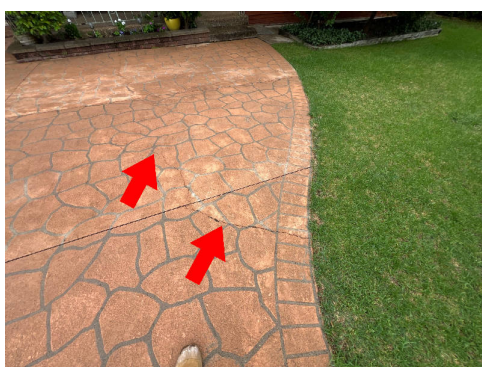
Defects 3.11

Finding: Cracking to Driveway and Side Path

Information: Cracking was observed to sections of the driveway surface as well as to the concrete pathway along the side of the dwelling. The cracks appear to extend through the surface finish and substrate in areas, indicating movement within the underlying base material. The affected sections were noted externally at ground level adjacent to the dwelling perimeter and within trafficked surface areas.

Cracking of external hard surfaces commonly occurs due to ground movement, soil reactivity, settlement, or long-term wear. While the cracking currently appears localised, continued movement may result in further separation, trip hazards, water ingress beneath slabs, and progressive deterioration if not addressed. It is recommended that the affected areas be monitored and assessed by a suitably qualified concreter or paving contractor, with repairs carried out as required to prevent further deterioration.

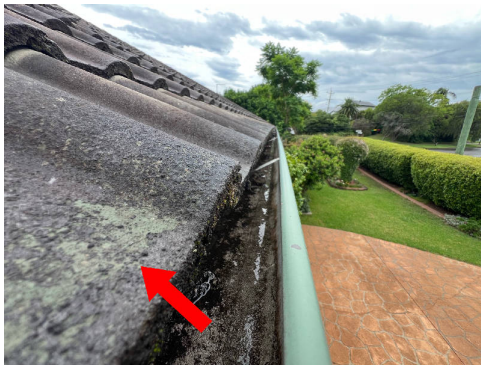
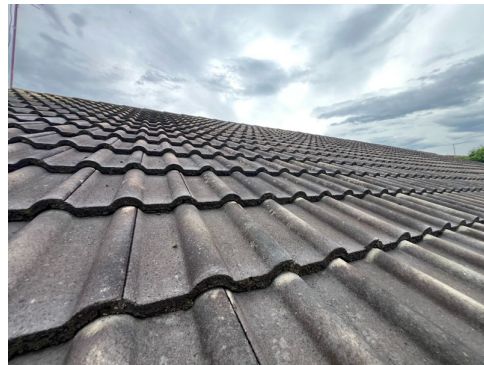
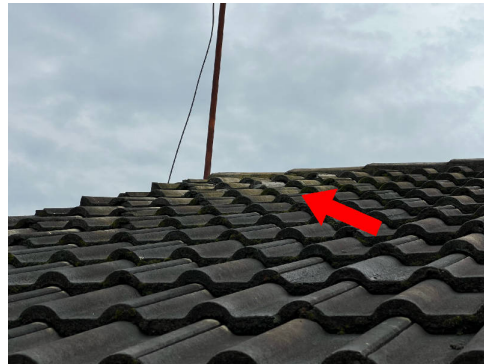
Defects 3.12

Information: The roof tiles were observed to be weathered and showing signs of age-related surface deterioration. Erosion to tile edges and surface wear were noted, along with areas of moss and organic growth. No widespread cracking or significant displacement was observed at the time of inspection from the accessible vantage points.

Roof tiles naturally deteriorate over time due to prolonged exposure to weather conditions. Surface erosion and organic growth can increase water absorption and may contribute to reduced service life if not maintained. While currently considered a minor defect, continued weathering may lead to increased porosity, cracking, or water ingress over time. Periodic maintenance and inspection by a suitably qualified roofing contractor is recommended to prolong the life of the roof covering.

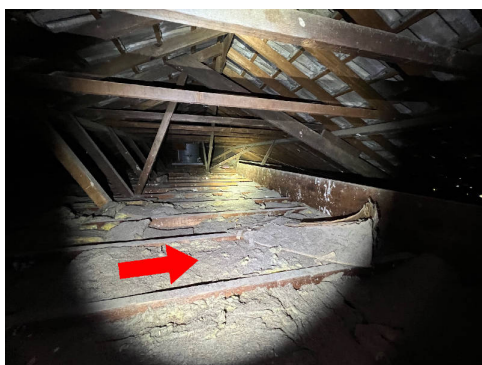
Information: Within the roof space, the existing bulk insulation was observed to be aged, compressed and unevenly distributed, with some sections displaced or providing inconsistent coverage. The insulation appears to be of an older style typical of the era of construction.

While no immediate defect was identified, older or uneven insulation may reduce the overall thermal efficiency of the home when compared to modern standards. Upgrading the insulation may improve comfort and energy performance. This item is provided for your information and can be considered as a future improvement if desired.

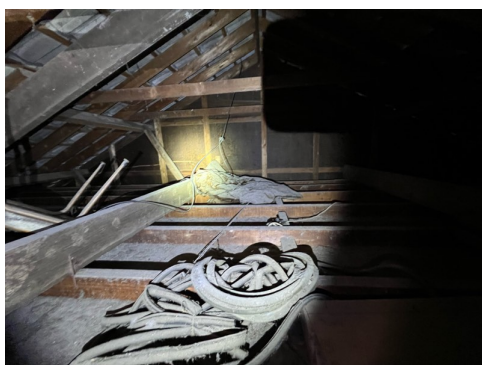
Information: Loose debris and stored materials were observed within the roof space, including sections of old insulation, loose cabling and miscellaneous items resting across ceiling joists. The presence of debris can restrict safe access for maintenance and may contribute to reduced ventilation or concealment of defects.

While no immediate structural defect was identified, accumulation of debris within the roof space is not considered best practice and may present a minor safety risk when accessing the area. It is recommended that the roof space be cleared of unnecessary materials by a suitably qualified person to improve accessibility and allow clearer monitoring of the structure and services. This item can be addressed as a maintenance matter in the short term.
