Building and Timber Pest Inspection Report

Inspection Date: Wed, 11 Mar 2026

Property Address: 8 Drinan St, Branxton NSW 2335, Australia

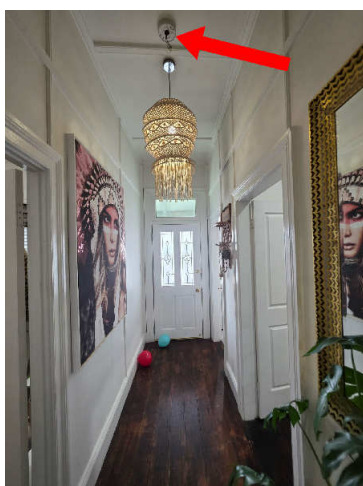
Information: A smoke alarm connection point was observed in the hallway; however, no smoke alarm unit was installed or connected at the time of inspection. The absence of a functioning smoke alarm in this location reduces early fire detection capability and may delay occupant warning in the event of a fire.

A licensed electrician should be engaged to assess and rectify as required. This should be done without delay.

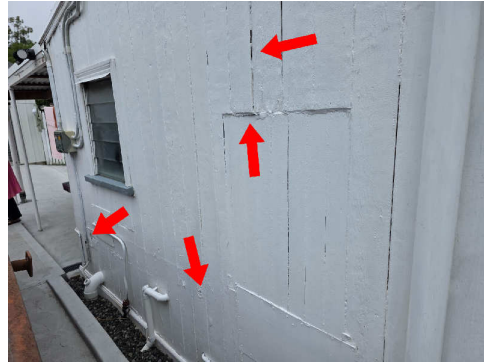
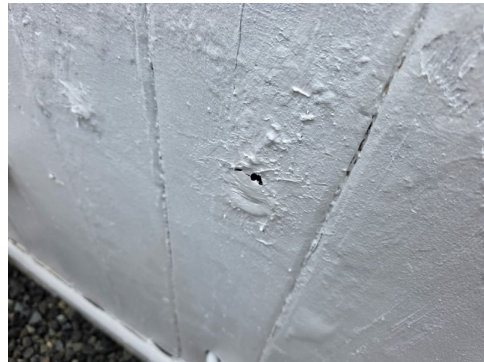
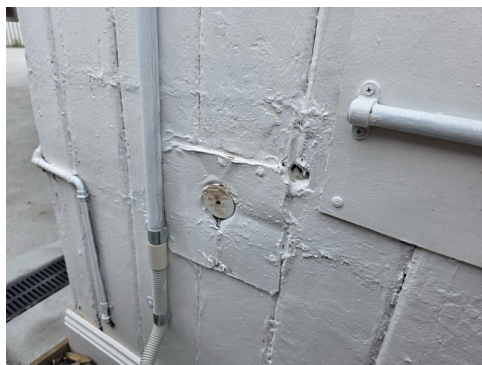
Finding: Weatherboard Cladding Open Joints and Patch Repairs – Bathroom Wall (External)

Information: The external weatherboard cladding to the bathroom wall shows several areas where joints are opening and previous filler repairs have been applied. An old service penetration appears to have been filled using a circular cut-out piece approximately 50mm in diameter, likely from melamine material. Open joints and patched penetrations may allow moisture entry into the wall cavity over time.

A licensed carpenter should be engaged to assess and rectify as required. This should be done as soon as practicable.

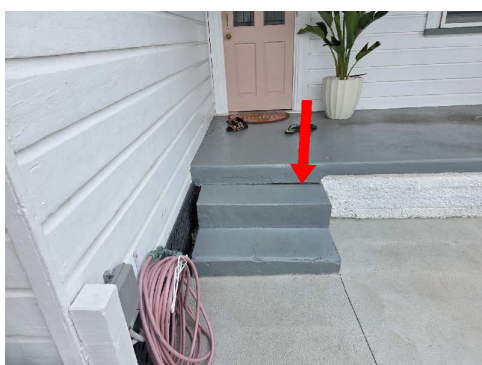
Finding 3.04

Information: Minor subsidence was observed at the two concrete steps leading to the front verandah. The movement appears limited and may be longstanding; however, the duration or progression of the movement cannot be determined during a visual inspection.

A licensed builder should be engaged to assess and rectify as required. This should be done at the owner's discretion.

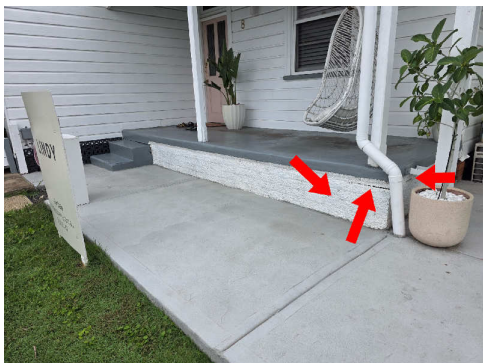
Finding 3.05

Finding: Cracking to Brick Nib Wall Supporting Front Verandah

Information: The front verandah consists of a concrete slab supported by a rendered brick nib wall. Cracking was observed in the rendered brickwork supporting the verandah. While the cracking may be associated with historical settlement, the extent or progression cannot be determined during a visual, non-invasive inspection.

A licensed builder should be engaged to assess and rectify as required. This should be done at the owner's discretion.

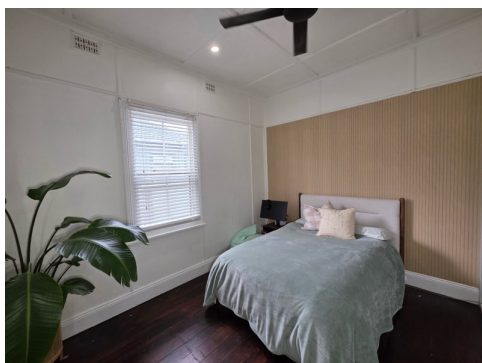
Finding 3.06

Finding: Missing Window Latch – Bedroom 4

Information: The window in Bedroom 4 was observed without a latch mechanism installed. Without a latch the window may not close or secure properly.

A licensed carpenter should be engaged to assess and rectify as required. This should be done as soon as practicable.

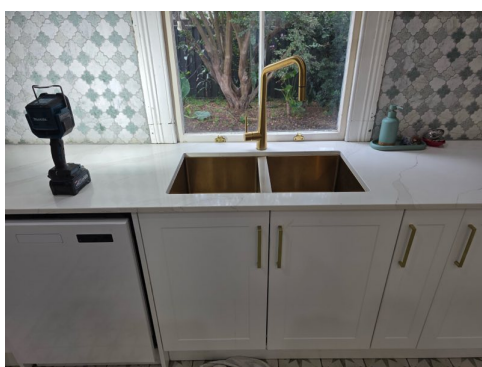
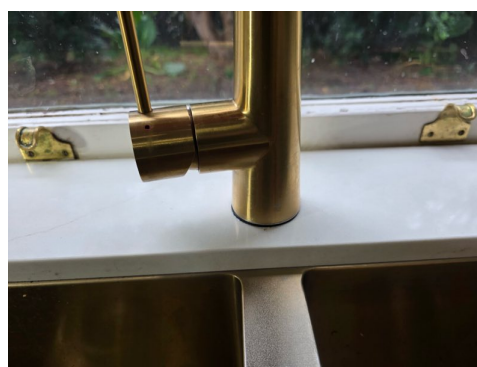
Finding 3.07

Finding: Loose Kitchen Tap – Kitchen Sink

Information: The kitchen tap was observed to be loose at its mounting point on the sink or benchtop. Movement at the base of the fitting may allow water to enter around the penetration or lead to further deterioration of the mounting surface over time.

A licensed plumber should be engaged to assess and rectify as required. This should be done as soon as practicable.

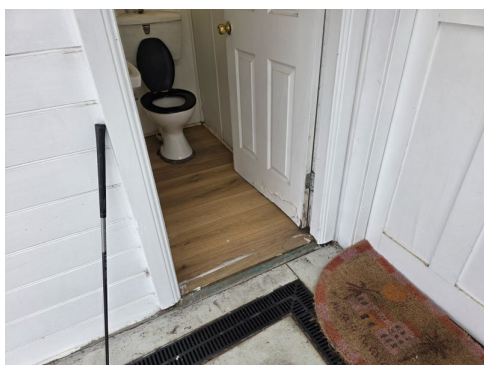
Finding 3.08

Finding: Damaged Door – Alfresco WC

Information: The door to the WC located within the alfresco area shows significant deterioration to the lower section. The base of the door has been previously patched and filled and is in poor condition, indicating deterioration of the door material.

A licensed carpenter should be engaged to assess and rectify as required. This should be done at the owner's discretion.

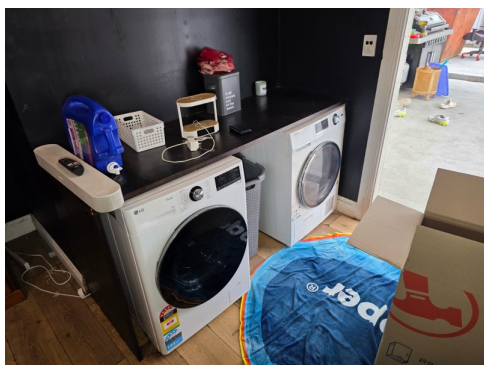
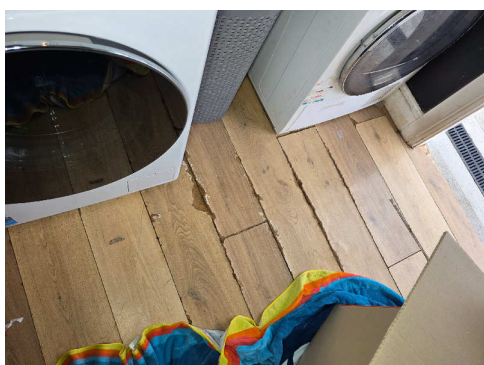
Finding 3.09

Finding: Water Damage to Laminate Flooring – Rumpus Room

Information: Significant swelling, lifting and deterioration of laminate flooring boards was observed in the rumpus room, particularly in the area adjacent to the washing appliances and external door. The boards have expanded and broken down, exposing the fibreboard core material. This type of deterioration is typically associated with ongoing or repeated moisture exposure.

A licensed builder should be engaged to investigate the source of moisture and replace the damaged flooring as required. This should be addressed as soon as practicable to prevent further deterioration of the floor covering and any underlying materials.

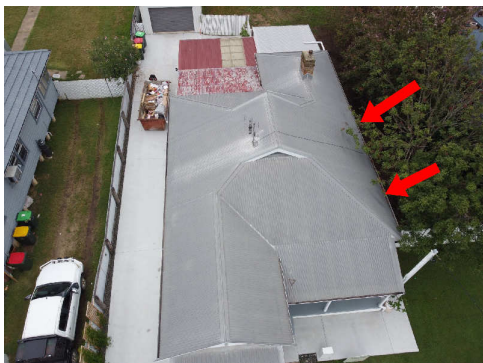
Finding 3.10

Information: The gutter along the side of the property was observed to be full of leaves, likely due to overhanging trees in this area. Accumulated debris can obstruct water flow and may cause water to overflow during rainfall events.

A builder should be engaged to assess and rectify as required. This should be done as soon as practicable.

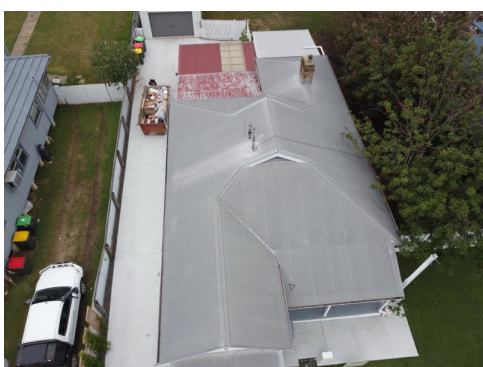
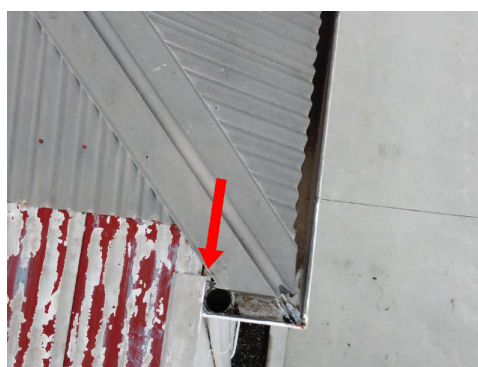
Finding 3.11

Information: At the lower end of the hip section of the main roof above the bathroom area, a small triangular section of what appears to be roof batten was visible and not covered by flashing. Exposed timber components in roof areas may be subject to weather exposure and gradual deterioration over time.

A licensed builder should be engaged to assess and rectify as required. This should be done as soon as practicable.

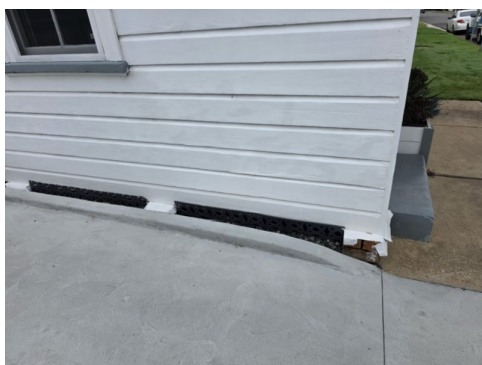
Finding 3.12

Finding: Subfloor Pier Mortar Deterioration – Front Corner Beside Driveway

Information: Subfloor access was significantly restricted at the time of inspection, limiting visibility of the supporting piers. One of the only clearly visible piers, located at the front corner of the dwelling beside the driveway, showed signs of mortar erosion to the brickwork joints. Mortar deterioration to brick subfloor piers is a common age-related condition in older dwellings. A brief visual check into a small section of the subfloor through a screen used to block access indicated the visible ground surface appeared dry and the limited piers visible in that area appeared serviceable; however, the condition of the remaining subfloor piers could not be confirmed during this visual, non-invasive inspection.

A licensed bricklayer should be engaged to carry out further investigation and rectify as required. This should be done as soon as practicable.

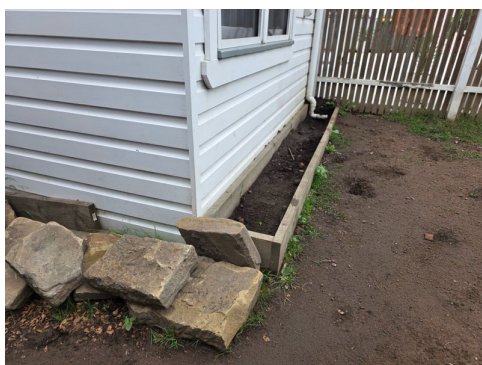
Information: Timber elements in direct contact with the ground, and consequently exposed to moisture or dampness, create conditions conducive to termite activity. Whether timber is used as part of a building structure, such as a fence or retaining wall, or stored as unused material, it can attract termite infestations.

When exposed to excessive moisture, timber begins to decay and develop wood rot. Any timber in direct contact with the ground - especially untreated or non-durable timber - provides an easy entry point for subterranean termites into the material.

To minimize the risk of termite attack, it is recommended to remove any materials that could foster termite activity. If removal is impractical or undesirable, it is strongly advised that termite or timber pest inspections be conducted every 6 to 12 months to protect the property from potential infestation.

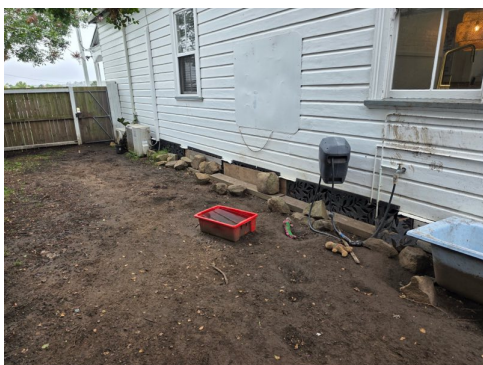
Finding 6.02

Finding: Ventilation - Inadequate subfloor ventilation

Information: Subfloor ventilation appears to be inadequate in one or more areas beneath the dwelling. Poor airflow can result in elevated moisture levels, which in turn create conditions conducive to fungal decay and termite activity. Signs of dampness or musty odours may also indicate restricted air movement.

Improved cross-ventilation should be established to help manage moisture and reduce the risk of concealed timber pest attack. A licensed builder should assess the subfloor and install additional vents or mechanical ventilation as needed. This should be addressed as soon as practicable.

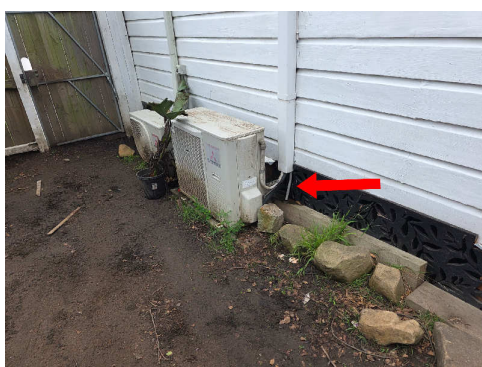
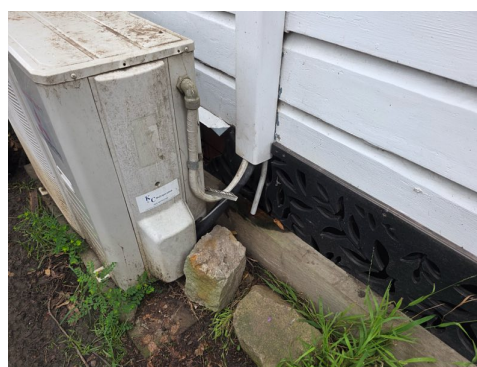
Finding 6.03

Information: At the time of inspection, the overflow from the AC unit along the side of the property was observed to be discharging directly onto the ground rather than into a connected stormwater system. This could potentially result in damp conditions around the perimeter of the dwelling.

Sustained dampness in these areas is considered conducive to concealed termite activity and may also contribute to timber decay or pest infestation. A licensed plumber should be engaged to redirect the discharge into an appropriate drainage system. Rectification should be undertaken without delay.

Regular timber pest inspections should also be carried out every 6–12 months.

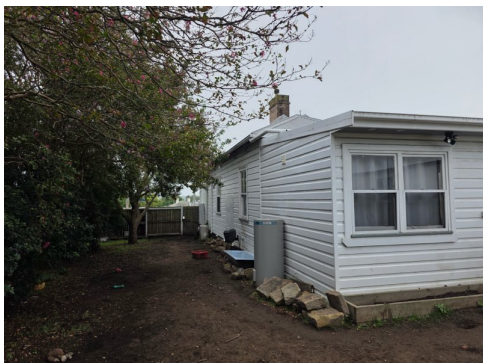
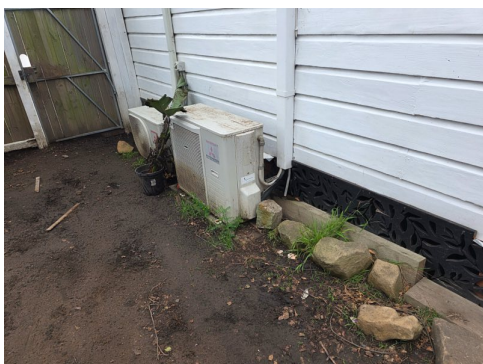
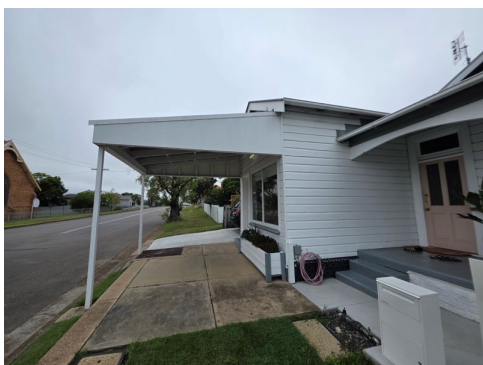
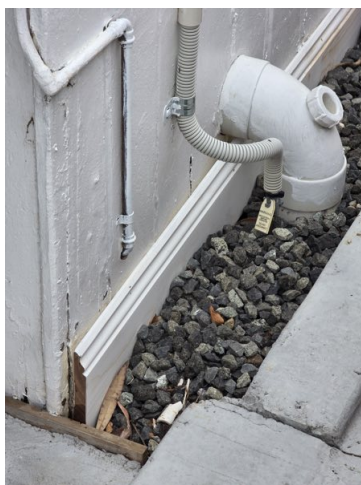
Finding: Access - Subfloor inaccessible

Information: The subfloor was inaccessible due to restricted access at the time of inspection. As a result, concealed structural defects, timber damage, or conditions conducive to deterioration could not be ruled out in this area. This has been noted for your information.

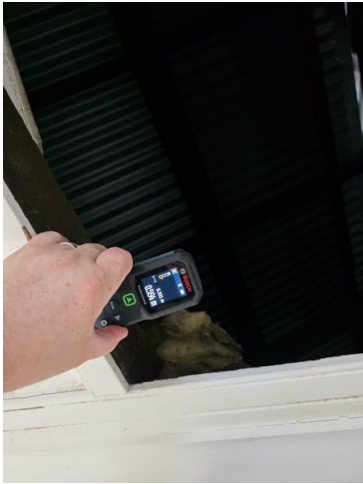
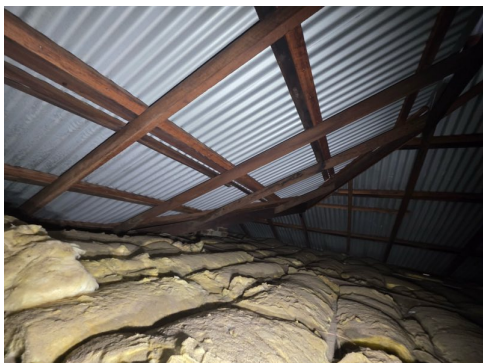
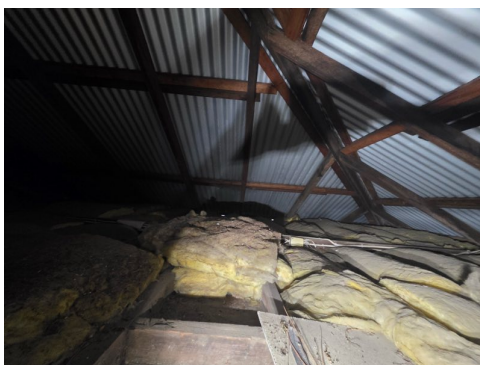
Finding: Roof Void Access Restricted – Roof Space

Information: The roof void could not be fully accessed due to height and hatch access limitations. A limited visual observation was made from the hatch opening only, which restricts the ability to inspect roof framing, insulation, and other concealed roof components throughout the full roof space.

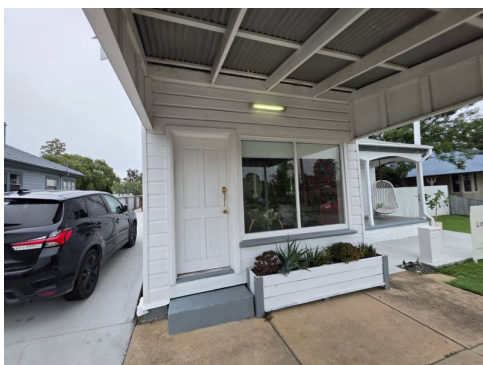
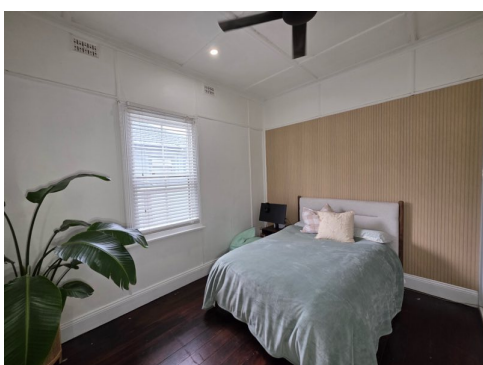
Building: Main Building
Location: Linings
Finding: Asbestos - Suspected Asbestos-Containing Materials (ACMs)

Reporting on asbestos is outside the scope of this inspection. Suspected asbestos-containing material (ACM) was observed in the ceiling linings bed 4 and the canopy over the street at the front of the property. Based on our experience in the building industry, there is a higher risk that the identified building elements contain asbestos, particularly given that any home constructed prior to 1990 may contain asbestos in various forms.

No sample testing has been undertaken to confirm the presence of asbestos. We strongly recommend a separate Asbestos Inspection and Condition Audit be carried out by a licensed assessor, which may include laboratory testing for definitive confirmation.

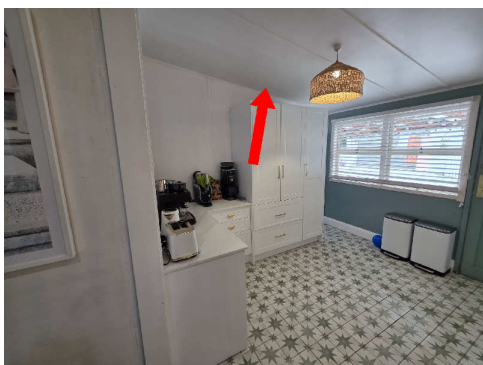
Information: Portions of the dwelling incorporate raked/vaulted ceilings and no roof void access was available at the time of inspection. The roof framing, sarking, insulation and flashing junctions could therefore not be visually inspected. Internal ceiling linings were checked and no active moisture staining or distortion was observed at the time of assessment.

Concealed roof construction limits the ability to identify early roof leaks or flashing defects, as moisture entry may not become visible internally until deterioration is advanced or after periods of heavy rainfall. The inspection of these areas is therefore restricted. The ceilings should be monitored during occupancy and any future staining, dampness or mould growth should be investigated by a licensed builder without delay.
