Building and Timber Pest Inspection Report

Inspection Date: Fri, 23 Jan 2026

Property Address: 8 Hervey St, Elmore VIC 3558, Australia

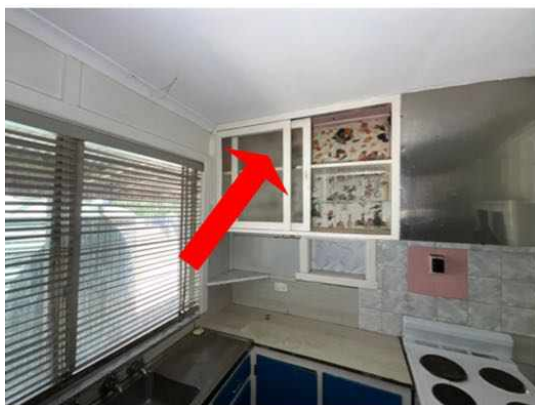
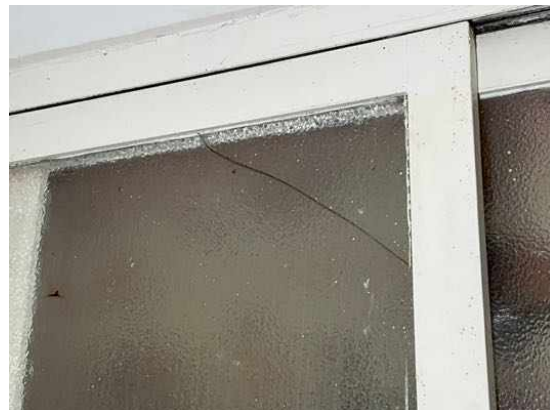
Building: Building 1
Location: Kitchen
Finding: Window - Cracked
Information: Cracks were identified in the cupboard window in this area. Cracking in windows is generally the result of impact damage, and is likely to develop further when left unmanaged.

The likelihood of this windowpane further cracking and shattering is increased exponentially, providing a safety hazard in the area. The cracked window also impairs the weather tightness of the building, creating potential for minor water leaks.

A qualified glazier is required to repair the window as soon as possible. Depending on the extent of the cracking, replacement of the window may be required. Please be advised that any persons coming into contact with the cracked window should do so with due caution to avoid any personal injury that may ensue.

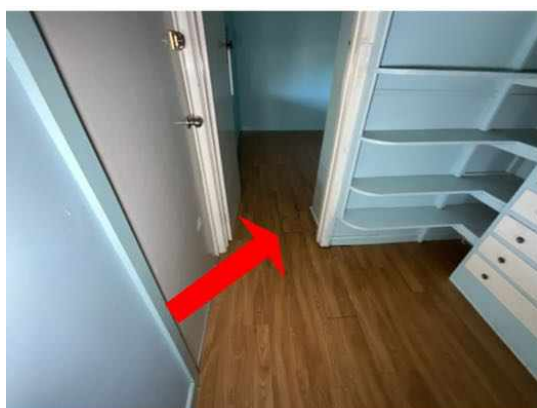
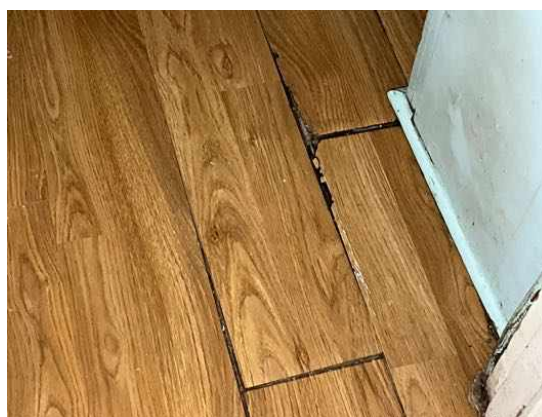
Bouncy floors generally indicate that the floorboards or the subfloor structures are coming loose from the joists that they are installed on. Bouncy flooring may also be the result of gaps between flooring and stumps or joist structures, which require packing.

The client is advised to seek quotations for required repairs from a Registered Builder specialising in re-stumping. The potential resolution may range from packing gaps in subfloor structures through to replacement of subfloors stumps and refixing of flooring.

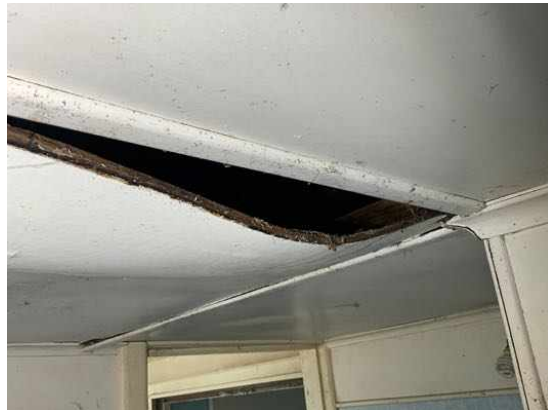
Finding 3.02

Building: Building 1
Location: Toilet (WC)
Finding: Ceiling - Sagging
Information: Sections of the ceiling were found to be sagging at the time of inspection. Sagging to the fixed ceiling structure generally indicates that the building materials have swollen, due to contact with water, or that fixings (e.g. nails or glue) have become loose and require reattachment.

In some cases, sagging ceiling linings may also indicate that there are structural issues, causing surfaces to warp, twist or sag. Where sagging appears to be major, appointment of a structural engineer is advised to further inspect the property and identify the source and rectification works required.

Where minor sagging is evident, comparatively minor works, such as re-gluing of ceiling sheets, may be required. Such works may be performed by relevant tradespeople, such as plasterers and painters. Where excessive moisture has caused the roofing structure to swell and sag, the source of the water leak should primarily be identified prior to any remedial works being performed.

The appropriate action should be taken by the client as soon as possible to ensure that any potential further damage is limited.

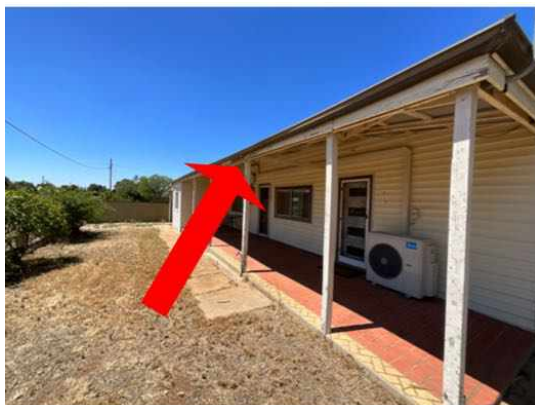
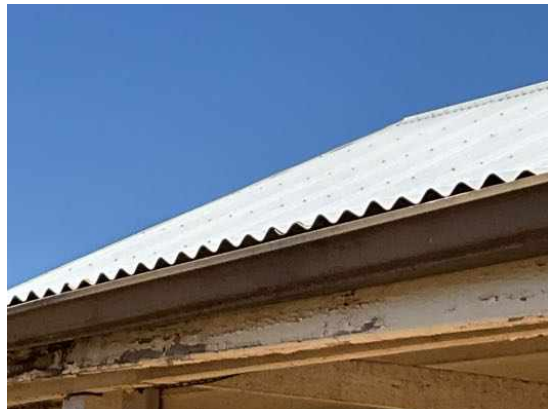
Finding 3.03

Building: Building 1
 Location: Eaves
 Finding: Gutters- Deteriorated
 Information: The guttering and some downpipes have deteriorated.

Although not a major problem now, they will deteriorate further if left for an extended period.

Sagging can be seen in the gutter pictured.

A Licensed Plumber should be engaged as soon as possible to advise on any repairs or maintenance that may be required.

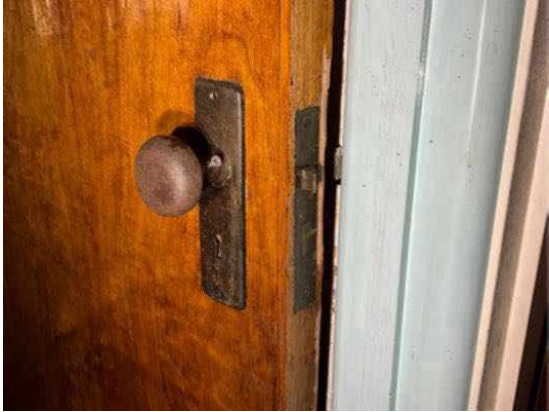
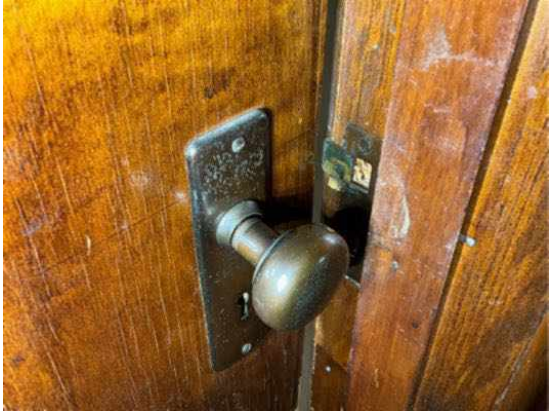
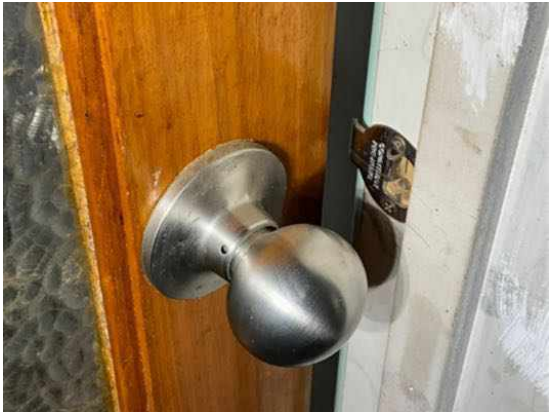
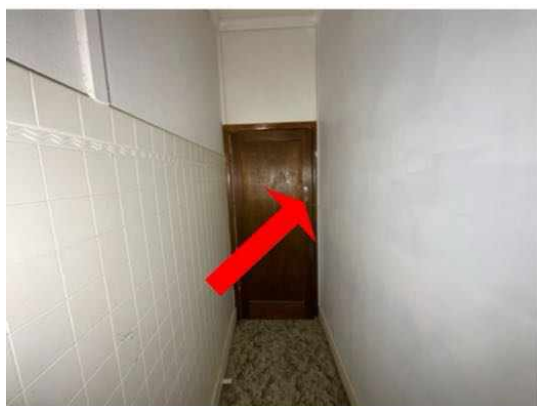
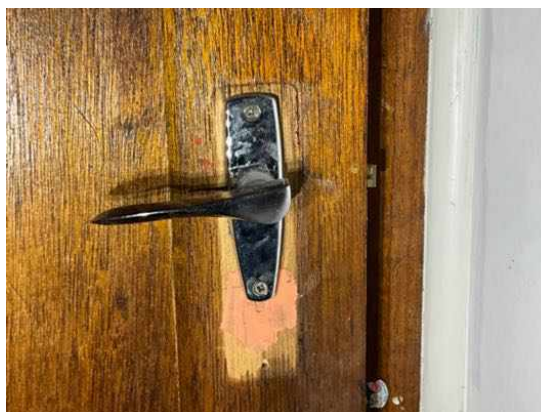
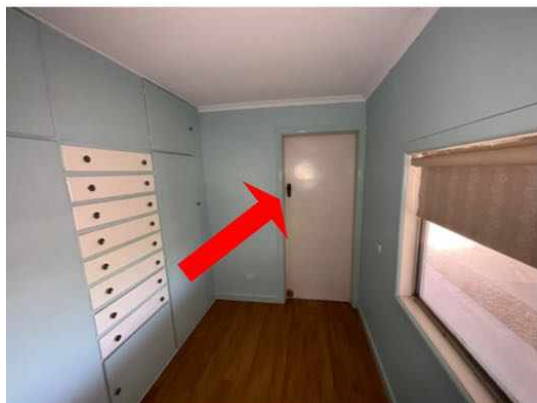
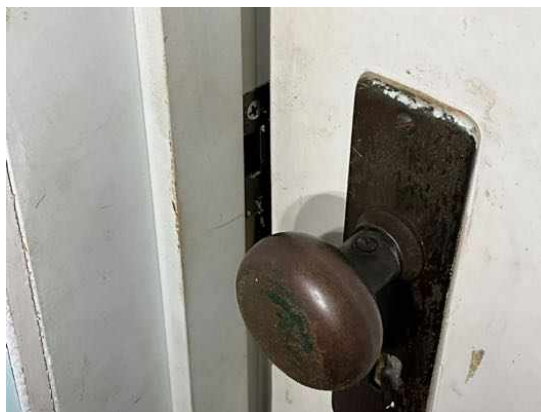
Finding 3.04

Building: Building 1
 Location: Bedroom 1, 2,4, hallway,
 Finding: Door - Striker plate misaligned

This is a common defect and is expected in a property of this age, whether being due to substandard installation or general deterioration of the door hardware.

Readjustment of the striker plate is recommended at client discretion. Works such as these can be completed by a general handyman or qualified carpenter.

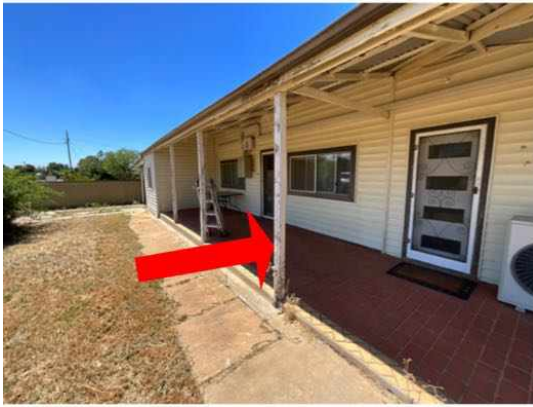
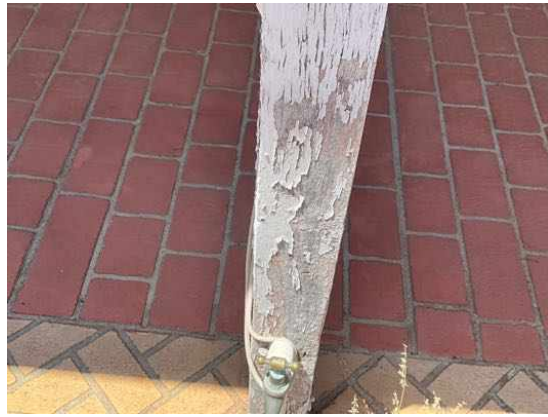
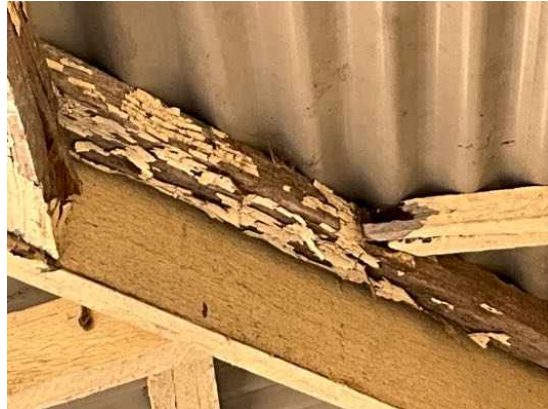
Finding 3.05

Building:	Building 1
Location:	All External Areas
Finding:	External painting deteriorated
Information:	Much of the external paintwork including but not limited to windows, fascias, guttering, veranda and other external fitments have been neglected and require attention to prepare and re-paint.

Whilst incomplete or missing paint finish is generally an appearance defect, it can also lead to the development of secondary building defects over time. Incomplete areas of paint finish expose the area to moisture, potentially accelerating the deterioration of underlying building materials.

Degraded paint finishes should be sanded back, filled, leveled and painted, as applicable. Where inadequate or missing paint protection has led to the deterioration of the associated building element, repair and/or replacement of this building element may be required.

A painting contractor should be appointed as soon as possible to perform necessary works to aid the appearance of the affected area and to ensure the area is protected against further deterioration. Alternatively, the homeowner following manufacturer instructions may perform these works.

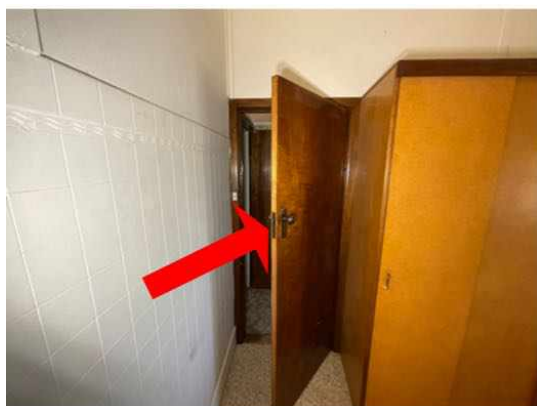
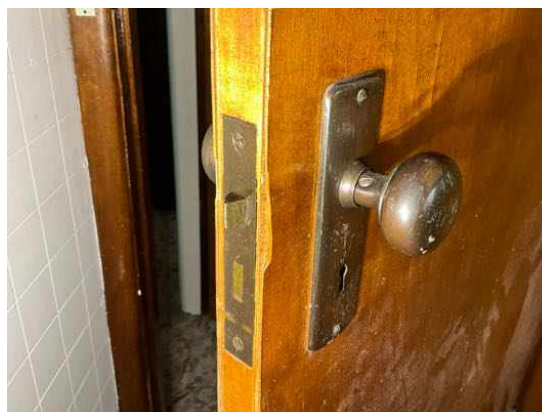
Finding 3.06

Building:	Building 1
Location:	Bedroom 2
Finding:	Door handle- Not latching
Information:	It was noted that the door in this area was not latching during operation at the time of inspection.

It is suspected that this defect has occurred due to minor issues with the associated hinges. Such damage is identified as general wear and tear, which is expected for building elements of this age.

A qualified carpenter or general handyperson may be appointed to perform rectification works as necessary, at client discretion.

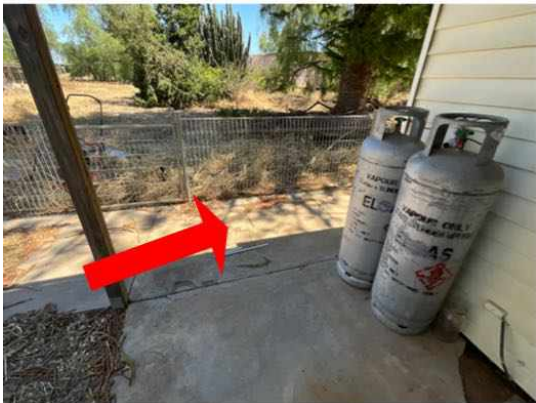
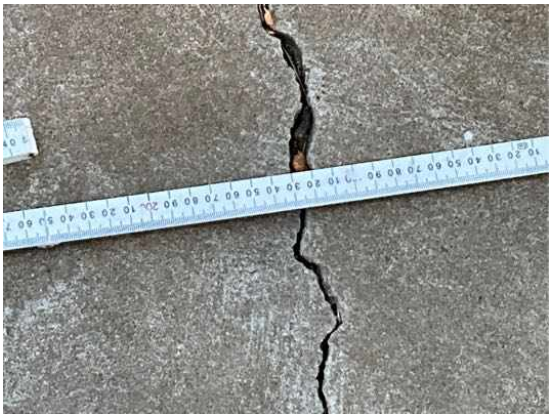
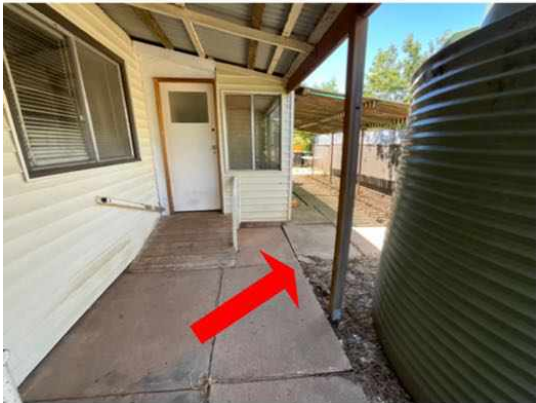
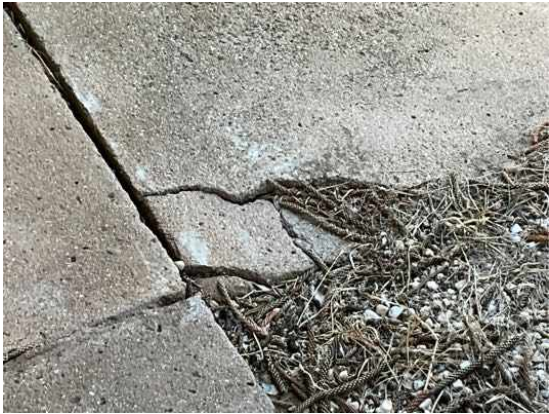
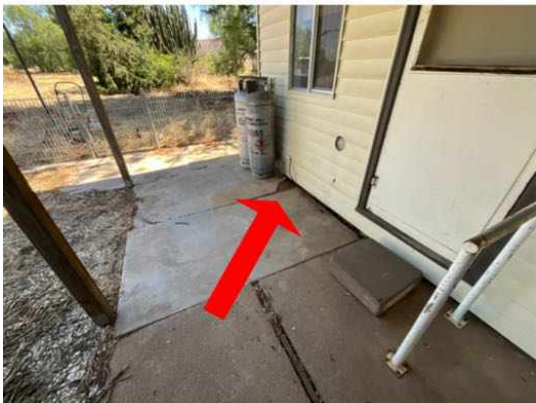
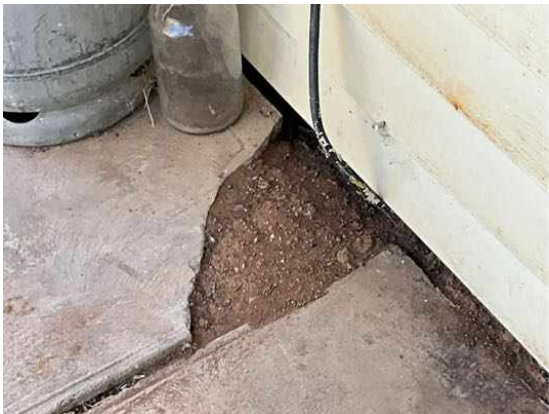
Finding 3.07

Building:	Building 1
Location:	Yard - Back
Finding:	Cracking - External Concrete Paving Damage Category 4 - Gaps in Slab (4mm - 10mm +)
Information:	Gaps in the slab were identified in external concrete paving. Gaps in the slab are significant and are likely to lead to the development of safety hazards and secondary defects if left unmanaged, such as the creation of a trip hazard.

General age and expected deterioration of the paved areas is a common cause of this type of cracking. However, expansion and contraction of the slab may also have occurred due to environmental factors. Such factors include variable moisture and weather conditions, the presence of trees and their roots having a settling or lifting affect on the soil, or the effect of load bearing, e.g. heavy vehicles over a sustained period of time.

Cracking to this degree may also be due to poor original installation of the concrete. Factors such as poor compaction of the sub surface and/or inadequate reinforcing of the slab may create cracking and other secondary defects. Gaps in the concrete paving may also have a more significant structural cause, such as subsidence of soils.

Where gaps in the concrete paving are adjacent to structural elements of the building, the advice of a Structural Engineer is advisable before undertaking repairs. Significant repair and likely replacement of the concrete paving is probable.

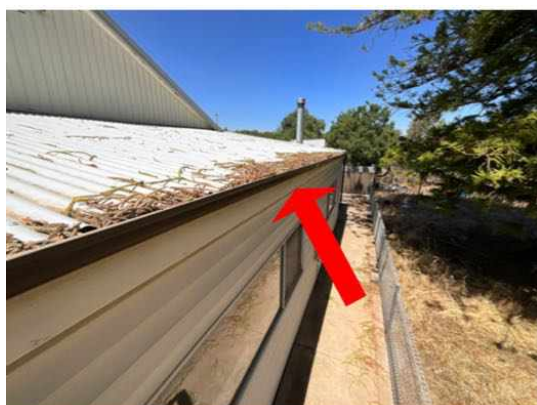
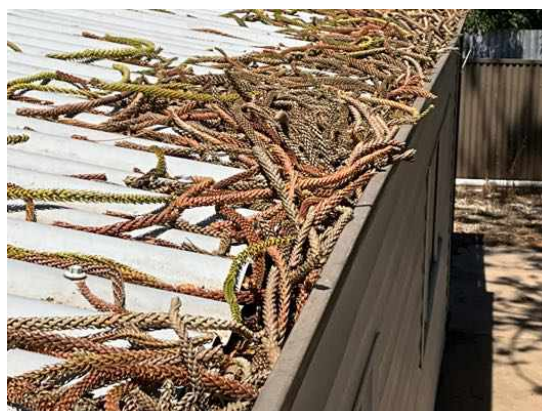
Blocked gutters are likely to lead to high levels of moisture in the affected areas. Such moisture will not only cause rust and decay of the associated building materials, but can also provide conditions that are conducive to termite and timber pest activity. Blockages in gutters should therefore be removed immediately to ensure dry conditions are maintained.

Consult a Licensed Plumber for further specific advice on remedial works that may be required. In the interim, it is highly advised that blocked gutters be removed by the homeowner or a general handyman as a matter of urgency.

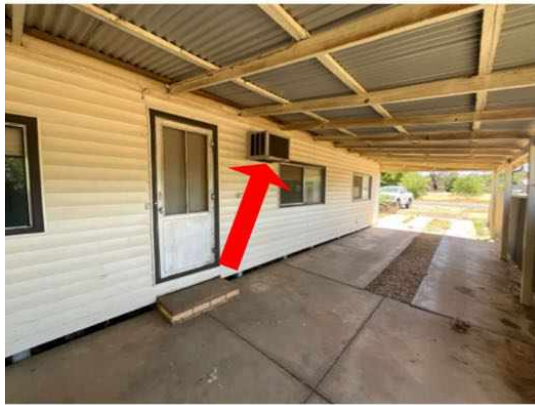
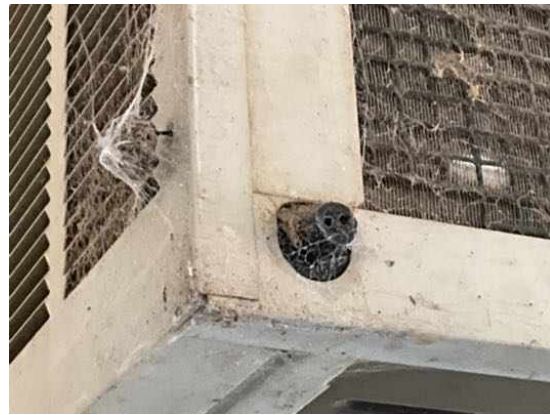
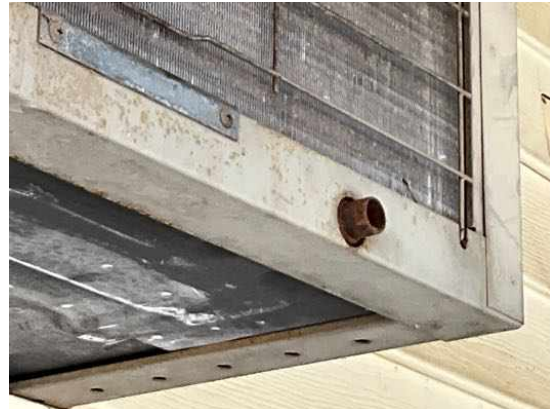
Finding 6.02

Building: Building 1
 Location: Carport, verandah
 Finding: Air conditioner - Disconnected overflow
 Information: The Air Conditioner (A/C) overflow was found to be disconnected from storm water drainage and is creating excessive moisture in the surrounding area.

Such leaking creates an environment which is conducive to an array of defects, including water damage to associated building elements and the attraction of termite or timber pest infestation.

It is highly recommended that a licensed plumber be appointed to connect the A/C overflow in order to prevent such an environment from being created. These minor works should be carried out as soon as possible.

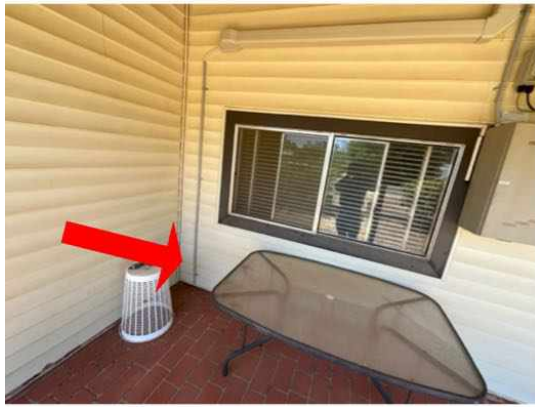
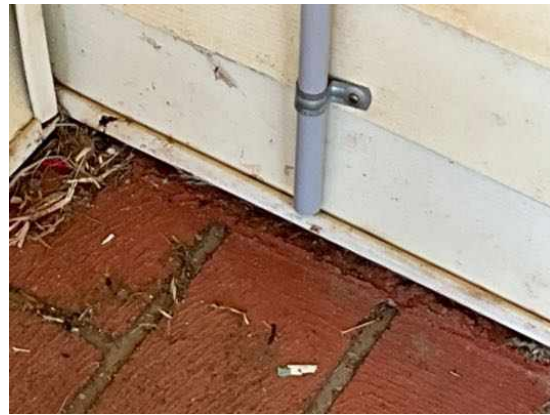
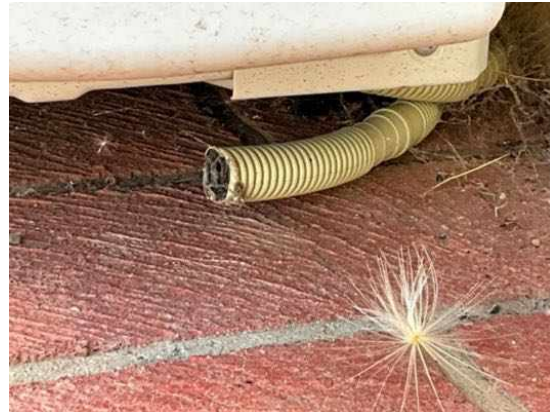
Finding 6.03

Building:	Building 1
Location:	Verandah
Finding:	Air conditioner - Disconnected overflow
Information:	The Air Conditioner (A/C) overflow was found to be disconnected from storm water drainage and is creating excessive moisture in the surrounding area.

Such leaking creates an environment which is conducive to an array of defects, including water damage to associated building elements and the attraction of termite or timber pest infestation.

It is highly recommended that a licensed plumber be appointed to connect the A/C overflow in order to prevent such an environment from being created. These minor works should be carried out as soon as possible.

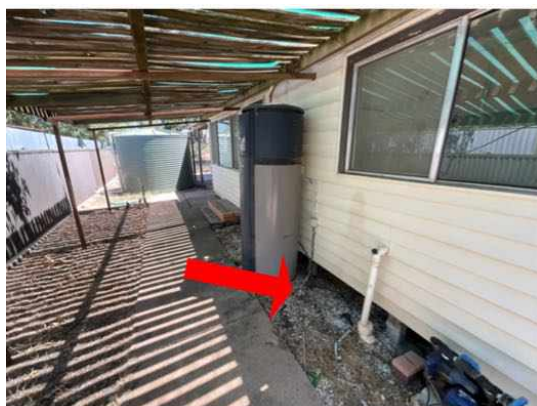
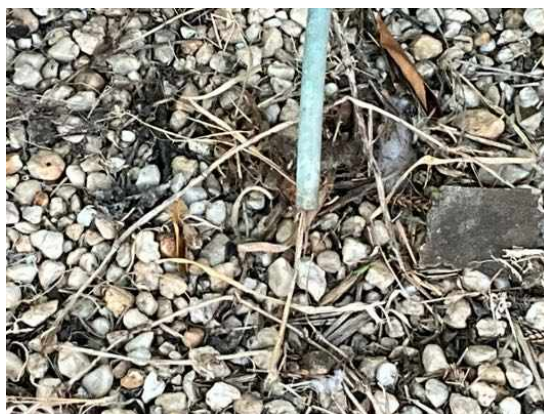
Finding 6.04

Building:	Building 1
Location:	Yard - Back
Finding:	HWS Overflow - Not Connected
Information:	The Hot Water System (HWS) overflow was found to be disconnected from storm water drainage and is creating excessive moisture in the surrounding area.

These damp conditions can lead to secondary defects such as rot, rust or corrosion of associated building elements, the formation of fungal decay, or even the creation of potential slip hazards. When coupled with poor site drainage, pooling of water may also attract termite activity to this area.

It is highly recommended that a licensed plumber be appointed to connect the HWS overflow in order to prevent such an environment from being created. These minor works should be carried out as soon as possible.

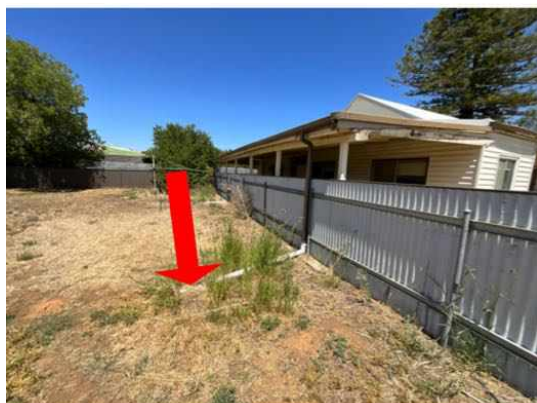
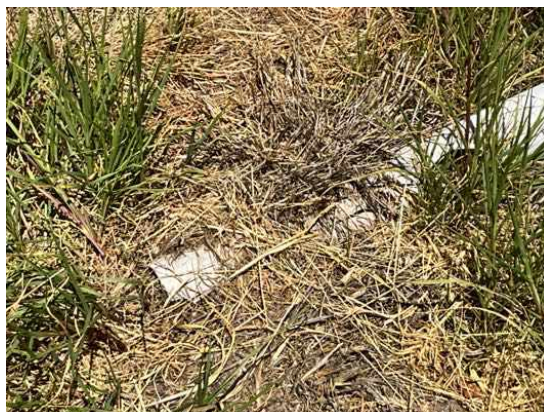
Finding 6.05

Building:	Building 1
Location:	Carport
Finding:	Stormwater drain - Not connected
Information:	The roof plumbing is not adequately connected to stormwater drainage on the site. This disconnection negatively impacts the functional capacity of the roof plumbing.

Where roof plumbing doesn't drain adequately, the area at the base perimeter can become excessively damp, potentially creating an environment that is susceptible to rust and corrosion of surrounding building elements, as well as attracting termites and other pests.

It is highly recommended that a plumber be appointed to further inspect the area and to install adequate drainage equipment where necessary.

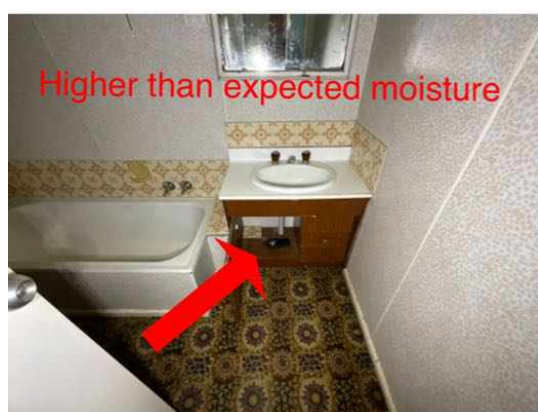
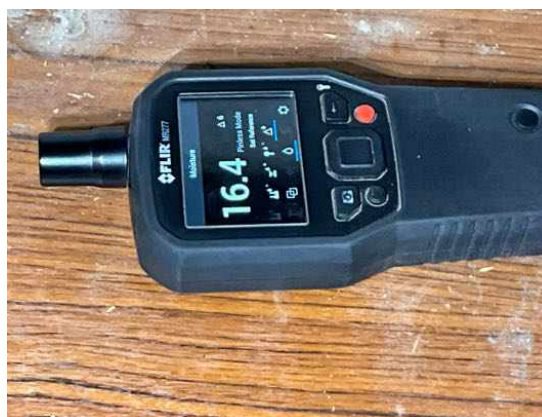
Finding 6.06

Building:	Building 1
Location:	Bathroom
Finding:	Excessive moisture- identified
Information:	Excessive moisture can attract termites and produce conditions that promote fungal growth and wood decay.

Initially monitoring is needed to establish the cause of the excess moisture in the area. In this case, it appears that leaking washing machine connections over time have caused moisture levels to be excessive.

Replacement of MDF board is at the discretion of the client.

A Licensed plumber may be needed to identify the cause of the excessive moisture. Works to remove affected building elements may then be necessary and should be performed by an appropriate tradesperson.

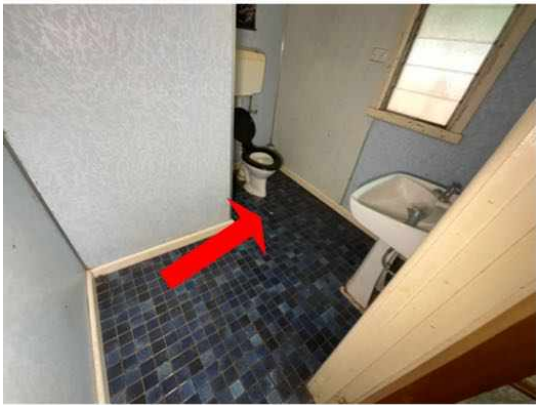
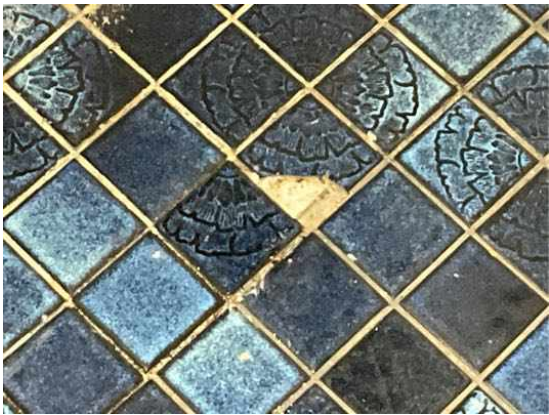
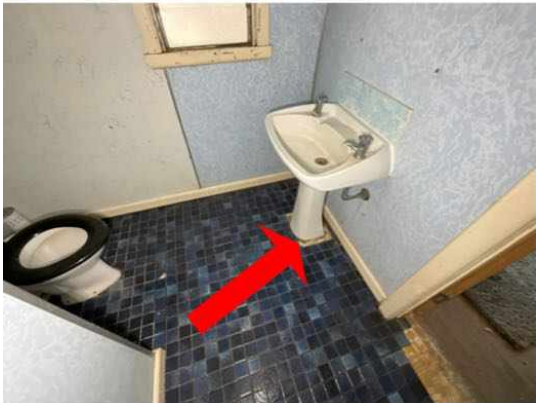
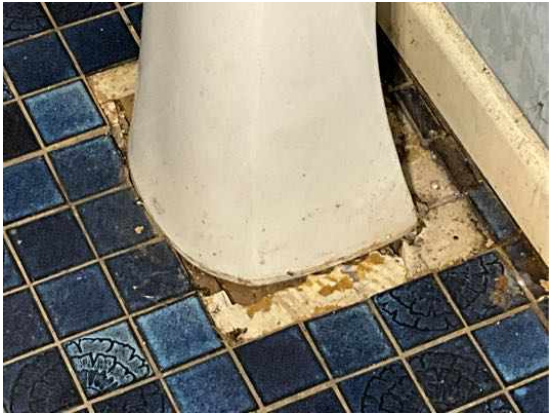
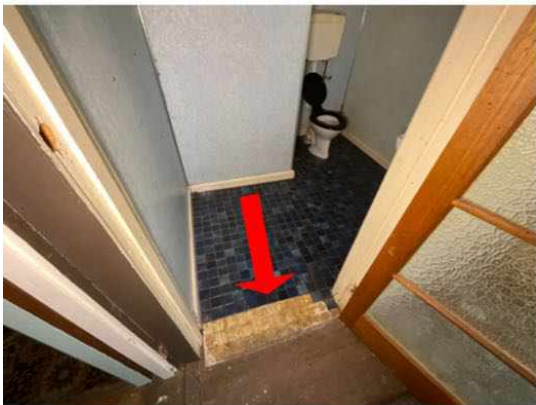
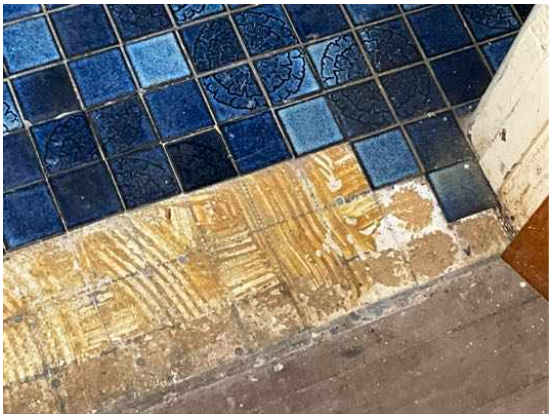
Finding 6.07

Building:	Building 1
Location:	Toilet (WC)
Finding:	Cracked floor tiles
Information:	Cracking in the floor tiles was evident in this area at the time of inspection. It is suspected that this cracking has occurred as a result of minor settlement or impact damage.

Cracked tiles throughout the household detract from the overall appearance of the affected areas however it is unlikely to create or lead to any secondary defects.

While not considered a matter of urgency, replacement of cracked floor tiles is recommended at the clients discretion. A tiling contractor may be appointed to perform these works. Where cracks become more numerous, contact a licensed building inspector for further investigation.

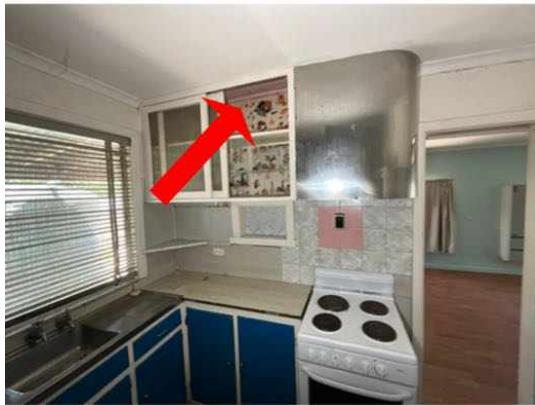
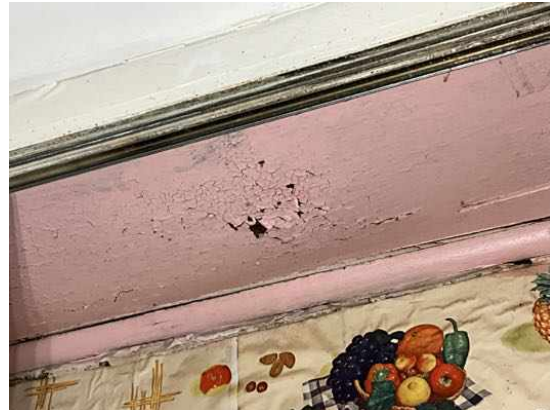
Finding 6.08

Information: Sections of paint in this area was found to have deteriorated. Paint flaking is generally an indication of excessive moisture in the area, that is currently hidden by the painted surface.

The presence of excessive moisture can have major implications on associated building elements if left unattended. While only seemingly minor at this stage, the damage cannot be determined due to the paint obstructing any further inspection of the damage.

A qualified Painter should be contacted at the Owner's discretion to re-paint the area.

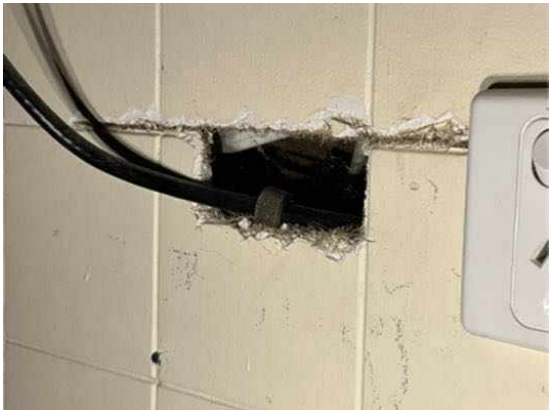
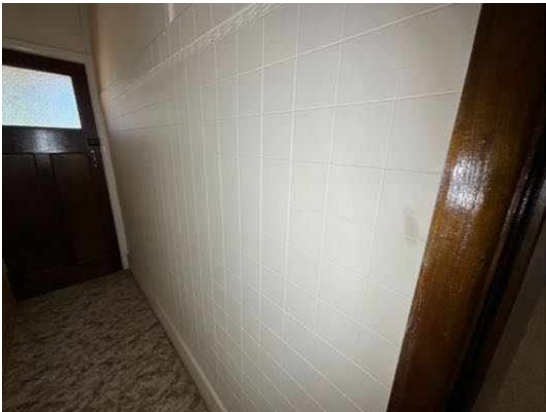
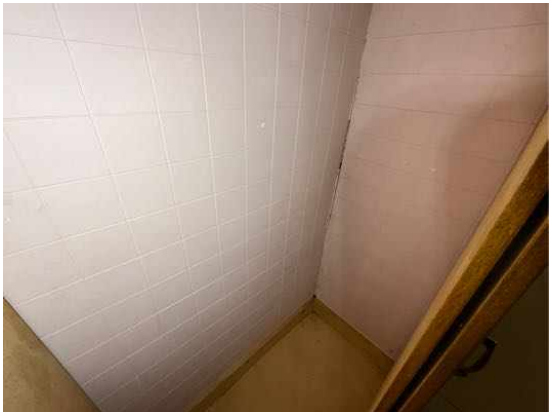
Building: Building 1
Location: All Areas
Finding: Asbestos - Suspected ACM Identified on Site
Information: Reporting on Asbestos is outside the Scope of this Report. This suspected defect is highlighted as a caution only. We suspect, based on our experience in the building industry, that there is a higher risk of the identified building element containing asbestos.

As Asbestos Reporting is outside the scope of this report, we advise that you consider a separate Asbestos Inspection and Condition Audit, which can include the taking of samples for definitive confirmation of the presence of Asbestos.

In the interim, the client is advised to act with caution, especially when considering any damage to building materials general wear and tear renovations extensions demolition and general maintenance activities due to the suspected presence of Asbestos.

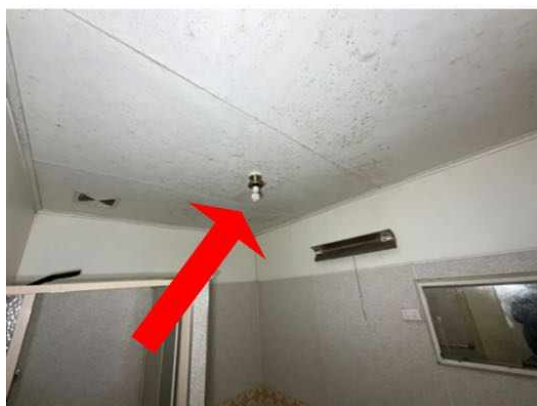
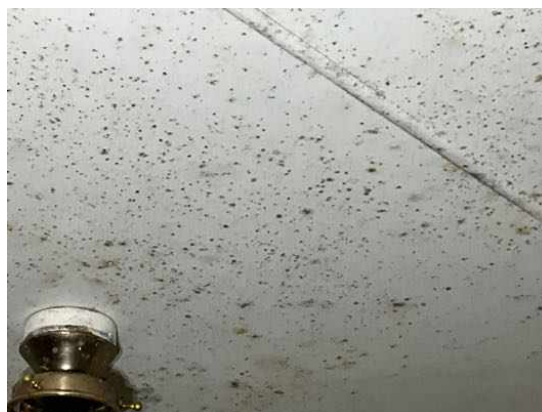
Building: Building 1
 Location: Bathroom
 Finding: Mould - Present
 Information: Where evidence of mould growth was noted, there may be environmental, biological or health issues associated with the report. A specialist inspection by a suitably qualified environmental health inspector is warranted, where mould is extensive or where any queries regarding air quality spores or other related issues apply.

Generally, the client is advised to ensure that the general environment is free of moisture and humidity to aid in the prevention of mould formation and development. Any mould found during the inspection should be cleaned immediately by a cleaning contractor or the homeowner as applicable.

Please note that severely affected building elements may require replacement by a registered builder or qualified carpenter.

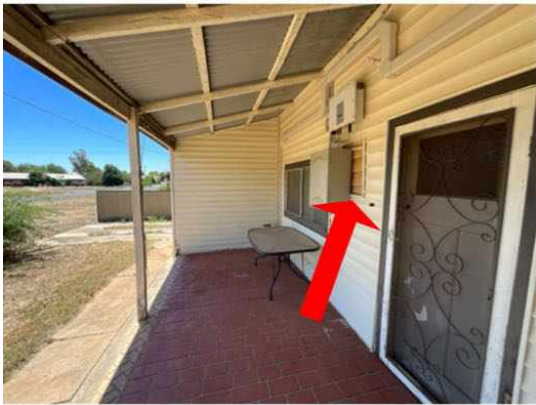
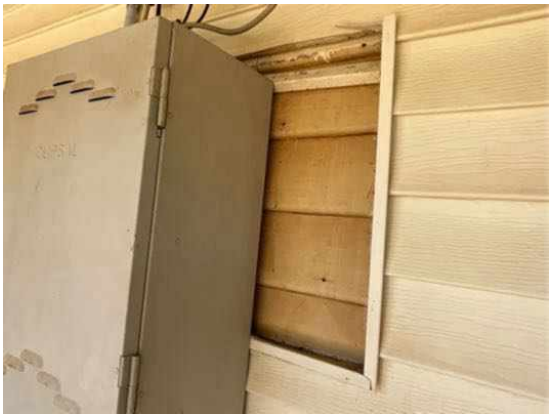
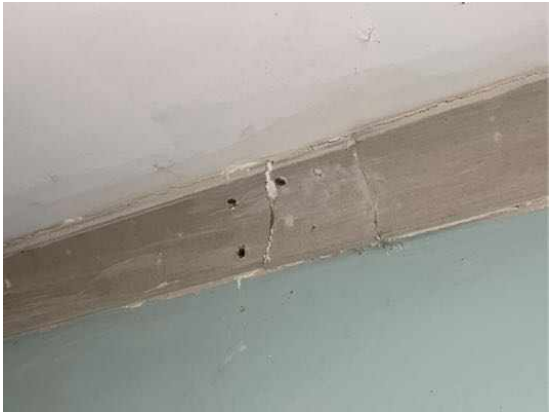
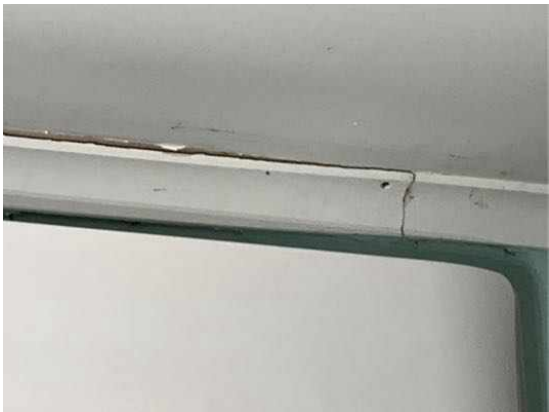
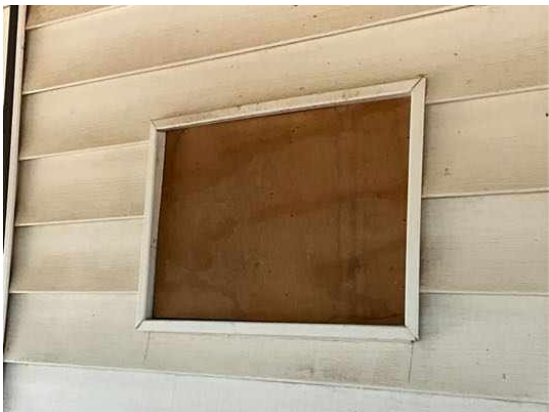
Building: Building 1
 Location: Verandah, living, carport
 Finding: Installation - substandard or incomplete
 Information: The installation of this building element appears to have been completed to a substandard level of workmanship or is incomplete. Generally substandard repairs or installation are related to poor workmanship, the use of inappropriate materials, or a failure to complete installation to a suitable standard.

Where installation is substandard and/or incomplete, the client should contact the responsible trade to undertake rectification. Unfinished and substandard building works are likely to degrade more quickly and may create potential for secondary defects to associated building elements.
