Building and Timber Pest Inspection Report

Inspection Date: Fri, 16 Jan 2026

Property Address: 18 Sandy Creek Ave, Camira QLD 4300,
Australia

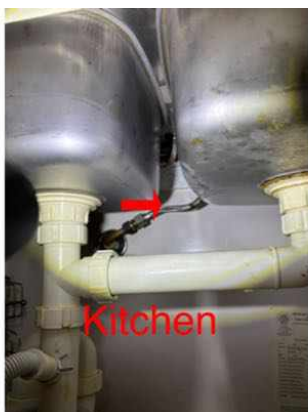
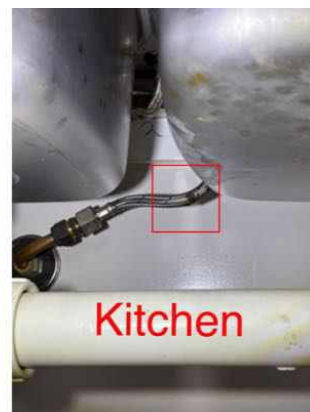
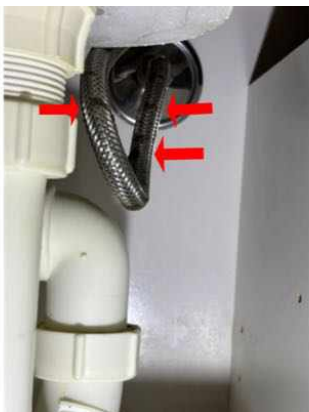
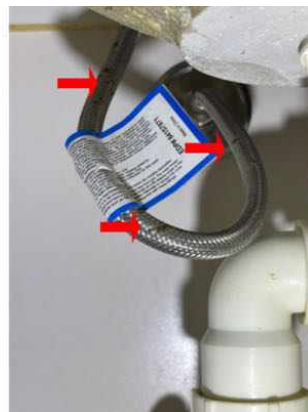
Finding 3.01

Building: Main Building
Location: Kitchen and ensuite
Finding: Kitchen and ensuite - flexible hoses have signs of rust
Information: At the time of the inspection, it was noted that a flexible hoses to the kitchen mixer and the ensuite vanity mixer had signs of rusting. This may be due to the age of the hose. Flexible hoses typically have a 5 - 10 year lifespan. It is recommended that they be changed if they have signs of bulging, fraying, kinking or rust.

A licensed plumber should be engaged to replace both the flexible hoses to the kitchen mixer and the ensuite vanity mixer. This should be done as a matter of urgency.

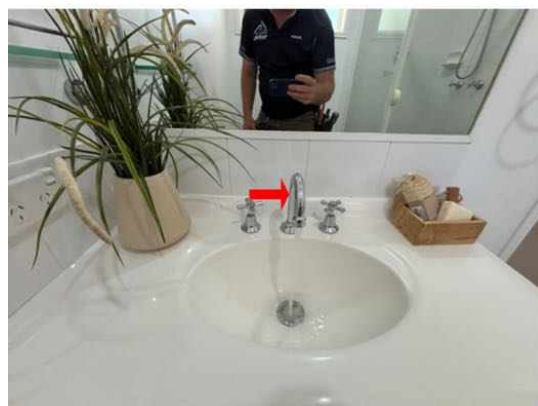
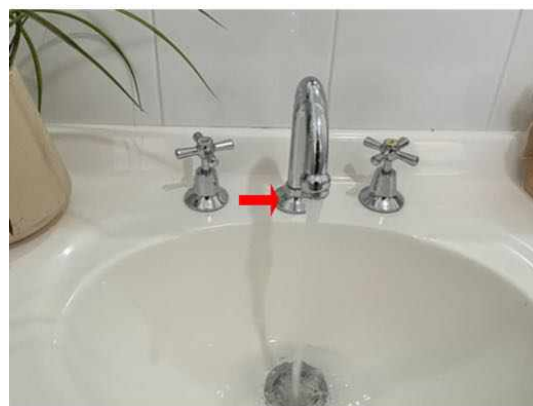
Finding 3.02

Finding: Ensuite - vanity spout loose

Information: At the time of the inspection, it was noted that the vanity spout was loose. If left unaddressed, deterioration may occur to this plumbing fixture which could lead to a water leak.

A licensed plumber should be engaged to secure the vanity spout. This should be done as a short term priority.

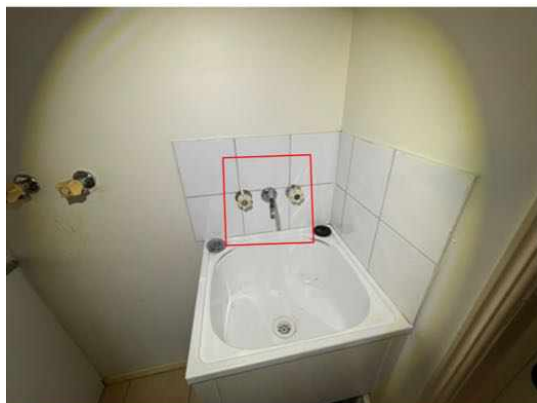
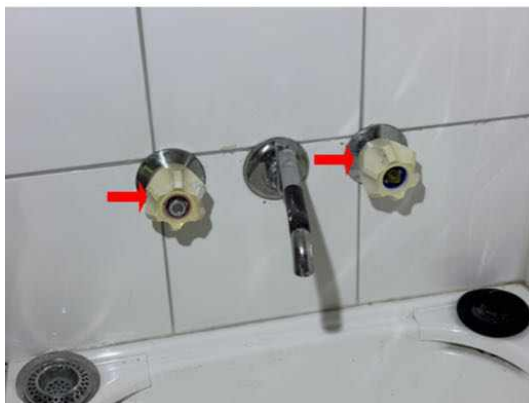
Finding 3.03

Finding: Laundry - taps not functional

Information: At the time of the inspection, it was noted that the hot and cold taps to the laundry tub could not be turned on. The plastic handles spin on the tap fittings. This may be due to general wear and tear.

A licensed plumber should be engaged to carry out the necessary repairs to restore the functionality of the taps. This should be done as a short term priority.

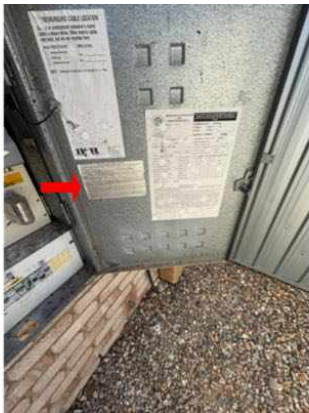
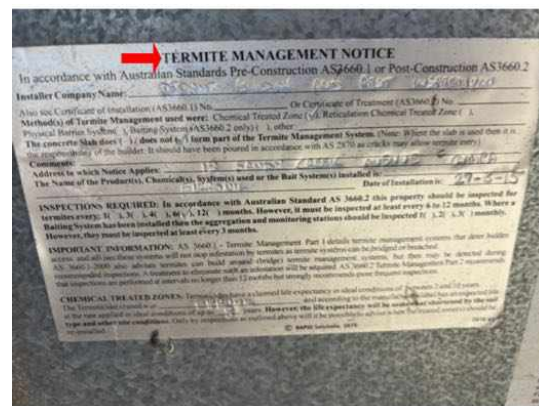
Finding 6.01

Building:	Main Building
Location:	All External Areas
Finding:	Termite Management System - no evidence of a current chemical installation
Information:	At the time of the inspection, no evidence of a current chemical termite management system was found. There is a durable notice in the meter box showing a chemical treatment was carried out on the 27/03/2015 with an expected lifespan of 8 years. This treatment will no longer be effective.

A durable notice should be placed in the switchboard unit to indicate current termite barriers. At the time of inspection, it appeared as though no termite management system has been installed, with no evidence to suggest preventative works taking place.

The application of a post-construction chemical termite barrier is highly recommended for all properties, particularly if live termite activity has been found on the site previously. Such barriers are highly effective in preventing termite attack on any timber building elements throughout the property.

The client may consider gaining further advice from a pest controller as to the costs and procedures involved with this application. It is recommended that obtaining such

advice be a short-term priority.

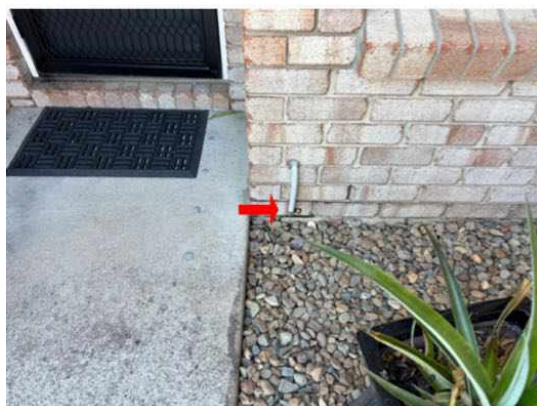
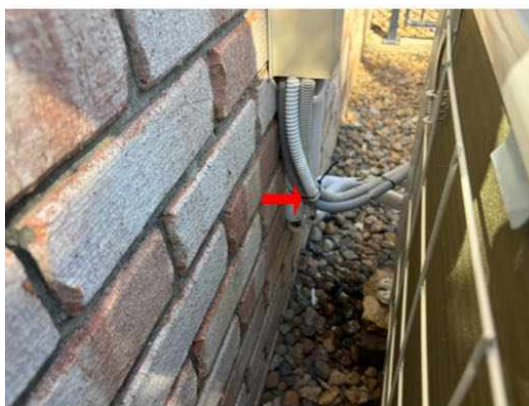
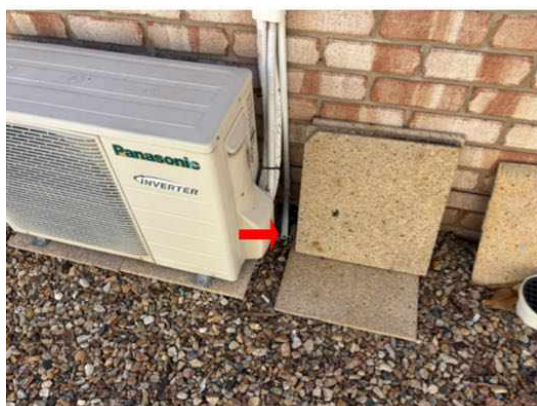
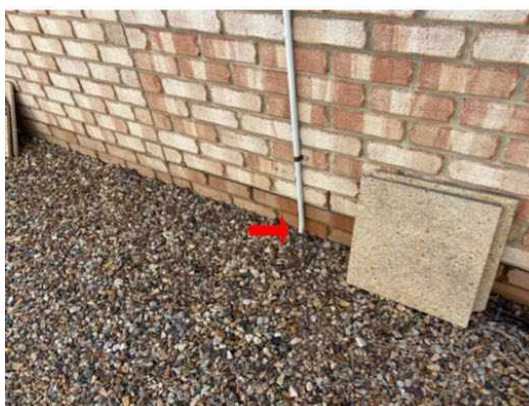
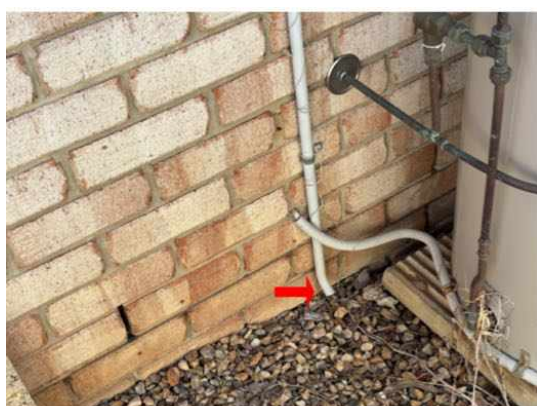
Finding 6.02

Building:	Main Building
Location:	All External Areas
Finding:	Air conditioner - Disconnected overflows
Information:	At the time of the inspection, it was noted that the air conditioner drain overflows to all the units were not connected to the storm water drainage and as a result are draining next to the foundations of the dwelling.

Air conditioning overflows that are not connected to the storm water drainage and are draining near the foundation can create excessive moisture in the surrounding area.

Such leaking creates an environment which is conducive to an array of defects, including water damage to associated building elements and the attraction of termite or timber pest infestation.

It is highly recommended that a licensed plumber be appointed to connect the A/C overflow in order to prevent such an environment from being created. These minor works should be carried out as soon as possible.

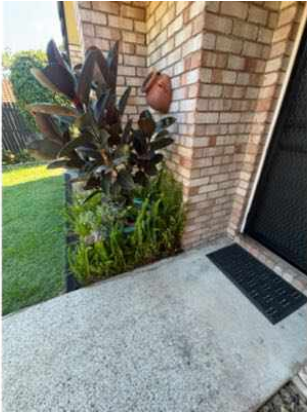
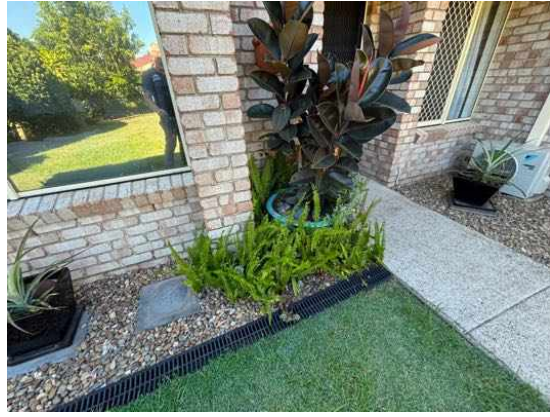
Finding 6.03

Building: Main Building
 Location: Front elevation
 Finding: Vegetation touching the building
 Information: At the time of the inspection, it was noted that there was vegetation touching the building at the front of the dwelling. This creates a potential access point for termites to enter the building undetected. This is a conducive condition for termite activity.

The client is to ensure that the vegetation is trimmed back to prevent undetected termite entry to the building and to provide a clear inspection area between the vegetation and the dwelling. This should be done as a matter of urgency.

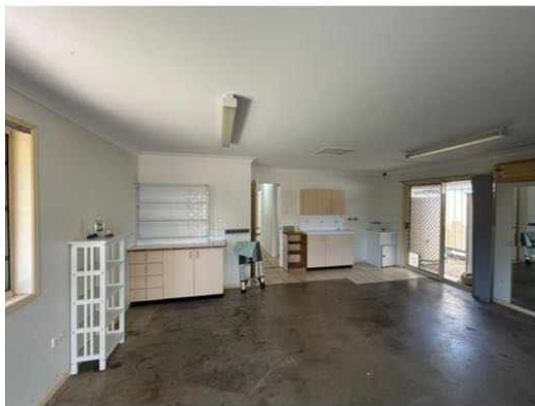
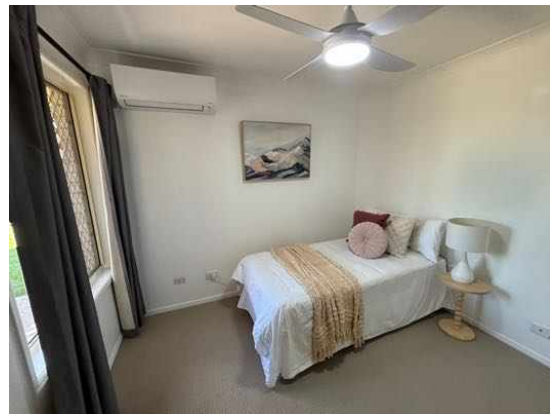
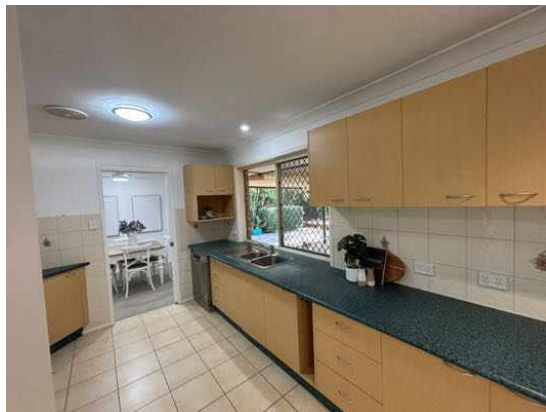
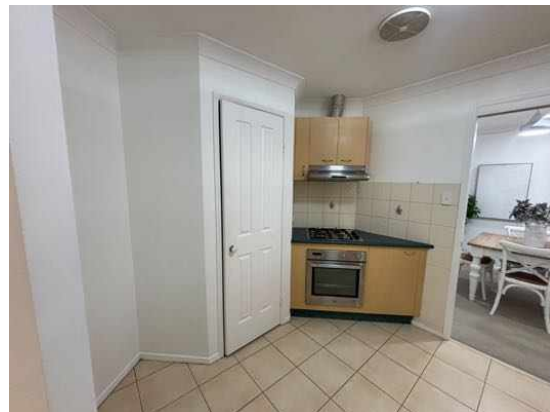
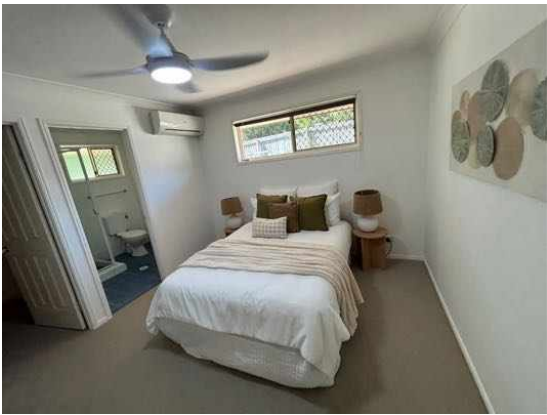
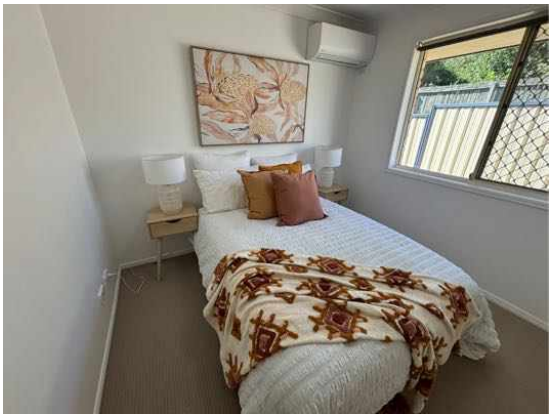
Building: Main Building
Location: All Internal Areas
Finding: Obstructions and Limitations - Internal areas
Information: These photographs are an indication of the obstructions and limitations which impeded full inspection of the property of the internal areas at the time of inspection. These obstructions can hide an array of defects and should be removed to allow full inspection to be carried out. A re-inspection is recommended once the areas are made accessible.

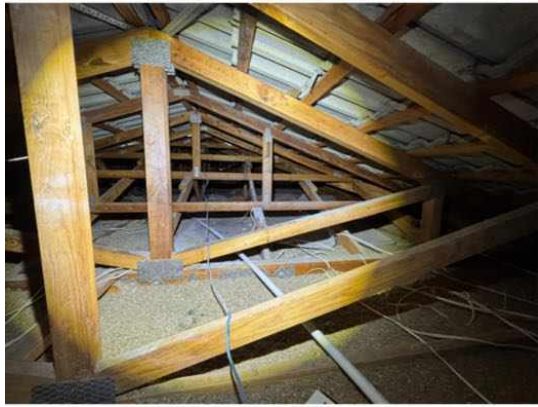
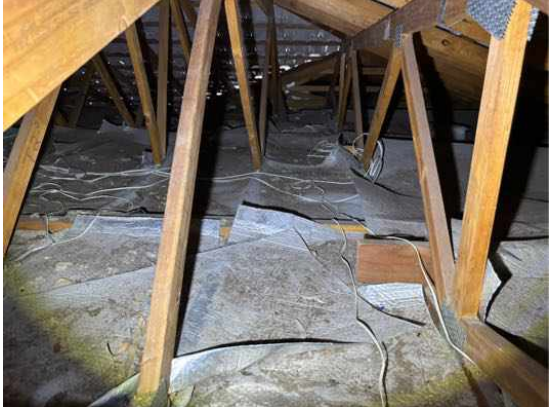
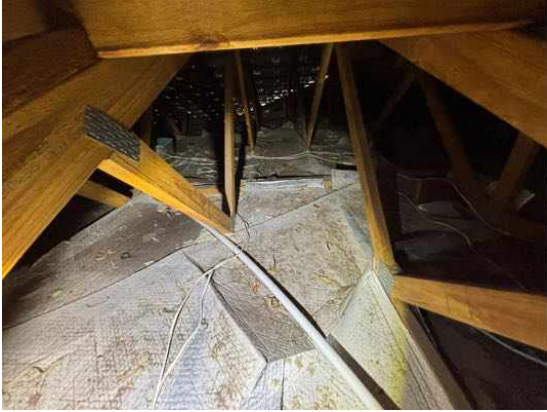
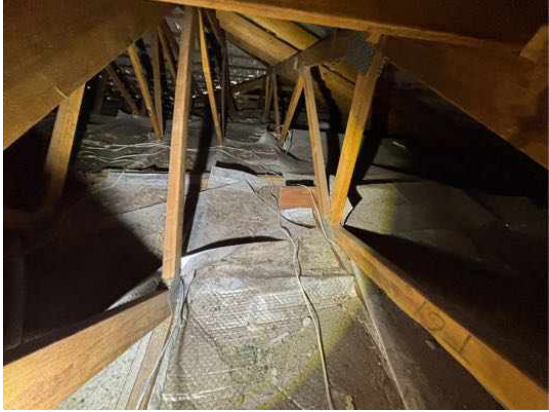
Building: Main Building
Location: Roof Void
Finding: Obstructions and Limitations - Roof cavity
Information: These photographs are an indication of the obstructions and limitations which impeded full inspection of the property of the roof cavity

at the time of inspection. These obstructions can hide an array of defects and should be removed to allow full inspection to be carried out. A re-inspection is recommended once the areas are made accessible.

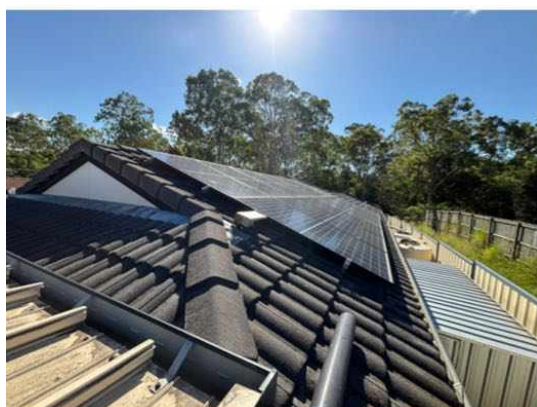
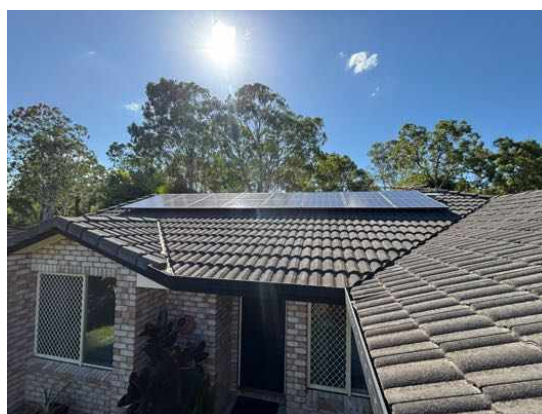
Building: Main Building
 Location: Roof Exterior
 Finding: Obstructions and Limitations - Roof exterior
 Information: These photographs are an indication of the obstructions and limitations which impeded full inspection of the property of the roof exterior

at the time of inspection. These obstructions can hide an array of defects and should be removed to allow full inspection to be carried out. A re-inspection is recommended once the areas are made accessible.

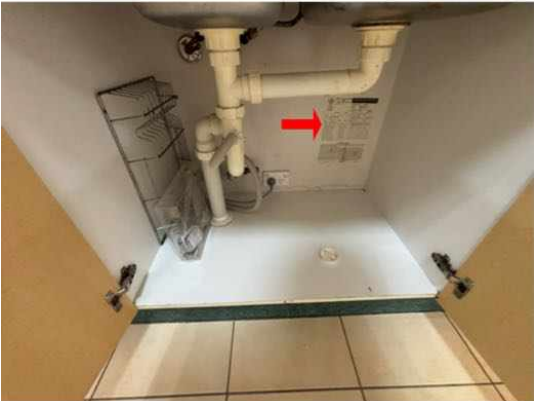
Building: Main Building
 Location: All External Areas
 Finding: Evidence of a physical termite management system was identified.
 Information: At the time of the inspection, evidence of a physical termite management system was found by way of a durable notice in the kitchen sink cabinet.

A physical termite barrier was installed to the slab penetrations, perimeter, paths/slabs and engaged piers during construction. The durable notice is dated the 02/10/2002. No record was found onsite of annual termite inspections having been carried out.

A termite and timber pest technician should be engaged to carry out annual termite inspections as per AS 3660 in order to further protect the dwelling. Annual termite inspections must be carried out in partnership with any termite treatment system, physical or chemical, as no termite treatment system can be expected to 100% effective.
