Building and Timber Pest Inspection Report

Inspection Date: Sat, 24 Jan 2026

Property Address: 101 North St, Casino NSW 2470, Australia

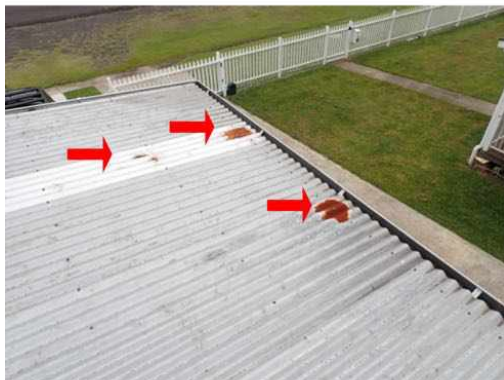
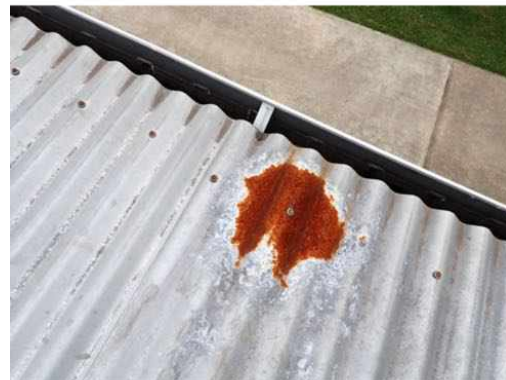
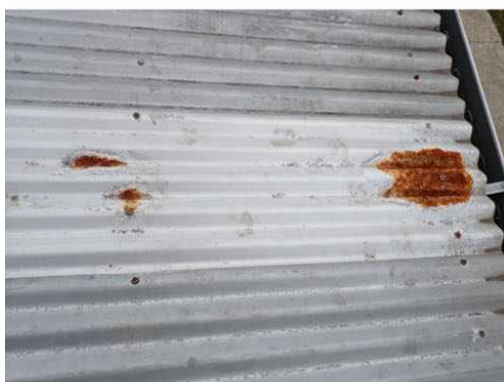
Finding 2.01

Building: Main Building
Location: Roof Exterior
Finding: Carport – Rusty Roof Cladding
Information: Rust was identified to the carport roof cladding. This appears consistent with age-related deterioration and ongoing maintenance is recommended to prevent further corrosion. Repairs or replacement, as required, can be carried out by a suitably qualified roofing contractor.

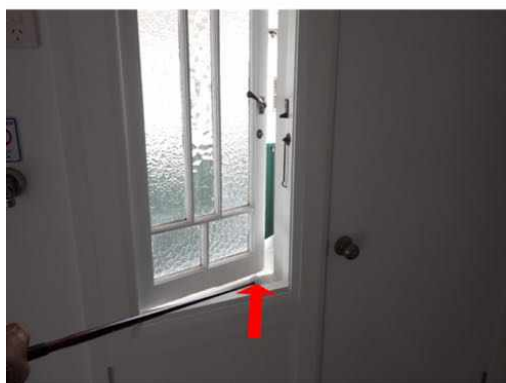
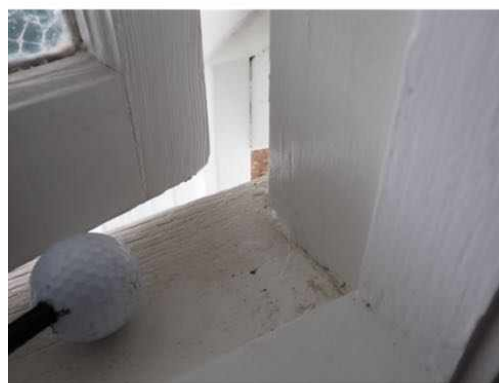
Finding 3.01

Building: Main Building
 Location: Laundry
 Finding: Laundry – Timber Window Operation and Fit
 Information: The laundry window was observed to catch on the frame during normal operation. This is a common defect with timber windows of this age and is typically associated with minor movement or wear over time. Adjustment or minor repairs can be carried out by a suitably qualified carpenter or handyman.

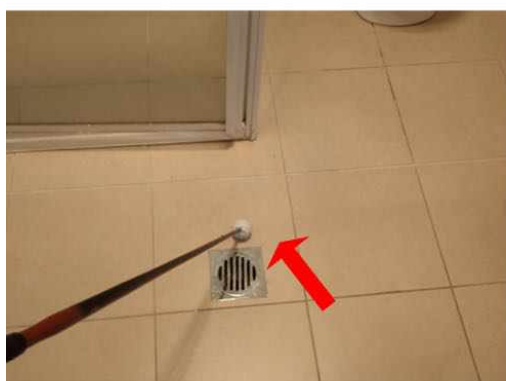
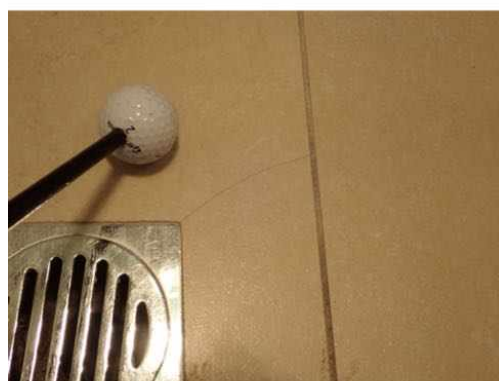
Finding 3.02

Building: Main Building
 Location: Bathroom
 Finding: Bathroom – Crack in Floor Tile
 Information: A crack was identified to a bathroom floor tile. This appears localised in nature and is commonly associated with impact or minor movement. Monitoring or replacement of the affected tile can be carried out by a suitably qualified tiler.

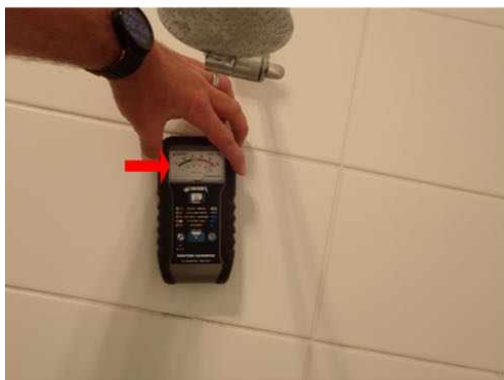
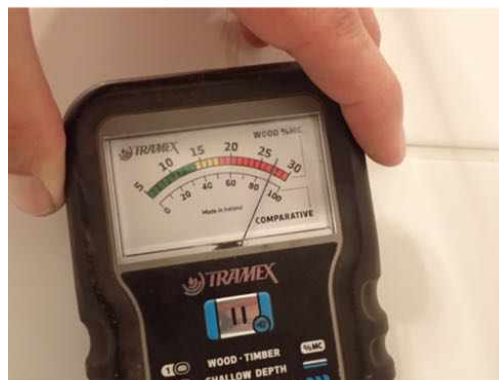
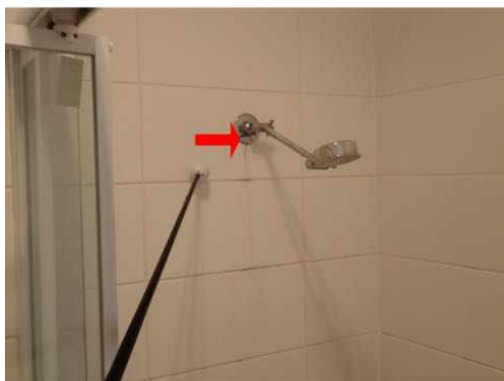
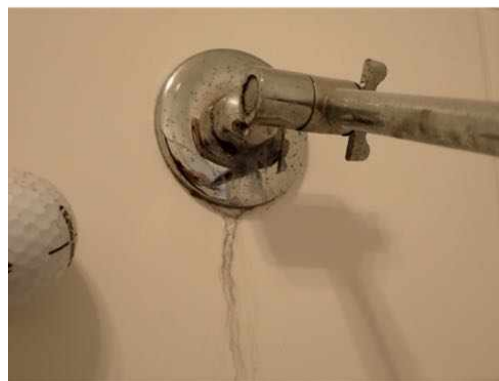
Finding 3.03

Building: Main Building
 Location: Bathroom
 Finding: Bathroom – High Moisture Around Shower Plumbing and Waterproofing

Information: High moisture readings were recorded around and below the shower head. This may be associated with the shower plumbing, fittings, or the waterproofing system behind the wall. Ongoing monitoring and maintenance is recommended. Further assessment and repairs can be carried out by a suitably qualified plumber or licensed builder specialising in bathroom renovations.

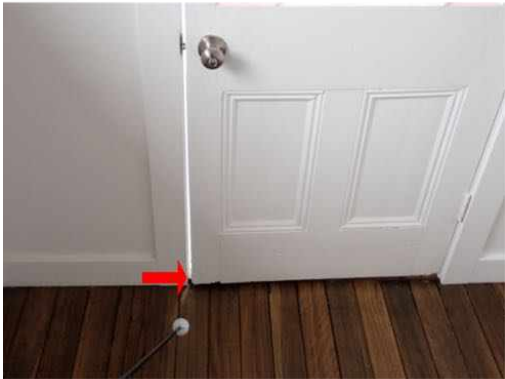
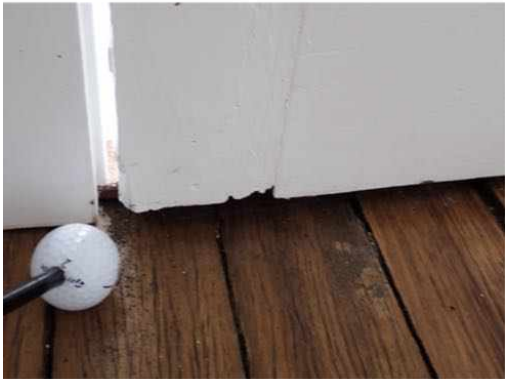
Finding 3.04

Building: Main Building
 Location: Entry
 Finding: Entry – Front Door Operation and Fit
 Information: The entry door was observed to catch on the door frame during normal operation. This is a common condition and is typically associated with minor movement or settlement. Adjustment or minor repairs can be carried out by a suitably qualified carpenter or handyman.

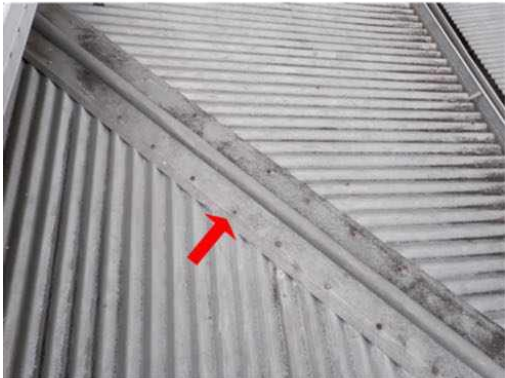
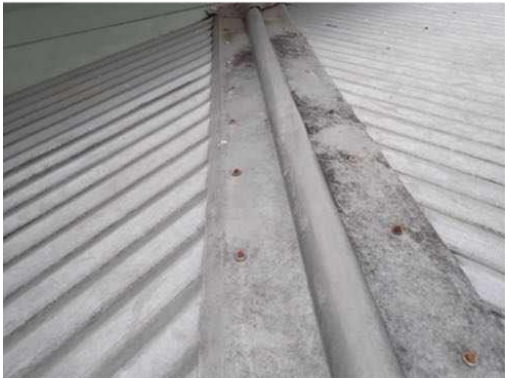
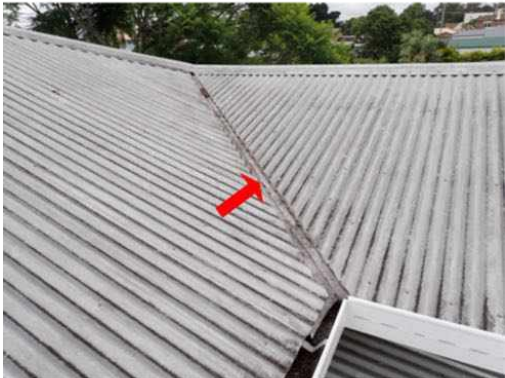
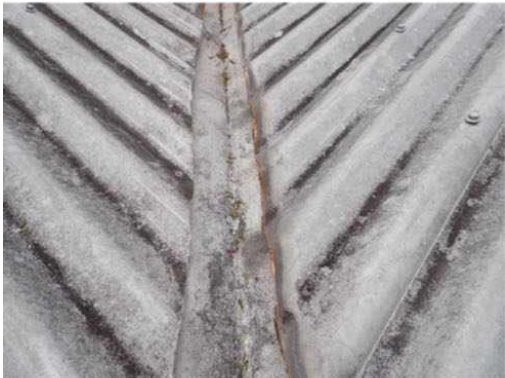
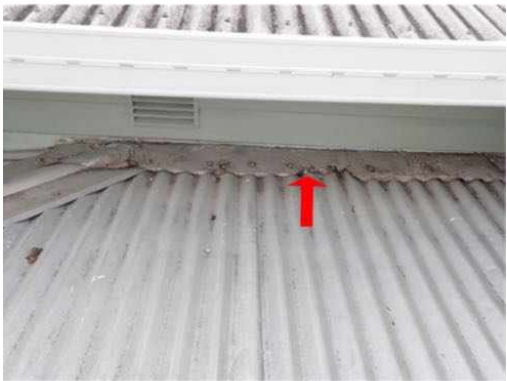
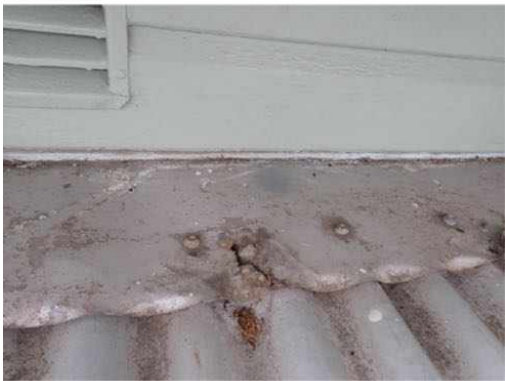
Finding 3.05

Building: Main Building
Location: Roof Exterior
Finding: Roof – Fixings, Valleys and Flashings
Information: Rust was identified to roofing screws, with minor rust also noted to roofing sheets within the valleys and to the apron flashings. This appears consistent with age-related deterioration and ongoing maintenance is recommended to prevent further corrosion. Repairs can be carried out by a suitably qualified roofing contractor.

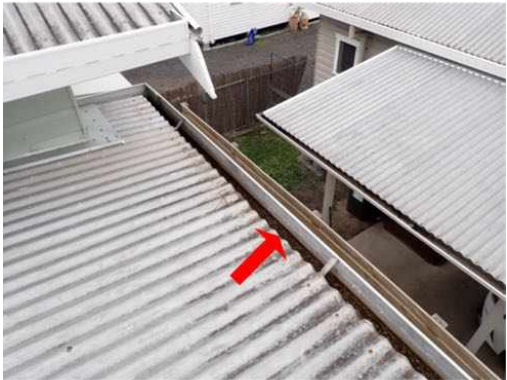
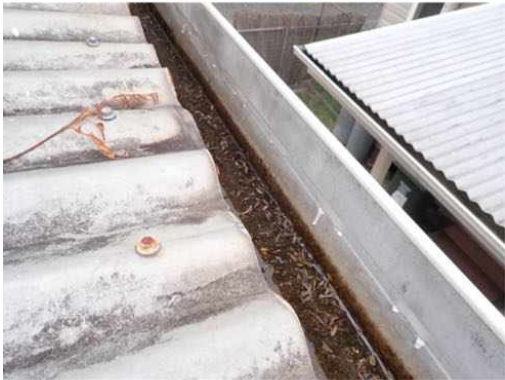
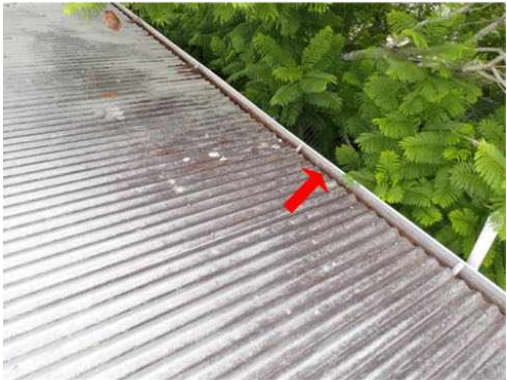
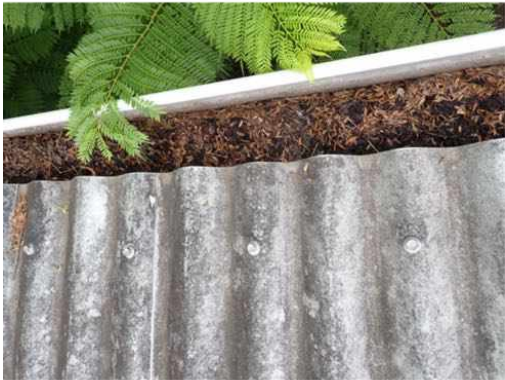
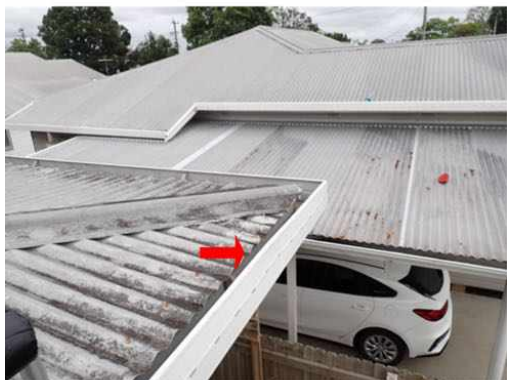
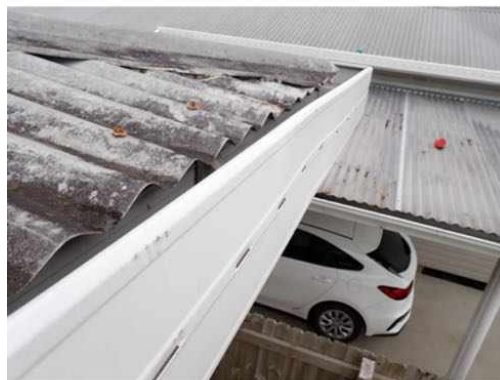
Finding 3.06

Building: Main Building
Location: Roof Exterior
Finding: Roof – Gutters Condition and Damage
Information: Blocked gutters were identified, along with surface rust and impact-related damage to one section. This condition may affect effective drainage and ongoing maintenance is recommended. Cleaning and repairs can be carried out by a suitably qualified roofing contractor or handyman.

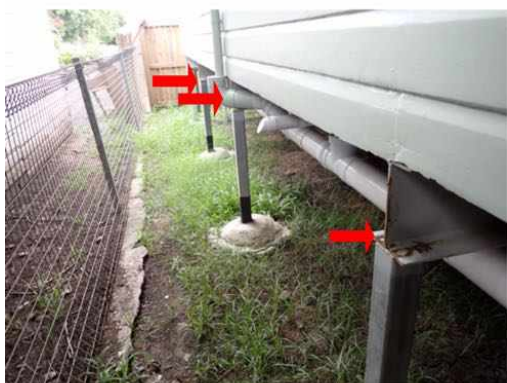
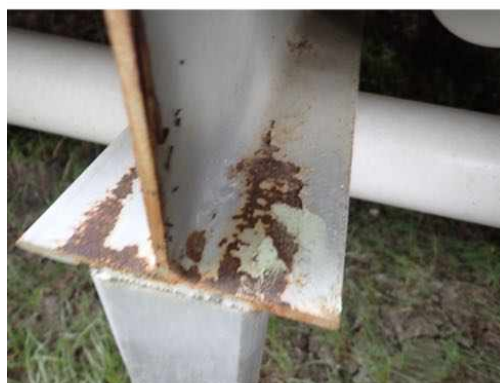
Finding 3.07

Building:	Main Building
Location:	Subfloor
Finding:	Subfloor – Surface Rust to Steel Bearers
Information:	Surface rust was identified to the ends of the subfloor steel bearers. This appears consistent with age-related exposure and maintenance is recommended to help prevent further rust. Treatment or repairs can be carried out by a suitably qualified builder or steel contractor.

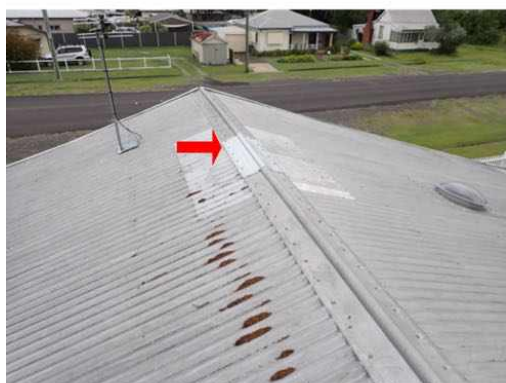
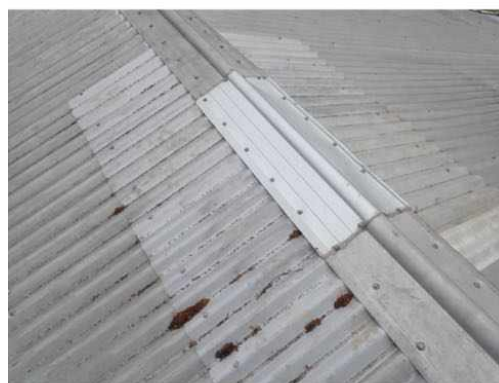
Noted Item

Building:	Main Building
Location:	Roof Exterior
Finding:	Roof – Cladding Patch Repairs
Information:	Patchwork repairs were identified to the roof cladding. This appears consistent with previous maintenance works and ongoing monitoring is recommended to ensure weatherproofing is maintained. Further assessment and repairs can be carried out by a suitably qualified roofing contractor if required.

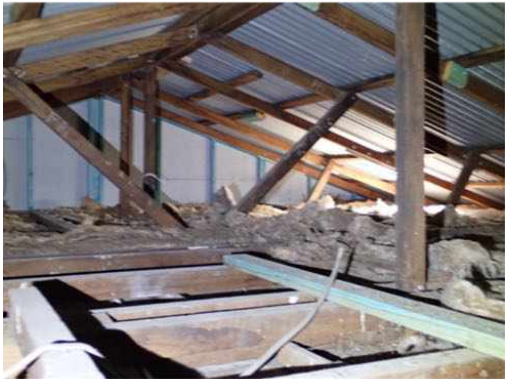
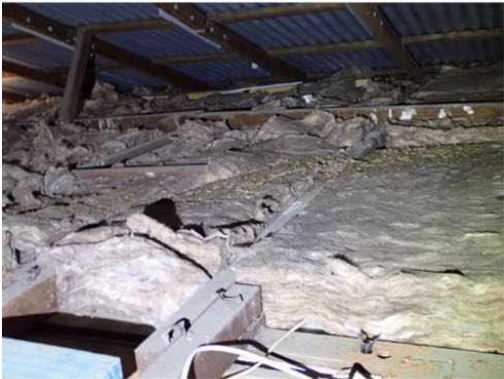
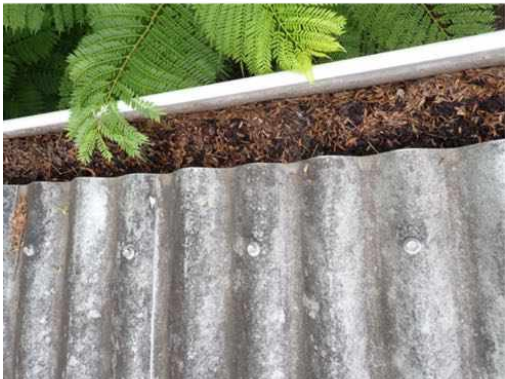
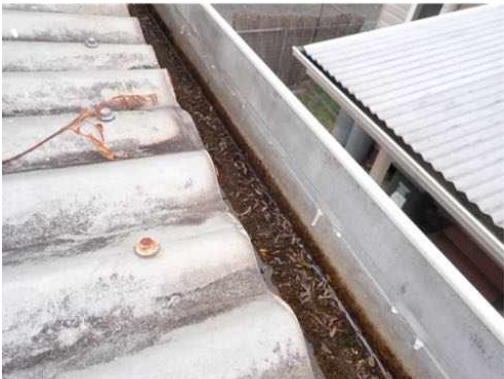
Noted Item

Building:	Main Building
Location:	All Areas
Finding:	Additional Photos - Obstructions and Limitations
Information:	These photographs are an indication of the obstructions and limitations which impeded full inspection of the area at the time of inspection. These obstructions can hide an array of defects and should be removed to allow full inspection to be carried out. A re-inspection is recommended once the areas are made accessible.
