Building and Timber Pest Inspection Report

Inspection Date: Thu, 19 Mar 2026

Property Address: 41 Brennon Rd, Gorokan NSW 2263,
Australia

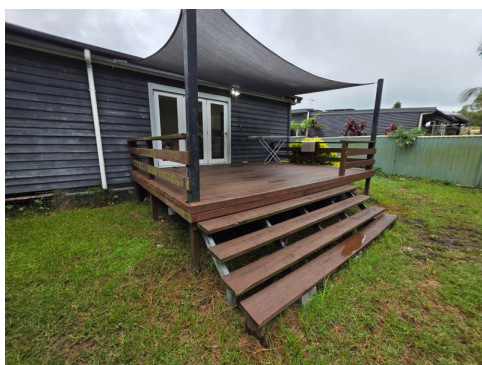
Finding: Loose and non-compliant step – Rear deck stairs

Information: The bottom step to the rear deck stairs is loose and has an inconsistent rise and run compared to the other steps.

This presents a trip hazard and may worsen with continued use.
A qualified carpenter should be engaged to assess and rectify as required.
This should be done without delay.

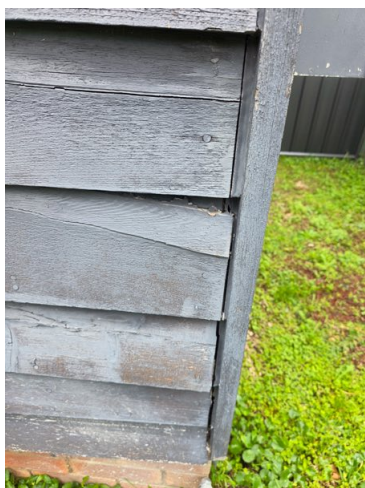
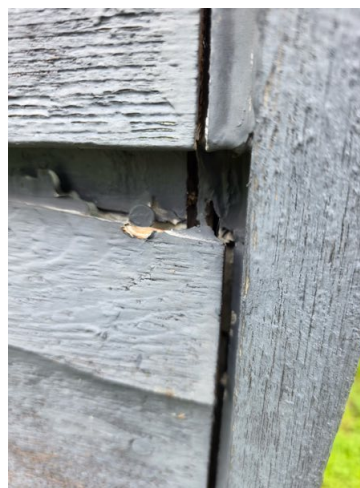
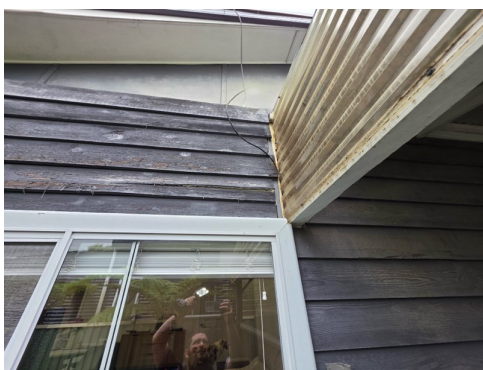
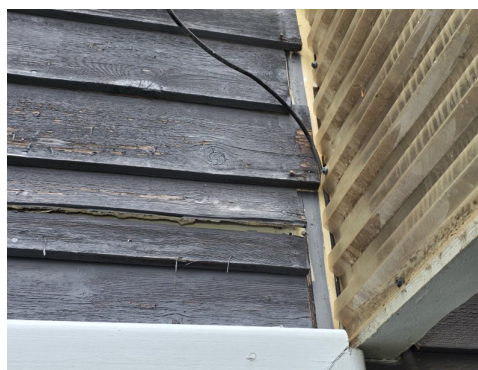
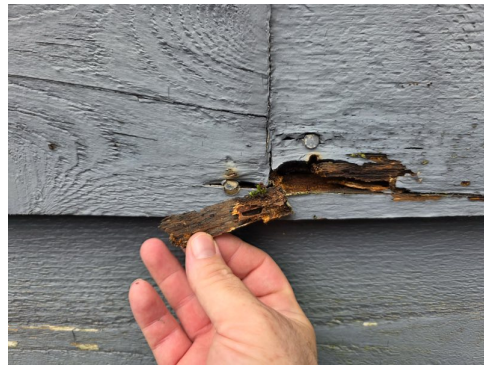
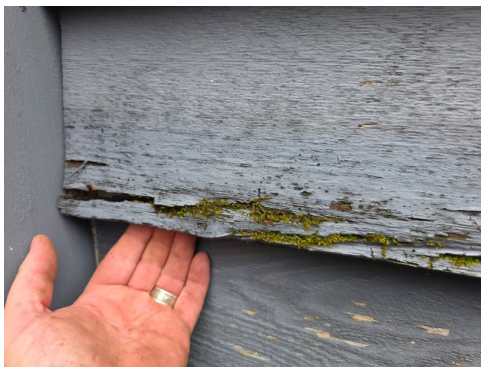
Finding 2.01

Finding: Deteriorated weatherboards and joints / Inadequate wall junction detail / Deteriorated wall plate ends – External walls and roof perimeter

Timber weatherboards show signs of fungal decay, with movement, warping, and separation at joints. Sealant to junctions is no longer effective, and underlying wall linings appear to include suspected asbestos sheeting. A junction detail was observed where weatherboards extend beyond adjacent gable end sheeting, with deteriorated tape and no effective sealing. This creates an opening for water entry behind the cladding. Timber elements, likely wall plate ends, extend beyond the wall line and show signs of past fungal decay. These have been partially filled but remain exposed, with some internal framing visible.

This condition may allow moisture ingress and may lead to ongoing deterioration of external wall components and concealed materials. A qualified carpenter should be engaged to carry out further investigation and rectify as required. This should be done as soon as practicable.

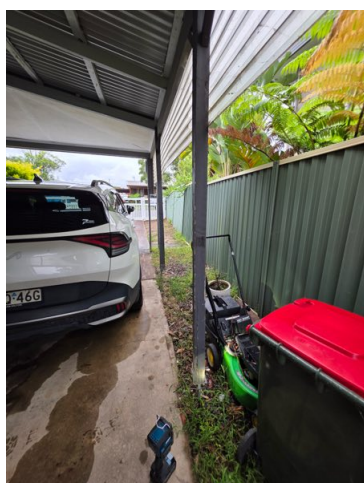
Finding 2.02

Finding: Decayed and unstable posts – Carport

Information: Carport posts show fungal decay at their bases. One post is loose within its metal shoe with unsecured fixings, and another is installed in a leaning stirrup. The timber at the base of at least one post is soft.

This affects the stability of the structure and may lead to further movement or failure if deterioration continues.

A qualified carpenter should be engaged to carry out further investigation and rectify as required. This should be done as soon as practicable.

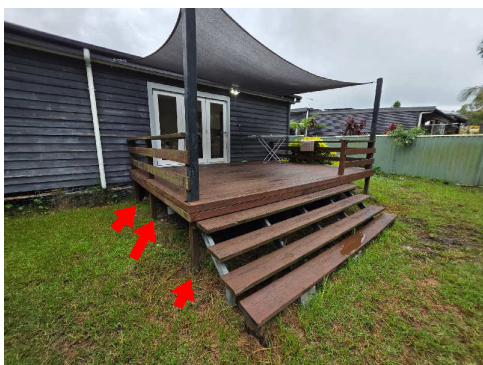
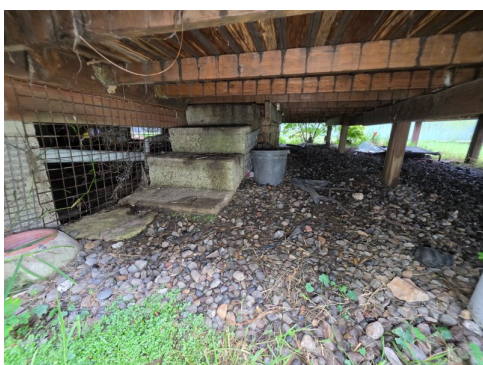
Finding: Timber posts in contact with ground and early decay – Rear deck

Information: Timber posts supporting the rear deck are installed in direct contact with the ground. Minor fungal decay was observed at the base of these posts, indicating early-stage deterioration. The full extent of any internal decay could not be determined at the time of inspection. These timber posts are not designed for in ground contact.

This condition may lead to progressive deterioration of the timber and could affect the long-term performance of the supporting elements if not addressed. A licensed builder should be engaged to carry out further investigation and rectify as required. This should be done as soon as practicable.

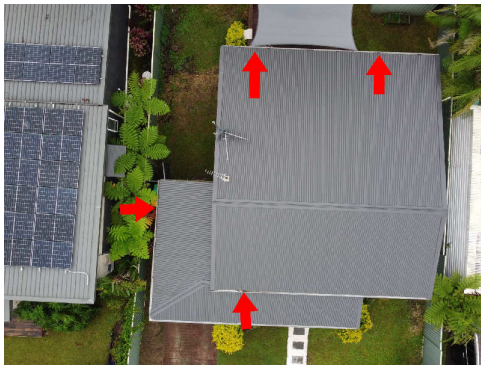
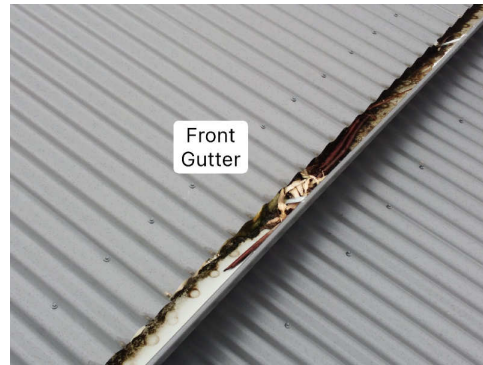
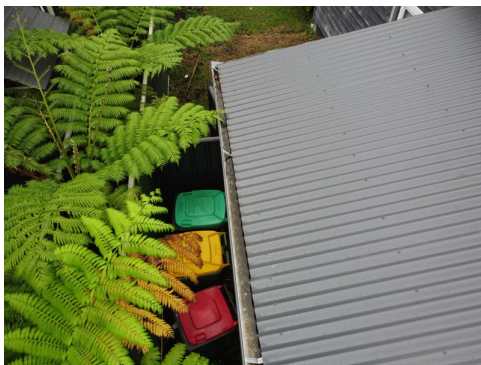
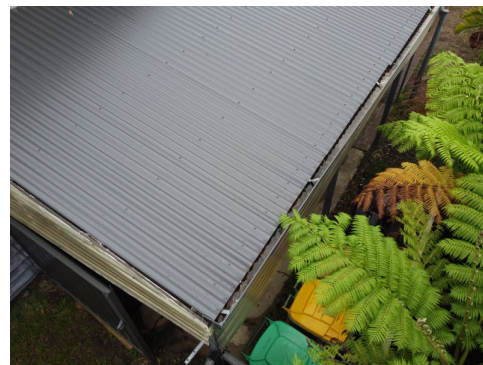
Finding 3.02

Finding: Leaking gutter, debris build-up, and inadequate fall – Carport and rear gutters

Information: The carport gutter is leaking, with water discharging onto an adjacent post and contributing to saturated ground conditions below. Debris was observed in sections of the guttering, and the carport gutter contains standing water, indicating inadequate fall toward the downpipe. Additional leaf litter is present in the rear gutters. From what can be seen, these conditions are restricting proper drainage.

This may accelerate deterioration of adjacent structural elements and contribute to ongoing moisture exposure. A licensed plumber should be engaged to clean, assess, and rectify the guttering, including correcting the fall as required. This should be done as soon as practicable.

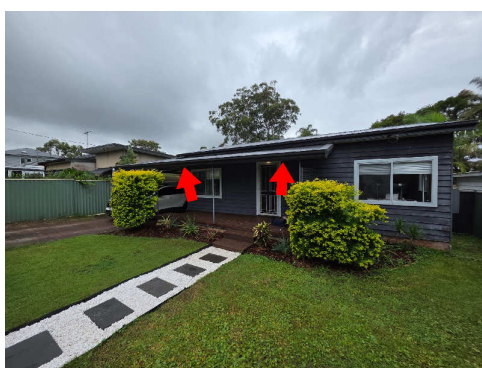
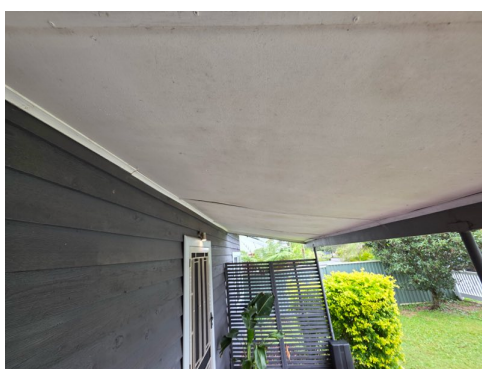
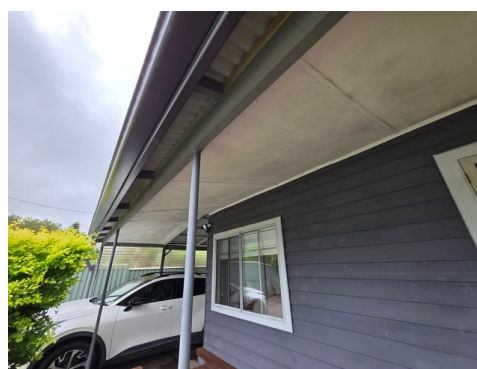
Finding 3.03

This indicates deterioration or loss of fixing support and may worsen over time.

A qualified carpenter should be engaged to assess and rectify as required. This should be done as soon as practicable.

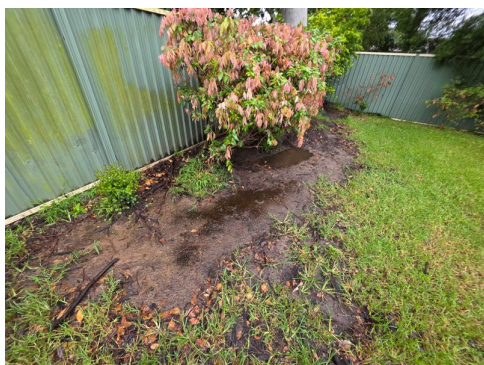
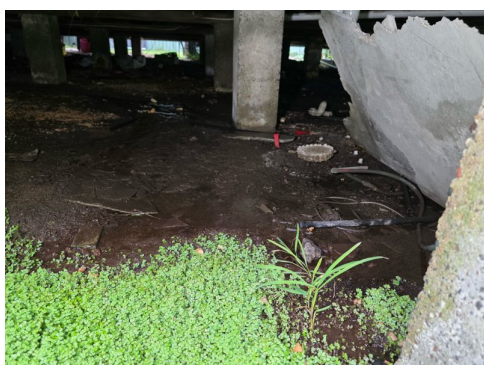
Information: The site exhibits poor drainage, with soggy ground conditions and areas of water accumulation observed around the property. Very wet conditions were also noted to the subfloor area. The extent to which this condition may impact the structure could not be determined at the time of inspection.

This indicates inadequate surface water management, which may contribute to moisture-related deterioration of building elements over time if conditions persist.

A licensed plumber should be engaged to carry out further investigation and rectify as required. This should be done as soon as practicable.

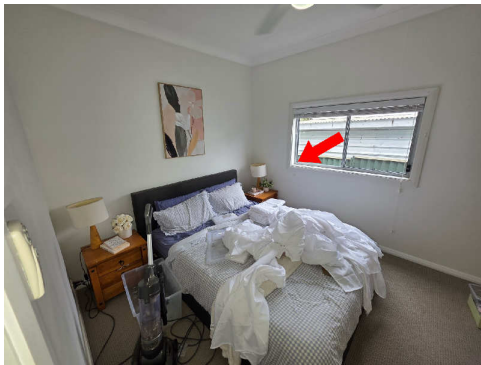
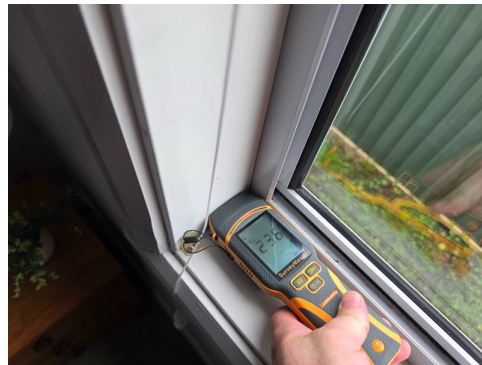
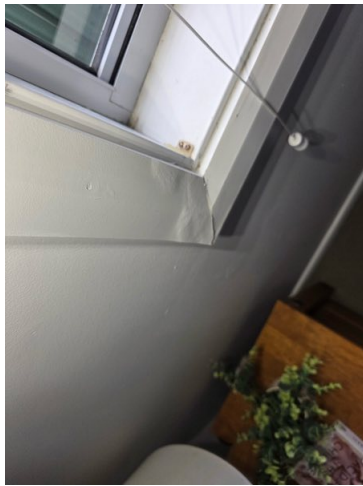
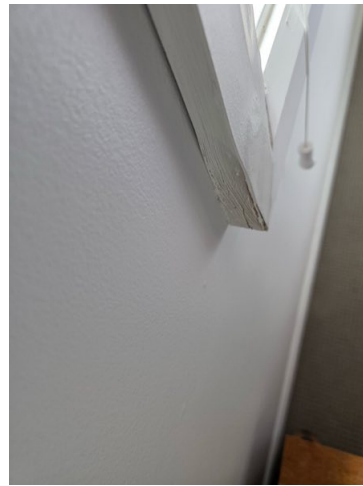
Finding 3.06

Finding: Moisture damage and swelling – Bedroom window area

Information: Elevated moisture readings were detected to a bedroom windowsill, with associated swelling to the adjacent architraves. This is consistent with moisture ingress, possibly from window sealing, although the exact source could not be confirmed.

This may lead to further deterioration of internal finishes and concealed framing if not addressed.

A qualified carpenter should be engaged to carry out further investigation and rectify as required. This should be done as soon as practicable.

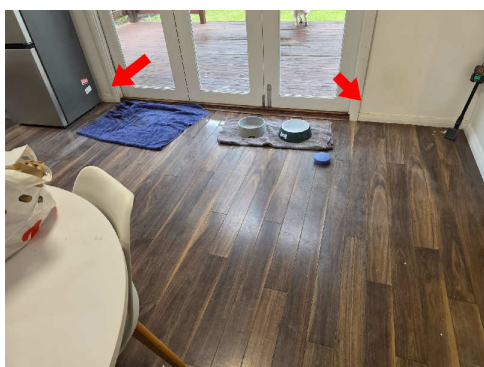
Finding 3.07

Finding: Elevated moisture readings – Rear doorway (both sides)

Information: Elevated moisture readings were recorded to wall areas on both sides of the rear doorway. No visible signs of active leakage were observed at the time of inspection, and the source of the moisture could not be confirmed.

This indicates a potential moisture issue in a high-risk area that may develop into visible damage if conditions persist. Monitoring is recommended, and further investigation should be undertaken if mould, discolouration, or paint deterioration becomes evident.

A licensed builder should be engaged to carry out further investigation and rectify as required. This should be done as soon as practicable.

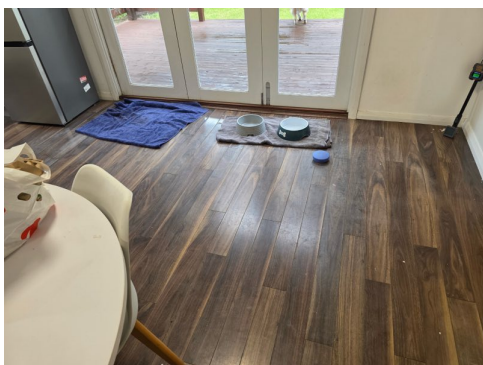
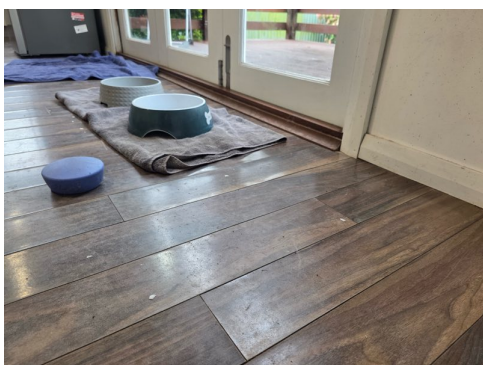
Finding 3.08

Information: Flooring adjacent to the rear doors shows minor swelling, cupping, and localised discolouration, consistent with moisture exposure. The extent of any underlying damage could not be determined.

This indicates moisture has affected the flooring in this area and may continue to cause deterioration if the source is ongoing.

A licensed carenter should be engaged to carry out further investigation and rectify as required. This should be done as soon as practicable.

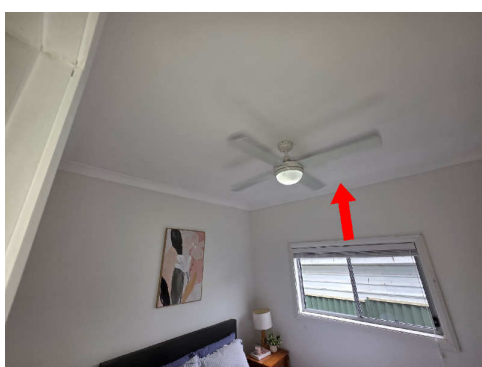
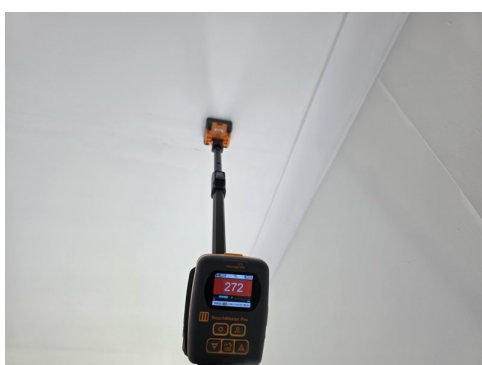
Finding 3.09

Finding: Ceiling lining deterioration – Bedroom 3

The ceiling lining in Bedroom 3 shows localised delamination of the plasterboard paper surface. Moisture readings in this area were inconclusive, with elevated readings noted more broadly across the ceiling, suggesting possible non-moisture influences; however, moisture ingress cannot be ruled out.

This condition may worsen if moisture is present, leading to further deterioration of the ceiling lining. Monitoring is recommended, and further investigation should be undertaken if additional deterioration, discolouration, or mould growth occurs.

A licensed builder should be engaged to carry out further investigation and rectify as required. This should be done as soon as practicable.

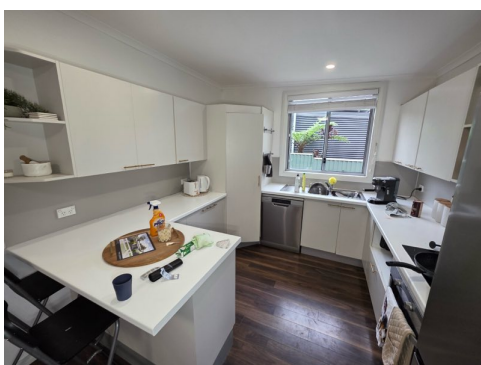
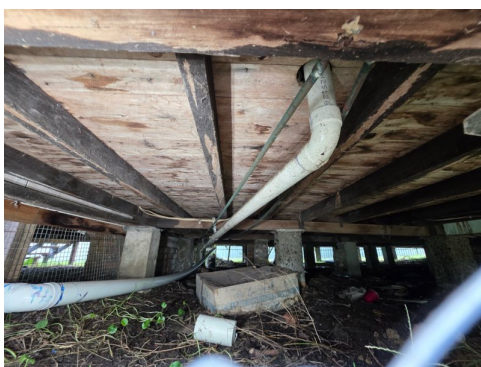
Finding 3.10

Building: Main Building
 Location: Kitchen
 Finding: Uneven and bouncy flooring – Kitchen

The kitchen floor was noted to feel bouncy underfoot and slopes across the room. This is consistent with movement or unevenness in the supporting structure, although the exact cause and extent could not be confirmed during a visual inspection.

This may indicate subfloor movement or deterioration that could worsen over time and affect floor performance.

A licensed builder should be engaged to carry out further investigation and rectify as required. This should be done as soon as practicable.

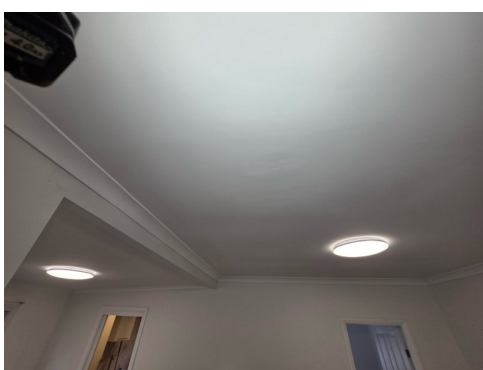
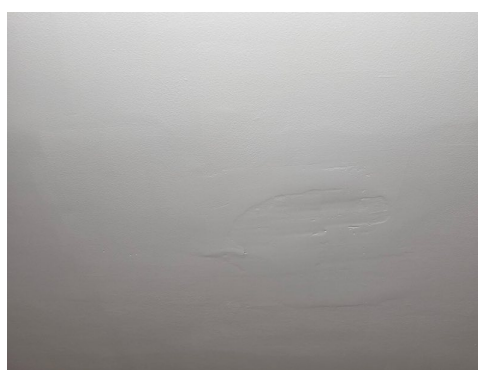
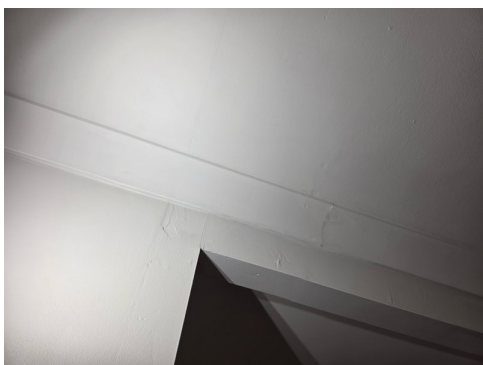
Finding 3.11

Patch repairs were observed to walls and ceilings throughout the property that have not been adequately sanded or finished, with filler visibly proud of surrounding surfaces. This results in an uneven appearance and indicates incomplete finishing works, which may affect overall presentation and durability of painted surfaces.

This condition is cosmetic in nature and may require further finishing to achieve an acceptable standard. Photos are indicative of the defect throughout.

A qualified tradesperson should be engaged to assess and rectify as required. This should be done at the owner's discretion.

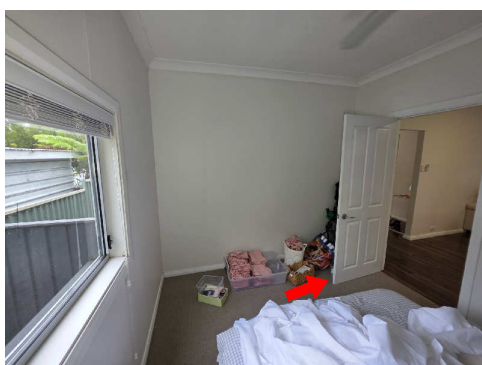
Finding 3.12

Information: The doors to all bedrooms were noted to rub slightly on the recently installed carpet. This appears to be due to reduced clearance following new floor coverings. the owner advised

This may cause ongoing wear to both the carpet and door edges if not addressed.

A qualified carpenter should be engaged to assess and rectify as required. This should be done at the owner's discretion.

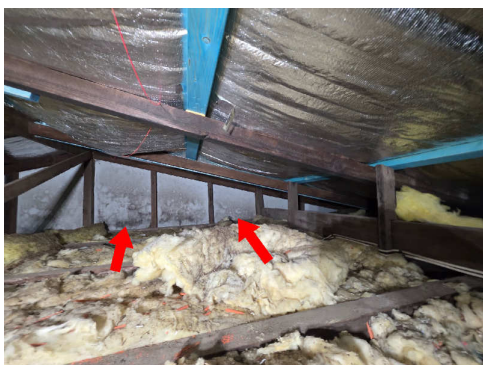
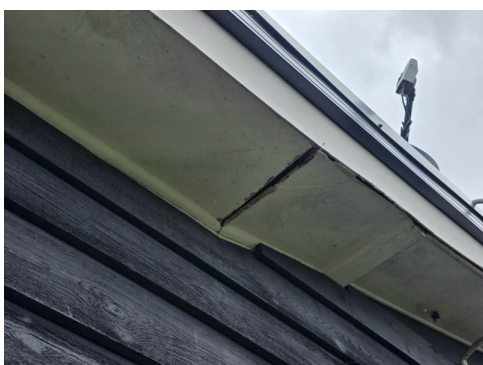
Finding 3.13

Information: Mould growth was observed to the rear face of the gable end wall sheeting and to the underside of the eave linings along both sides of the house. The extent of mould and any associated moisture source could not be determined at the time of inspection.

This indicates prolonged moisture presence in these areas, which may contribute to material deterioration and potential health concerns if widespread.

A licensed builder should be engaged to carry out further investigation and rectify as required. This should be done as soon as practicable.

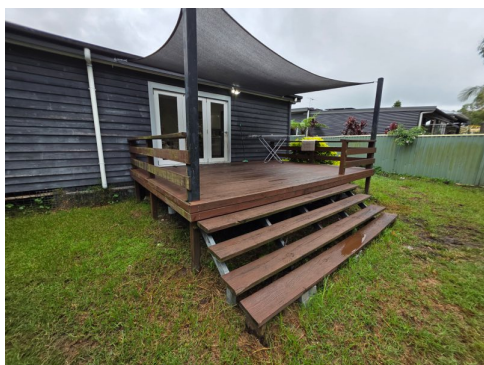
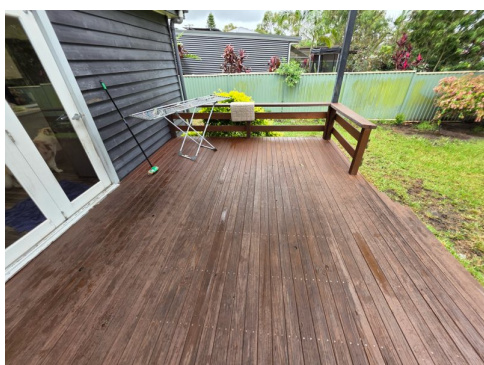
Finding 3.14

Information: An elevated external deck was observed at the rear of the property. Even if the structure appears sound or recently built, it may still pose a safety risk if inadequately supported. A detailed structural assessment is required to confirm its stability and load-bearing capacity.

A structural engineer should be engaged to carry out this assessment without delay. Until this has been completed and any necessary rectification works undertaken, users should take care not to overload the structure.

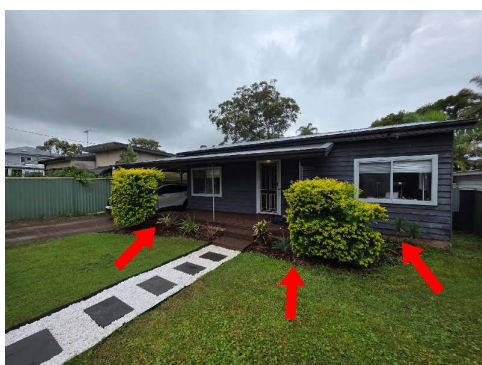
Finding: Garden Beds - Conditions Conducive to Termites

Information: Garden beds, particularly those constructed from untreated timber, were noted adjacent to the dwelling. These create a highly conducive environment for termite activity due to the combination of retained soil moisture from watering, direct soil contact, and the organic material in the soil and timber edging. Such conditions increase the risk of concealed termite ingress into the property, as termites can travel through the garden beds and enter the structure undetected.

Where practical, garden beds should be removed, relocated, or modified so that they do not abut the dwelling. Where this is impractical or undesirable, the risk of concealed termite activity remains. In these cases, a licensed pest controller should establish an ongoing termite management plan, and regular timber pest inspections should be carried out every 6–12 months to assist in protecting the property against infestation.

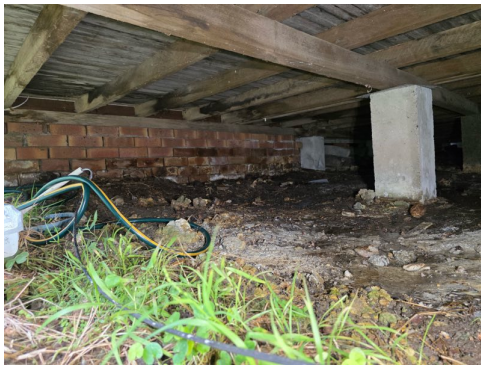
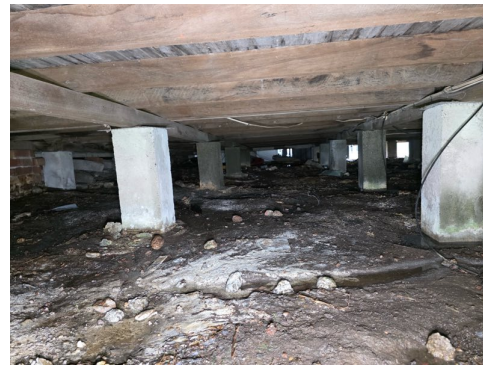
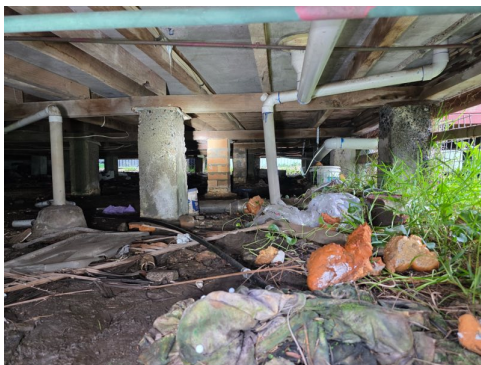
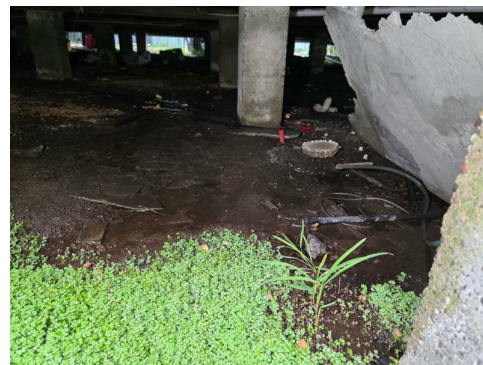
Finding 6.02

Finding: Damp Subfloor - Evidence of excessive moisture

Information: The subfloor area was observed to be broadly wet, with signs of water tracking across the ground surface rather than remaining localised. This indicates poor site drainage or uncontrolled water ingress beneath the dwelling. Prolonged moisture exposure in subfloor environments can contribute to timber deterioration and creates conditions conducive to termite activity.

A licensed plumber should be engaged to carry out further investigation and rectify drainage and moisture management as required. Regular timber pest inspections should also be carried out every 6–12 months. This should be done as soon as practicable.

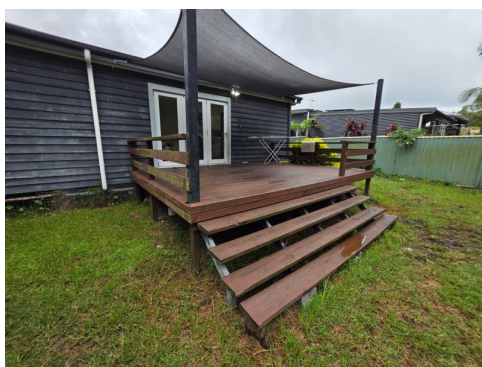
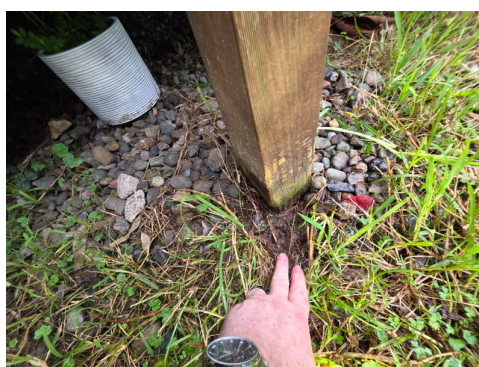
Finding 6.03

Timber elements in direct contact with the ground, and consequently exposed to moisture or dampness, create conditions conducive to termite activity. Whether timber is used as part of a building structure, such as a fence or retaining wall, or stored as unused material, it can attract termite infestations.

When exposed to excessive moisture, timber begins to decay and develop wood rot. Any timber in direct contact with the ground - especially untreated or non-durable timber - provides an easy entry point for subterranean termites into the material.

To minimize the risk of termite attack, it is recommended to remove any materials that could foster termite activity. If removal is impractical or undesirable, it is strongly advised that termite or timber pest inspections be conducted every 6 to 12 months to protect the property from potential infestation.

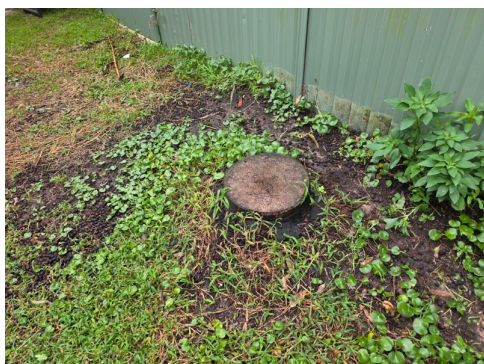
**Finding 6.04**

Location:	Yard - Back
Finding:	Tree Stumps - Tree stumps in yard may attract termites
Information:	Tree stumps were observed in the yard at the time of inspection. Decaying timber in contact with soil provides an ideal environment for termite nesting and activity, particularly when located near the dwelling.

Although no active timber pest activity was noted, concealed areas within the stumps could not be inspected. These stumps should be professionally treated or removed where practical, particularly if located near the dwelling. Ongoing monitoring and timber pest inspections are recommended every 6–12 months.

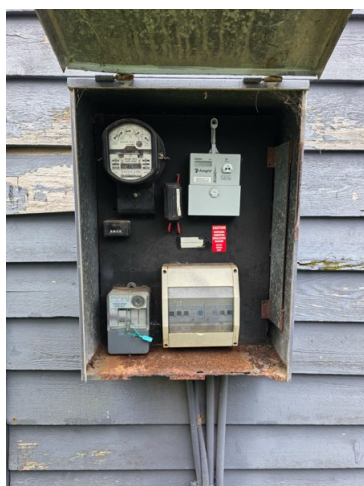
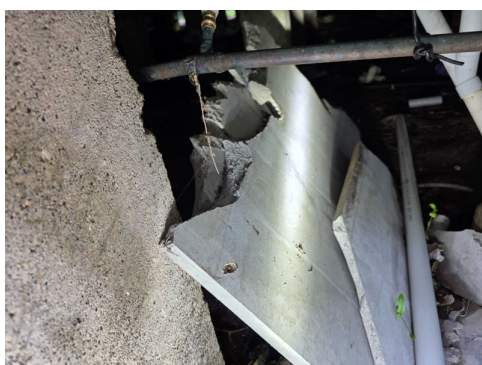
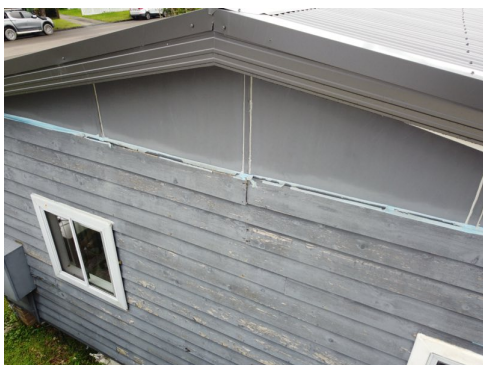
Information: Reporting on asbestos is outside the scope of this inspection. Suspected asbestos-containing material (ACM) was observed in the meter box, subfloor floor sheet debris, external wall linings behind weatherboards and the gable ends of the roof void. Based on our experience in the building industry, there is a higher risk that the identified building elements contain asbestos, particularly given that any home constructed prior to 1990 may contain asbestos in various forms.

No sample testing has been undertaken to confirm the presence of asbestos. We strongly recommend a separate Asbestos Inspection and Condition Audit be carried out by a licensed assessor, which may include laboratory testing for definitive confirmation.

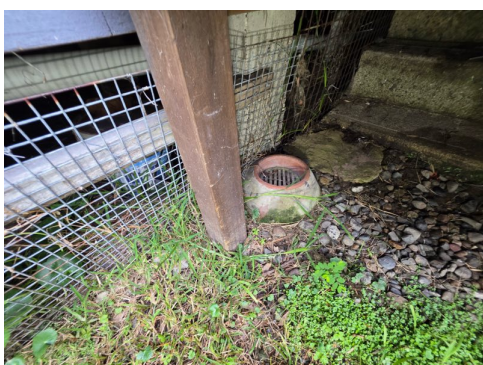
Information: Earthenware drainage pipes were identified on the property. These materials are rigid and commonly subject to cracking or displacement due to ground movement or root intrusion.

This may result in reduced performance or failure of the drainage system. It would be worth engaging a licensed plumber to carry out a further investigation to determine the condition of the in-ground pipework. This should be done as soon as practicable.
