# Building and Timber Pest Inspection Report

Inspection Date: Tue, 27 Jan 2026

Property Address: 1/17 Banool Cct, Bomaderry NSW 2541,  
Australia

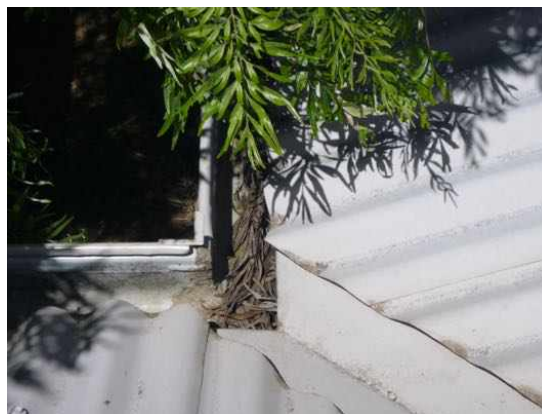
Blocked gutters are likely to lead to high levels of moisture in the affected areas. Such moisture will not only cause rust and decay of the associated building materials, but can also provide conditions that are conducive to termite and timber pest activity. Blockages in gutters should therefore be removed immediately to ensure dry conditions are maintained.

Consult a Licensed Plumber for further specific advice on remedial works that may be required. In the interim, it is highly advised that blocked gutters be removed by the homeowner or a general handyperson as a matter of urgency.

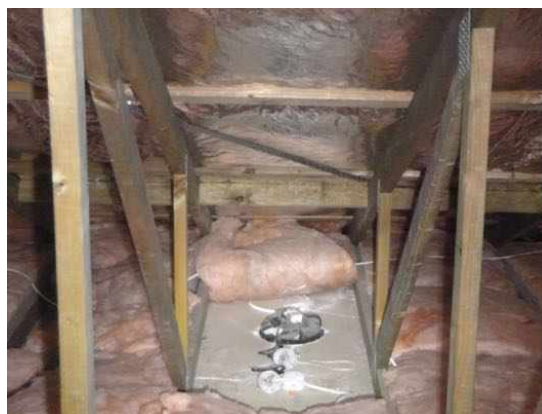
Building:	Main Building
Location:	Roof Void
Finding:	Exhaust fans - Sarking on roof (Ducting, Roof Vent or Eave Vents are required)
Information:	On inspection of the roof void, it was observed that the exhaust fans to the bathroom and ensuite do not exhaust directly to the outside of the building, which is required by the NCC if sarking has been fitted, as it has in this home.

(A) is adequately ventilated by open eaves, and/or roof vents or

(B) is covered by roof tiles WITHOUT SARKING or similar materials which would prevent venting through gaps between the tiles.

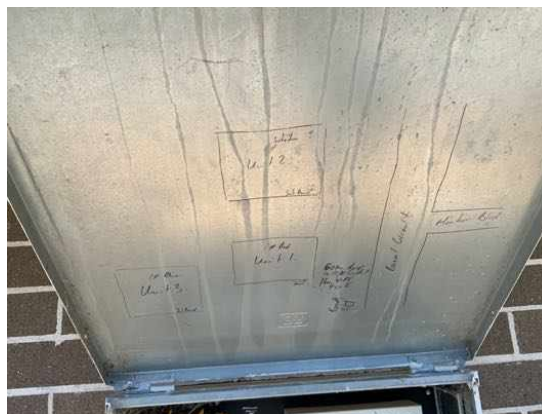
Building:	Main Building
Location:	All Areas
Finding:	Termite Management System - no evidence of a chemical installation
Information:	The application of a post-construction chemical termite barrier is highly recommended for all properties, particularly if live termite activity has been found on the site previously. Such barriers are highly effective in preventing termite attack on any timber

A durable notice should be placed in the switchboard unit to indicate current termite barriers. At the time of inspection, it appeared as though no termite management system has been installed, with no evidence to suggest preventative works taking place.

The client may consider gaining further advice from a pest controller as to the costs and procedures involved with this application. It is recommended that obtaining such advice be a short-term priority.

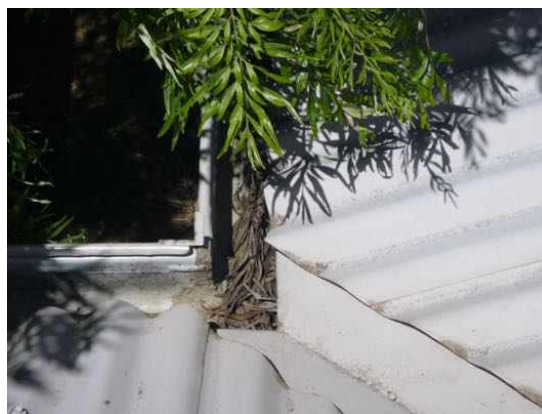
## Finding 6.02

Building:	Main Building
Location:	Roof Exterior
Finding:	Gutters - Blocked
Information:	Roof plumbing structures, such as guttering and downpipes, should be free of all debris to prevent blockages. Blockages of the guttering and downpipes will lead to pooling and accumulated water overflows, which is likely to subsequently flood eaves and exterior walls.

Blocked gutters are likely to lead to high levels of moisture in the affected areas. Such moisture will not only cause rust and decay of the associated building materials, but can also provide conditions that are conducive to termite and timber pest activity. Blockages in gutters should therefore be removed immediately to ensure dry conditions are maintained.

Consult a Licensed Plumber for further specific advice on remedial works that may be required. In the interim, it is highly advised that blocked gutters be removed by the homeowner or a general handyperson as a matter of urgency.

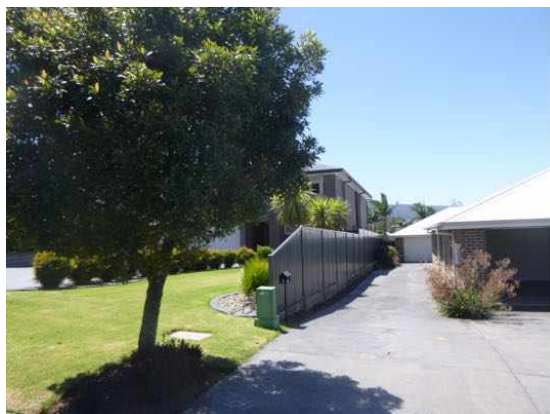
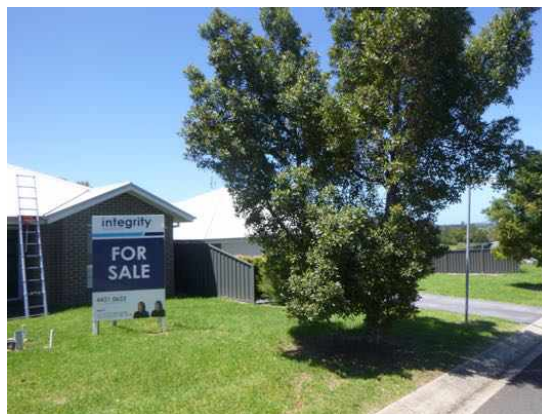
## Finding 6.06

Building:	Main Building
Location:	All Areas
Finding:	Trees within 50m of the property
Information:	Trees within 50m of the property can be conducive to termite activity. It is recommended an invasive inspection of all trees with 50m to the property be carried out by a qualified pest control expert.

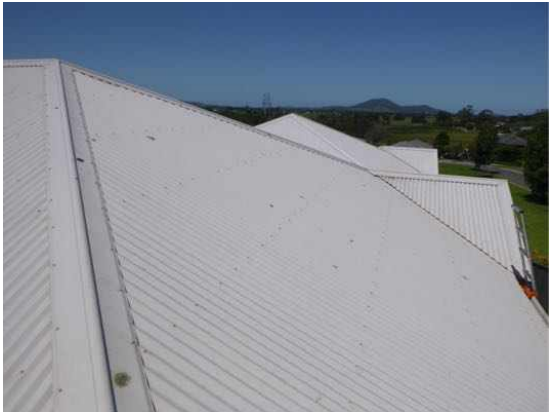
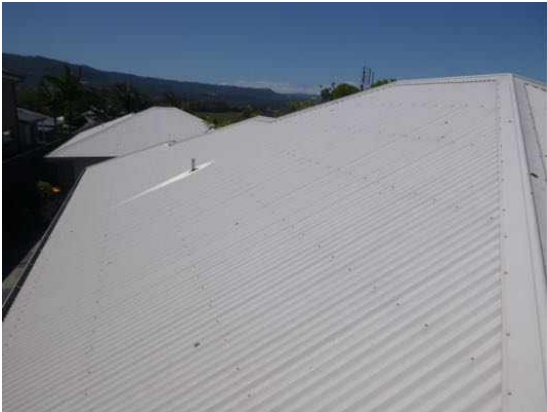
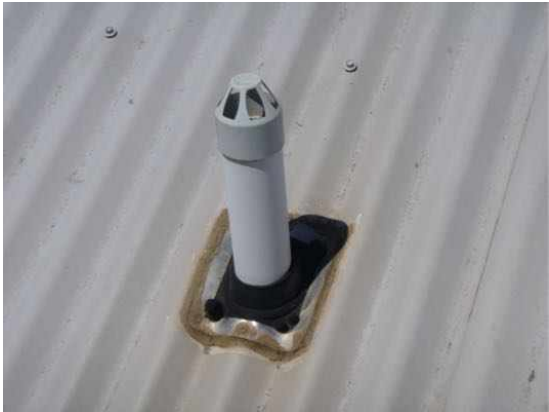
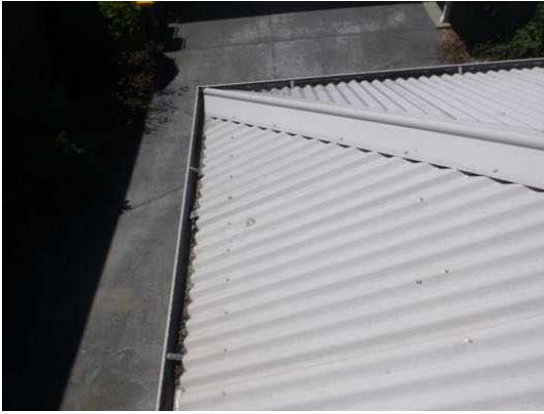
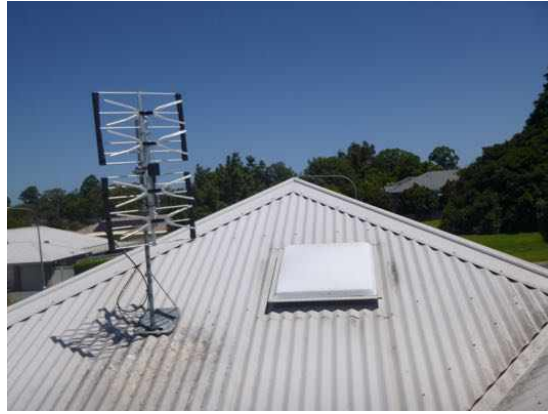
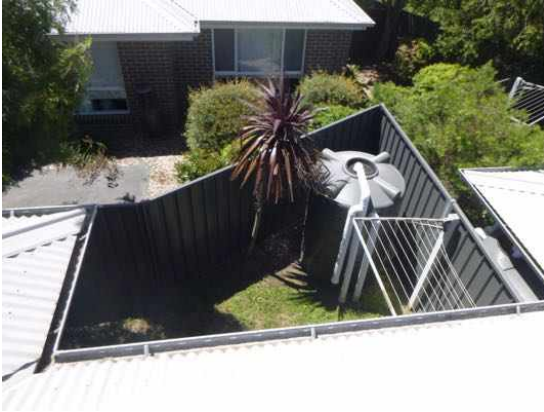
Building: Main Building  
Location: Roof Exterior  
Finding: Additional Photos - Obstructions and Limitations  
Information: These photographs are an indication of the obstructions and limitations which impeded full inspection of the property at the time of inspection. These obstructions can hide an array of defects and should be removed to allow full inspection to be carried out. A re-inspection is recommended once the areas are made accessible.

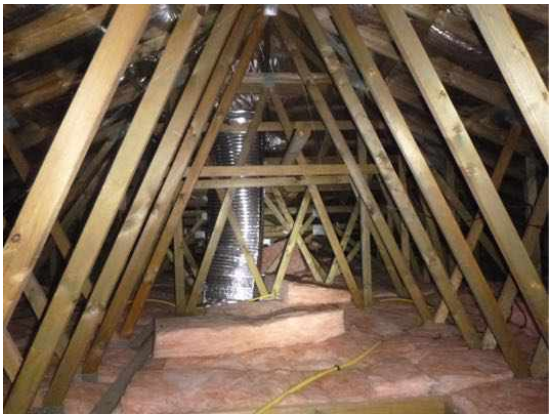
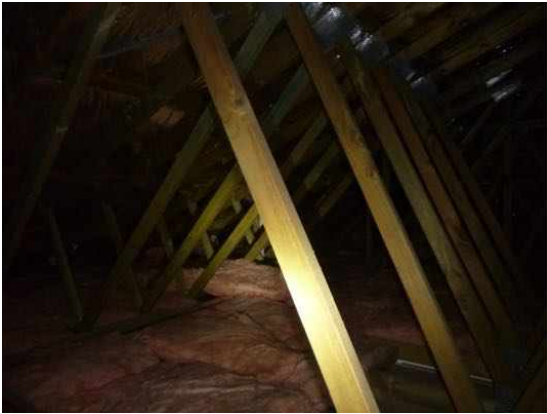
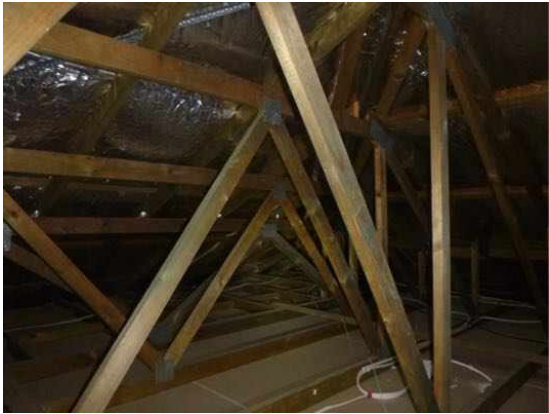
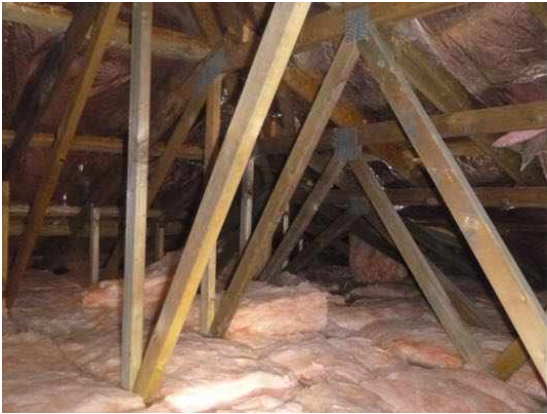
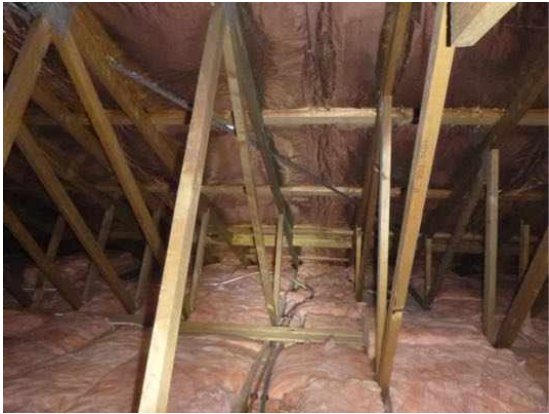
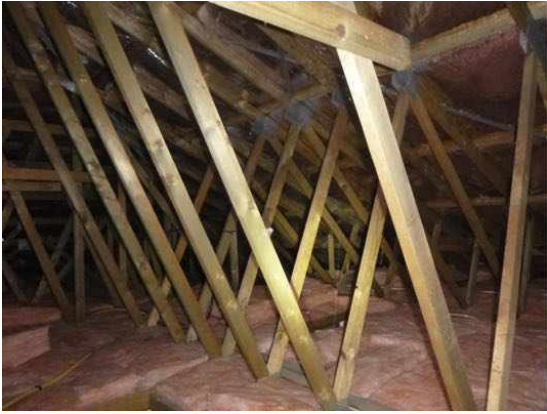
Building:	Main Building
Location:	Roof Void
Finding:	Additional Photos - Obstructions and Limitations
Information:	These photographs are an indication of the obstructions and limitations which impeded full inspection of the property at the time of inspection. These obstructions can hide an array of defects and should be removed to allow full inspection to be carried out. A re-inspection is recommended once the areas are made accessible.

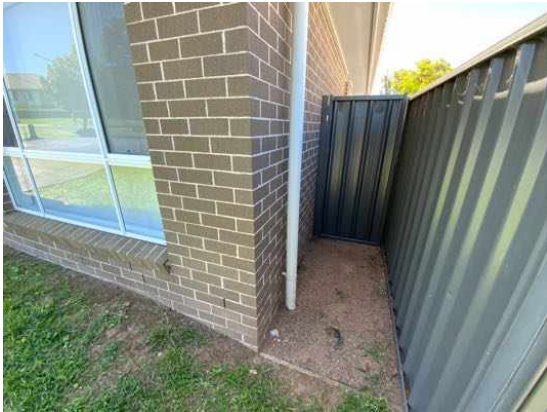
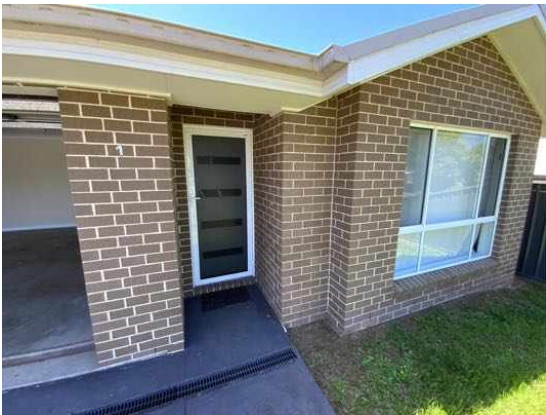
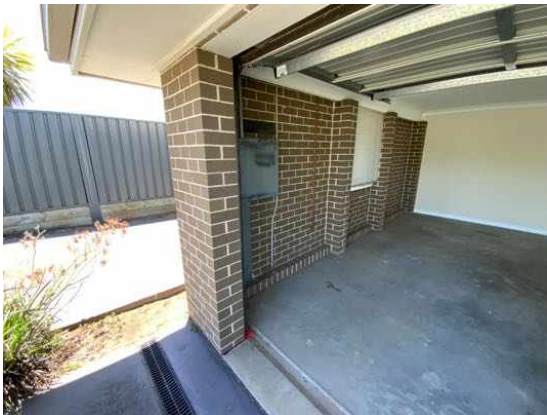
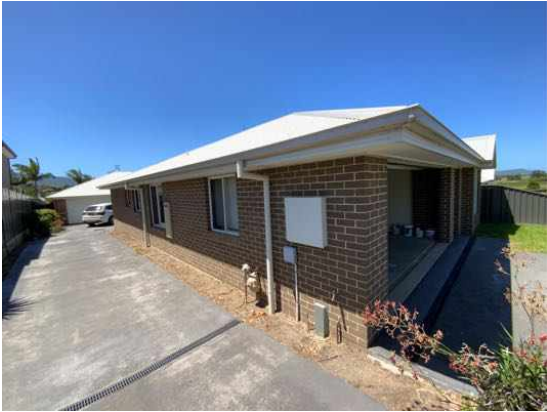
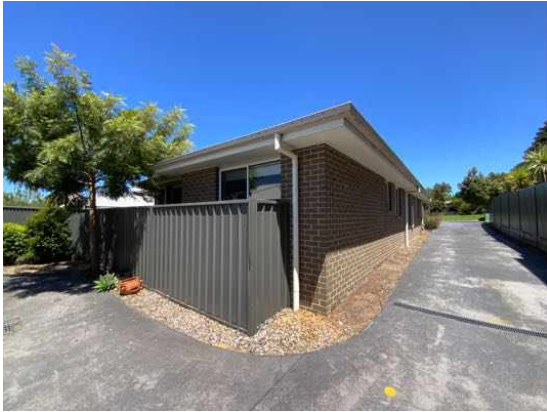
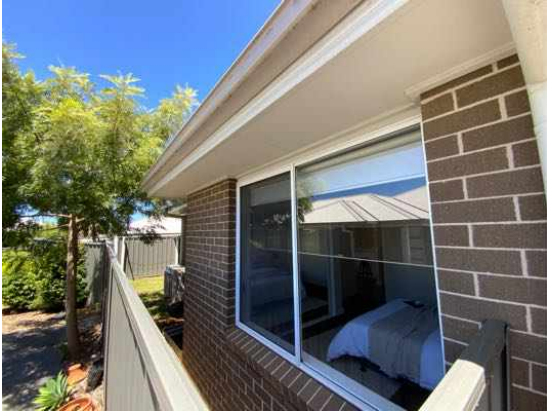
Building: Main Building  
Location: All Areas  
Finding: Additional Photos - Obstructions and Limitations  
Information: These photographs are an indication of the obstructions and limitations which impeded full inspection of the property at the time of inspection. These obstructions can hide an array of defects and should be removed to allow full inspection to be carried out. A re-inspection is recommended once the areas are made accessible.

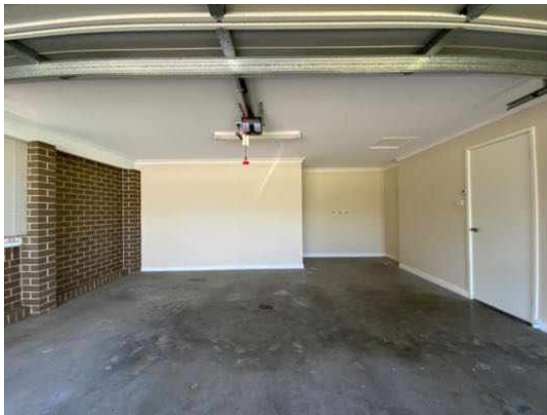
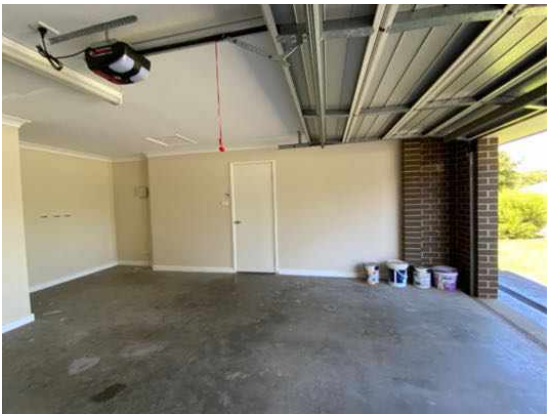
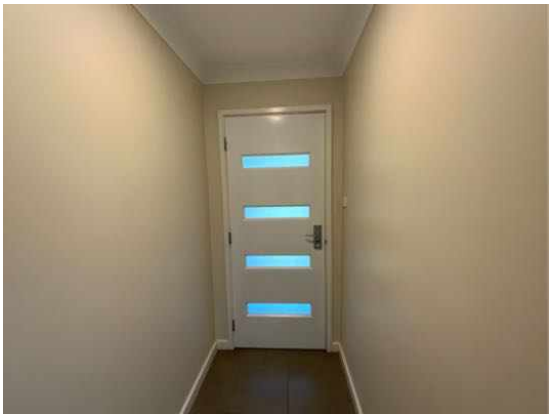
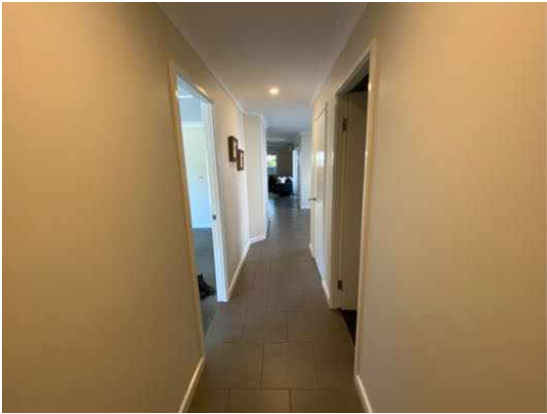
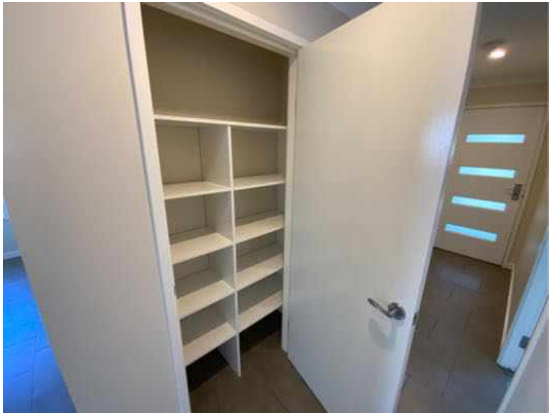
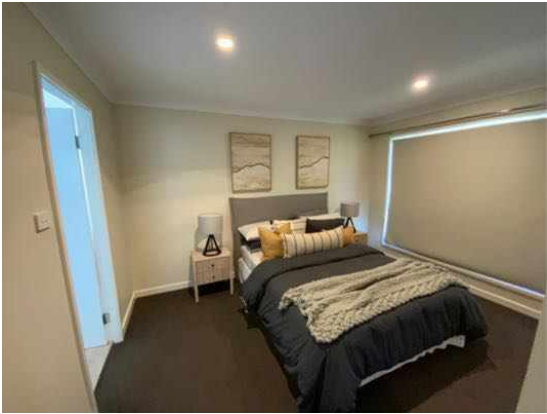
Building: Main Building  
Location: All Areas  
Finding: Additional Photos - Obstructions and Limitations  
Information: These photographs are an indication of the obstructions and limitations which impeded full inspection of the property at the time of inspection. These obstructions can hide an array of defects and should be removed to allow full inspection to be carried out. A re-inspection is recommended once the areas are made accessible.

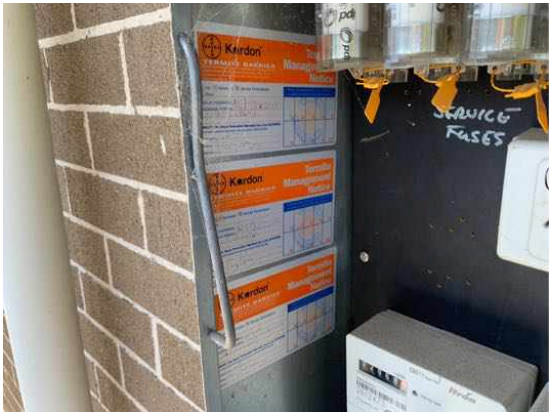
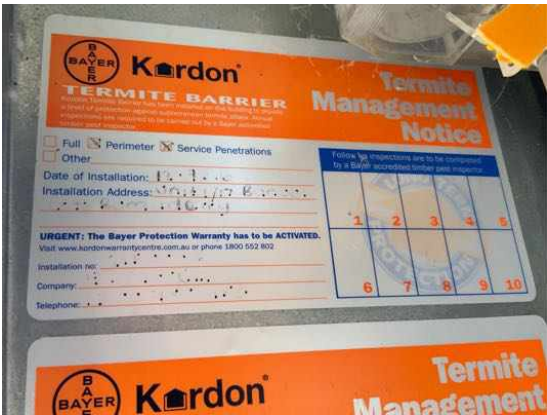
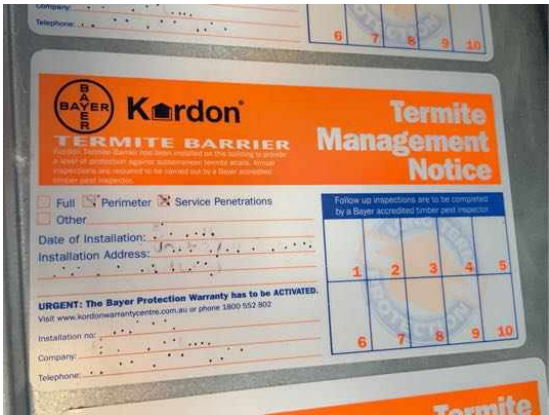
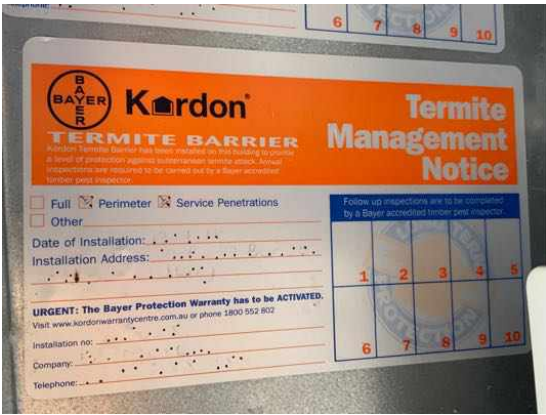
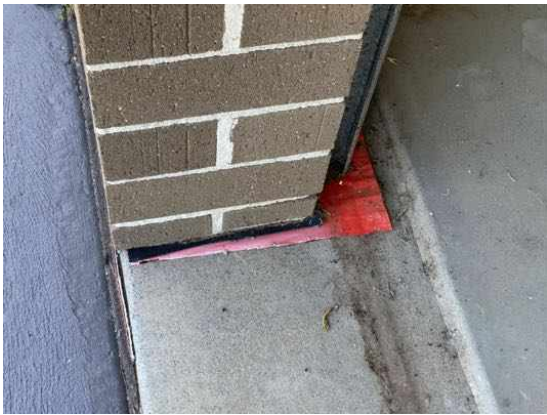
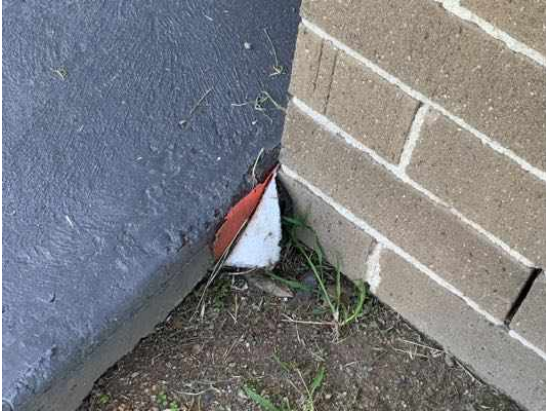
Where a Termite Management System has been identified you should refer to the type of barrier date of installation warranty conditions and any documentation provided by a builder or past owner. Consult the company who installed the barrier to confirm whether the system is still under warranty.

Most chemical termite management systems expire and require replenishment and all physical systems are primarily designed to prevent concealed entry.
