# Building and Timber Pest Inspection Report

Inspection Date: Wed, 18 Feb 2026

Property Address: 76A Kingborn Ave, Seaton SA 5023,  
Australia

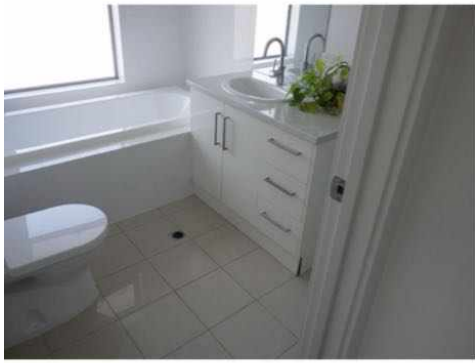
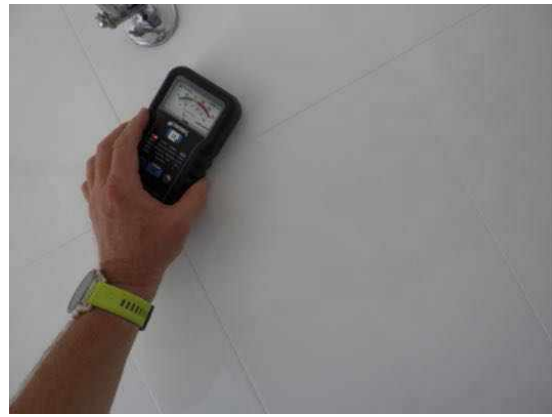
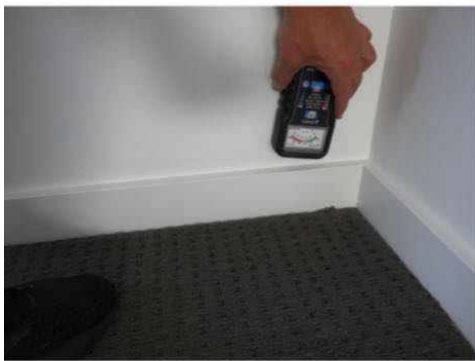
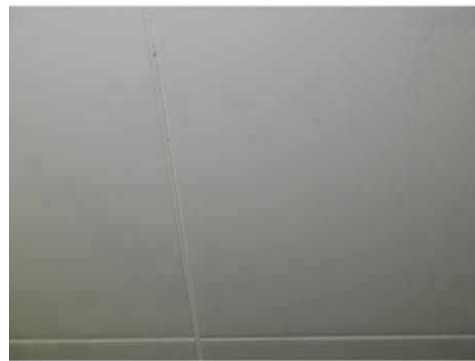
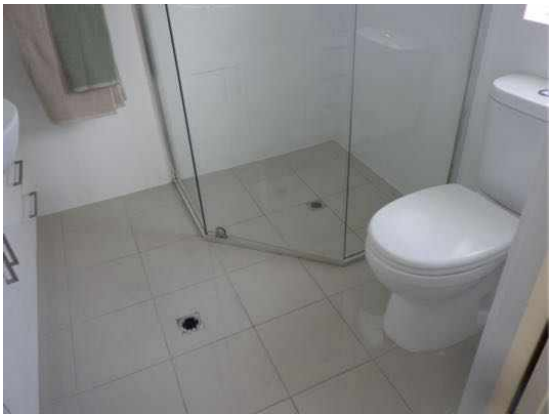
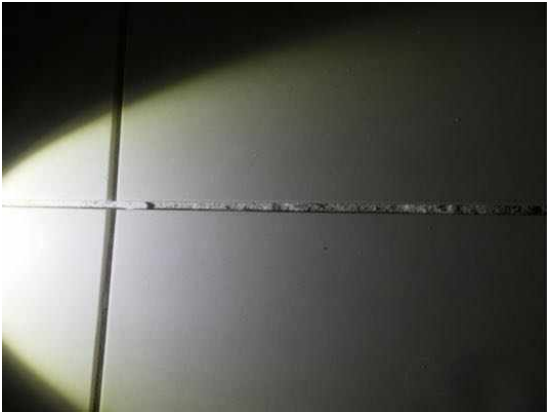
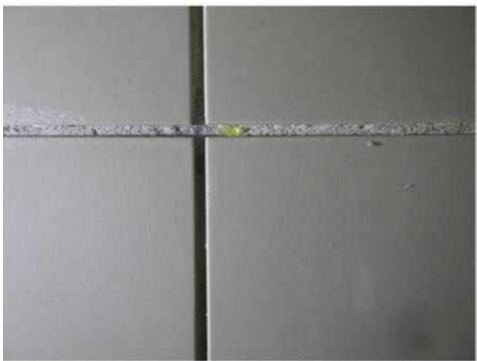
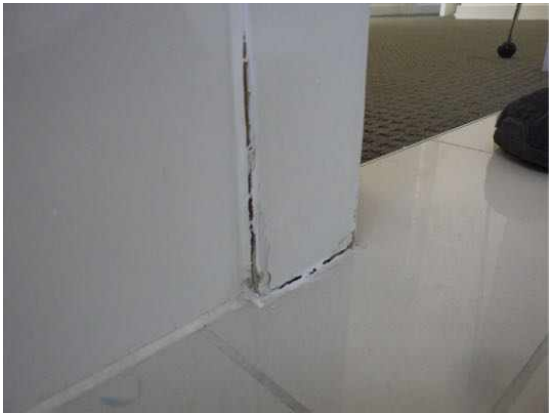
#### Finding 2.01

Building:	Building 1
Location:	Upstairs bathrooms
Finding:	Shower - Damp
Information:	Damp was evident to the lower wall to the shower alcoves at the time of inspection. Minor moisture damage is also evident to the door frame entering the bathroom.

This defect is quite common, and is suspected to have been caused by moisture permeating through the tiling, grouting and or sealant in this area, which shows evidence of minor deterioration.

Leaking pipes within the adjoining wall is also a possible cause however it seems unlikely in this instance as there was no high readings around the taps nor transferring to the other side of the wall.

Consultation with a qualified plumber or bathroom sealant specialist is advised in the short term to identify the cause of damp and to perform remedial works as required.

Always ensure that sealant and grout is in good condition to prevent any moisture issues occurring in the future. Sealant and grout should be maintained every five years at a minimum and it would appear that the silicon and grout in this instance is original.

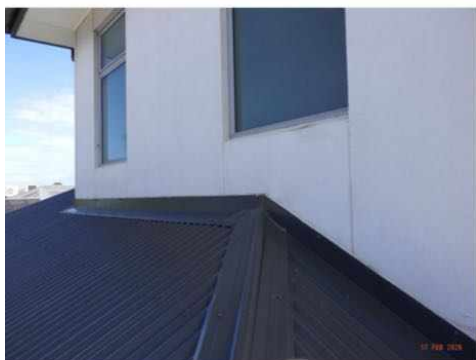
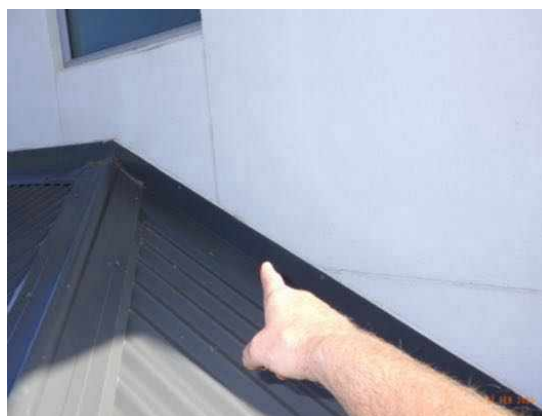
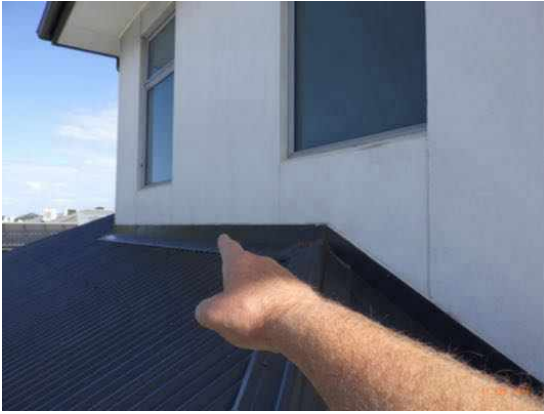
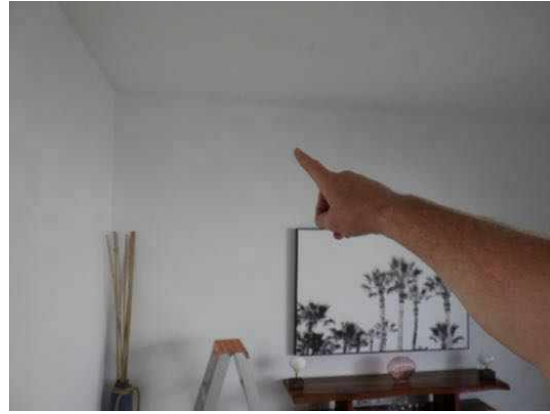
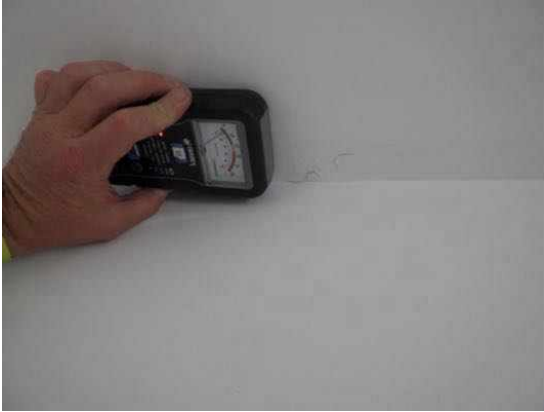
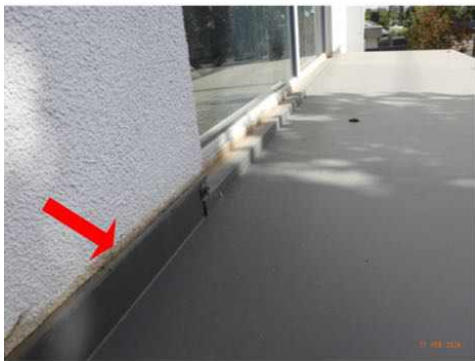
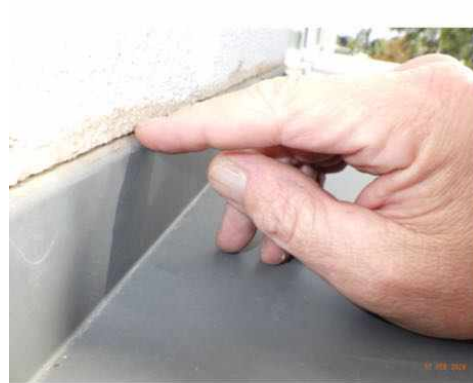
### Finding 3.01

Building: Building 1  
Location: Exterior walls - upper  
Finding: External Sealant - maintenance required  
Information: It was noted on inspection that sealant is showing evidence of repair at the rear upper wall of the dwelling with water appears to be some small old damage to the ceiling below. However the side is still in original condition and should be over sealed to ensure adequate sealing of the dwelling, and the front hoods also require sealant

Secondary defects can occur if maintenance is not carried out ranging from moisture in walls to deterioration of adjacent building elements

Flexible and materials should be applied to affected areas to prevent any subsequent water damage that can occur. Regular maintenance and replacement of damaged/ deteriorated sealant is highly recommended as this is a regular wear and tear defect.

Repairs are required and should be carried out by a licensed sealant specialist at your soonest convenience.

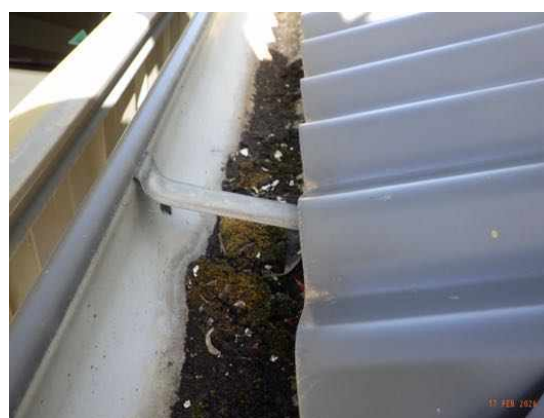
### Finding 3.02

Finding: Gutters - Blocked

Blocked gutters are likely to lead to high levels of moisture in the affected areas. Such moisture will not only cause rust and decay of the associated building materials, but can also provide conditions that are conducive to termite and timber pest activity. Blockages in gutters should therefore be removed immediately to ensure dry conditions are maintained.

Consult a Licensed Plumber for further specific advice on remedial works that may be required. In the interim, it is highly advised that blocked gutters be removed by the homeowner or a general handyperson as a matter of urgency.

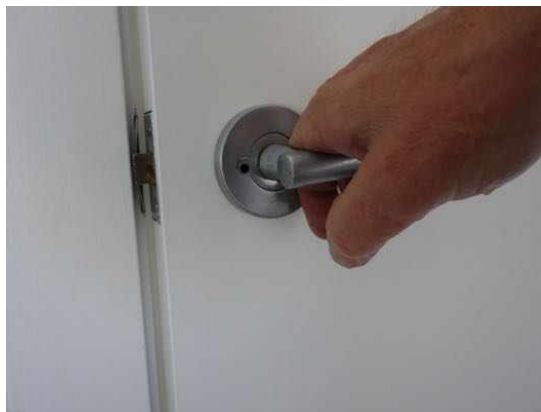
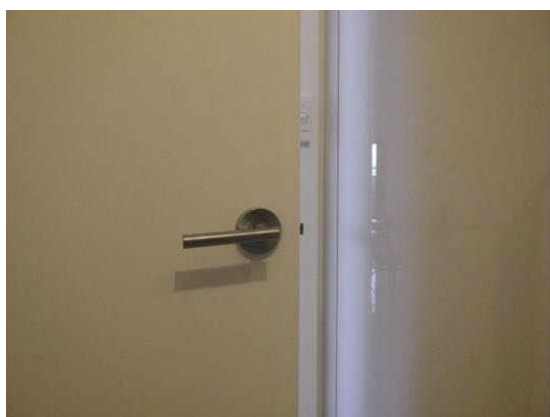
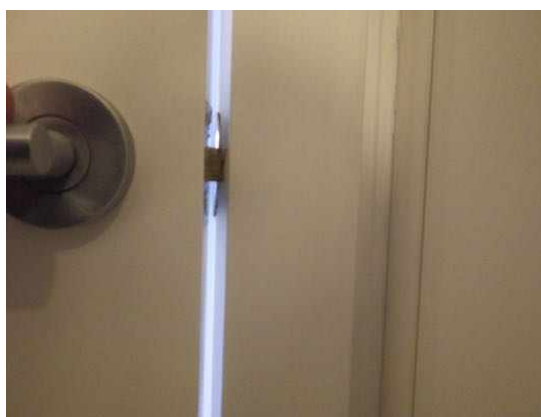
### Finding 3.03

Building:	Building 1
Location:	All Internal Areas
Finding:	Several Doors - Striker plate misaligned
Information:	The striker plate to several doors appears to have become misaligned and has consequently resulted in the door's operation being compromised.

This is a common defect and is expected in a property of this age, whether being due to substandard installation or general deterioration of the door hardware and or seasonal changes. .

Readjustment of the striker plates is recommended at client discretion. Works such as these can be completed by a general handyman or qualified carpenter.

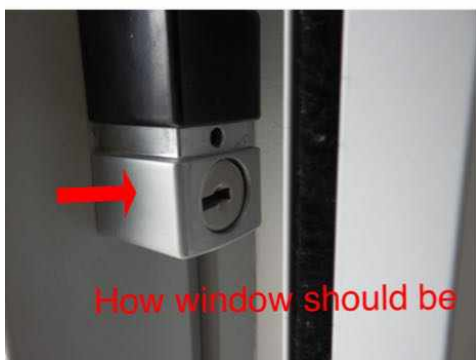
### Finding 3.04

Building:	Building 1
Location:	Bedroom 4
Finding:	Window lock - damaged
Information:	The window lock to the lower bedroom did not appear to be operating correctly at the time of inspection. This window latch appears different to the rest indicating that the locking mechanism may be damaged or missing.

Where locks have deteriorated to a point where they are no longer usable, the security of the property is immediately compromised.

Repair/ replacement of the lock is highly recommended.

Consultation with a locksmith or general handyman is required to gain further advice on any added security that may be available for the area.

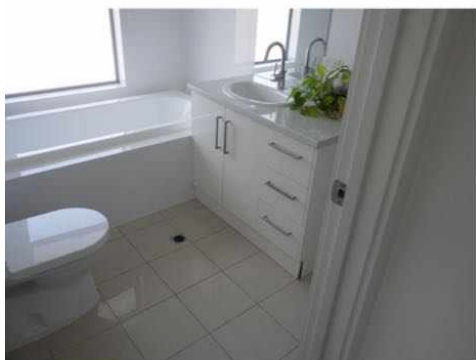
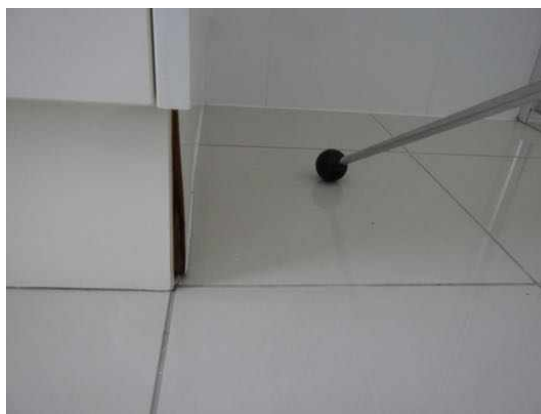
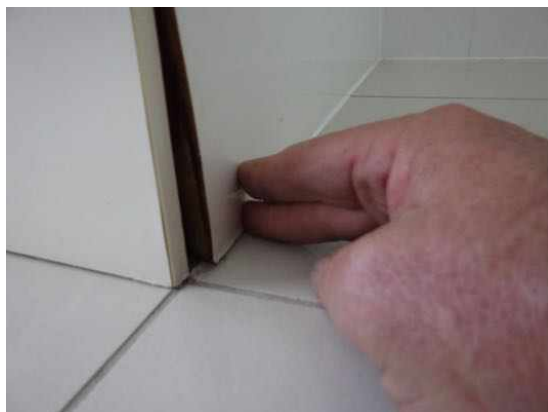
### Finding 3.05

Building:	Building 1
Location:	All Areas
Finding:	Minor defects present
Information:	There were several age and maintenance related defects evident to the dwelling at the time of inspection. These defects include but are not limited to

- Exterior lights rusting.
- Side sliding door rollers deteriorated.
- Garage roller door malfunctioning. Service required.
- Bathroom kickers deteriorated.

Appropriate licensed trades people could be appointed to make repairs at the discretion of the client.

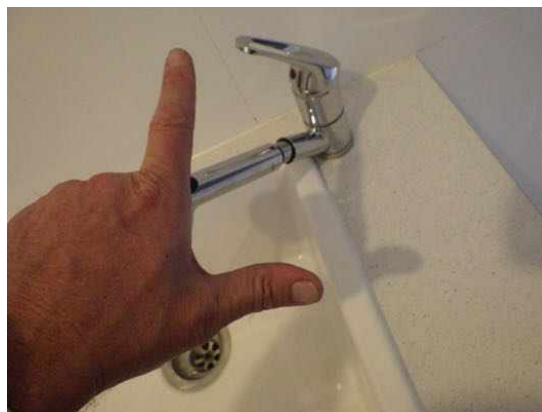
### Finding 3.06

Building:	Building 1
Location:	All Internal Areas
Finding:	Plumbing issues.
Information:	All plumbing should to be maintained in good order.

However Issues noted by the inspector include but are not limited to

- Drain plugs corroded and likely require replacement.
- Loose laundry sink outlet.

It is highly recommended that the client makes contact with a licensed plumber to make required investigations and adjustments prior to any further secondary defects being created.

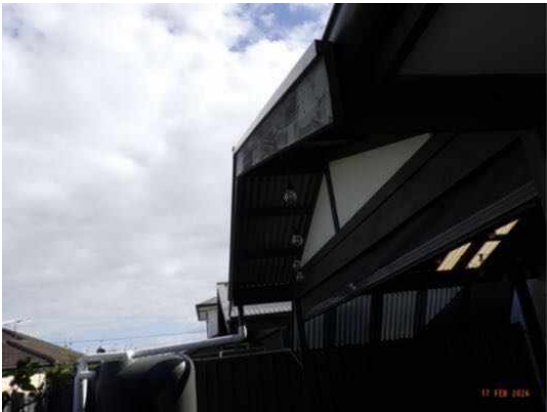
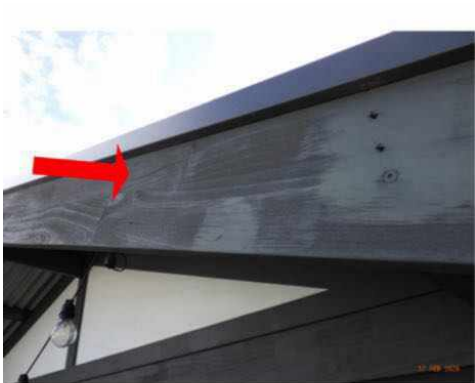
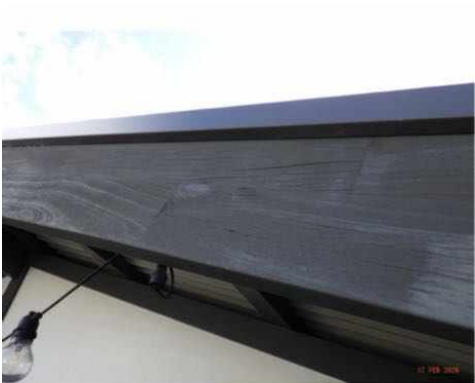
### Finding 3.07

Building:	Building 1
Location:	Pergola
Finding:	External painting deteriorated
Information:	Some of the external paintwork including but not limited to the pergola have been neglected and require attention to prepare and re-paint.

It was also noted that the pergola barge beam is twisted and will require reattaching or replacement.

Whilst incomplete or missing paint finish is generally an appearance defect, it can also lead to the development of secondary building defects over time. Incomplete areas of paint finish expose the area to moisture, potentially accelerating the deterioration of underlying building materials.

Degraded paint finishes should be sanded back, filled, leveled and painted, as applicable. Where inadequate or missing paint protection has led to the deterioration of the associated building element, repair and/or replacement of this building element may be required.

A painting contractor should be appointed as soon as possible to perform necessary works to aid the appearance of the affected area and to ensure the area is protected against further deterioration. Alternatively, the homeowner following manufacturer

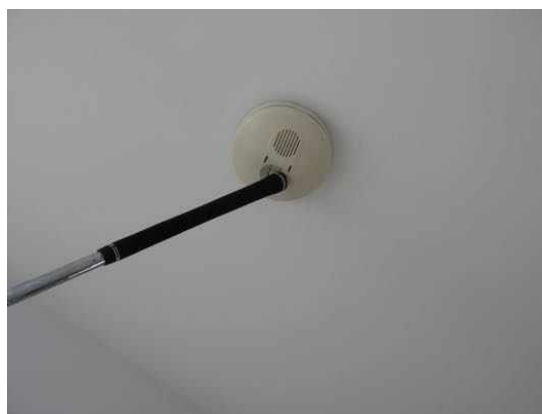
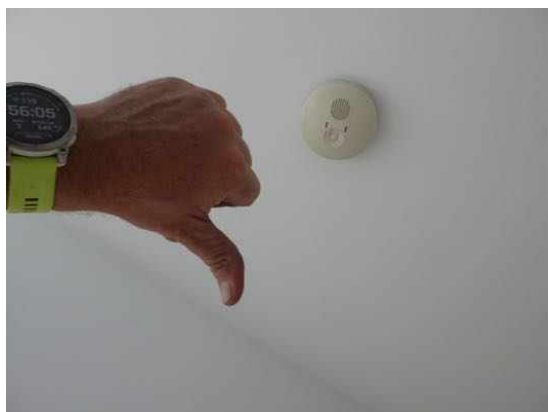
Noted Item

Building: Building 1  
Location: Downstairs  
Finding: Smoke Detectors and Alarms  
Information: Reporting on Smoke Detectors or Alarms, including hard wired smoke detection systems and their legislative requirements, is outside the Scope of this Report.

Please note that this defect is highlighted as a caution only. We suspect, based on our experience in the building industry, that the absence of smoke detectors, or their poor condition, should be addressed as a matter of urgency to improve occupant safety.

Always ensure sufficient working and suitable smoke detectors are installed prior to occupying any building. Additionally, it is advised that all smoke detectors be tested by the homeowner on a monthly basis.
