Building and Timber Pest Inspection Report

Inspection Date: Mon, 9 Mar 2026

Property Address: 10 Peace Ave, Pymble NSW 2073, Australia

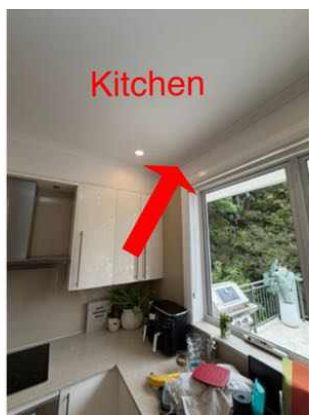
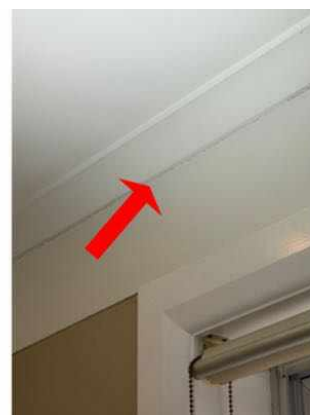
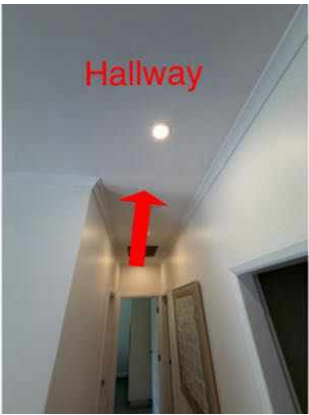
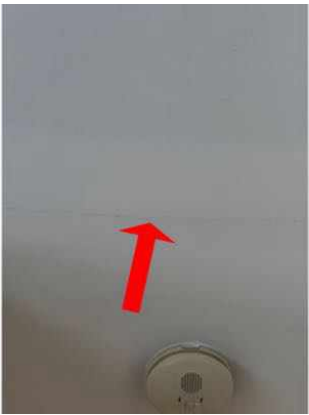
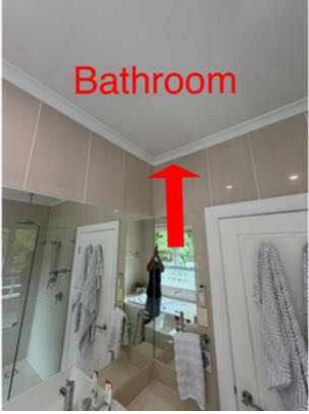
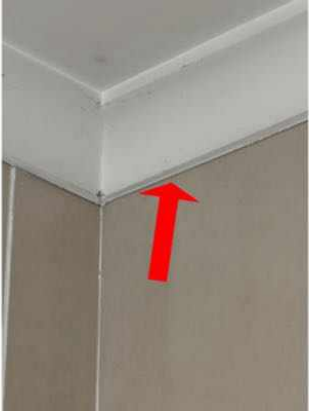
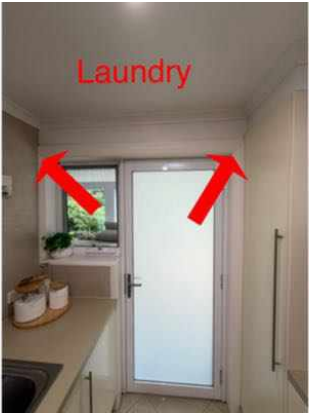
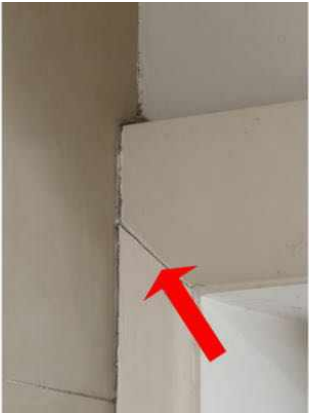
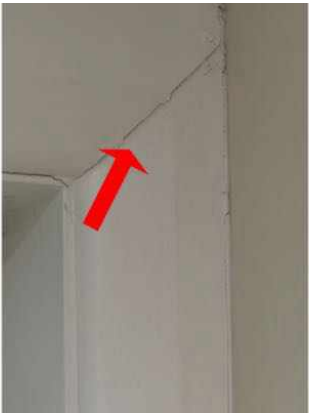
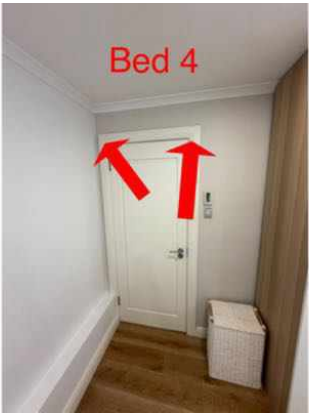
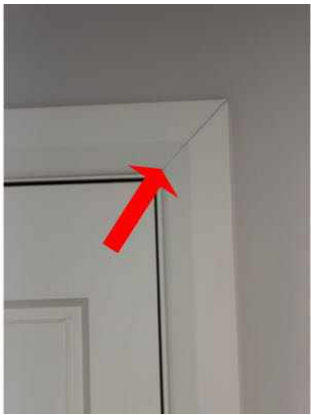
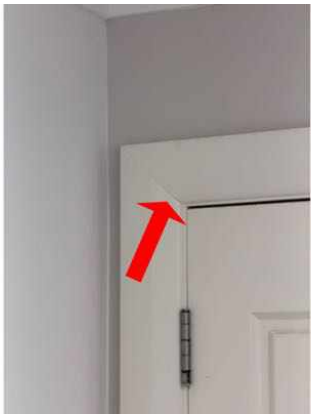
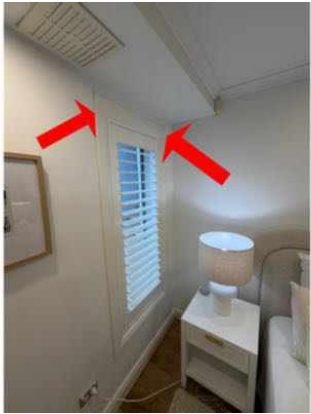
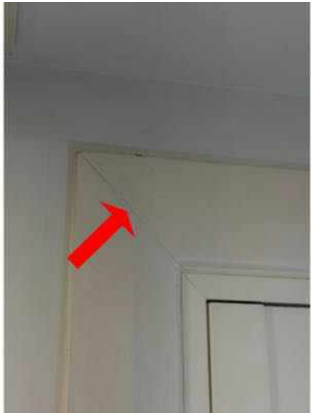
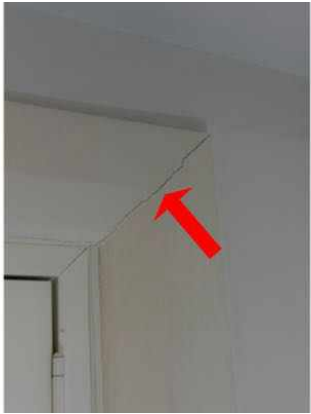
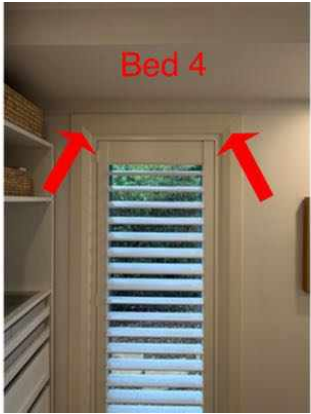
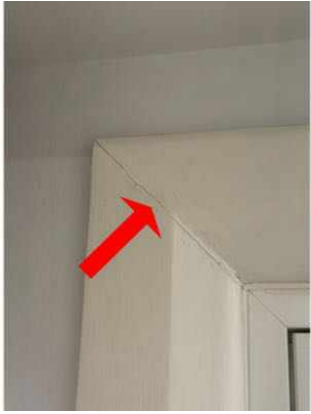
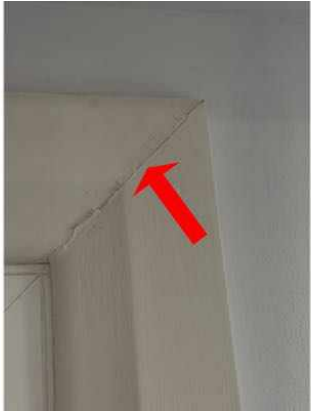
Building: Main Building
Location: All Internal Areas
Finding: Fine Cracking to Skirtings, Architraves, Cornice
Information:

Fine cracking was observed to corner junctions of skirting boards, architraves and cornices throughout the dwelling.

The cracking appears minor in nature and is commonly associated with normal building movement, settlement, material shrinkage, or minor seasonal expansion and contraction of finishes.

At the time of inspection, no significant distortion or major structural concern was evident; however, the cracking affects the cosmetic finish of the internal linings.

I recommend to Seal, patch and repaint affected areas as part of routine maintenance. Monitor for any progression or widening of cracking which may warrant further assessment if changes are observed.

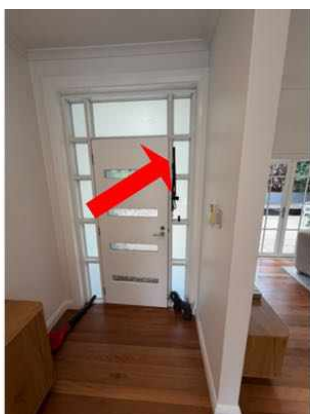
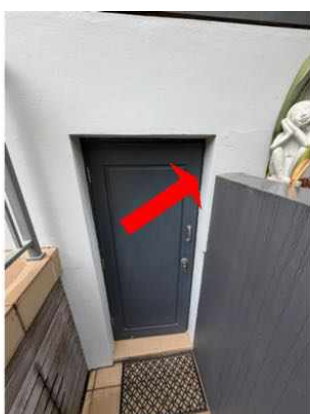
Finding 3.02

Building: Main Building
Location: All Internal Areas
Finding: Doors - Binding/Jamming
Information: Binding and/or jamming of several doors throughout the property were evident during standard operation. This defect inhibits the functionality of affected doors as well as creating potential for secondary defects to associated building elements, such as damage to the floor covering.

A door that binds to flooring or to the associated door frame may have several causes, ranging from minor defects, such as poor installation of the door or deteriorated hinges, through to major structural issues, such as damage to subfloor structures.

Where door binding/jamming appears to indicate major structural issues, a registered builder specialising in re-stumping should be appointed to provide an estimate on the cost of rectification.

For minor causes, a qualified carpenter or general handyperson should be appointed to perform minor rectification works at client discretion.

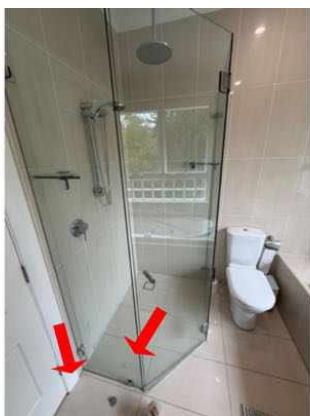
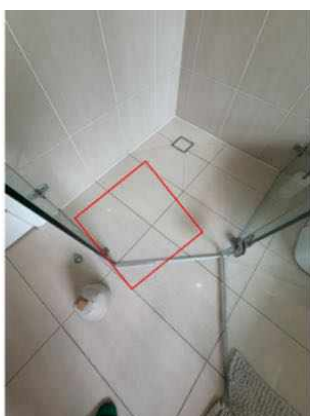
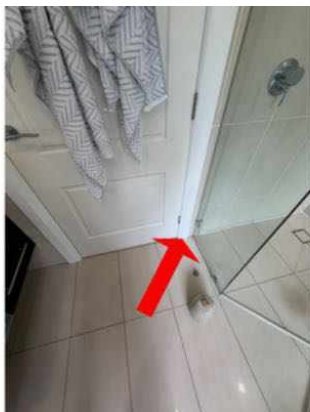
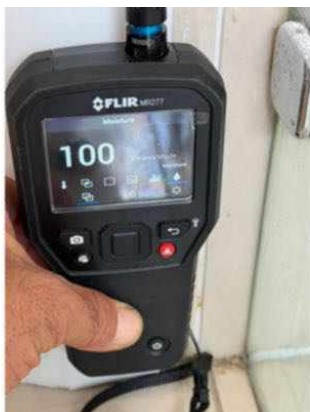
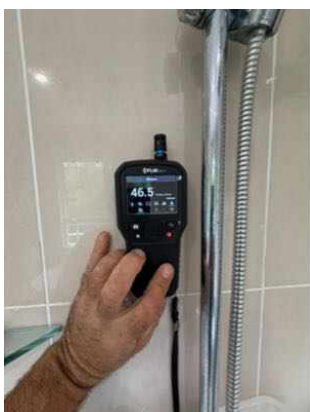
Finding 3.03

Location: Bathroom
Finding: Shower–Water Pooling
Information: At the time of inspection, one section of the floor tiling within the main bathroom shower was observed to be incorrectly graded, resulting in water pooling in that area. The affected tile falls back toward the shower screen rather than toward the waste, which may allow water to sit against the screen or track toward adjoining building elements.

Although no active leakage outside the shower screen was observed at the time of inspection, elevated moisture readings were detected in the adjacent door architrave. The architrave was also noted to be deteriorated and showing signs consistent with previous wood rot that appears to have been painted over. This indicates that moisture ingress has likely occurred in the past.

It is recommended that the affected architrave be removed and replaced, and the shower floor grading be assessed and rectified as required to prevent ongoing or future moisture issues. Moisture readings taken to the remaining shower walls were within normal limits at the time of inspection.

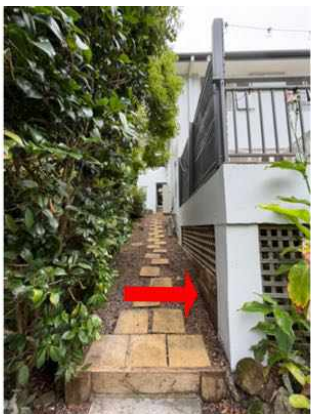
Building:	Yard
Location:	Yard
Finding:	In ground contact
Information:	Any timbers in direct ground contact provide opportunity for concealed termite entry and are likely to be subject to premature rot and decay as the soil retains moisture or damp conditions against the timbers.

Treated Timbers can decay or be poorly treated at manufacturing and as they degrade overtime can allow for termite attack.

Remove any timber that is in direct contact with external grounds. Consider replacement with more durable materials i.e. non timber elements. Frequent pest inspections are advised to readily identify any termite activity in these areas.

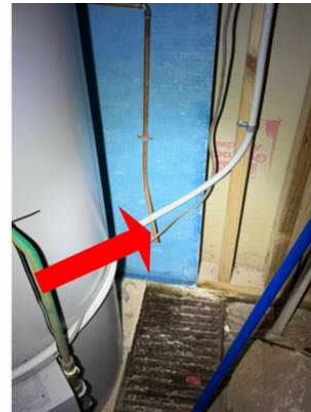
These damp conditions can lead to secondary defects such as rot, rust or corrosion of associated building elements, the formation of fungal decay, or even the creation of potential slip hazards. When coupled with poor site drainage, pooling of water may also attract termite activity to this area.

It is highly recommended that a qualified plumber be appointed to install adequate drainage to the overflow. These works will ensure that the area remains dry and free of any secondary defects.

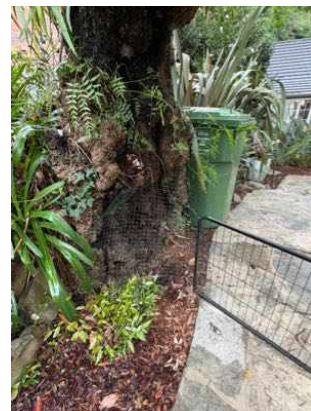
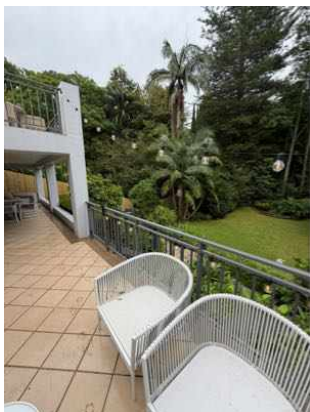
Finding 6.04

Building:	Main Building
Location:	Yard
Finding:	Large trees/stumps within 30m of house
Information:	There are a number of large trees/stumps within 30m of the house which may contain natural termite activity. It is important to monitor these areas to ensure no natural activity is allowed to progress into the main house.

Regular inspections are recommended. Consider test drilling any large trees.

A pest controller can be contacted to carry out such testing at the owners discretion.

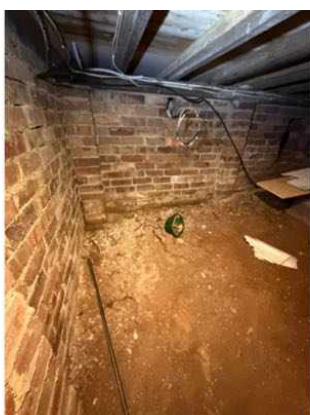
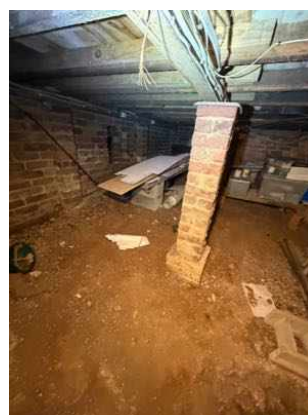
Finding 6.05

Building:	Main Building
Location:	Subfloor
Finding:	Excessive subfloor moisture
Information:	Excessive moisture can attract termites and produce conditions that promote termite attack fungal growth and wood decay.

Excessive moisture is generally caused by inadequate subfloor ventilation and poor site drainage.

There appear to be inadequate vents installed to the perimeter of the building and I would suggest that further solar powered fans or the like be installed to improve cross flow ventilation and aid in keeping the subfloor area relatively dry.

The installation of additional surface drainage to the property would also be beneficial to keeping the subfloor dry.

It is highly recommended that both subfloor ventilation and site drainage be improved and maintained regularly in order to prevent excessive moisture being present in the external / internal property.

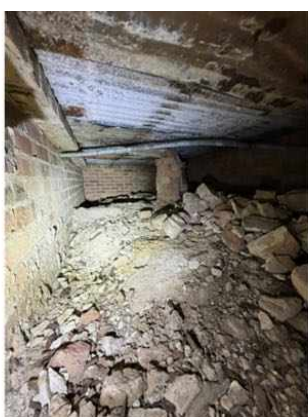
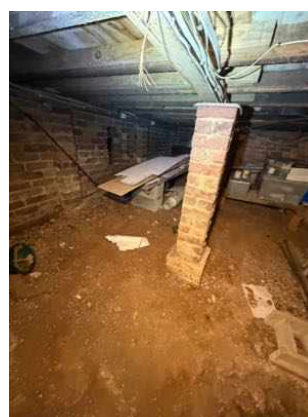
Finding 6.06

Building:	Main Building
Location:	Subfloor
Finding:	Subfloor - Lack of ventilation
Information:	It was noted at the time of inspection that the subfloor area lacks adequate ventilation. Ventilation can be restricted by a variety of minor defects, including obstructions in the subfloor space, a lack of vents or a low clearance.

A well ventilated subfloor aids in maintaining dry conditions, preventing secondary damage such as wood rot and pest activity, as well as preventing the development of mould and mildew (which can lead to respiratory safety hazards for occupants).

The initial step in improving ventilation is to ensure that the subfloor area is free of any debris or stored items. Where ventilation is still inadequate, it is advised to ensure that all vents are clear of blockages, and additional vents may be installed.

The client may also consider mechanical ventilation (powered fans) to improve subfloor airflow. Remedial works should be conducted as a matter of urgency to protect against the development of potentially harmful subfloor conditions.

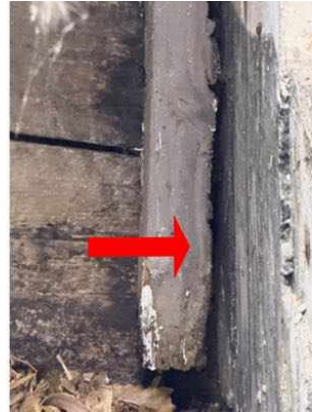
Finding 7.01

Building:	Main Building
Location:	All Areas
Finding:	Fungal decay - present at the time of inspection
Information:	Fungal decay also known as wood decay or wood rot occurs when timbers and other cellulose building materials are exposed to damp conditions on an ongoing basis. This could be the result of exposure to weathering in the long term or the pooling of water or absorbed moisture from other abutting building materials or a shower leak. It is advisable to remove these affected timbers to prevent any chance of termite attack in the future.

Wood decay is more susceptible to termite attack and these timbers should be replaced to limit termite attack.

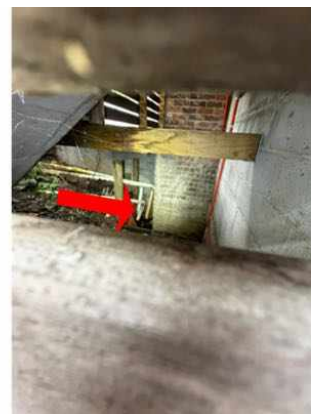
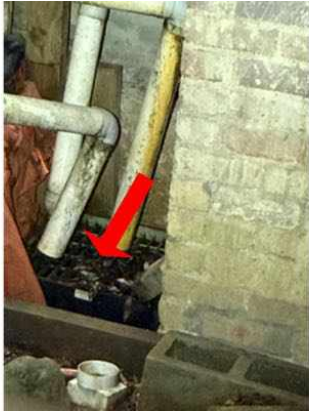
Building:	Main Building
Location:	Front area decking
Finding:	For Your Information – Stormwater Pit Access (Front Deck Area)
Information:	At the time of inspection, a stormwater pit was noted beneath the timber decking at the front of the dwelling. Several stormwater pipes discharge into this pit, whilst not ideal it is considered acceptable; however, the pit forms a critical collection point for the stormwater system.

A regular access point must be provided to this pit so that it can be inspected and cleaned as required. Should the pit become blocked with leaves, debris, or sediment, it is highly likely that stormwater will overflow and could result in flooding to the downstairs area of the dwelling.

Ongoing maintenance is therefore essential. The pit should be periodically checked and cleared of leaves and debris to ensure the stormwater system continues to function effectively and to reduce the risk of water ingress into the building.

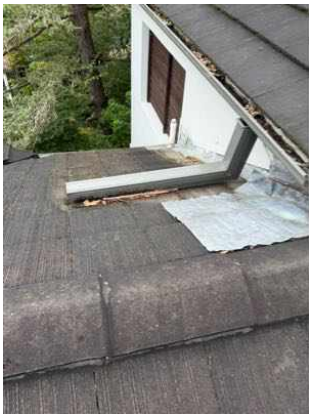
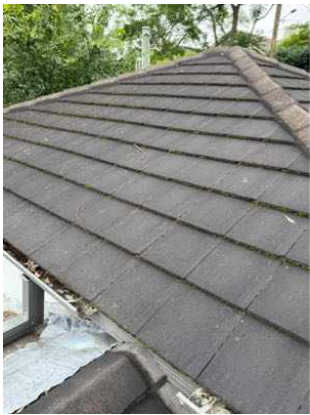
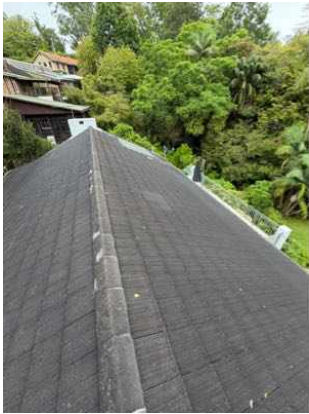
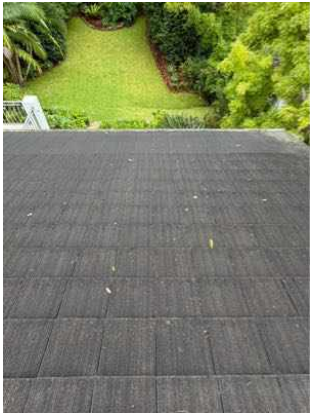
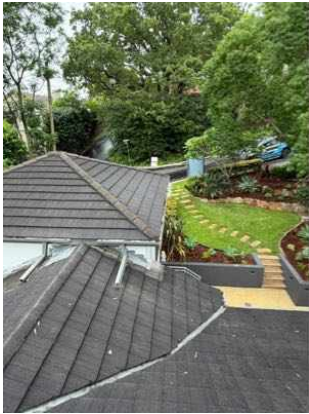
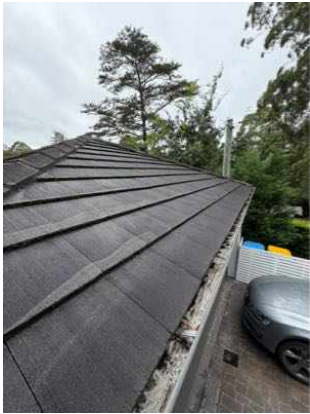
5 or 6 tiles were observed to be cracked at the lower corners which should be replaced.

Consultation with a roofing contractor is highly advised to gain advice on cost of remedial works that may be required in the short to medium term. Remedial works are likely to increase the longevity of the exterior roofing structure.
