Building Inspection Report

Inspection Date: Mon, 9 Feb 2026

Property Address: 33 Radstock Ave, HIGHTON, VIC, 3216,
Australia

Company Name: Jim's Building Inspections (Essendon West)

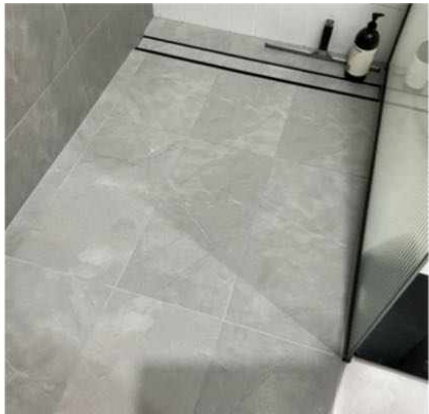
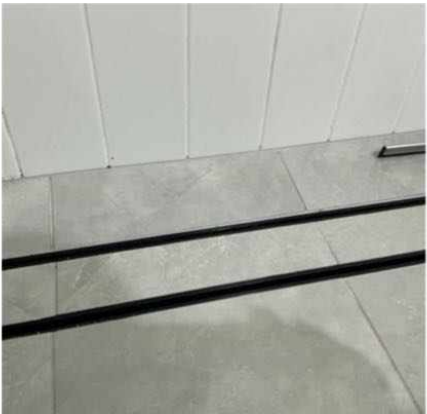
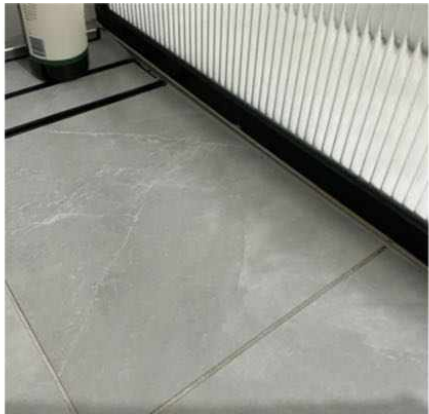
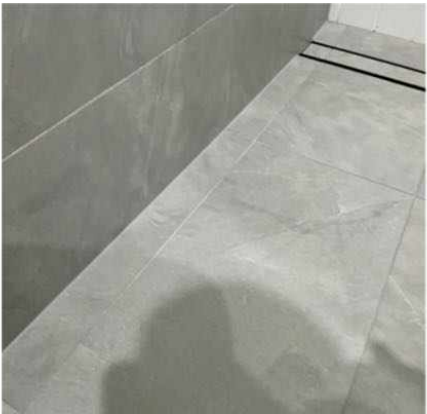
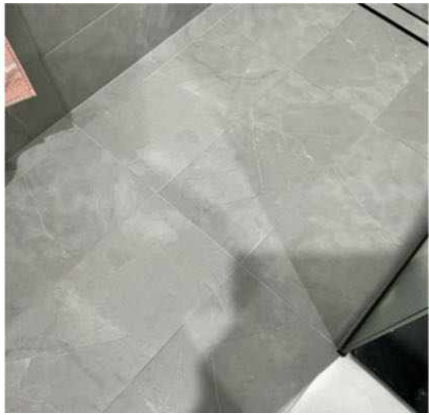
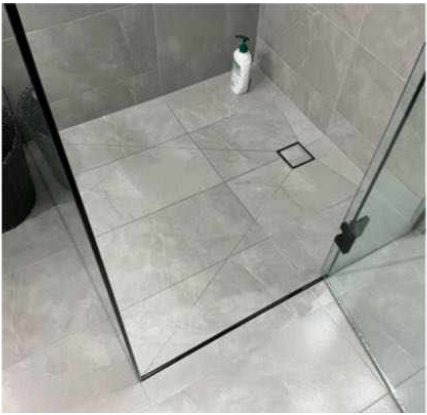
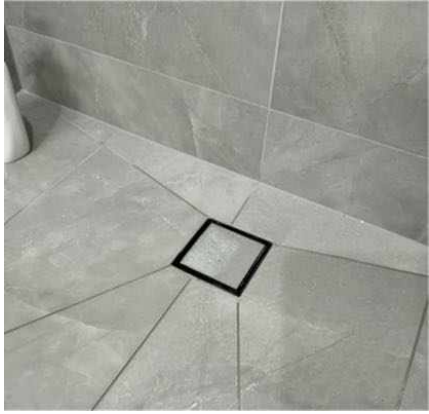
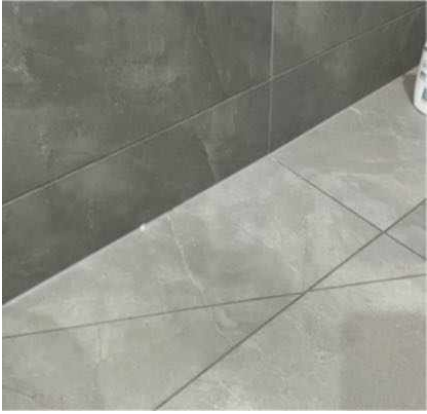
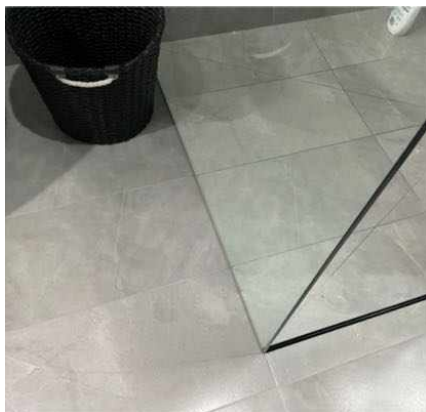
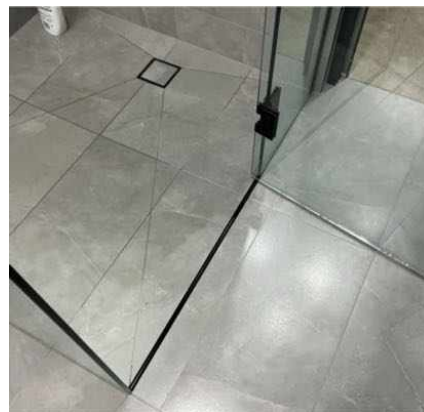
Defects 2.01

Building: Main Building
Location: Showers
Finding: Absence of Waterstops at Shower Entrances and Beneath Shower Screens
Information: Although the showers generally present in good visible condition, inspection indicates that waterstops do not appear to have been installed at the shower entrances or beneath the fixed shower screens. No visible evidence of waterstop angles or compliant terminations was observed at these locations. A waterproofing certificate has been supplied; however, based on the visible finishes, it is unclear whether the installed waterproofing and waterstop detailing is compliant with the requirements of AS 3740.

- The apparent absence of waterstops increases the risk of water migrating beyond the shower area and beneath adjoining floor finishes
- Moisture ingress may occur without being immediately visible, potentially affecting substrates and adjacent areas
- Where waterstop installation does not align with AS 3740 requirements, the long-term performance of the wet area may be compromised

At the time of inspection, the absence of visible waterstops at the shower entrances and beneath the shower screens raises compliance concerns, and further verification and rectification may be required to ensure the wet areas perform as intended.

- Seek written clarification from the waterproofing contractor confirming the location and compliance of installed waterstops in accordance with AS 3740
- If compliant waterstops have not been installed, engage a qualified waterproofing contractor to carry out rectification works
- Ensure any rectification is supported by updated documentation confirming compliance with AS 3740

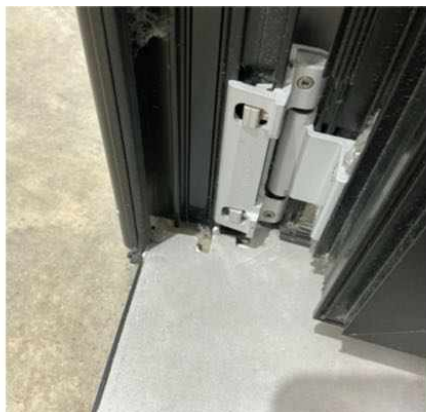
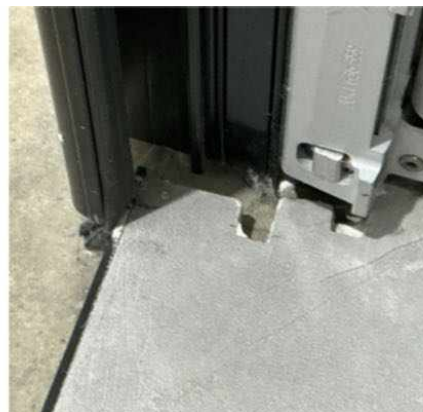
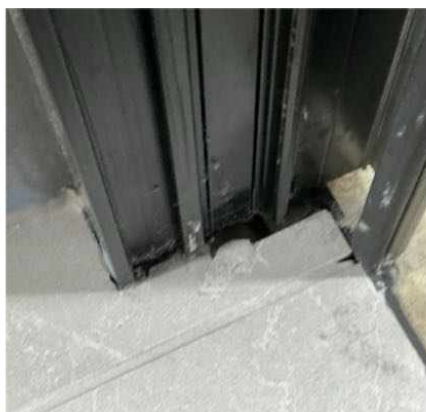
Defects 2.02

Building:	Main Building
Location:	Bathroom
Finding:	Incomplete Waterstop at Doorway and Poor Tile Termination to Door Jamb
Information:	At the doorway, the waterstop installation is incomplete, as it does not terminate against the door jamb. The waterproofing membrane was not visible at the doorway location, and the waterstop does not appear to provide continuous protection across the full width of the opening. A waterproofing certificate has been supplied; however, based on the visible finishes, it is unclear whether the doorway waterproofing and waterstop detailing has been installed in a compliant manner. In addition, the floor tiles have been cut irregularly around the door jambs, resulting in poor detailing and finish at this junction.

- An incomplete waterstop at the doorway increases the risk of moisture migration beneath the tiled floor and into adjoining areas
- Lack of proper termination of the waterstop against the door jamb compromises the effectiveness of the waterproofing system
- Poorly cut and irregular tile edges reduce the quality of finish and may be more susceptible to deterioration over time
- Moisture ingress at this location may lead to concealed damage to substrates and adjoining finishes

At the time of inspection, the doorway waterproofing and tile detailing raise compliance concerns. Further verification and rectification may be required to reduce the risk of moisture ingress and to achieve an acceptable standard of durability and finish.

- Confirm that the waterproofing membrane provides continuous and compliant protection across the full width of the doorway threshold
- Remove and re-cut tiles at the door jamb as required to achieve a neat, uniform, and properly detailed finish

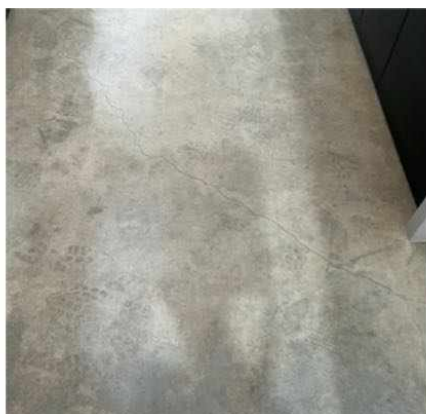
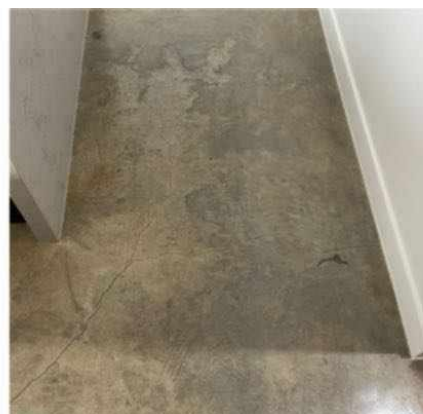
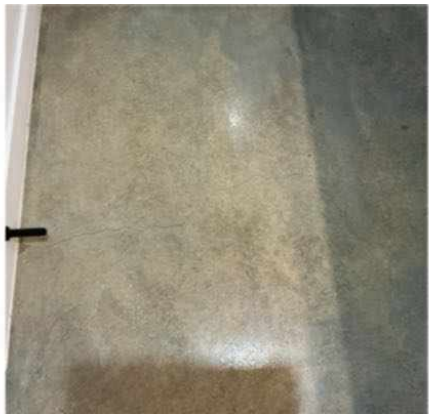
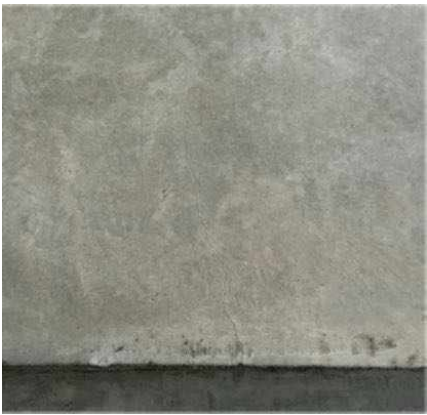
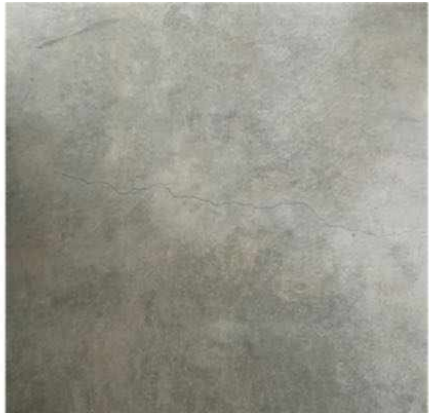
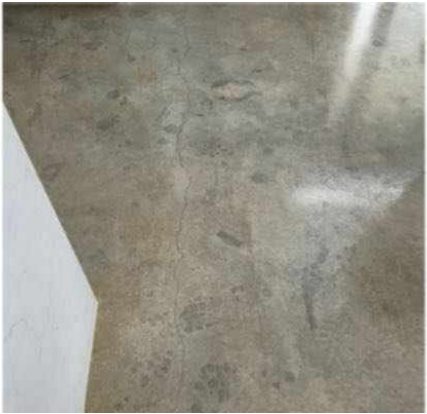
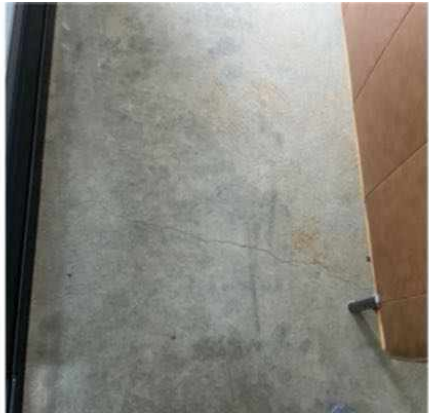
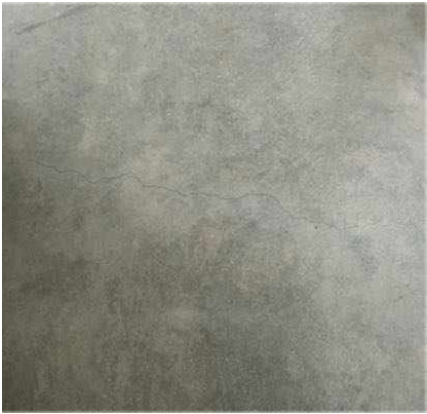
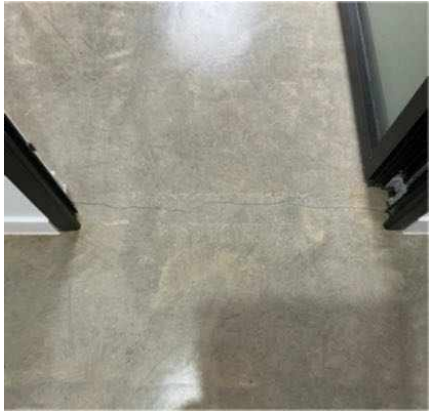
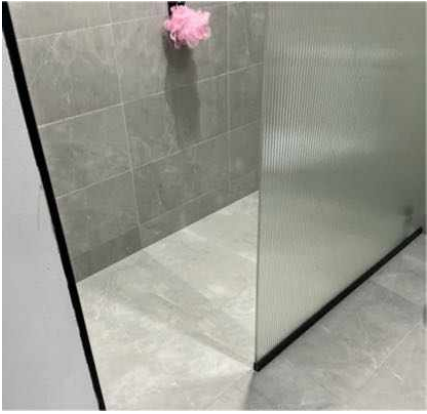
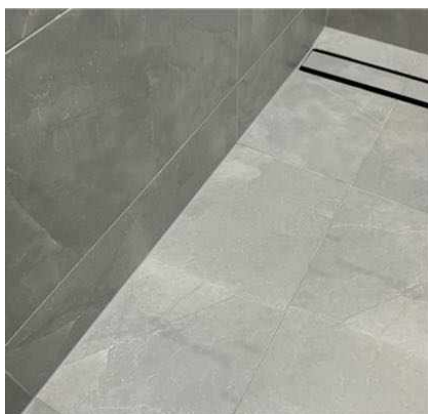
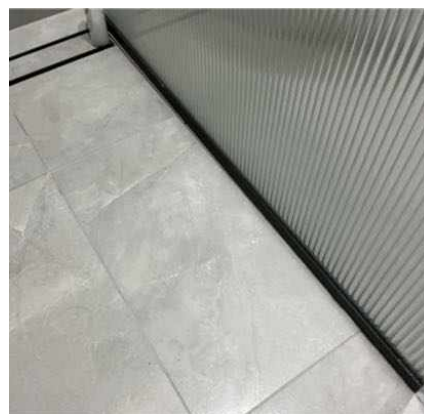
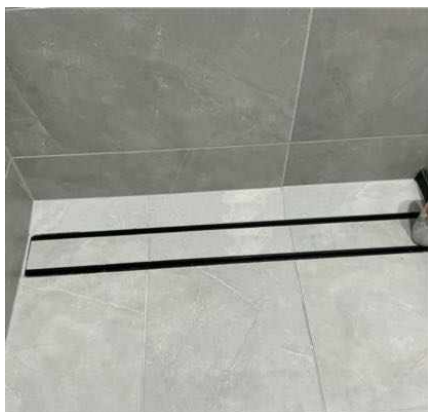
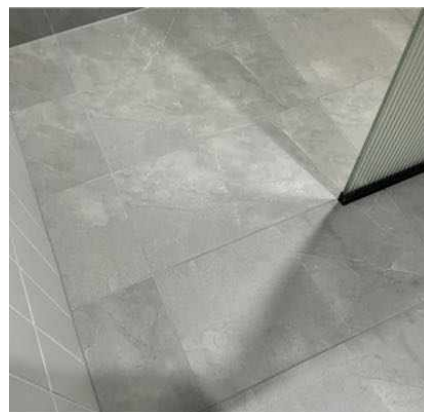
Defects 3.01

Building:	Main Building
Location:	All Internal Areas
Finding:	Minor Shrinkage Cracks to Polished Concrete Floors Throughout
Information:	Minor hairline cracking was observed to the polished concrete floor surfaces throughout the dwelling. These cracks are typical of concrete shrinkage during the curing process and are common in slab-on-ground construction, particularly where large continuous floor areas are present. The cracks appear cosmetic in nature at the

time of inspection and no differential displacement or edge lifting was noted.

- Although currently minor, shrinkage cracks can become more visually apparent over time, particularly in polished or exposed concrete finishes
- Cracks may allow moisture, dirt, or contaminants to enter, which can affect the appearance and maintenance of the polished surface
- Future movement or thermal changes may cause some cracks to widen, potentially impacting aesthetics rather than structural performance

At the time of inspection, the cracking appears consistent with minor shrinkage and is considered a cosmetic condition rather than a structural defect; however, ongoing monitoring is recommended to ensure the condition does not deteriorate.

- Monitor the cracks over time for any signs of widening, displacement, or moisture ingress
- Seek advice from a concreting or flooring specialist regarding crack filling or sealing options if visual appearance is a concern
- Maintain appropriate internal humidity and temperature conditions to minimise further movement

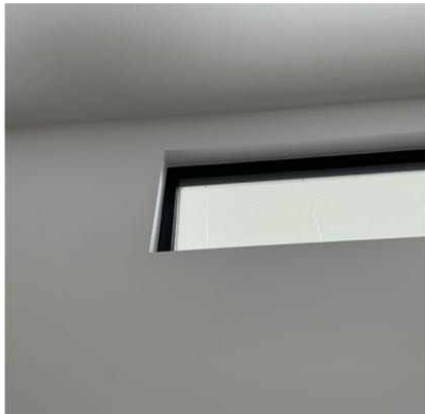
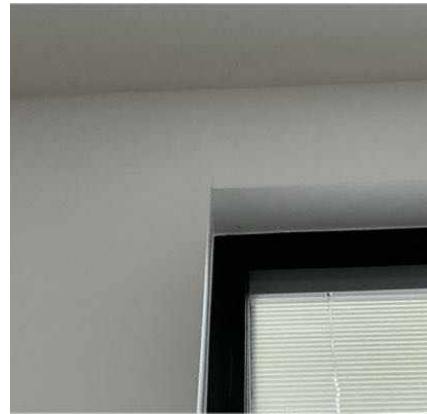
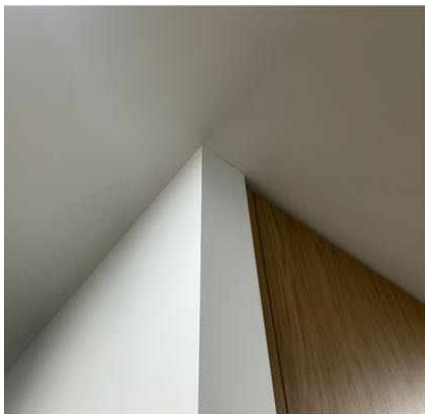
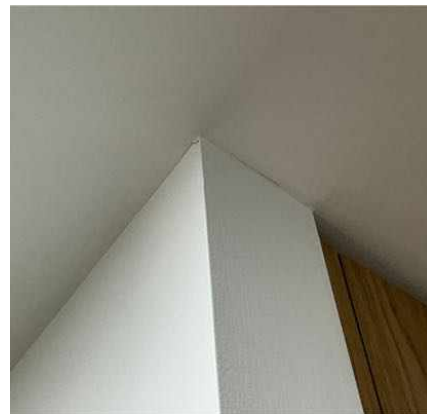
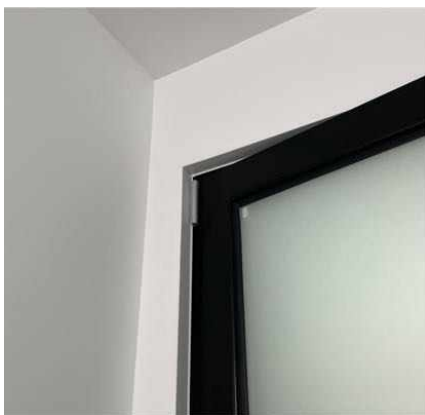
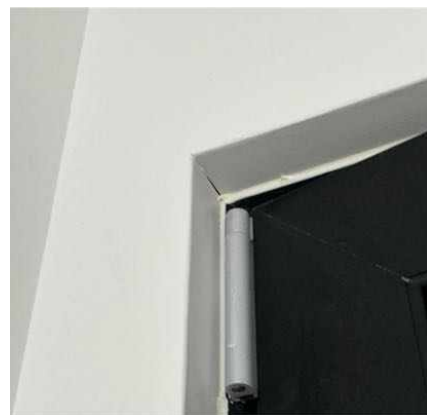
Defects 3.02

Building:	Main Building
Location:	Some Internal Areas
Finding:	Cracking to Internal Wall Linings
Information:	Cracking was observed to internal wall linings during the inspection. These types of cracks are generally considered common and are typically the result of natural building movement, age-related wear, thermal expansion and contraction, or minor installation-related issues in plasterboard or supporting framing members.

The cracking noted is typical of minor building movement and does not currently present as structural. Regular monitoring and cosmetic repair will assist in preserving the internal presentation and allow early intervention if future issues arise.

- Engage a qualified plasterer to repair cracks and consider installing expansion joints if necessary to accommodate ongoing building movement.
- Arrange for repainting by a qualified painter following any plaster repairs.

- Monitor cracks over time for signs of progression (e.g. widening, lengthening, or new cracks forming).
- If deterioration continues or operational issues with doors/windows arise, seek further assessment from a building inspector or structural engineer.

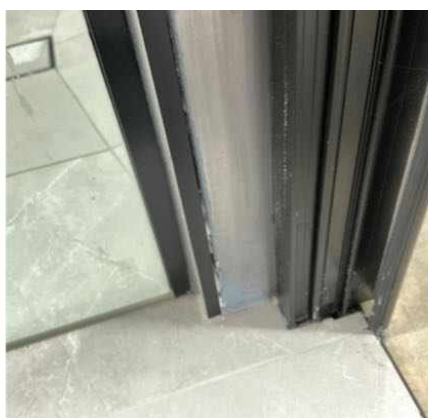
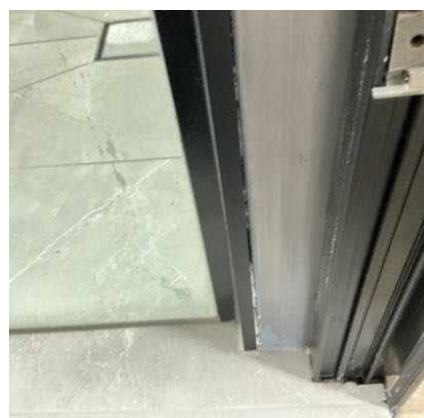
Defects 3.03

- Gaps between tiled wall finishes and door jambs can allow moisture, dirt, and debris to collect or migrate behind finishes
- Poor detailing detracts from the overall quality and presentation of the tiled wall installation
- Unsealed or poorly finished junctions may contribute to long-term deterioration of finishes and adjacent materials

At the time of inspection, the tiled wall finish at the doorway was considered a workmanship issue, and rectification is recommended to improve finish quality and durability.

- Rectify the tiled wall finish so the tile trim terminates neatly and consistently against the door jamb
- Seal the junction with an appropriate flexible sealant where required to reduce moisture ingress
- Ensure the final finish achieves an acceptable standard of workmanship and detailing

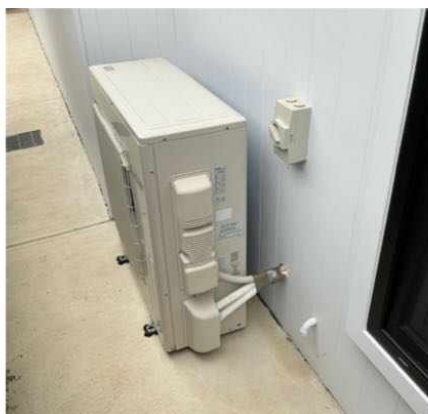
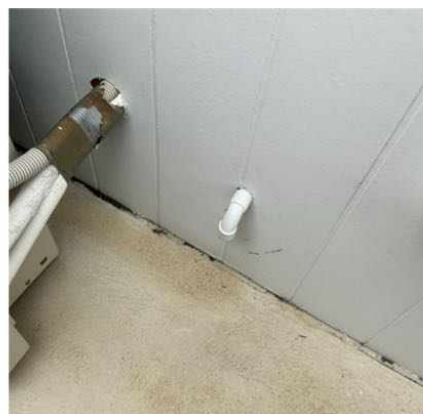
Defects 3.04

Location: Rear Wall
Finding: Uncontrolled Discharge from Air Conditioner Overflow Pipe
Information: The air conditioning unit's overflow pipe discharges directly onto the adjacent surface, rather than being connected to a compliant stormwater or drainage system. This results in persistent dampness in the immediate area, particularly during extended periods of use.

- Elevated moisture levels near the structure may promote fungal growth or decay in adjacent materials.
- Prolonged dampness can lead to corrosion of nearby metal components or deterioration of timber framing and finishes.
- Termites are attracted to damp and decaying conditions, increasing the risk of termite ingress and concealed structural damage.
- Pooling water may create slip hazards on nearby paved or hard surfaces.

Although this is a relatively minor plumbing oversight, it presents an ongoing risk to nearby building elements and termite management. Correction is typically straightforward and should be planned as part of post-settlement maintenance to preserve building durability and reduce pest-related risks.

- Engage a licensed plumber to assess and reroute the overflow pipe into a compliant drainage system, ensuring water is directed safely away from the property.
- Monitor adjacent building elements for signs of moisture damage, corrosion, or fungal growth.
- Ensure that landscaping, garden beds, or other features around the area do not trap moisture against the building.
- Incorporate this item into ongoing property maintenance schedules to reduce the risk of long-term damage or pest attraction.

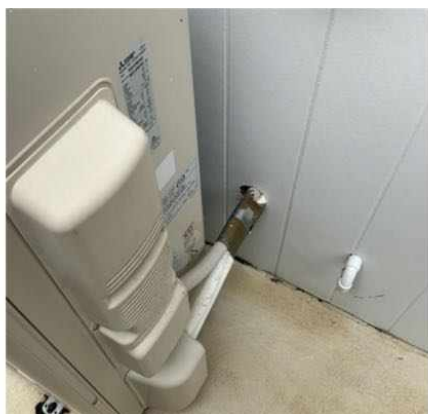
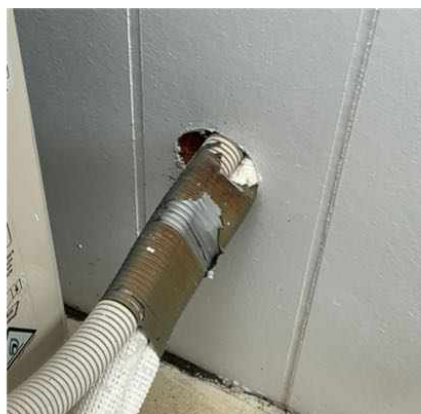
Defects 3.05

Information: An external service penetration through the wall cladding was observed to be unsealed. Flexible conduit and refrigerant lines pass through the external wall lining with visible gaps remaining around the penetration. No effective sealant, flashing, or proprietary collar was observed to seal the opening and provide weatherproofing at this junction.

- Unsealed penetrations allow water ingress into the wall cavity, increasing the risk of moisture damage to framing, insulation, and internal linings
- Open gaps provide potential entry points for pests and vermin
- Air leakage through the penetration may reduce the thermal performance of the building envelope
- Ongoing moisture exposure may contribute to deterioration of cladding edges and concealed building elements

At the time of inspection, the unsealed service penetration represents a

weatherproofing defect, and rectification is recommended to reduce the risk of moisture ingress, pest entry, and long-term deterioration.

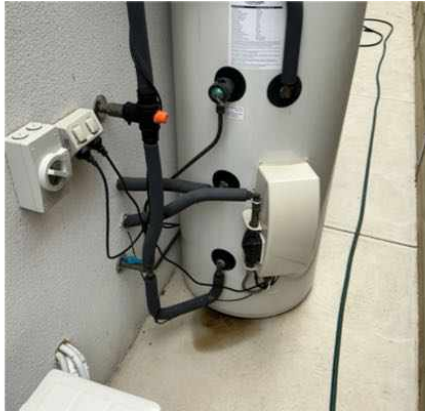
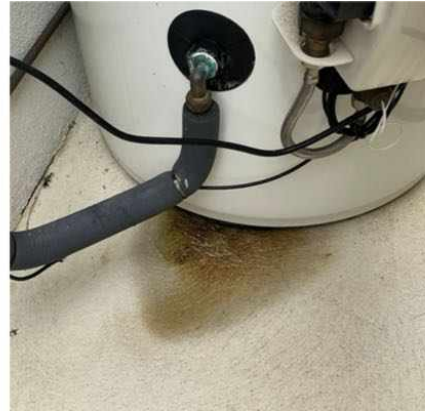
Defects 3.06

Building:	Main Building
Location:	Right-hand Side
Finding:	Evidence of Previous Leakage at Hot Water Unit
Information:	During the inspection, rust staining and mineral deposits were observed on the lower section of the external hot water unit and along the adjacent concrete slab. The staining is concentrated beneath the inlet/drain connection point, indicating that water has previously discharged from this location. No active leak was visible at the time of inspection.

- Past leakage may indicate previous valve failure, loose fittings, or internal tank seepage.
- Staining suggests moisture has been present for an extended period, which can contribute to corrosion of the unit's casing or pipework.
- If leakage recurs, the area may become a source of increased moisture around the dwelling's perimeter.
- Potential for future malfunction if the underlying cause was not properly rectified.

The staining observed suggests a previous water discharge event. Further assessment is recommended to ensure the system is functioning correctly and to minimise the risk of future leaks.

- Engage a licensed plumber to assess the hot water unit and confirm whether the inlet/drain assembly has been repaired or requires further attention.
- Monitor the area for any renewed moisture, drips, or staining.
- Maintain adequate clearance around the unit to allow early detection of future issues.

- If the unit is nearing the end of its service life, discuss replacement options with a plumber to prevent unexpected failure.

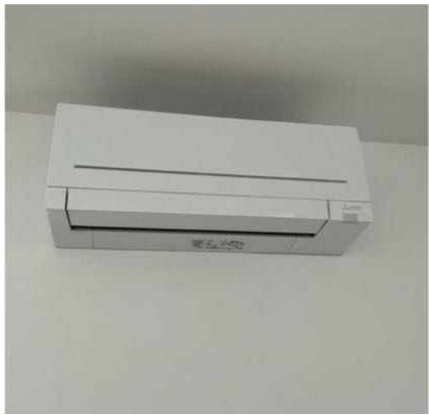
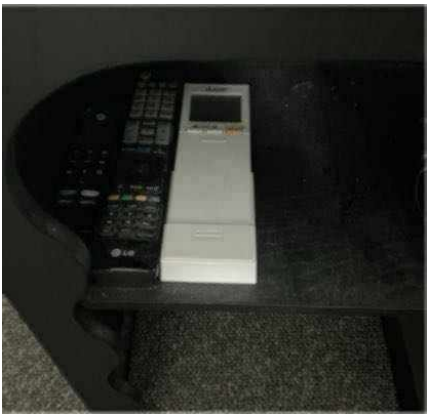
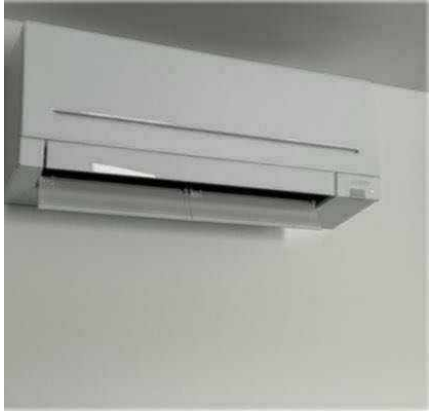
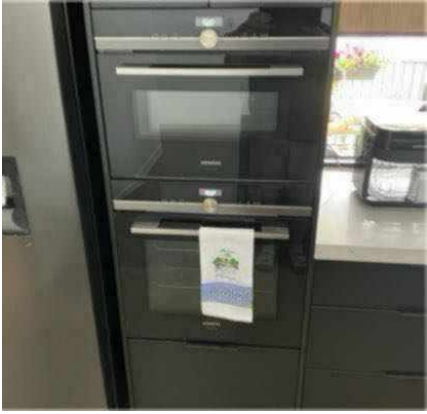
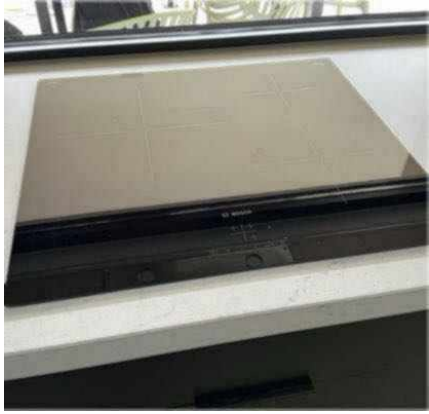
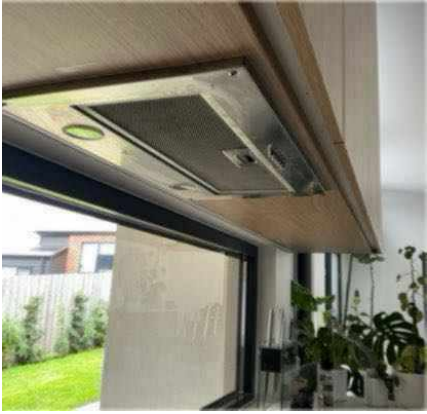
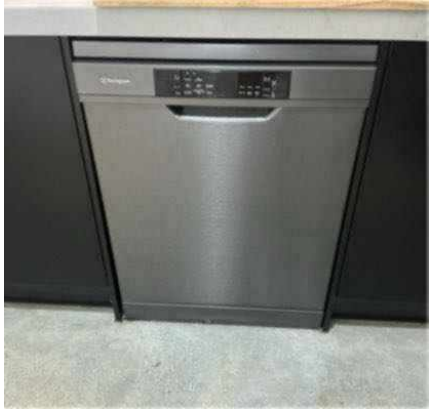
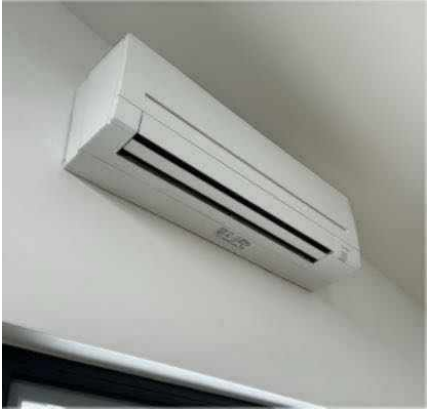
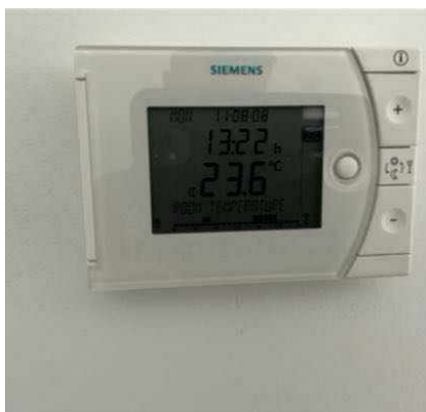
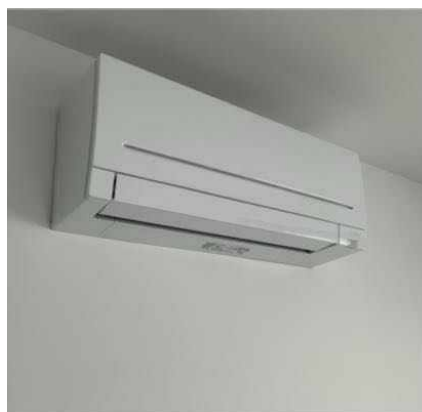
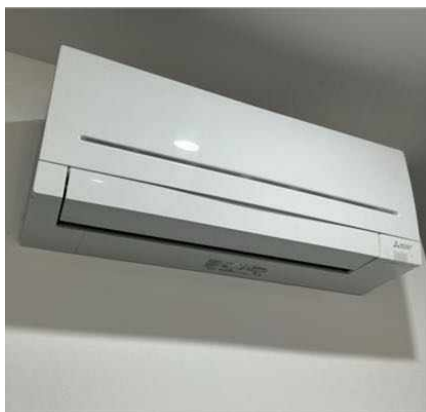
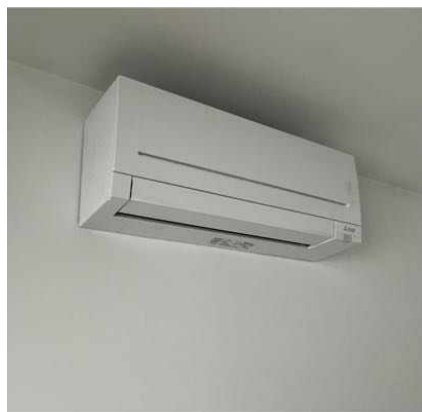
Building: Main Building
Location: All Internal Areas
Finding: Condition of Installed Appliances and Air Conditioner - Operational
Information: the time of inspection, the installed appliances—including the oven, cooktop, rangehood, dishwasher, and reverse cycle air conditioner—were checked for basic operational function. All appliances powered on and responded as expected to standard user inputs, indicating they are in working condition.

- Appliances, including the reverse cycle air conditioner, appear to be functioning as intended at the time of inspection.
- No obvious signs of damage, malfunction, or missing components were observed.

While the appliances and reverse cycle air conditioner were operational during the inspection, it should be noted that a full performance test was not conducted, and future performance or safety compliance cannot be guaranteed.

- Confirm inclusions with the sales contract to ensure all appliances and the reverse cycle air conditioner are covered.
- Retain user manuals and warranty information where available.
- Re-test all appliances and the air conditioning system upon settlement and prior to first use, as function may vary with time, load, or power supply conditions.
- Engage a licensed electrician or suitably qualified appliance or air conditioning technician to conduct a safety and performance check, particularly if installation dates, service history, or compliance documentation are unknown.

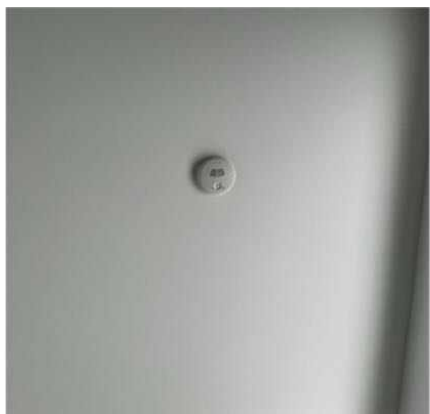
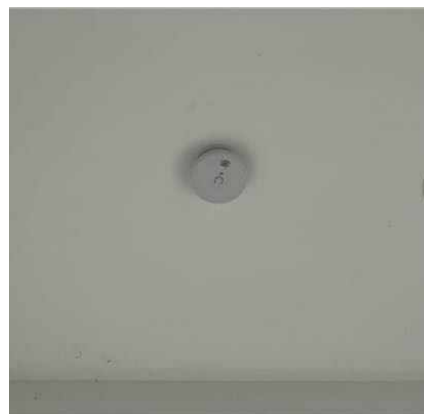
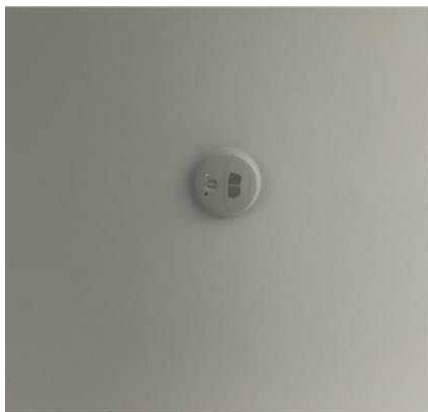
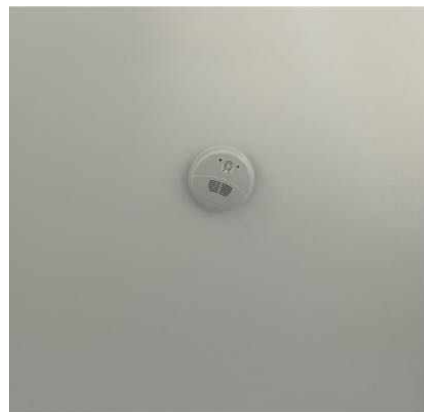
Building:	Main Building
Location:	All Internal Areas
Finding:	Smoke Detector Compliance Not Assessed
Information:	The inspection and reporting on the presence, function, and compliance of smoke detectors—whether battery-operated or hard-wired—fall outside the formal scope of this pre-purchase building inspection. However, general observations regarding smoke alarm coverage or deficiencies are noted for the client's awareness.

This report does not verify the number, condition, location, or legal compliance of smoke detection systems. Clients are strongly advised to confirm fire safety measures prior to occupancy through a specialist inspection.

- Inspect all existing smoke detectors for compliance, functionality, and correct placement.
- Install new or additional units where necessary, ensuring compliance with AS 3786 and state-based legislation.
- For optimal fire safety, ensure smoke detectors are:
 - Interconnected where required.
 - Positioned in all sleeping areas and paths of travel as per current regulations.
 - Maintained according to manufacturer instructions and replaced every 10 years.
 - Tested monthly, with annual battery replacement where applicable.

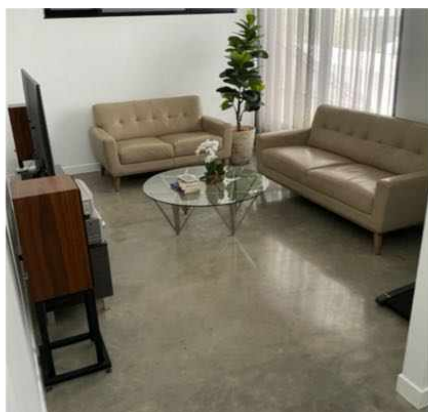
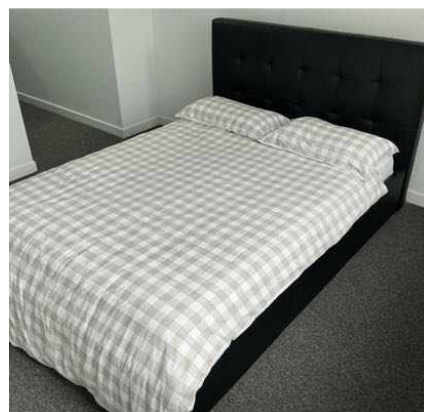
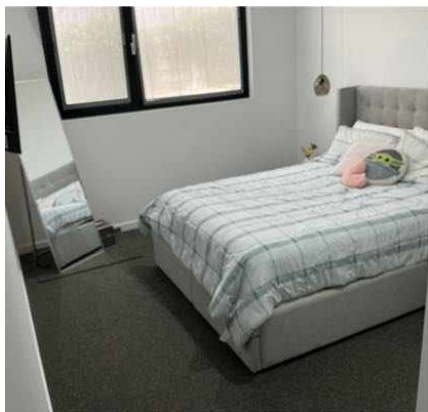
Building: Main Building
 Location: All Internal Areas
 Finding: Internal Inspection Limitations – Obstructed Areas
 Information: Several internal areas of the dwelling were obstructed by stored items, furniture, appliances, and general household belongings at the time of inspection. These obstructions restricted inspection access, prevented visibility of key building elements, and limited the ability to assess these areas in accordance with AS 4349.1-2007.

These photographs are provided as evidence of the obstructions and the resulting inspection limitations. It must be acknowledged that concealed conditions behind or beneath such obstructions cannot be assessed, and defects may exist in these areas that were not visible at the time of inspection.

If these obstructions are removed, a re-inspection is strongly recommended to allow full access and a complete assessment of the concealed building elements.

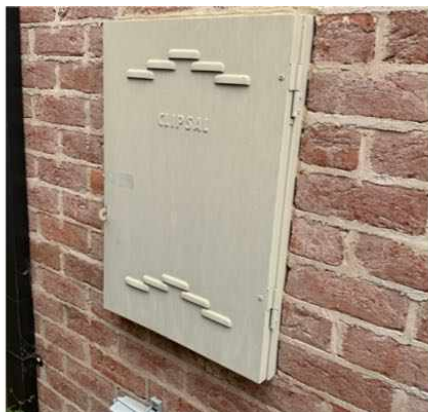
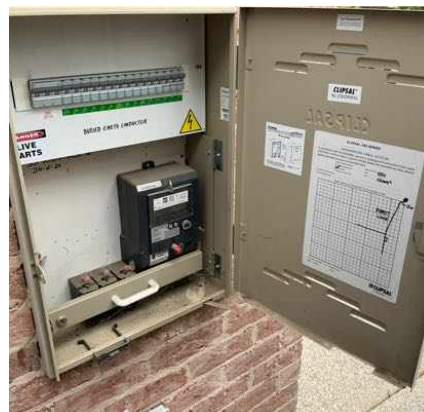
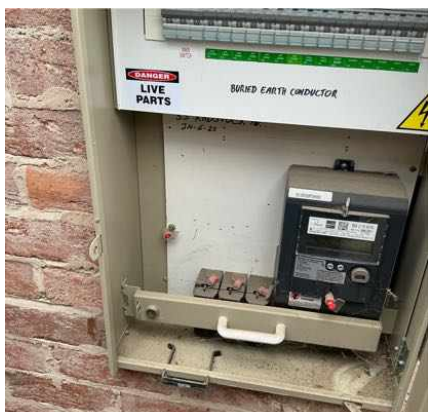
Building:	Main Building
Location:	All Areas
Finding:	No Termite Management System Present – Recommendation for Post-Construction Chemical Barrier - Termite
Information:	At the time of inspection, there was no visible evidence of a termite management system having been installed on the property. No durable notice was located within the switchboard or any other accessible areas to indicate the presence of a current chemical or physical termite barrier.

The absence of a termite management system presents a preventable risk to the property. Early implementation of a chemical barrier will significantly reduce the likelihood of termite attack and support long-term structural protection.

- Once installed, ensure a durable notice is affixed to the switchboard or another prominent location in accordance with AS 3660.1:2014 – Termite management – New building work, Clause 8.1.
- Maintain regular termite inspections as advised by the installer or at least annually, in line with AS 3660.2:2017 – Termite management – In and around existing buildings.

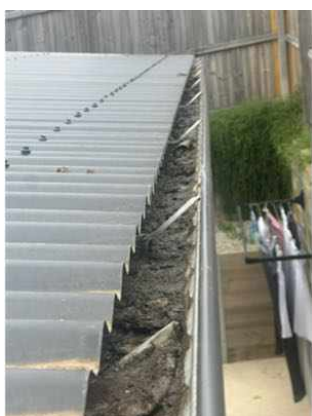
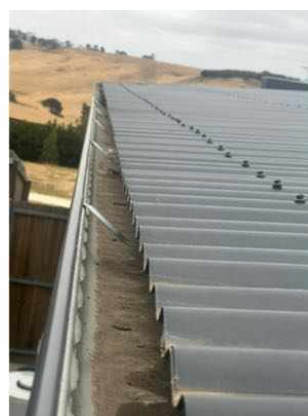
Building: Main Building
 Location: Gutters
 Finding: General Gutter Maintenance Requirements
 Information: Regular maintenance of the guttering system is essential to ensure effective roof drainage and to prevent avoidable damage to the building structure. Gutters naturally collect leaves, dirt, and other debris over time, which can reduce their ability to channel water away from the home.

- Blocked or restricted gutters can cause water to overflow onto fascias, eaves,

- Prolonged overflow may contribute to moisture damage, deterioration of building materials, and internal leaks.
- Inadequately maintained gutters increase the risk of debris accumulation and associated fire hazards in bushfire-prone areas.

Routine gutter maintenance is a simple but important measure to protect the home from water ingress, deterioration, and potential fire hazards.

- Carry out regular cleaning of gutters and downpipes—typically twice a year, and more frequently in areas with nearby trees.
- Inspect for signs of sagging, corrosion, or leaks, and repair as required.
- Consider installing gutter guards to assist with reducing debris build-up and improving long-term performance.
- Ensure gutters remain clear during high-risk bushfire seasons by removing any combustible debris.
