Building and Timber Pest Inspection Report

Inspection Date: Wed, 11 Feb 2026

Property Address: 63 Bennett Rd, Thurgoona NSW 2640,
Australia

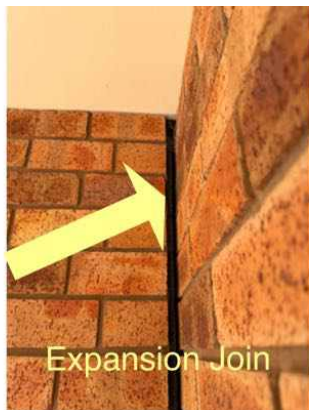
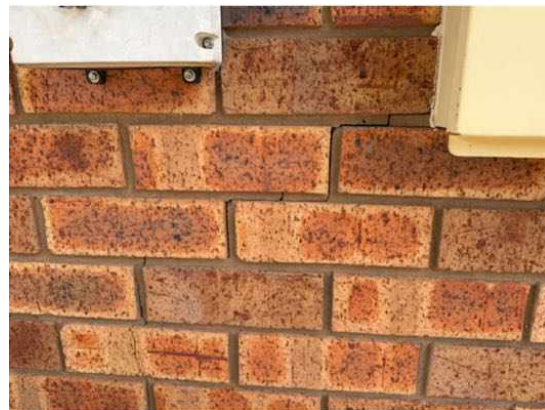
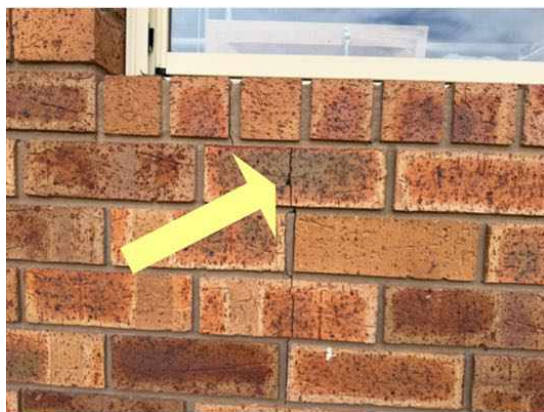
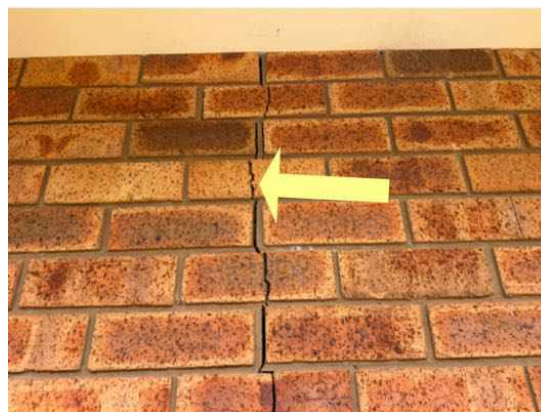
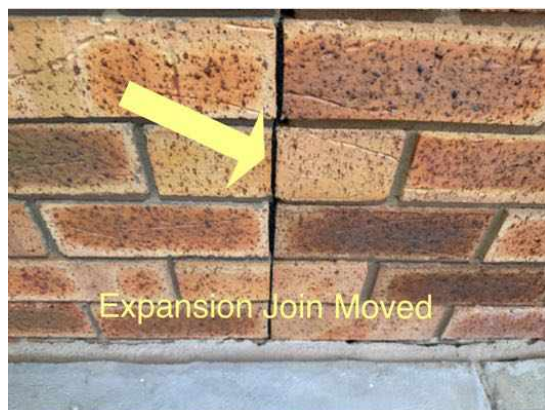
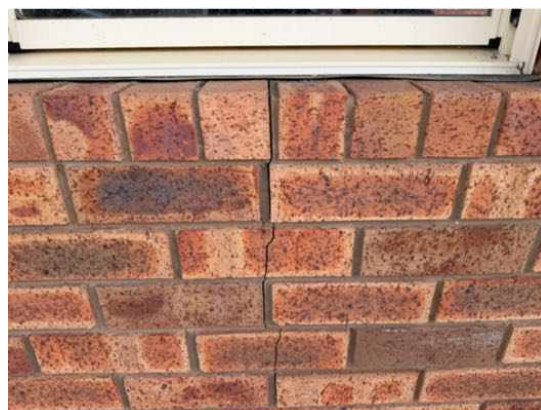
Finding 3.01

Building: Main Building
Location: Brickwork
Finding: Brickwork - Cracking & Movement
Information: Cracking & evidence of movement was identified to some areas of the brickwork at the time of inspection. Cracking, has a variety of possible causes. However, the most common is movement of adjacent footings. Some expansion joints were also found to have moved.

All areas of cracking & movement in the brickwork should be closely monitored to identify any further movement. Should cracking lengthen, widen, or become more numerous, a structural engineer should be engaged promptly, for further evaluation.

The client should monitor these areas. Should the step cracking lengthen, widen or become more numerous, a structural engineer should be engaged promptly, to provide further advice.

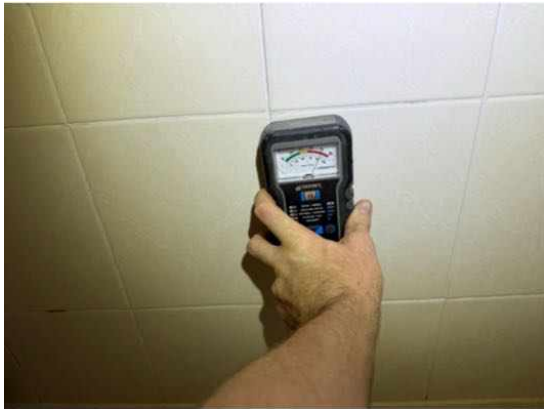
Finding 3.02

Building: Main Building
 Location: Main Shower
 Finding: Shower - High Moisture
 Information: It appears that high moisture is present at but not limited to, the base of the main shower wall. Potential causes of high moisture include but are not limited to loose or damaged plumbing fittings and fixtures, and/or deteriorated seals or waterproofing. It is also recommended that enclosed shower screens are installed to avoid water pooling in the surrounding areas.

Areas of leaking and high moisture create an environment conducive to termite activity.

Recommend engaging a licensed plumber and/or tiling contractor promptly, to provide remedial works where necessary.

Evidence of high moisture was identified at, but not limited to the base of the main shower walls. Recommend engaging a licensed plumber and/or tiling contractor promptly, provide remedial works where necessary. Installation of an enclosed shower screen is also recommended to limited water pooling in the area.

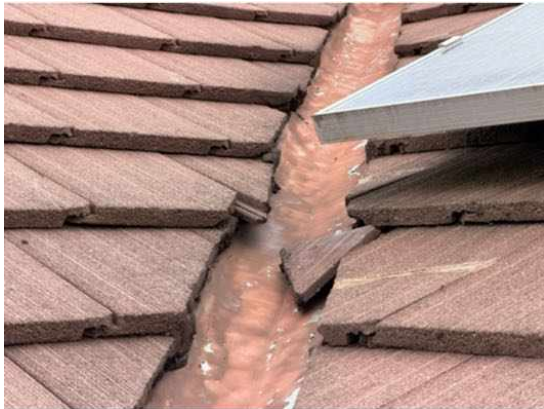
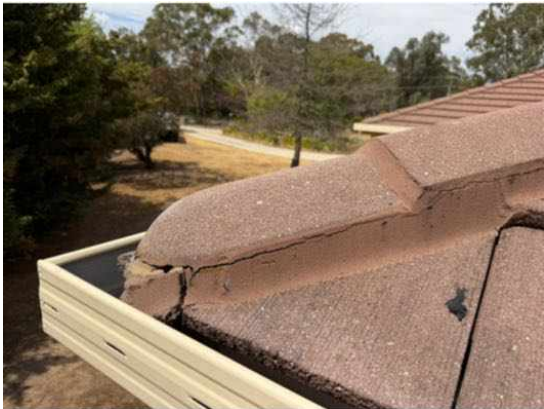
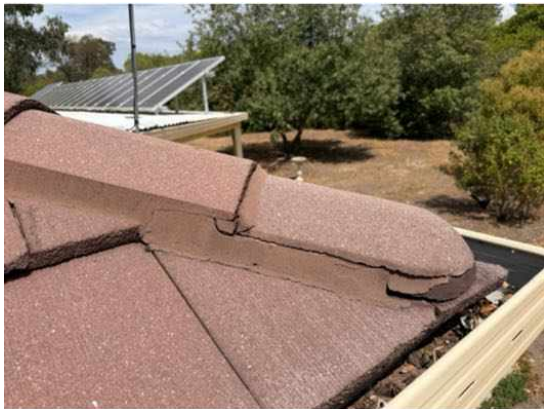
Finding 3.03

Building: Main Building
Location: Roof Exterior
Finding: Roof Exterior - Minor Cracking, Weathering
Information: Areas of minor cracking were noted to the tile pointing of the roof exterior. Cracking of the tile pointing is consistent with the age of the property.

The client can engage a licensed roofing contractor at their discretion, to provide further advice on future maintenance works.

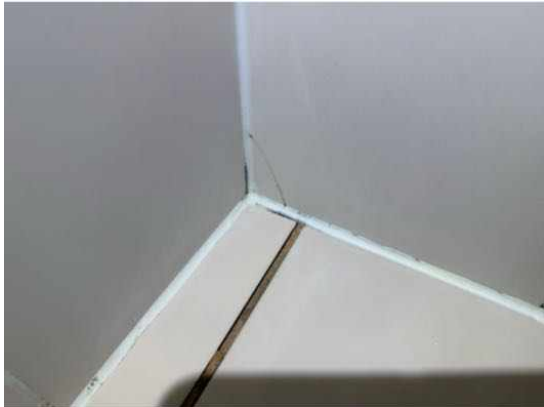
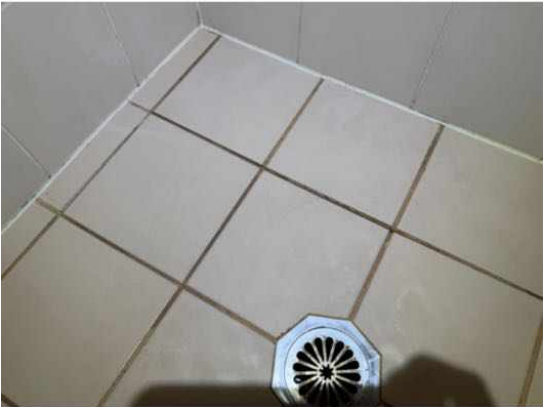
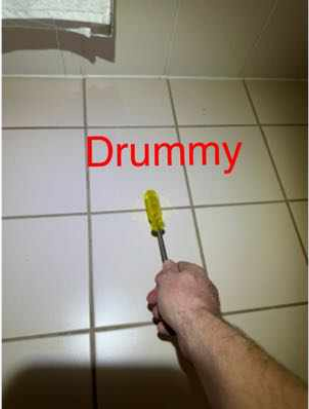
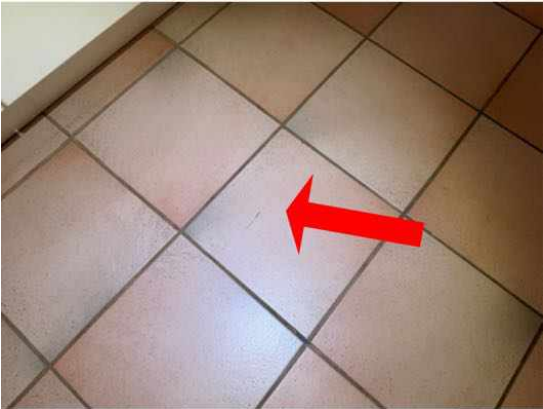
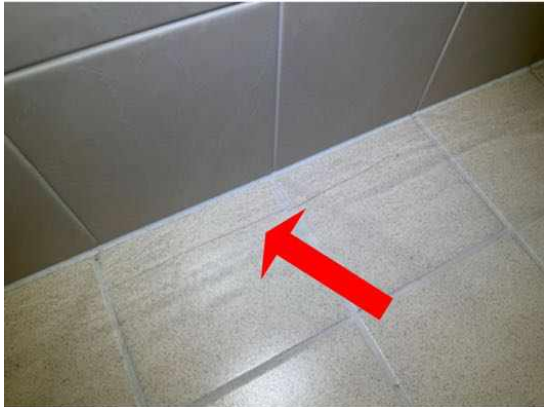
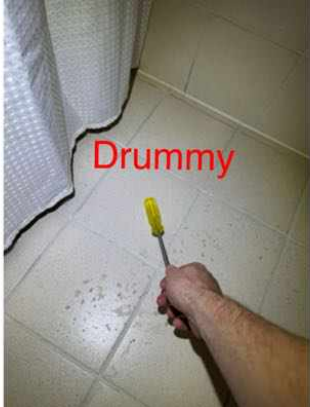
Finding 3.04

Building: Main Building
Location: Tiled Areas
Finding: Sealant / grouting - deteriorated or missing & Cracked & Drummy Tiles
Information: It appears that the sealant and grout has deteriorated in some tiled areas, a common defect in buildings of a similar age. Areas of cracked & drummy tiles were also noted, which can allow for moisture ingress behind the tiles, if neglected.

Sealant and grouting in areas that come into regular contact with water should be maintained for the long term care of your property.

Recommend engaging a licensed tiling contractor in the short term, to provide maintenance works where necessary.

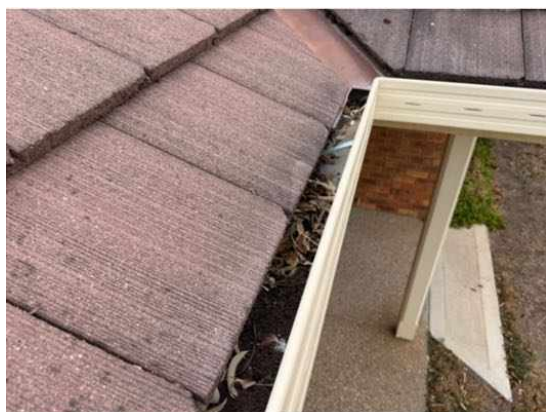
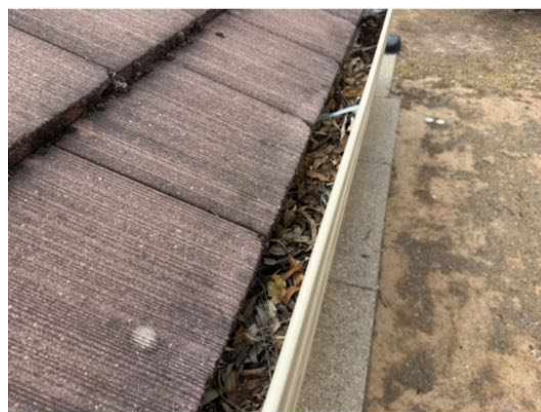
Finding 3.05

Building:	Main Building
Location:	Gutters
Finding:	Debris in Gutters
Information:	It appears that there is some debris in the gutters. Accumulation of debris can lead to blockages of the gutters & water overflows, if neglected.

Recommend engaging a general handyman to remove all debris from the gutters to prevent overflows & blockages.

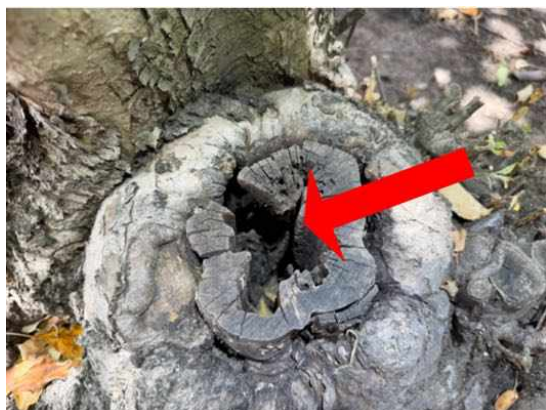
Finding 5.01

Building:	Main Building
Location:	Rear Tree
Finding:	Evidence of termite damage
Information:	Although no live termite activity was identified at the time of inspection, termite damage was identified at, but not limited to, a tree in the backyard.

Recommend engaging a licensed pest controller to provide further advice regarding installation of a termite treatment. 12 monthly ongoing termite inspections, conducted by a qualified termite inspector, are also recommended

Installation of a termite barrier is strongly recommended as there was no evidence of installation of a previous termite management system & previous termite damage was identified at, but not limited to a rear tree. 12 monthly termite inspections, conducted by a qualified termite inspector are also advised. Recommend engaging a licensed pest controller, to provide further advice.

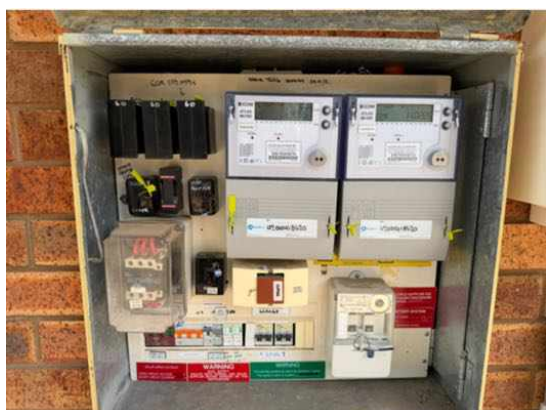
Finding 6.01

Building:	Main Building
Location:	Switchboard
Finding:	Termite Management System - no evidence of a chemical installation
Information:	The application of a termite barrier is strongly recommended, as it appears no termite management system has been installed, with no evidence or durable notice to suggest works taking place. Generally, a durable notice is placed in the meter box to indicate current termite barriers.

Such barriers are highly effective in preventing termite attack on the building and therefore should be installed.

Recommend seeking further advice from a licensed pest controller.

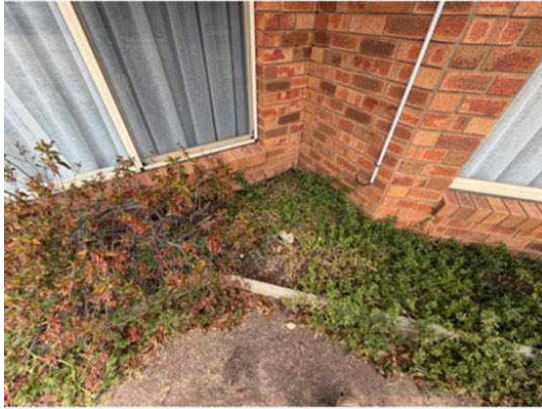
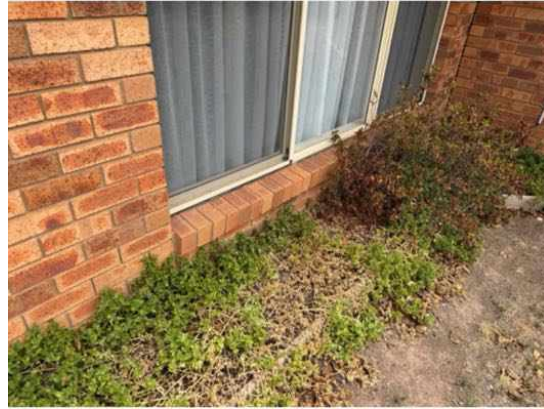
Finding 6.02

Building:	Main Building
Location:	All external areas
Finding:	Potential Water pooling - against property

Information: Potential areas of water pooling around the perimeter of the property were identified. Where garden beds against the house are present, water pooling is likely to occur, and can create areas conducive to timber pests.

Recommend consulting with a licensed plumber and/or landscaping contractor to provide further advice.

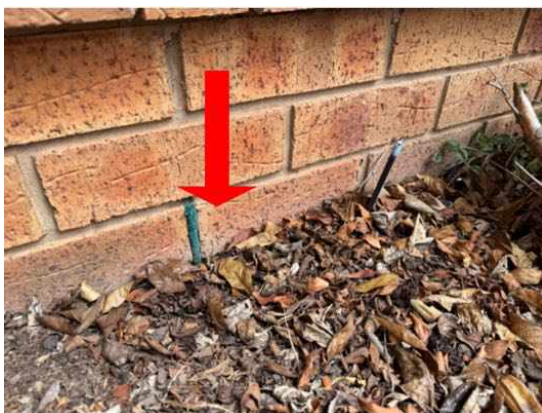
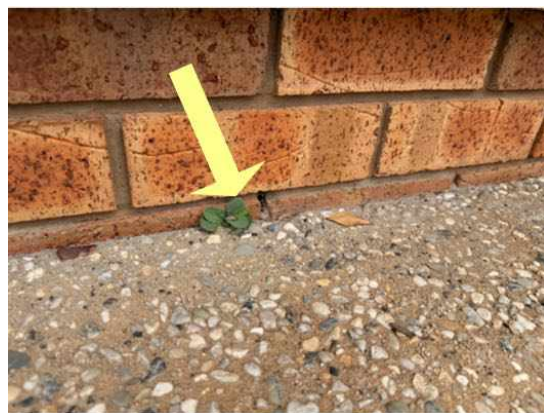
Finding 6.03

Location: Front Elevation

Finding: Weep holes - Blocked

Information: It appears several weep holes of the brickwork are blocked by the external finished ground level. This can restrict moisture escape and can create conducive conditions to termite activity. This also allows for termites to bypass any termite barriers & allows for concealed entry into the building.

Recommend engaging a licensed landscaping contractor in the short term to lower external ground levels where feasible and restore adequate weep hole drainage and inspection zones.

Some weep holes were blocked by the external finished ground level. Recommend engaging a landscaping contractor to lower external ground levels where feasible to restore adequate weep hole drainage and inspection zones.

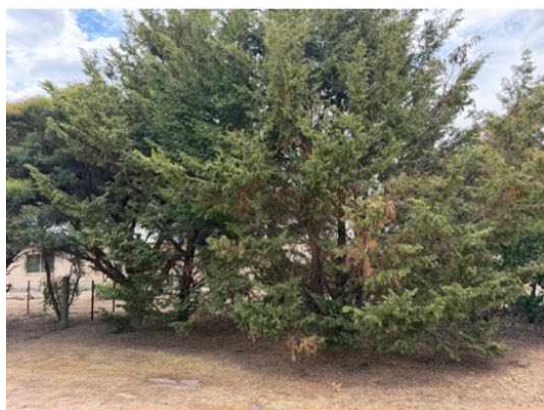
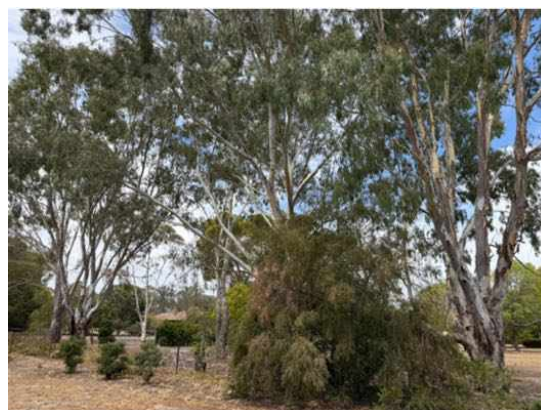
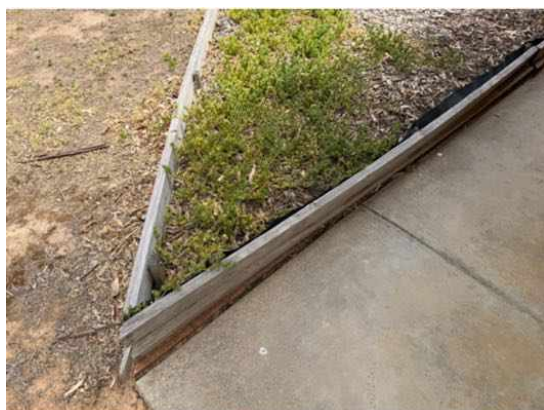
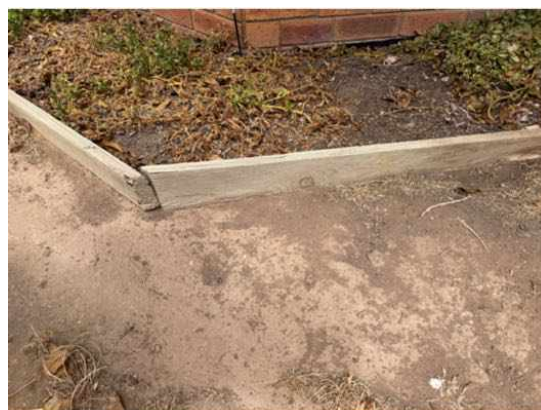
Finding 6.04

Building:	Main Building
Location:	All External Areas
Finding:	Timber in direct ground contact & trees - conducive to termites
Information:	Where timber materials are in direct contact with the ground and consequently moisture, they become conducive to termite activity. The tree stumps, landscaping timbers and trees surrounding the building create an environment conducive to termite activity.

Where feasible, any timbers in direct contact with the ground should be removed and any trees in close proximity to the building should be removed or test drilled (inspected) at least annually to reduce the risk of termite infestation & detect any early signs of termite activity.

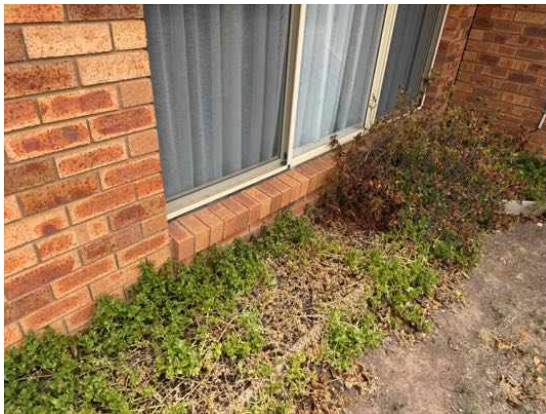
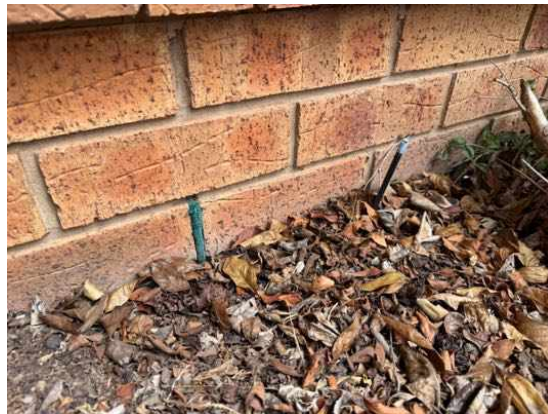
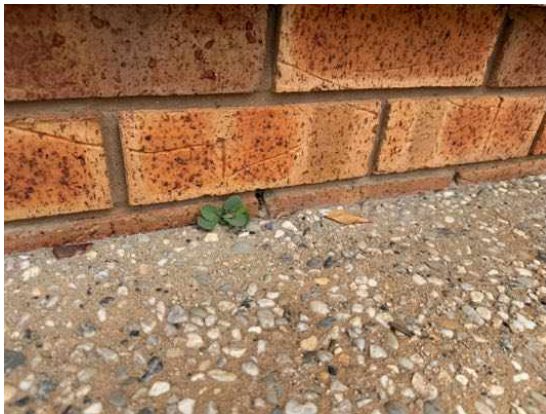
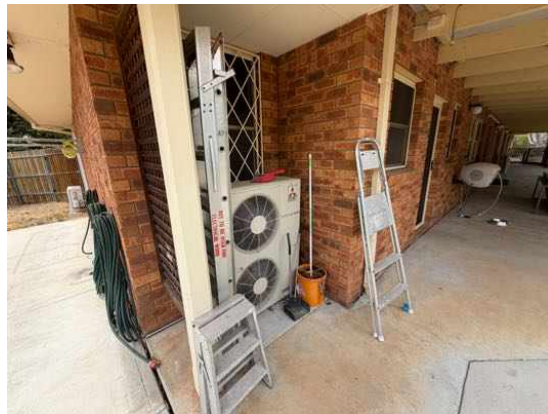
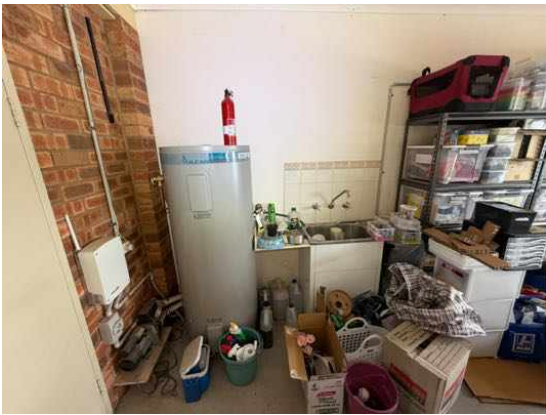
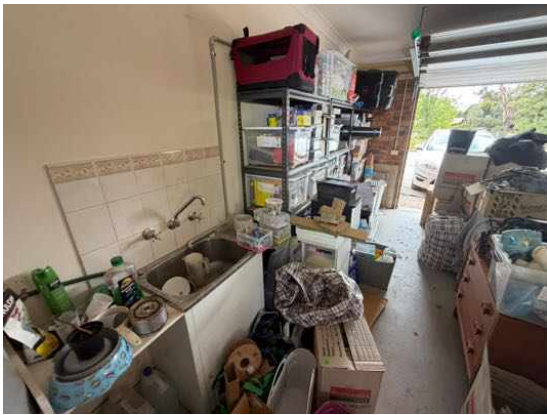
Building: Main Building
Location: All Areas
Finding: Additional Photos - Obstructions and Limitations
Information: These photographs are an indication of the obstructions and limitations which impeded full inspection of the property at the time of inspection. These obstructions can hide an array of defects and should be removed to allow full inspection to be carried out. A re-inspection is recommended once the areas are made accessible.

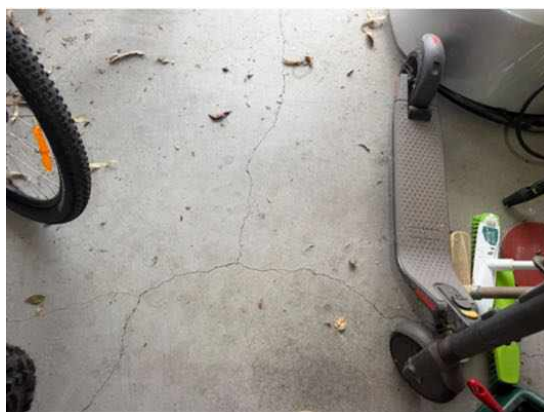
Building: Main Building
 Location: Garage
 Finding: Cracking - Garage Slab
 Information: Minor Cracking was identified in the garage slab. Cracking in concrete slabs is common, and can be caused by general movement of the footings over time or “settling” of the building after construction.

The client should monitor the cracking. Should the cracking of the garage slab widen, lengthen or become more numerous, a structural engineer should be engaged for further evaluation.

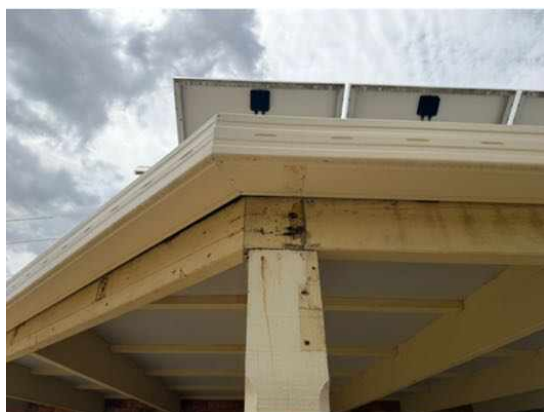
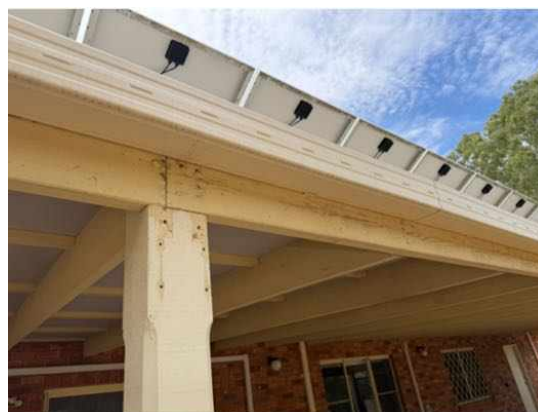
Building: Main Building
 Location: Patio Beam
 Finding: External Timbers - General Weathering
 Information: Some external timbers at, but not limited to the patio framing had areas of general weathering. This is a common defect in buildings of a similar age.

Recommend engaging a licensed painting contractor in the short term to provide additional protection to the external timbers. Regular maintenance of external timbers will extend the useful life of the materials.

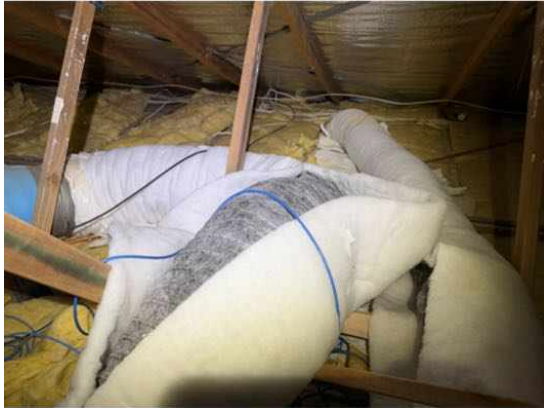
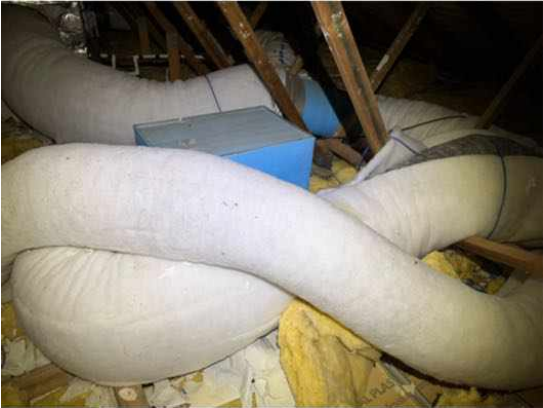
Building: Main Building
Location: Roof Void
Finding: Heating / Cooling Ducts - deteriorated
Information: It appears that areas of the heating/cooling ducts were found to be deteriorated at the time of inspection. The deterioration may detract from the functionality of the ductwork. Recommend engaging a heating/cooling specialist to provide further advice, at clients discretion.
