Building and Timber Pest Inspection Report

Inspection Date: Tue, 7 Apr 2026

Property Address: 60 Redgrave Rd, Normanhurst NSW 2076,
Australia

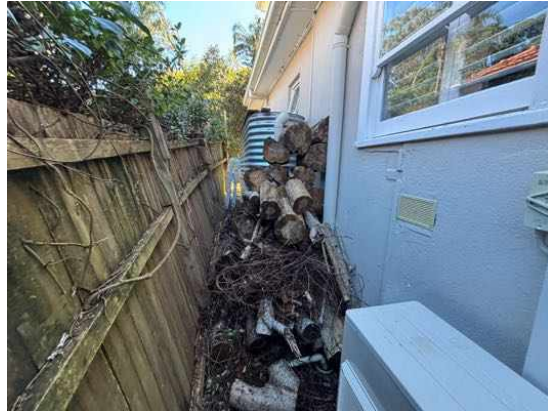
Therefore, it is strongly recommended that the obstructions be removed and a re-inspection be scheduled once the affected areas are made fully accessible. This will ensure a complete evaluation of the property's exterior and provide the client with a clear understanding of any potential issues that may have been concealed during the initial inspection.

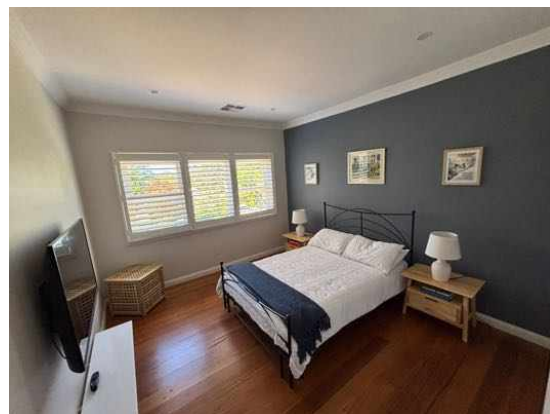
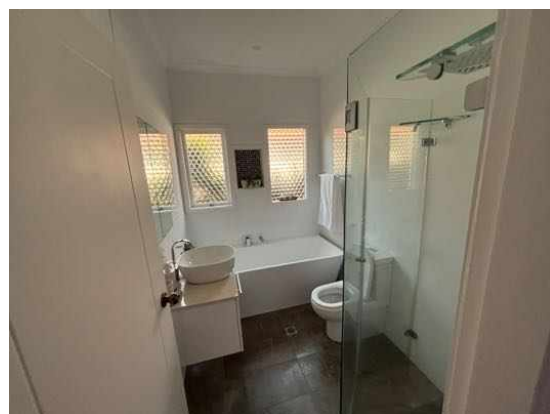
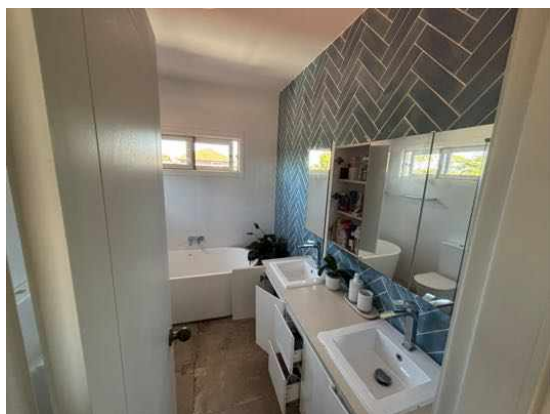
Building:	Main Building
Location:	All Internal Areas
Finding:	Obstructions and Limitations - Internal Areas
Information:	The accompanying photographs provide clear evidence of the obstructions and limitations that restricted a comprehensive inspection of the internal areas of the property at the time of assessment. These obstructions, which may include furniture, personal belongings, stored items, or structural elements such as wall coverings and built-ins, significantly hindered the ability to thoroughly evaluate these areas. It is important to note that such obstructions can potentially conceal a wide array of defects, ranging from hidden structural damage, water leaks, pest infestations, or

It is highly recommended that all obstructions be cleared to facilitate a complete and thorough inspection of the internal areas. Once the obstructions have been removed and full access is available, a re-inspection should be carried out to ensure that any previously concealed issues can be properly identified and rectified. This follow-up inspection will provide a more accurate assessment of the property's internal condition and help the client make informed decisions about any necessary repairs or maintenance.

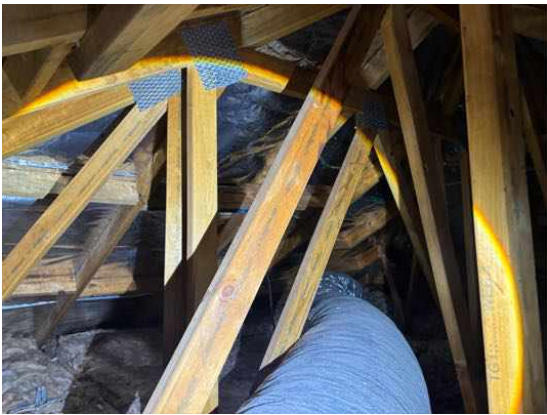
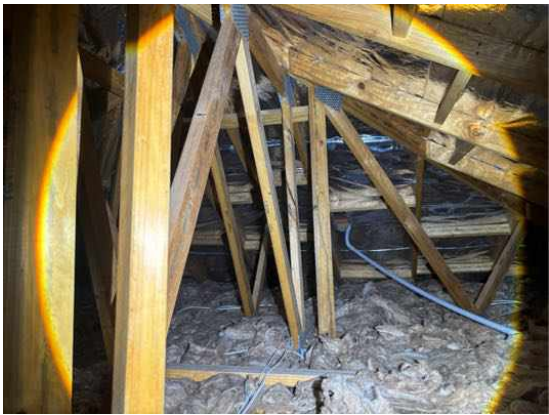
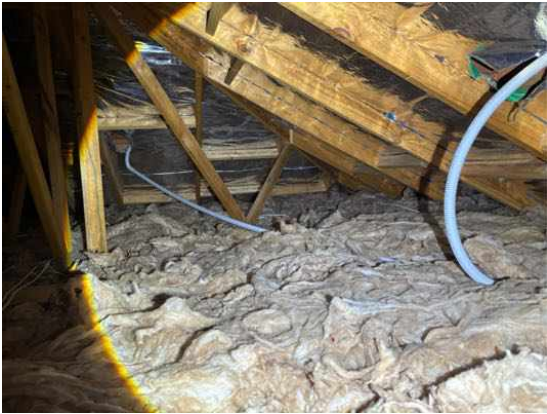
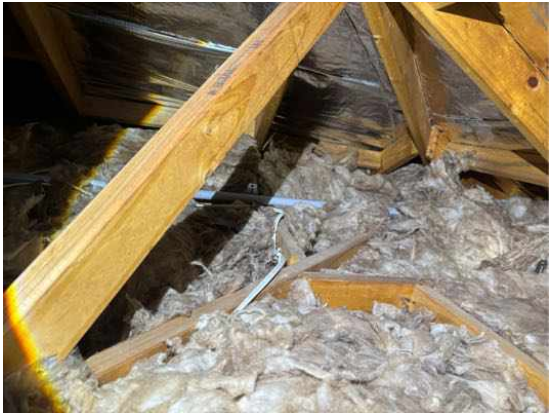
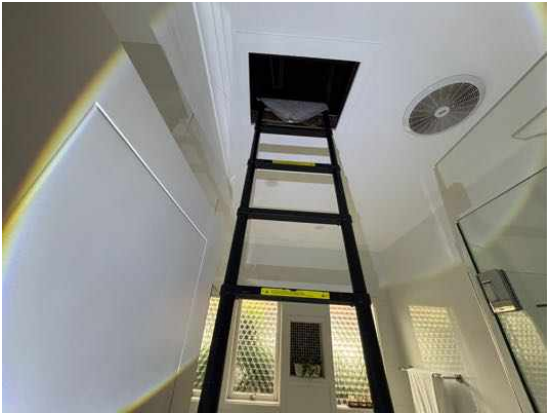
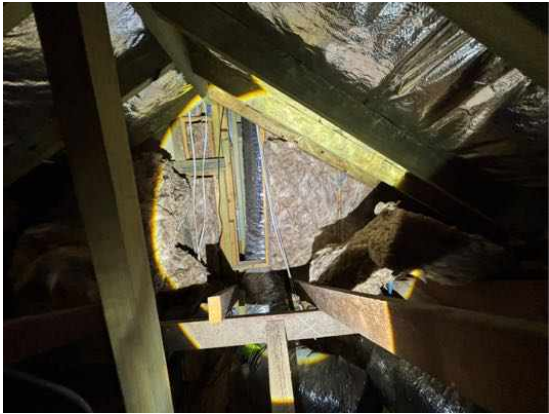
Building: Main Building
 Location: Roof Void
 Finding: Obstructions, Limitations, and General Roof Space Condition
 Information: The photographs provided document both the general condition and the obstructions and limitations that were present in the roof cavity of the main building at the time of inspection. These obstructions—such as insulation materials, stored items, structural elements, or electrical wiring—restricted safe and adequate access to key areas within the roof space. As a result, a comprehensive inspection of all components could not be completed.

It is recommended that these barriers be removed or repositioned to facilitate full and safe access to the roof space. Once clear, a follow-up inspection should be conducted to allow for a thorough assessment of all concealed areas. This will help ensure that the condition of the roof cavity is accurately evaluated and any hidden issues are appropriately identified and addressed.

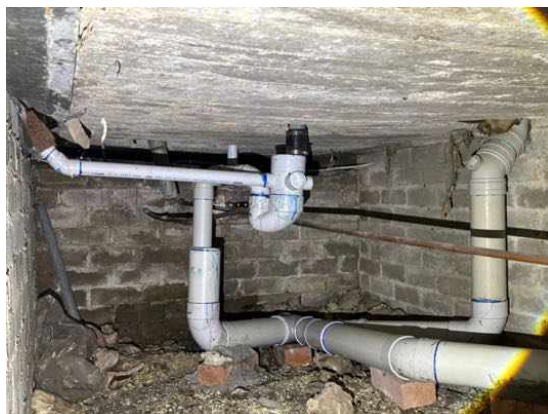
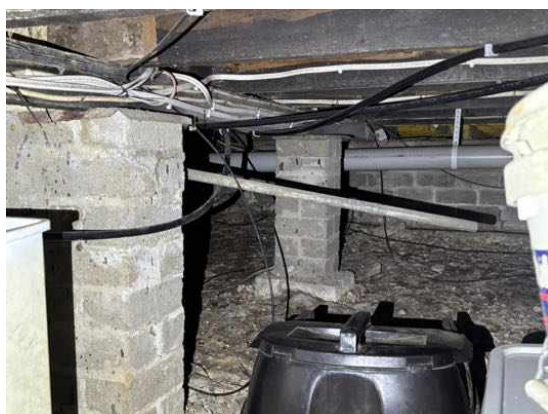
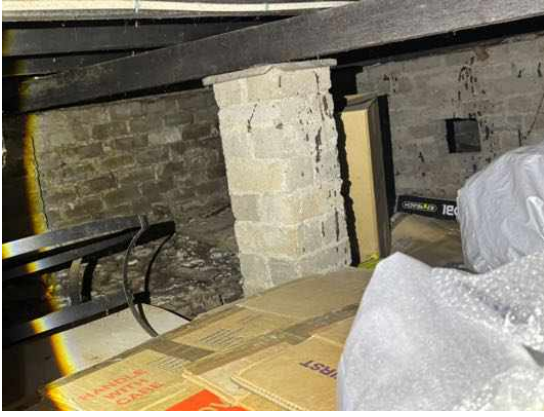
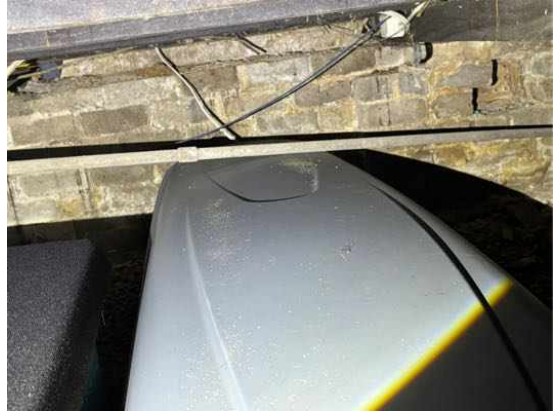
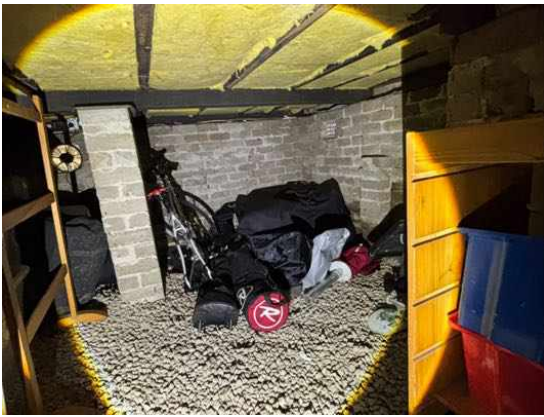
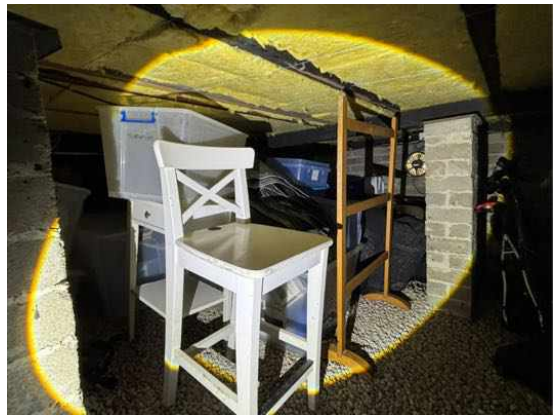
important elements such as floor joists, bearers, stumps, drainage, subfloor ventilation, and signs of moisture or pest activity. These obstructions may also conceal defects such as timber decay, water ingress, termite damage, inadequate support, or ventilation issues that are not immediately visible during a limited inspection.

While no major concerns were identified in the accessible areas, a full and unobstructed inspection is necessary to properly assess the overall condition of the subfloor. It is recommended that obstructions be removed and access improved where possible. Once adequate clearance is provided, a re-inspection should be arranged to ensure that any concealed defects can be identified and addressed accordingly. This will assist in providing a more comprehensive understanding of the subfloor's condition and reduce the risk of unforeseen issues.

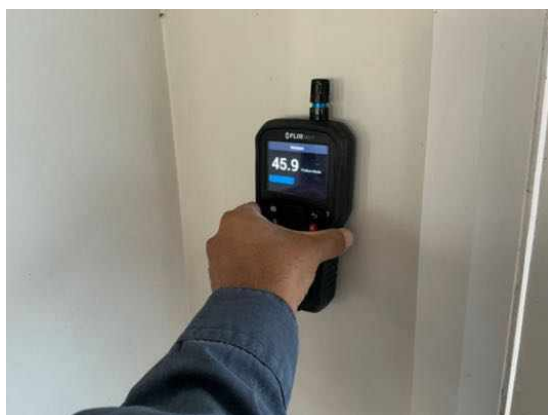
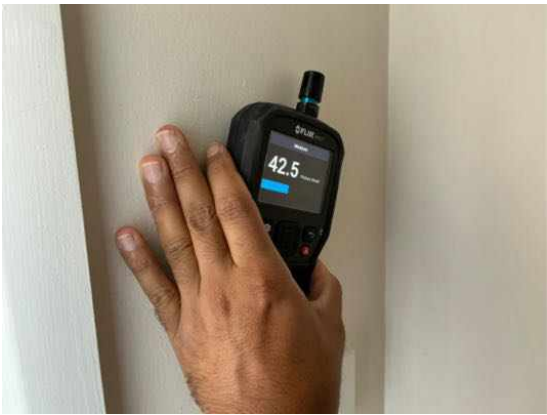
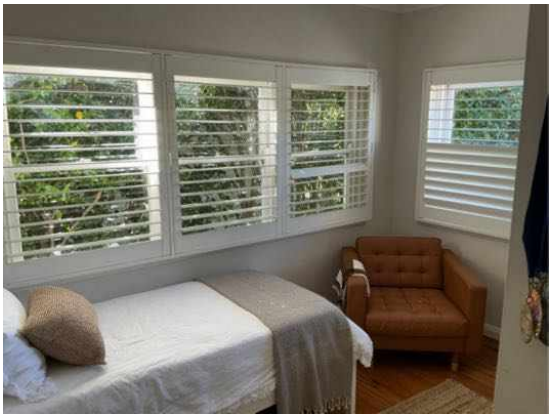
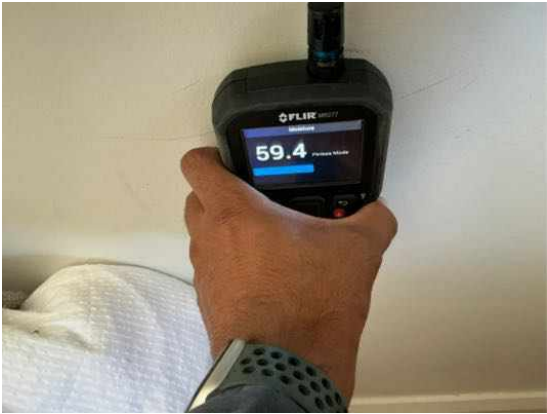
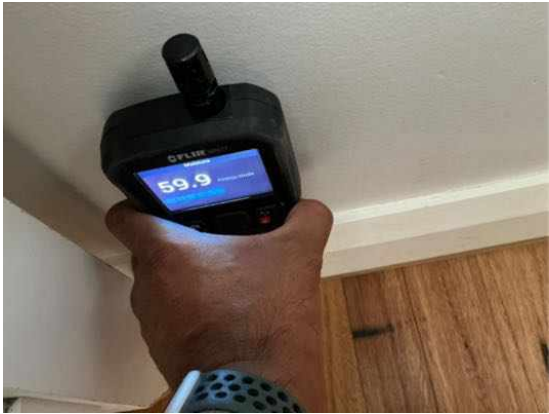
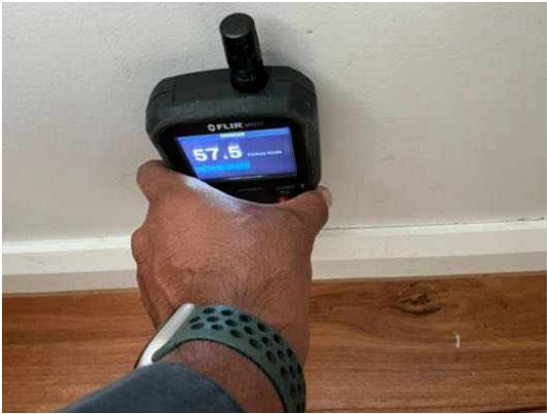
Building: Main Building
Location: All Areas
Finding: Additional Photos - Moisture Meter Readings
Information: Additional moisture meter reading photos have been provided for the property to offer further clarity on areas tested during the inspection. These photos are intended to give a visual reference for the specific locations where moisture levels were measured. These readings were taken at the time of the inspection to assess any potential moisture-related issues within the property. Any defects related to moisture that were identified during the inspection have been separately mentioned in the defect statements within the report.

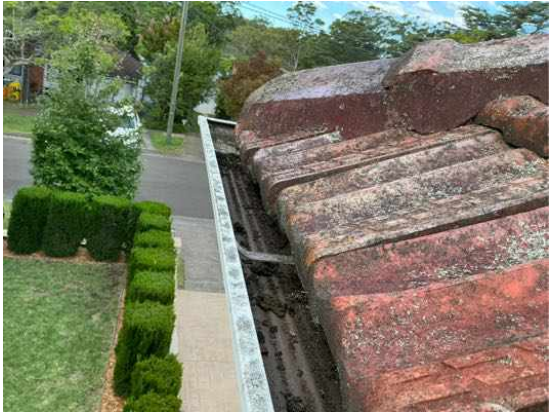
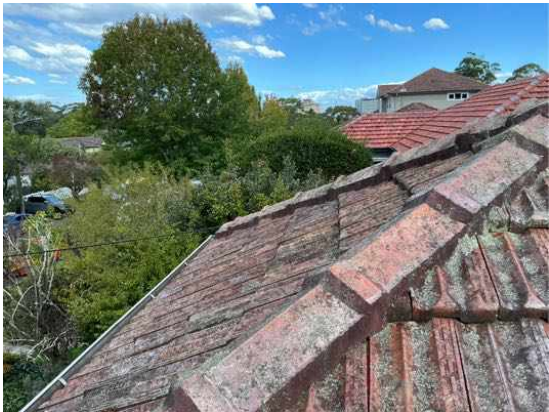
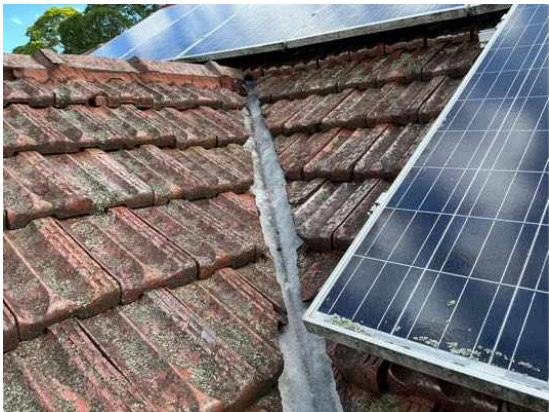
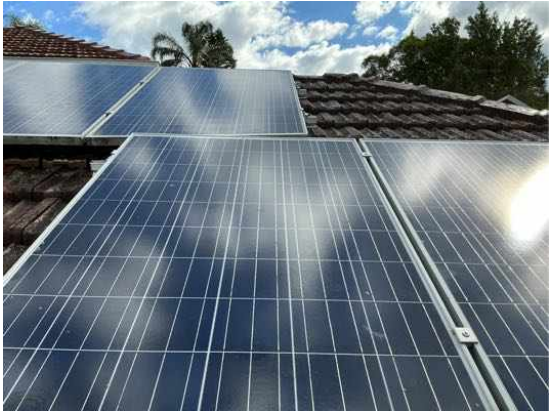
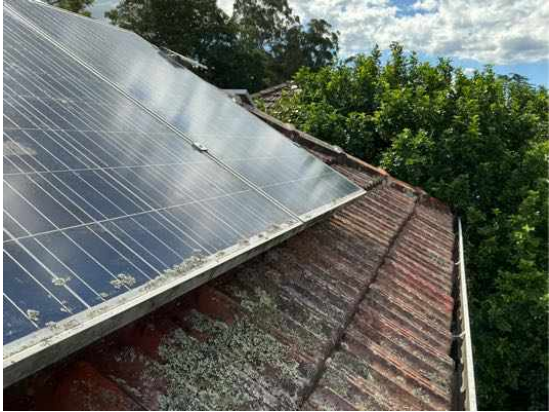
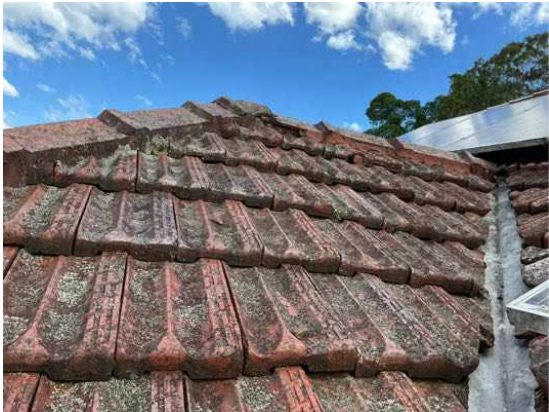
Building: Main Building
Location: Roof Exterior
Finding: Additional Roof Photos
Information: As part of the information provided, please note that the attached roof photos represent the condition of the roof at the time of inspection. These photos are for visual reference only and do not constitute a detailed roofing assessment. Any defects or issues identified with the roof are mentioned separately in the defect statements. It is strongly recommended that the client engage a qualified roofer to conduct a thorough inspection of the roof, ensuring that any potential issues, such as leaks, structural integrity, or wear and tear, are properly identified and addressed.
