Building Inspection Report

Inspection Date: Wed, 18 Feb 2026

Property Address: 6 Rogers St, Merrylands NSW 2160,
Australia

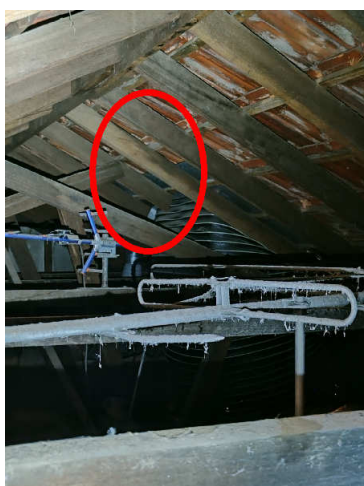
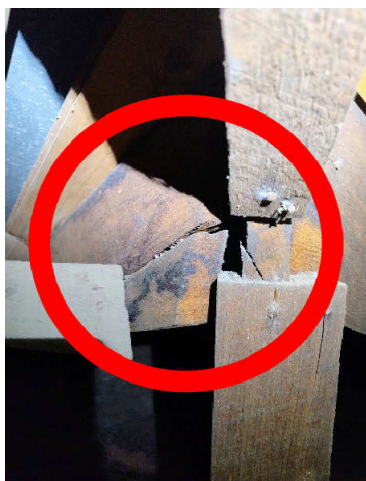
Defects 2.01

Finding: Roof structure - Altered and Damaged - Major Defect

Information: Alterations and damage to the roof structure have observed at the time of inspection. The modifications do not comply with current building practices and standards and require remedial works to reinstate to a suitable standard.

Replacement of major sections of roofing is likely to be required in order to comply with building regulations. Further assessment and necessary works should be performed immediately by a registered builder.

Until works are completed to bring the roofing structure to an appropriate level, the surrounding area should be avoided by all persons as a safety precaution.

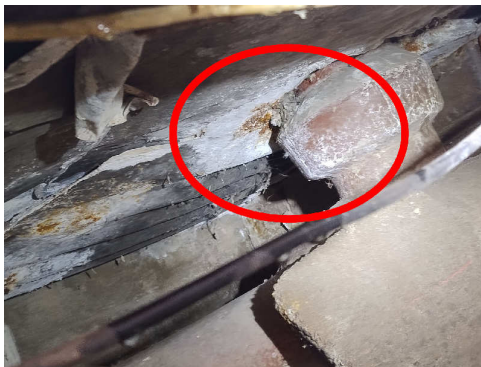
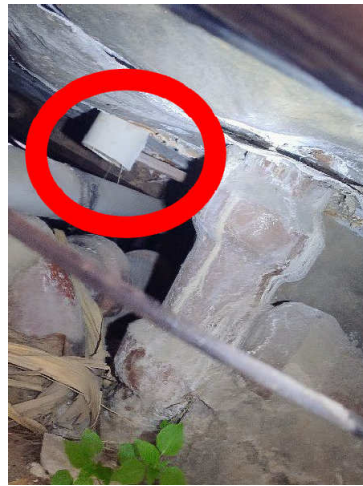
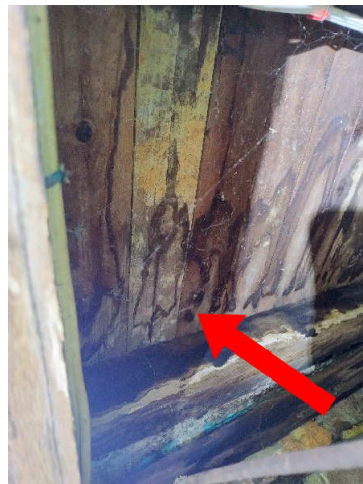
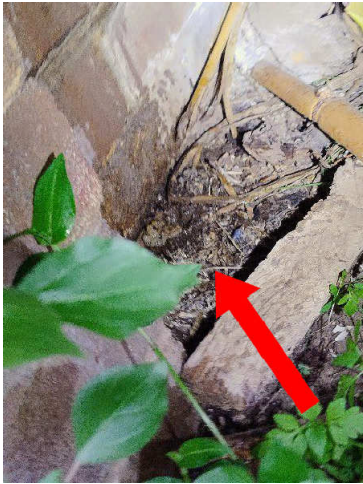
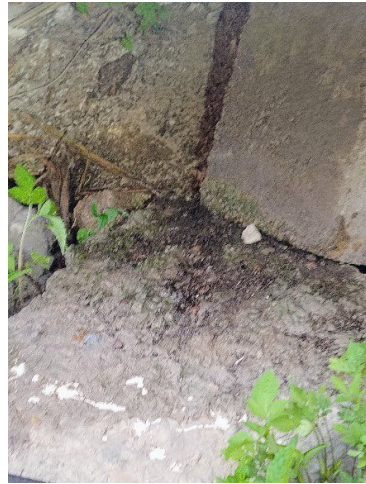
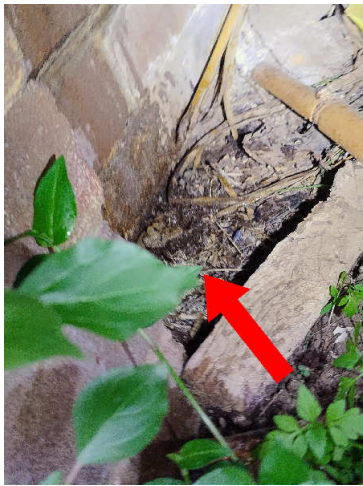
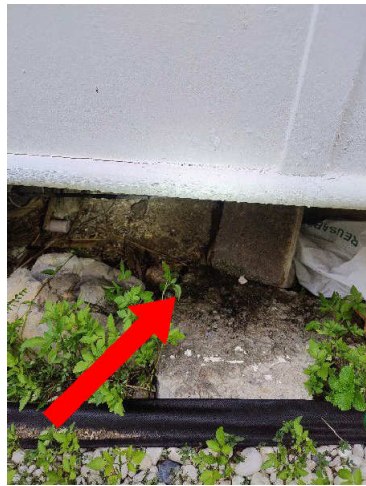
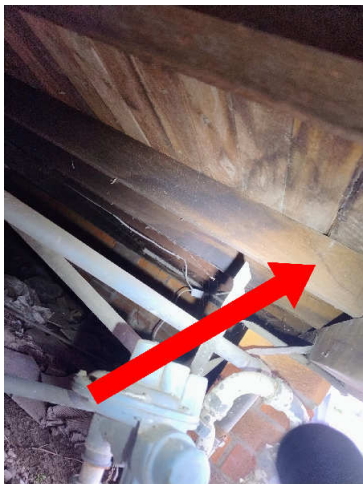
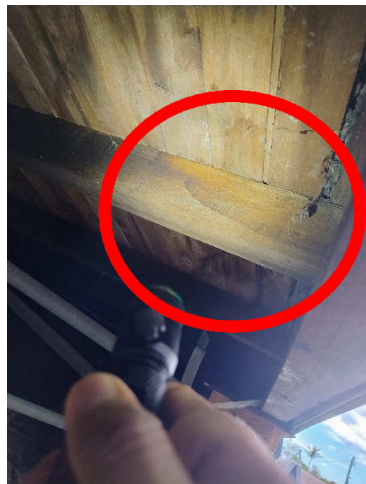
Defects 2.02

Finding: Water leak - Active - Detoriation to timber flooring

Information: Water ponding and active water leak was observed in subfloor at the time of inspection below toilet and bathroom area. Also Tiber structure below floor is deteriorated due to water leak at the time of inspection.

Generally, water leaks occur when a particular area of the property is not weather or water tight. As the surrounding area was found to be very damp at the time of inspection, and the leak was also ongoing and hence requires urgent action.

It is highly advised that the cause of the leak be identified and resolved immediately by a licensed plumber to prevent any further damage. Depending on the extent of the damage previously sustained, repair and/or replacement of any affected building materials may be required.

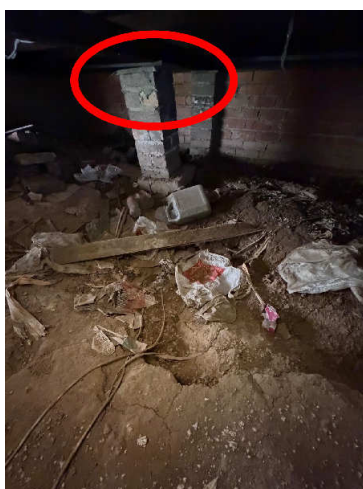
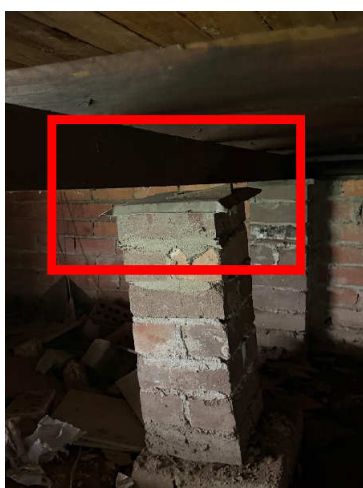
Defects 2.03

Finding: Subfloor stumps - Unstable or deteriorated - Major Defect

Information: Stumps to the subfloor structure are observed unstable and not supporting the wooden floor, indicating that their structural integrity has been affected. The cause of this instability is likely to be movement or extensive wood rot, both of which may deteriorate stumps at a rapid rate.

The stumps are suspected to be failing in their structural purpose, which is likely to lead to a range of major and minor defects. Further (potentially major) damage to the stumps and structure may be imminent if left unattended.

Appointment of a Registered Builder specialising in re-stumping is required immediately to assess the condition of the stumps and provide advice on remedial works. This defect should not be left unmanaged.

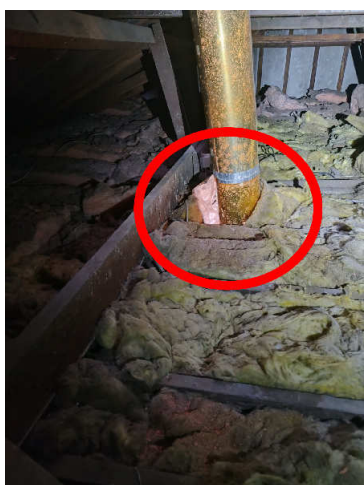
Defects 3.01

Finding: Skylight/flashing - Damaged

Information: The skylight/flashing covering appears to have been subject to minor damage at the time of inspection. The damage to this skylight is likely to allow rain penetration and provides potential for water damage to the surrounding ceiling area.

Repair or replacement of the skylight covering is required to prevent any further damage to the surrounding area. Works should be completed as soon as possible by a qualified carpenter or general handyperson.

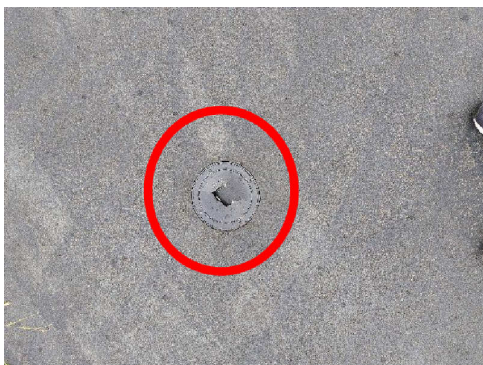
Defects 3.02

Finding: Pipe cover - Broken

Information: Upon inspection of the driveway, broken pipe covering, were identified. Broken and friable plastic cover are generally the result of ageing and weathering or sudden impact of something on it.

Replacement of broken pipe cover is required and should be performed by a licensed plumber as at the client's discretion.

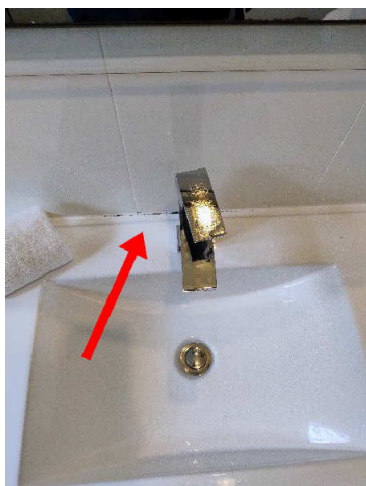
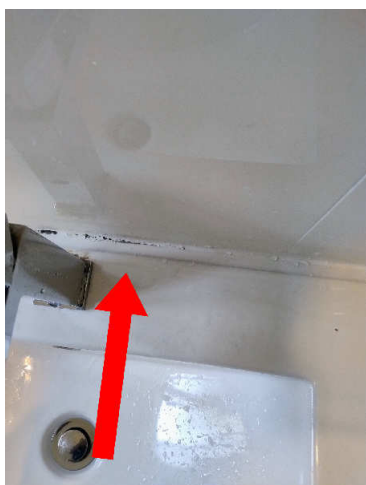
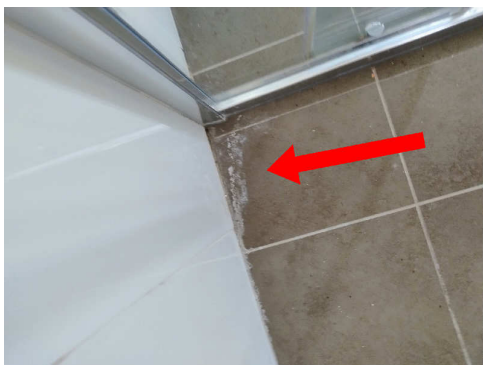
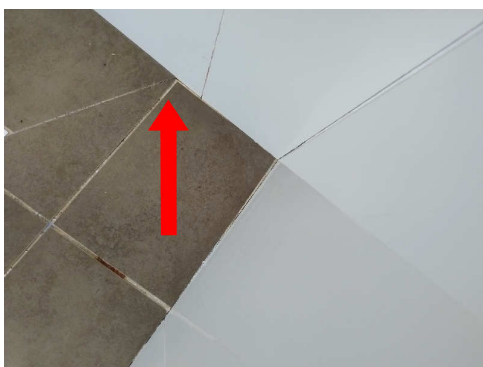
Defects 3.03

Evidence of Mould growth and water efforance was noted in all area of bathroom at the time of inspection. Which is believed to have grown due to lack of ventilation and water leak to the area.

Generally, the client is advised to ensure that the general environment is free of moisture and humidity to aid in the prevention of mould formation and development. Any mould found during the inspection should be cleaned immediately by a cleaning contractor or the homeowner as applicable.

Please note that severely affected building elements may require replacement by a registered builder or qualified carpenter.

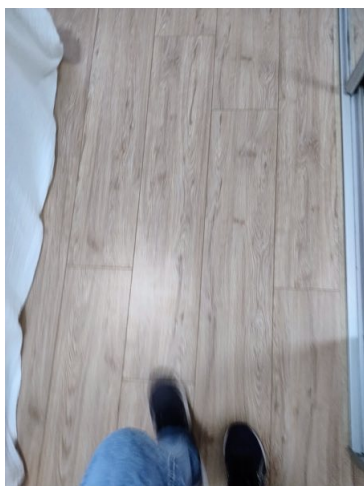
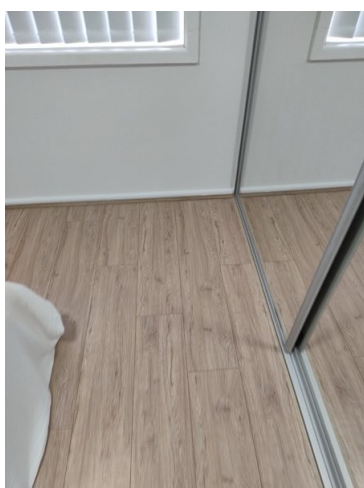
Defects 3.04

Building: Main Building
Location: Bedroom 3 + Living room
Finding: Floors - bouncy

Bouncy floors generally indicate that the floorboards or the subfloor structures are coming loose from the joists that they are installed on. Bouncy flooring may also be the result of gaps between flooring and stumps or joist structures, which require packing.

The client is advised to seek quotations for required repairs from a Registered Builder specialising in re-stumping. The potential resolution may range from packing gaps in subfloor structures through to replacement of subfloor stumps and refixing of flooring.

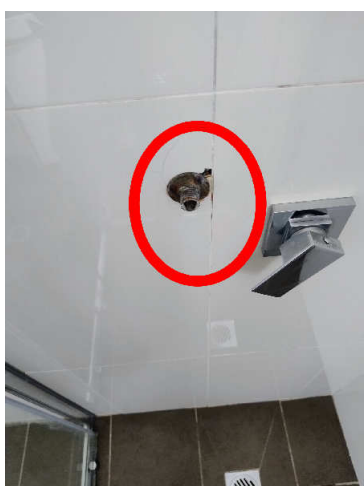
Defects 3.05

Information: The shower water tap and shower door fixings are missing and installation is observed to be substandard at the time of inspection. The primary defects if not attended can become a safety issue of major defects.

Works should be completed as soon as possible by a qualified carpenter or general handyperson or qualified plumber.

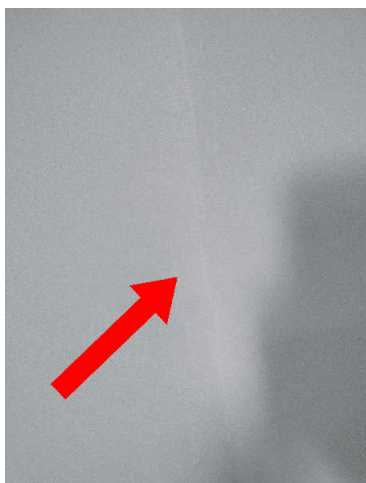
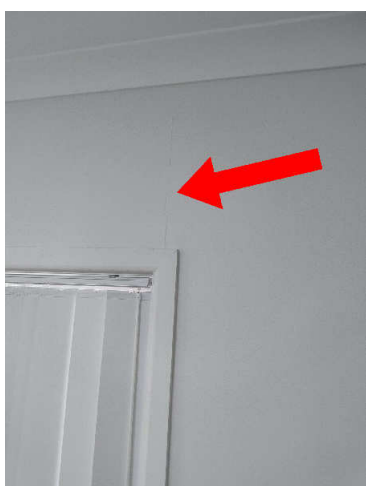
Defects 3.08

Finding: Cracks to internal rendered surfaces - Category 2

Information: Several cracks and patches to ceiling and wall to all internal areas of building was observed at the time of inspection.

The degree of damage falls within Category 2, described as noticeable cracks which are easily filled.

Damage of this category is required to be monitored for a period of 12 months, after which time a crack rated at Category 2 or above is considered a defect that requires rectification. Always contact your building inspector should cracks widen, lengthen, or become more numerous.

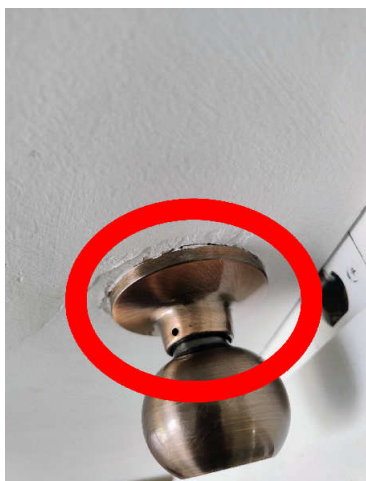
Defects 3.09

Finding: Door handle - Not latching and damaged

Information: It was noted that the door bedroom area was not latching during operation at the time of inspection and has damage around door handle. Whilst detracting from the functionality of this building element, this minor defect may also be a security risk, and may therefore have serious implications if left unattended.

It is suspected that this defect has occurred due to minor issues with the associated hinges. Such damage is identified as general wear and tear, which is expected for building elements of this age.

A qualified carpenter or general handyperson may be appointed to perform rectification works as necessary, at client discretion. If left unattended, further functional impairment is likely to occur.

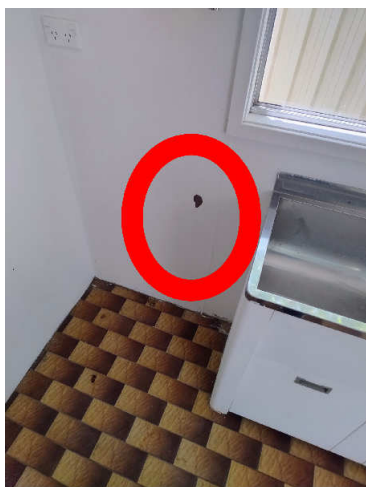
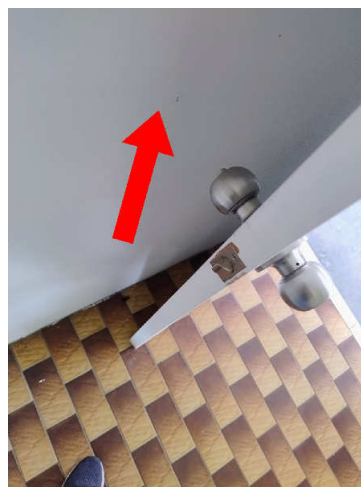
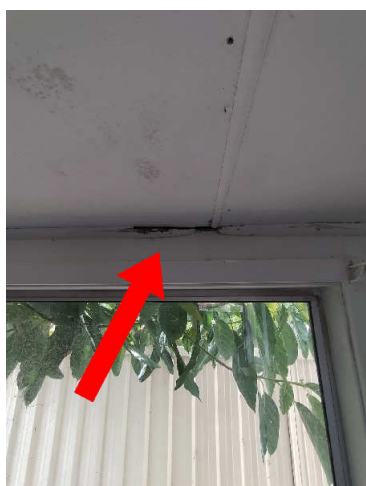
Defects 3.12

Building: Main Building
Location: Laundry
Finding: Wall cladding - dents and damage
Information: Dents and damage was observed in the Laundry walls and ceiling at the time of inspection.
Dents and damage is considered to be a defect under Standards and Tolerances. Works should be fixed as per the client's discretion by a qualified carpenter or general handyperson.

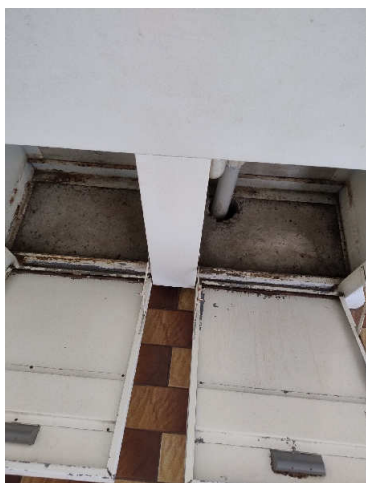
Defects 3.13

Building: Main Building
Location: Laundry
Finding: Joinery - Water stained

Water staining to joinery of laundry area was evident at the time of inspection. Water staining indicates that surfaces have been exposed to excessive moisture over time. The minerals and other elements in the water lead to staining, which may graduate to corrosion and deterioration if left unmanaged.

While mostly an appearance defect, water staining can be indicative of more serious defects, which may be currently concealed by interior ceilings.

Where water staining is active, a licensed plumber must be consulted to identify the cause of the staining and to provide advice on any reparation works that may be required. Replacement of any damaged structures is advised.

Conversely, where water staining is old and inactive, affected building materials may be repaired or replaced at client discretion.

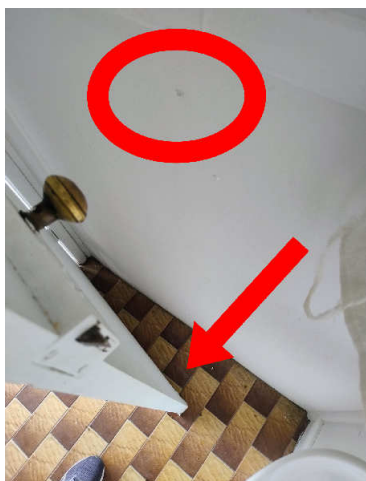
Defects 3.15

Finding: Door stop - Missing and damage to wall

Information: The door stop is missing and not stopping the door handle from damaging the wall at the time of inspection. Although some building elements may seem irrelevant or unnecessary, all building elements play a key role in the operation and function of the overall structure and its performance.

Re-installation or replacement of the door stop is advised as soon as possible to prevent any subsequent damage to the door or associated structures. A general handyman may be appointed to perform these works at client discretion.

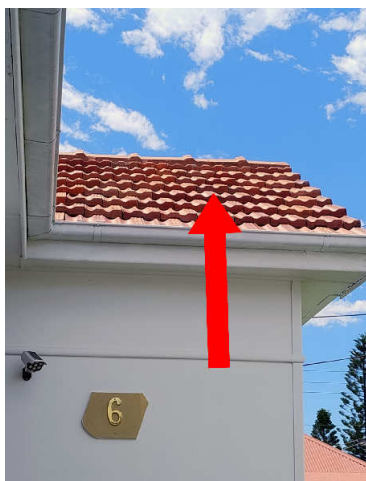
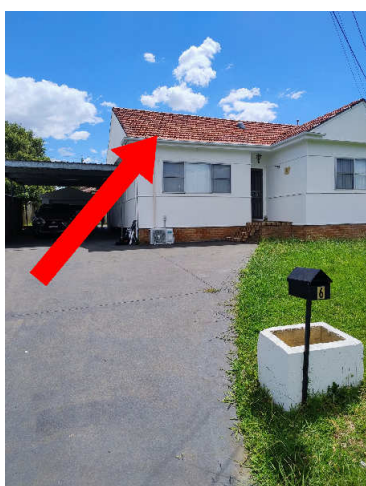
Defects 3.16

Information: Upon inspection of the exterior roofing, the majority of roof tiles were considered to be in a fair condition. While weathering of the tiles is consistent with the age of the property, maintenance works are required.

Isolated areas of mortar have come loose in the valleys and minor cracking is also present. Re-pointing and re-sealing the may be considered as an interim solution by the client to help preserve and extend the life span of the tiles.

Where left unmanaged, deteriorating roof tiles are likely to lead to a number of secondary defects, including minor water leaks and weather exposure to internal roofing structures.

Consultation with a roofing contractor is highly advised to gain advice on cost of remedial works that may be required in the short to medium term. Remedial works are likely to increase the longevity of the exterior roofing structure.

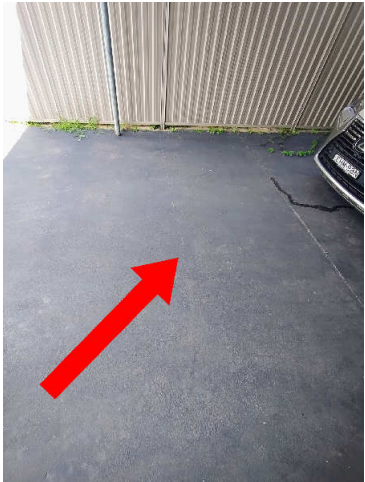
Defects 3.17

Finding: Crack in concrete slab - Category 1

Information: A crack on drive way was observed at the time of inspection. A crack coded as Category 1 was identified in the slab. A Category 1 crack is described as a fine but noticeable crack, with the slab at an otherwise reasonable level.

To be considered Category 1, the approximate width of the crack is less than 1.0mm, or a less than 10mm change in offset when a 3m straight edge is placed over the defect.

Category 1 cracks should be monitored for a period of 12 months. At the end of the monitoring period, identified cracks that are rated greater than Category 2 are considered defects, and require rectification.
