Building and Timber Pest Inspection Report

Inspection Date: Fri, 6 Feb 2026

Property Address: 17 Wahroonga Rd, Wyongah NSW 2259,
Australia

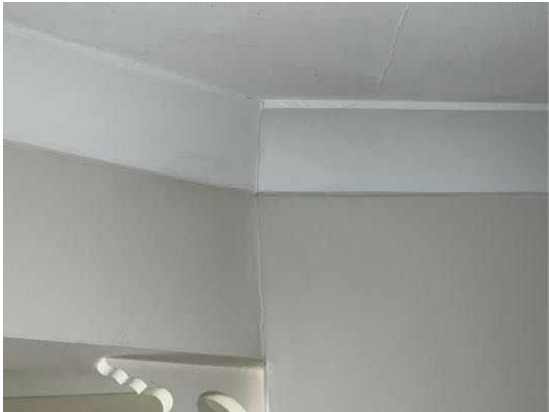
Building:	Main Building
Location:	All Internal Areas > All Areas
Finding:	Cracking - Damage Category 1 - Fine (up to 1mm)
Information:	It was evident at the time of the inspection that there were a number of cracks to the cornice predominantly to the internal mitres. Although fine cracks are quite noticeable, they are often only considered to be an appearance defect, and usually do not indicate any structural damage. Generally, the cause of a fine crack is indicative of a separation between building materials and finishes (e.g. paint, plaster, etc.) along joins.

Cracking of this nature can generally be repaired with minor sanding, filling and/or repainting. Such works should be performed by a qualified painter or a general handyman.

Monitoring of all cracking should be conducted frequently. Always contact a building inspector should cracks widen, lengthen, or become more numerous.

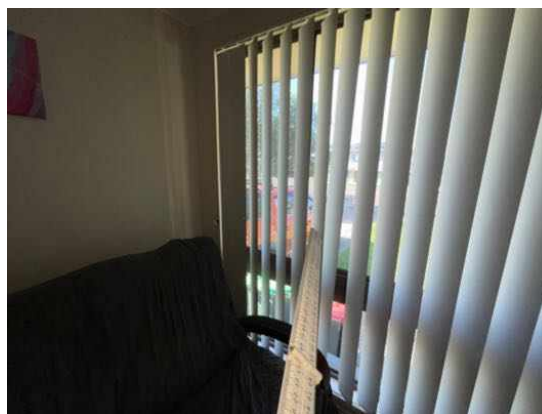
Building: Main Building
Location: Living Room > Front Right
Finding: Window - Stiff to slide
Information: The window in this area was jammed and difficult to operate at the time of the inspection. Windows provide ventilation to the adjoining area and should be at a fully operational level to ensure user comfort. Restricted function of the window may also pose as a potential safety hazard if required for emergency egress from the building.

Generally, factors such as general age of the building element and a lack of maintenance are the usual causes for this type of defect.

Replacement of window hardware or frame may be required, as well as minor repairs and cleaning. A registered builder or general handy person will be required to repair the window.

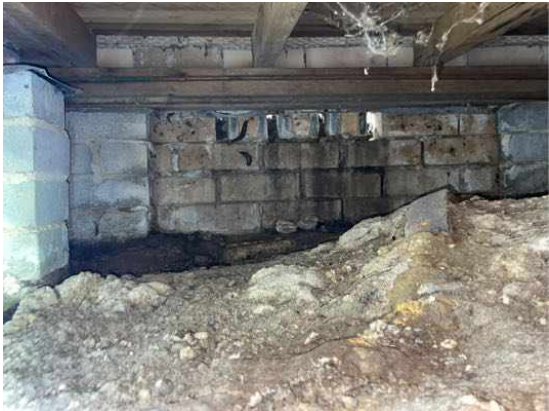
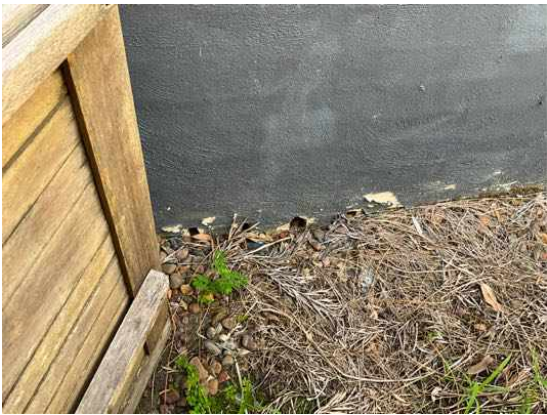
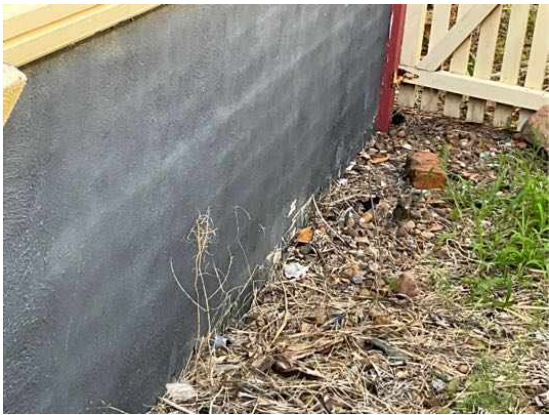
Building:	Main Building
Location:	Subfloor > All Areas
Finding:	Subfloor Site Drainage - Inadequate
Information:	The site drainage within the subfloor area was found to be inadequate at the time of inspection. The exterior ground level was higher than the ground level within the subfloor creating damp brickwork and a moist subfloor area surrounding the building thus creating potential for subsequent water damage to associated building elements. This is also apparent as there appears to be some subsidence to the soils within the subfloor space. Poor site drainage can also lead to subsidence of the stumps. In some areas the exterior ground level sits above the vents to which water can enter freely.

Where site drainage is inadequate, installation of an Agricultural (Aggie) Drain may be required. A qualified plumber should be appointed to further inspect the property and perform any remedial works as necessary. Water damage and secondary defects are likely to occur if left unmanaged.

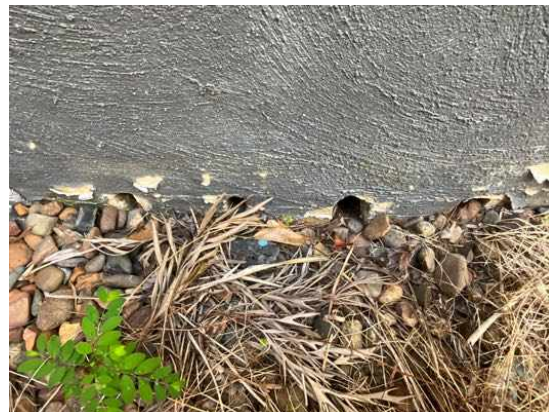
Finding 3.15

Building: Main Building
Location: Subfloor > All Areas
Finding: Subfloor ventilation - Inadequate
Information: Adequate subfloor ventilation aids in preventing excessive moisture wood rot and termite activity by ensuring a dry subfloor environment.

Subfloor ventilation can be improved in most cases by addressing the causes such as exposing subfloor vents installing additional new vents installing mechanical (forced airflow) ventilation and removing debris from the subfloor.

A registered builder should be appointed as soon as possible to perform these works as necessary.

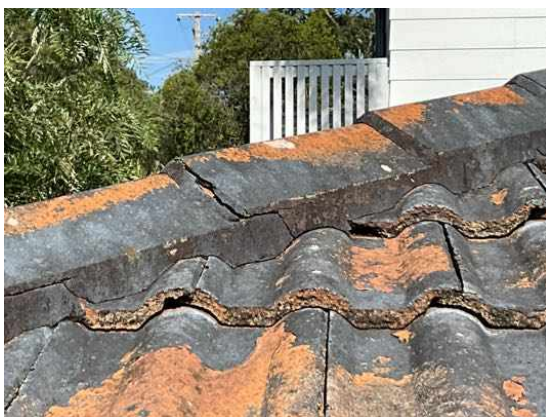
Where left unmanaged, deteriorating roof tiles are likely to lead to a number of secondary defects, including minor water leaks and weather exposure to internal roofing structures.

Consultation with a roofing contractor is highly advised to gain advice on cost of remedial works that may be required in the short to medium term. Remedial works are likely to increase the longevity of the exterior roofing structure.

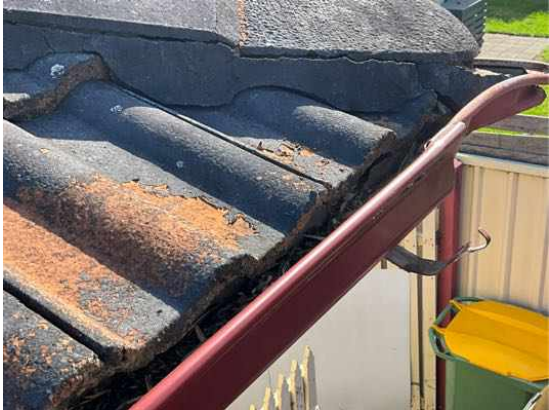
Blocked gutters are likely to lead to high levels of moisture in the affected areas. Such moisture will not only cause rust and decay of the associated building materials, but can also provide conditions that are conducive to termite and timber pest activity. Blockages in gutters should therefore be removed immediately to ensure dry conditions are maintained.

Consult a Licensed Plumber for further specific advice on remedial works that may be required. In the interim, it is highly advised that blocked gutters be removed by the homeowner or a general handyperson as a matter of urgency.

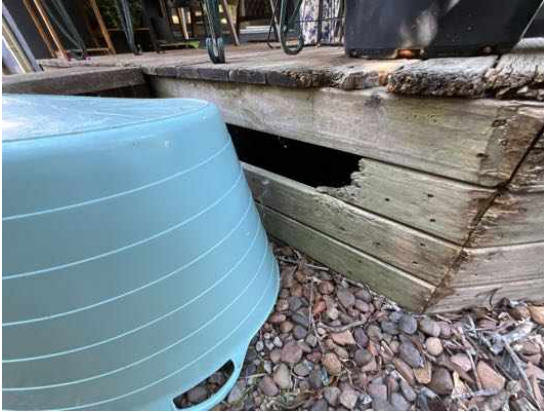
Finding: Deck - Damage

Deteriorated decking timbers may continue to degrade over time, particularly when exposed to moisture and weather. This can reduce the structural integrity of the deck, create potential safety hazards such as unstable or weakened boards, and may allow further water ingress into adjoining subfloor framing.

It is recommended that a licensed builder or qualified carpenter further assess the deck structure and carry out necessary repairs or replacement of damaged timbers. Sealing and protective coating should be applied following rectification to improve durability and reduce further deterioration.

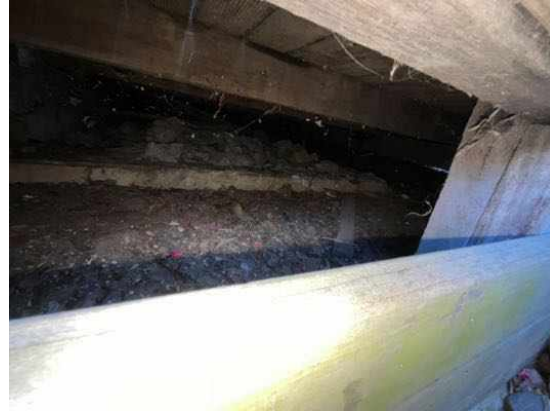
Generally this takes the form of finished ground levels external paving or concrete being retrospectively installed above the damp course level the adjacent internal floor level or weep and ventilation holes.

Where bridging has occurred full inspection is prevented and termites may enter a property in a concealed or undetectable manner.

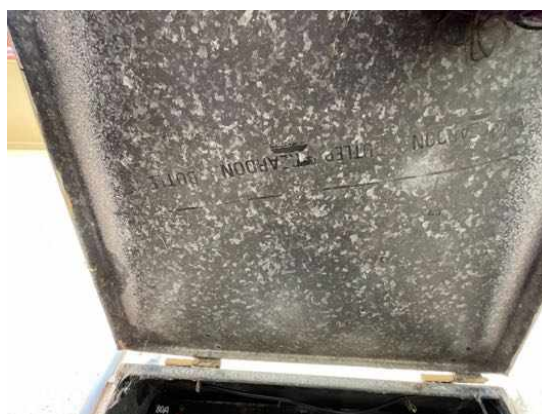
A durable notice should be placed in the switchboard unit to indicate current termite barriers. At the time of inspection, it appeared as though no termite management system has been installed, with no evidence to suggest preventative works taking place.

The client may consider gaining further advice from a pest controller as to the costs and procedures involved with this application. It is recommended that obtaining such advice be a short-term priority.

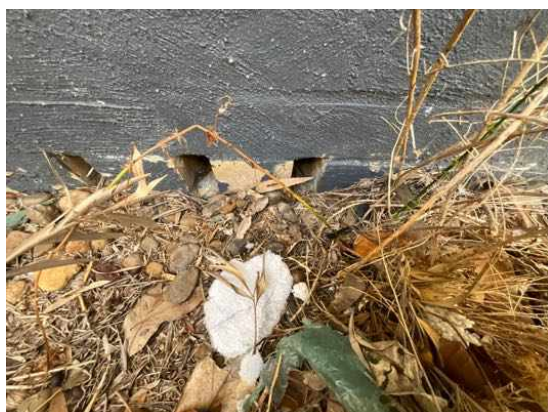
Finding 6.10

Building: Main Building
Location: Exterior walls - left side > Centre Left,Front Left,Rear Left
Finding: Bridging or breaching of termite barriers - ventilation holes
Information: Bridging is the spanning of a termite barrier or inspection zone so that subterranean termites are provided with passage over or around that barrier.

Where weep holes are covered by external ground levels such as paving or garden beds concealed entry is available for termites from these grounds into the brickwork or external wall materials.

It is highly recommended that ventilation holes are left exposed in all areas throughout the external property. Therefore if any termite activity leading into weep holes becomes easily detectable during frequent pest inspections.

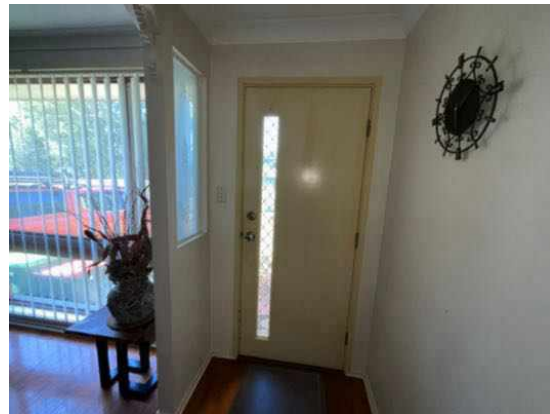
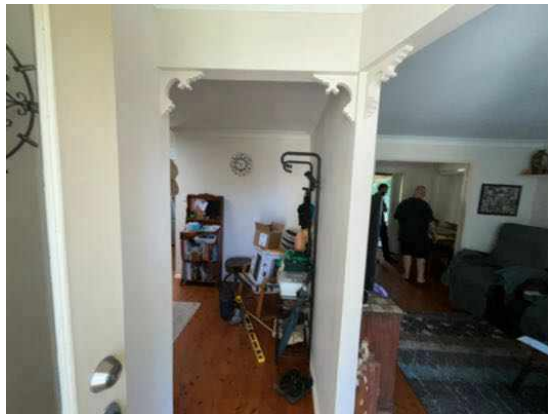
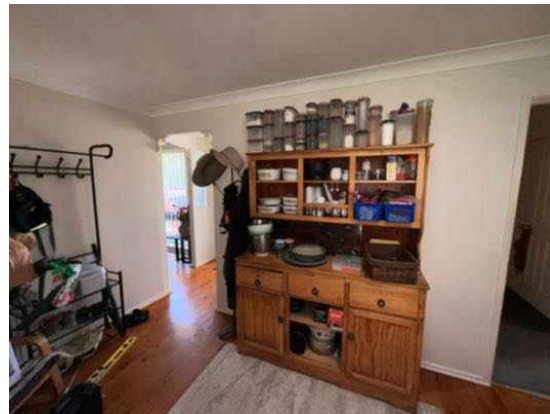
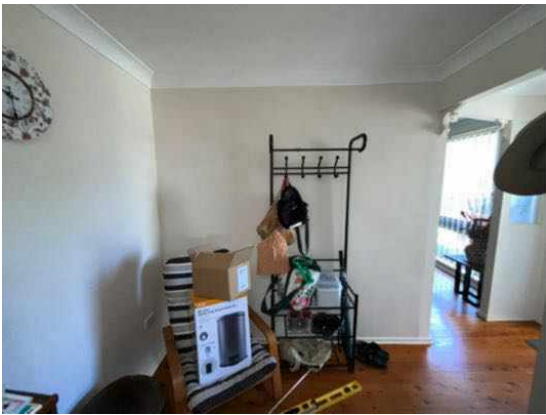
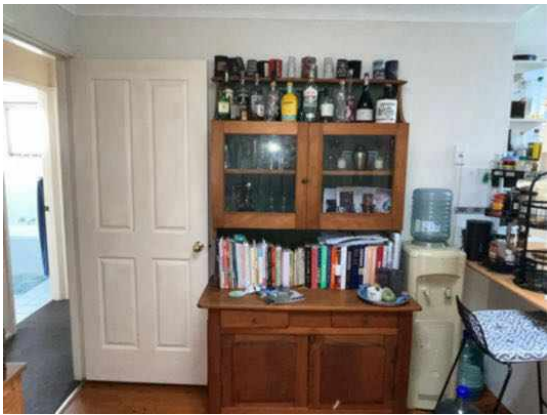
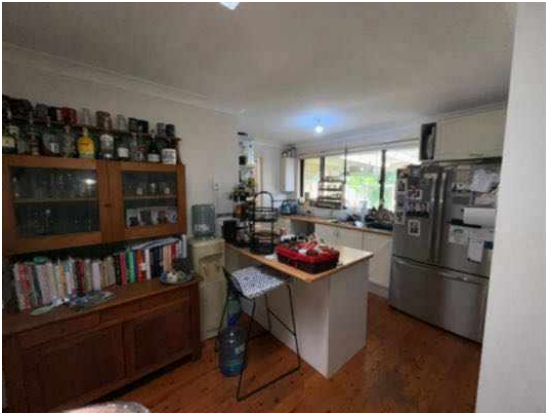
Building: Main Building
Location: All Internal Areas > All Areas
Finding: Additional Photos - Obstructions and Limitations - Internal Areas
Information: These photographs are an indication of the obstructions and limitations which impeded full inspection of the property at the time of inspection. These obstructions can hide an array of defects and should be removed to allow full inspection to be carried out. A re-inspection is recommended once the areas are made accessible.

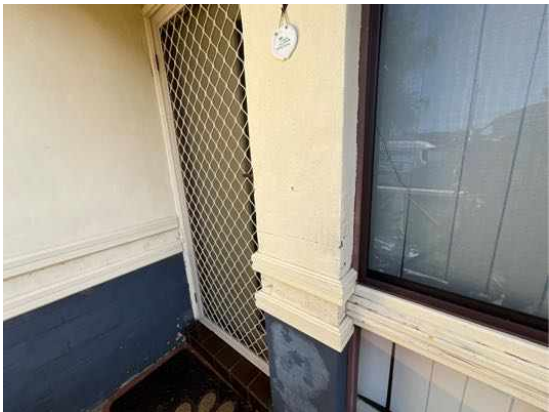
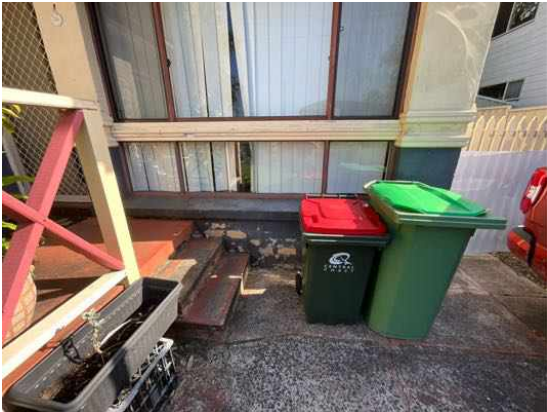
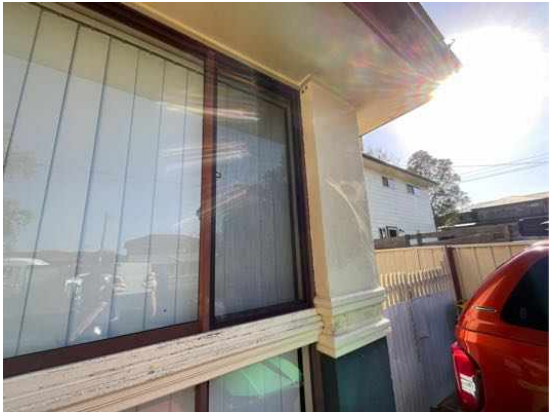
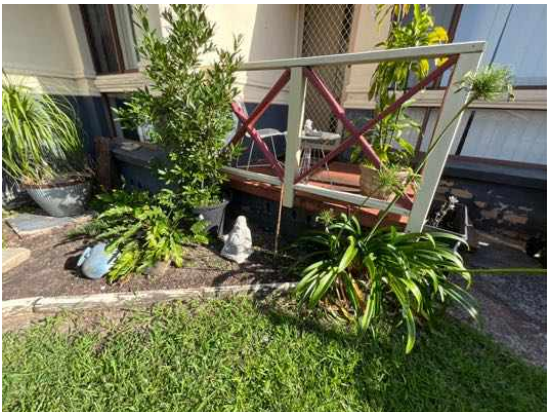
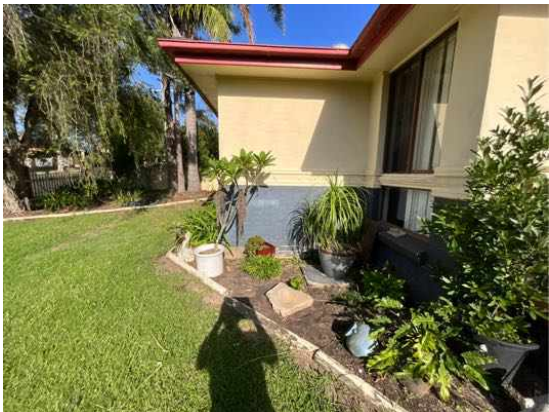
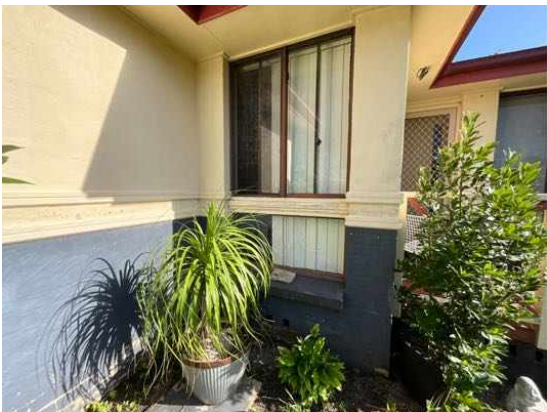
Building:	Main Building
Location:	All External Areas > All Areas
Finding:	Additional Photos - Obstructions and Limitations - External Areas
Information:	These photographs are an indication of the obstructions and limitations which impeded full inspection of the property at the time of inspection. These obstructions can hide an array of defects and should be removed to allow full inspection to be carried out. A re-inspection is recommended once the areas are made accessible.

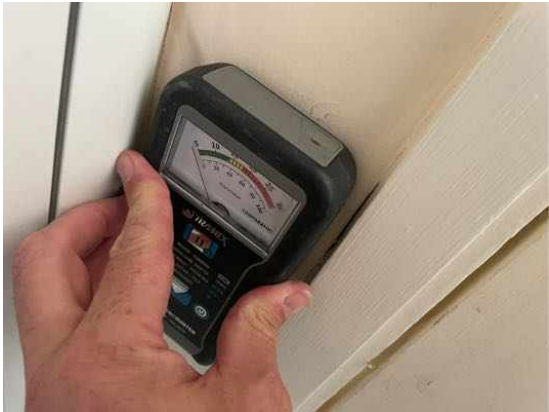
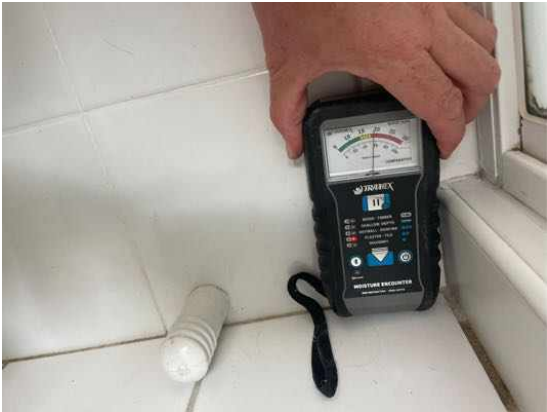
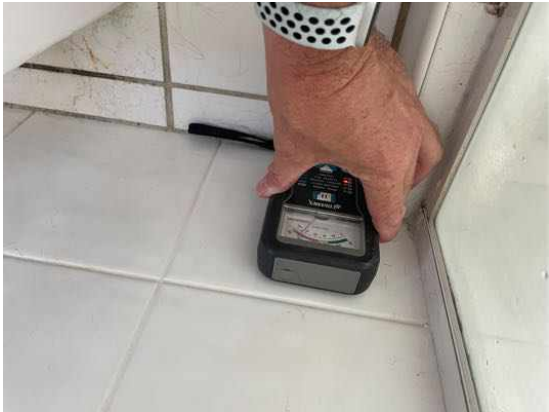
Building: Main Building
Location: All Areas > All Areas
Finding: Moisture Readings
Information: Moisture readings were taken to the wet areas and below and beside windows.
